**Re: GE Pittsfield/Housatonic River Site
Upper ½-Mile Reach Removal Action (GEC800)
2006 Annual Monitoring Report**

2006 Annual Monitoring Report

**Upper 1/2-Mile Reach of the
Housatonic River**

Prepared by:
ARCADIS of New York, Inc.
6723 Towpath Road
Syracuse
New York 13214-0066
Tel 315.446.9120
Fax 315.449.0017

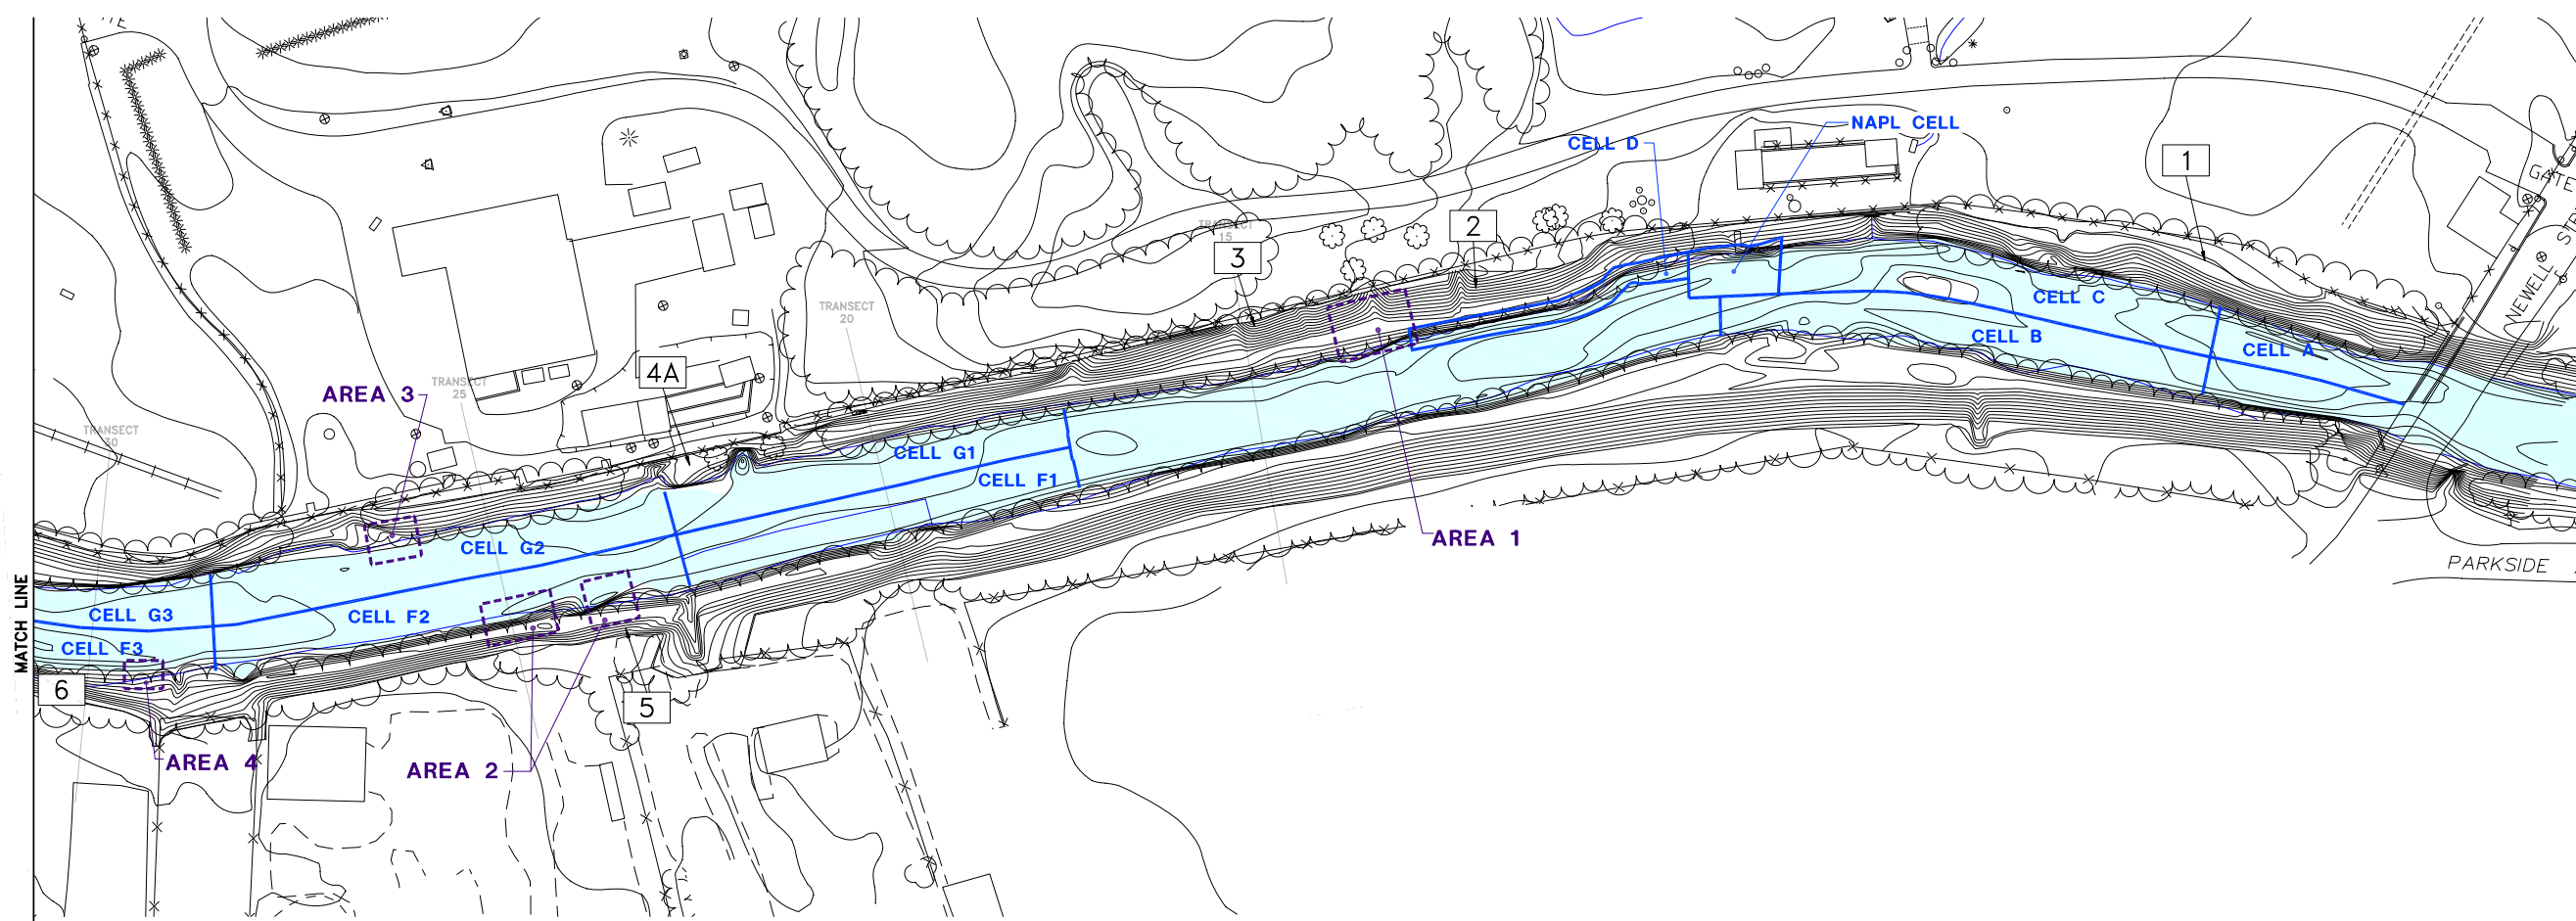
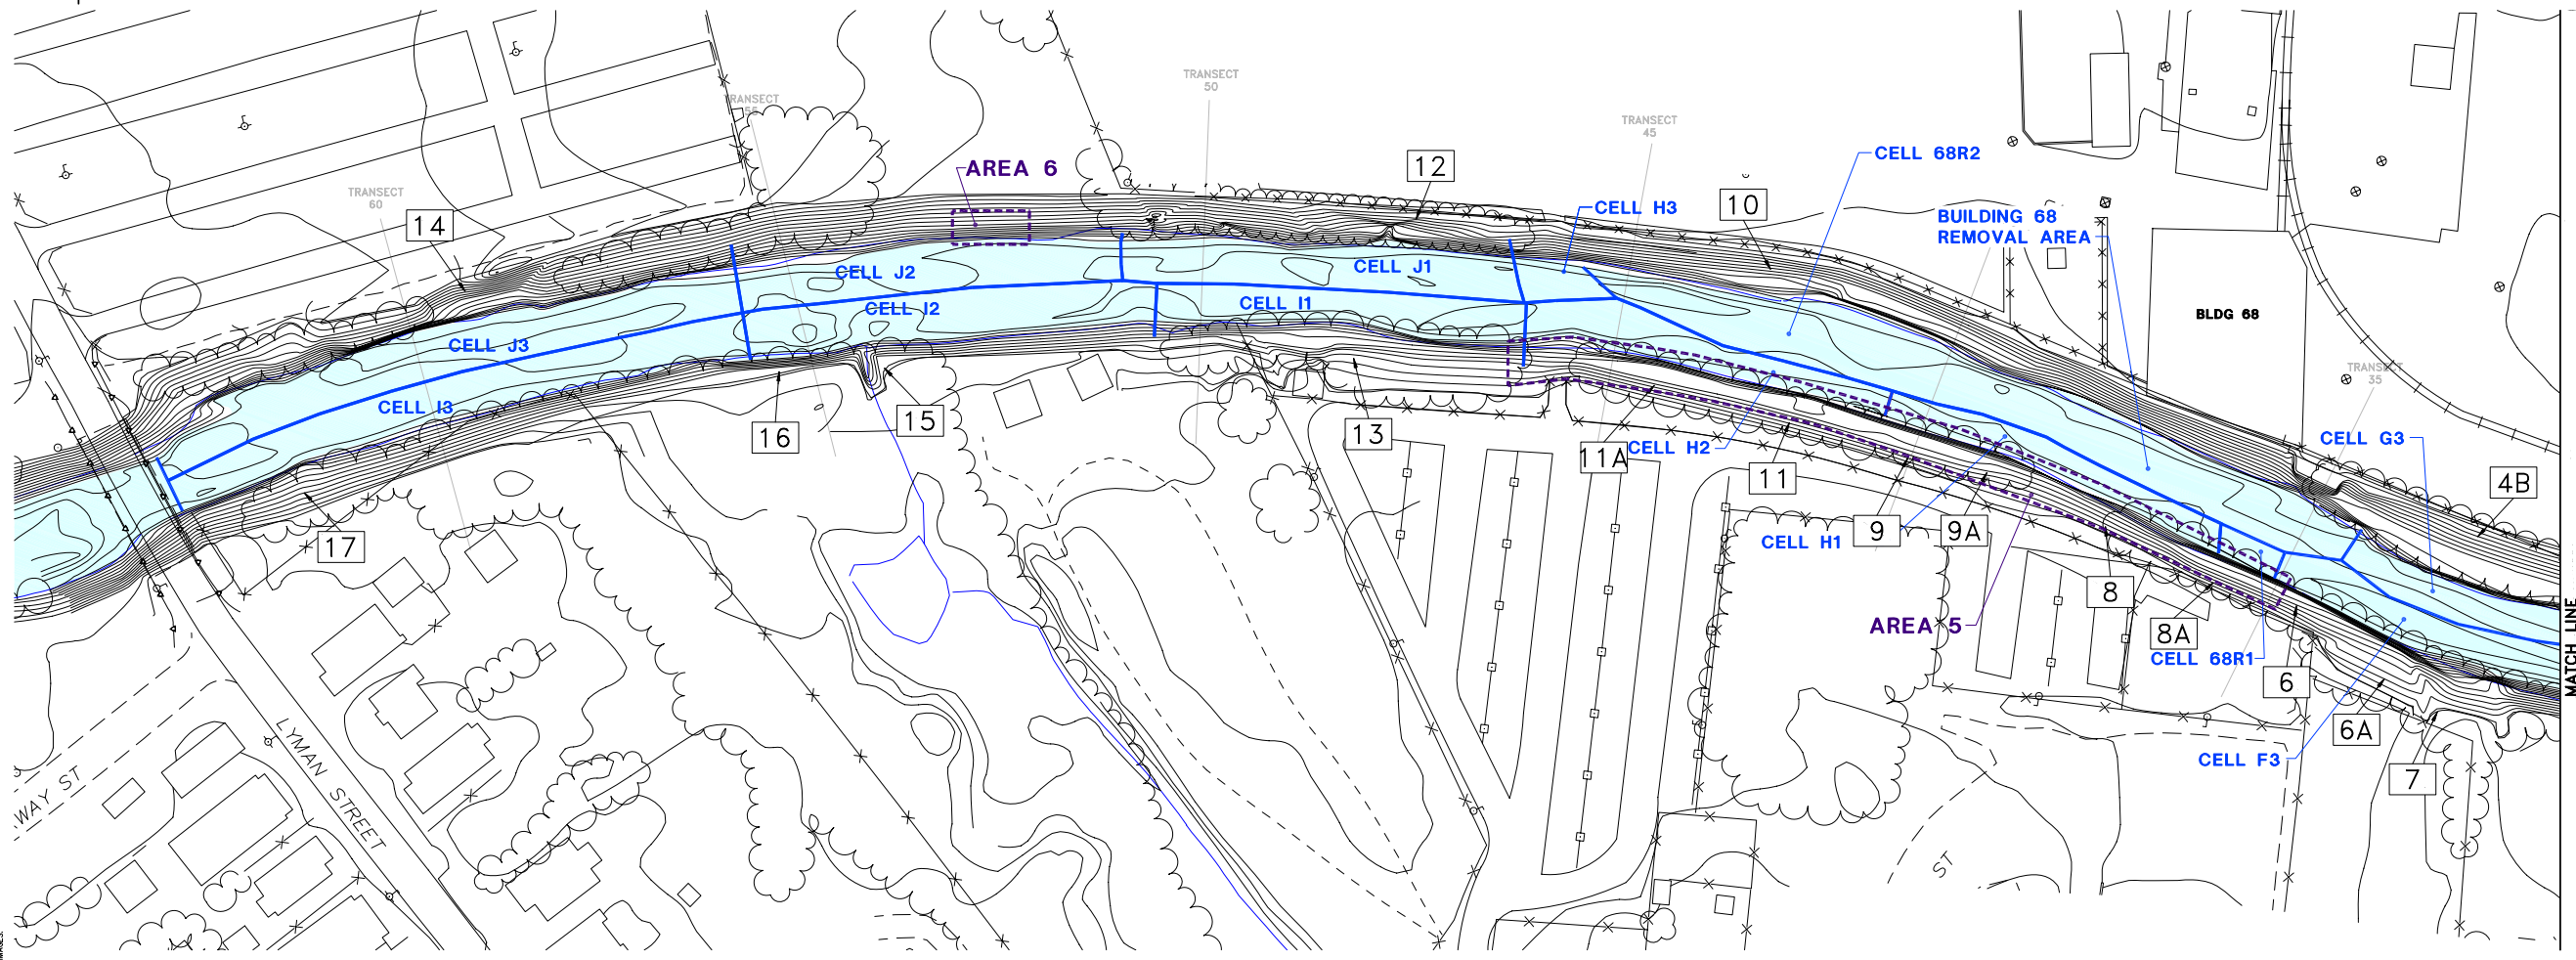
GENERAL ELECTRIC COMPANY
 PITTSFIELD, MASSACHUSETTS
 2006 ANNUAL MONITORING REPORT
 UPPER 1/2-MILE REACH OF THE HOUSATONIC RIVER
**2006 RESTORED BANK
 EROSION INSPECTION**

Restored bank erosion monitoring was conducted in June 2006. During the monitoring event, erosion was noted in six areas. GE has proposed response actions for these areas, and plans to complete these activities during the 2007 construction season.

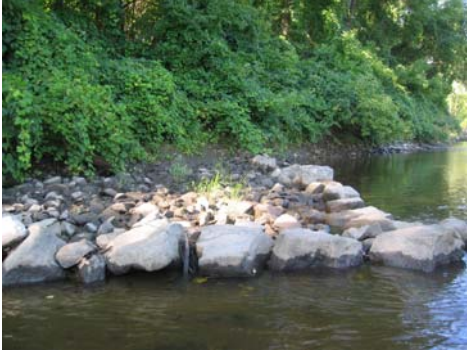
Cell	Aquatic Structures	Armor Stone Condition/General Biological Observations	
B	1. Single wing deflector

<ol style="list-style-type: none"> 1. Structures appear stable. 2. Structure induced variations in flow patterns observed in areas immediately downstream of the deflector. 3. Numerous benthic invertebrates were observed on stone pulled up from around the deflector.

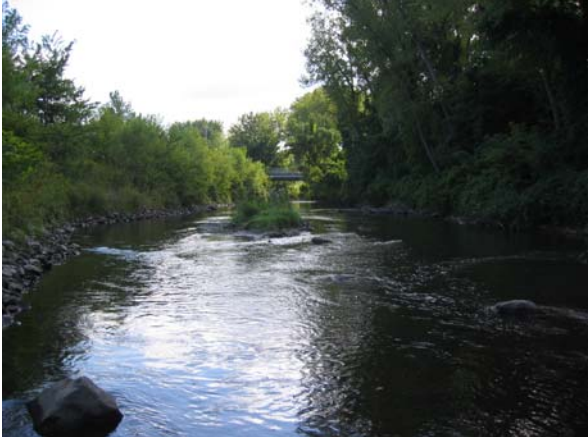
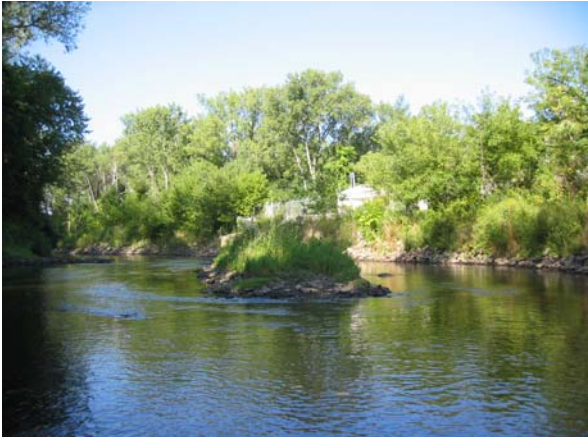
Cell	Aquatic Structures	Armor Stone Condition/General Biological Observations	
C	1. Boulders 2. Island

<div data-bbox="1178 777 1894 1112" style="border: 1px solid black; padding: 10px;"> <ol style="list-style-type: none"> 1. Structures appear stable. 2. Structure induced variations in flow patterns observed in areas immediately downstream of the island. 3. The island appears well vegetated with wetland herbaceous species and cottonwood seedlings. 4. Boulders near island appear to be creating scour holes in the immediate area; good cover. </div>

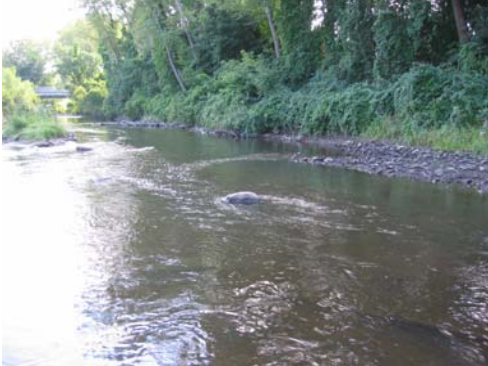
Cell	Aquatic Structures	Armor Stone Condition/General Biological Observations	
D	1. Boulders

<div data-bbox="1083 553 1896 802" style="border: 1px solid black; padding: 5px;"> <ol style="list-style-type: none"> 1. Structures were functional and appear to be providing variation in habitat. 2. Numerous benthic invertebrates observed on stone pulled up in the area. </div>
G1	1. Boulder Cluster

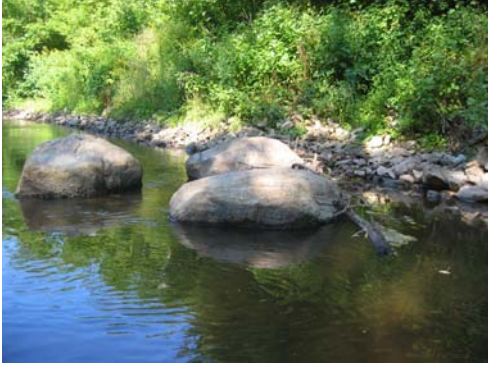
<div data-bbox="1083 971 1871 1208" style="border: 1px solid black; padding: 5px;"> <ol style="list-style-type: none"> 1. Structures were functional and appear to be providing variation in habitat. 2. Numerous benthic invertebrates observed on stone pulled up in the area. </div>

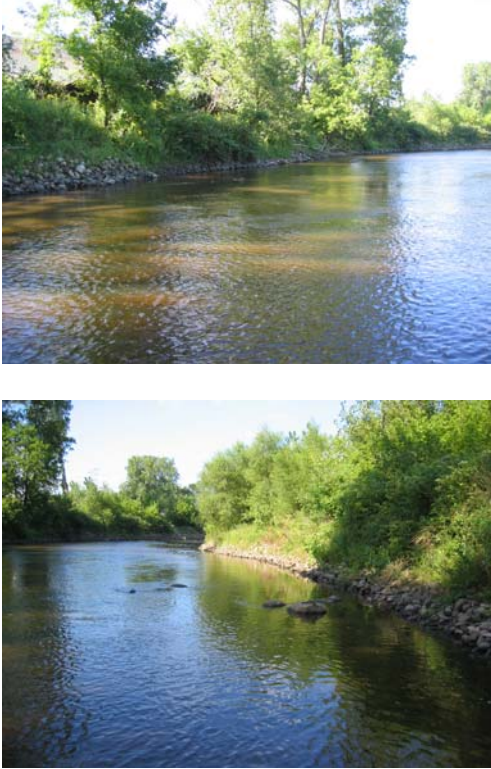
Cell	Aquatic Structures	Armor Stone Condition/General Biological Observations
G2/F2	1. W-weir

<p data-bbox="1081 743 1896 935">1. Much of the weir appears to be buried in soft silt/sand; above-grade portion of structure appears to offer good cover for aquatic organisms</p>

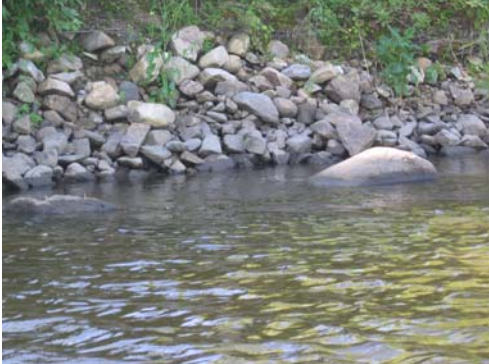
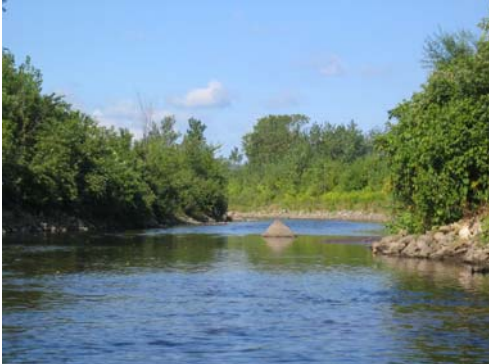
Cell	Aquatic Structures	Armor Stone Condition/General Biological Observations	
F3	<ol style="list-style-type: none"> 1. Three-boulder cluster 2. Two-boulder cluster 3. Three-boulder cluster

<div data-bbox="1104 732 1871 899" style="border: 1px solid black; padding: 10px;"> <ol style="list-style-type: none"> 1. All structures in this cell appear stable. 2. Structures appear to be providing diversity in habitat. </div>

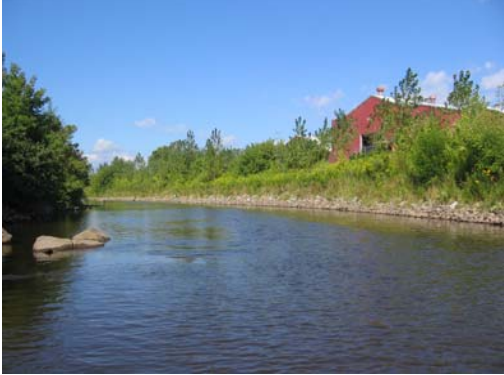
<div data-bbox="1108 789 1969 1003" style="border: 1px solid black; padding: 5px;"> <ol style="list-style-type: none"> 1. Structure is stable and appears to be providing diversity in habitat. 2. Structure induced variations in velocity and flow patterns appear to be producing variations in stream bottom topography; good habitat. </div>
H2	1. Single boulder	<ol style="list-style-type: none"> 1. Structure is stable and appears to be providing diversity in habitat. 2. Structure induced variations in velocity and flow patterns appear to be producing variations in stream bottom topography; good habitat.

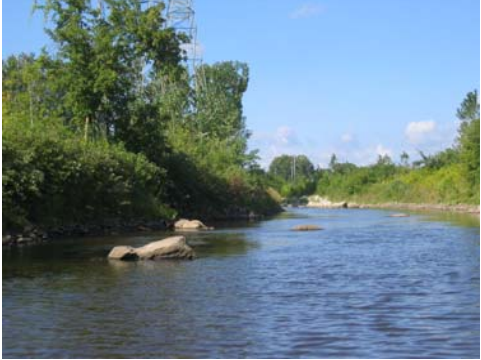
Cell	Aquatic Structures	Armor Stone Condition/General Biological Observations	
J1	1. Two-boulder cluster 2. Three-boulder cluster 3. Single-boulder

<ol style="list-style-type: none"> 1. Structure is stable and appears to be providing diversity in habitat. 2. Structure induced variations in velocity and flow patterns appear to be producing variations in stream bottom topography; good habitat. 3. Boulders observed as being used as perches for feeding birds
J2	1. “J”- boulder formation

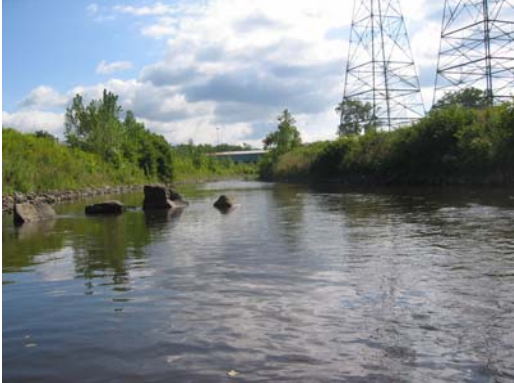
<ol style="list-style-type: none"> 1. 1. Structure is stable and appears to be providing diversity in habitat. 2. 2. Structure induced variations in velocity and flow patterns appear to be producing variations in stream bottom topography; good habitat.

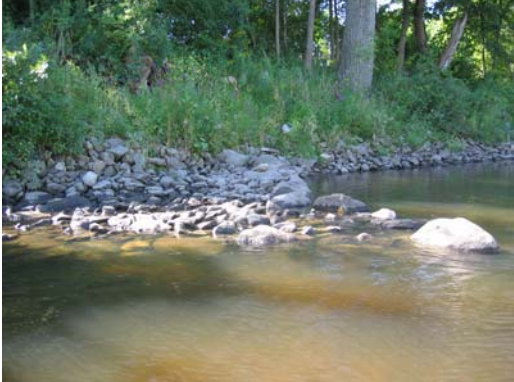
Cell	Aquatic Structures	Armor Stone Condition/General Biological Observations	
I3	1. Single-wing deflector

<p>1. Structure is stable and appears to be providing diversity in habitat.</p> <p>2. Structure induced variations in velocity and flow patterns appear to be producing variations in stream bottom topography; good habitat.</p>
I3/J3	1. Vortex rock weir

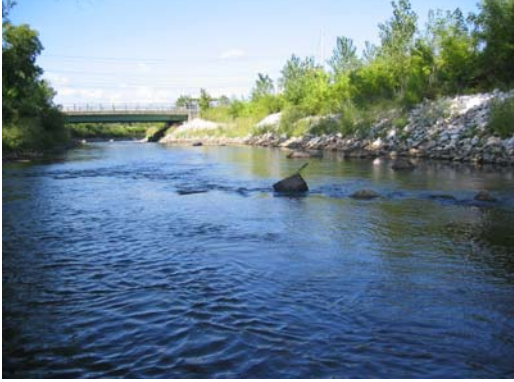
<p>1. Structure is stable and appears to be providing diversity in habitat.</p> <p>2. Structure induced variations in velocity and flow patterns appear to be producing variations in stream bottom topography; good habitat.</p>

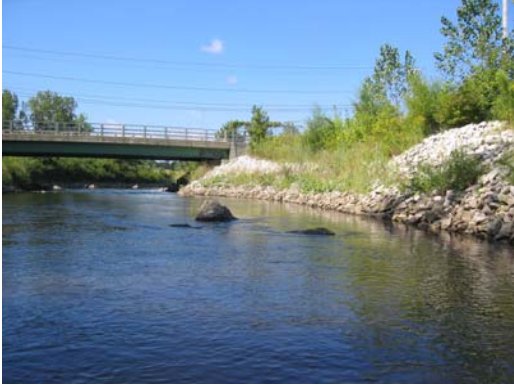
Cell	Aquatic Structures	Armor Stone Condition/General Biological Observations	
J3	<ol style="list-style-type: none"> 1. Boulder cluster 2. Three-boulder cluster 3. Three-boulder cluster

<ol style="list-style-type: none"> 1. Structure is stable and appears to be providing diversity in habitat. 2. Structure induced variations in velocity and flow patterns appear to be producing variations in stream bottom topography; good habitat.

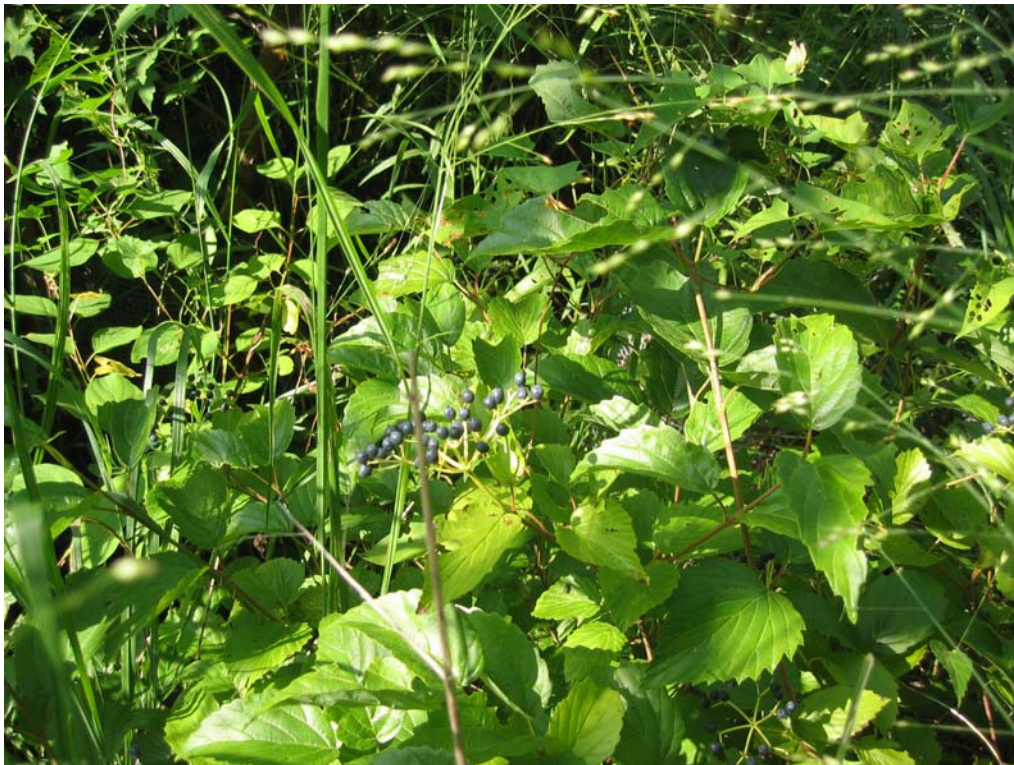
Photograph 2: Planting Area 4B; Note fruit of northern arrowwood

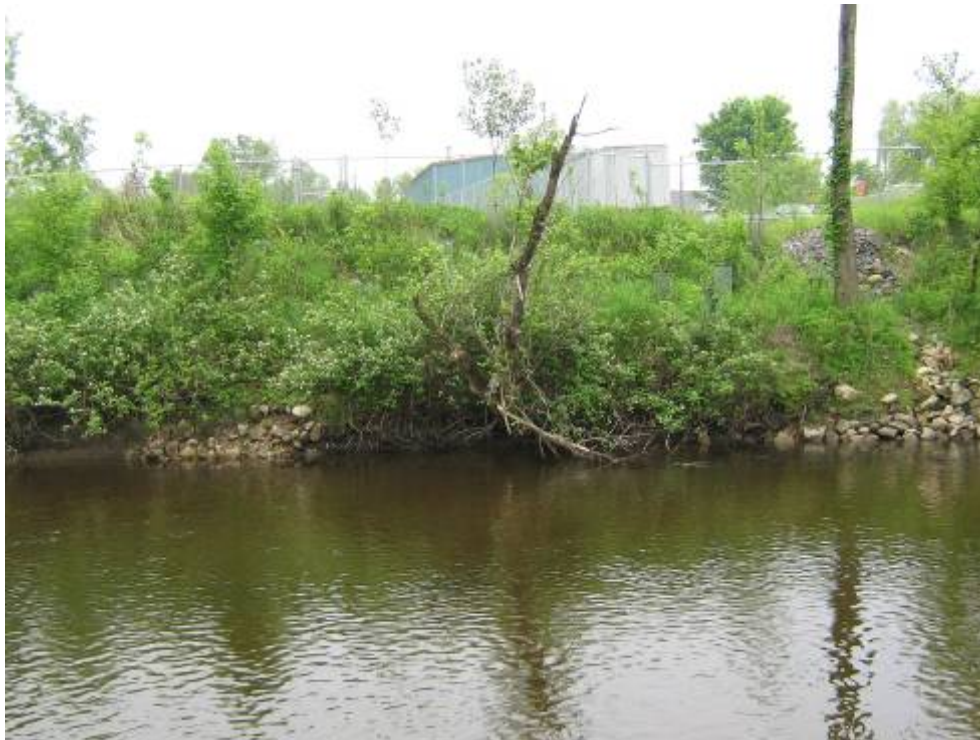
Area 2 includes two areas (see Figure 3-1). The first area consists of approximately 40 feet of undercut bank, located on the southern bank directly across the river from Building 64W in a non-remediated bank area directly upstream of a riprap swale. The second area is a slight undercut of the lower banks that extends for approximately 100 feet downstream of the same drainage swale. In these areas, a total of less than 10 cy of bank soil appears to have eroded from the bank. The source of the eroded material appears to be native material from the low- and mid-bank area. The cause of erosion appears to be high velocity water flow, likely associated with the extreme flood event discussed above. No evidence of eroded soil was observed in the adjacent portion of the river and, therefore, no removal activities are planned at this location. The proposed response action in this area will consist of placement of armor stone to replace eroded materials and protect against further such erosion.

Photo 2 – Area 2: Approximately 40 feet of undercut bank upstream of swale.

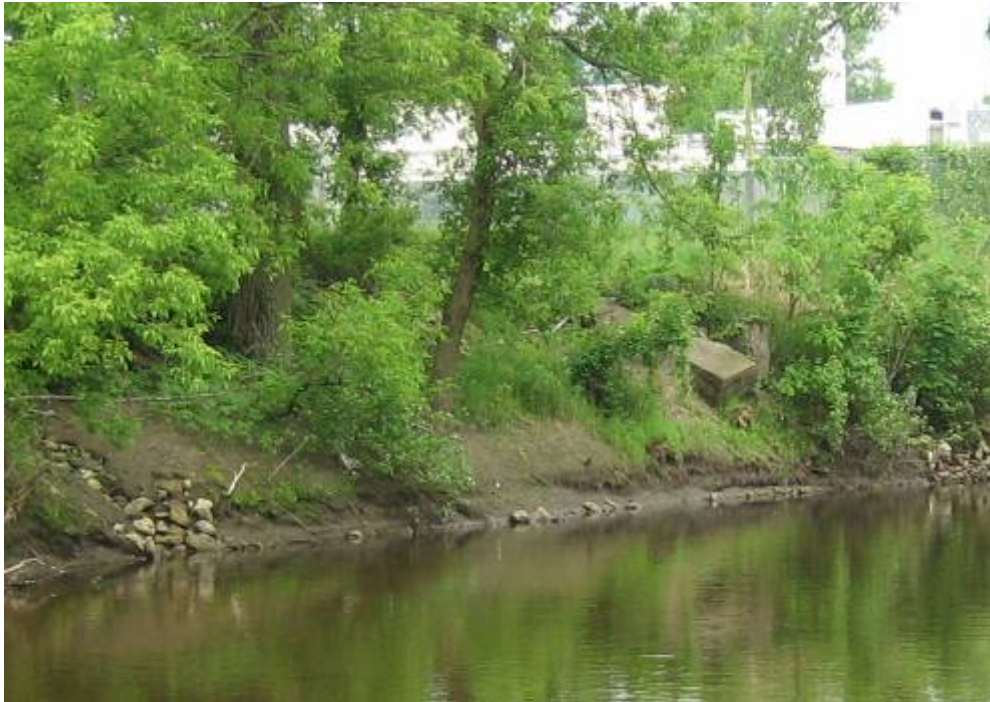
Area 4 consists of a slightly undercut bank in a non-remediated area (see Figure 3-1). In this area, less than 1 cy of bank soil appears to have eroded from the bank. The source of the eroded material appears to be native material from the low-bank area. The cause of erosion appears to be high velocity water flow, likely associated with the extreme flood event discussed above. No evidence of eroded soil was observed in the adjacent portion of the river and, therefore, no removal activities are planned at this location. Armor stone will be placed in this area to replace eroded materials and protect against further such erosion.

Photo 5 – Area 4: Slight undercut between rip-rap.

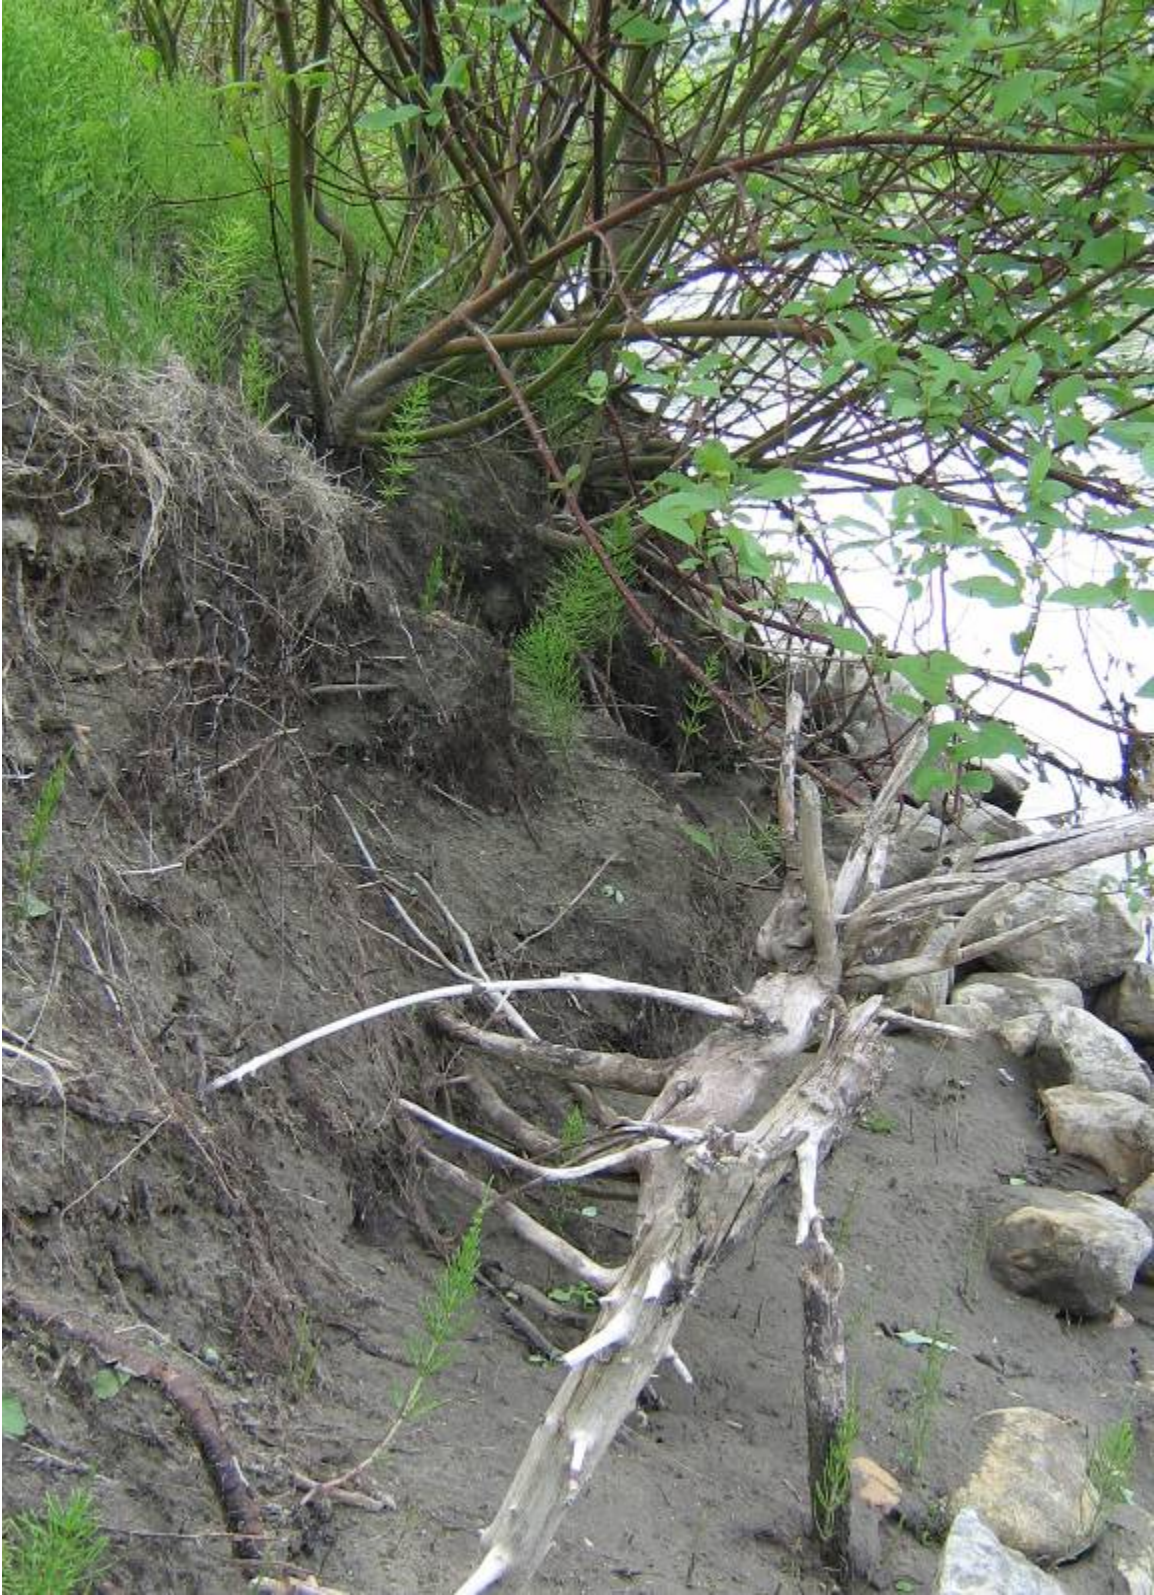
Photo 7 – Area 5: Example of near vertical face proposed for removal.

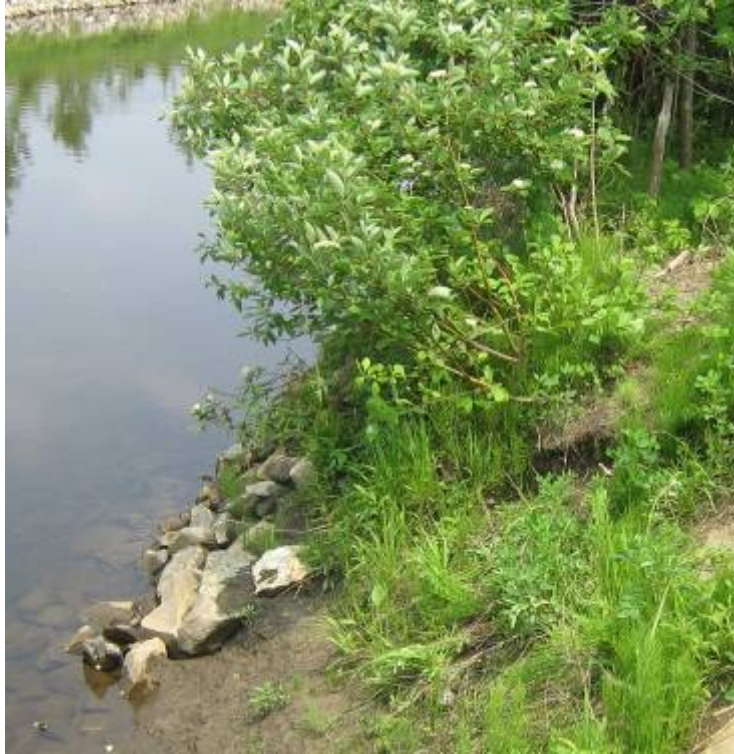
Photo 8 – Area 5: Slight undercut proposed to be armored.
