**Re: GE Pittsfield/Housatonic River Site
Upper ½-Mile Reach Removal Action (GECD800)
2006 Bank Erosion Inspection**

This trip report has been prepared to describe the findings of the 2006 bank erosion inspection – i.e., the areas identified with evidence of measurable erosion or armoring material movement – and the response actions proposed to address those areas. Figure 1 illustrates the location of the areas at which measurable erosion or material movement was observed. In addition, in accordance with requirements of the Work Plan, GE has identified, to the extent practicable, the likely cause of the erosion and has evaluated the source, dispersal, and quantity of eroded soil (if any) in the river. This evaluation, and GE's proposed measures to restore the identified areas to previous conditions and to protect against further erosion, are described below for each area, and are summarized in Table 1.

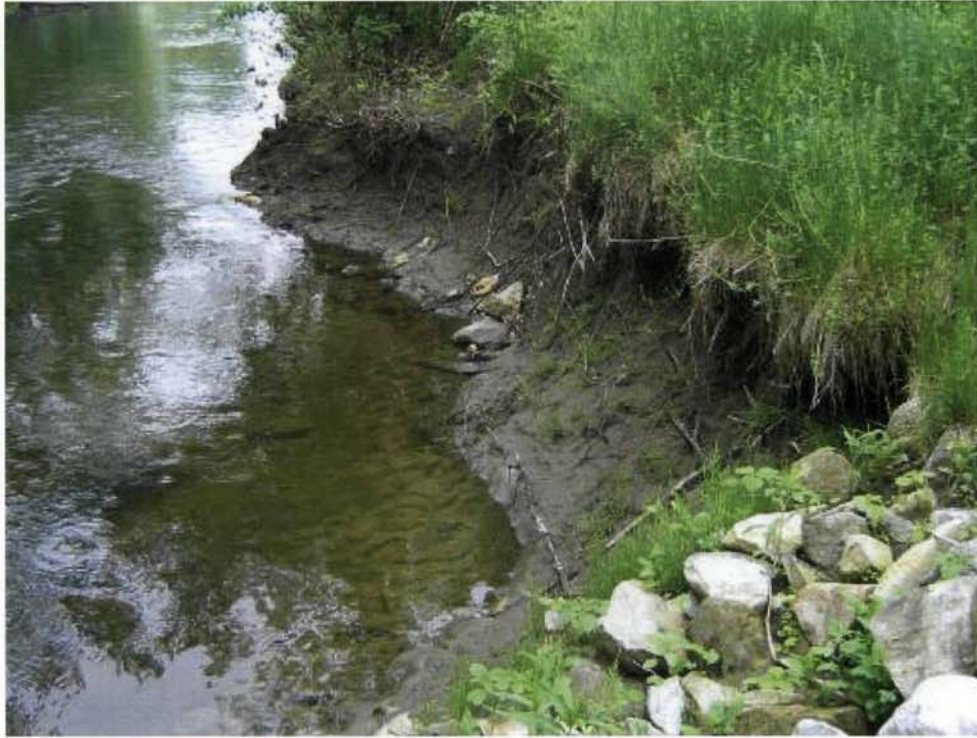
Area 1 – This area consists of approximately 25 feet of undercut bank, located on the northern bank of the river approximately 200 feet downstream of Building 64X in an area where no remedial activities were performed either in the river or on the riverbank (see Figure 1 and Photo 1). This area of observed erosion is located downstream of rip-rap placed adjacent to sheetpiles installed during past remedial activities, where the bank transitions from riprap to bank soil. In this area, less than 10 cubic yards (cy) of bank soil appear to have eroded from the bank. The source of the eroded material appears to be native material from the low- and mid-bank area directly down-slope from established grassy vegetation. The cause of erosion appears to be a combination of the transition from riprap to unprotected bank soils and the high velocity flows associated with the extreme flood event discussed above. No eroded soil was observed in the adjacent portion of the river and, therefore, no removal activities are planned at this location.

Photo 1 – Area 1: Approximately 25 feet of undercut bank at the end of a section of rip-rap.

As discussed during the inspection, the proposed response action in this area will consist of placement of armor stone to replace eroded materials and protect against further such erosion. To the extent practicable, armor stone placed in this area will be keyed into the bank such that areas receiving armor stone will be restored to previous grades, resulting in no net change in the location-specific flood storage or conveyance capacity. GE plans to complete such activities during the 2007 construction season.

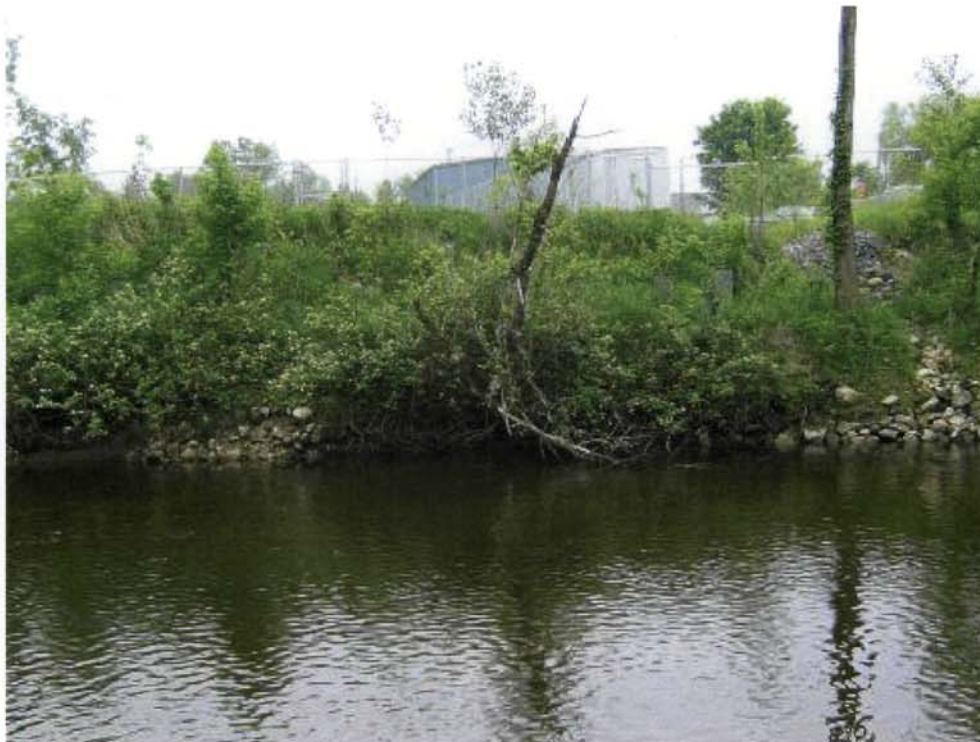
Area 2 – Area 2 includes two areas (see Figure 1). The first area consists of approximately 40 feet of undercut bank, located on the southern bank directly across the river from Building 64W in a non-remediated bank area (see Photo 2). In this area, less than 5 cy of bank soil appears to have eroded from the bank. The source of the eroded material appears to be native material from the low- and mid-bank area directly upstream of a riprap swale. The cause of erosion appears to be high velocity water flow, likely associated with the extreme flood event discussed above. No evidence of eroded soil was observed in the adjacent portion of the river and, therefore, no removal activities are planned at this location. As discussed during the inspection, the proposed response action in this area will consist of placement of armor stone to replace eroded materials and protect against further such erosion. To the extent practicable, armor stone placed in this area will be keyed into the bank such that areas receiving armor stone will be restored to previous grades, resulting in no net change in the location-specific flood storage or conveyance capacity.

Photo 2 – Area 2: Approximately 40 feet of undercut bank upstream of swale.

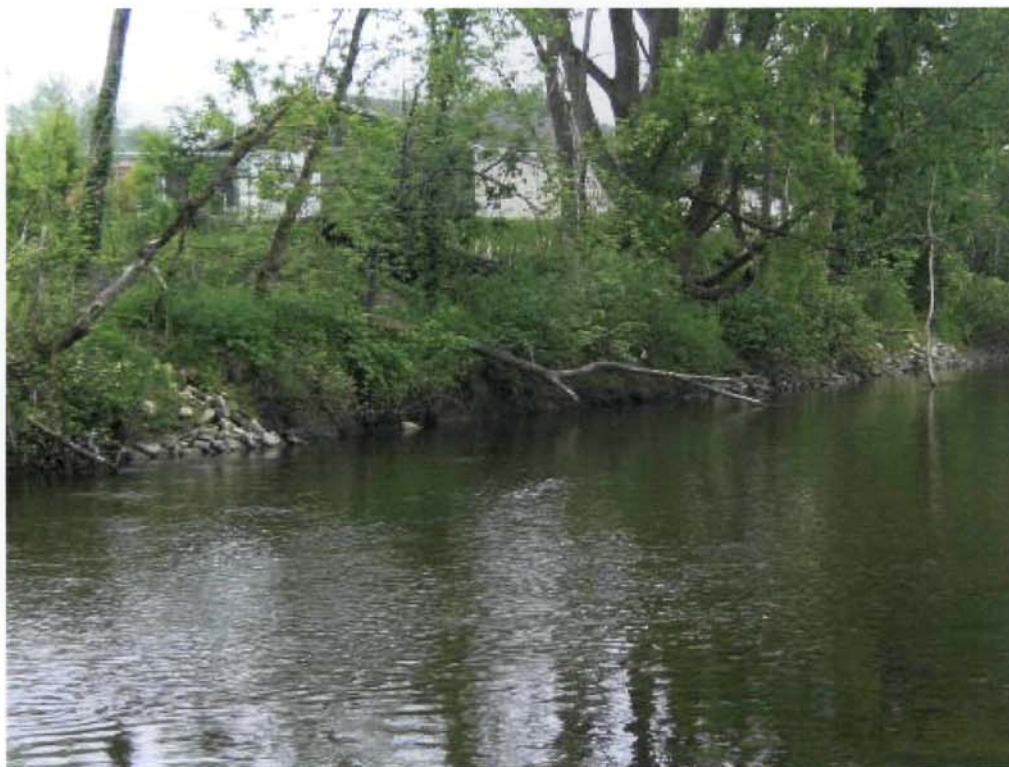
Additionally, there is a slight undercut that extends for approximately 100 feet downstream of the same drainage swale discussed above and that appears to have involved the erosion of less than 5 cy (see Photo 3). To the extent practicable, GE will place armor stone (similar to above) within this undercut to limit any future erosion from this area.

Photo 3 – Area 2: Approximately 100 feet of slight undercut downstream of swale.

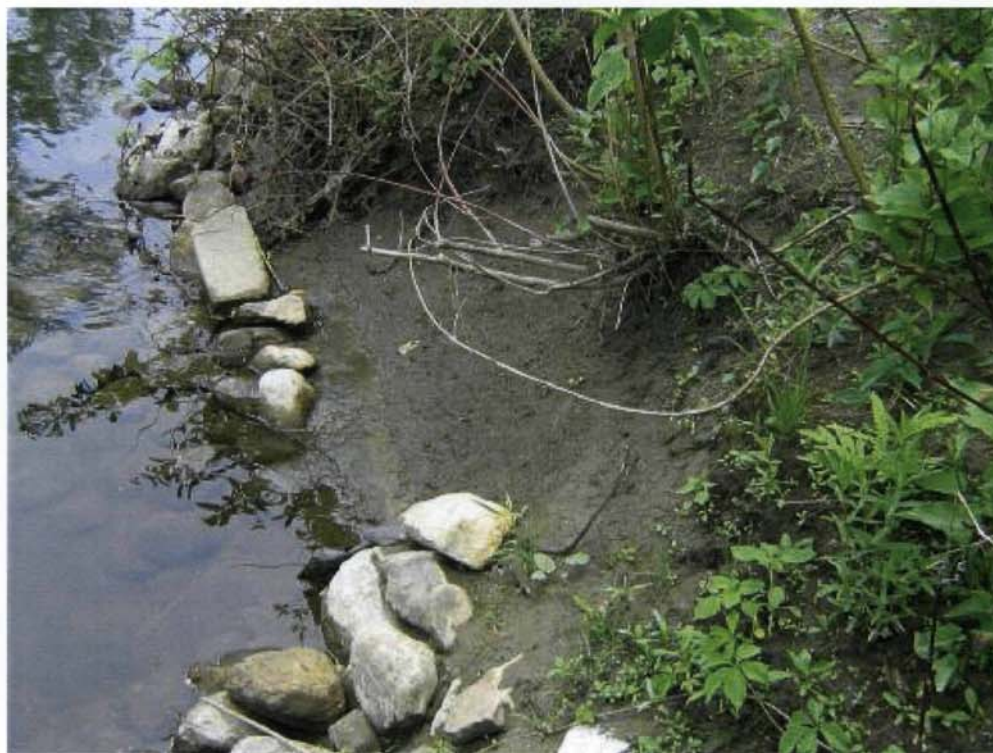
Area 3 – This area is located on the northern bank, in a non-remediated area, approximately 200 feet downstream of Building 64W (see Figure 1). In this area, less than 1 cy of bank soil appears to have eroded from within a 5-foot long slight undercut just above a riprap area in the channel (see Photo 4). The source of the eroded material appears to be native material from the mid-bank area. The cause of erosion appears to be high velocity water flow, likely associated with the extreme flood event discussed above. No evidence of eroded soil was observed in the adjacent portion of the river and, therefore, no removal activities are planned at this location. As discussed during the inspection, armor stone will be placed in this area to replace eroded materials and protect against further such erosion. As in Areas 1 and 2, to the extent practicable, armor stone placed in this area will be keyed into the bank such that areas receiving armor stone will be restored to previous grades, resulting in no net change in the location-specific flood storage or conveyance capacity. GE plans to complete such activities during the 2007 construction season.

Photo 4 – Area 3: Slight undercut above rip-rap.

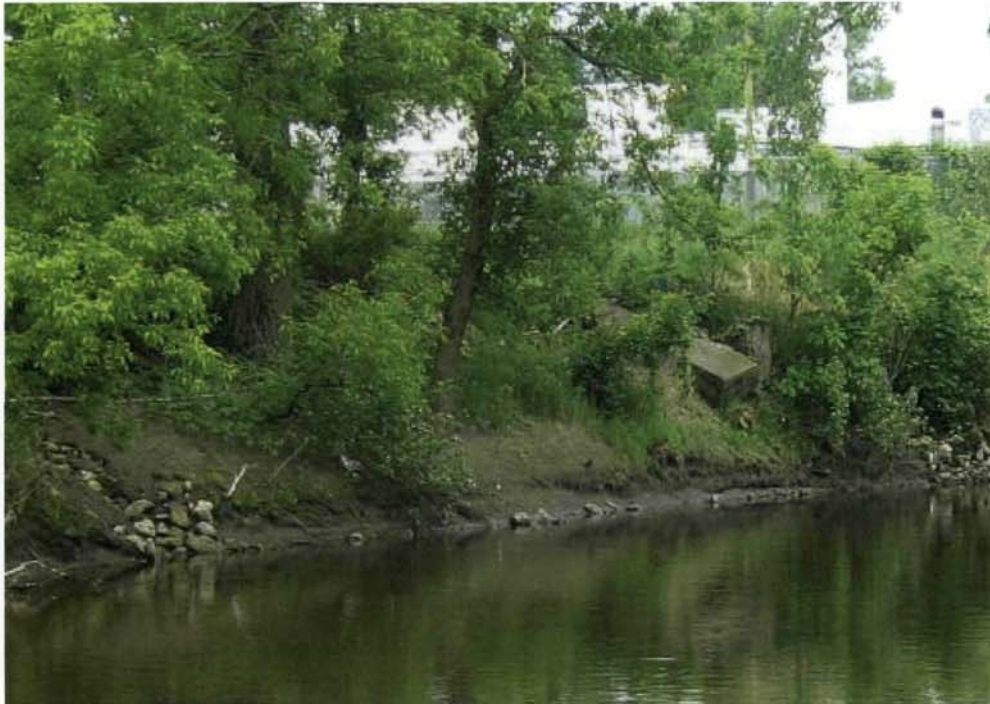
Area 4 – This area consists of a slightly undercut bank, extending over approximately 30 feet of the southern riverbank just upstream of riprap-protected banks, in a non-remediated area approximately 200 feet upstream of the eastern edge of the Newell Street Area II Parking Lot (see Figure 1 and Photo 5). In this area, less than 1 cy of bank soil appears to have eroded from the bank. The source of the eroded material appears to be native material from the low-bank area. The cause of erosion appears to be high velocity water flow, likely associated with the extreme flood event discussed above. No evidence of eroded soil was observed in the adjacent portion of the river and, therefore, no removal activities are planned at this location. As discussed during the inspection, armor stone will be placed in this area to replace eroded materials and protect against further such erosion. Again, to the extent practicable, armor stone placed in this area will be keyed into the bank such that areas receiving armor stone will be restored to previous grades, resulting in no net change in the location-specific flood storage or conveyance capacity. GE plans to complete such activities during the 2007 construction season.

Photo 5 – Area 4: Slight undercut between rip-rap.

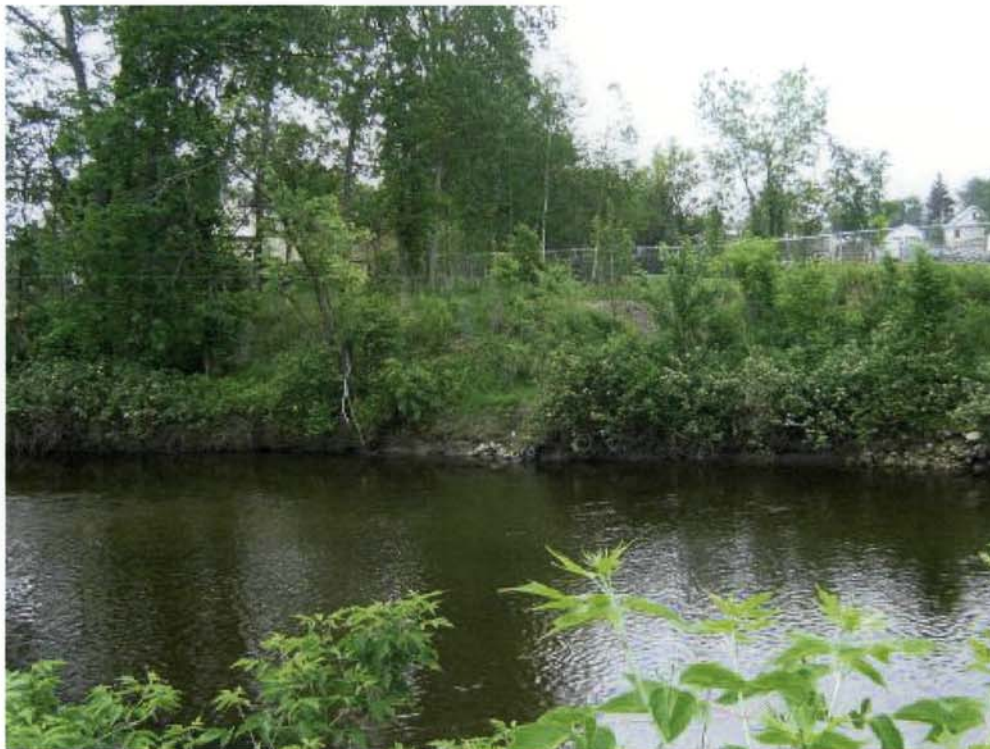
Area 5 – Area 5 is located on the southern bank adjacent to the Newell Street Area II Parking Lot, and extends from a point approximately 15 feet downstream of the former pedestrian bridge to approximately 500 feet upstream of the bridge (see Figure 1). Within Area 5 there are several intermittent areas of undercut bank, from which bank soils have been eroded (see Photo 6), and steep, near-vertical slopes are present that potentially could further erode or fail (Photo 7). The observed erosion is likely a result of the high velocity flow associated with the extreme flood event discussed above, but may also be related, to some extent, to settling of the riprap in this area. The sources of eroded materials in this area appear to be native materials or clean backfill, as portions of Area 5 proposed for removal intersect areas that have been previously remediated. No evidence of eroded soil was observed in the adjacent portion of the river and, therefore, no removal activities are planned at this location. During the inspection, it was discussed that this area would likely require excavation of the remaining steep slopes to tie into post-construction Newell Street Area II grades, as well as armor stone placement to restore this area to grade and reduce the potential for further erosion.

Photo 6 – Area 5: Several small areas undercut above rip-rap.

Following the site visit, GE made a preliminary assessment of the removal of certain bank materials in this area to reduce the grade of the remaining slopes. It was assumed that excavation of bank materials would be performed to reduce the slope in those areas where undercutting has left near-vertical banks. Figure 2 shows the locations of six representative cross sections drawn through Area 5, as well as the extent of Area 5 where GE proposes to remove bank materials. In addition, Figure 2 shows those areas that have previously been remediated, and the concentrations of polychlorinated biphenyls (PCBs) in remaining bank soils. Figure 3 shows the six cross

Following removal, those portions of the approximate 300-foot length of bank subject to removal will be lined with a non-woven geotextile and covered with armor stone to replace eroded materials, restore this area to previous grades (i.e., pre-erosion), stabilize these banks, and protect against further such erosion. At this time, it is not anticipated that additional excavation will be required to accommodate armor stone placement. Armor stone placement will include an approximate 1-ft thick layer of $D_{100}=12$ -inch graded riprap, as discussed above, that will be tied into existing armoring at the toe of the slope and extend approximately 10 to 15 feet up the bank. Such armor stone placement in this area is anticipated to require approximately 200 cy of armor stone, resulting in a net gain in flood storage capacity as the anticipated volume of armor stone is less than the anticipated removal volumes discussed above.

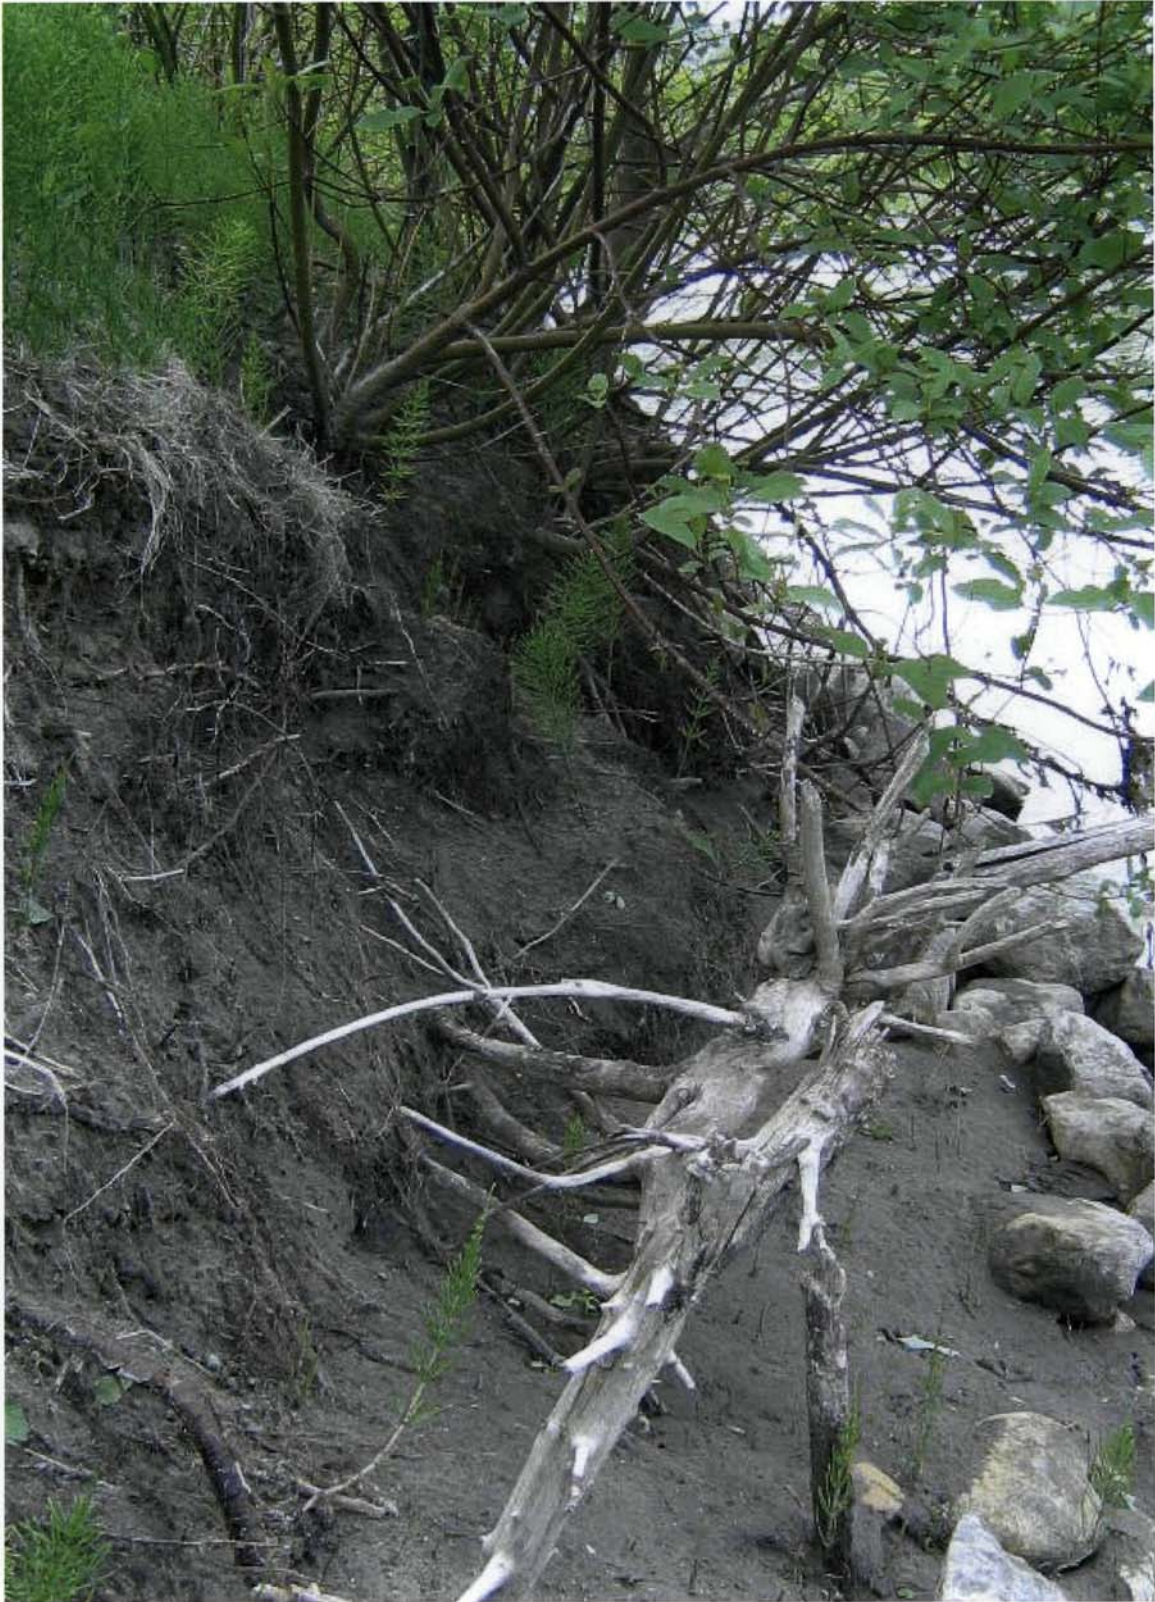
Photo 7 – Area 5: Example of near vertical face proposed for removal.

As shown on Figures 2 and 3, removal is proposed to be conducted between Station 1+20 and Station 4+50, and is anticipated to proceed up the bank such that approximate 2:1 (horizontal to vertical) bank slopes will extend from the upper extent of the removal area to the edge of armoring around the perimeter of the engineered barrier placed over the Newell Street Area II Parking Lot. Total removal of in-situ bank material in this area is estimated to be approximately 220 cy. Removal is anticipated to be performed with conventional equipment from the top-of-bank (with appropriate safeguards to protect the engineered barrier in that area).

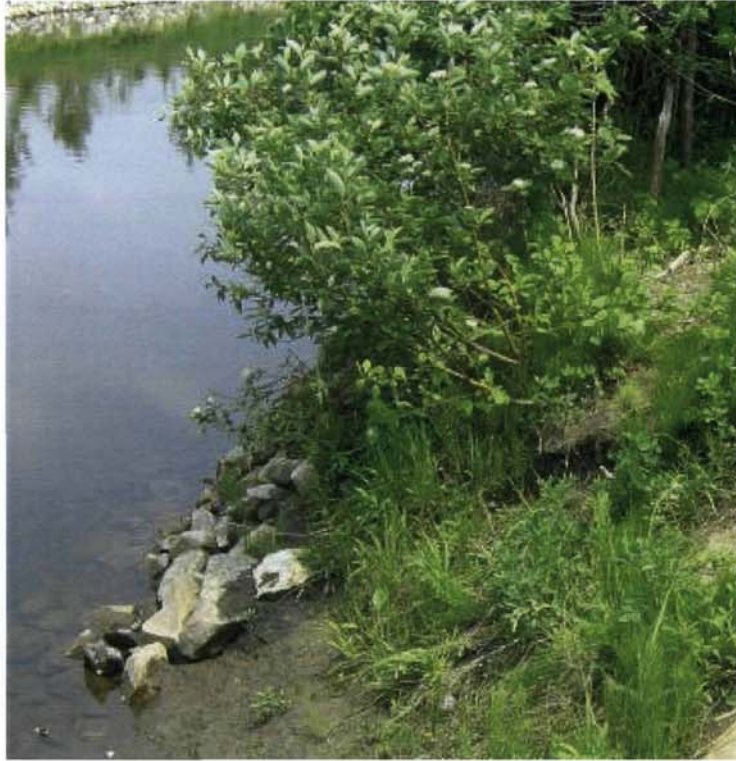
In addition, several small areas of slightly undercut banks were observed between Station 0+00 and Station 1+20, and upstream of Station 4+50 (Photo 8). Following completion of bank soil

Photo 8 – Area 5: Slight undercut proposed to be armored.

removal activities as described above, armor stone will be placed in these undercut areas to protect against further such erosion (see Figure 2).

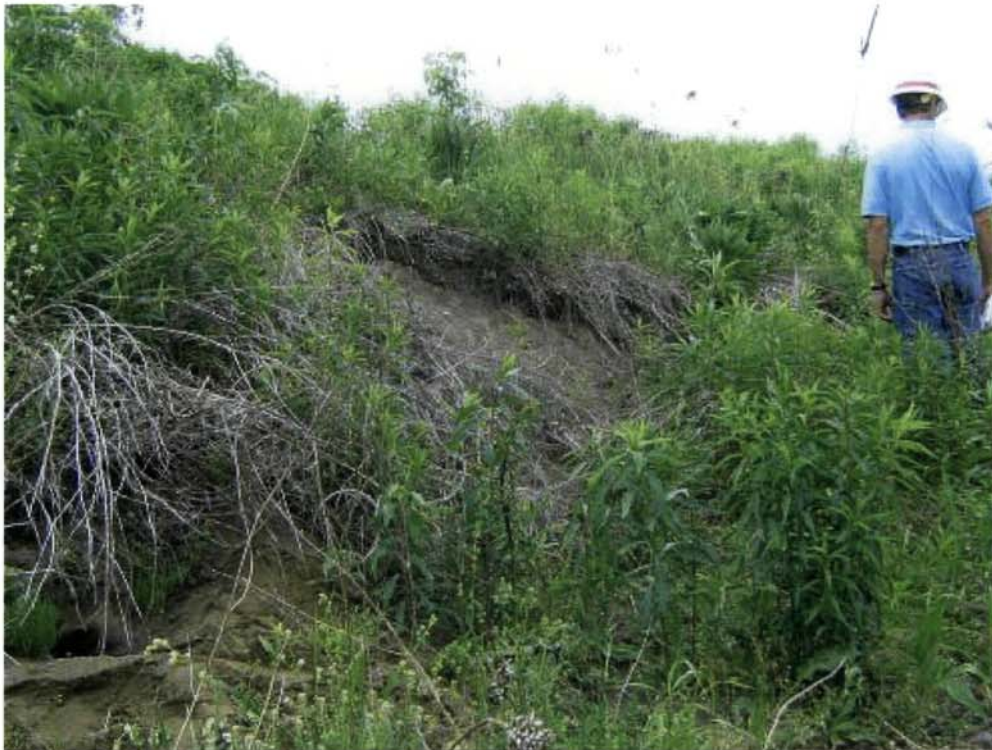
Area 6 - This area is located on the northern bank between Building 62 and the Lyman Street Parking Lot (see Figure 1). In this area, an approximate 30-foot long section of the top of bank appears to have sloughed and slid to the bottom of the bank (see Photo 9). Despite this sloughing, there does not appear to have been any erosion or material loss in this area, and there were no observations of eroded materials in the adjacent portion of the river. As discussed during the inspection, the sloughed portions of the bank in this area will be removed, and armor stone will be placed in this area to provide increased stabilization. Any such armor stone will be installed in this area such that it is tied into existing armor stone at the toe of the slope to provide a continuous line of protection from further erosion. Similar to plantings in Area 5, and in accordance with the Work Plan, a single band of red-osier dogwoods will be installed above the upper extent of armor stone in this area at a planting density of one plant every four lineal feet. GE plans to complete such activities during the 2007 construction season.

Photo 9 – Area 6: Bank sloughing, no erosion evident.
