**Re: GE-Pittsfield/Housatonic River Site  
Upper ½-Mile Reach of the Housatonic River (GEC800)  
Trip Report - Summer 2006 Inspection of Restored Bank Vegetation, Aquatic Habitat  
Structures, and Armor Stone**

SUBJ: Trip Report;  
Summer 2006 Monitoring Visit  
Upper ½-Mile Reach of the Housatonic River  
Pittsfield, Massachusetts

**2006 AQUATIC HABITAT ENHANCEMENT STRUCTURE INSPECTION  
UPPER ½ MILE REACH OF THE HOUSATONIC RIVER  
GENERAL ELECTRIC CORPORATION – PITTSFIELD, MASSACHUSETTS**

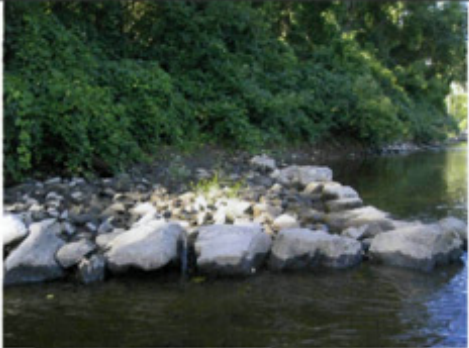
| Cell | Aquatic Structures | Armor Stone Condition/General Biological Observations | |
|---|---|--|--|
| B | 1. Single wing deflector | | <ol style="list-style-type: none"> <li>1. Structures appear stable.</li> <li>2. Structure induced variations in flow patterns observed in areas immediately downstream of the deflector.</li> <li>3. Numerous benthic invertebrates were observed on stone pulled up from around the deflector.</li> </ol> |

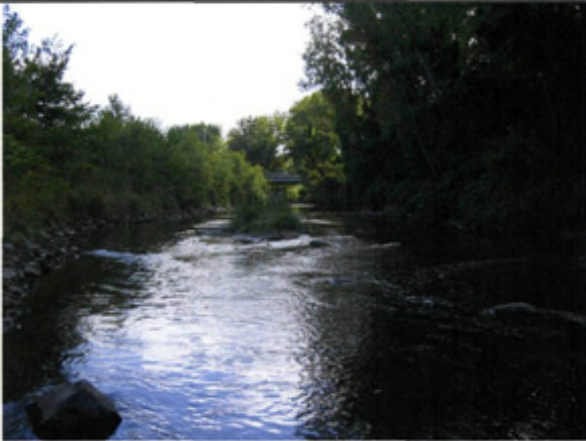
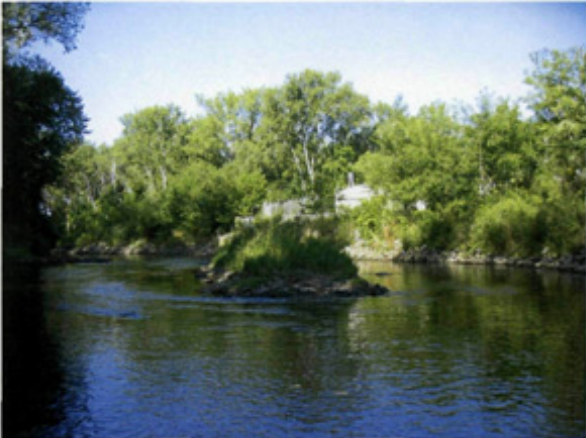
| Cell | Aquatic Structures | Armor Stone Condition/General Biological Observations | |
|---|---|---|--|
| C | 1. Boulders<br>2. Island | | <div data-bbox="1161 776 1881 1114" style="border: 1px solid black; padding: 10px;"> <ol style="list-style-type: none"> <li>1. Structures appear stable.</li> <li>2. Structure induced variations in flow patterns observed in areas immediately downstream of the island.</li> <li>3. The island appears well vegetated with wetland herbaceous species and cottonwood seedlings.</li> <li>4. Boulders near island appear to be creating scour holes in the immediate area; good cover.</li> </ol> </div> |

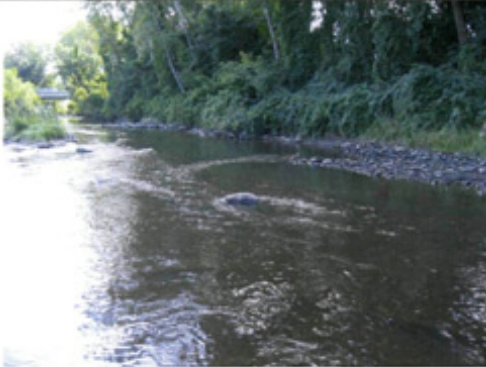
| Cell | Aquatic Structures | Armor Stone Condition/General Biological Observations | |
|---|---|---|---|
| D | 1. Boulders | | <div data-bbox="1066 553 1881 797" style="border: 1px solid black; padding: 5px;"> <ol style="list-style-type: none"> <li>1. Structures were functional and appear to be providing variation in habitat.</li> <li>2. Numerous benthic invertebrates observed on stone pulled up in the area.</li> </ol> </div> |

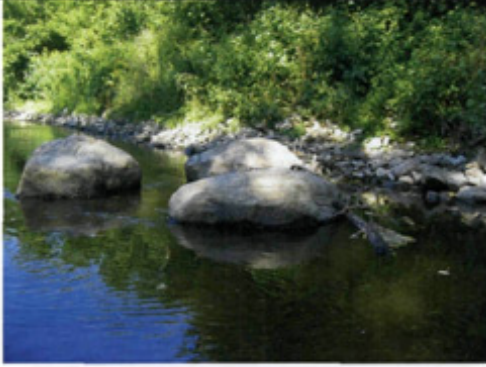
| Cell | Aquatic Structures | Armor Stone Condition/General Biological Observations | |
|---|---|---|---|
| G1 | 1. Boulder Cluster | | <div data-bbox="1066 967 1856 1211" style="border: 1px solid black; padding: 5px;"> <ol style="list-style-type: none"> <li>1. Structures were functional and appear to be providing variation in habitat.</li> <li>2. Numerous benthic invertebrates observed on stone pulled up in the area.</li> </ol> </div> |

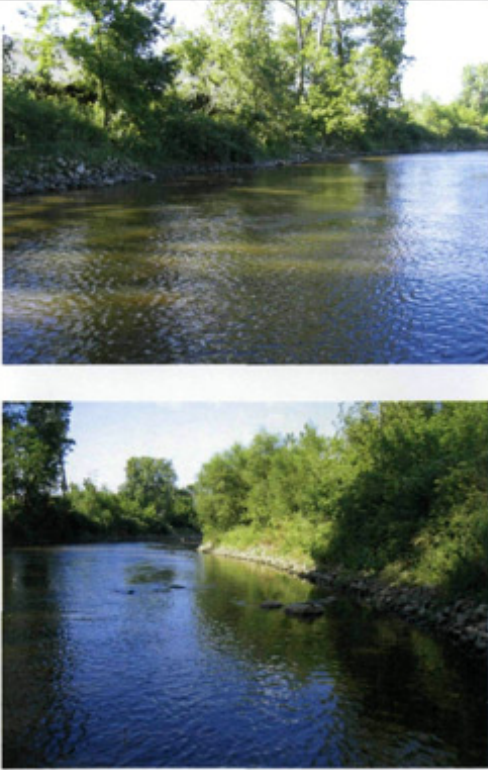
| Cell | Aquatic Structures | Armor Stone Condition/General Biological Observations |
|---|---|---|
| G2/F2 | 1. W-weir | <p data-bbox="1062 740 1877 932">1. Much of the weir appears to be buried in soft silt/sand; above-grade portion of structure appears to offer good cover for aquatic organisms</p> |

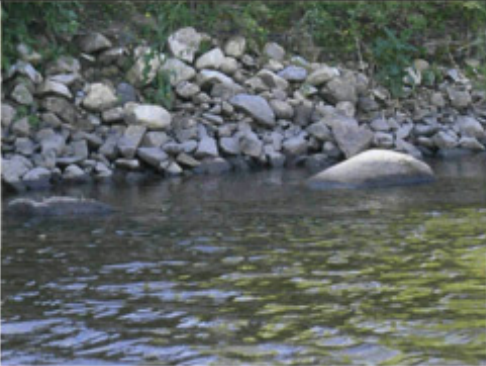
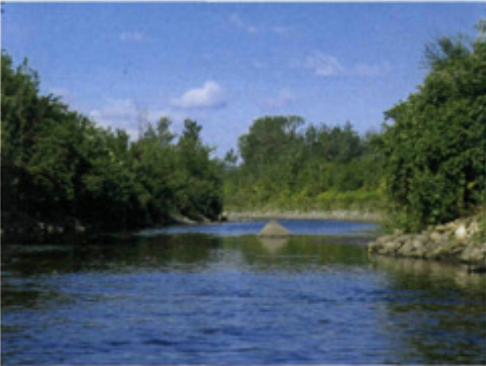
| Cell | Aquatic Structures | Armor Stone Condition/General Biological Observations | |
|---|--|---|--|
| F3 | 1. Three-boulder cluster<br>2. Two-boulder cluster<br>3. Three-boulder cluster | | <div data-bbox="1087 737 1856 906" style="border: 1px solid black; padding: 10px;"> <ol style="list-style-type: none"> <li>1. All structures in this cell appear stable.</li> <li>2. Structures appear to be providing diversity in habitat.</li> </ol> </div> |

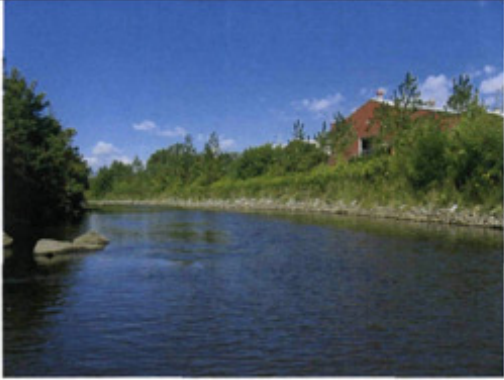
| Cell | Aquatic Structures | Armor Stone Condition/General Biological Observations |
|---|---|---|
| H1/J1 | 1. Rock weir | <div style="display: flex; align-items: center;"> <div style="margin-left: 20px;"> <ol style="list-style-type: none"> <li>1. Structure is stable and appears to be providing diversity in habitat.</li> <li>2. Structure induced variations in velocity and flow patterns appear to be producing variations in stream bottom topography; good habitat.</li> </ol> </div> </div> |

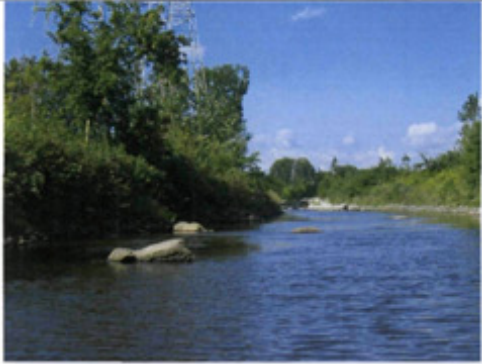
| Cell | Aquatic Structures | Armor Stone Condition/General Biological Observations | |
|---|---|---|---|
| J1 | <ol style="list-style-type: none"> <li>1. Two-boulder cluster</li> <li>2. Three-boulder cluster</li> <li>3. Single-boulder</li> </ol> | | <ol style="list-style-type: none"> <li>1. Structure is stable and appears to be providing diversity in habitat.</li> <li>2. Structure induced variations in velocity and flow patterns appear to be producing variations in stream bottom topography; good habitat.</li> <li>3. Boulders observed as being used as perches for feeding birds</li> </ol> |

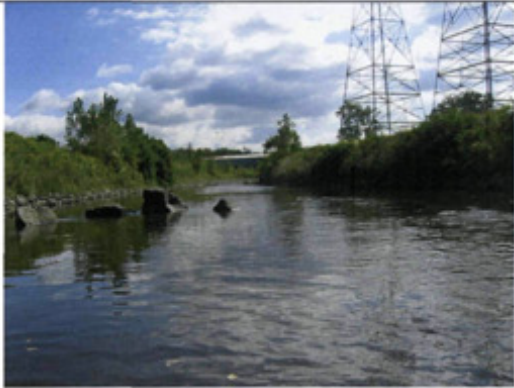
| Cell | Aquatic Structures | Armor Stone Condition/General Biological Observations | |
|---|---|---|---|
| J2 | <ol style="list-style-type: none"> <li>1. "J"- boulder formation</li> </ol> | | <ol style="list-style-type: none"> <li>1. Structure is stable and appears to be providing diversity in habitat.</li> <li>2. Structure induced variations in velocity and flow patterns appear to be producing variations in stream bottom topography; good habitat.</li> </ol> |

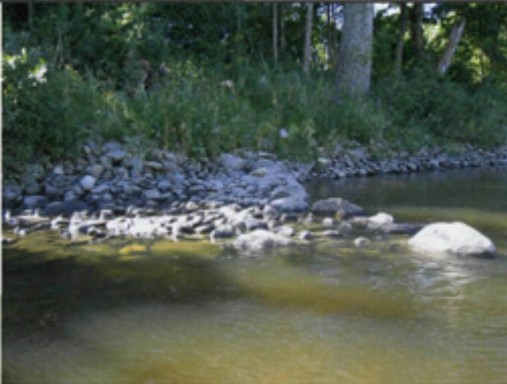
| Cell | Aquatic Structures | Armor Stone Condition/General Biological Observations | |
|---|---|---|--|
| I3 | 1. Single-wing deflector | | <div style="border: 1px solid black; padding: 5px;"> <ol style="list-style-type: none"> <li>1. Structure is stable and appears to be providing diversity in habitat.</li> <li>2. Structure induced variations in velocity and flow patterns appear to be producing variations in stream bottom topography; good habitat.</li> </ol> </div> |

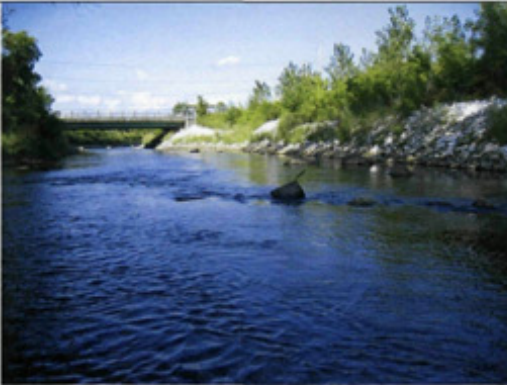
| Cell | Aquatic Structures | Armor Stone Condition/General Biological Observations | |
|---|---|---|--|
| I3/J3 | 1. Vortex rock weir | | <div style="border: 1px solid black; padding: 5px;"> <ol style="list-style-type: none"> <li>1. Structure is stable and appears to be providing diversity in habitat.</li> <li>2. Structure induced variations in velocity and flow patterns appear to be producing variations in stream bottom topography; good habitat.</li> </ol> </div> |

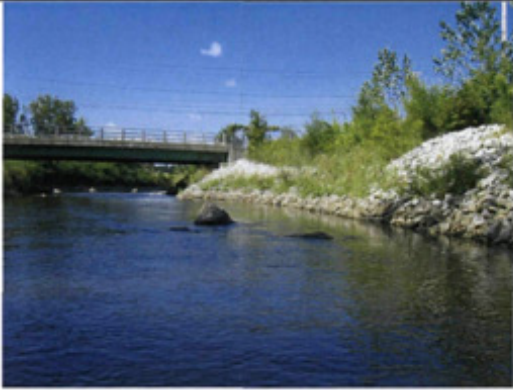
| Cell | Aquatic Structures | Armor Stone Condition/General Biological Observations | |
|---|--|--|--|
| J3 | <ol style="list-style-type: none"> <li>1. Boulder cluster</li> <li>2. Three-boulder cluster</li> <li>3. Three-boulder cluster</li> </ol> | | <ol style="list-style-type: none"> <li>1. Structure is stable and appears to be providing diversity in habitat.</li> <li>2. Structure induced variations in velocity and flow patterns appear to be producing variations in stream bottom topography; good habitat.</li> </ol> |

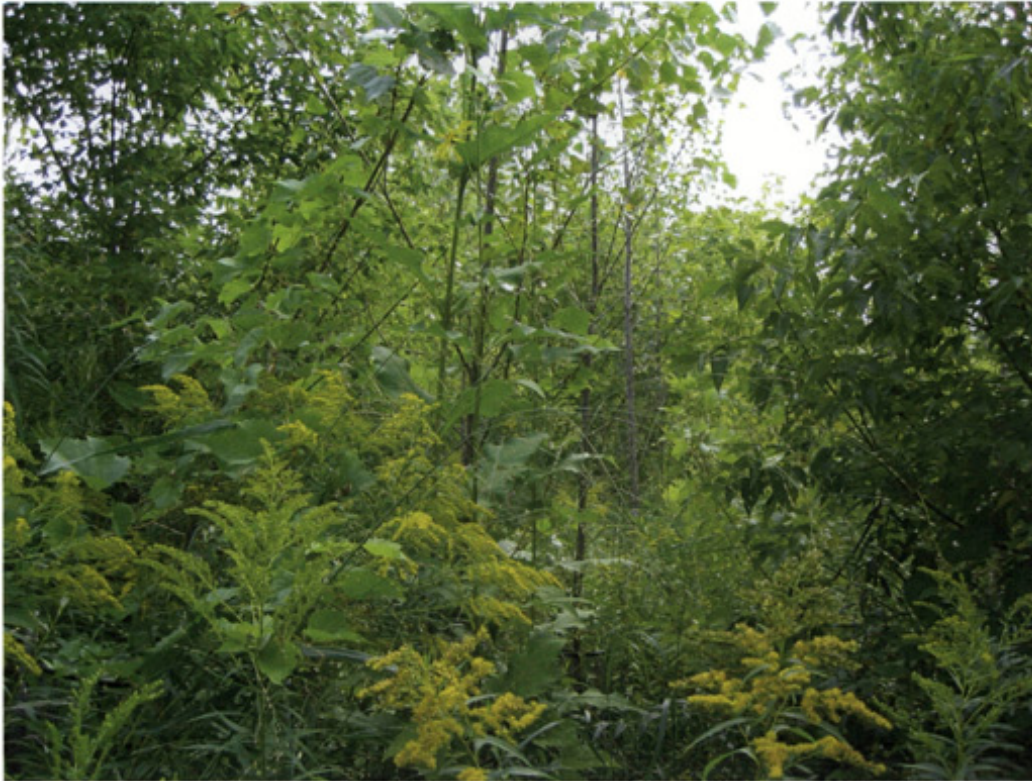
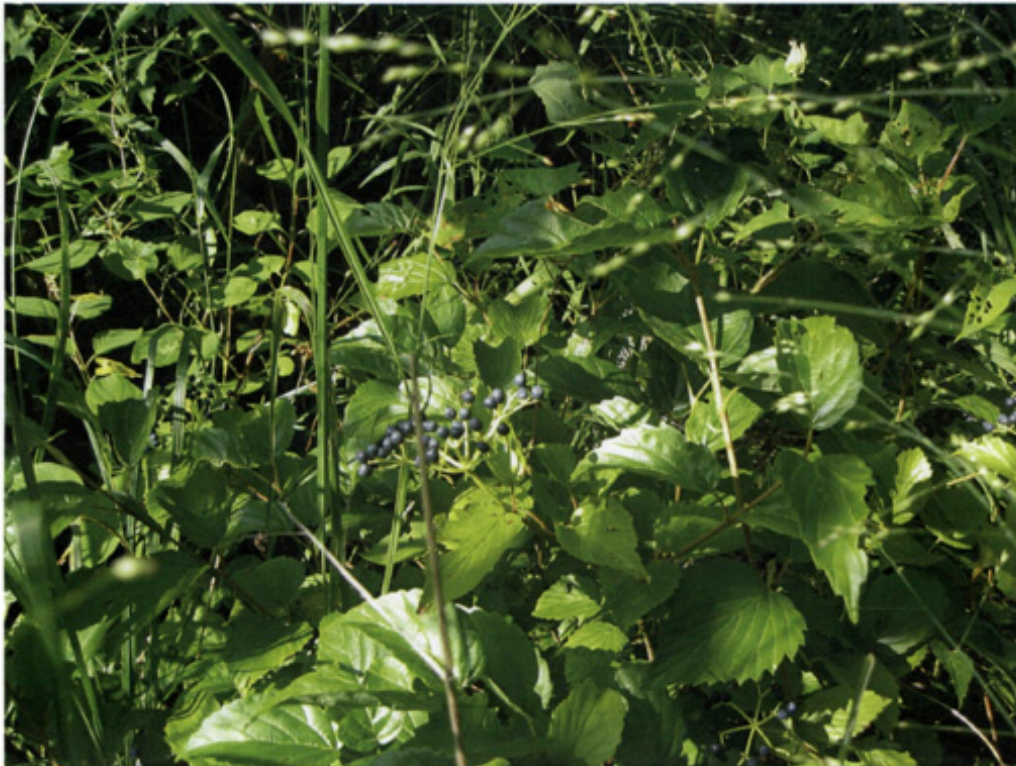
4. Planting area 4B was visited for the first time since August 2004. This area showed significant vegetative growth for all vegetative components of the restoration. Though growth was excellent, the understory species did not meet the performance standard, with a variation of 13 shrubs less than the standard. (The corrective action for this variation is discussed below.) All other components of the vegetative community (e.g. canopy, red-osier dogwood, herbaceous coverage, and invasive species) met their performance standards.

**Photograph 1: Planting Area 4B**

**Photograph 2: Planting Area 4B; Note fruit of northern arrowwood**

To meet the performance standards, the following numbers of shrubs were installed by C. L. Frank and Associates on November 14, 2006:

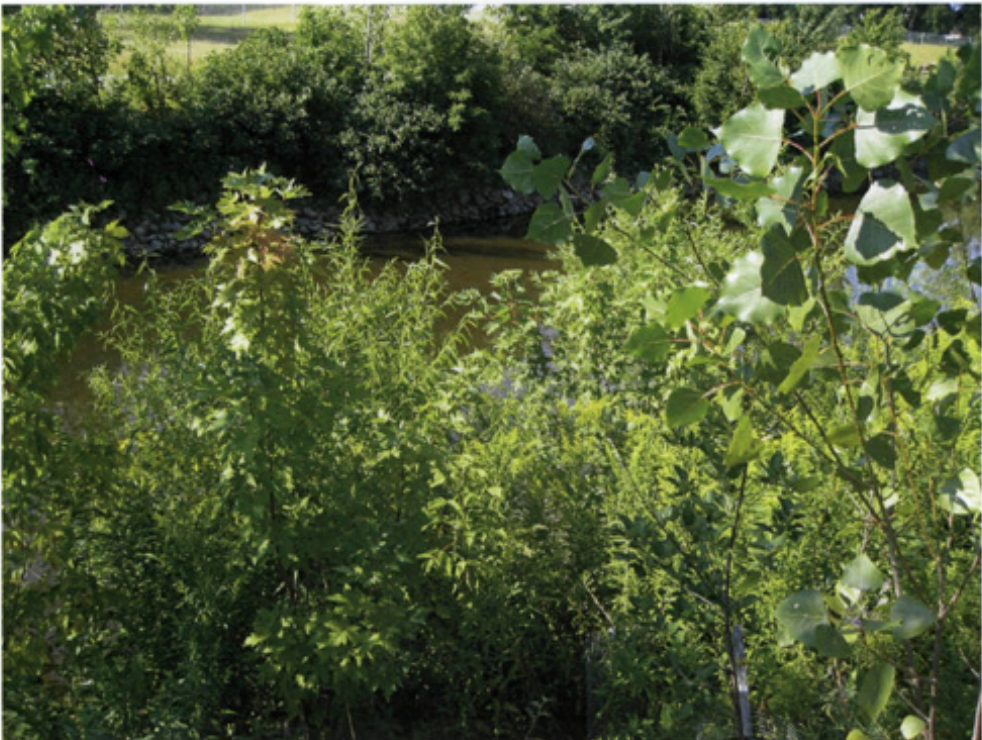
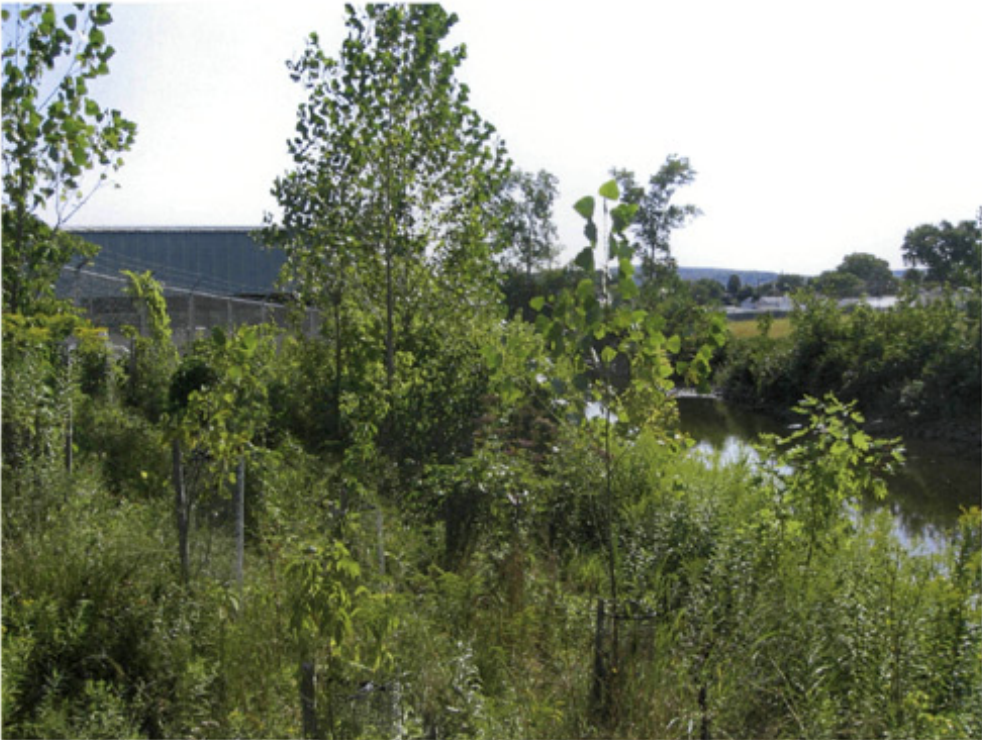
Photograph 3: Planting Area 10

5. Planting area 10 was also visited for the first time since August 2004. This area met the performance standard for canopy species, though it did not meet the performance standard for understory specimens, with a variation of 1 shrub less than the standard. (The corrective action for this variation is discussed below.) All other components of the vegetative community (e.g. herbaceous coverage and invasive species) met their performance standards.

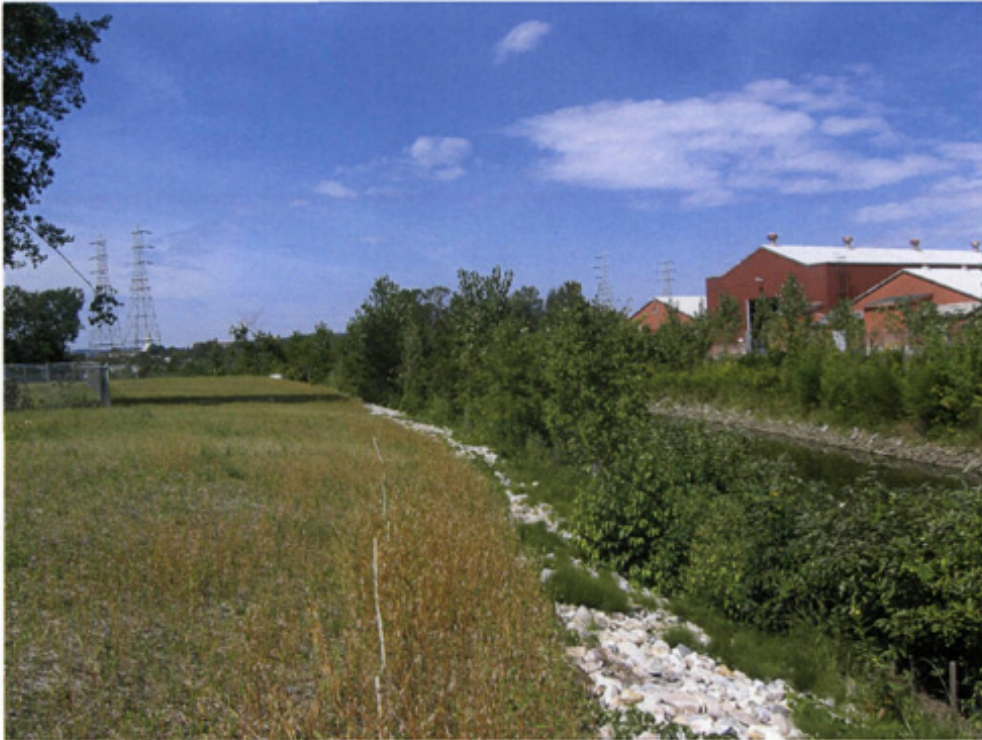
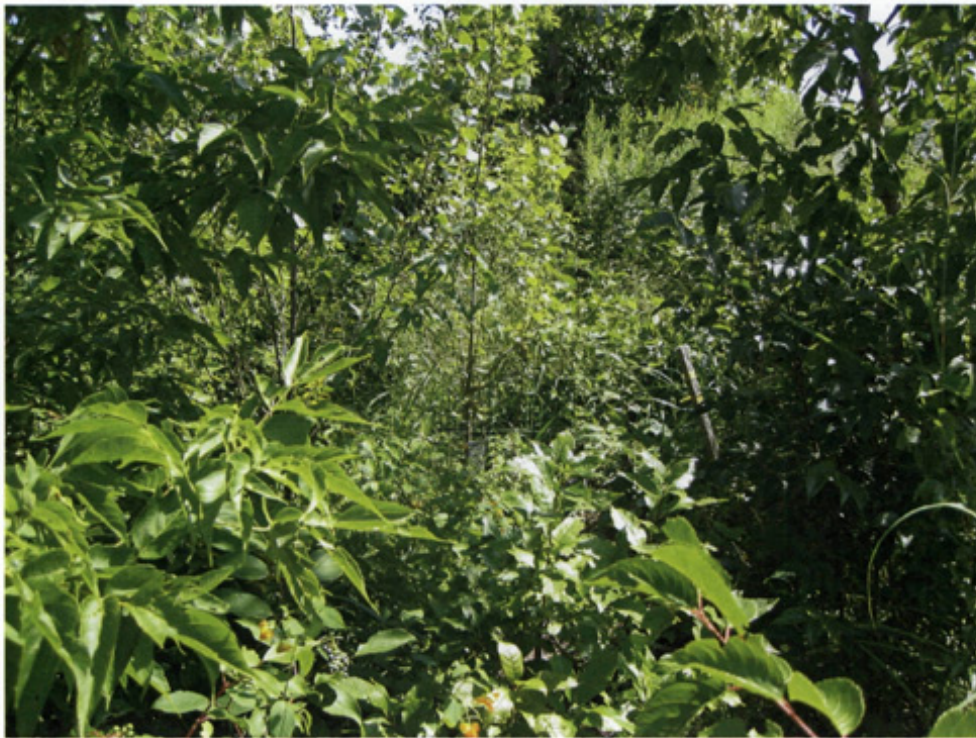
Photograph 5: Planting Area 6, 6A, 7, 8A

6. Planting areas 6, 6A, 7 and 8A were visited for the first time since August 2004. These areas met the performance standard for canopy specimens. No understory patches were planted in these areas. All other components of the vegetative community (e.g. red-osier dogwood, herbaceous coverage, and invasive species) met their performance standards.

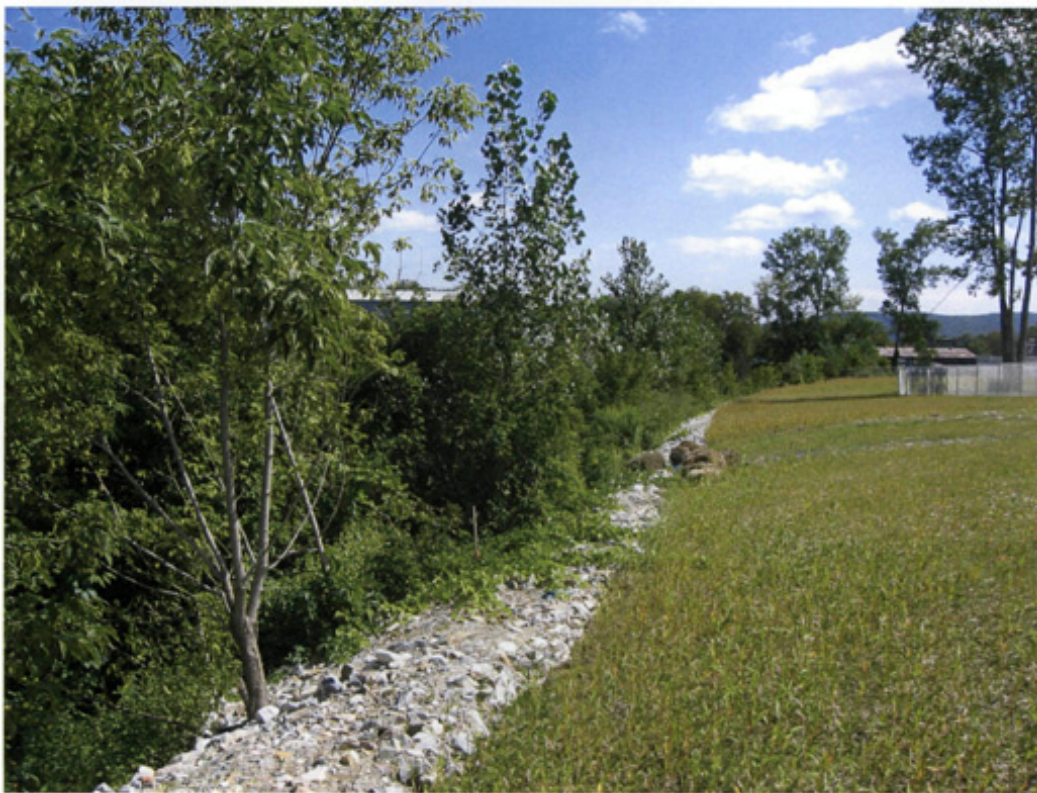
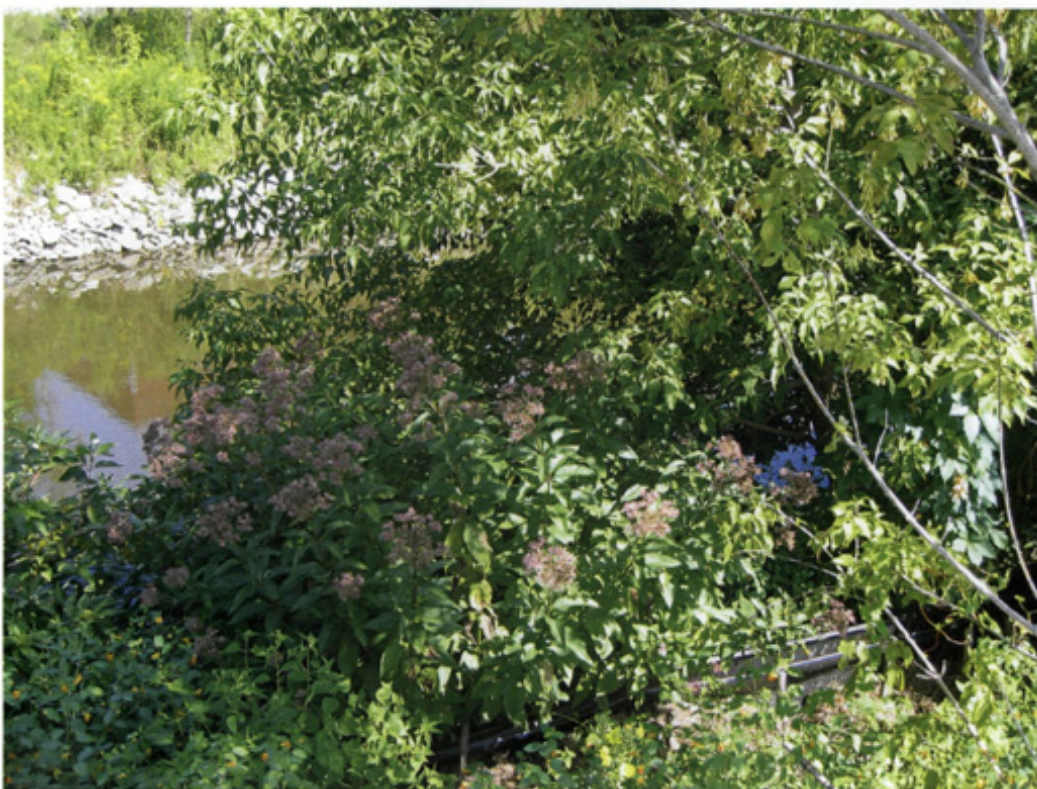
Photograph 7: Planting Area 8, 9, 9A, 11, 11A

7. Planting areas 8, 9, 9A, 11, 11A were also visited for the first time since August 2004. These areas met the performance criteria for canopy and for red-osier dogwood. However, the understory species were below the performance standard, with a variation of 24 shrubs less than the standard. It appears that the recent Newell Street Area II parking lot construction resulted in a narrowing of the riparian area and a corresponding loss of a portion of the shrub patch. (The corrective action for this

variation is discussed below.) While a grape vine patch was initially planned for planting area 9A in the fall of 2005, it was not planted due to lack of available stock. However, a sufficient number of wild grapes have colonized across this combination of planting areas to meet the performance standard. All other components of the vegetative community (e.g. herbaceous coverage and invasive species) met their performance standards.
