GE
159 Plastics Avenue
Pittsfield, MA 01201
USA

**Re: GE Pittsfield/Housatonic River Site
Upper ½-Mile Reach Removal Action (GEC800)
2006 Bank Erosion Inspection Report - Revised**

**2006 BANK
EROSION INSPECTION**

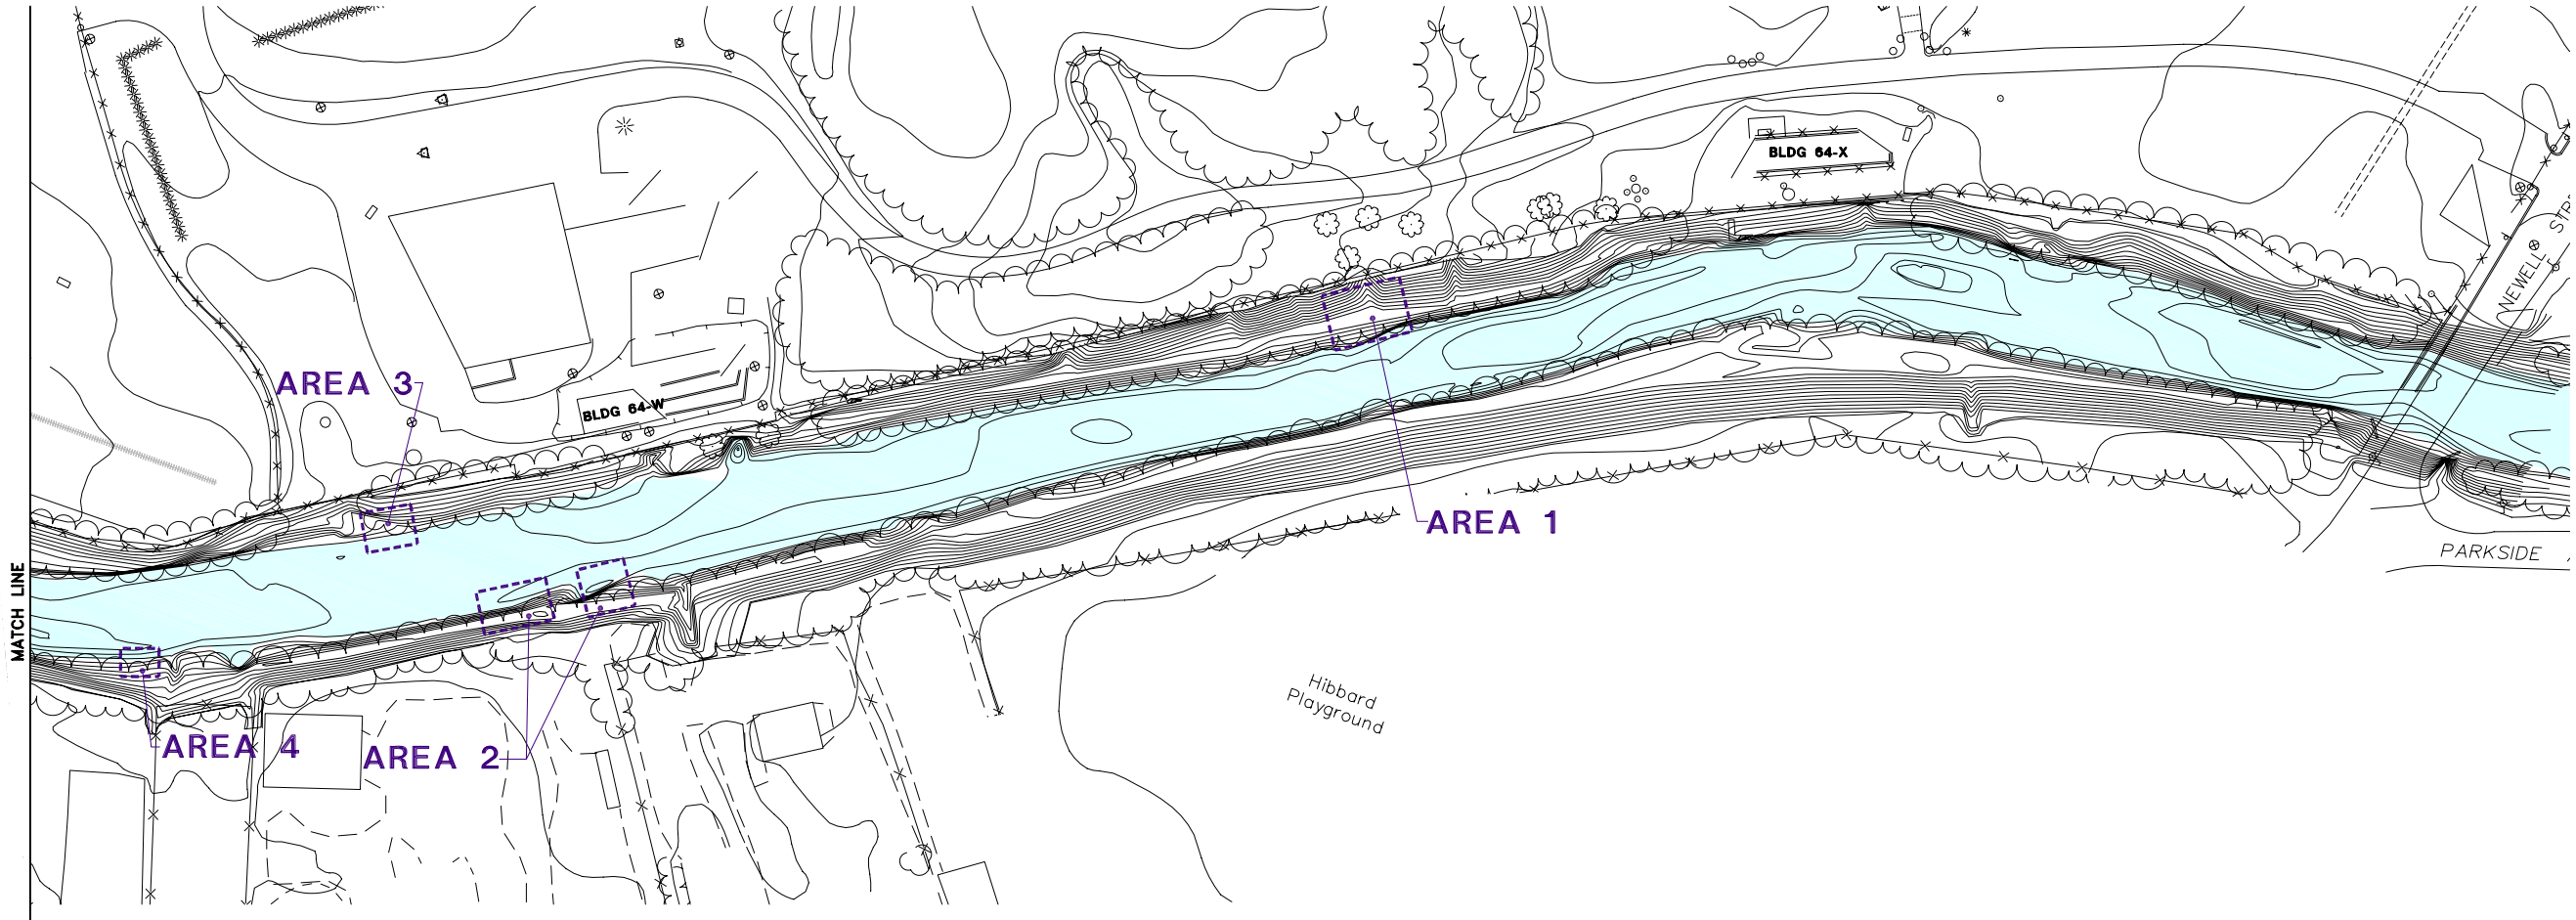
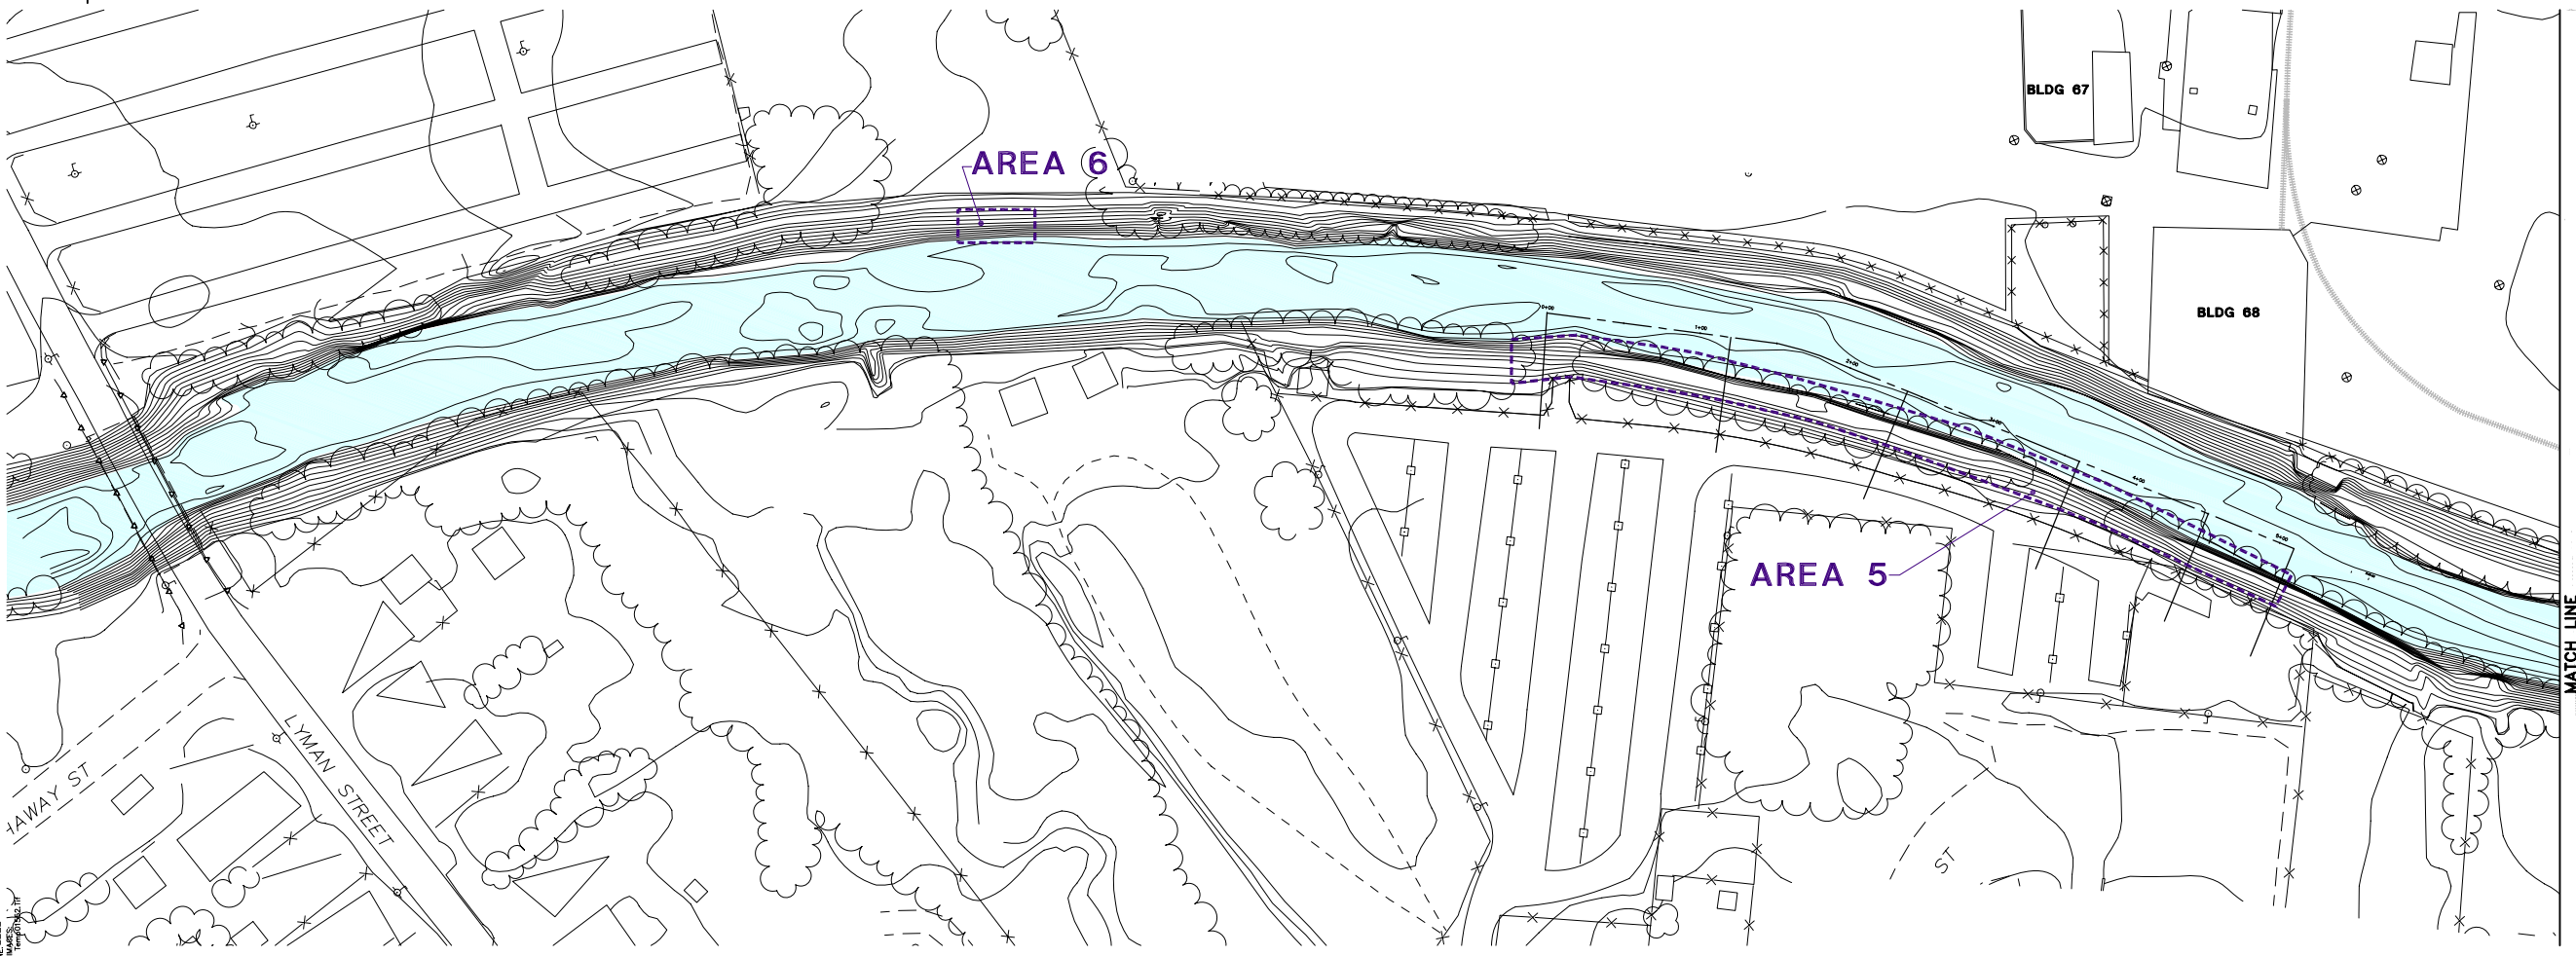
FIGURE
1

At the time of the inspection, several areas were noted with either a visually observable loss of bank soil or movement of bank armoring. These areas are identified on Figure 1. Where appropriate, certain areas may require protection from further erosion through the placement of armor stone. Armor stone placed as part of these activities will be similar to that used during the implementation of the Upper ½ Mile Reach Removal Action (i.e., graded riprap, $D_{100}=12$ -inch), as fully described in the Work Plan. GE plans to complete the remedial activities discussed below during the 2007 construction season, and will coordinate scheduling with EPA as the construction season approaches.

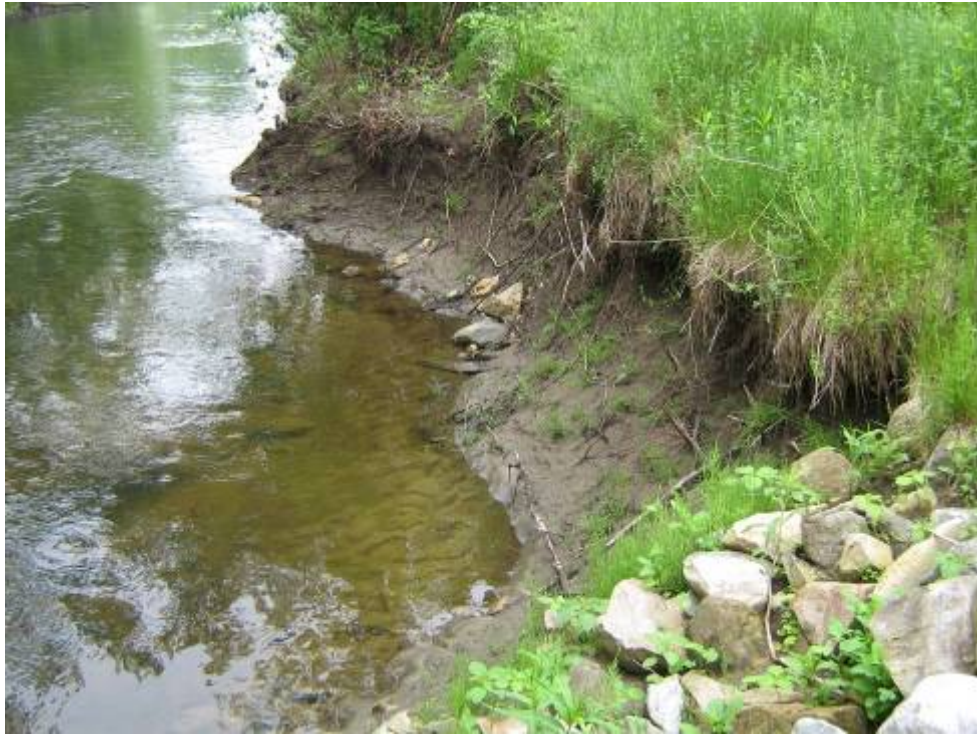
Area 1 – This area consists of approximately 25 feet of undercut bank, located on the northern bank of the river approximately 200 feet downstream of Building 64X in an area where no remedial activities were performed either in the river or on the riverbank (see Figure 1 and Photo 1). This area of observed erosion is located downstream of rip-rap placed adjacent to sheetpiles installed during past remedial activities, where the bank transitions from riprap to bank soil. In this area, less than 10 cubic yards (cy) of bank soil appear to have eroded from the bank. The source of the eroded material appears to be native material from the low- and mid-bank area directly down-slope from established grassy vegetation. The cause of erosion appears to be a combination of the transition from riprap to unprotected bank soils and the high velocity flows associated with the extreme flood event discussed above. No eroded soil was observed in the adjacent portion of the river and, therefore, no removal activities are planned at this location.

Photo 1 – Area 1: Approximately 25 feet of undercut bank at the end of a section of rip-rap.

As discussed during the inspection, the proposed response action in this area will consist of placement of armor stone to replace eroded materials and protect against further such erosion. In this area, an approximate 1-ft thick layer of $D_{100}=12$ -inch graded riprap will be placed along the lower portion of the bank extending up the bank to the limit of the undercut. To the extent practicable, armor stone placed in this area will be keyed into the bank, as well as blended with adjacent bank armoring, such that areas receiving armor stone will be restored to previous grades.

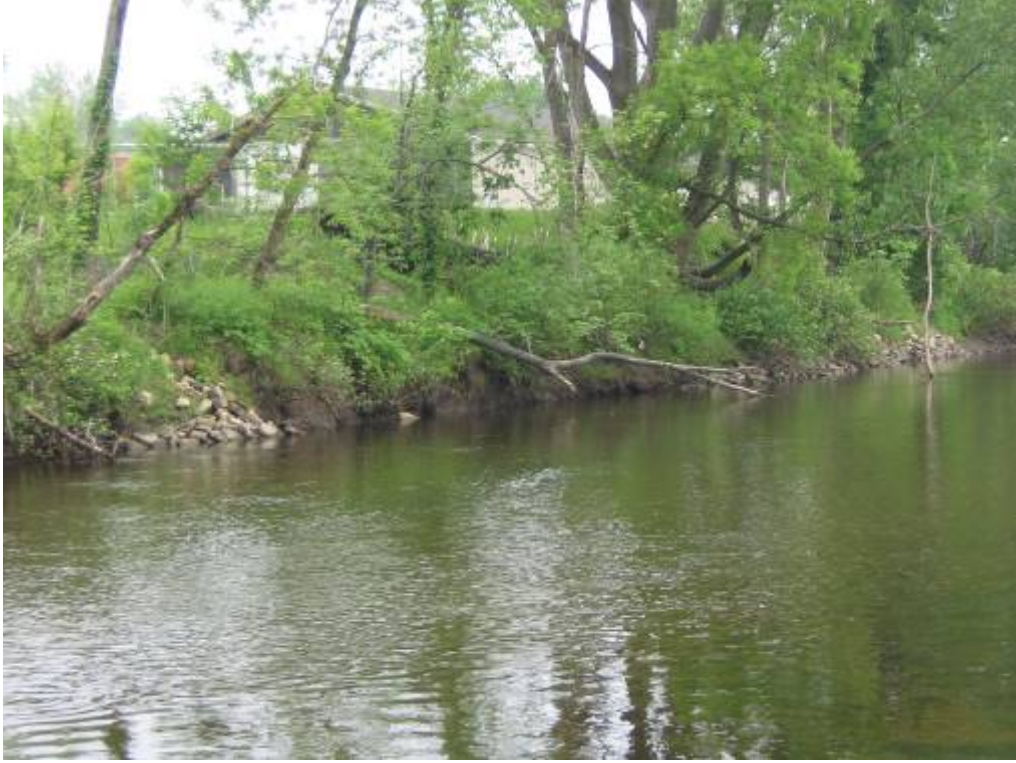
Additionally, there is a slight undercut that extends for approximately 100 feet downstream of the same drainage swale discussed above and that appears to have involved the erosion of less than 5 cy (see Photo 3). To the extent practicable, GE will place armor stone (similar to above) within this undercut to limit any future erosion from this area.

Photo 3 – Area 2: Approximately 100 feet of slight undercut downstream of swale.

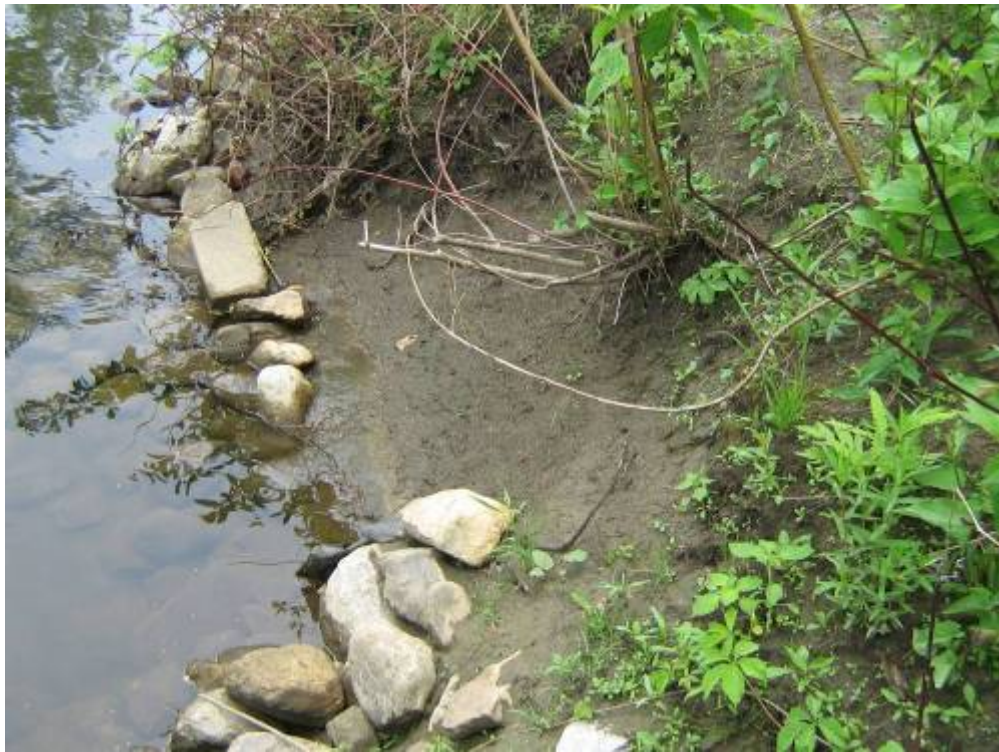
Area 3 – This area is located on the northern bank, in a non-remediated bank area, approximately 200 feet downstream of Building 64W (see Figure 1). In this area, less than 1 cy of bank soil appears to have eroded from within a 5-foot long slight undercut just above the existing riverbed armor layer (see Photo 4). The source of the eroded material appears to be native material from the mid-bank area. The cause of erosion appears to be high velocity water flow, likely associated with the extreme flood event discussed above. No evidence of eroded soil was observed in the adjacent portion of the river and, therefore, no removal activities are planned at this location. As discussed during the inspection, armor stone will be placed in this area to replace eroded materials and protect against further such erosion. In this area, armor stone (i.e., D_{100} =12-inch graded riprap) will be keyed into the bank to fill the undercut such that the lower bank above the existing riverbed armor layer will be restored to previous grades.

Photo 4 – Area 3: Slight undercut above rip-rap.

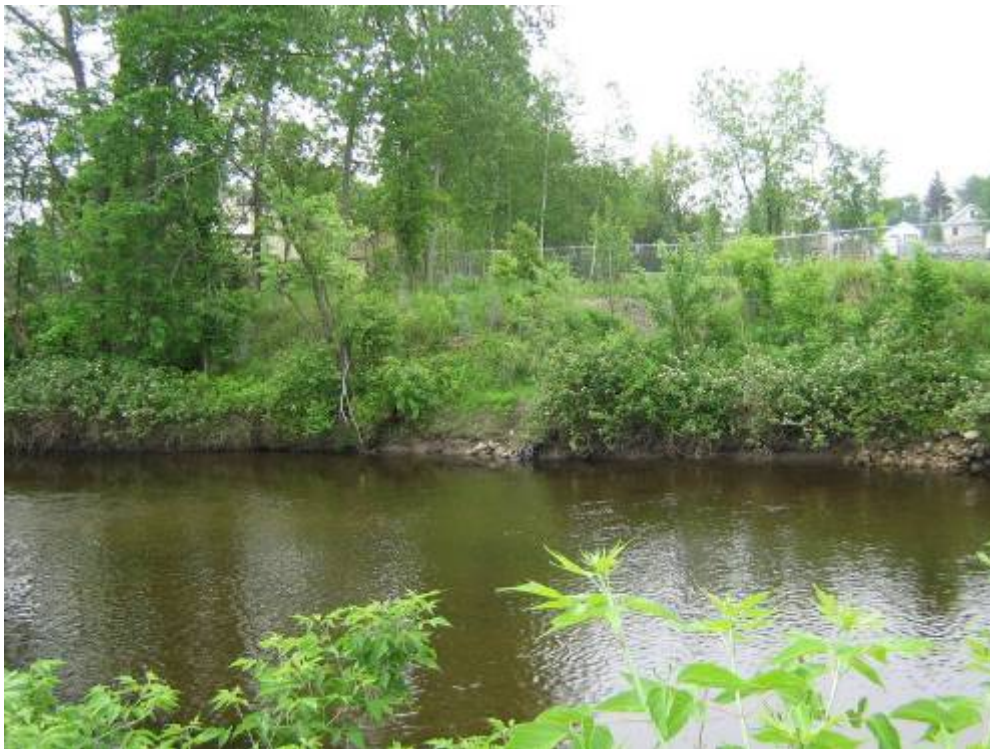
Area 5 – Area 5 is located on the southern bank adjacent to the Newell Street Area II Parking Lot, and extends from a point approximately 15 feet downstream of the former pedestrian bridge to approximately 500 feet upstream of the bridge (see Figure 1). Within Area 5 there are several intermittent areas of undercut bank, from which soils have been eroded from bank areas above the adjacent existing riverbed armor layer (see Photo 6), and steep, near-vertical slopes are present that potentially could further erode or fail (Photo 7). The observed erosion is likely a result of the high velocity flow associated with the extreme flood event discussed above, but may also be related, to some extent, to settling of the riprap in this area. The sources of eroded materials in this area appear to be native materials or clean backfill, as portions of Area 5 proposed for removal intersect areas that have been previously remediated. No evidence of eroded soil was observed in the adjacent portion of the river and, therefore, no removal activities are planned at this location. During the inspection, it was discussed that this area would likely require excavation of the remaining steep slopes to tie into post-construction Newell Street Area II grades, as well as armor stone placement (tied into the existing riverbed armor layer at the toe of the slope) to restore this area to grade and reduce the potential for further erosion. Any such armor stone will be installed in this area such that it is to provide a continuous line of protection against further erosion.

Photo 6 – Area 5: Several small areas undercut above rip-rap.

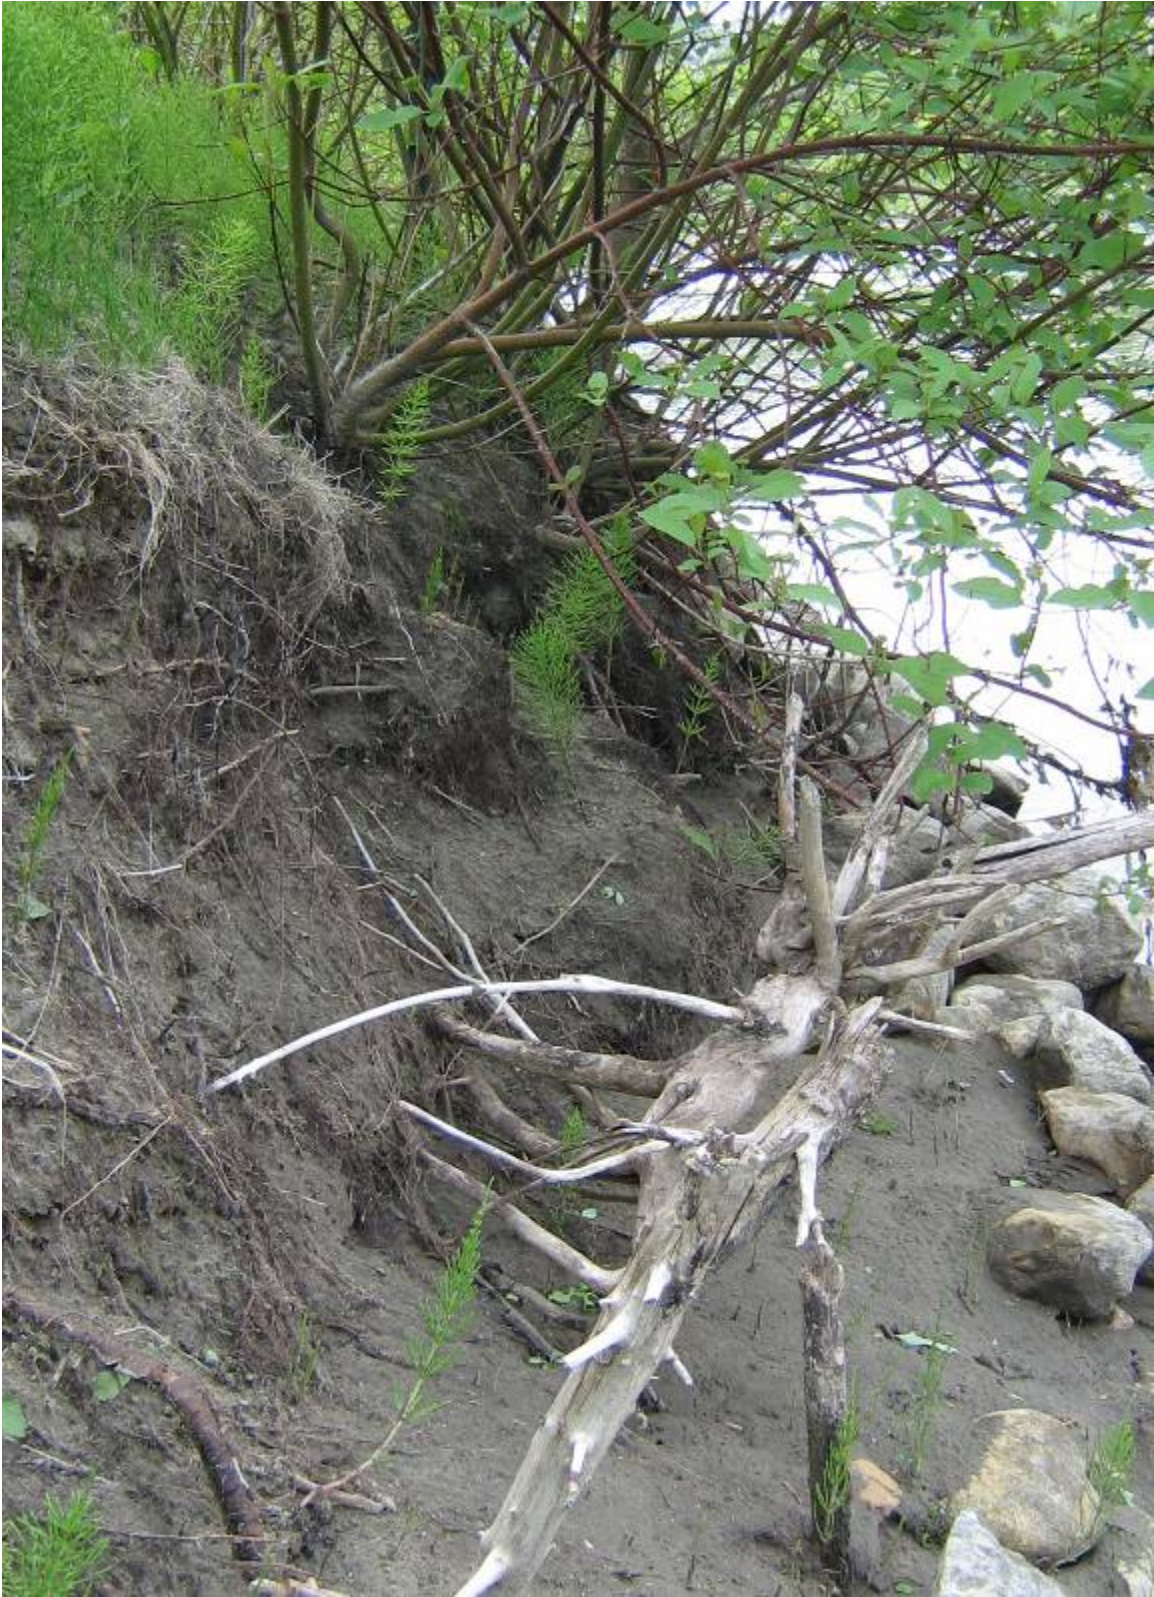
Photo 7 – Area 5: Example of near vertical face proposed for removal.

As shown on Figures 2 and 3, removal is proposed to be conducted between Station 1+20 and Station 4+50, and is anticipated to proceed up the bank such that approximate 2:1 (horizontal to vertical) bank slopes will extend from the upper extent of the removal area to the edge of armoring around the perimeter of the engineered barrier placed over the Newell Street Area II Parking Lot. Total removal of in-situ bank material in this area is estimated to be approximately 220 cy. Removal is anticipated to be performed with conventional equipment from the top-of-bank (with appropriate safeguards to protect the engineered barrier in that area).

Following removal, those portions of the approximate 300-foot length of bank above the river bed armor layer subject to removal will be covered with armor stone to replace eroded materials, restore this area to previous grades (i.e., pre-erosion), stabilize these banks, and protect against further such erosion. At this time, it is not anticipated that additional excavation will be required to accommodate armor stone placement. Because this area will include large areas of disturbed

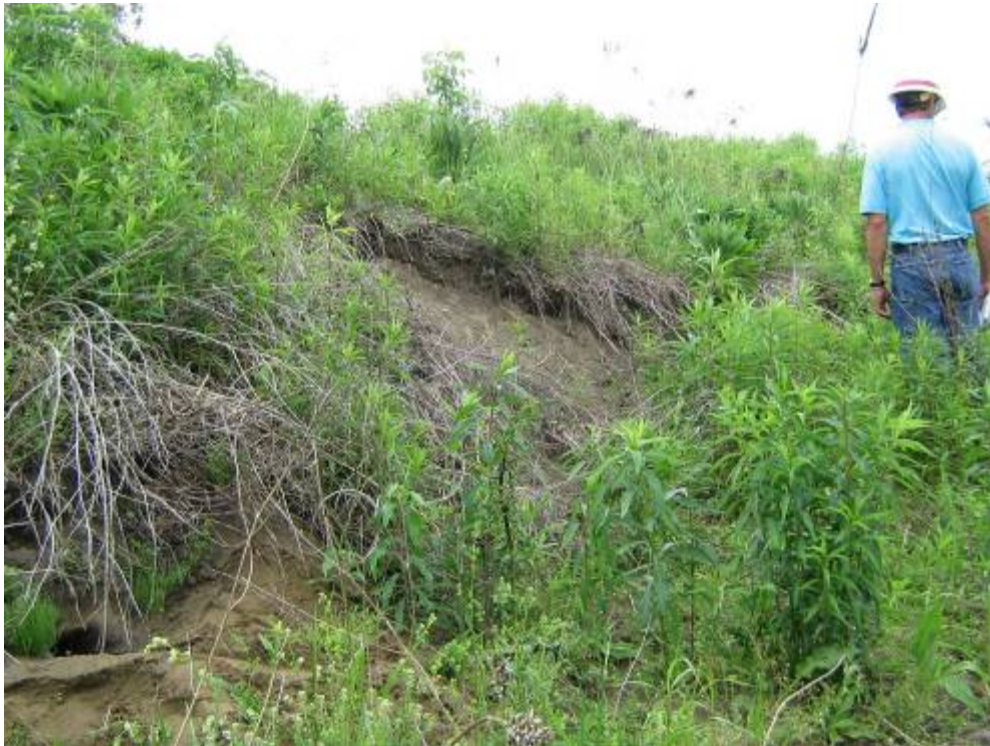
Area 6 - This area is located on the northern bank between Building 62 and the Lyman Street Parking Lot (see Figure 1). In this area, an approximate 30-foot long section of the top of bank appears to have sloughed and slid to the bottom of the bank (see Photo 9). Despite this sloughing, there does not appear to have been any erosion or material loss in this area, and there were no observations of eroded materials in the adjacent portion of the river. As discussed during the inspection, the sloughed portions of the bank (less than 5 cy) in this area will be removed; and, as necessary, armor stone will be placed along the bottom of the bank and blended with the existing riverbed armor layer to provide increased stabilization and a continuous line of protection from further erosion. Similar to plantings in Area 5, and in accordance with the Work Plan, a single band of red-osier dogwoods will be installed above the upper extent of armor stone in this area at a planting density of one plant every four lineal feet.

Photo 9 – Area 6: Bank sloughing, no erosion evident.
