**Re: 2007 Bank Erosion Inspection  
GE Pittsfield/Housatonic River Site  
Upper ½-Mile Reach Removal Action (GECD800)**

**TABLE 1**  
**2007 RESTORED BANK EROSION INSPECTION SUMMARY**  
**UPPER ½ -MILE REACH OF THE HOUSATONIC RIVER**  
**GENERAL ELECTRIC COMPANY – PITTSFIELD MASSACHUSETTS**

**2007 BANK EROSION INSPECTION**

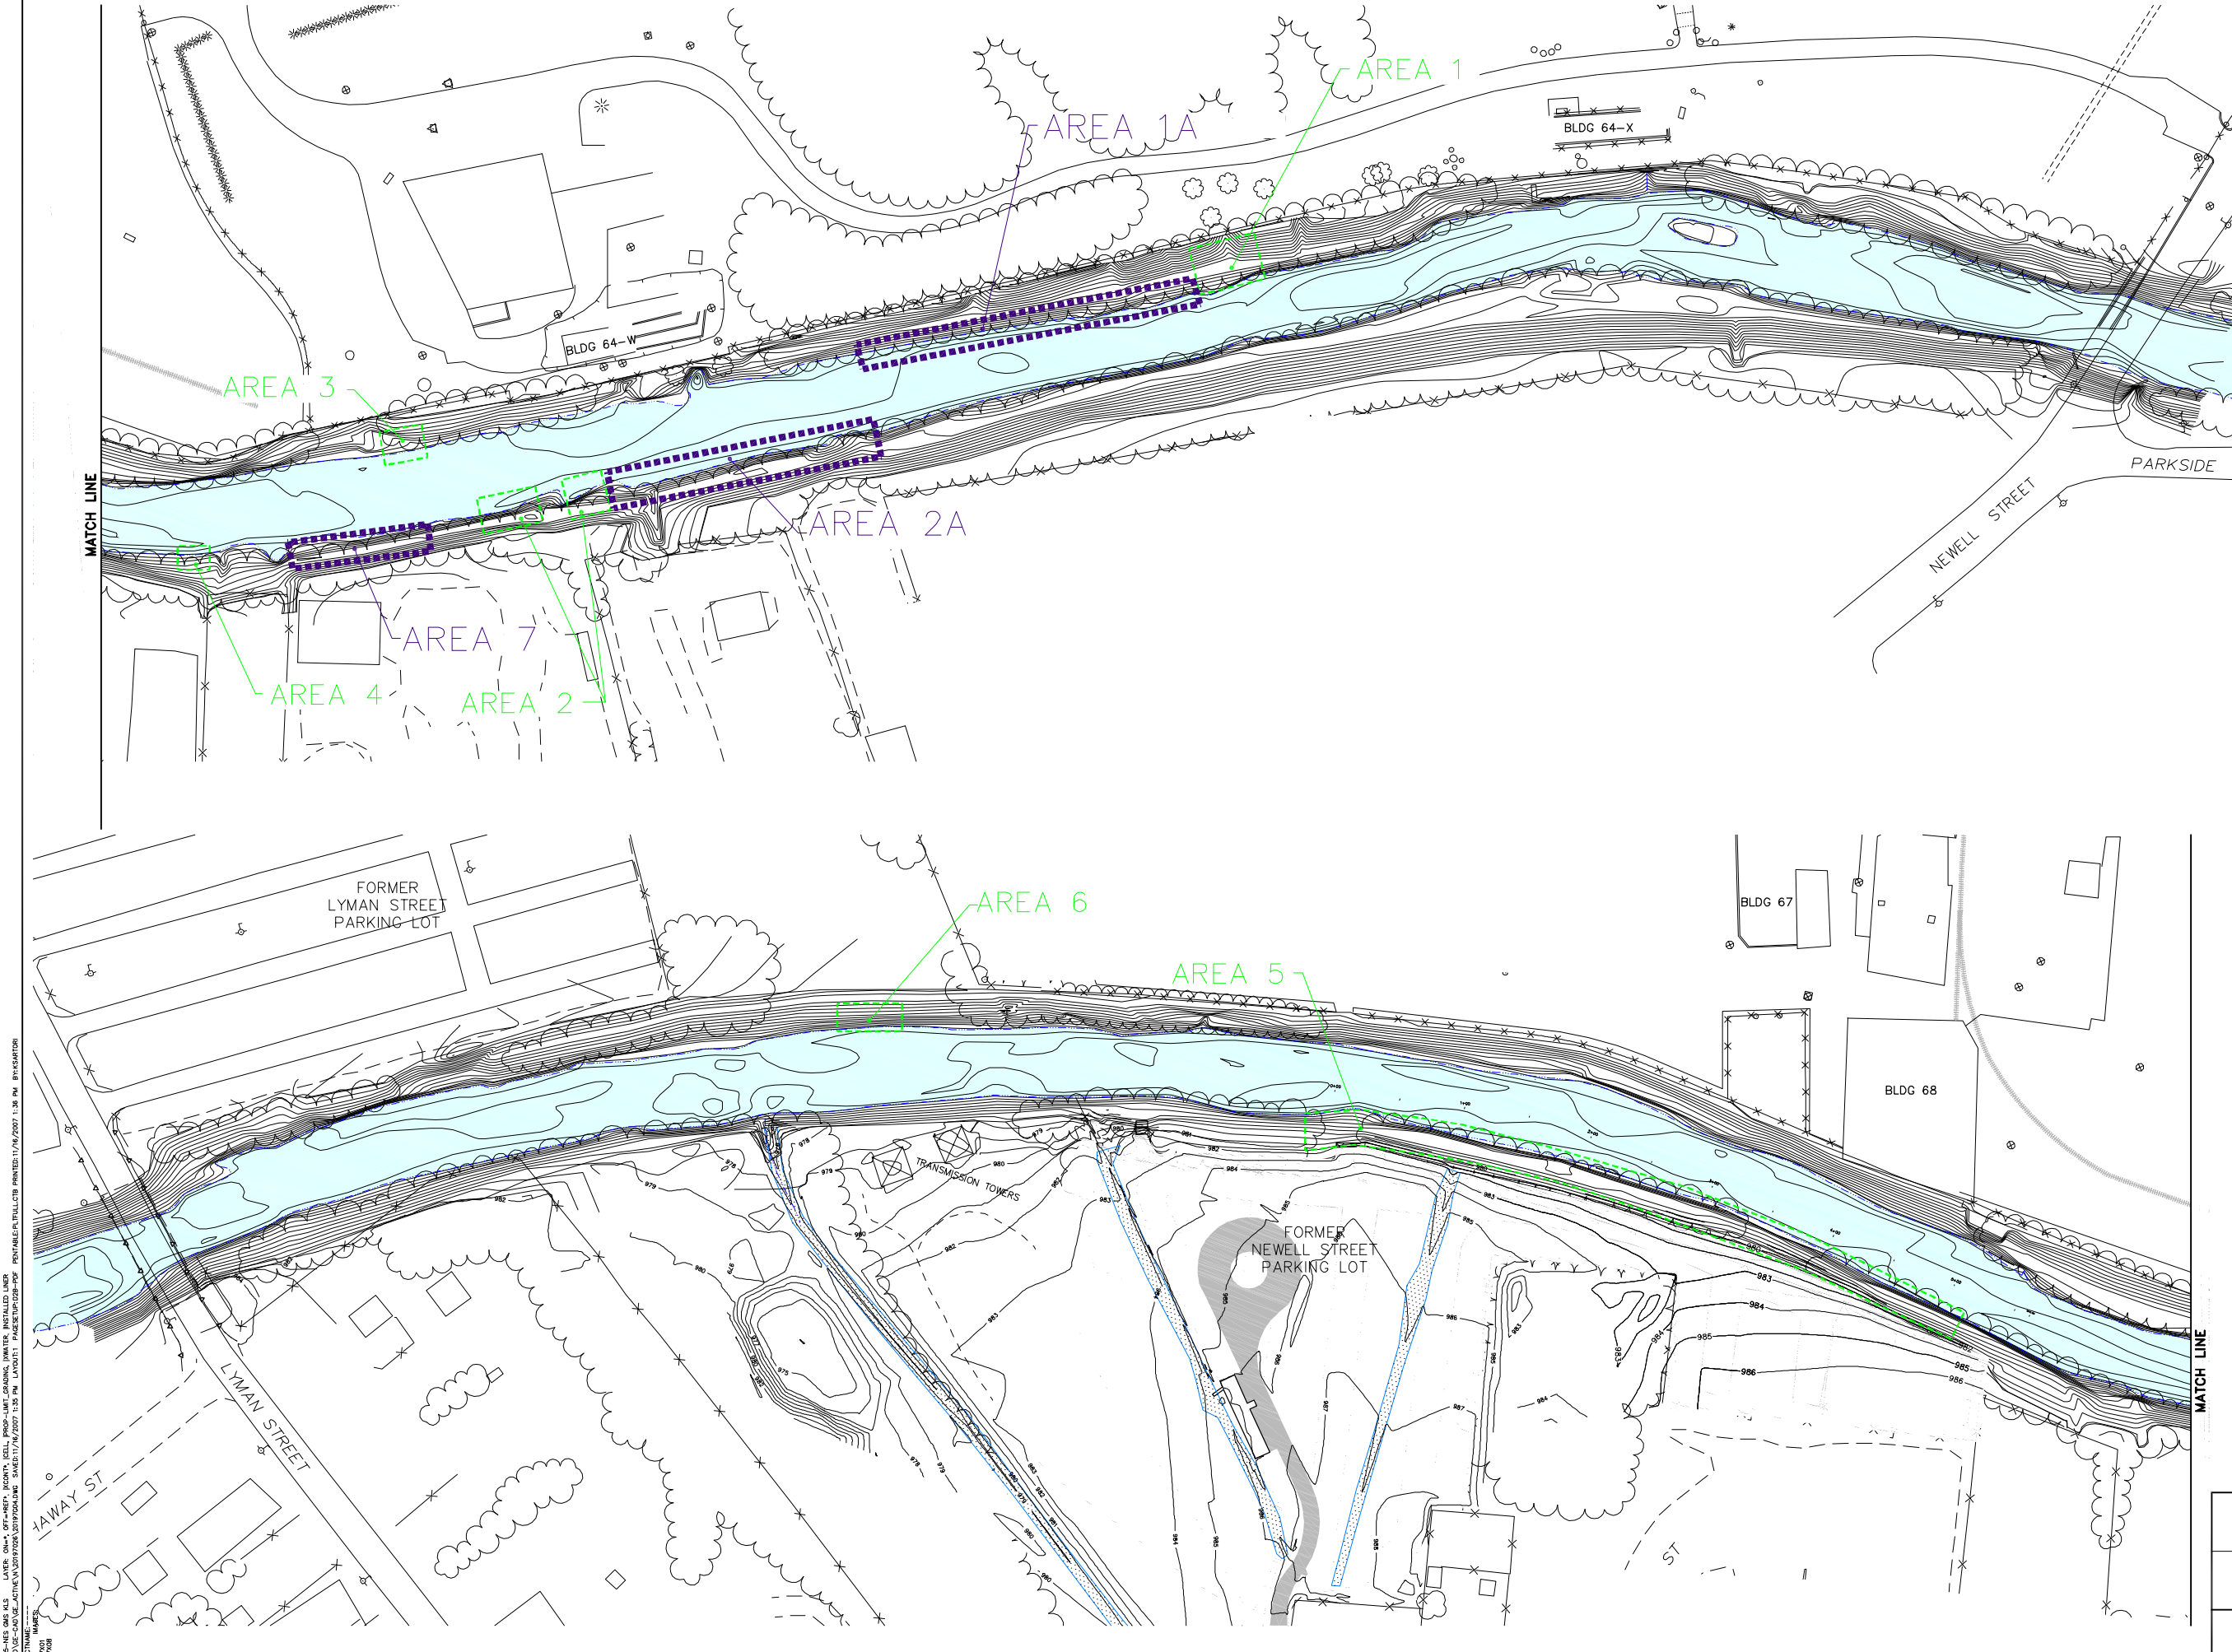
FIGURE  
**1**

Three areas were noted with either a visually observable loss of bank materials or movement of bank armoring during the 2007 inspection. Portions of these areas, or in one case the entire area of erosion

As noted above, the restoration of the areas of erosion identified above (except for Area 7) was initiated in October 2007, with EPA consent, in conjunction with the ongoing restoration of the areas of erosion noted in 2006. GE will continue to seek access to perform the restoration in Area 7. Further, GE will summarize the performance of these activities in the 2007 Annual Report. With the performance of the 2007 inspection, GE has completed the restored bank erosion monitoring program as outlined in the Work Plan. In the upcoming 2007 Annual Report, GE will propose a long-term monitoring plan related to erosion in the ½-Mile. The 2007 Annual Report will also include a summary of the performance of recent restoration activities performed in the ½-Mile in the areas of erosion discussed herein.

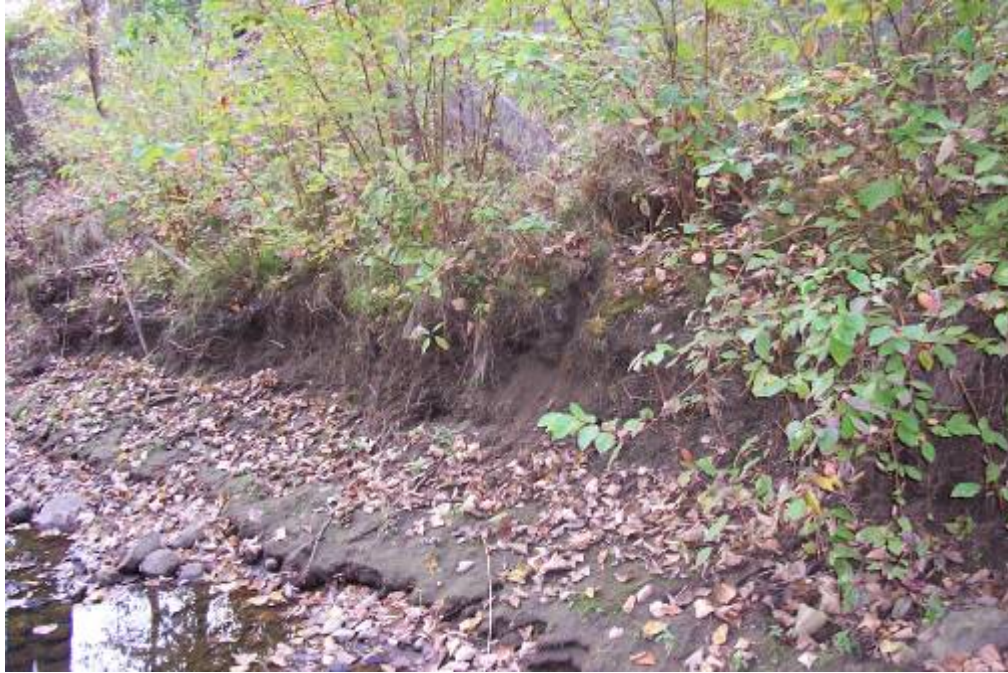
*Area 1A* – This area consists of undercut banks along the northern bank starting downstream of Building 64X (immediately west of 2006 Area 1) and extending approximately 250 ft downstream (Figure 1, Photos 1 and 2). Portions of this area intersect or are adjacent to previously cleared or restored areas. Erosion in this area is generally located in the mid-bank area (i.e., above adjacent riprap and the apparent bank-full elevation). The total volume of eroded material is estimated to be less than approximately 15 cubic yards (cy) of native materials and/or clean backfill; however, there was no evidence of eroded soil in the river. To reduce the potential for further erosion in this area, riprap will be added to the affected areas and keyed into the bank such that, to the extent practicable, areas receiving armor stone will be restored to previous grades. [Note that any armor stone placed as part of the proposed remedial/restoration activities will be similar to that used during the implementation of the Upper ½-Mile Reach Removal Action (i.e., graded riprap,  $D_{100} = 12$ -inch), as fully described in the Work Plan.]

Photo 1 – Area 1A: Undercut bank

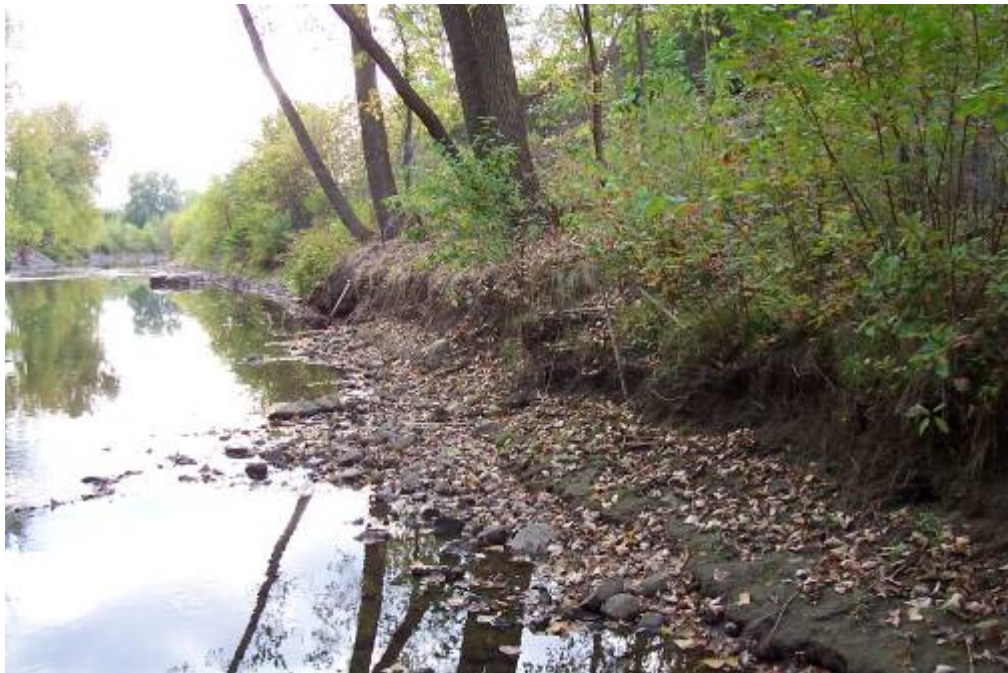
Photo 2 – Area 1A: Approximately 250 ft of undercut bank

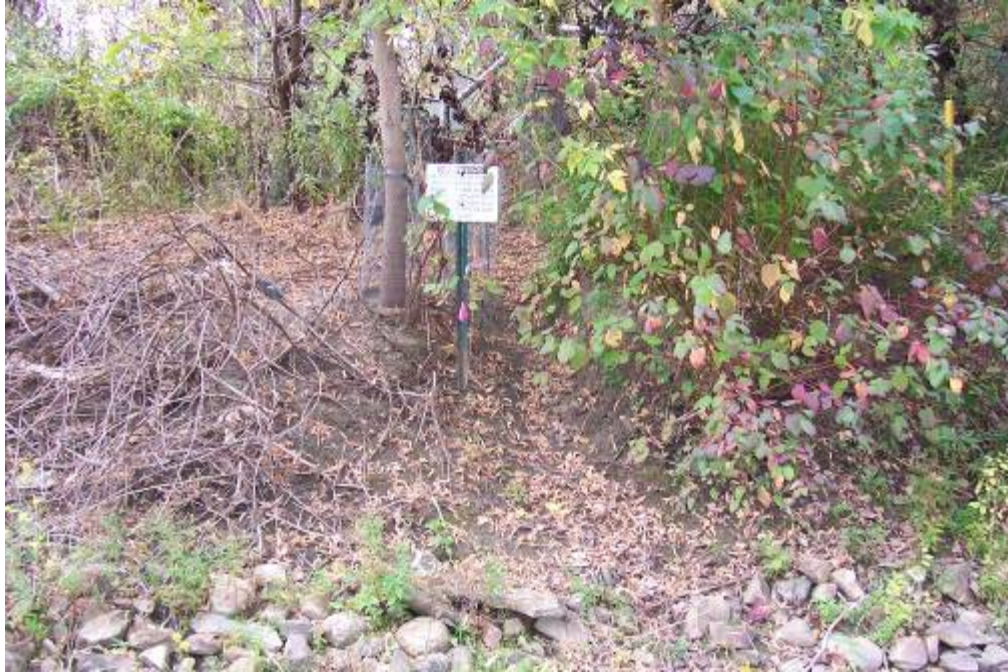
In addition, there are two areas of erosion located near the top-of-bank (Figure 1, Photos 3 and 4) in this area. This erosion was likely caused by concentrated surface run-off. To reduce the potential for future erosion in this area, hay bales will be positioned, as appropriate, to help divert concentrated runoff, and riprap will be placed within the eroded areas.

Photo 3 – Downstream Swale: Top-of- bank erosion in Area 1A

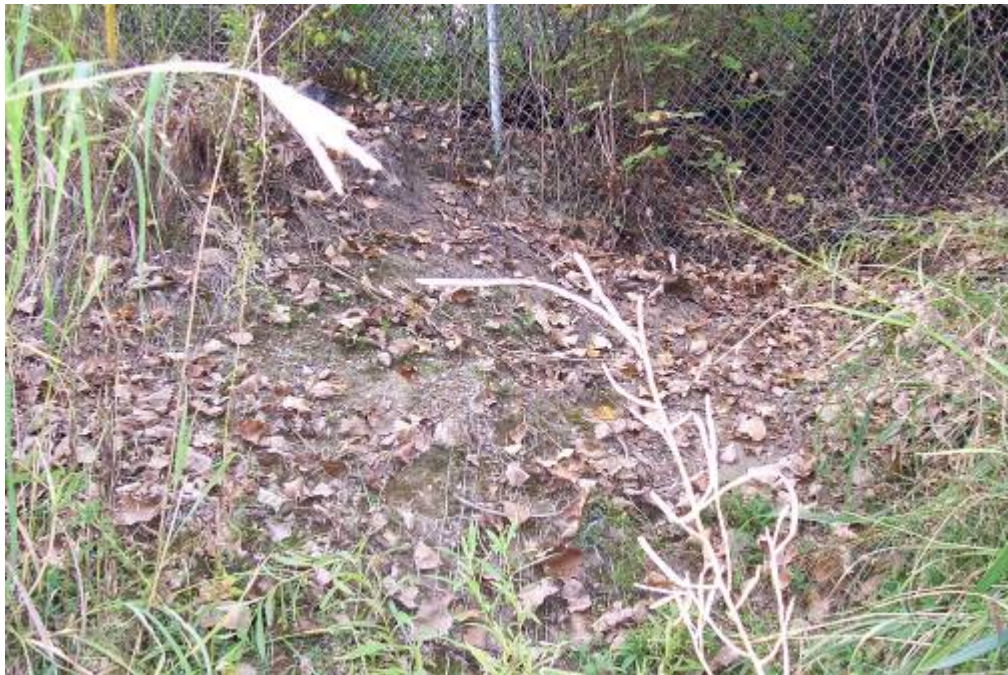
Photo 4 – Upstream Swale: Top-of- bank erosion in Area 1A

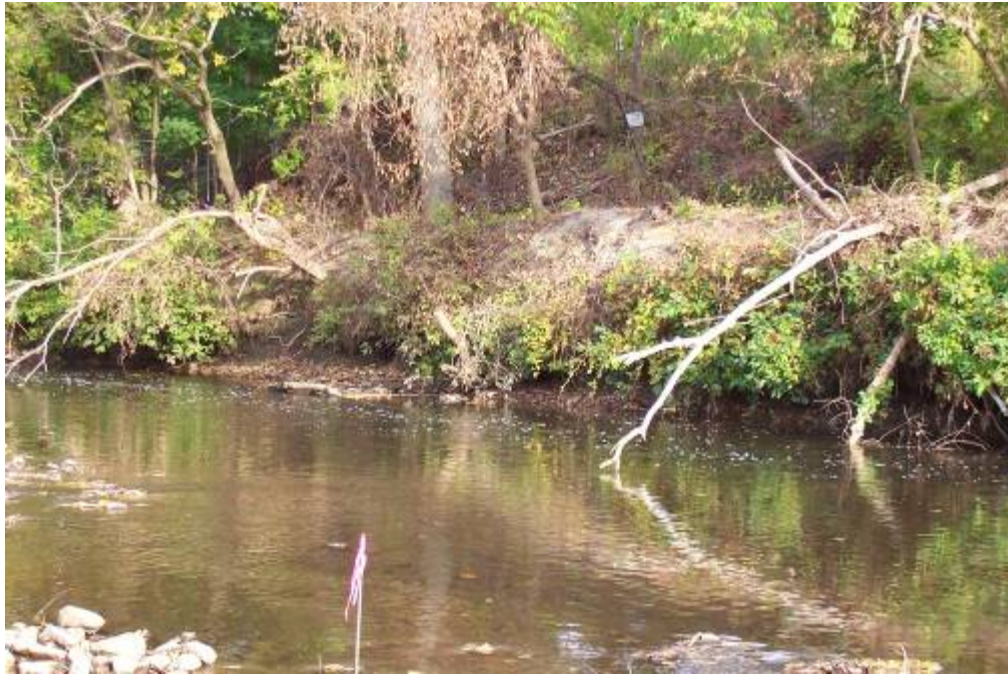
*Area 2A* – This area consists of approximately 200 ft of undercut banks along the southern bank immediately upstream of 2006 Area 2 directly across the river from Building 64 (Figure 1, Photos 5 and 6). Portions of this area intersect or are adjacent to previously cleared or restored areas. As with Area 1A, erosion in this area is generally located in the low- to mid-bank area. The total volume of eroded material is estimated to be less than approximately 30 cy of native materials and/or clean backfill; however, there was no evidence of eroded soil in the river. Riprap will be added to this area and keyed into the bank such that the undercut area is entirely filled and restored to approximate previous grades.

Photo 5 – Area 2A: Approximately 200 ft of undercut bank

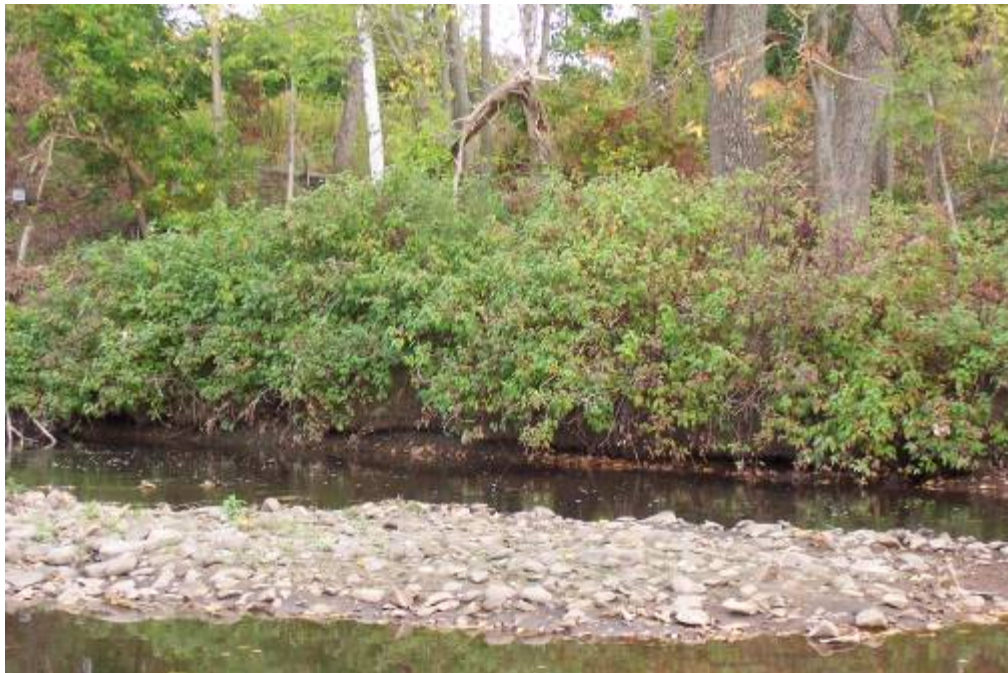
Photo 6 – Area 2A: Approximately 200 ft of undercut bank

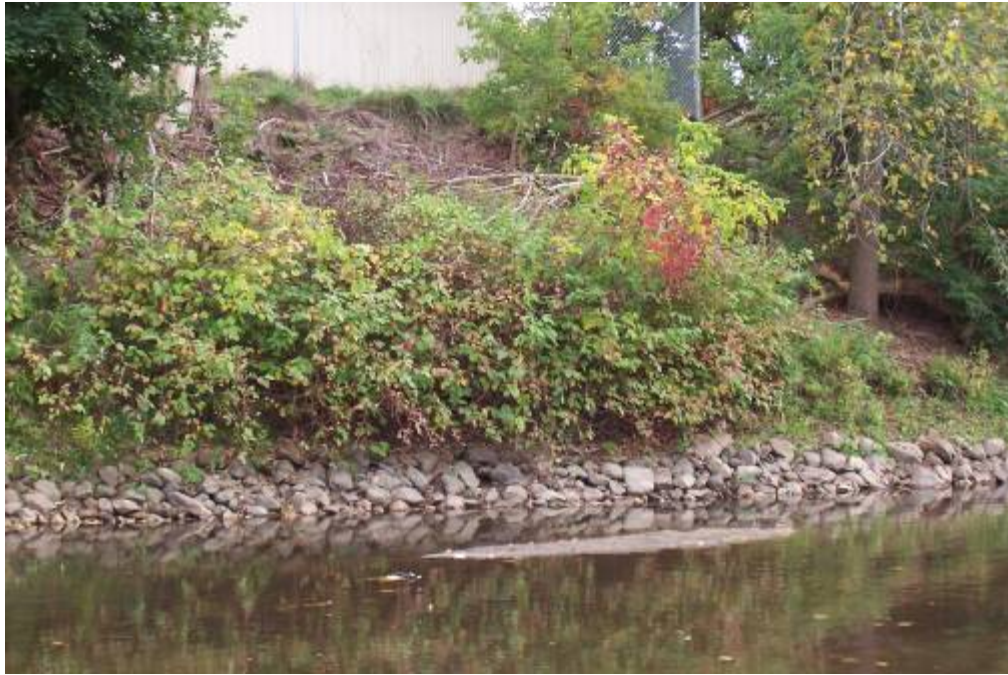
*Area 7* – This area consists of approximately 30 ft of undercut banks along the southern bank approximately 130 feet downstream from the western edge of Area 2A (Figure 1, Photo 7 through 8). Erosion in this area is generally located at the mid-bank elevation. The total volume of eroded material from this area is estimated to be less than 1 cy of native material from an area that was not previously cleared or restored as part of the Upper ½-Mile Reach Removal Action. There was no evidence of eroded soil in the river. Riprap will be added to this area and keyed into the bank such that the undercut area is entirely filled and restored to approximate previous grades. Note that GE has not yet been able to reach agreement with the property owner adjacent to this area for permission to access Area 7 to perform these restoration activities. GE is continuing to negotiate with the property owner for appropriate access, and to the extent access permission is obtained, will address this area.

Photo 7 – Area 7: Approximately 30 ft of undercut bank above Riprap

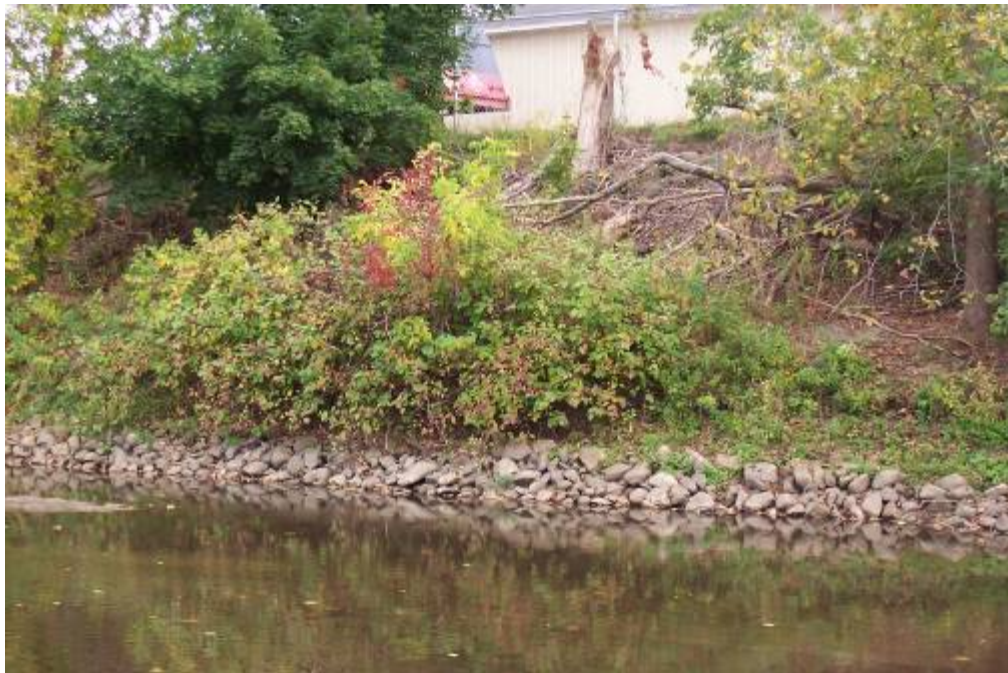
Photo 8 – Area 7: Approximately 30 ft of undercut bank above Riprap
