**SECOND FIVE-YEAR REVIEW REPORT**

**DUTCHTOWN TREATMENT PLANT SUPERFUND SITE  
DUTCHTOWN, ASCENSION PARISH, LOUISIANA**

**SEPTEMBER 2007**

**United States Environmental Protection Agency  
Region 6  
Dallas, Texas**

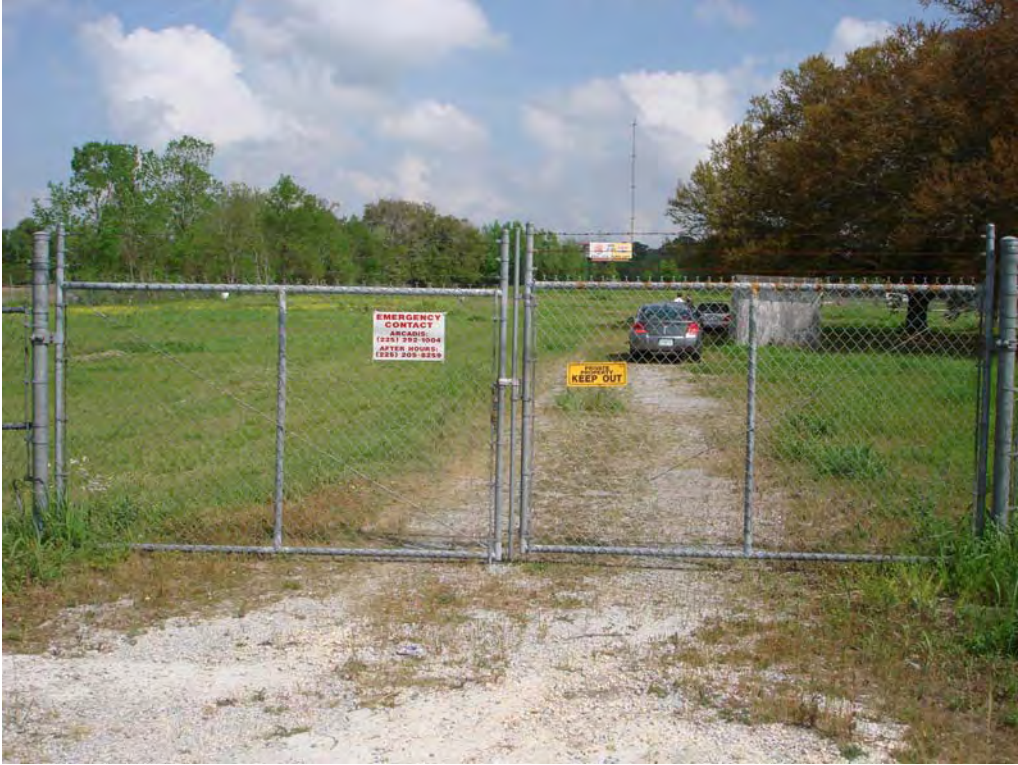
- **Signs:** Only three warning signs on the perimeter fence were noted at the time of the site visit.
- **Vegetation on exterior side of fence:** The vegetation is overgrown and has the potential to damage the fence, but is currently not compromising it.

Photograph No. 1 Site: Dutchtown Treatment Plant Superfund Site  
Description: Entrance gate to site with warning signs Date: March 29, 2007

4. The O&M section of the Revised RA Report (Geraghty & Miller, Inc. [G&M] 1997) stated the placement of "Danger Keep Out" signs every 200 feet along the fence. These signs should be replaced as previously agreed.

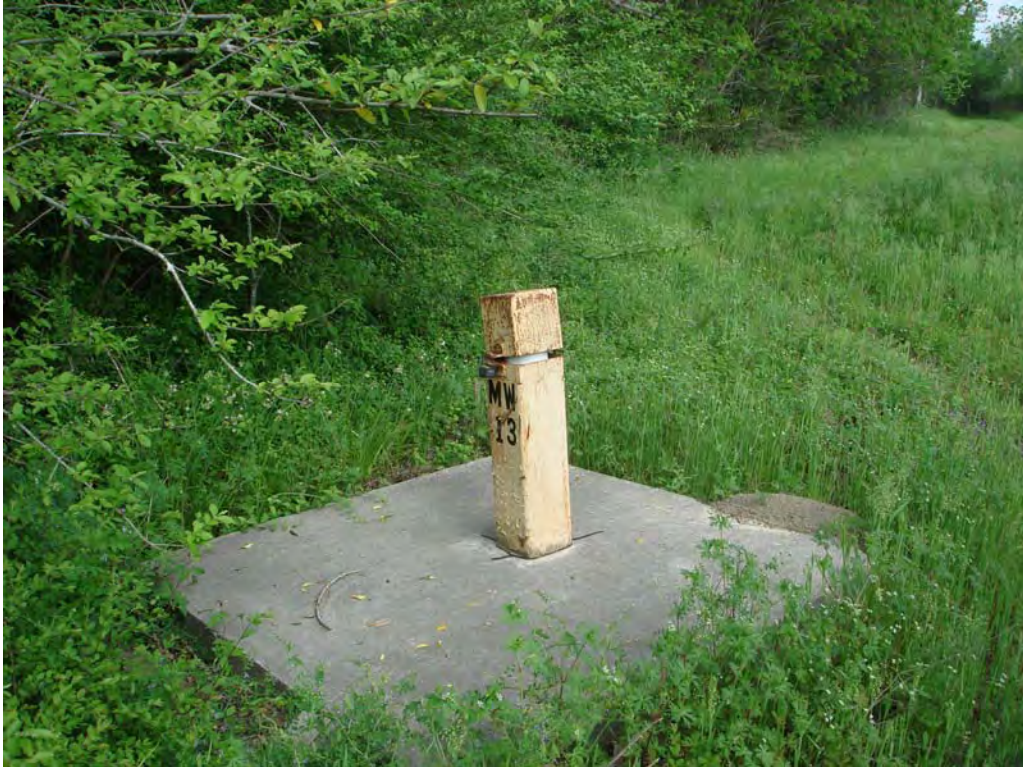
2. The hinge to monitoring well MW-13 has been damaged, leaving a large gap between the protective metal well cap and casing.
3. Three areas of fence damage were observed during the March 2007 site visit; one on the northwest side of the site and two along the eastern side of the site.

- **Monitoring well MW-13:** The hinge on MW-13 appears to have been damaged, leaving a large gap between the protective metal well cap and the casing.

Photograph No. 7 Site: Dutchtown Treatment Plant Superfund Site  
Description: Monitoring well MW-13 north of site Date: March 29, 2007  
(note gap caused by damaged hinge)

2. The hinge on monitoring well MW-13 should be repaired properly, if excessive corrosion inhibits access to the well.
3. The three areas of damaged fence noted during the site visit should be repaired, including the barbed-wire strands along the top of the fence, to prevent unauthorized access to the site.

2. Repair the hinge on monitoring well MW-13 if excessive corrosion inhibits access.
3. Repair the damaged portions of the fence.
4. Replace “Danger Keep Out” signs along the fence.

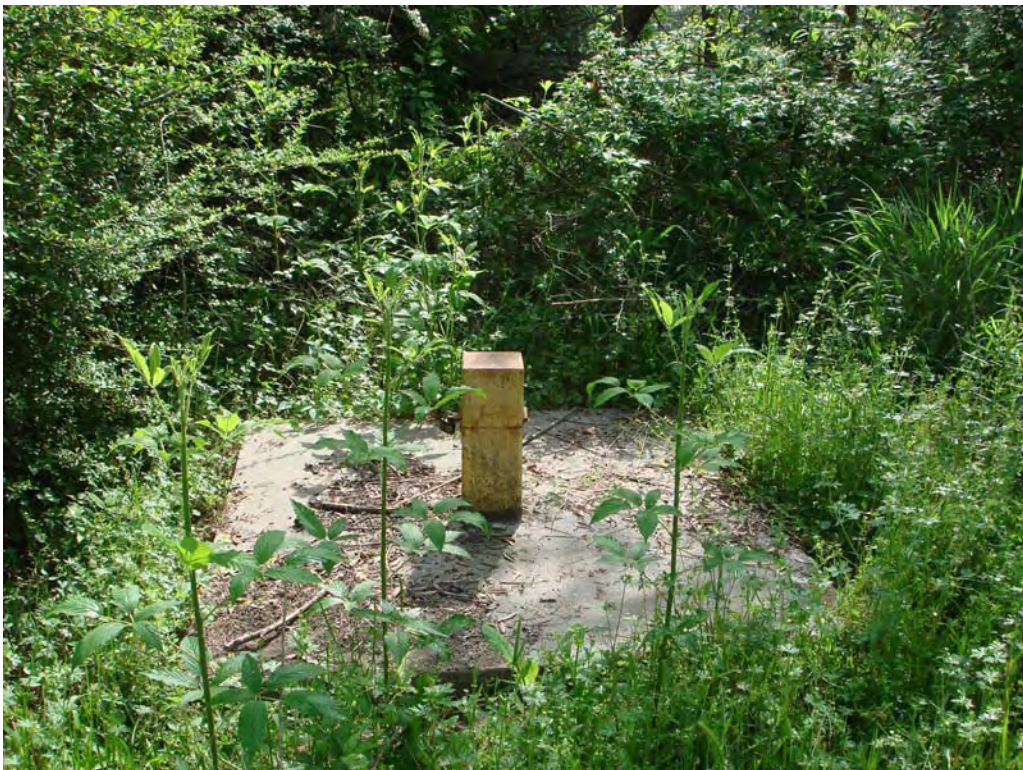
Photograph No. 8 Site: Dutchtown Treatment Plant Superfund Site  
Description: Monitoring well MW-12 Date: March 29, 2007  
(note heavy vegetation surrounding concrete pad)

5. Vegetation immediately adjacent to the fence should be removed to prevent damage to the perimeter fence.
6. Vegetation surrounding MW-12 should be cleared to maintain access of the well during sampling events.

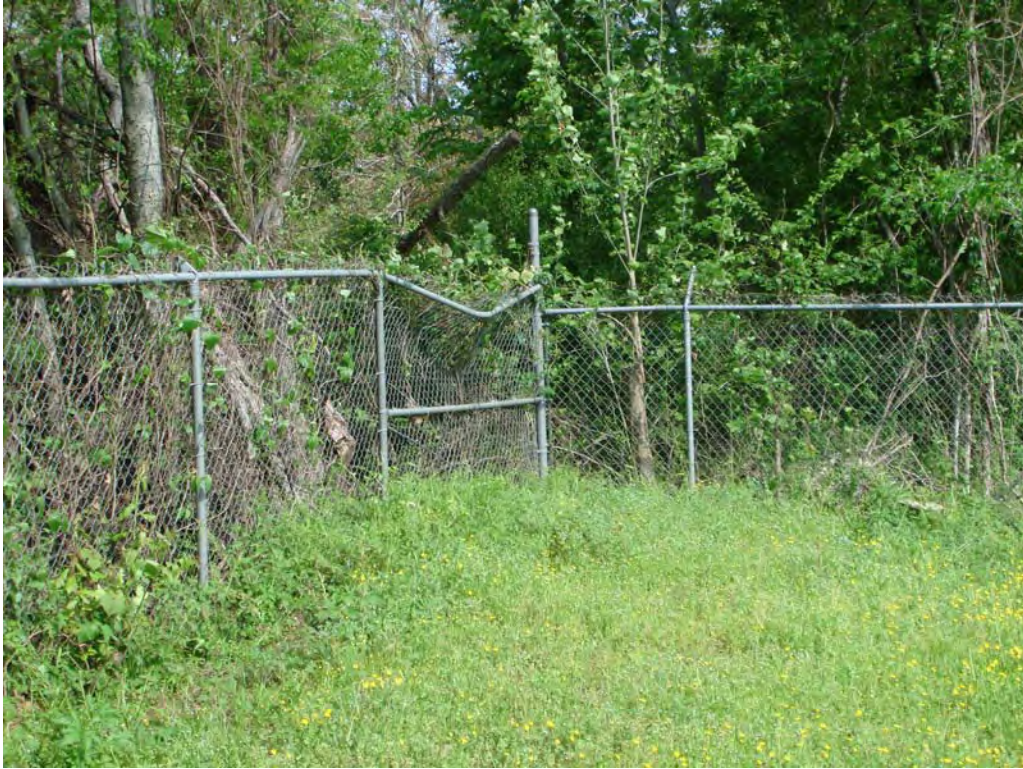
- **Fence damage:** Three areas of fence damage were observed during the March 2007 site visit; one on the northwest side of the site and two along the eastern side of the site.

Photograph No. Site: Dutchtown Treatment Plant Superfund Site  
Description: Damaged perimeter fence northwest corner of site Date: March 29, 2007

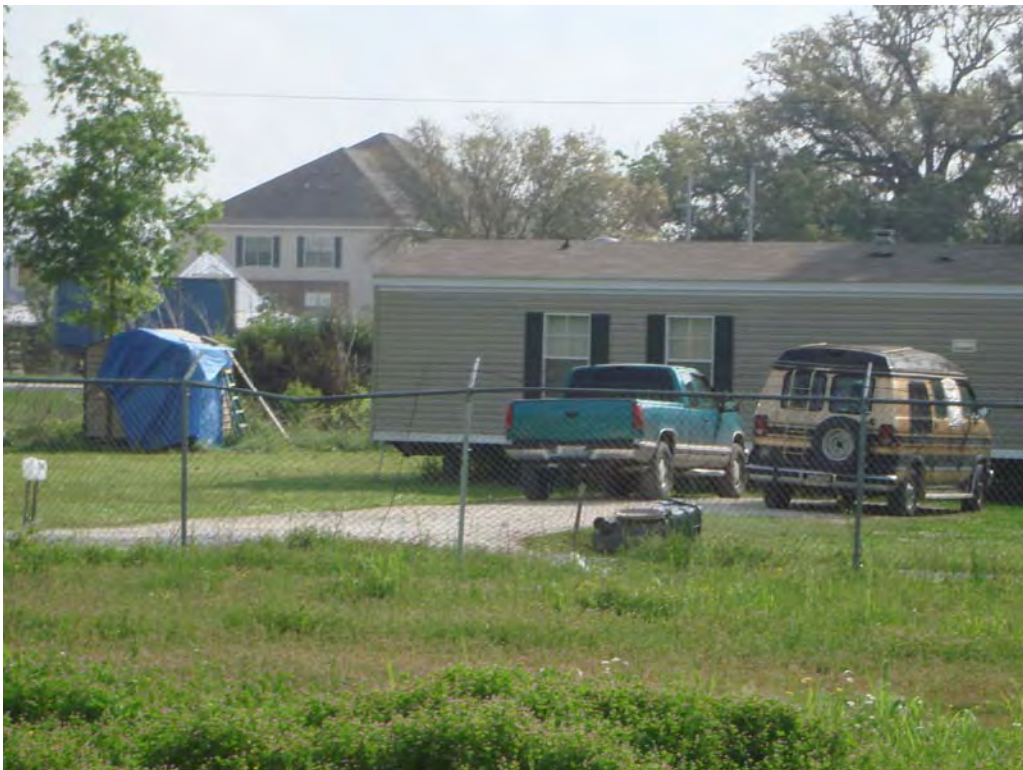
- “I know that the fence on the east side of the site has been damaged. I suspect that it occurred during clearing of the land and placement of the manufactured housing and or by residents and visitors backing into it. We had two major hurricanes with hurricane force winds that felled trees and blew things against the fences on all sides. There is little evidence of ‘trespassing’. It seems that the large wire in the transmission box would have been scavenged by trespassers if many were coming on the site. I wasn’t aware of any ‘emergencies’ until during the site walk, when George Cramer mentioned the ‘fireworks incident’ that had ignited the grass.”

Photograph No. 10 Site: Dutchtown Treatment Plant Superfund Site  
Description: Damaged fence on east side Date: March 29, 2007  
(note residential property developments)
