THIRD FIVE-YEAR REVIEW REPORT

HIGHLANDS ACID PIT SUPERFUND SITE
HIGHLANDS, HARRIS COUNTY, TEXAS

September 2007

United States Environmental Protection Agency
Region 6
Dallas, Texas

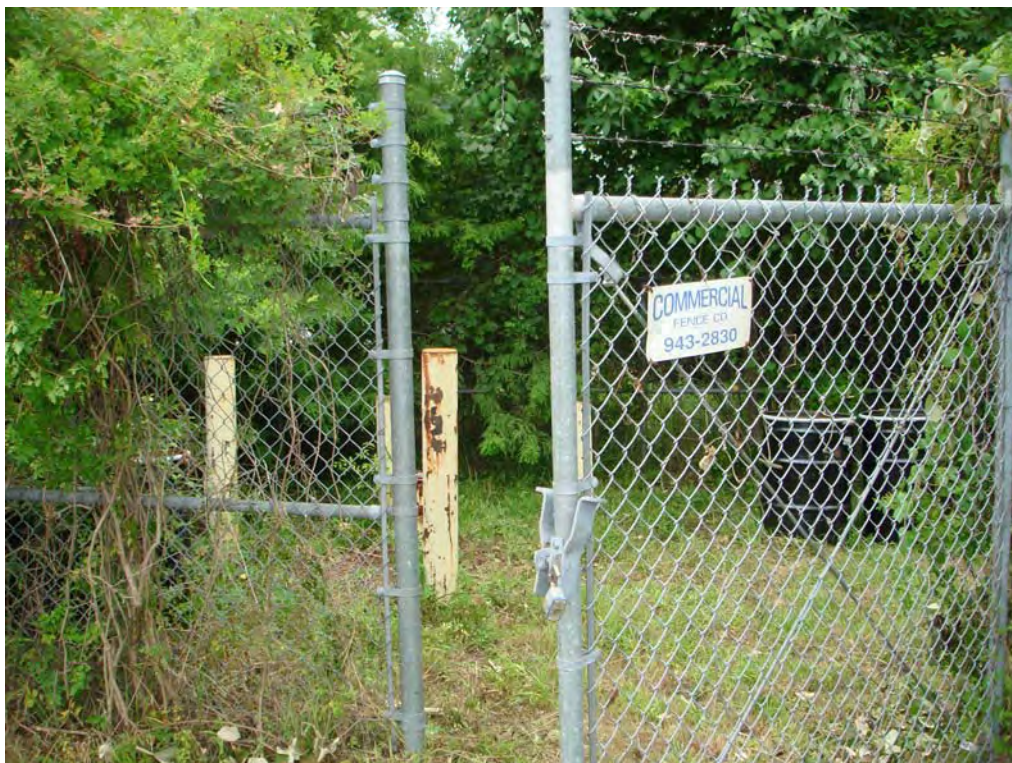
Photograph No. 3

3. **Fencing O&M**–Vegetation within and adjacent to the cluster fencing was noted at the time of the site visit. The perimeter and cluster fencing for the site generally appeared to be in good condition, with the exception of a bent top rail and broken barb wire at the UA-11 cluster fence (see photograph 13). The integrity of the fences could be compromised if the vegetative overgrowth continues. Warning signs were located on the main entry gates of the site’s main entrance, but nowhere else on the HAP site.

Description: DA-05 well within cluster fencing; note overgrowth of vegetation on and within fencing

- Vegetative growth and bushes were noted near and on the concrete pads of monitoring wells. The overgrowth should be cut and removed. Also, vegetative overgrowth should be removed from the perimeter fences, and the site grass should be maintained by regular mowing.

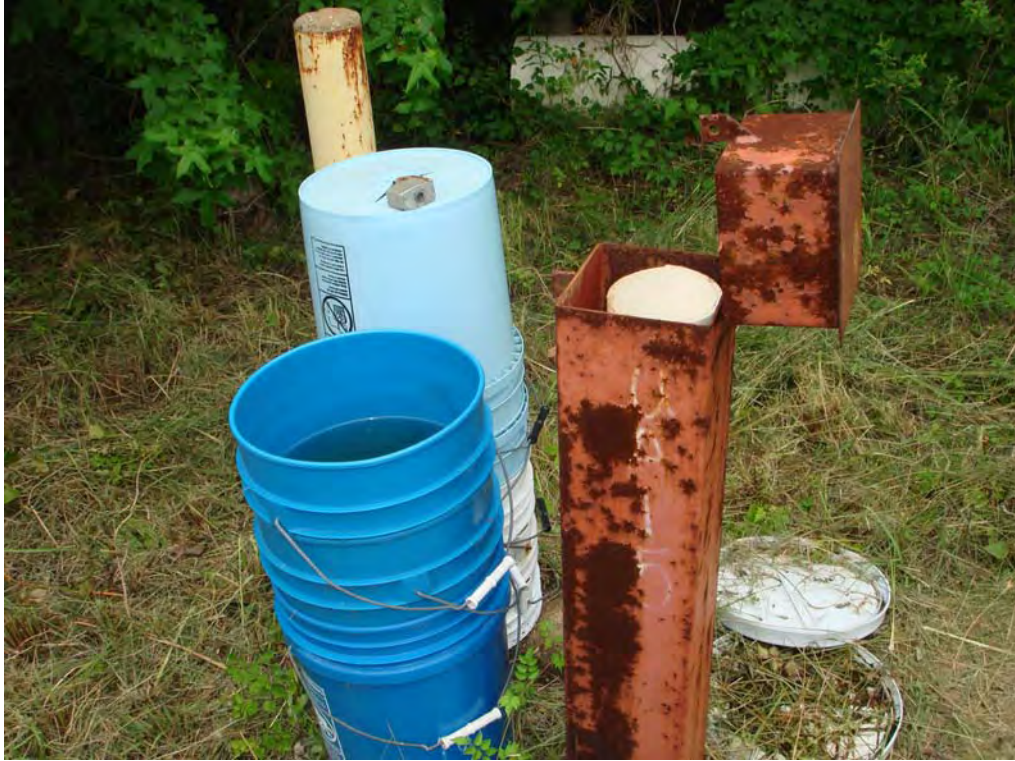
2. **Monitoring Well O&M**–During the site inspection, monitoring well compression caps were either missing or in need of replacement for all of the site wells. The hinge to the metal well protector for UA-11 was broken. The locking pins for the caps to the metal well protectors were missing for wells, DA-01, DA-02 and MA-02. Additionally, vegetative growth was covering some of the concrete monitoring well pads, with bushes (up to 5 inches in trunk diameter at MA-02) growing adjacent to the concrete pads. Photographs 8 (MA-02) and 10 show examples of the vegetative growth next to and on the concrete pads. Significant subsidence was noted under the concrete pad of MA-06 (see photograph 14), with animal burrowing activities noted around monitoring wells DA-02 and MA-05. The polyvinyl chloride (PVC) riser at MA-02 is extremely low within the metal protective casing, which may make it difficult to obtain accurate water level readings during sampling events. Several monitoring well metal protector casings were noted to be rusty and in need of repainting and reidentification.

Photograph No. 5 Site: Highlands Acid Pit Superfund Site
Description: UA-15 well-missing compression cap, in need of paint, removal of discarded 5-gallon buckets Date: June 20, 2007

- New compression caps should be placed on all monitoring wells. The hinge on monitoring well UA-11 should be repaired. For security, missing metal well cap locking pins should be replaced. The top rail and barb wire at the cluster fence for UA-11 should be repaired. Warning signs should be placed on posts within the cluster fencing of the monitoring wells.

- The riser within MA-02 should be extended and surveyed during the next surveying event (O&M benchmark survey). Monitoring well metal protector casings should be repainted and reidentified, as necessary to inhibit rusting. Additionally, steps should be taken to eliminate burrowing animals in the vicinity of the monitoring wells.

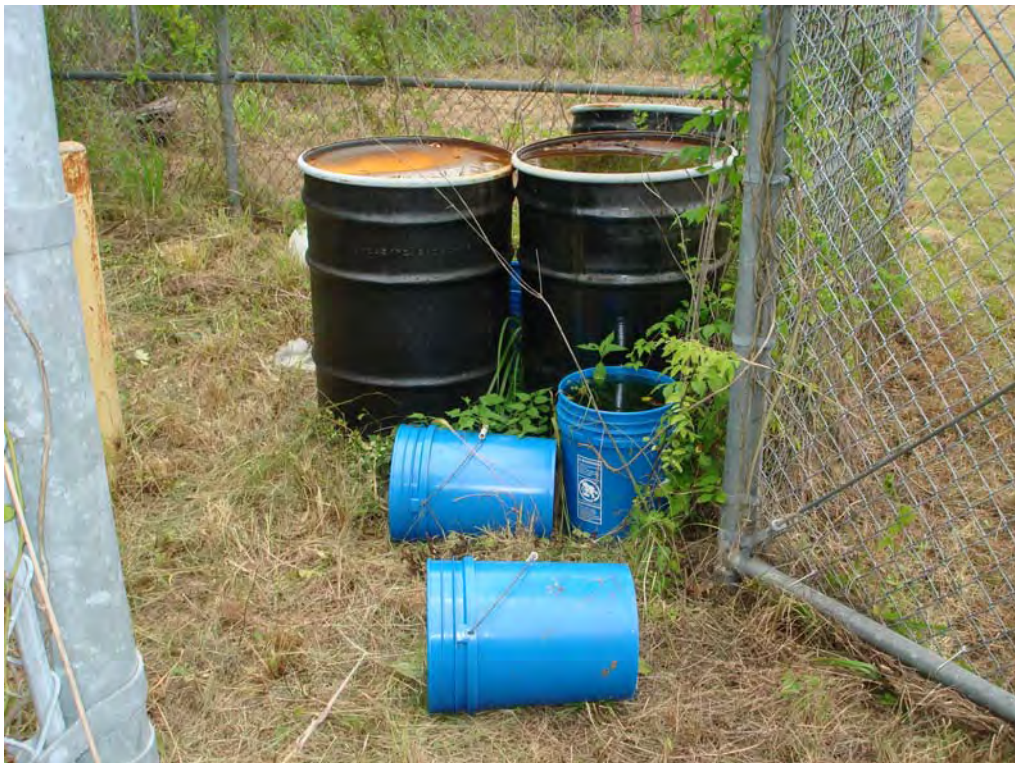
of this report, this activity had not been conducted. General debris (i.e., visqueen, five-gallon buckets) was noted in various locations throughout the site. Minor difficulties were encountered while unlocking/locking deadbolts located at the gates of the cluster fencing and on the caps of the metal well protectors. Weathered 55-gallon drums, some lacking completed identification, were noted in several of the cluster fencing units on the north side of the site.

Photograph No. 6 Site: Highlands Acid Pit Superfund Site
Description: Investigative derived water within 55-gallon drums, with discarded 5-gallon buckets in need of disposal Date: June 20, 2007

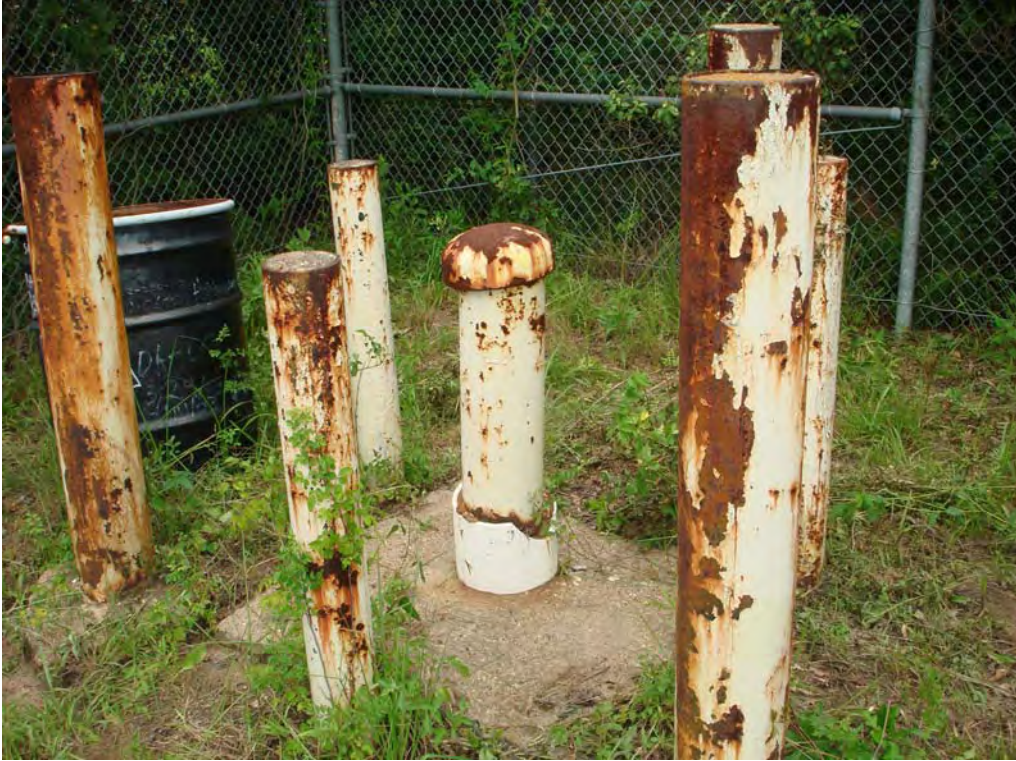
Photograph No. 7

locking security pin from cap of protective metal casing

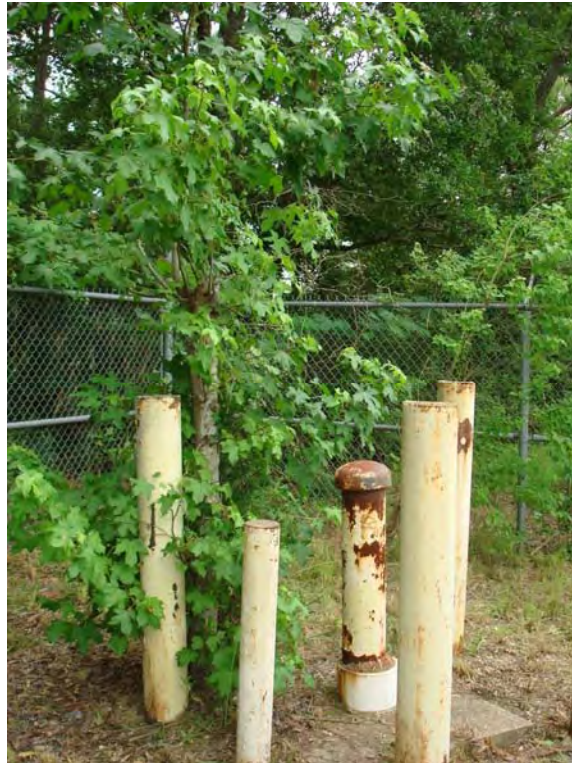
Photograph No. 8

cap, note 5-inch diameter bush adjacent to well pad, in need of paint

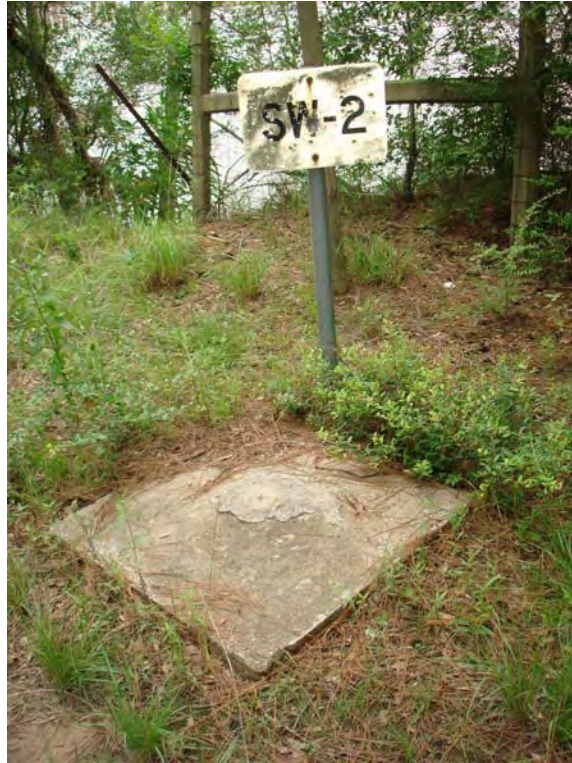
Photograph No. 9

Description: Sign indicating location for surface water and sediment sampling; note pellet holes in face of sign

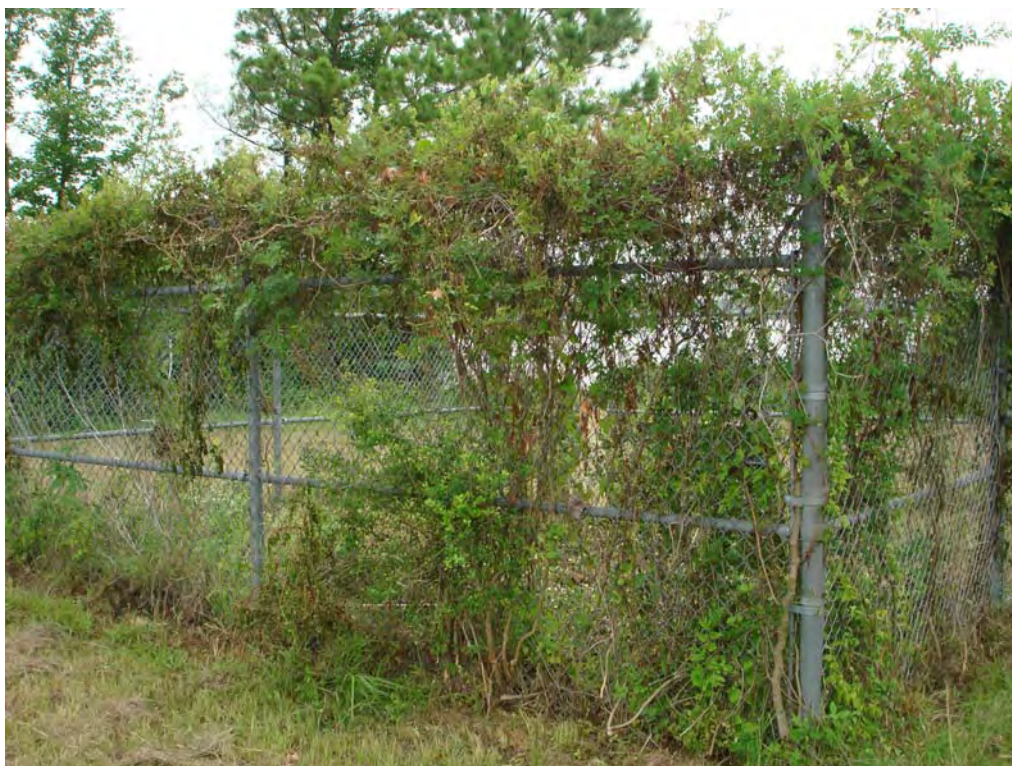
Photograph No. 11 Site: Highlands Acid Pit Superfund Site
Description: Vegetative overgrowth on cluster fencing; Date: June 20, 2007
maintenance activities indicated it had been recently cut at the base

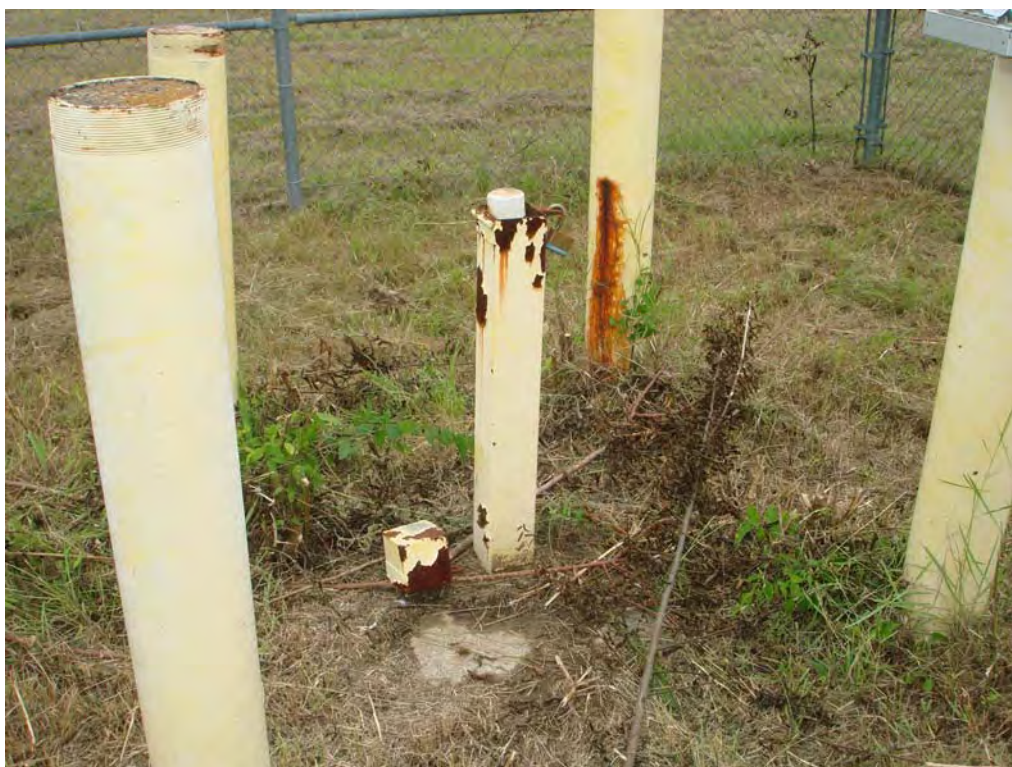
The wells appeared to be in fair to good condition, with some wear indicating the need for repair, repainting, and replacement of compression caps. Site access appeared to be sufficiently restricted due to the cluster fencing. No vandalism was observed with the exception of pellet holes in the face of the SW-02 sign. The fence and gates were in good condition, with one area of minor damage to the top railing and the top strand of barb wire fence at monitoring well UA-11. One hinge was noted to be broken and in need of repair.

Photograph No. 12 Site: Highlands Acid Pit Superfund Site
Description: Monitoring well UA-11 with a broken hinge Date: June 20, 2007

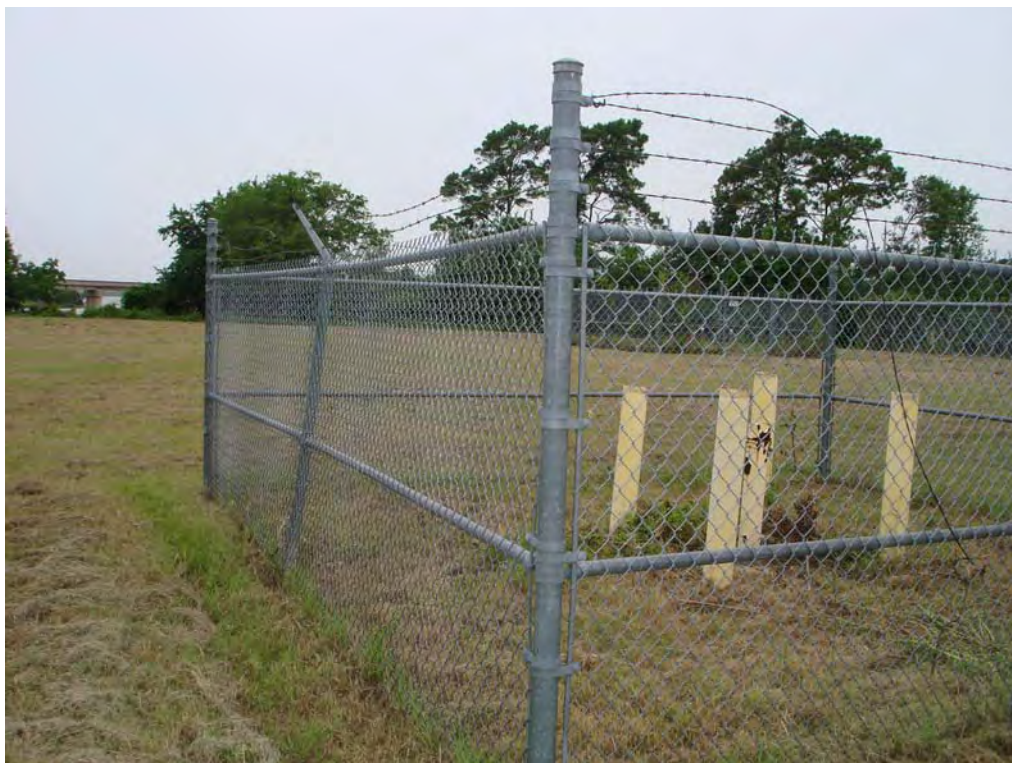
Photograph No. 13

Description: Cluster fencing with bent top rail and broken
barb wire
