FIVE-YEAR REVIEW

**Jacksonville Municipal Landfill Superfund Site
EPA ID# ARD980809941
Lonoke County, Arkansas**

FIRST FIVE-YEAR REVIEW REPORT
for
Jacksonville Municipal Landfill Superfund Site
Lonoke County, Arkansas
EPA ID# ARD980809941

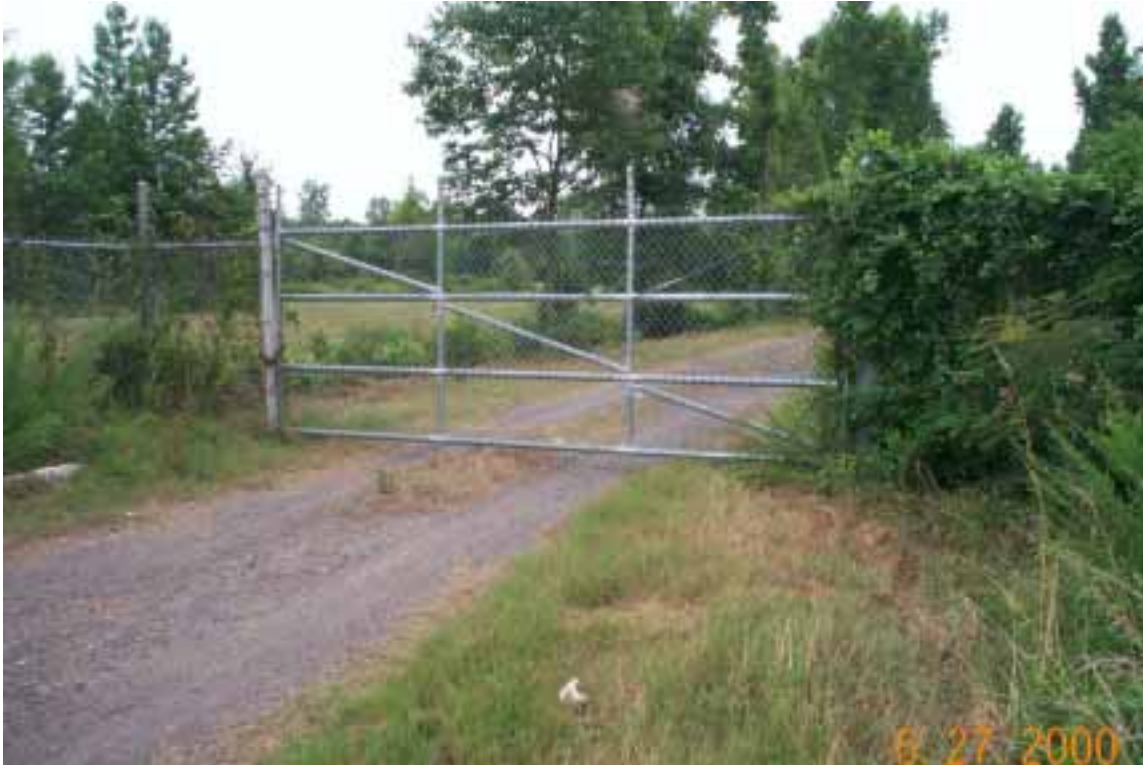
Photograph 1.

The area around the site is densely wooded (Photos 1, 13 and 14, Attachment 4). The fencing around the site appeared intact and secure, although no signs were posted on the fence or the gate (Photo 1, Attachment 4). No vandalism was evident, and the roads were adequate (Photos 10 and 11, Attachment 4). The soil cover appeared to be in good condition; no settlement, cracks, or erosion was evident (Photos 10 and 11, Attachment 4). The presence of poison oak, poison ivy, and numerous ticks were observed.

Main access gate for Jacksonville
Municipal Landfill property; gate located at
north end of property along Graham Road.

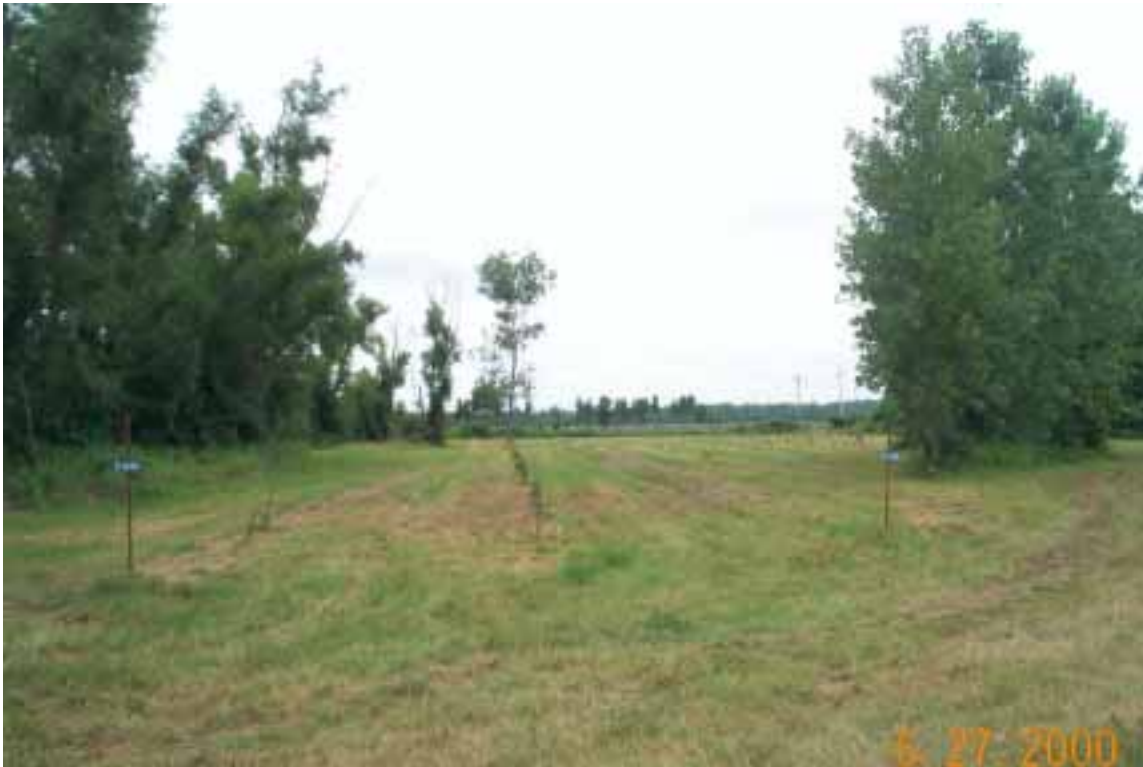
Photograph 2.

Facing north toward one of the tree farms maintained by the City of Jacksonville on the landfill property. Graham Road is visible at mid-center of photograph beyond tree farm.

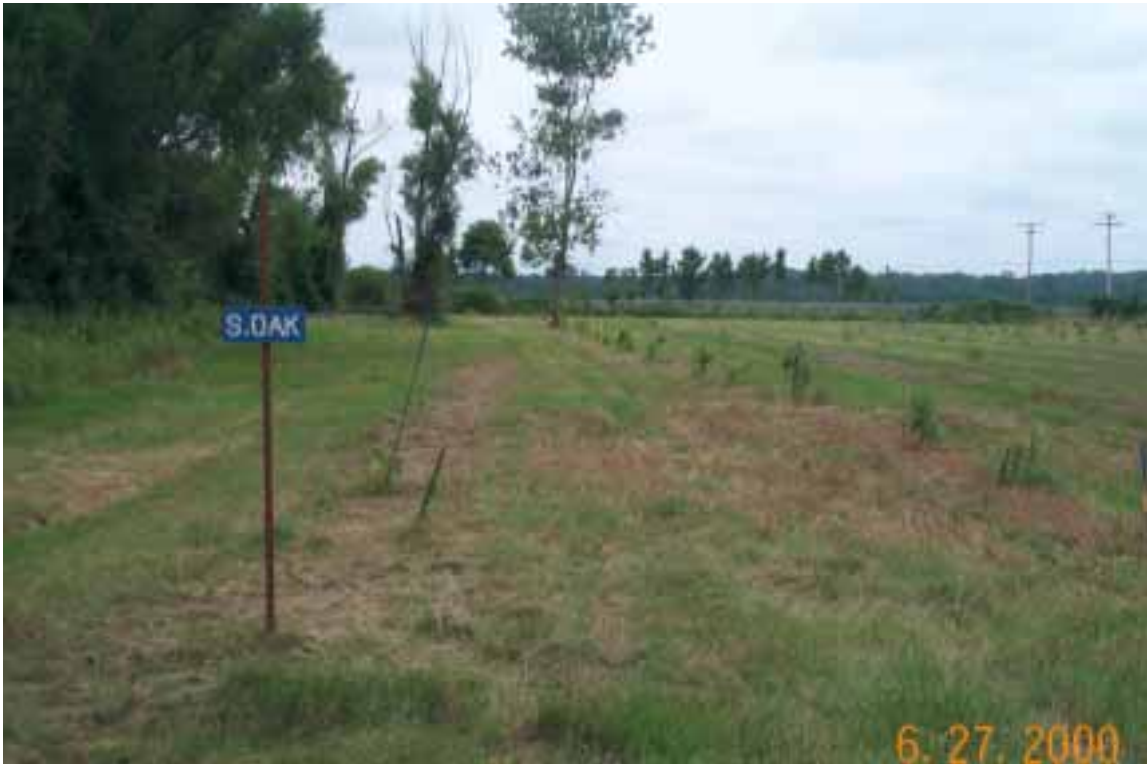
Facing north; closer view of tree farm seen in Photograph 3.

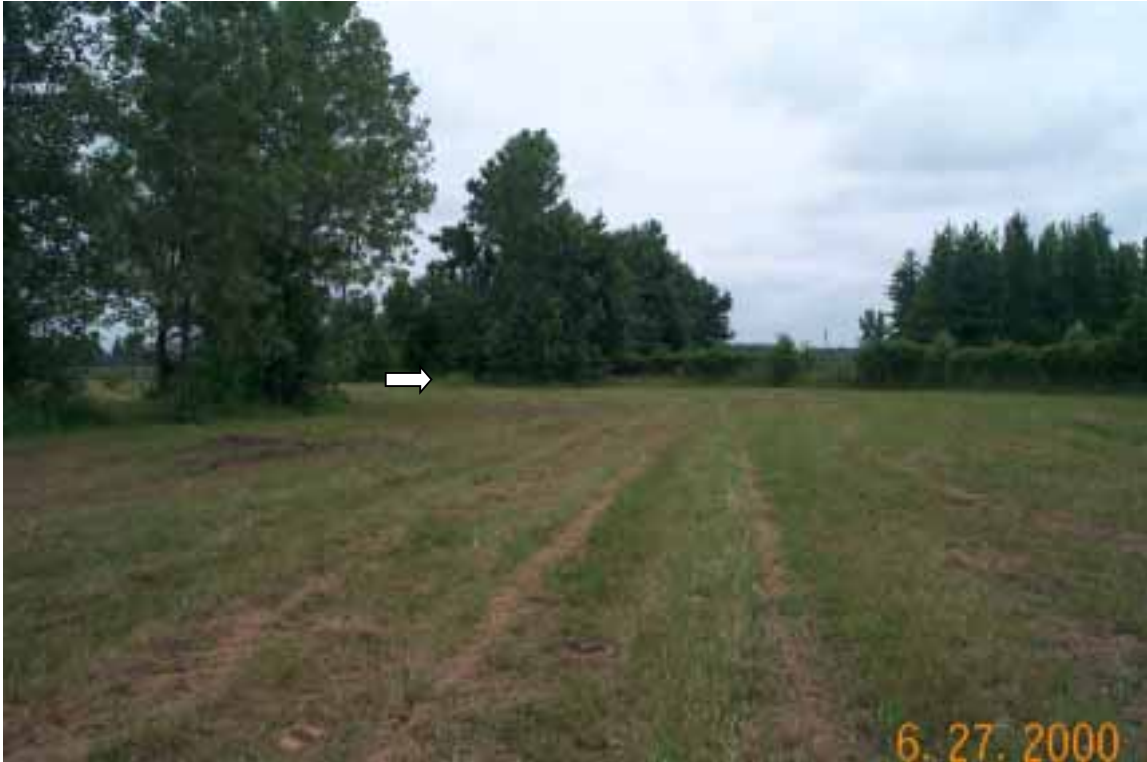
Photograph 4.

Facing northeast along Teppco pipeline right-of-way. To left of view is the tree farm visible in Photographs 2 and 3.

MWJ-05 is visible just left of center (see arrow).

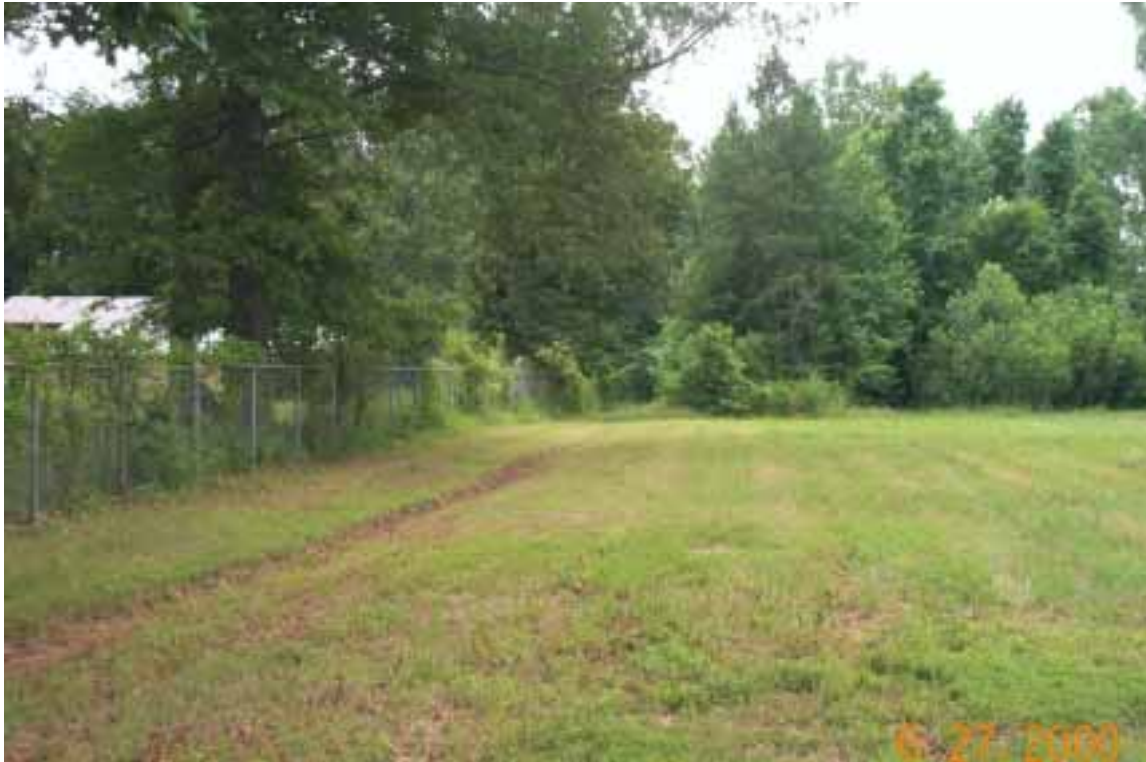
Photograph 5.

Facing south along perimeter fence on east side of Jacksonville Municipal Landfill property, near wells MWJ-08 and 09.

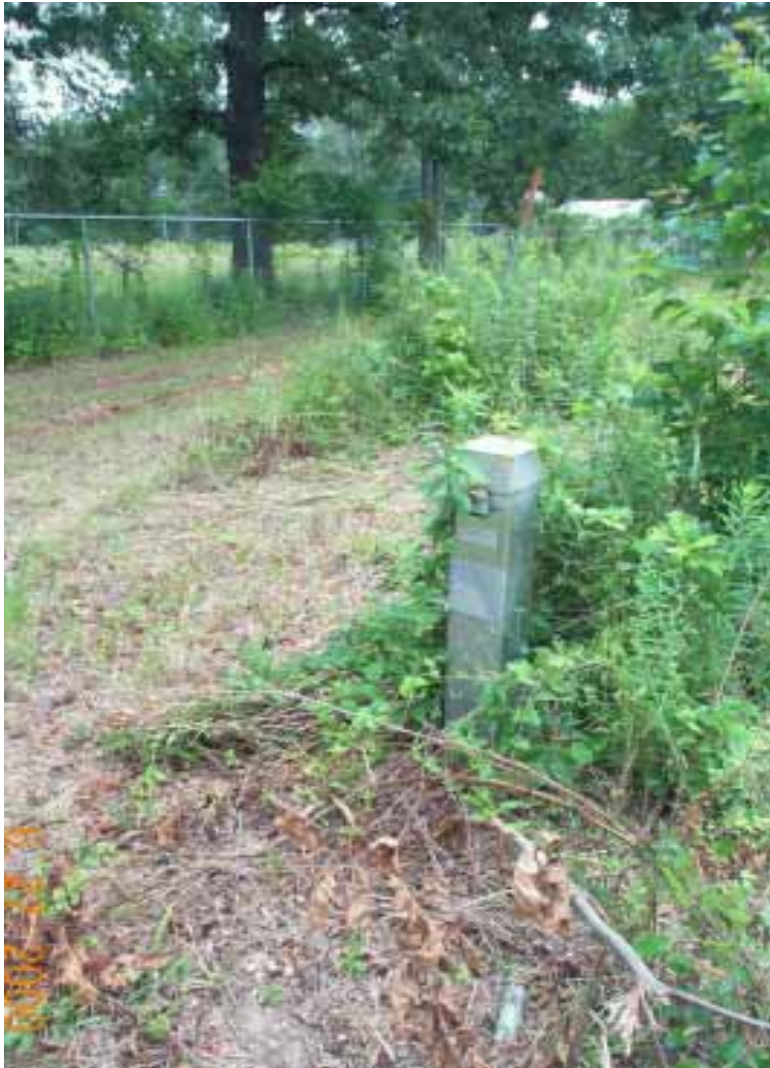
Photograph 6.

Facing southeast toward perimeter fence, monitor well MWJ-07 visible in foreground.

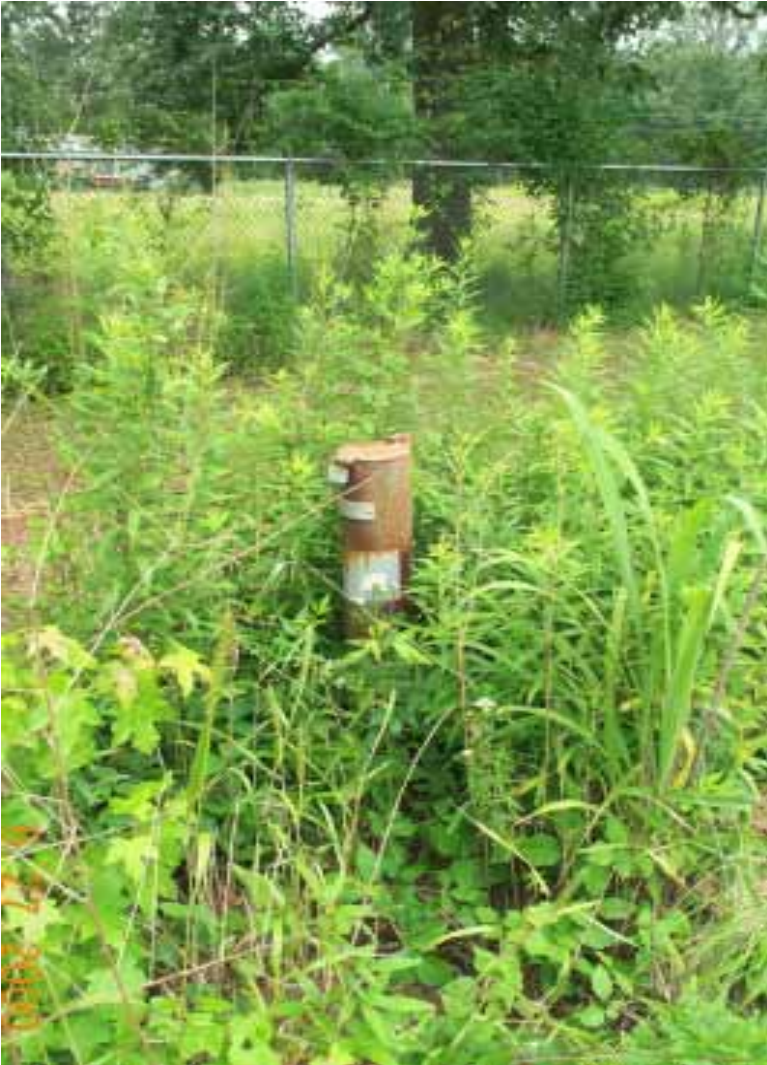
Photograph 7.

Facing east-southeast toward perimeter fence, monitor well MWJ-08 visible in foreground. MWJ-07 (Photograph 6) is located to left of view.

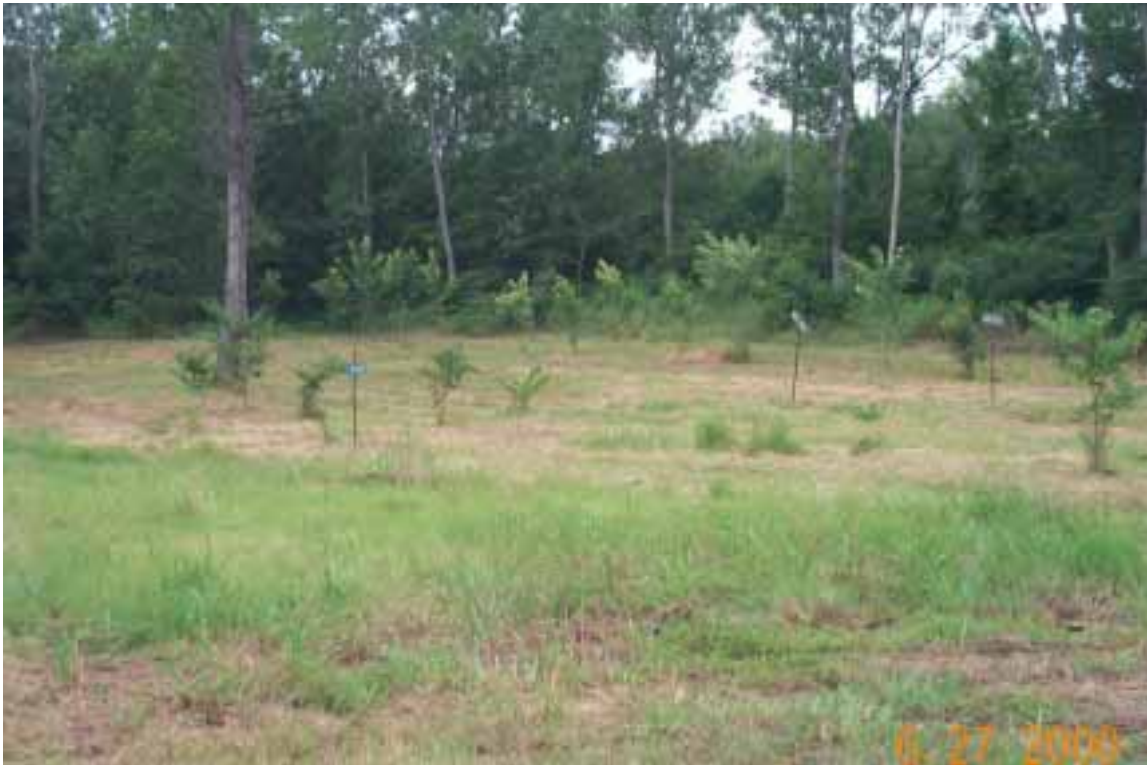
Photograph 8.

Facing west; overview of the second tree farm maintained by the City of Jacksonville on the municipal landfill property. Tree farm is located west of monitor well MWJ-09 (the well is not visible in the photograph).

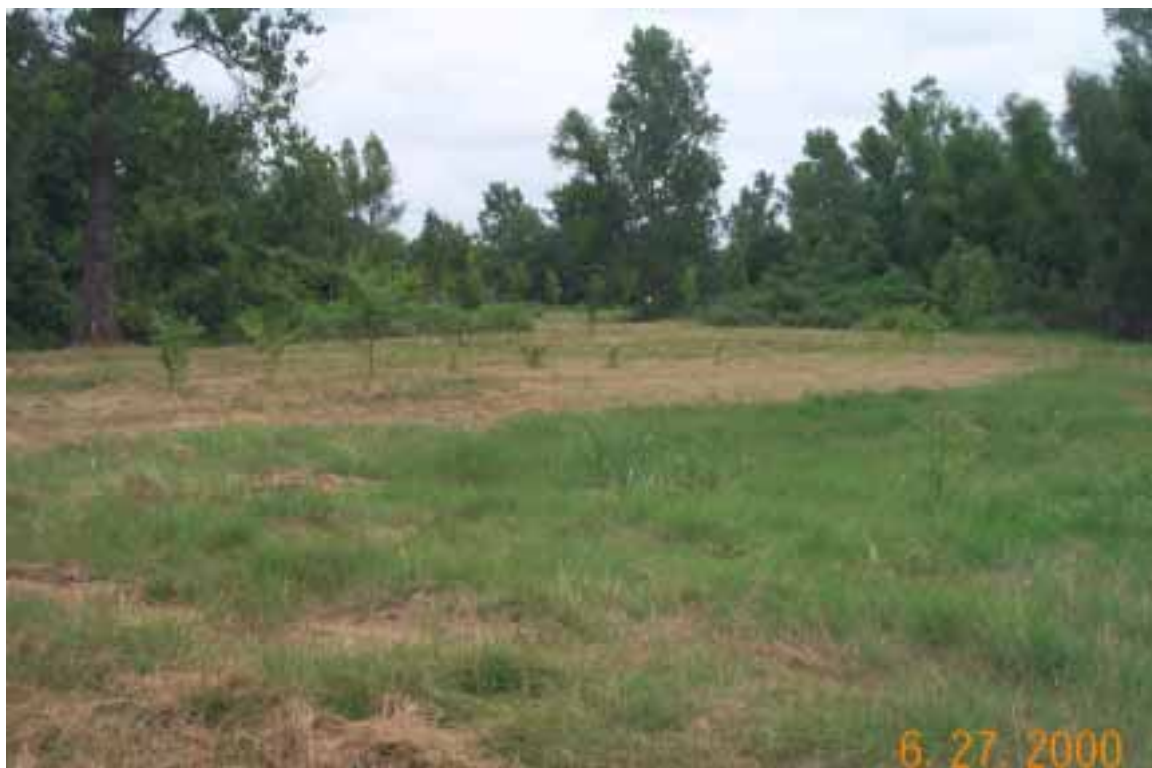
Photograph 9.

Facing north, different view of tree farm
seen in Photograph 8.

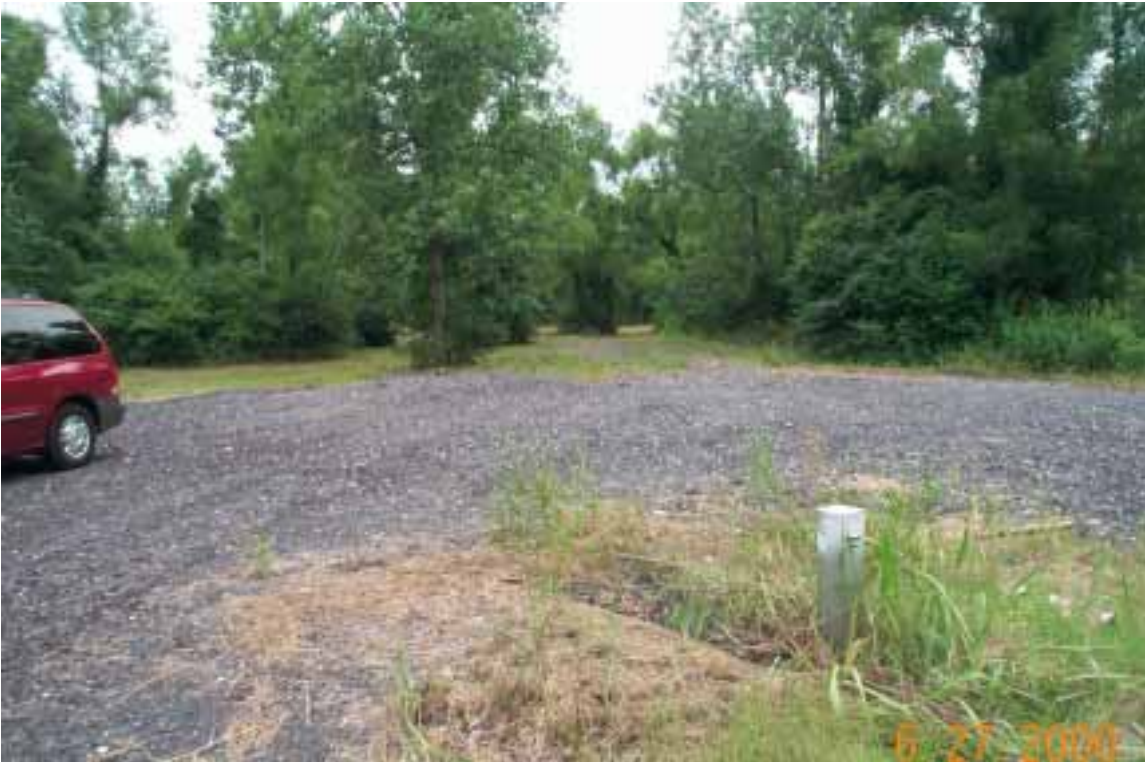
Photograph 10.

Facing north; overview of main remediated area of Jacksonville Municipal Landfill.

Monitor well MWJ-13 is visible in right foreground. Blacktop is a vehicle turn-around constructed by the City of Jacksonville over the remediated area cover.

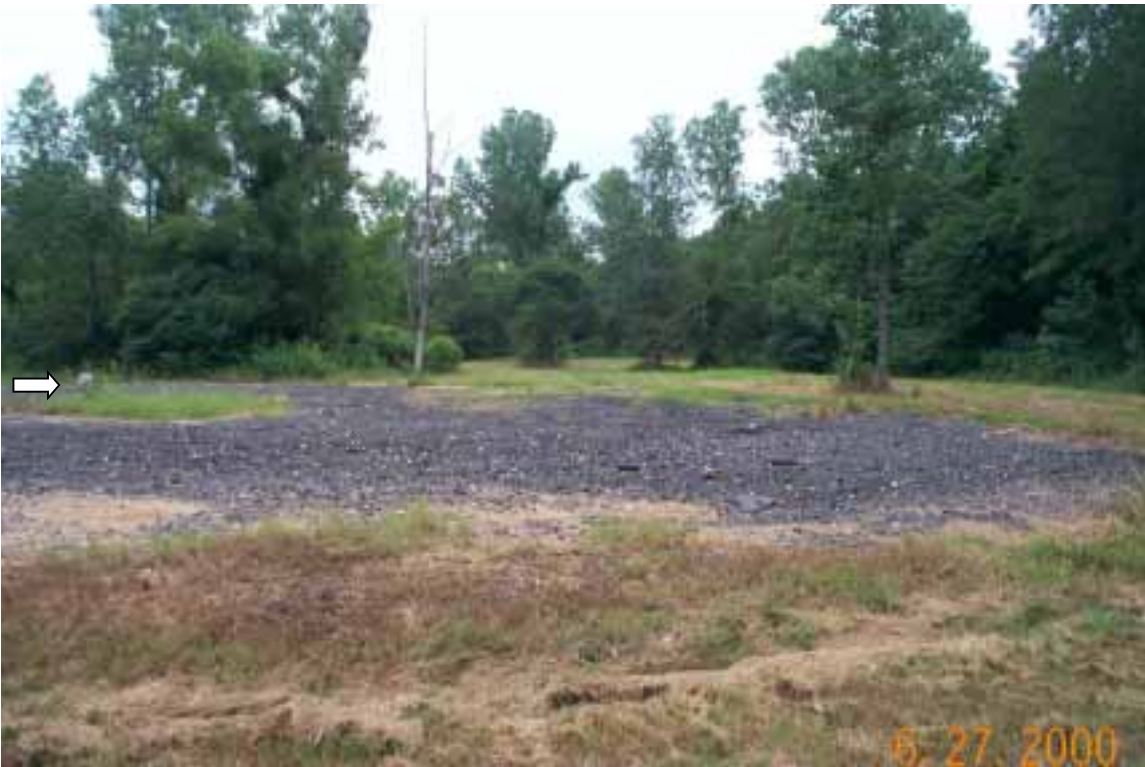
Photograph 11.

Facing north-northeast; overview of main remediated area of Jacksonville Municipal Landfill.

Monitor well MWJ-13 is visible at center left (see arrow). Blacktop is a vehicle turn-around constructed by the City of Jacksonville over the remediated area cover.

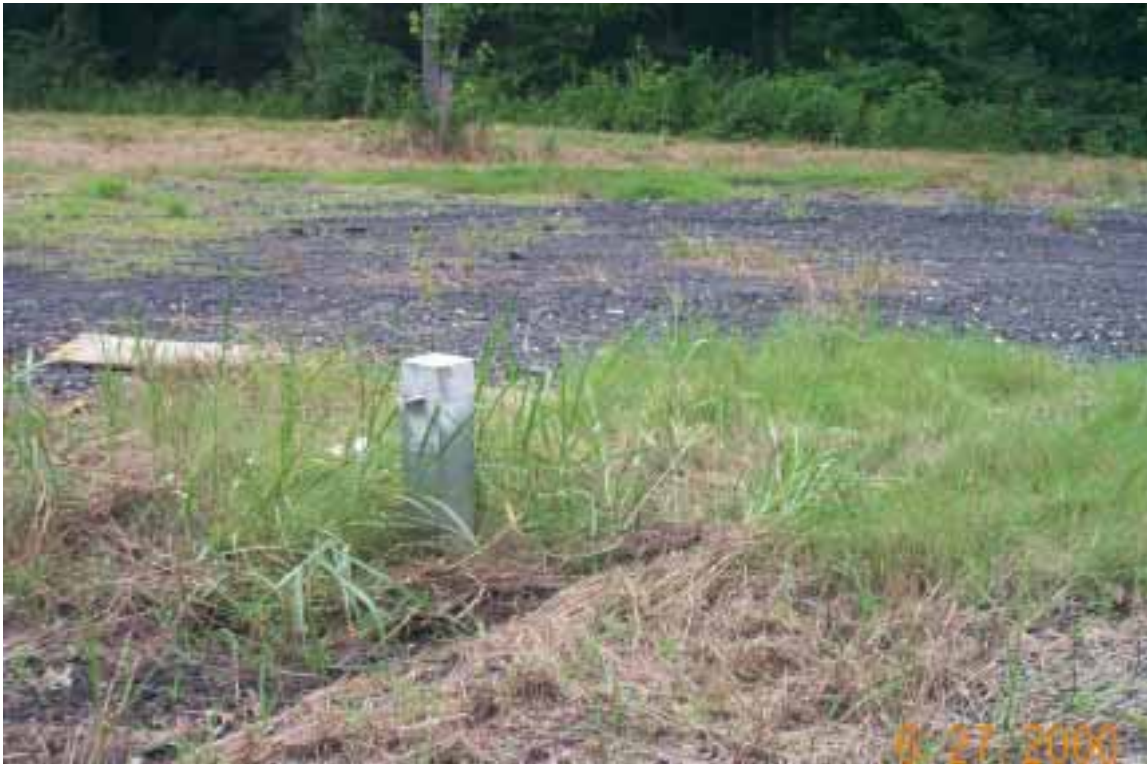
Photograph 12.

Facing southwest; closeup of monitor well MWJ-13 (also visible in Photographs 10 and 11).

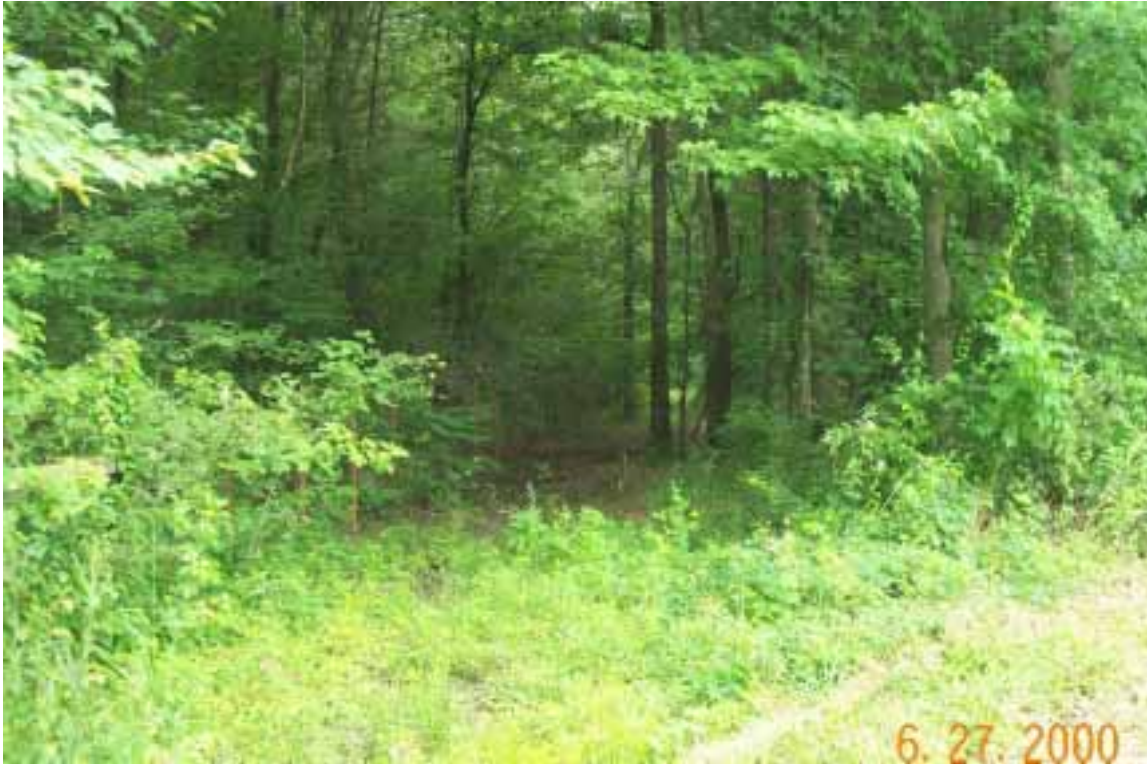
Photograph 13.

Facing west along perimeter fence south of remediated area. Area along fence is kept clear by the City of Jacksonville.

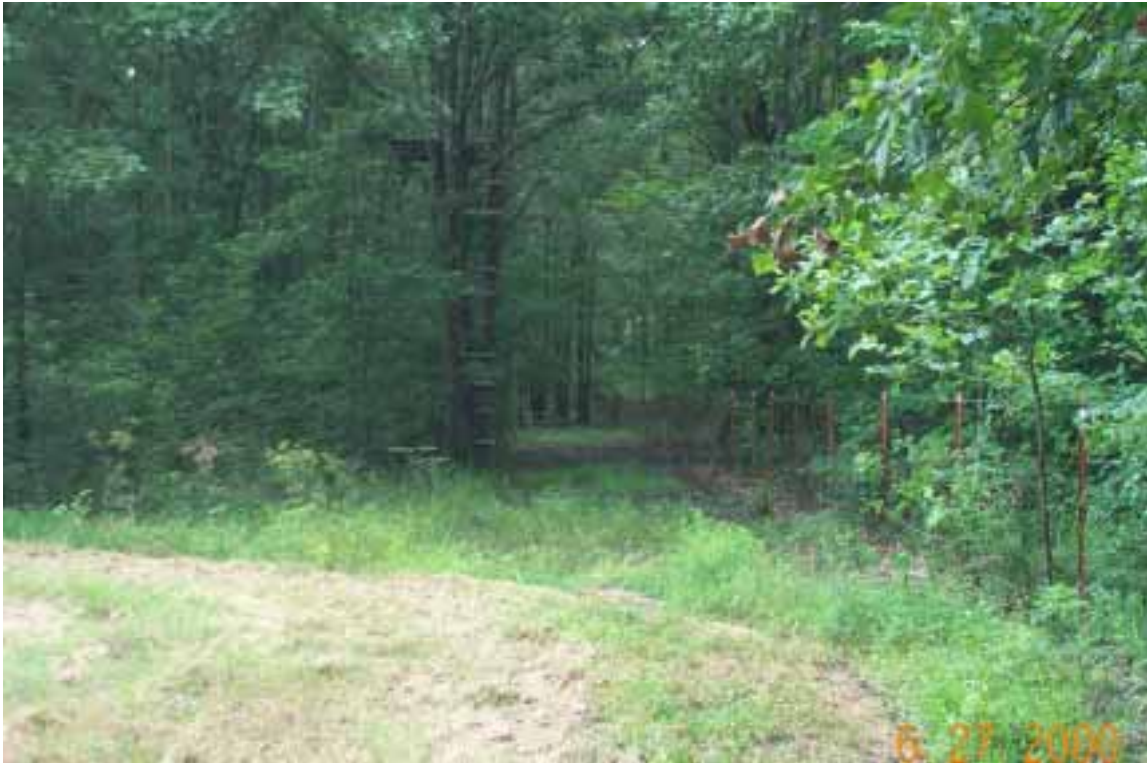
Photograph 14.

Facing east along perimeter fence south of remediated area. Area along fence is kept clear by the City of Jacksonville.

Note deer stand in tree, left of center.

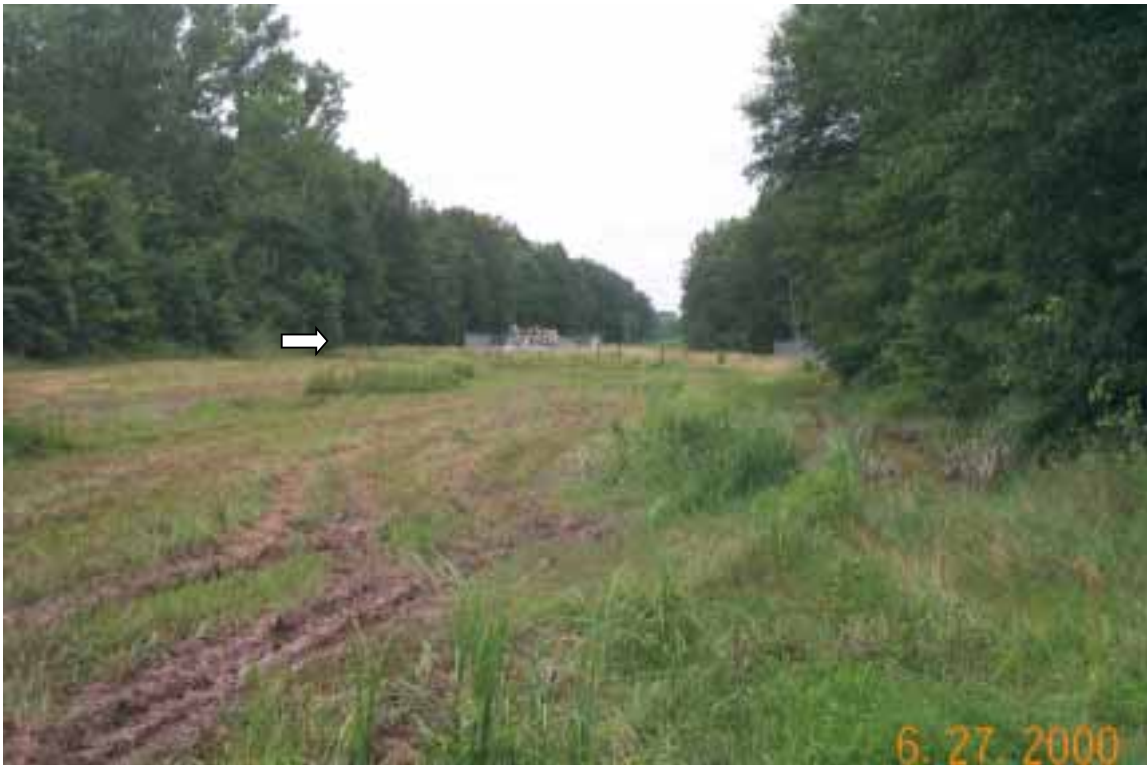
Photograph 15.

The site was dry on the day of the site inspection and appeared well-graded. However, the site is situated in a natural low area, and standing water in the area surrounding Jacksonville Landfill has been noted by the City of Jacksonville staff following rain events. The area where the Teppco pipeline runs diagonally across the site appeared well maintained (Photo 15, Attachment 4).

Facing southwest along Teppco pipeline right of way.

Perimeter fence is visible at center of photo, trending left to right; structure in center of right-of-way is associated with the pipeline. Monitor MWJ-12 located left of center along perimeter fence (see arrow).

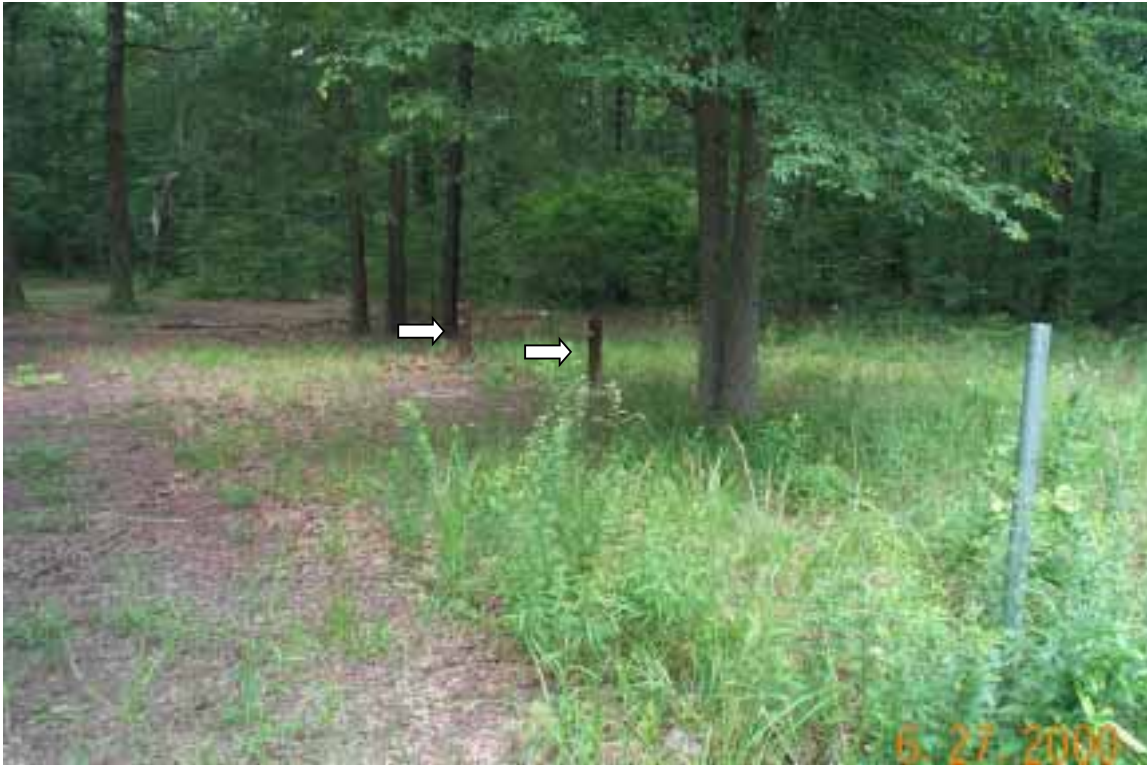
Photograph 16.

Monitor wells MWJ-07, MWJ-08, MWJ-10, MWJ-11, MWJ-13 and an unused residential well were located during the site inspection and photographed (Photos 6, 7, 10, 16, 17, 18, and 19; see also Figure1). Surface completions appeared to be in good condition with the exception of MWJ-10, where a cracked pad was noted (Photo 17, Attachment 4). Not all wells were located during the site inspection due to the presence of dense vegetation, including poison oak and ivy, and the abundance of ticks observed in the area. The wells are visited by city personnel during the periodic inspections several times per year.

Facing west, toward two monitor wells (MWJ-10 and MWJ-11) located along Morgan Road (residential street which parallels eastern border of Jacksonville Municipal Landfill).

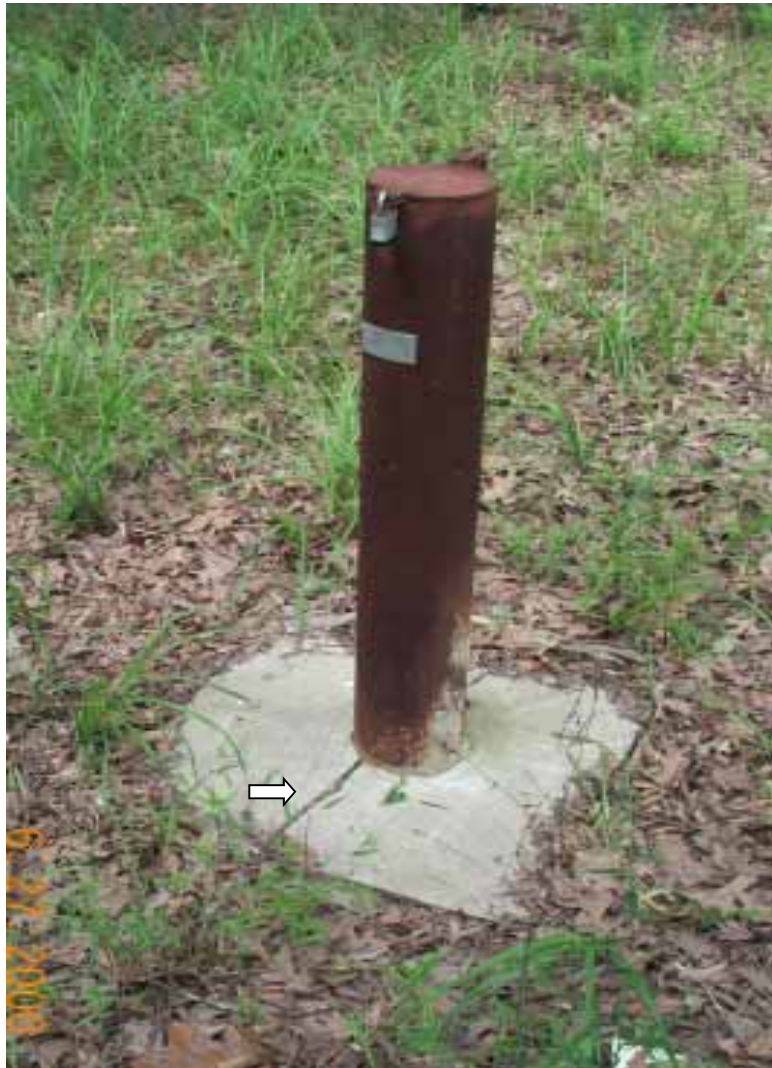
Photograph 17.

Closeup of Monitor well MWJ-10. Note concrete pad is cracked (see arrow).

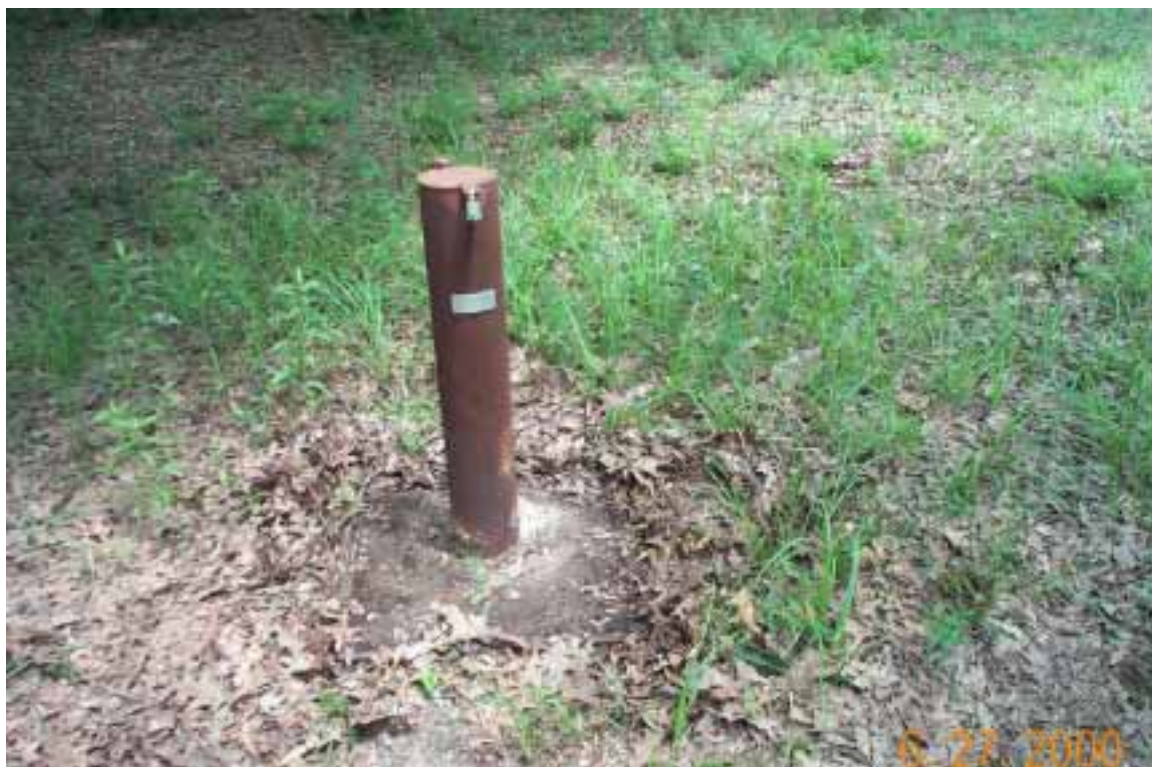
Photograph 18.

Closeup view of monitor well MWJ-11.

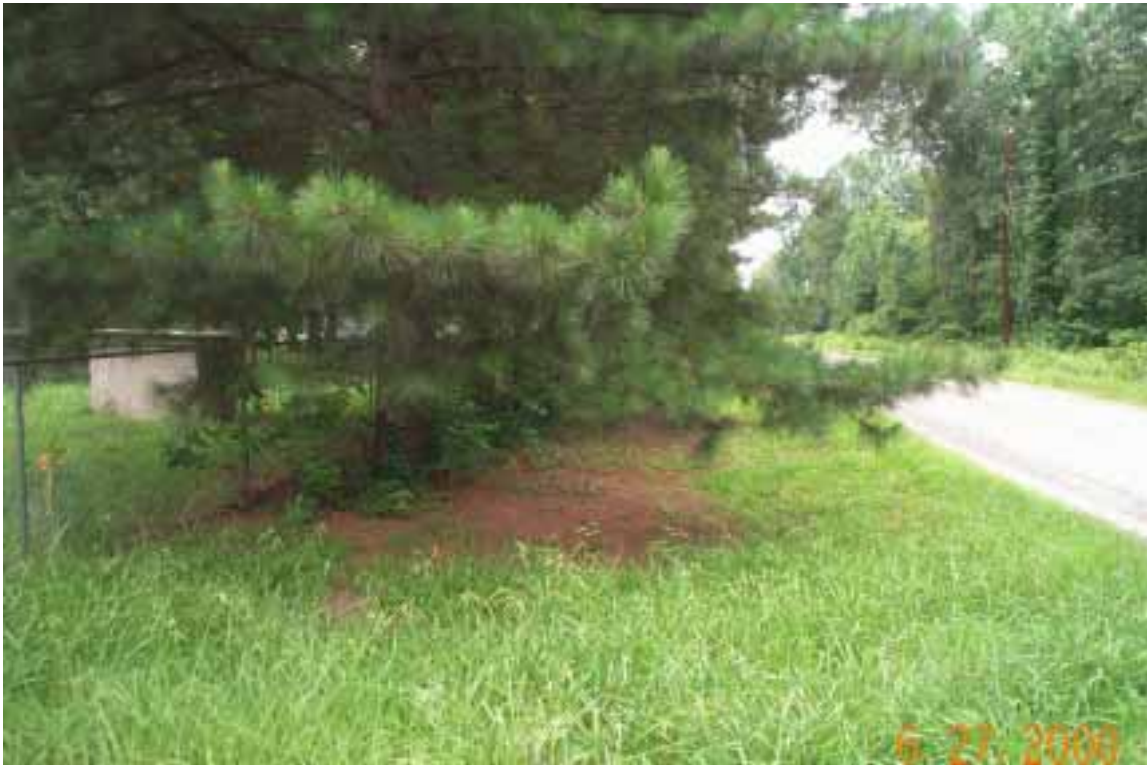
Photograph 19.

Facing north along Morgan Road
(residential street which parallels eastern
border of Jacksonville Municipal Landfill).
