FIVE-YEAR REVIEW

Rogers Road Municipal Landfill Superfund Site

Pulaski County, Arkansas

FIRST FIVE-YEAR REVIEW REPORT
for
Rogers Road Municipal Landfill Superfund Site
Pulaski County, Arkansas
EPA ID#ARD981055809

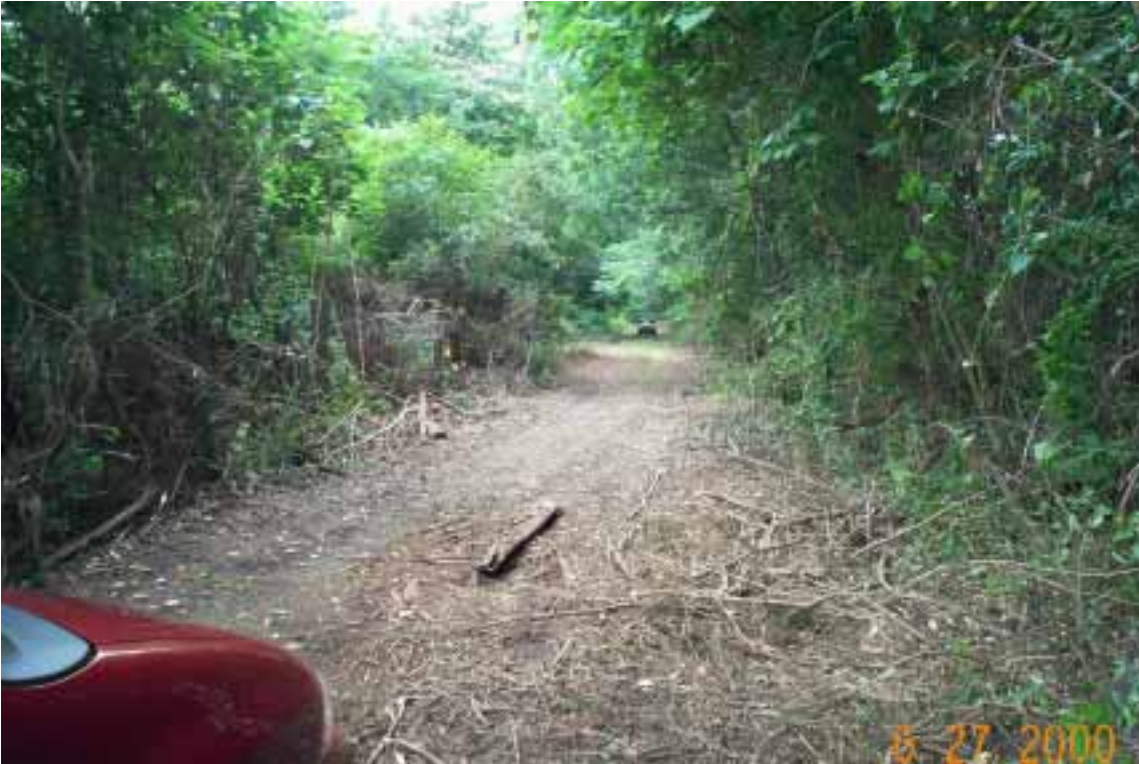
Photograph 1.

(Photos 1 and 9, Attachment 4). Unauthorized dumping reportedly took place prior to the remedial action, and debris was noted outside the perimeter of the site. The soil cover appeared to be in good condition; no settlement, cracks, or erosion was evident (Photos 2-4, and 6, Attachment 4). The site was dry on the day of the site inspection and appeared well-graded. The presence of poison oak, poison ivy, and numerous ticks were observed.

Facing south along Rogers Road. Photo taken from south of Rogers Road residences/north of site.

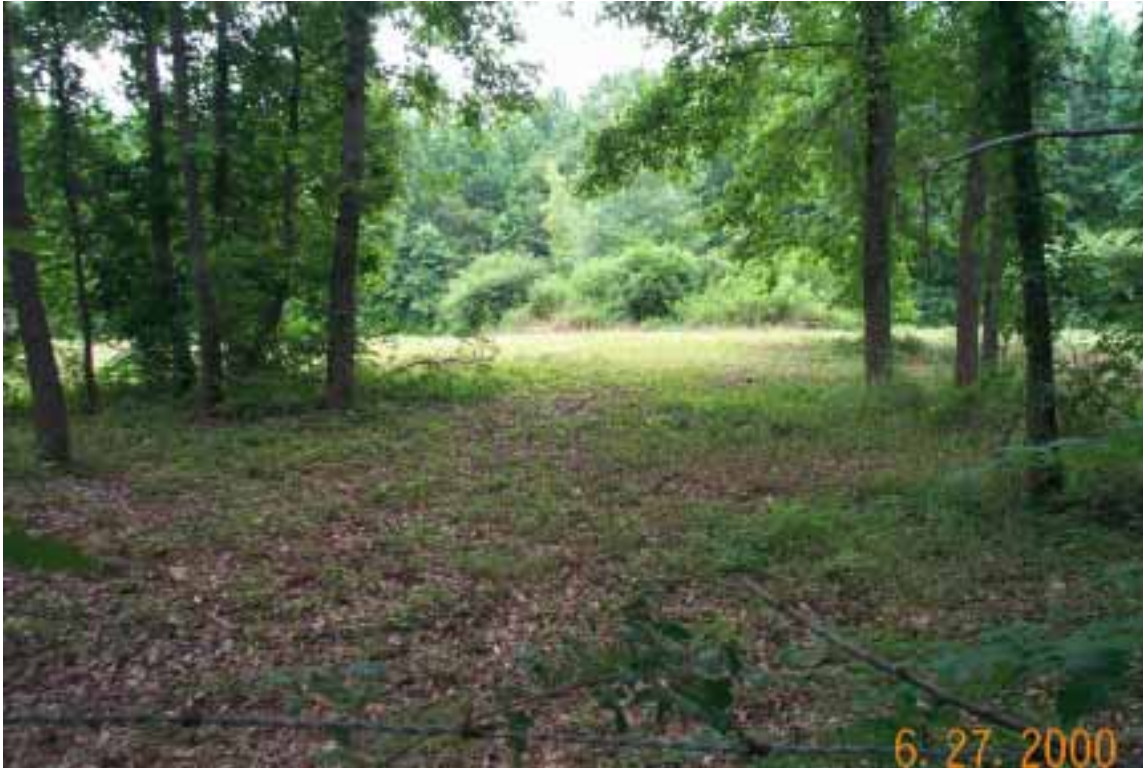
Photograph 6.

Facing east, from outside perimeter fence, on Rogers Road just south of main access gate.

Perimeter fence visible in near foreground.

Excavated/backfilled area is the vegetated area without trees.

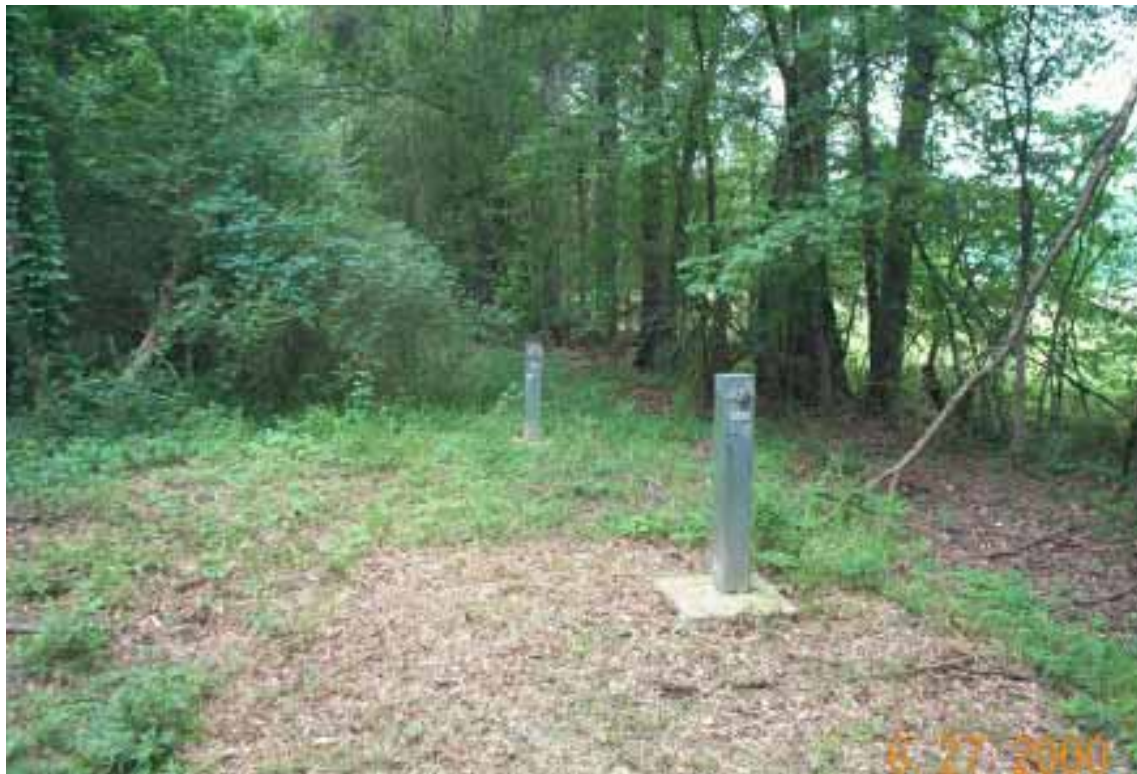
Photograph 8.

However, the site is situated in a natural low area, and standing water in the area surrounding Rogers Road Landfill has been noted by the City of Jacksonville staff following rain events. Monitor wells MWR-01 and MWR-02 were located and photographed (Photo 8, Attachment 4; locations noted on Figure 1). Surface completions appeared to be in good condition. Not all wells were located during the site inspection due to the presence of dense vegetation, including poison oak and ivy, and the abundance of ticks observed in the area. The wells are visited by City personnel during the periodic inspections several times per year.

Facing south at south end of Rogers Road. Monitor wells MWR-01 (foreground) and MWR-02 (background). Surface completions appear in good condition.

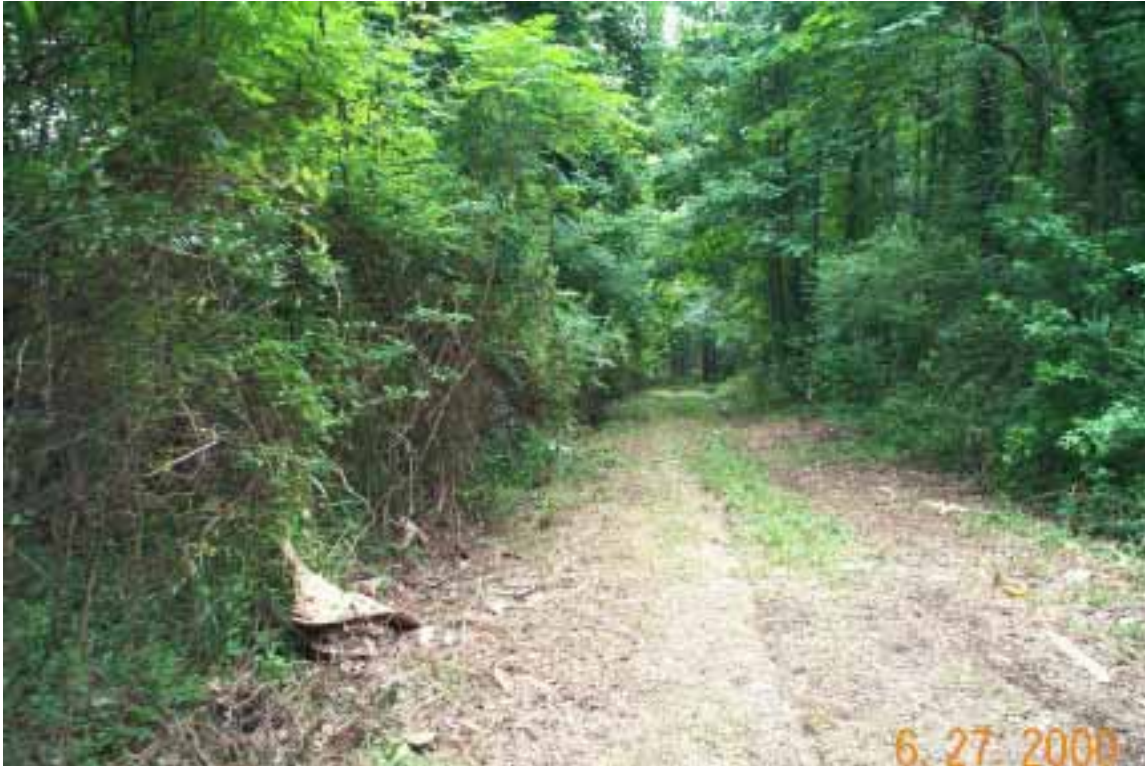
Photograph 9.

Facing east along southern perimeter road along south side of site.

Perimeter fence runs along north side of road, at left.
