**Five-Year Review
South Cavalcade Street Superfund Site
Houston, Harris County, Texas**

September 2007

**FIVE_YEAR REVIEW
South Cavalcade Street Site
EPA ID# TXD980810386
Houston, Harris County, Texas**

**Second Five-Year Review Report for
South Cavalcade Street Superfund Site
Houston
Harris County, Texas**

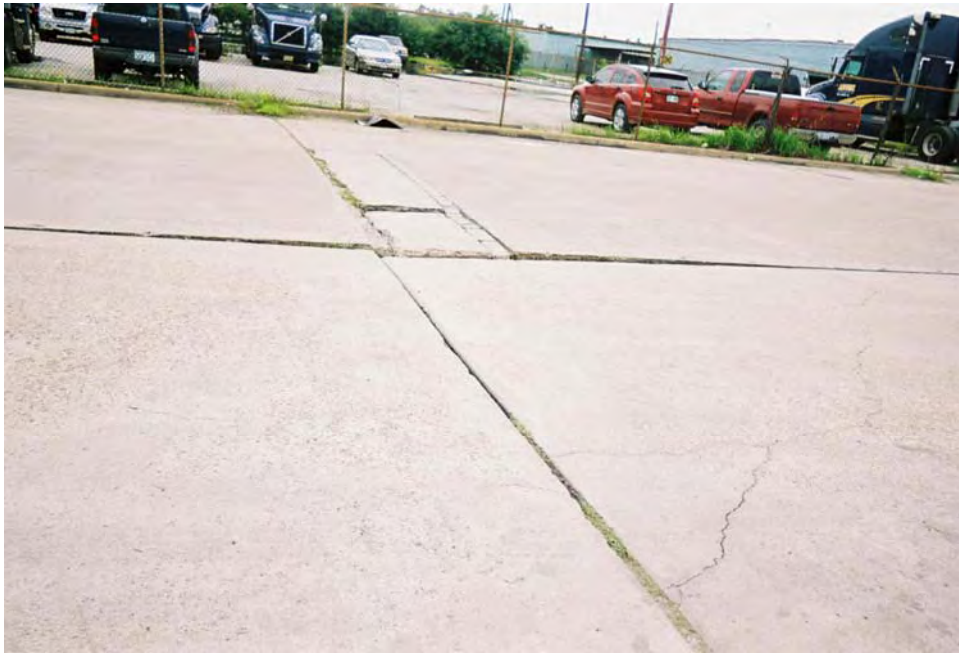
An offset in the pavement was observed just to the east of the eastern edge of the southwest cap and may have been the result of a washout created when the water supply line broke during 2000-2001 timeframe. The offset appears to be the same as observed in August 2002 for the First Five-Year Review and does not appear to have impacted the integrity of the cap or the protectiveness of the remedy,

1.	Settlement (Low spots)	G Location shown on site map	X Settlement not evident
2.	Cracks Remarks: A vertical off-set in a driveway joint adjacent to the east boundary of the southwest cap was noted during the site inspection. It is most likely related to a break in a water pipe, and washout after the cap was completed. Conditions are unchanged since 2002.	G Location shown on site map	G Cracking not evident

View looking east showing driveway in the southwest area which is offset along the joints

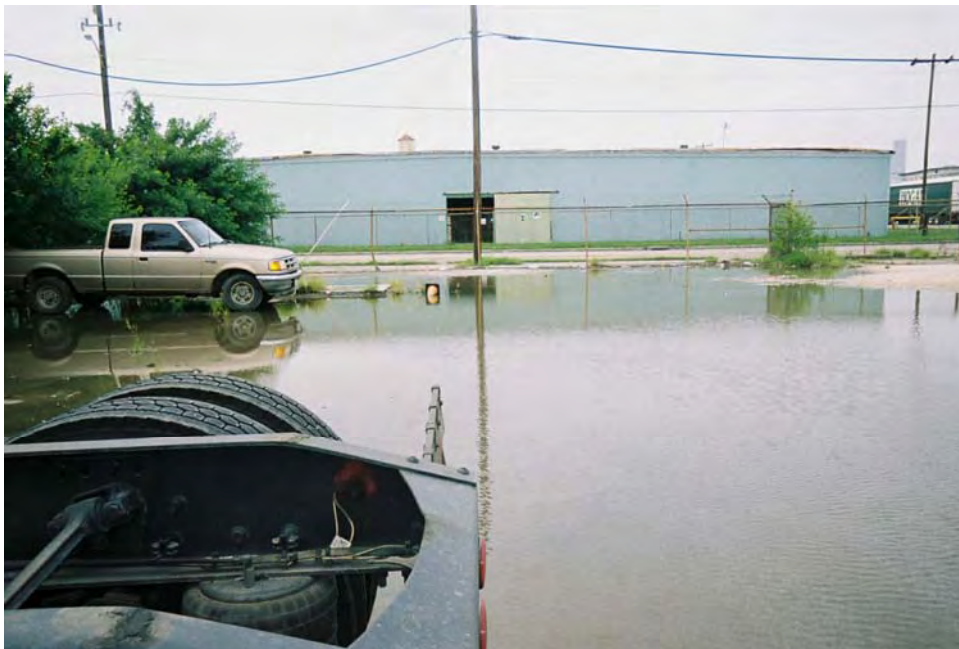
View looking south towards Collingsworth Street showing RWS-2 surrounded by water

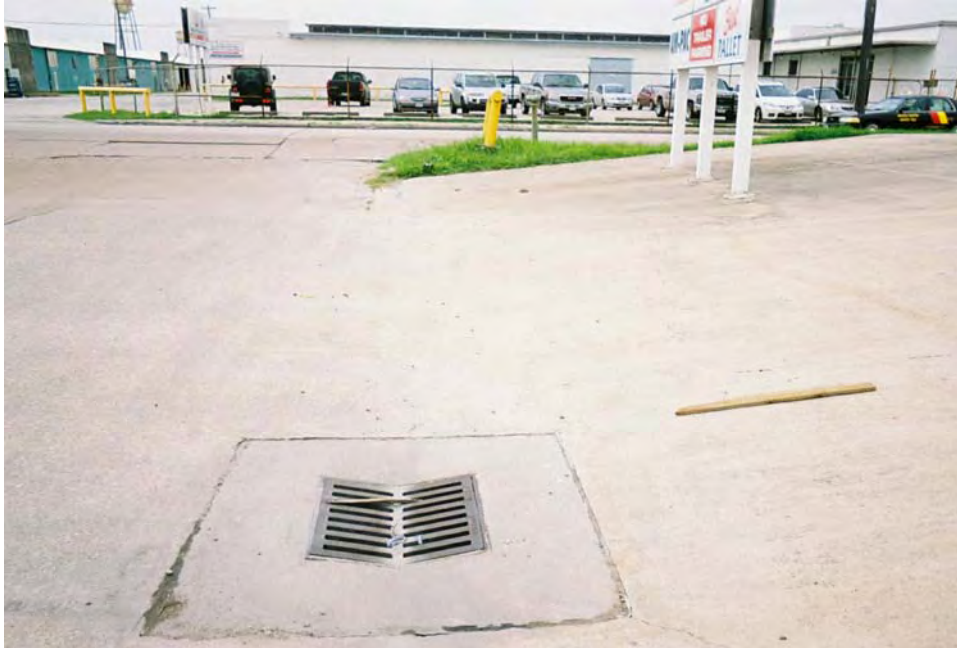
View looking south towards Collingsworth Street showing a storm drain adjacent to the southwest cap

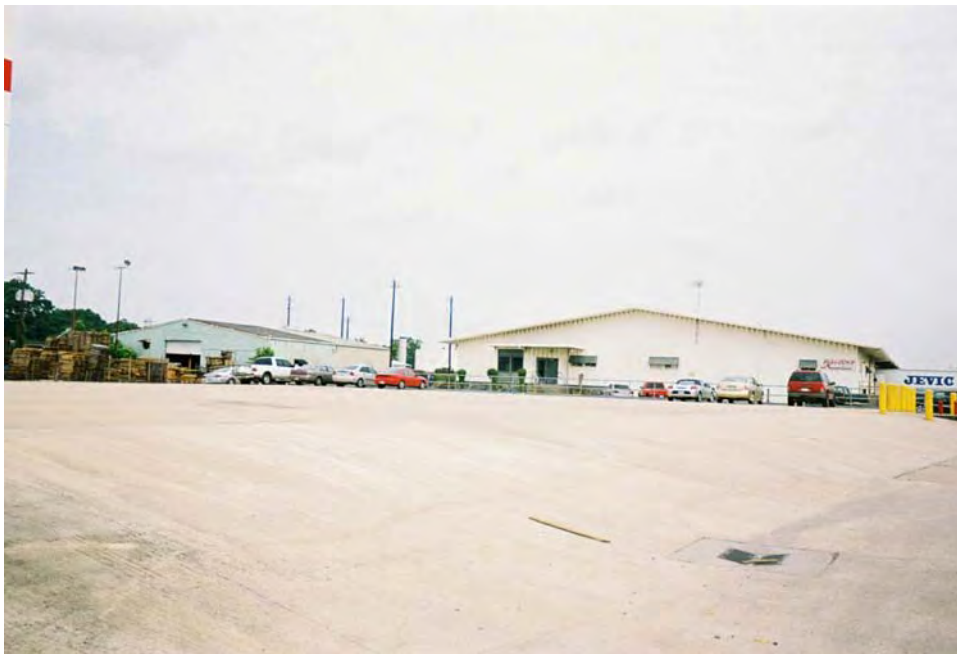
View looking northwest showing the southwest cap

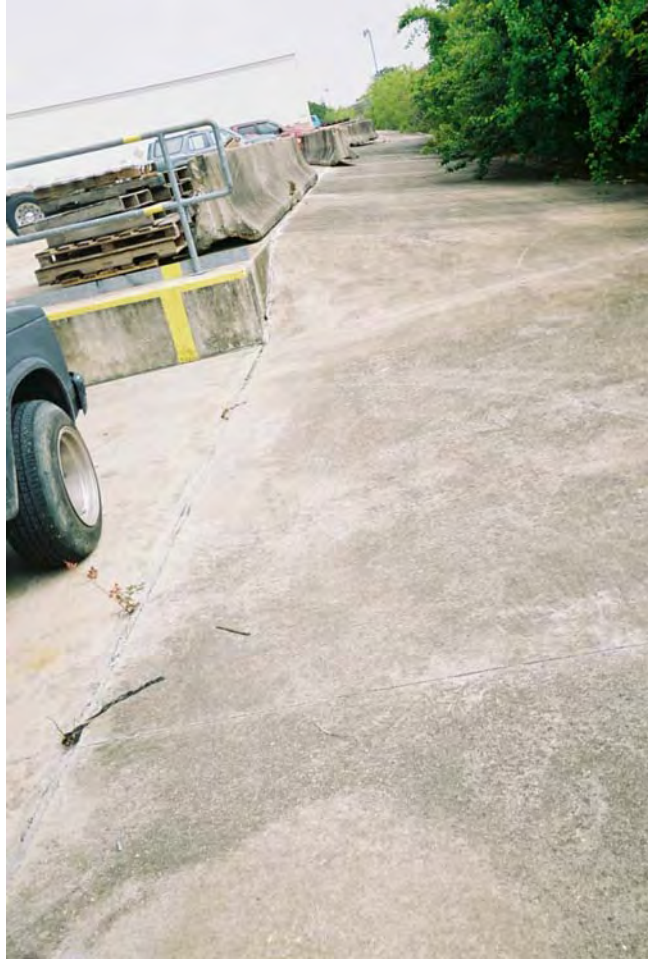
5.	Vegetative Cover: Not Applicable		
6.	Alternative Cover (armored rock, concrete, etc.) Remarks: See all the above comments. Concrete cap in good condition at both southeast and southwest locations. Some shallow rooted vegetation was observed in the southeast cap area at the expansion joints. This will be removed once a month during site walkthrough.	G N/A

View looking north showing the southeast cap with growth in the joints

Property owners are to inspect and maintain joint systems and repair cracks and joint systems as required. Beazer is responsible for continuing annual cap inspections.

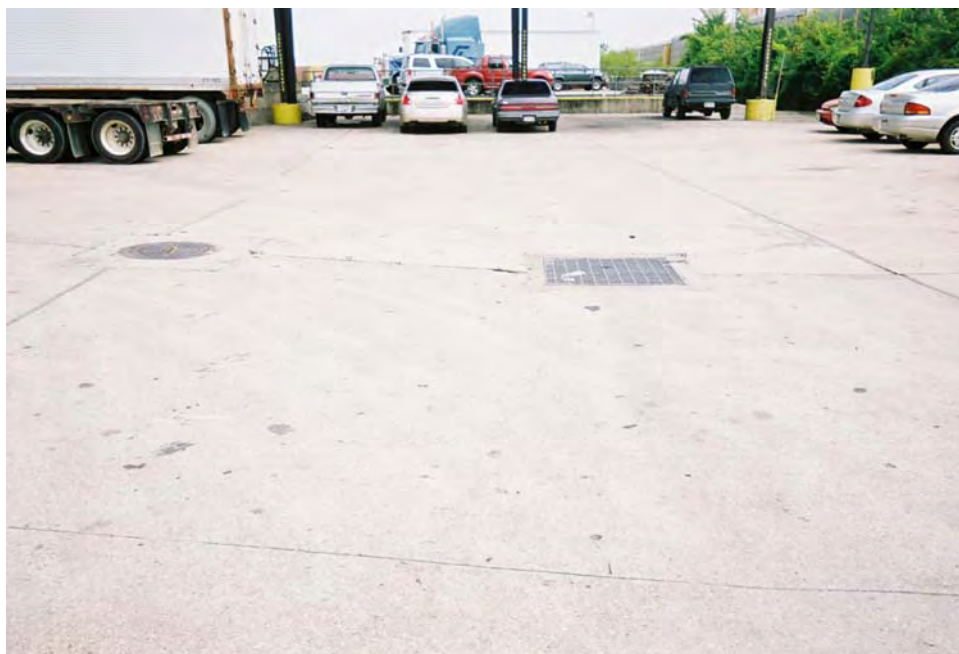
View looking north of southeast cap showing storm drain

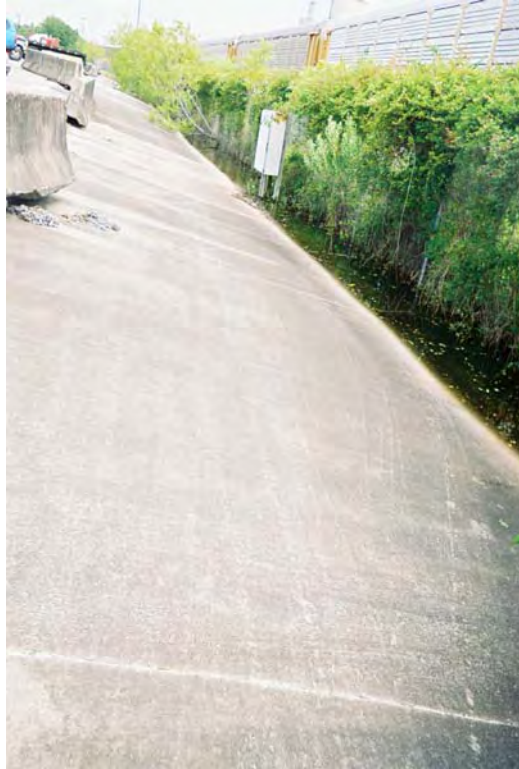
View looking north showing southeast cap boundary with standing water

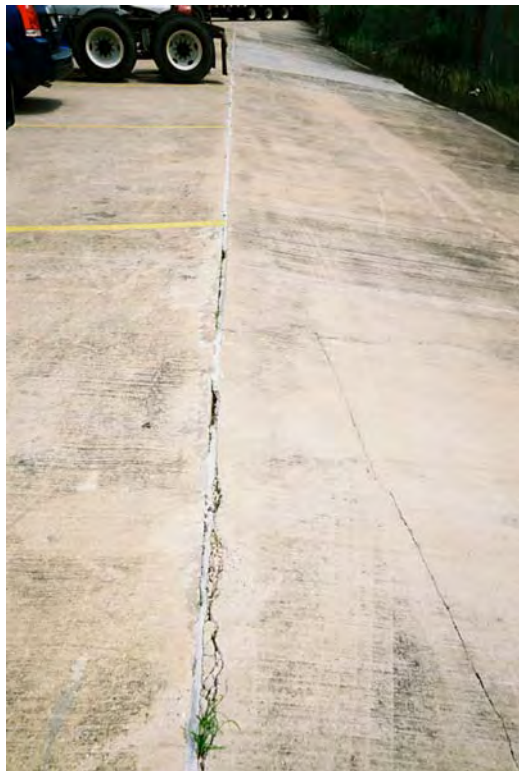
The concrete cap in both the southeast and southwest were in good condition (see photographs). Minor surface cracks associated with curing will be monitored through Beazer's annual inspections. Minor weed growth was observed in the southeast area and the property owner removes these once a month.

View looking north showing southeast cap with minor cracking

- Monitor the surficial cracks (from curing) in the caps for any significant changes over time.
- Verify property ownership for the entire Site.

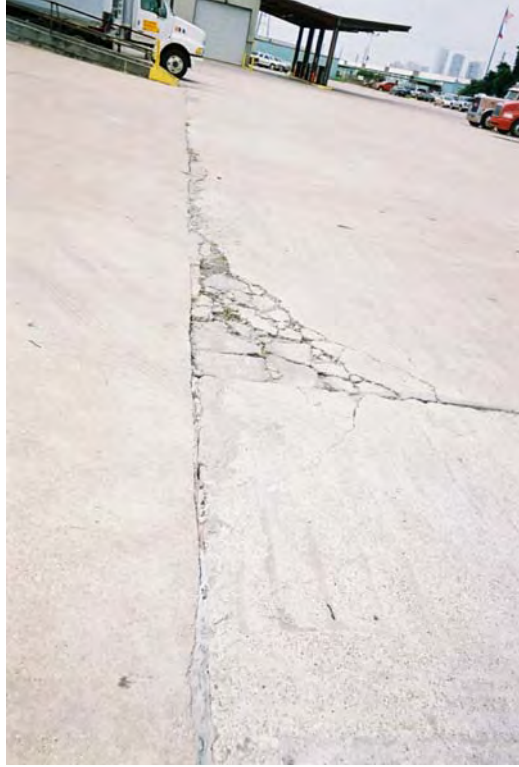
View looking south showing cracked concrete outside the southeast cap area

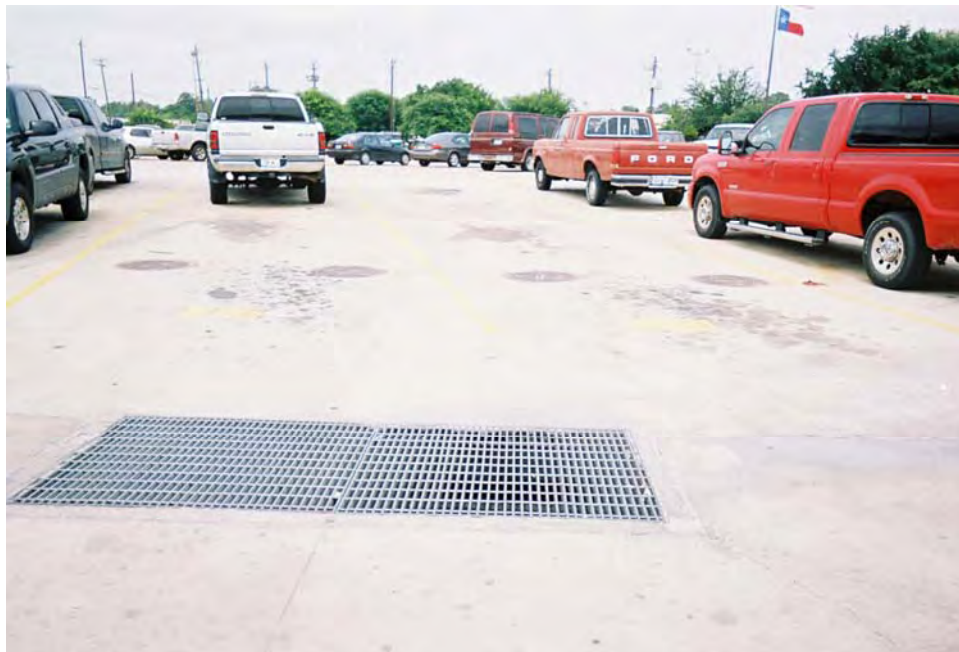
View looking west showing storm drain and detention basin covers in the southeast area
