Five-Year Review Report

Third Five-Year Review Report
for the
Triangle Chemical Company Superfund Site
Bridge City, Orange County, Texas

Region 6
United States Environmental Protection Agency
Dallas, Texas

April 2006

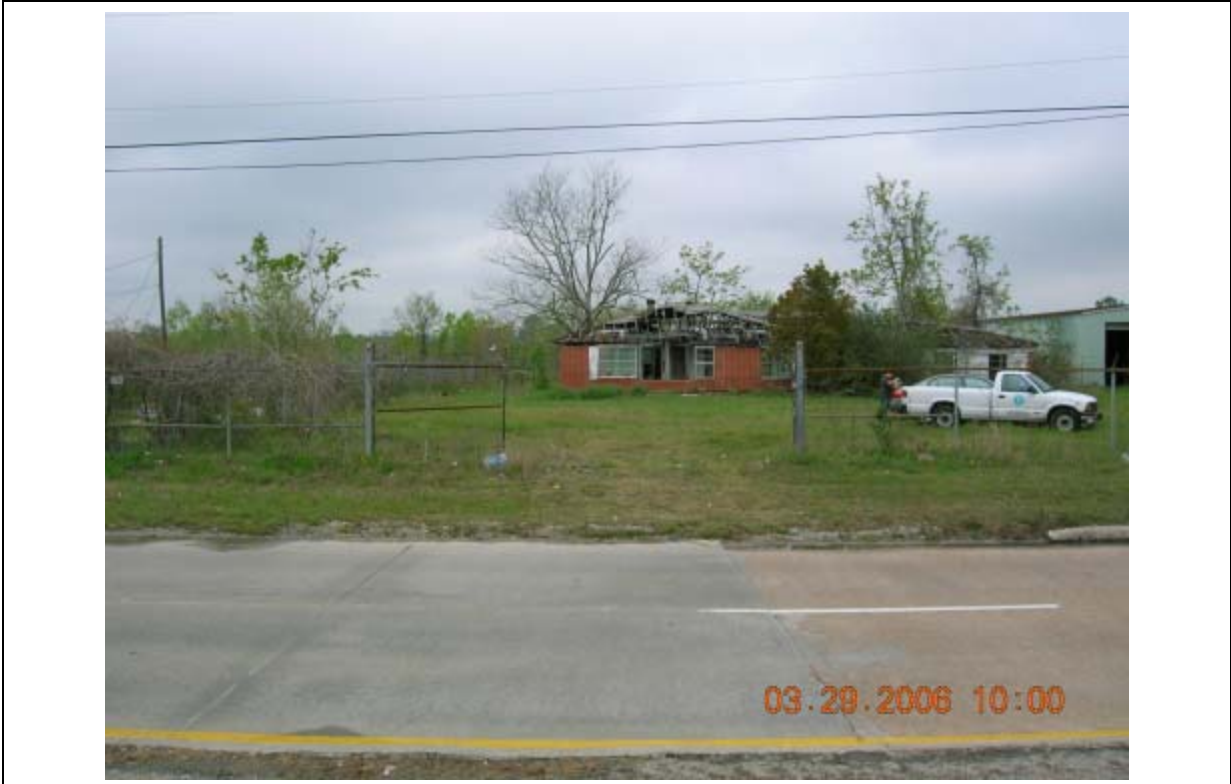
As observed during the site inspection, a fence surrounds the perimeter of the Site, and the entrance to the Site is controlled through a locked gate located on SH 87 ([Photograph 1](#)). The perimeter fence was observed to be in good condition, and repairs had been made to the fence as recommended in the last five-year review ([Photographs 1, 2, 3, 15, and 18](#)). Only one faded warning sign was observed posted on the southern portion of the fence. The section of the fence located at the south entry doors to Process Building No. 1 had been repaired in March 2006 ([Photograph 8](#)).

Photo 1: View of the front entrance on Texas State Highway 87.

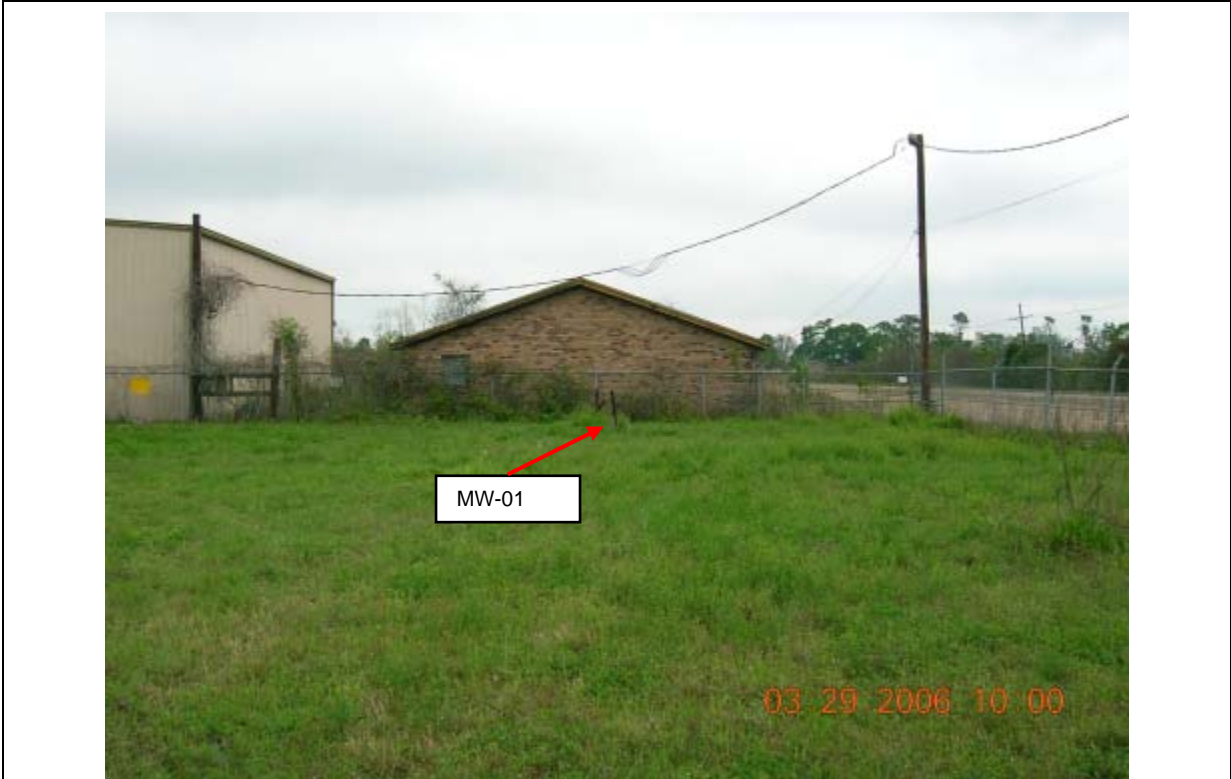
Each existing monitor well was visited and photographed during the site inspection. Well MW-1 had a bent guard posts ([Photograph 2](#)). All monitor wells were in good condition and secured with locks ([Photograph 2, 3, 4, 5, 7, 9, 10, 11, 14, 15, and 16](#)).

Photo 2: View of the northeast corner of the site, looking north towards monitor well MW-01.

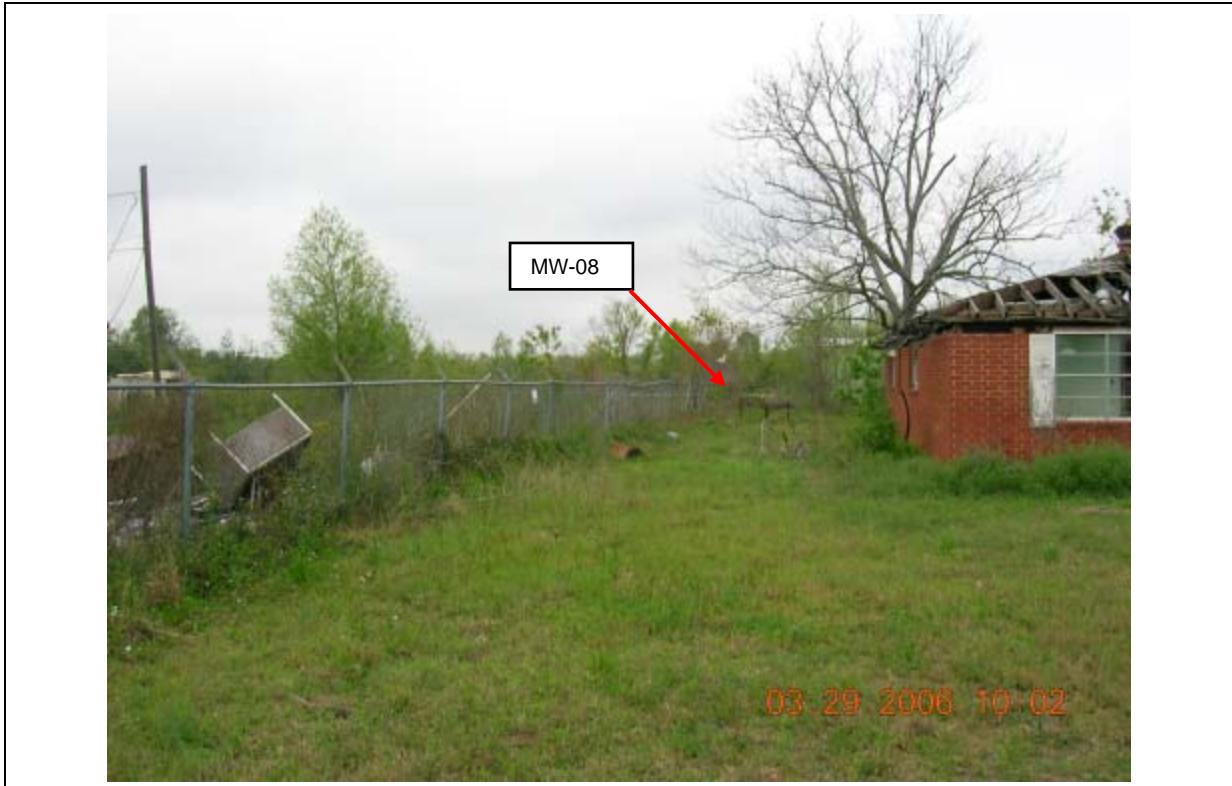
Photo 3: View of fence along south end of property, facing west. Monitor well MW-08 is in background.

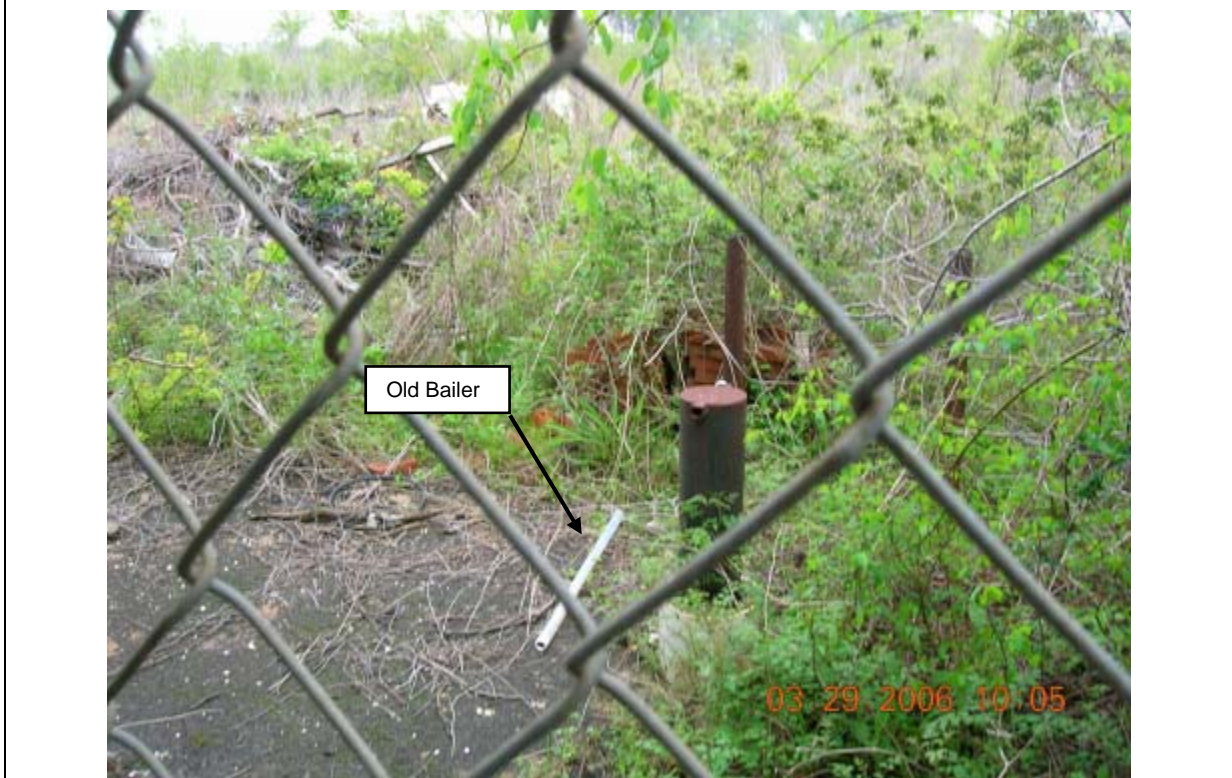
Photo 4: View of monitor well MW-11, located on north side of Process Building No. 2. An old bailer, used for sampling, is lying next to the well.

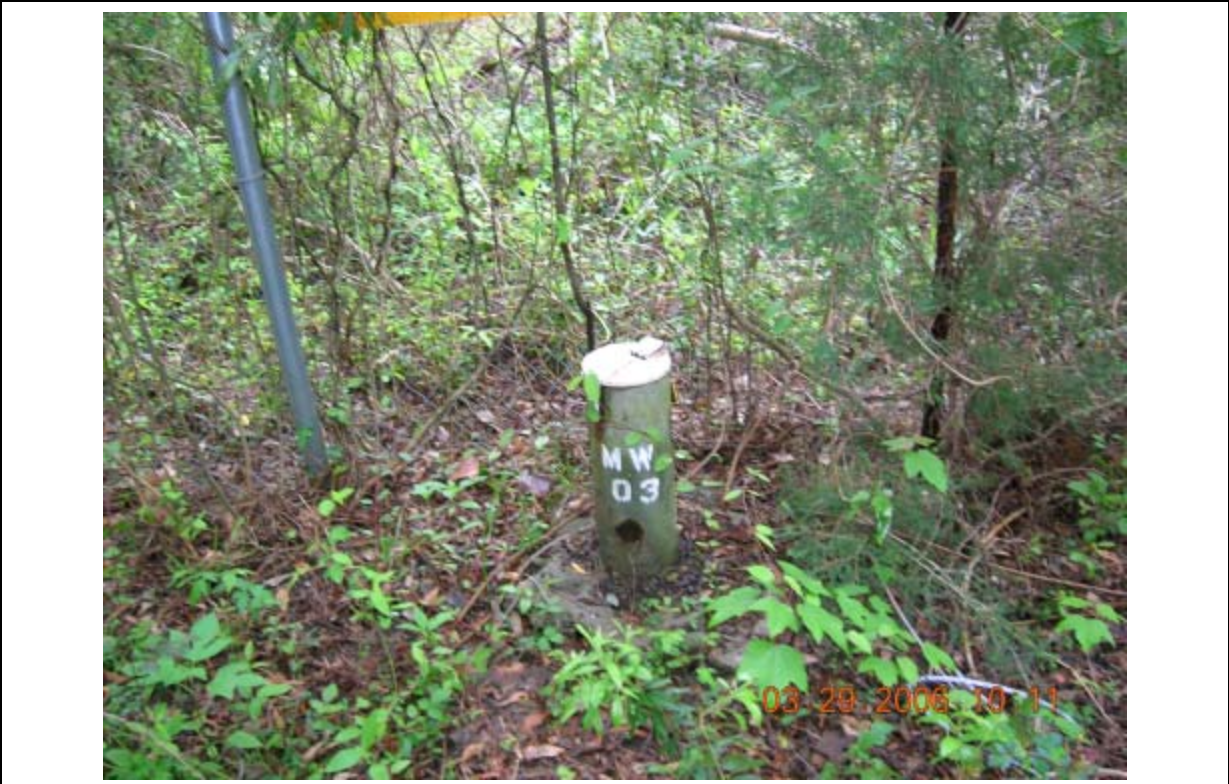
Photo 5: View of monitor well MW-03, located at northwest corner of the site.

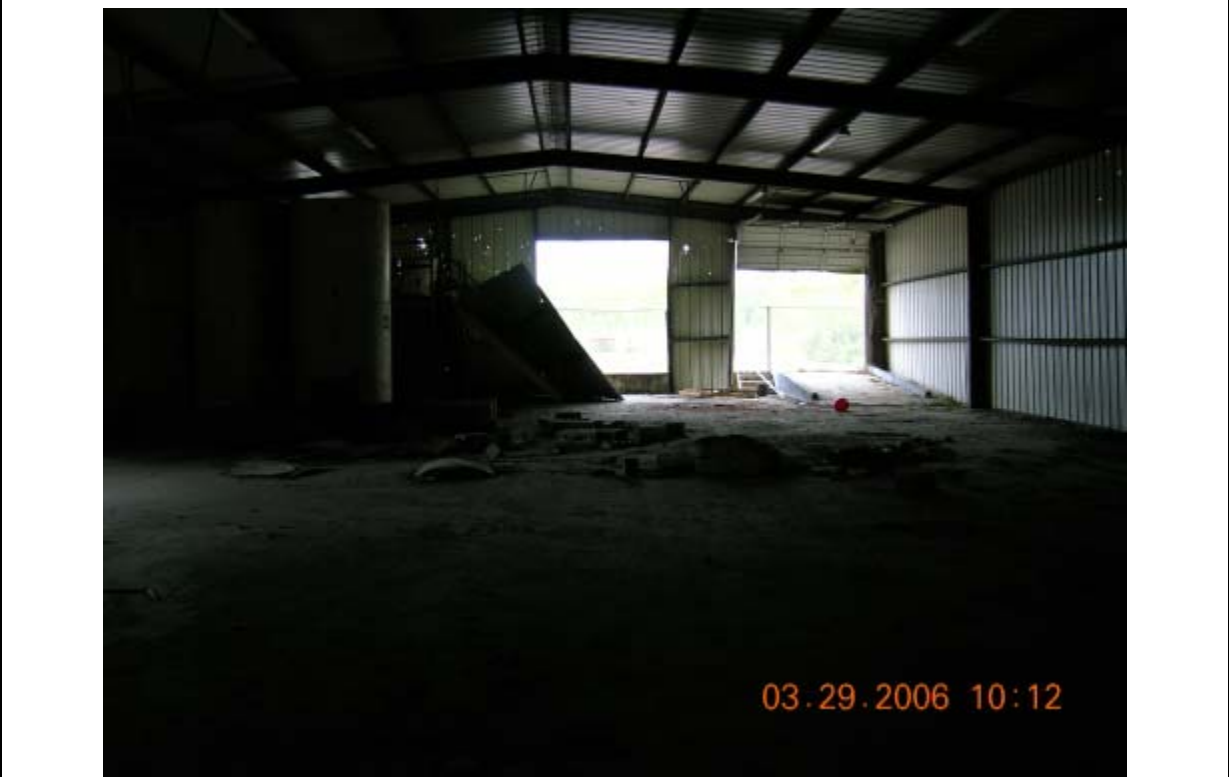
Photo 6: View of inside of Process Building No. 1, facing south. Old debris is lying on the floor inside the building. Doors at the back of the building are fenced to prevent access. These fences are where trespassers have entered the site in the past.

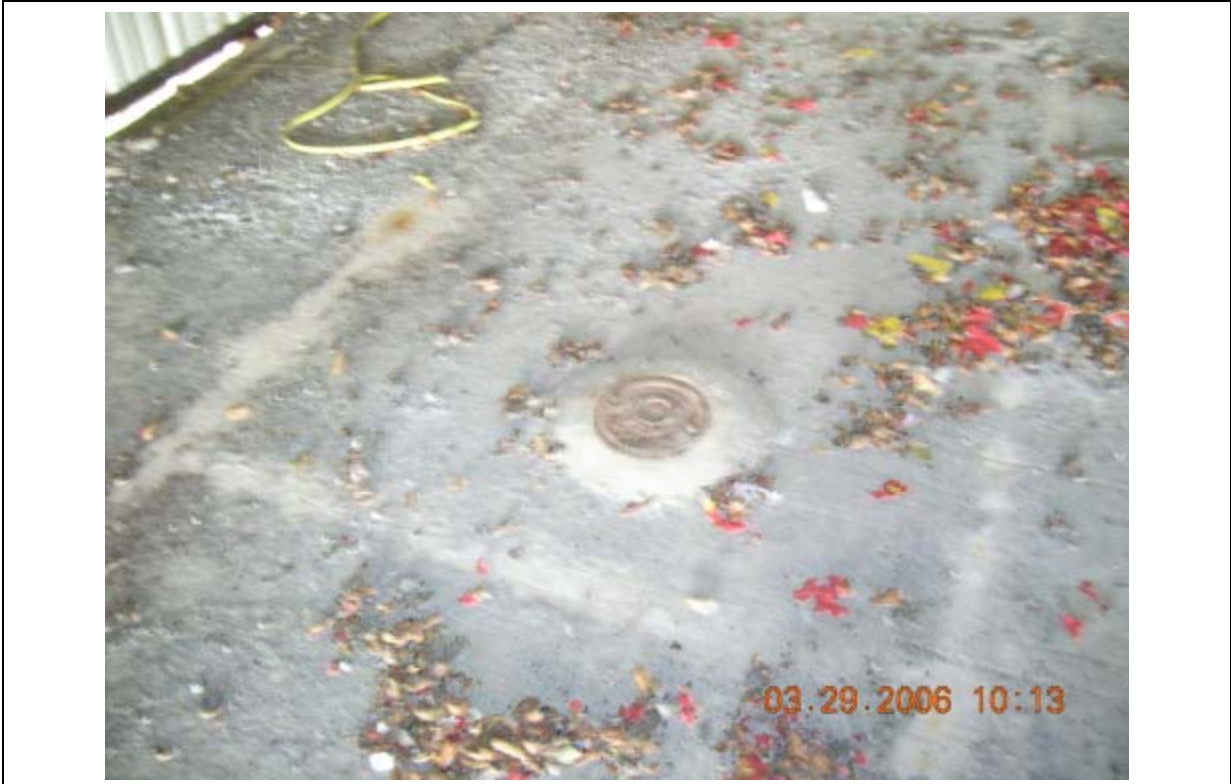
Photo 7: View of monitor well MW-09, located inside Process Building No. 1.

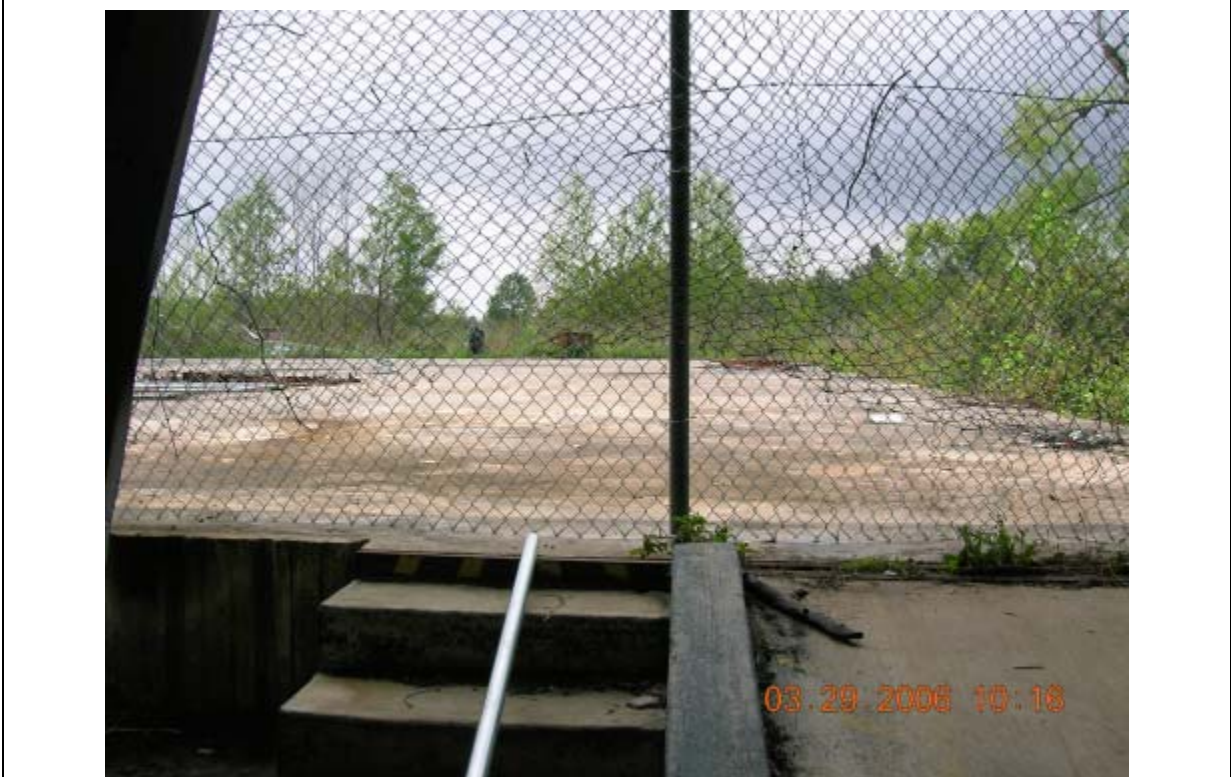
Photo 8: View of fence at doors on south side of Process Building No. 1, facing south. Fence was repaired due to trespassers.

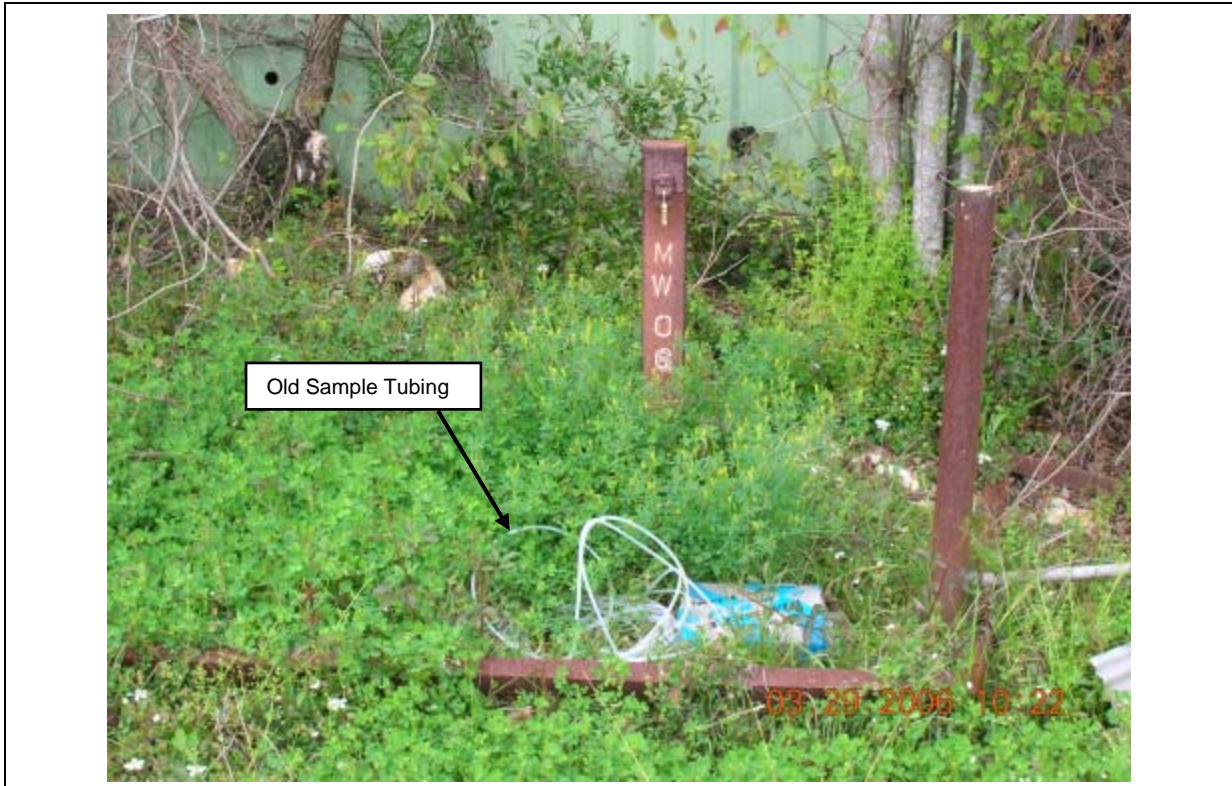
Photo 9: View of monitor well MW-06, located on east side of Process Building No. 1. Old sample tubing is lying on ground next to the well.

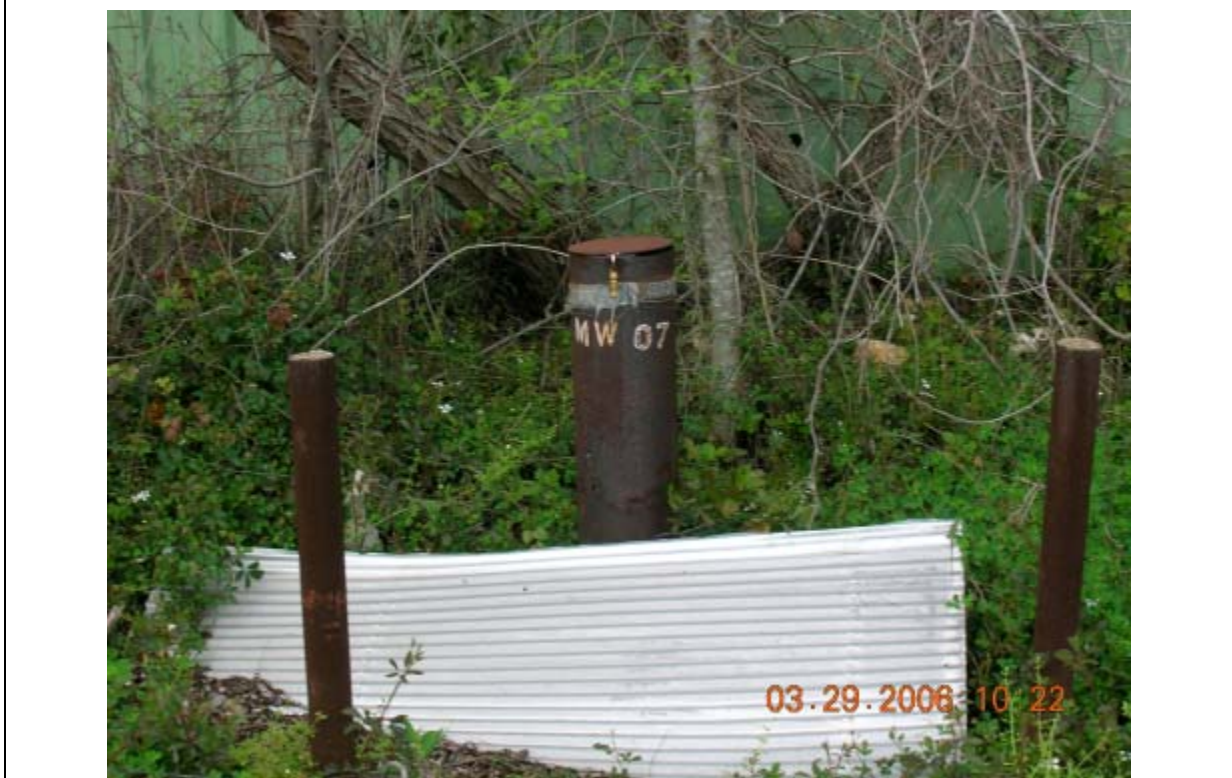
1. Low levels of contamination below MCLs have been detected in deep aquifer monitor well MW-7. Possible causes of the detections need to be investigated, including, but not limited to: changes of sampling contractors and sampling procedures; changes in detection limits and analysis procedures; and change in laboratory protocols. Because the deep ground water aquifer (30 to 80 feet below ground surface) has been deemed to be a usable ground water source, monitoring of MW-7 must continue.

Photo 10: View of monitor well MW-07, located on east side of Process Building No. 1. MW-06 is located north of this well (outside but to the right of this view).

1. **Continue monitoring the ground water contaminant concentrations in MW-7, and evaluate possible causes of the low level detections.** If contaminant concentrations continue to increase and/or approach the MCLs, evaluate measures to address potential contamination in the deeper aquifer. Consider incorporating adjacent private wells (neighboring residential wells) into the sampling program if contaminant concentrations continue to increase.

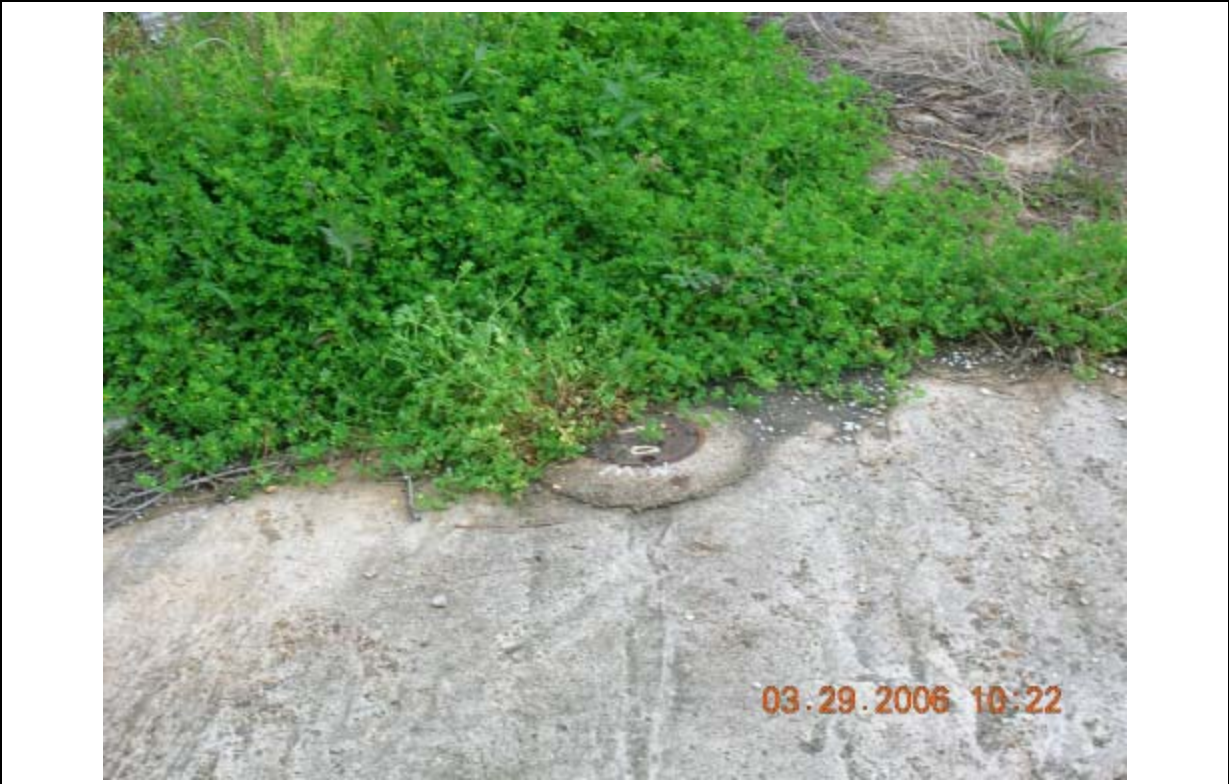
Photo 11: View of monitor well MW-10.

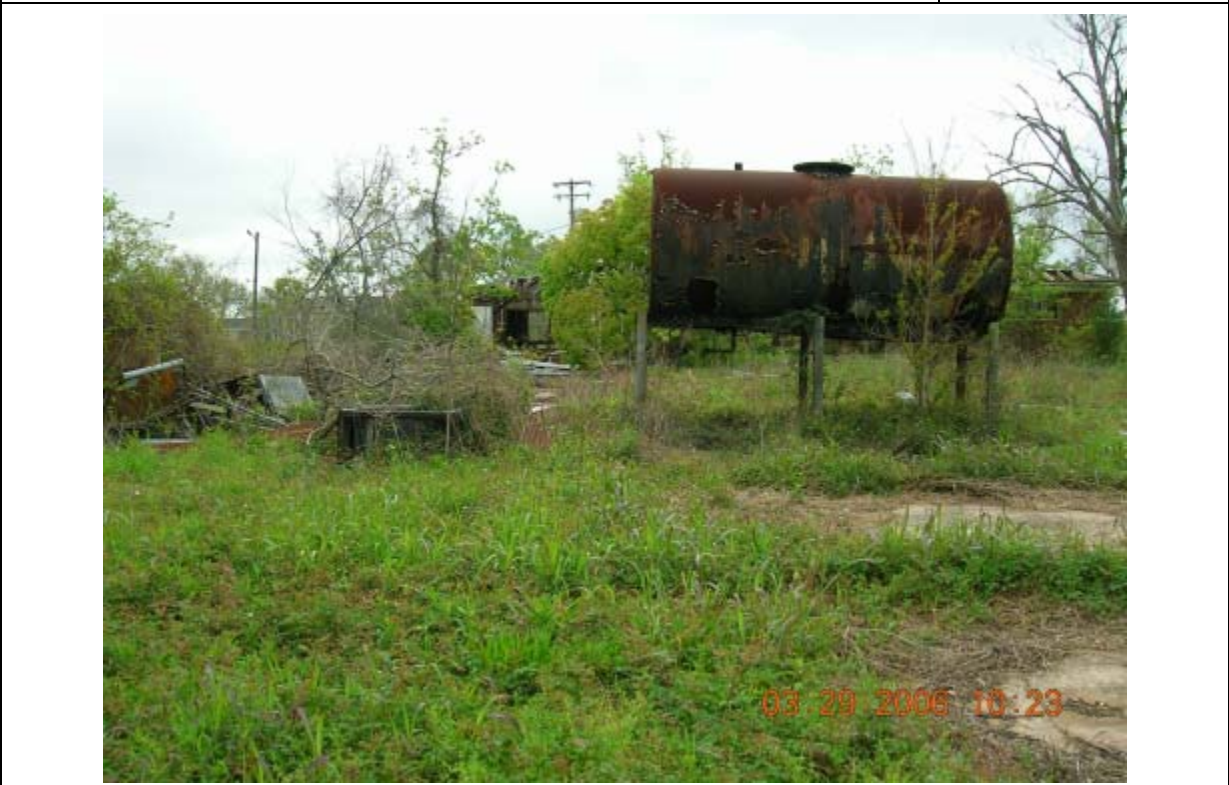
The onsite buildings were noted as being in poor condition. The former office building had most of the roof missing, and the building formerly located next to the office building had collapsed ([Photographs 1, 12, and 17](#)). The tanks located near the corner where Process Buildings No. 1 and 2 join had fallen over ([Photograph 13](#)). One drum of purge water from sampling activities, along with some supplies was stored inside Process Building No. 2. Several empty drums reported in the second five-year review were still staged inside Process Building No. 2. The Site had been recently mowed ([Photograph 1, 2, 3](#)).

Photo 12: View of site, facing east towards the Office Building. The building is in very poor, deteriorated condition.

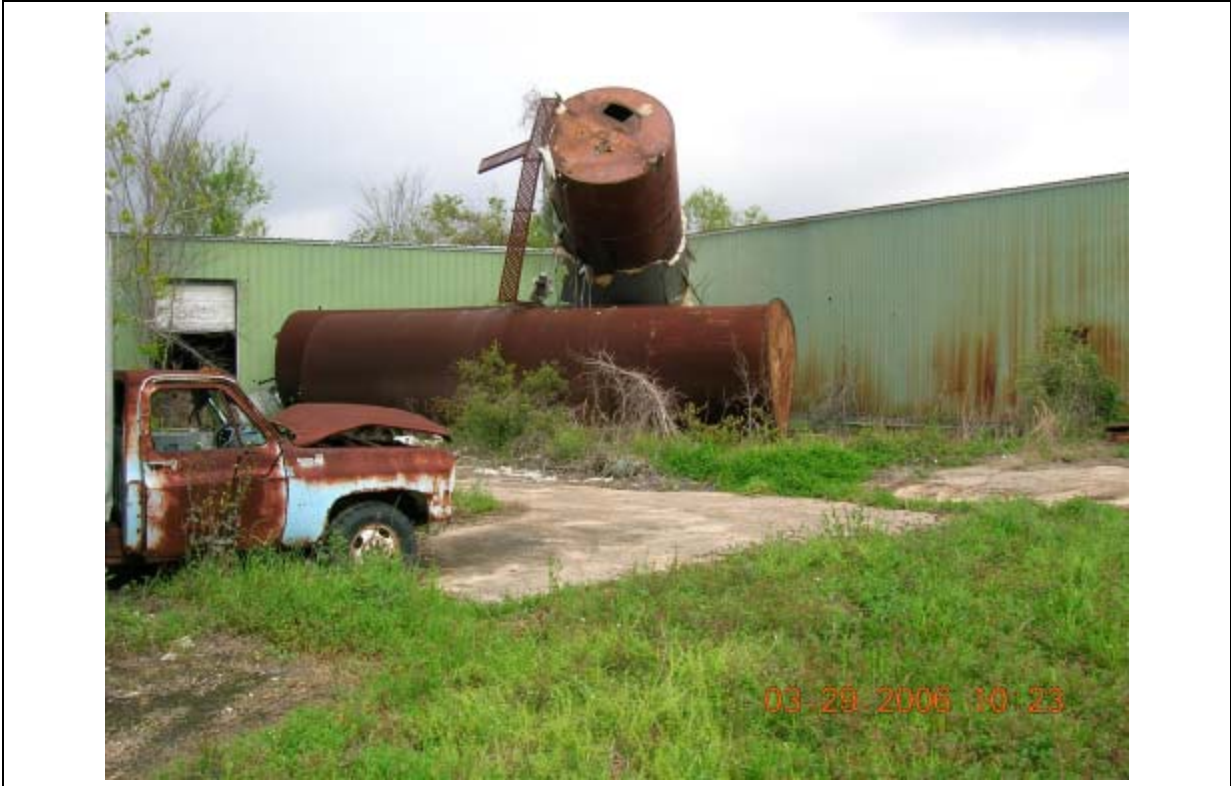
Photo 13: View of site facing northwest, towards corner where Process Building Nos. 1 and 2 join. Old tanks have fallen over.

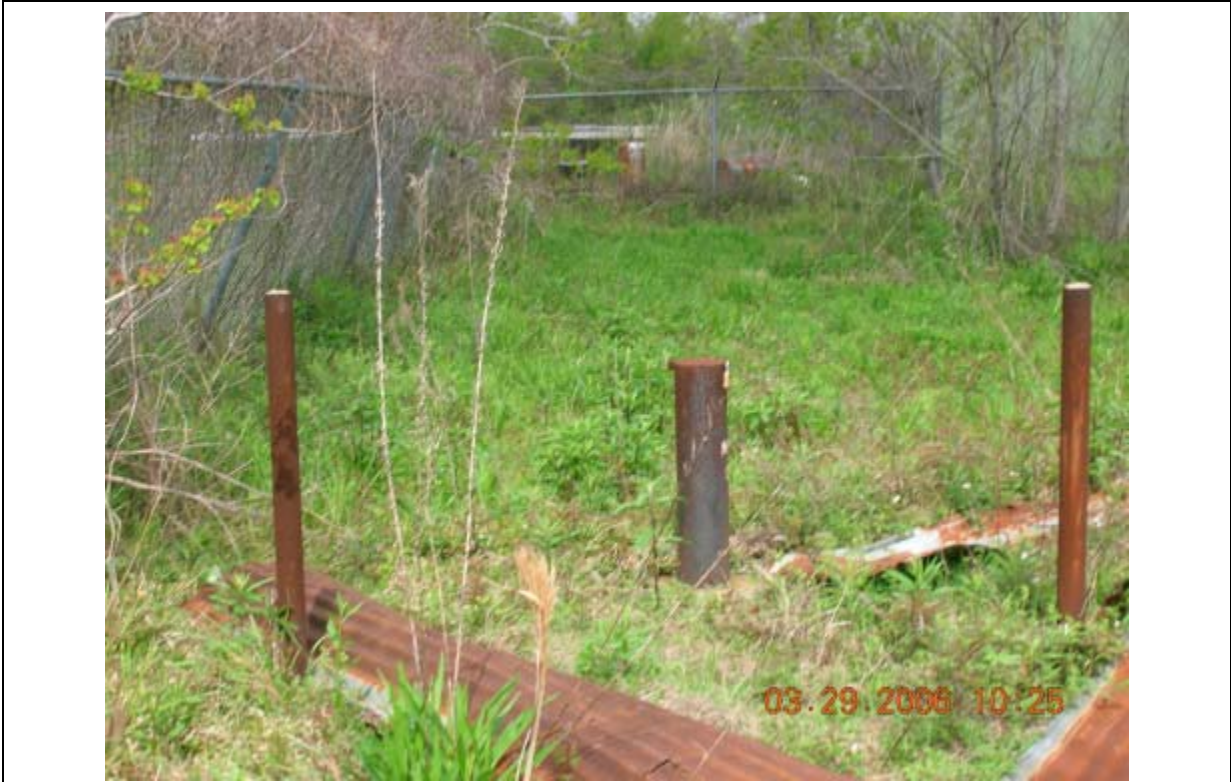
Photo 14: View of monitor well MW-08, facing west.

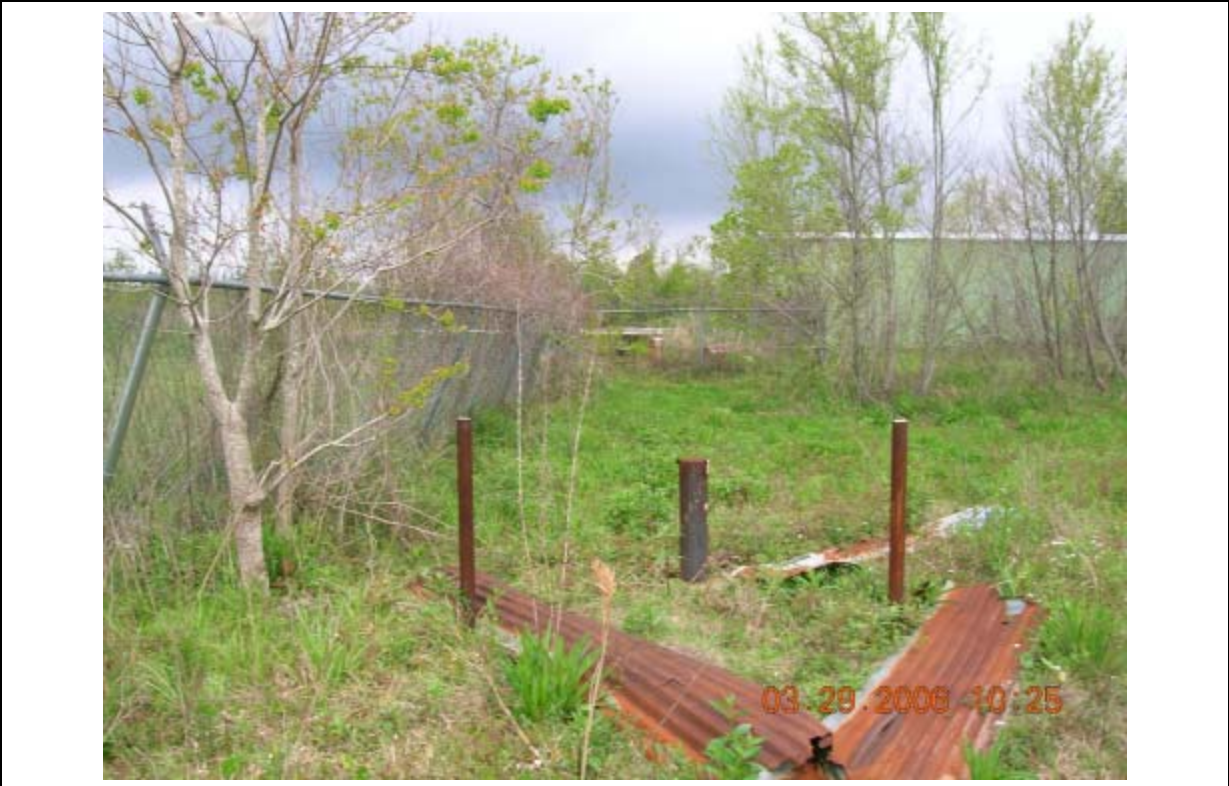
Photo 15: View of monitor well MW-08 and fence line along south side of property, facing west.

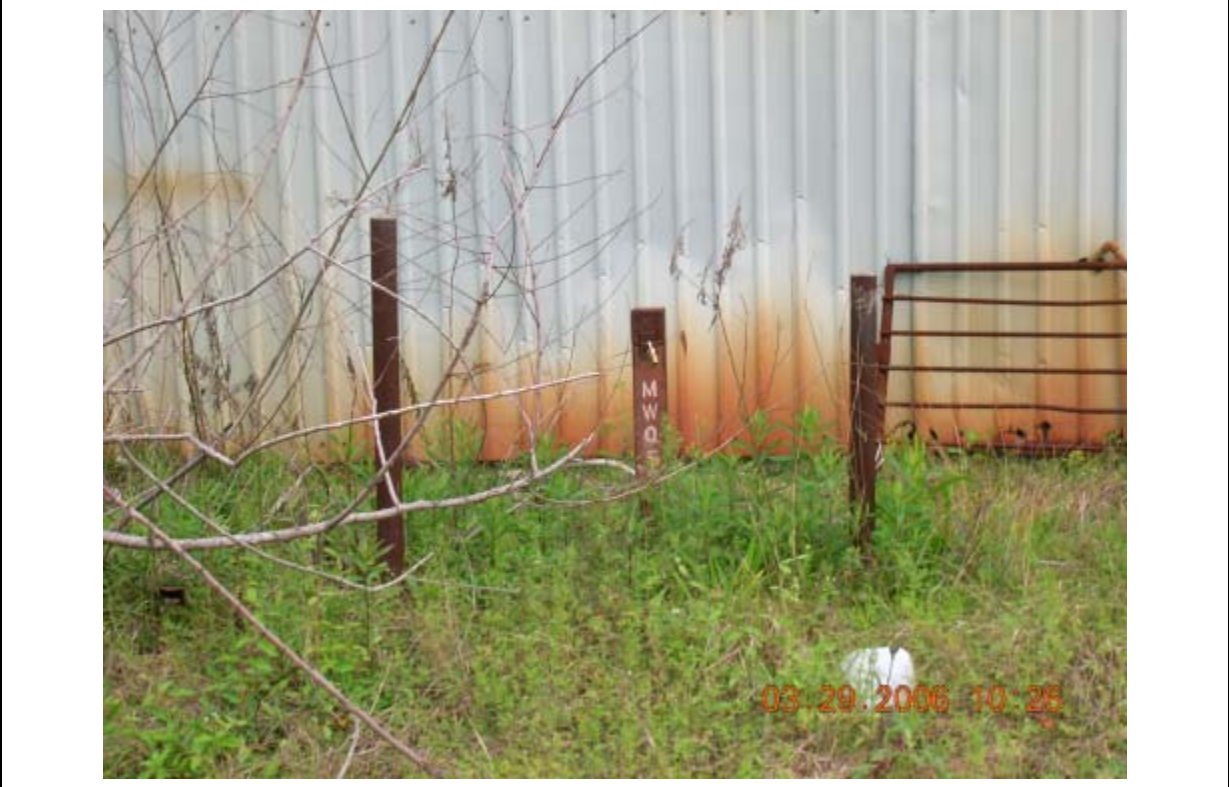
Photo 16: View of monitor well MW-05, located on the south side of Process Building No. 3.

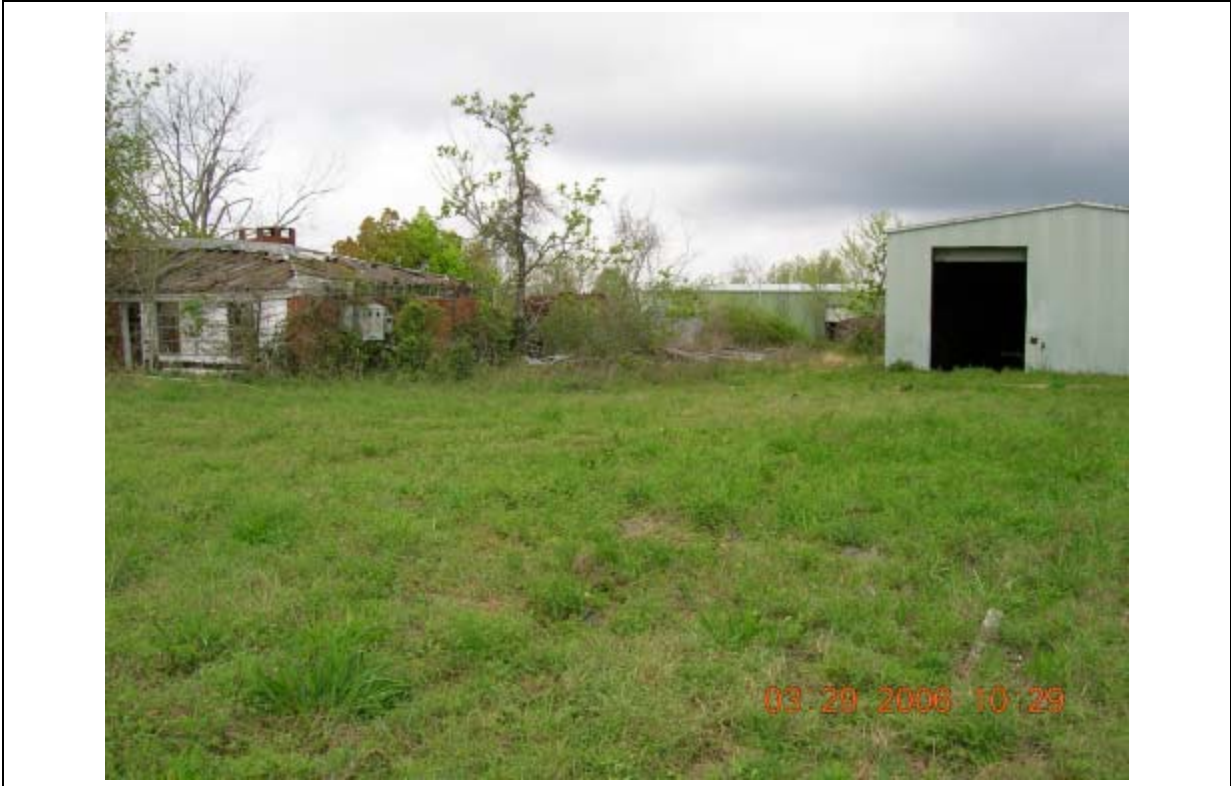
Photo 17: View of site, facing southwest from monitor well MW-01 and towards the Office building.

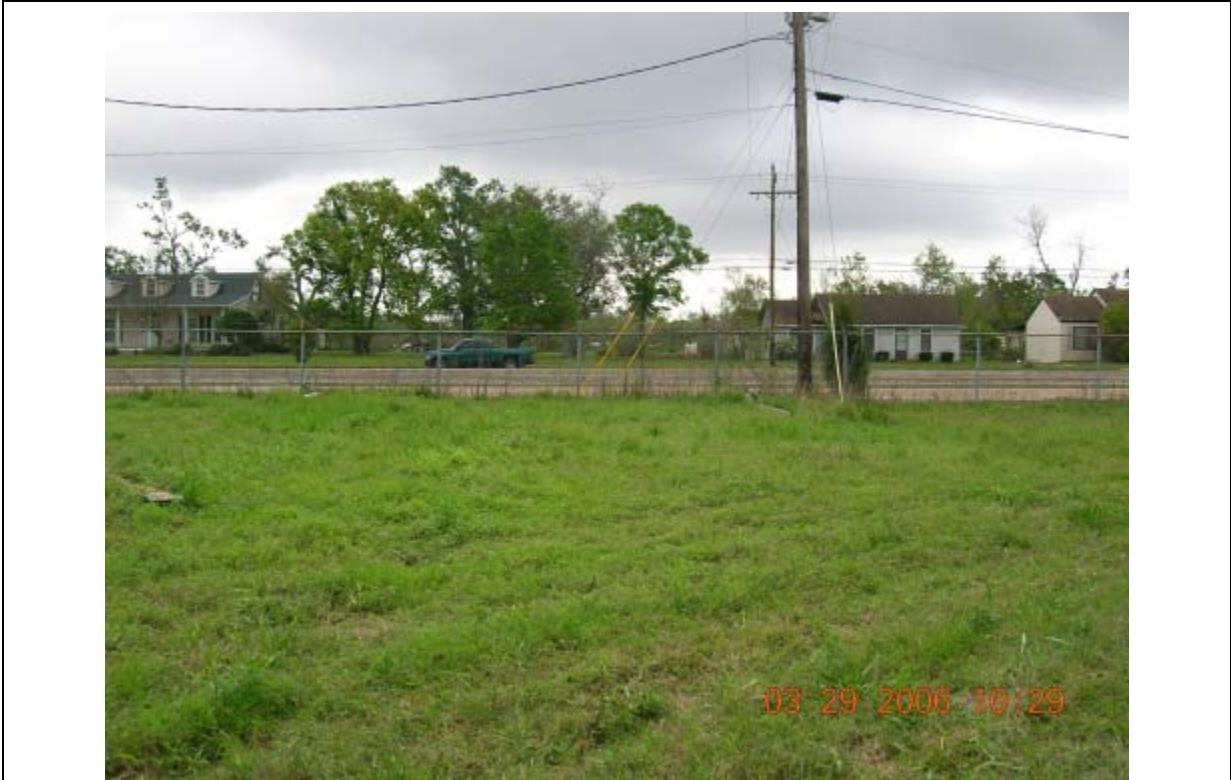
Photo 18: View of the fence along the east side of the property, facing east.

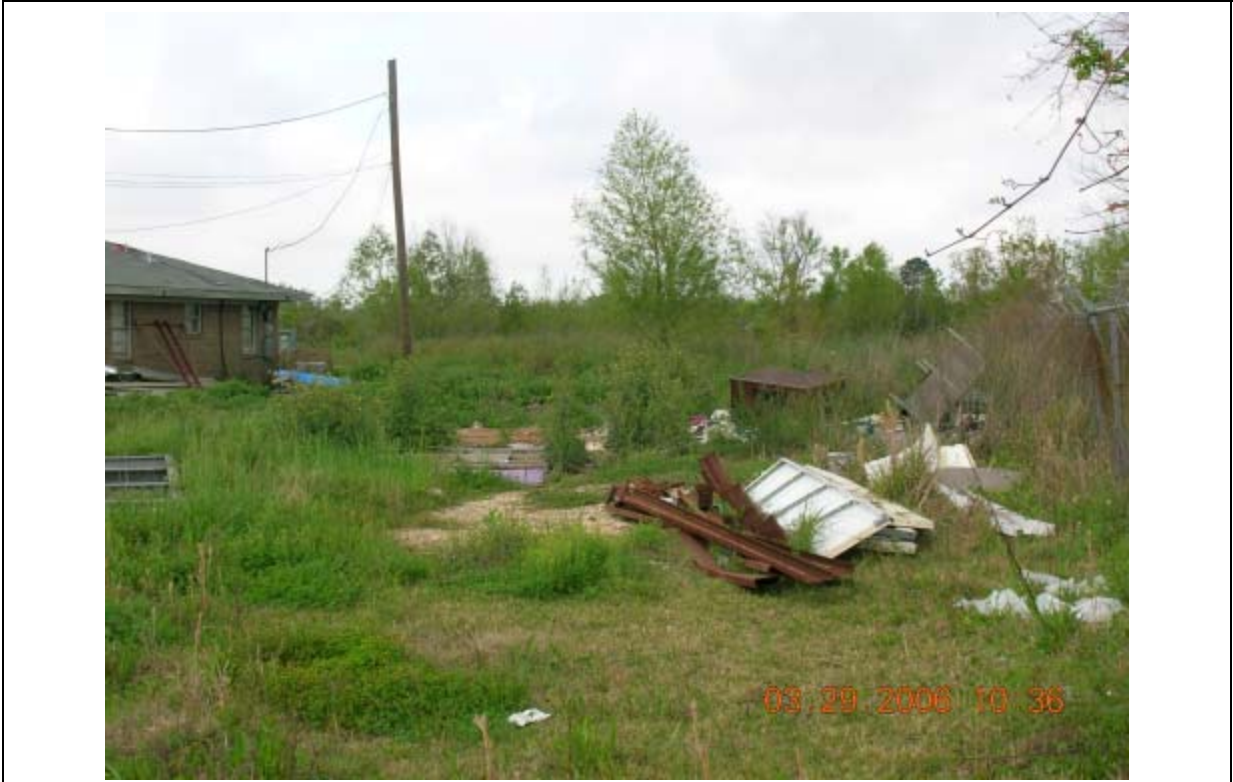
3. **Adjacent Property Owner (Broussard Property) to the south has discarded trash, and scrap metal pieces, on the dock driveway entrance site property** (see site inspection photographs in Attachment D). The debris affects aesthetics of the site and creates a deterrent to the re-sale and reuse of this site and its large structure, dock and facilities.

Photo 19: View of debris placed on property next to the south fence. The fence is not located along the property line, but is set back approximately 20 feet.
