Cimarron Mining Superfund Site Carrizozo, New Mexico

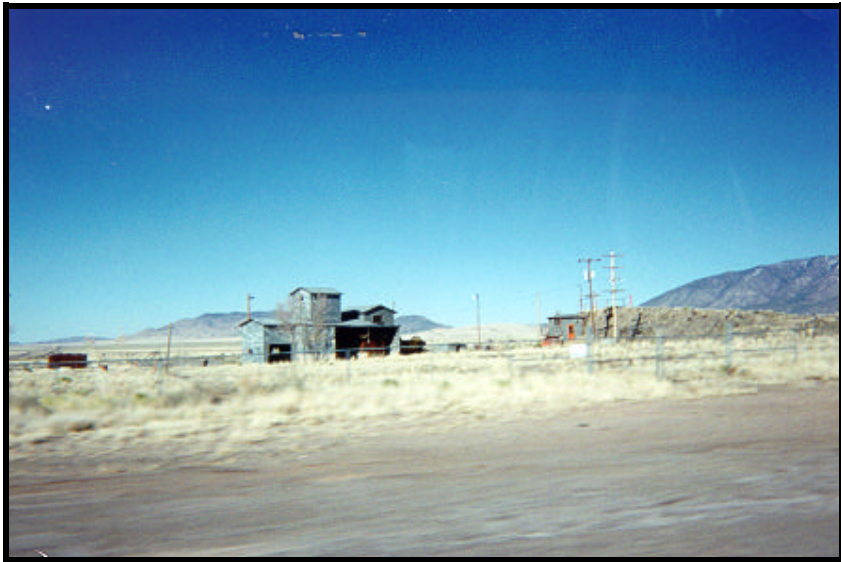
PHOTO #1 - Abandoned buildings of the Cimarron Mining Superfund site are enclosed by a 6 foot chain-link fence. The site processed precious metal containing ores using conventional methods. Several piles of ore remain on the site (right side of picture)

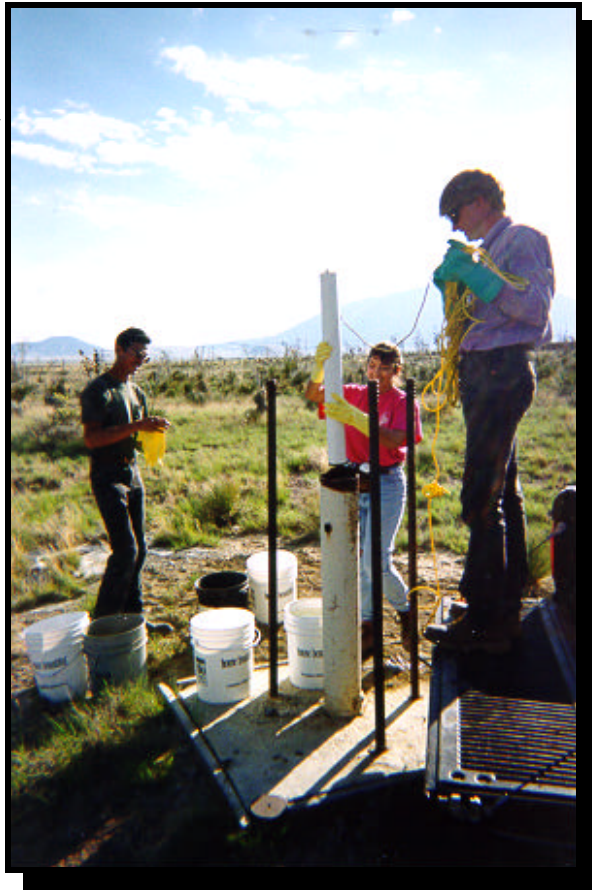
PHOTO #2 - Groundwater sampling by EPA and the Corps of Engineers in August 1998 was conducted to evaluate the effectiveness of the remedy. Groundwater contaminated with cyanide is being extracted from a string of 6 groundwater recovery wells and conveyed to a publically owned treatment works (POTW) facility.
