**APPENDIX A
SITE INSPECTION PHOTO LOG**

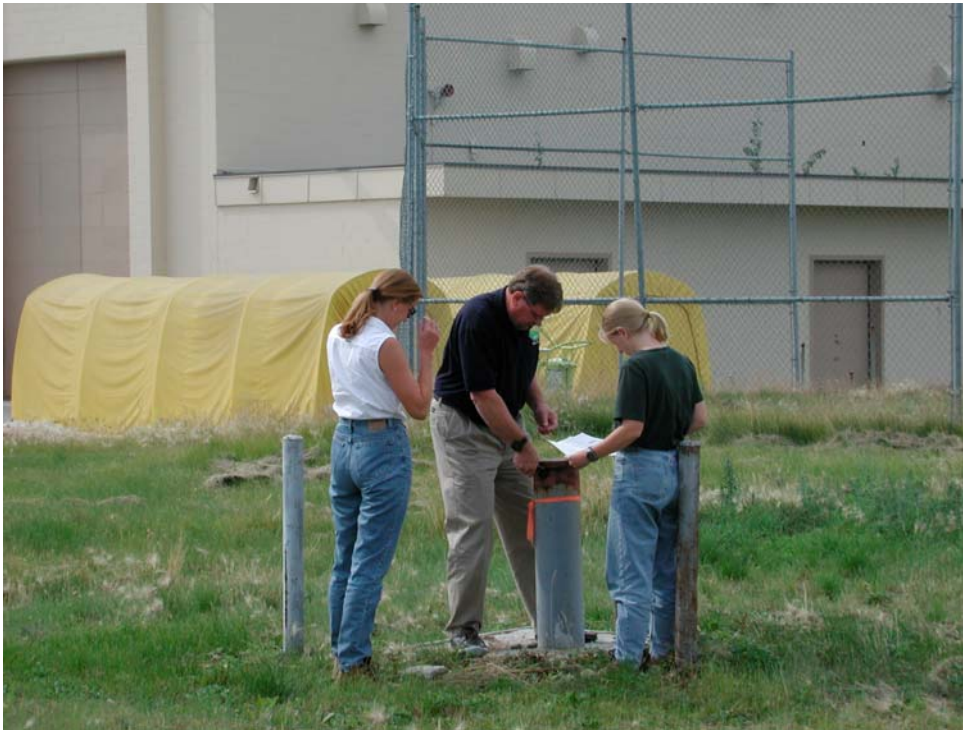
Photo 1: Site inspection team discussing monitoring well locations and sample results for site WP45/SS57. The inspection team includes USAF, USEPA, and ADEC representatives, by EA Engineering staff.

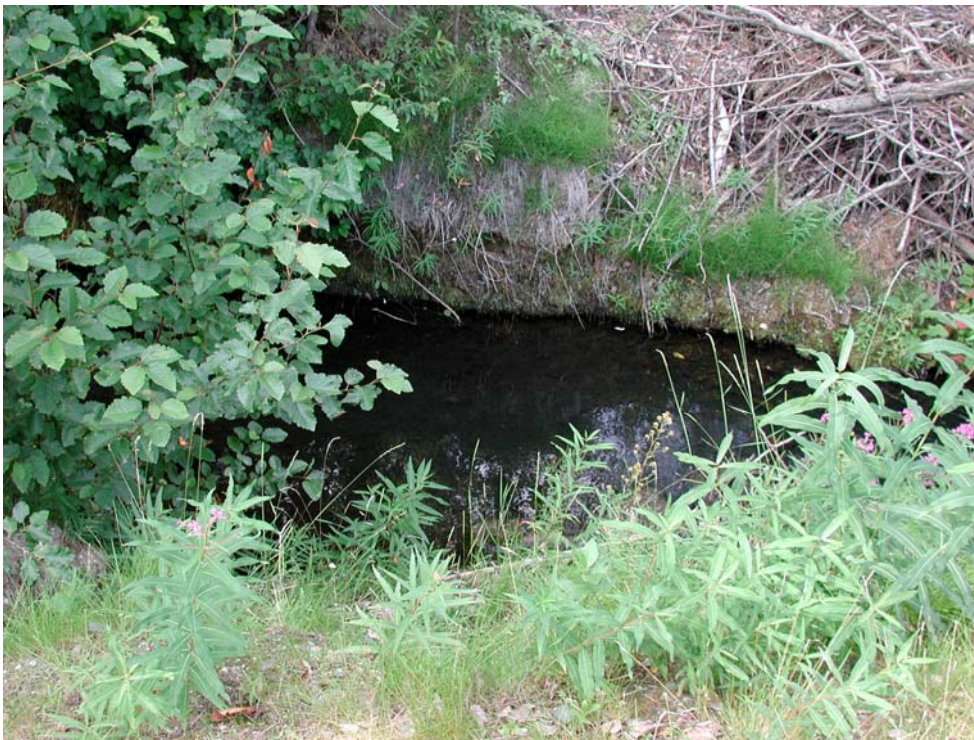
Photo 2: Garrison Slough exiting the Water Treatment Plant Pond at SS35.

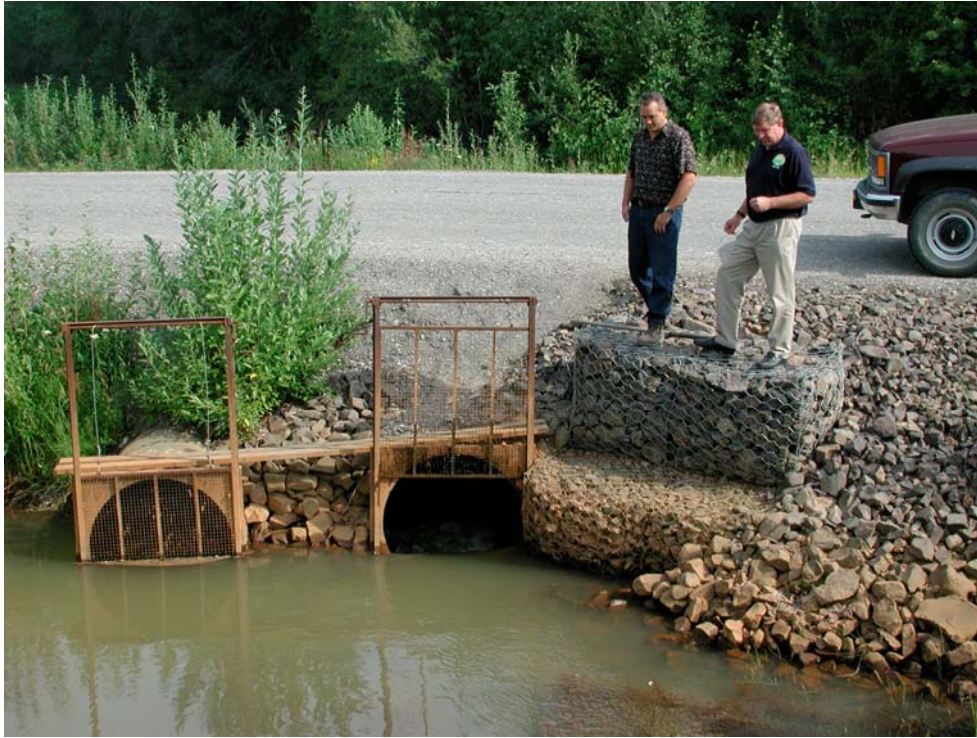
Photo 3: Fish screens along Garrison Slough.

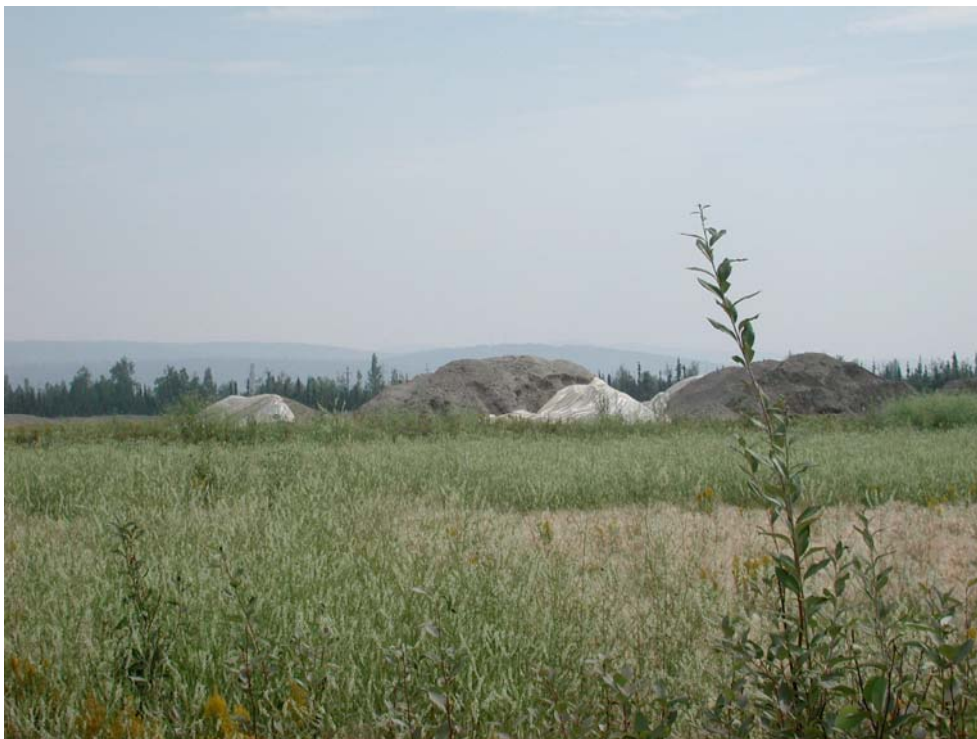
Photo 4: Containment cells storing POL impacted soils at LF03.

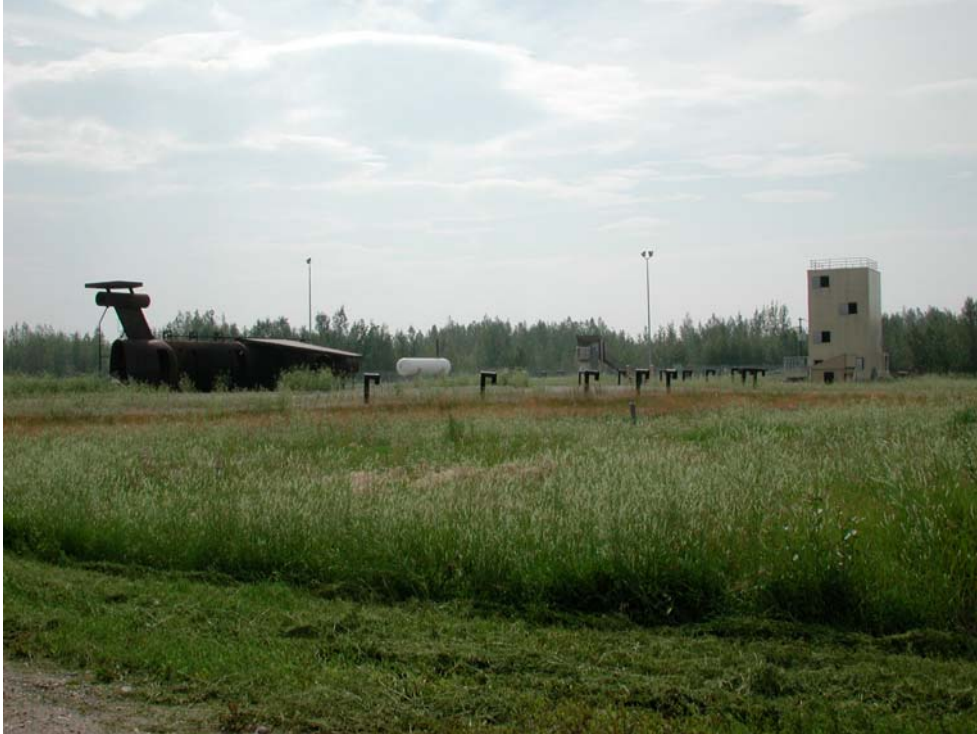
Photo 5: Fire Training Facility at FT09.

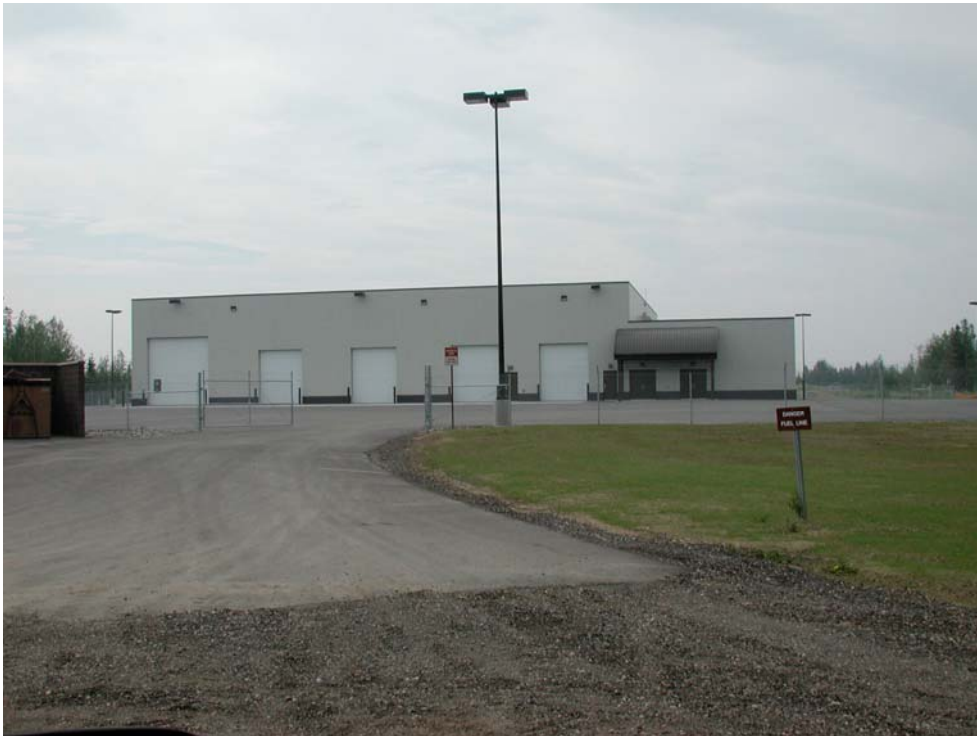
Photo 6: Munitions storage facility constructed at LF03.

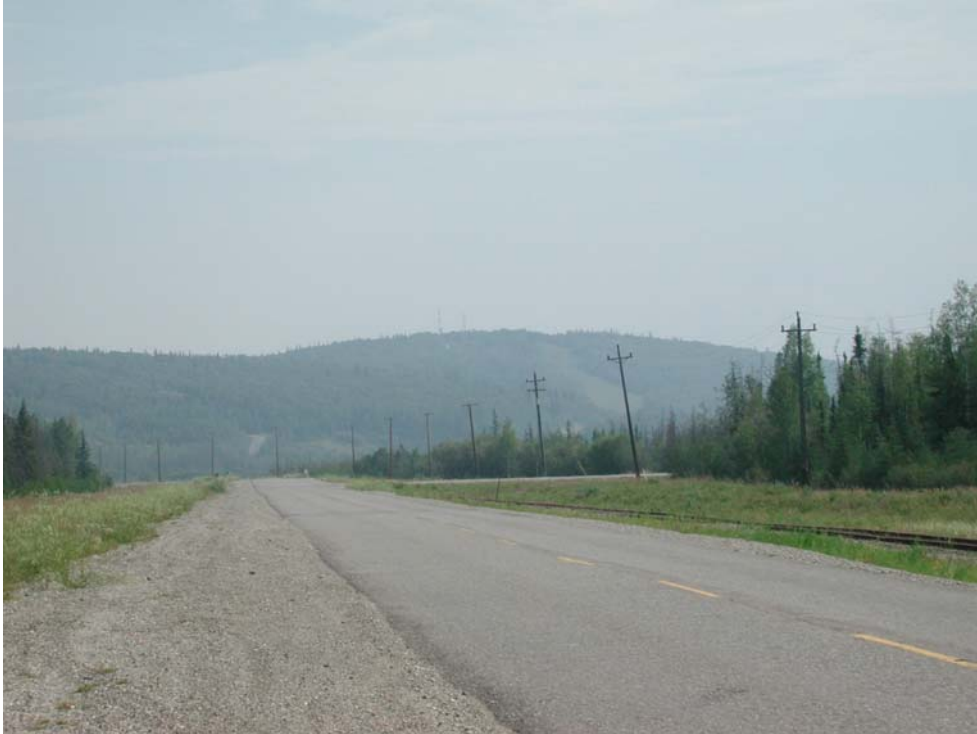
Photo 7: Looking north at WP38.

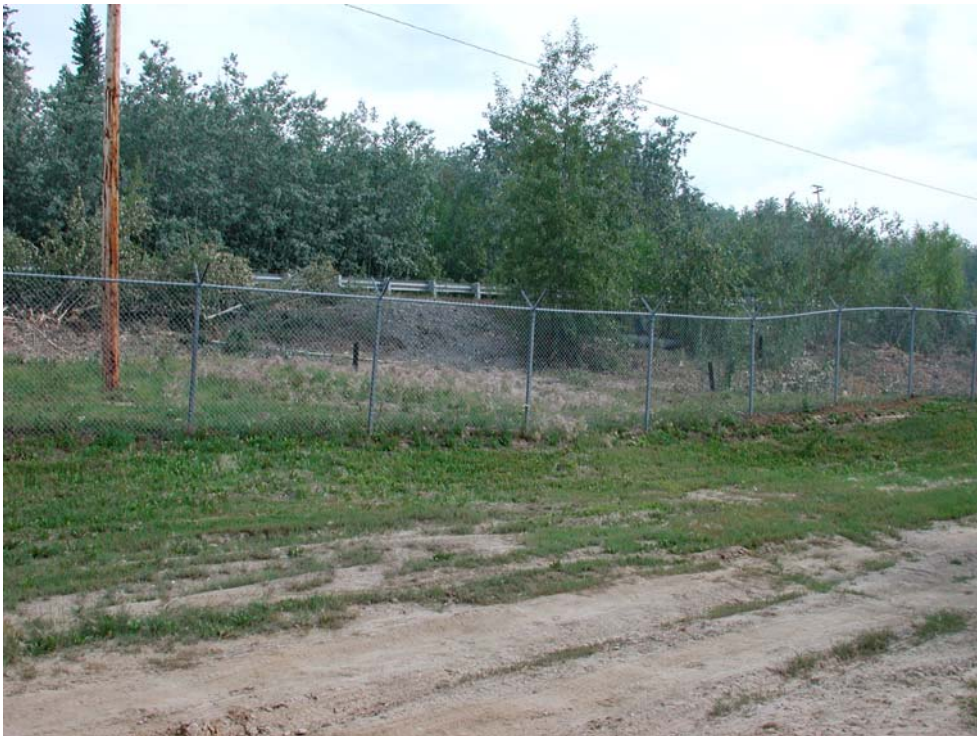
Photo 8: Engineer Hill (ST56) septic system location.
