Third Five-Year Review Report

FMC YAKIMA

Superfund Site

SEPTEMBER 2008

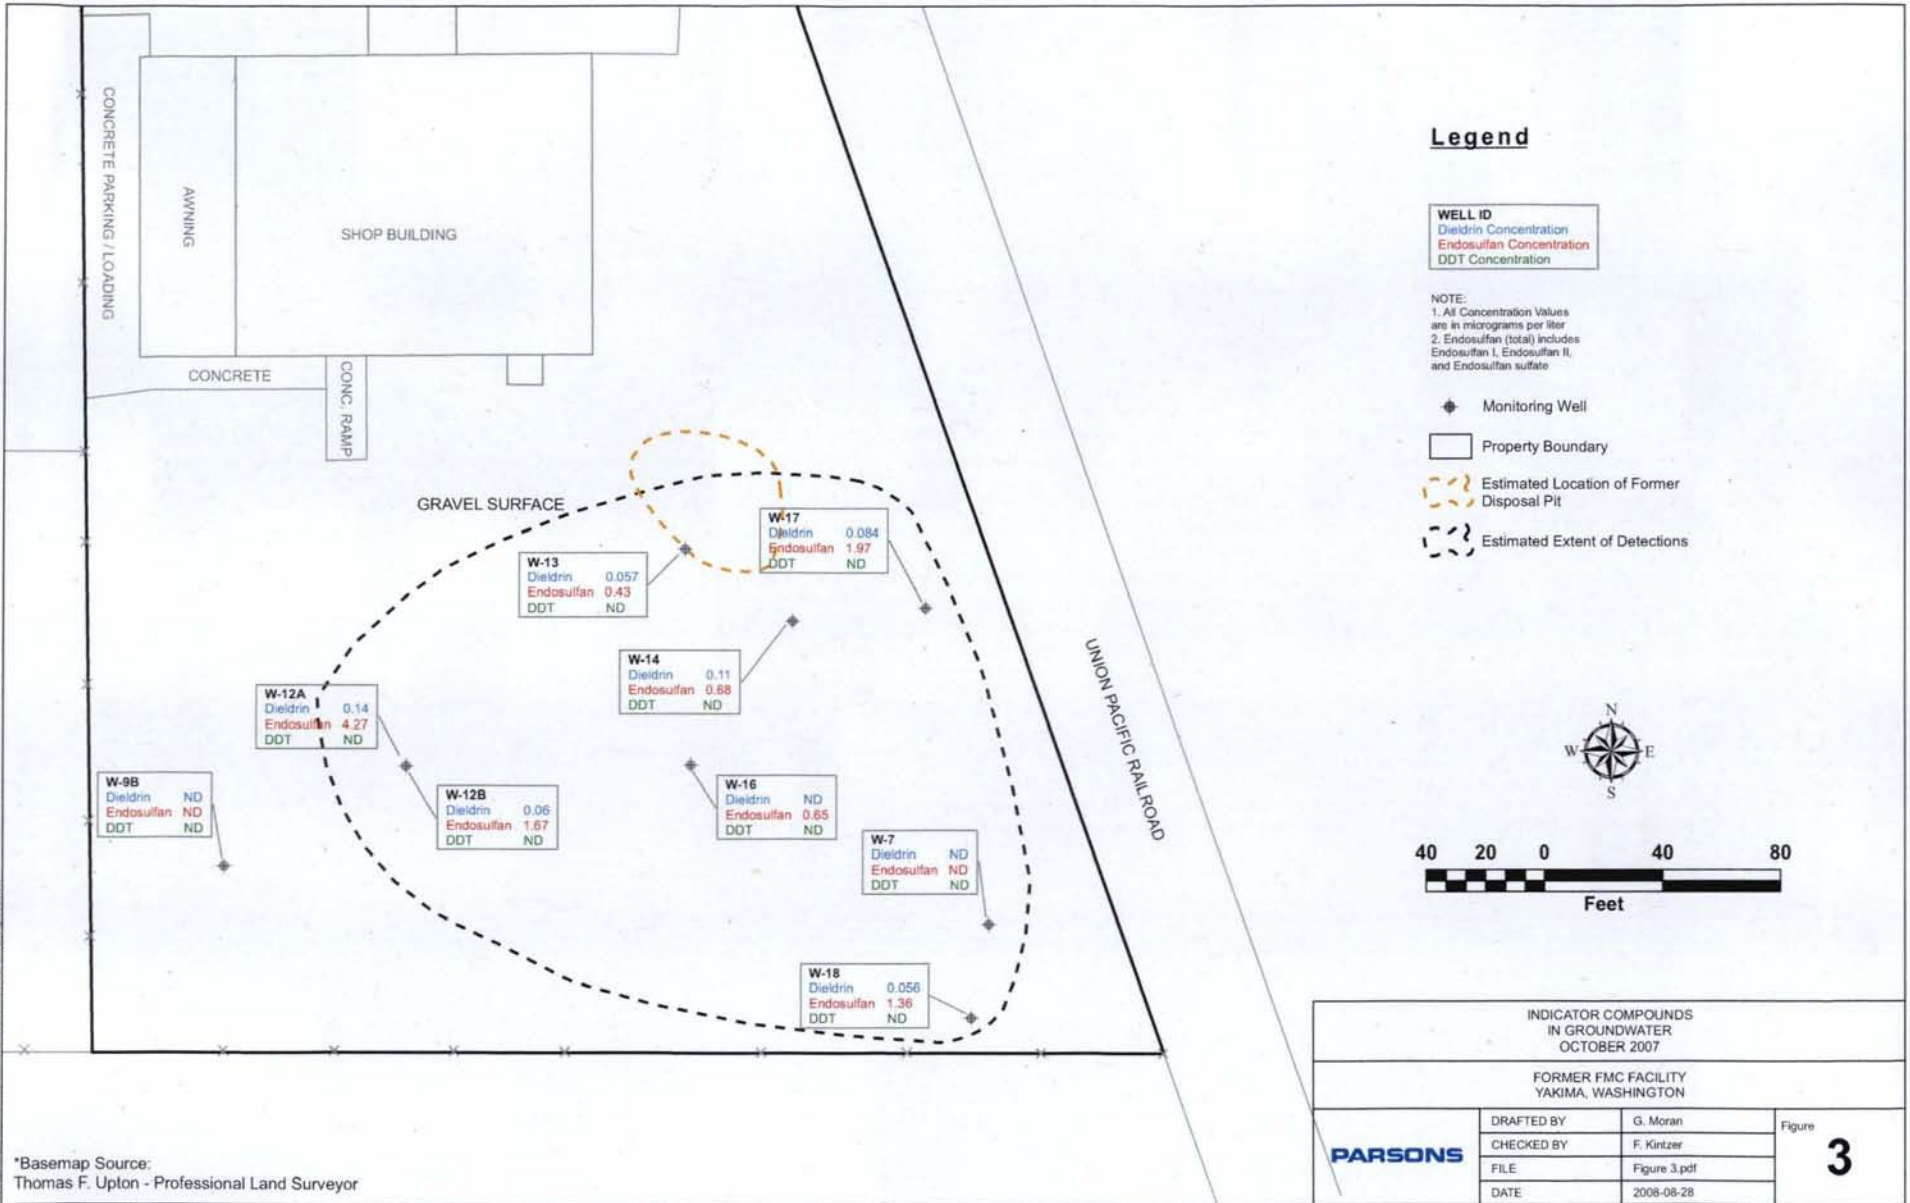
The 2007 groundwater samples contained low levels of pesticides (see Table 2 or Figure 3 in Appendix A.1). The highest detected level for dieldrin (0.14 µg/L) occurred at well W-12A (see Table 2 or Figure 3). The highest detected level of endosulfans (4.27 µg/L) was also found at well W-12A. When this data is plotted with data from previous monitoring events, an overall decreasing trend can be observed (see Figures 4 and 5 from Appendix A.1) since the completion of soil remedial action, although dieldrin concentrations remain above pre-excavation levels.

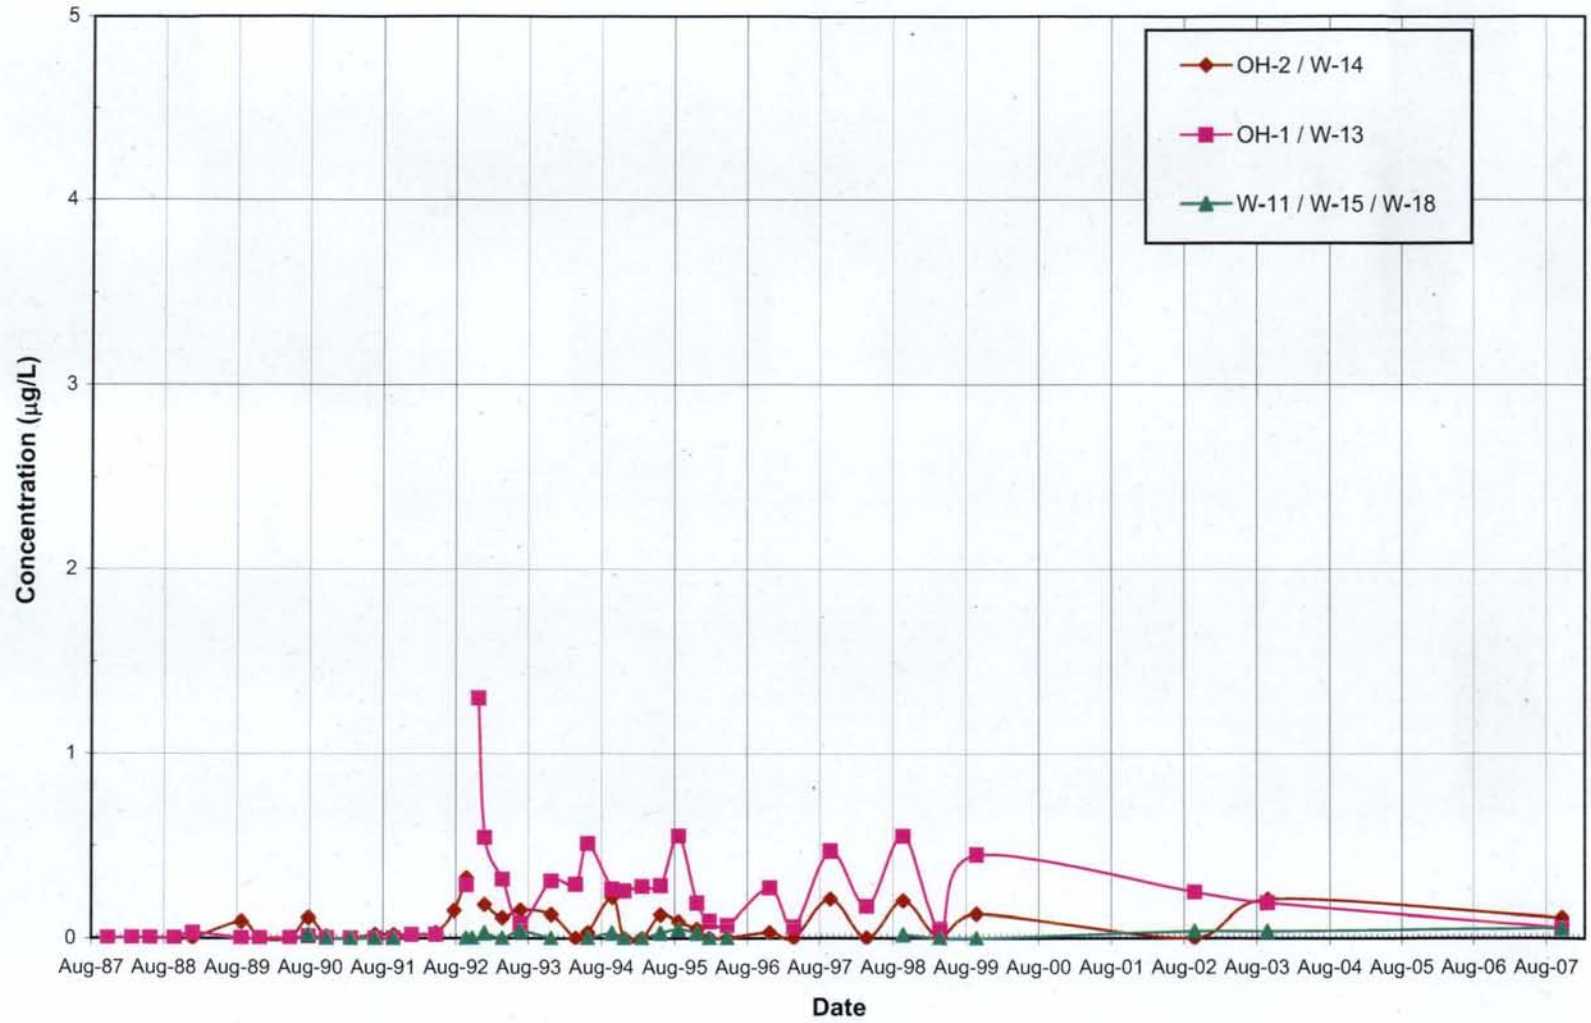
Figure 5 - Dieldrin plus Aldrin in Groundwater

While dieldrin is a COC for soils, it is not listed as a COC for groundwater in the ROD or ESD. Dieldrin is being monitored in groundwater because it is a hazardous substance present at the site that persists at levels above the ROD groundwater cleanup goal of 1×10^{-6} excess cancer risk. However, dieldrin is not currently counted toward the calculation of excess cancer risk because it is not listed as a groundwater COC.

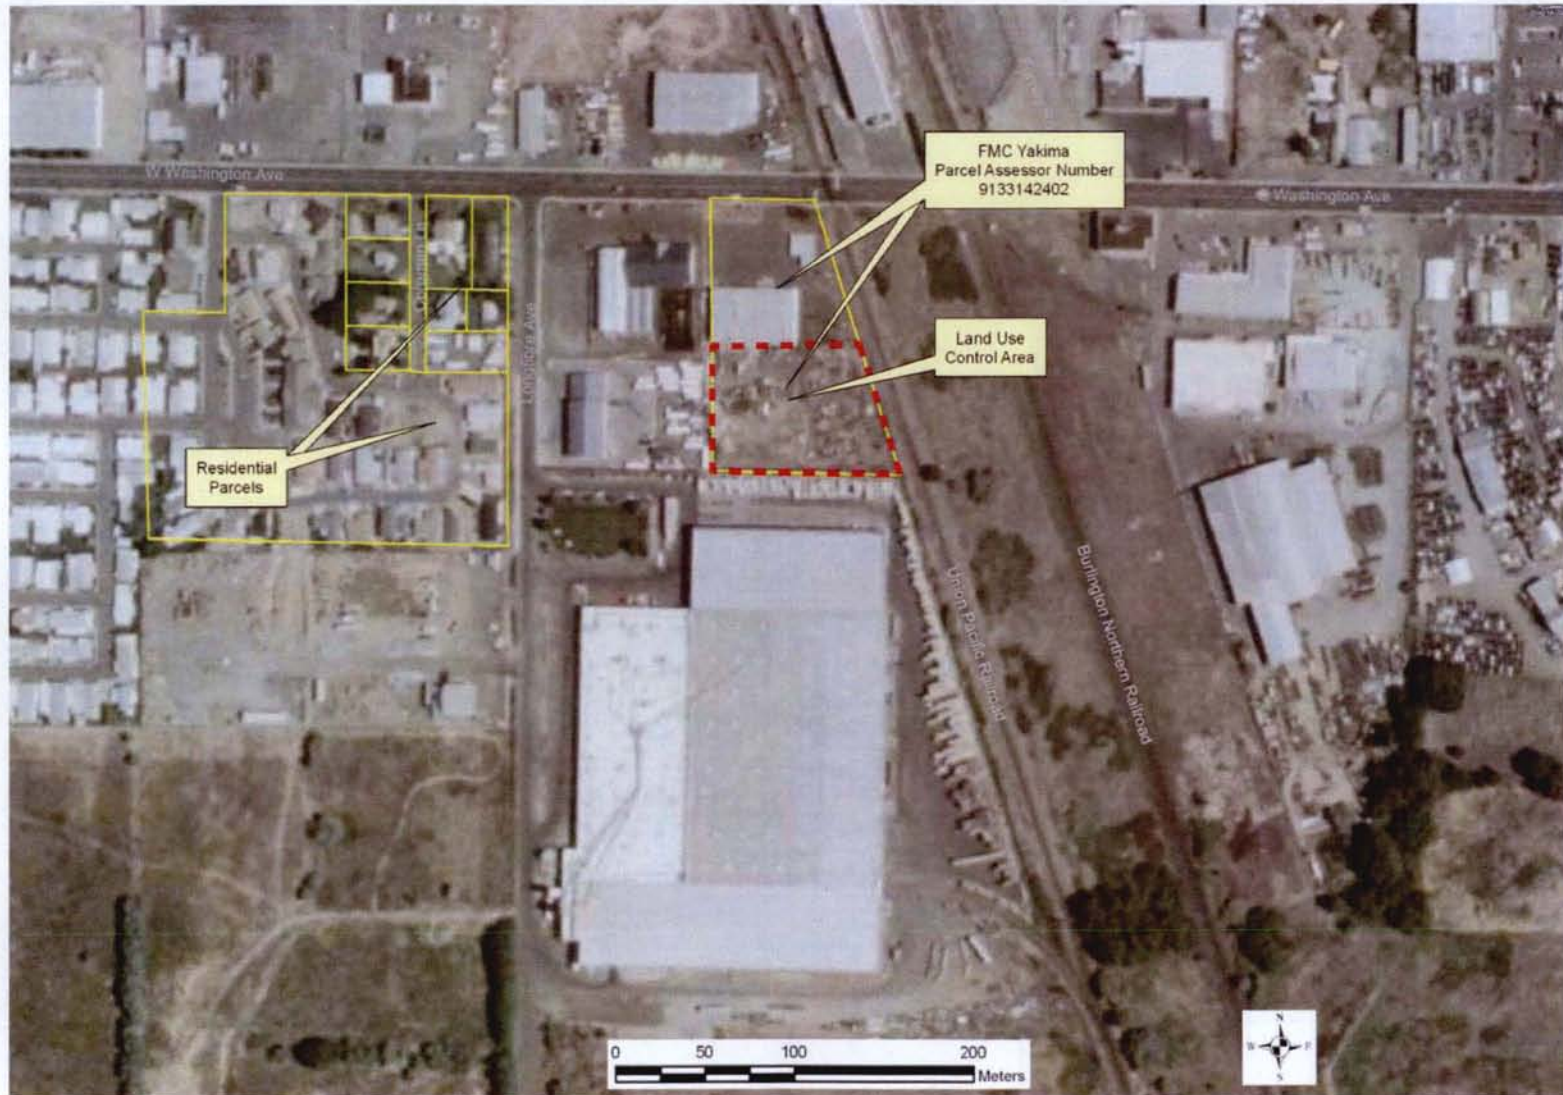
Figure 6 - Projected Land Use Control Area for the FMC Yakima Site and Proximity to Residentially Zoned Parcels

No institutional controls are required by the ROD, even though hazardous substances remain on site below 7 feet and in the groundwater. To remain protective in the long term, institutional controls should be developed and implemented. EPA intends to incorporate institutional controls into the remedy in a ROD Amendment following public comment, specifically in the form of enforceable land use restrictions in a covenant pursuant to the recently enacted Washington Uniform Environmental Covenant Act or an equivalent easement to prevent or appropriately restrict groundwater use and intrusion into subsurface contamination. A Proposed Amendment for public comment is anticipated in early 2009, with later FY 2009 ROD Amendment issuance. See Figure 6 in Appendix A.1 for the land use control area where institutional controls are projected to be implemented within the site.

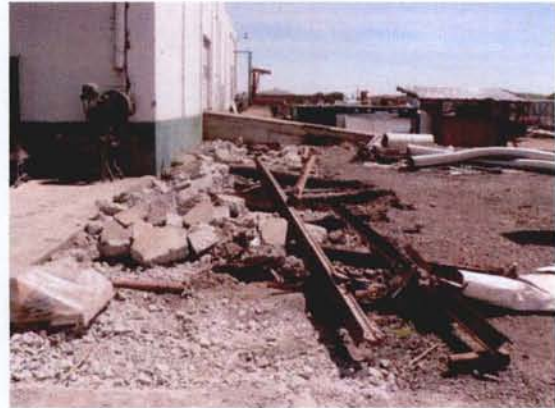
Demolition of old railroad spur looking east towards the southwest corner of Stephens Metal Products warehouse

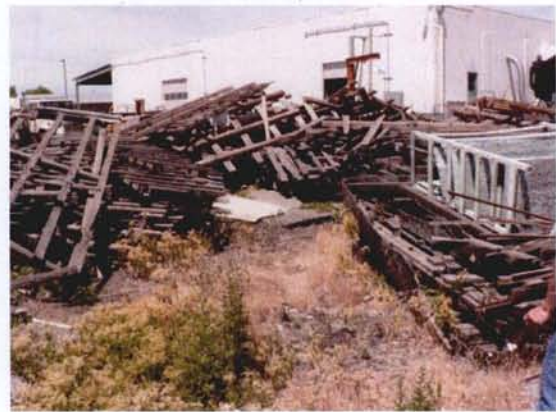
B. Other Site Conditions			
Remarks <u>There is a lot of debris piled here and there, but that is expected for a laydown yard. Flush well heads should be safe and allow use as a laydown yard. Like this year's site visit, future visits should be preceded by a request to make sure there is proper access to all monitoring wells.</u>			
VII. LANDFILL COVERS		Applicable	<u>N/A</u>

Debris around monitoring well W-13
