**Third Five-Year Review of the Silver Mountain Mine Superfund Site,
Okanogan County, Washington**

Five-Year Review Summary Form

Date(s) of site inspection: June 26, 2007

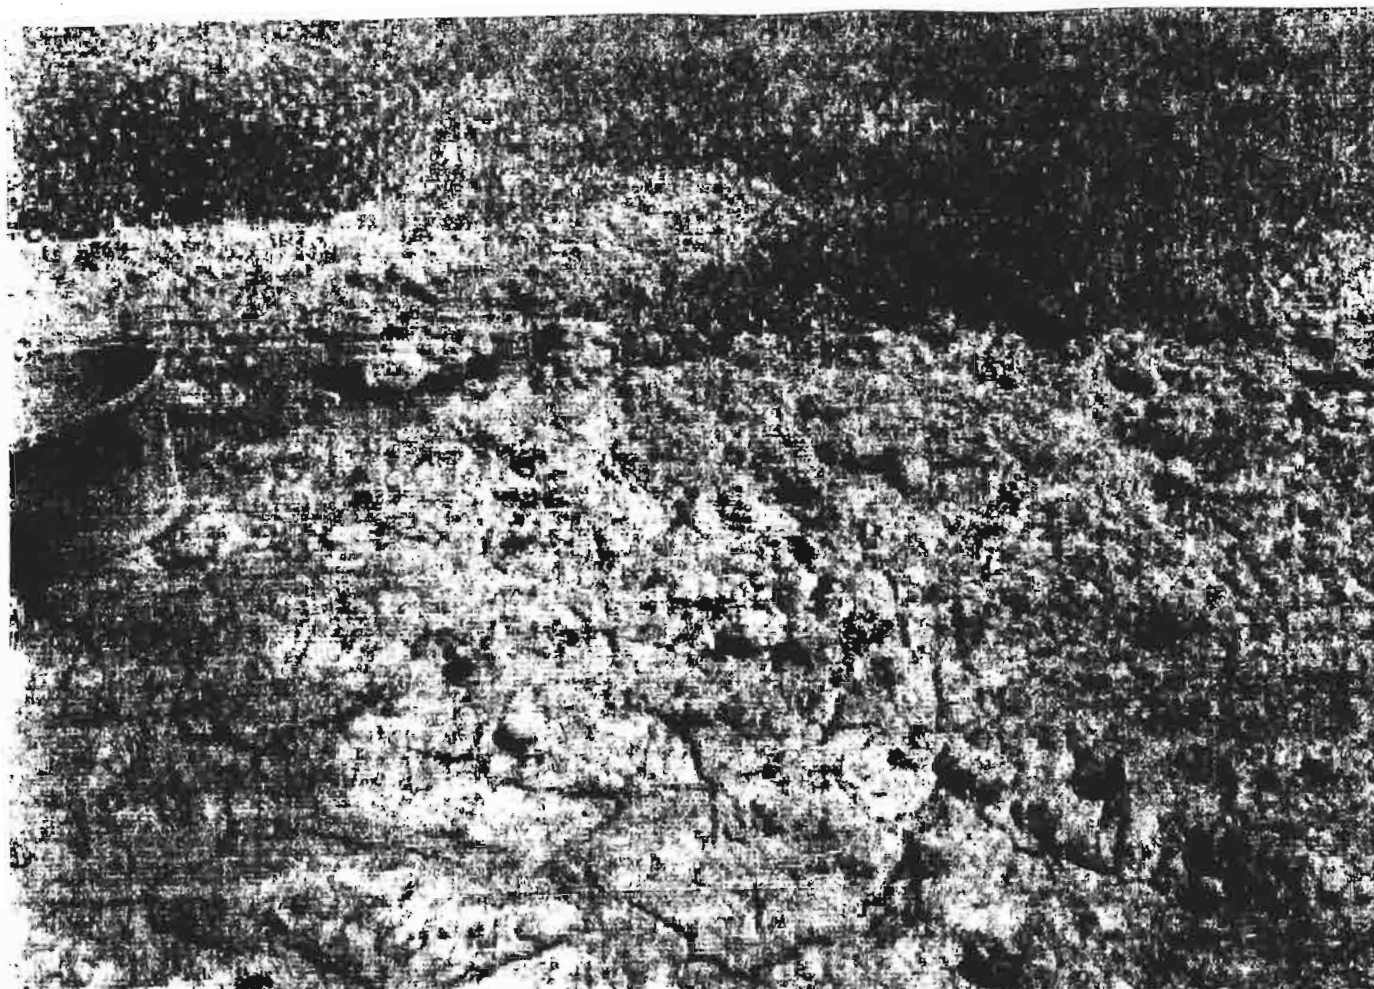
Adit seepage area

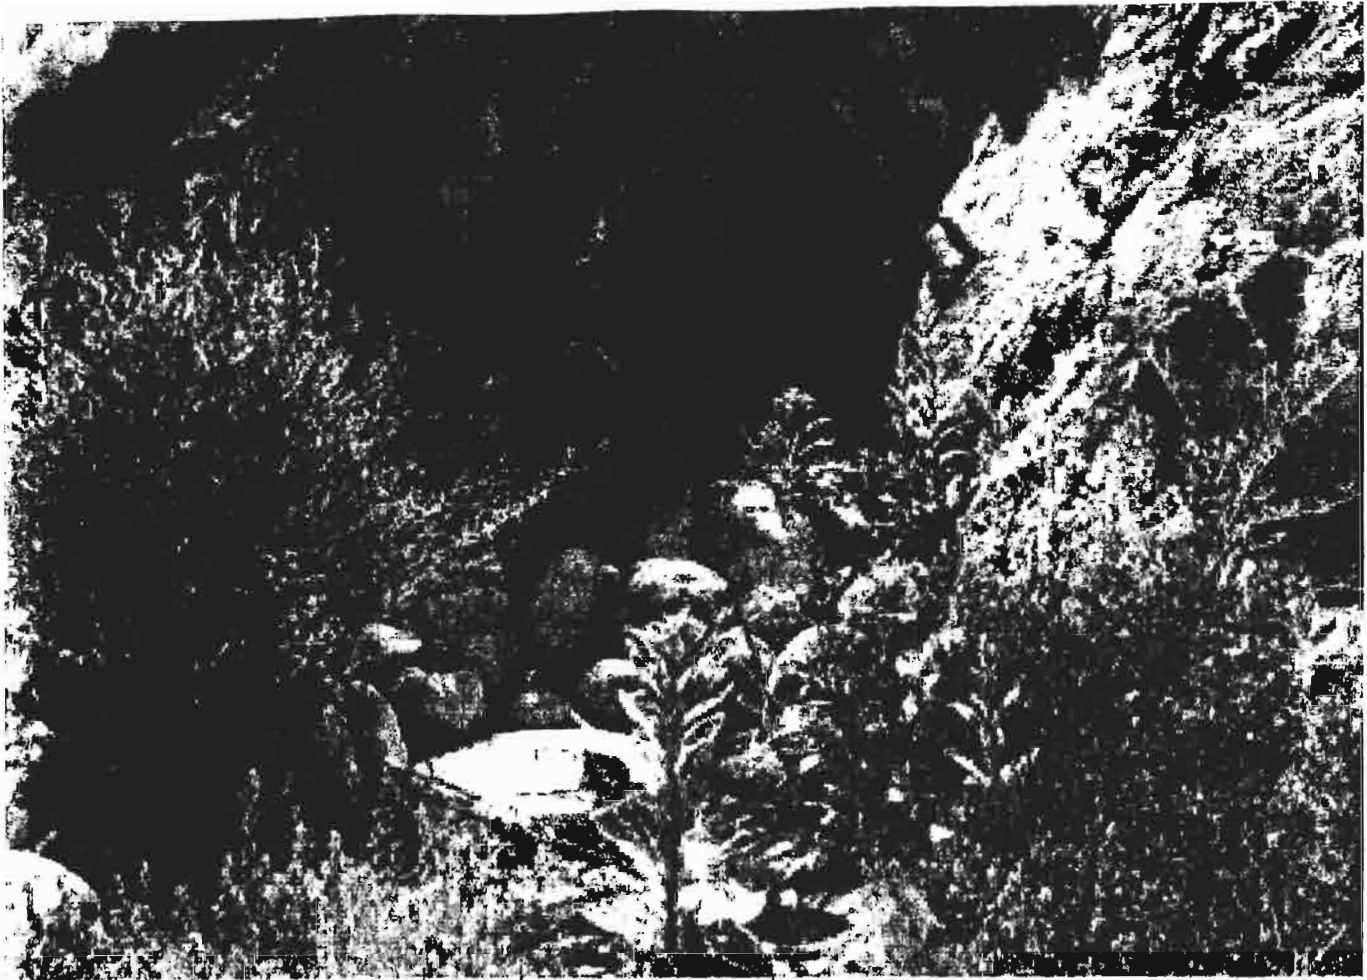
closed mine entrance

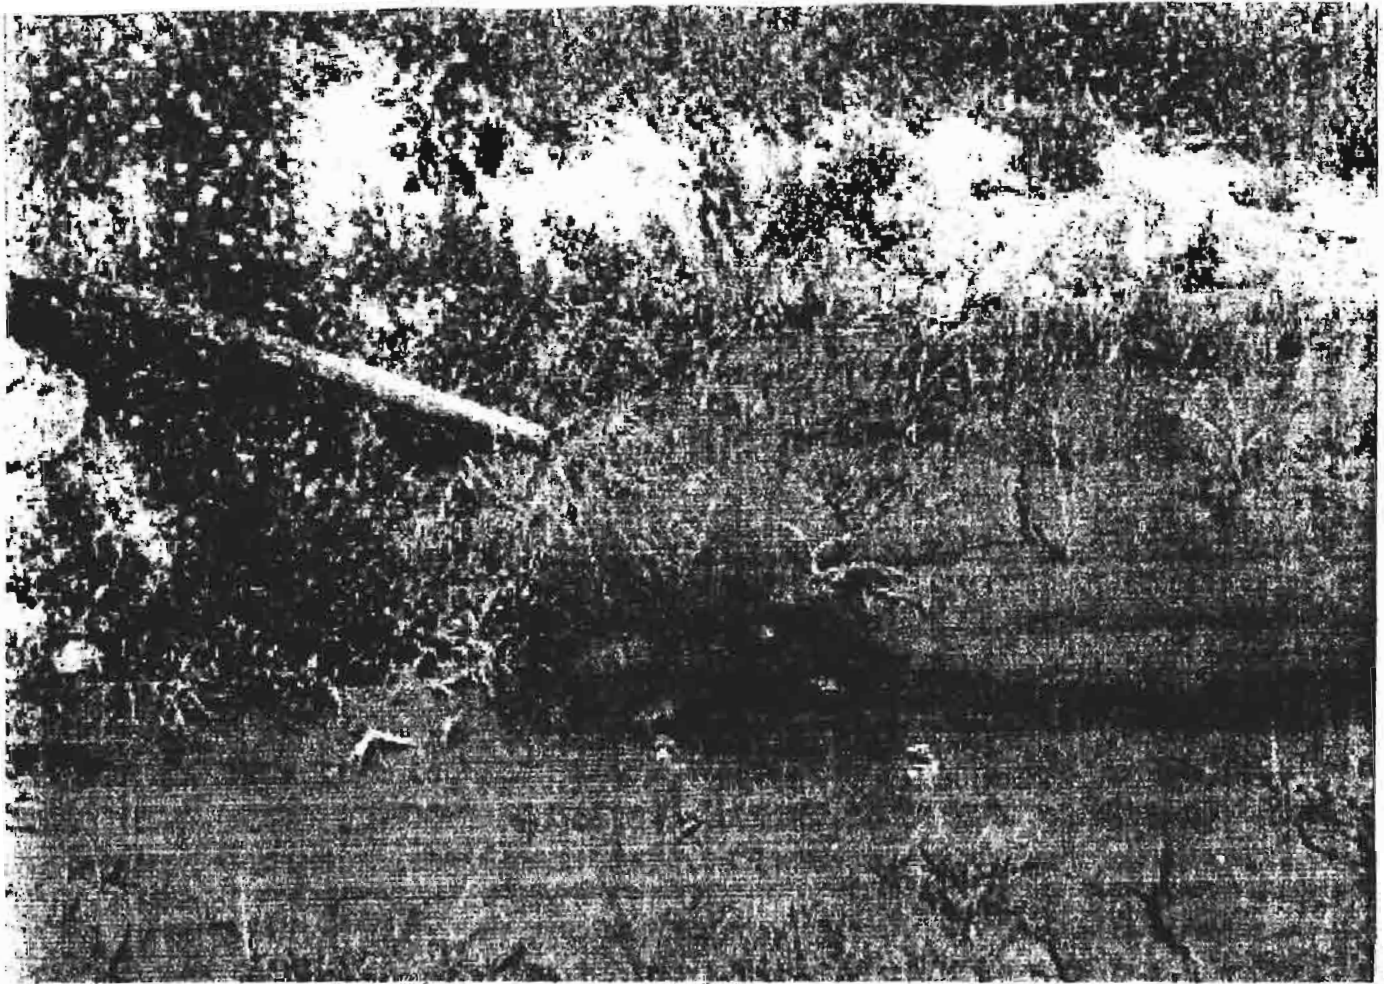
Adit seepage

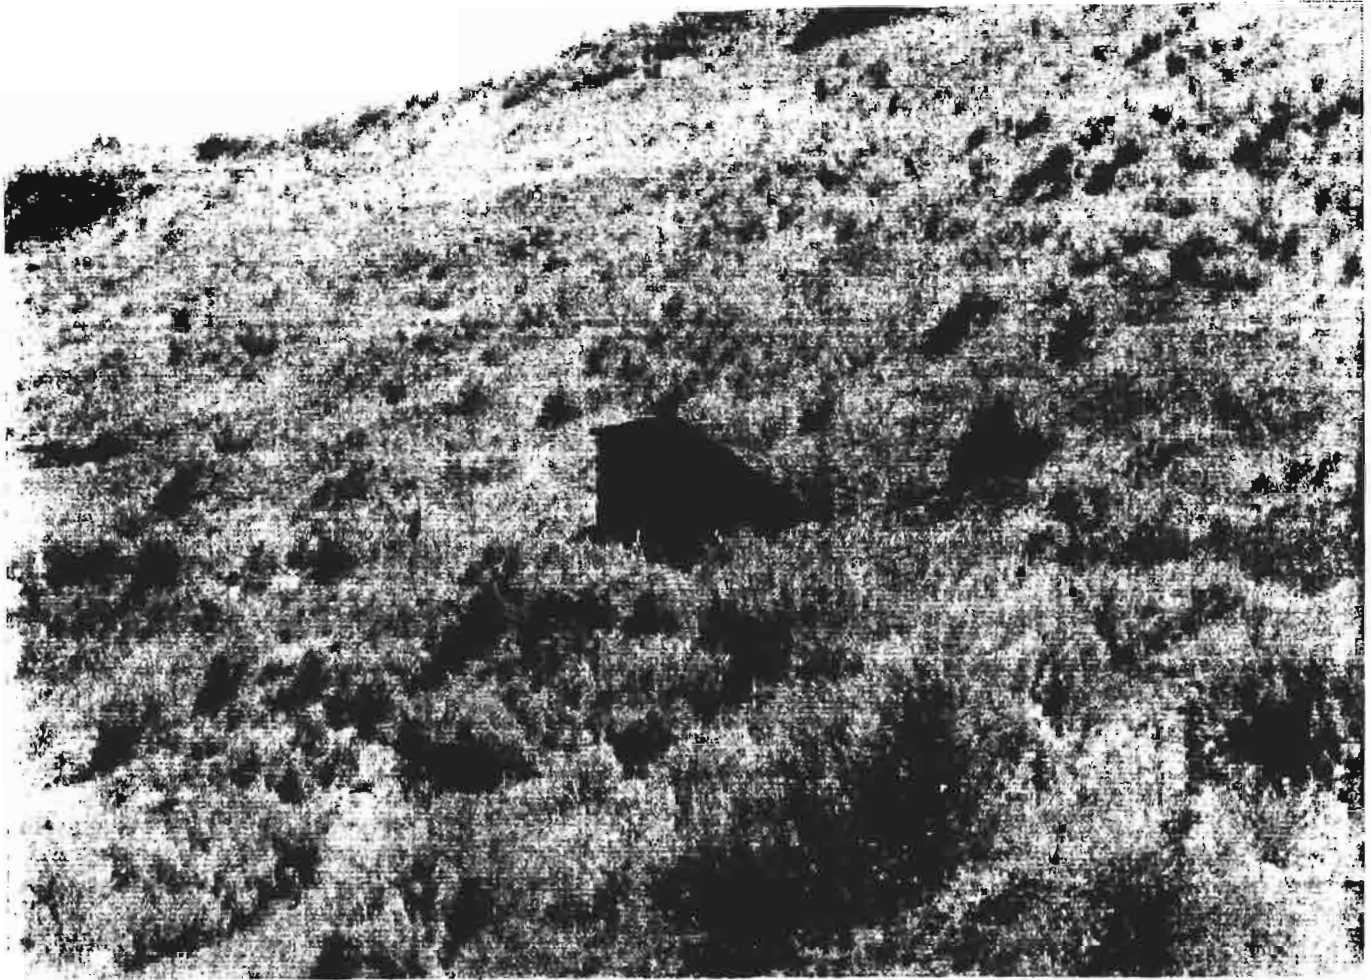
old mine structure

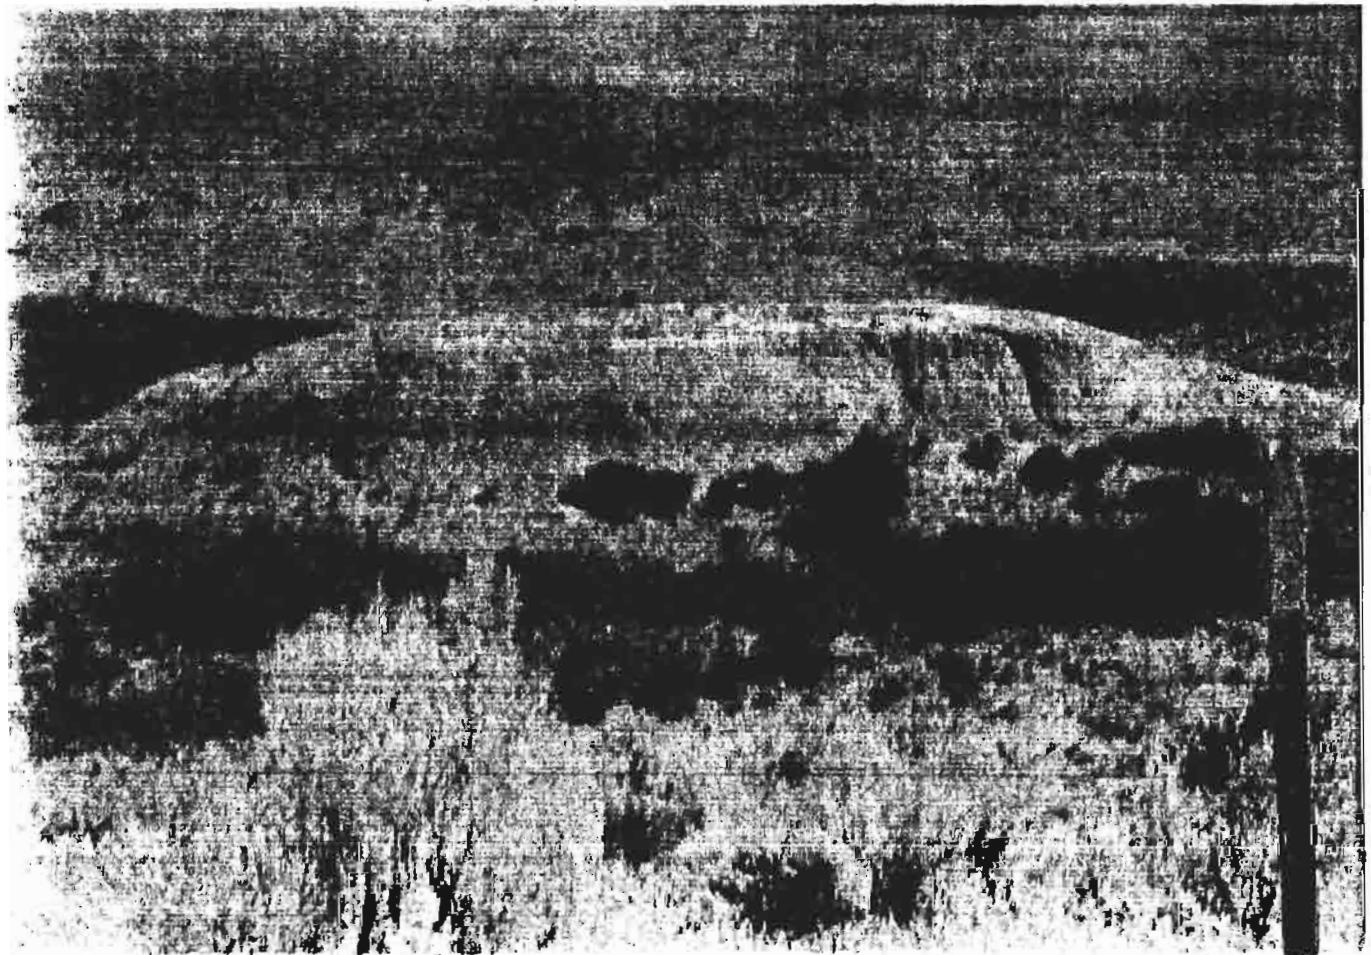
View of old mine structure from below (see photo of hillside)

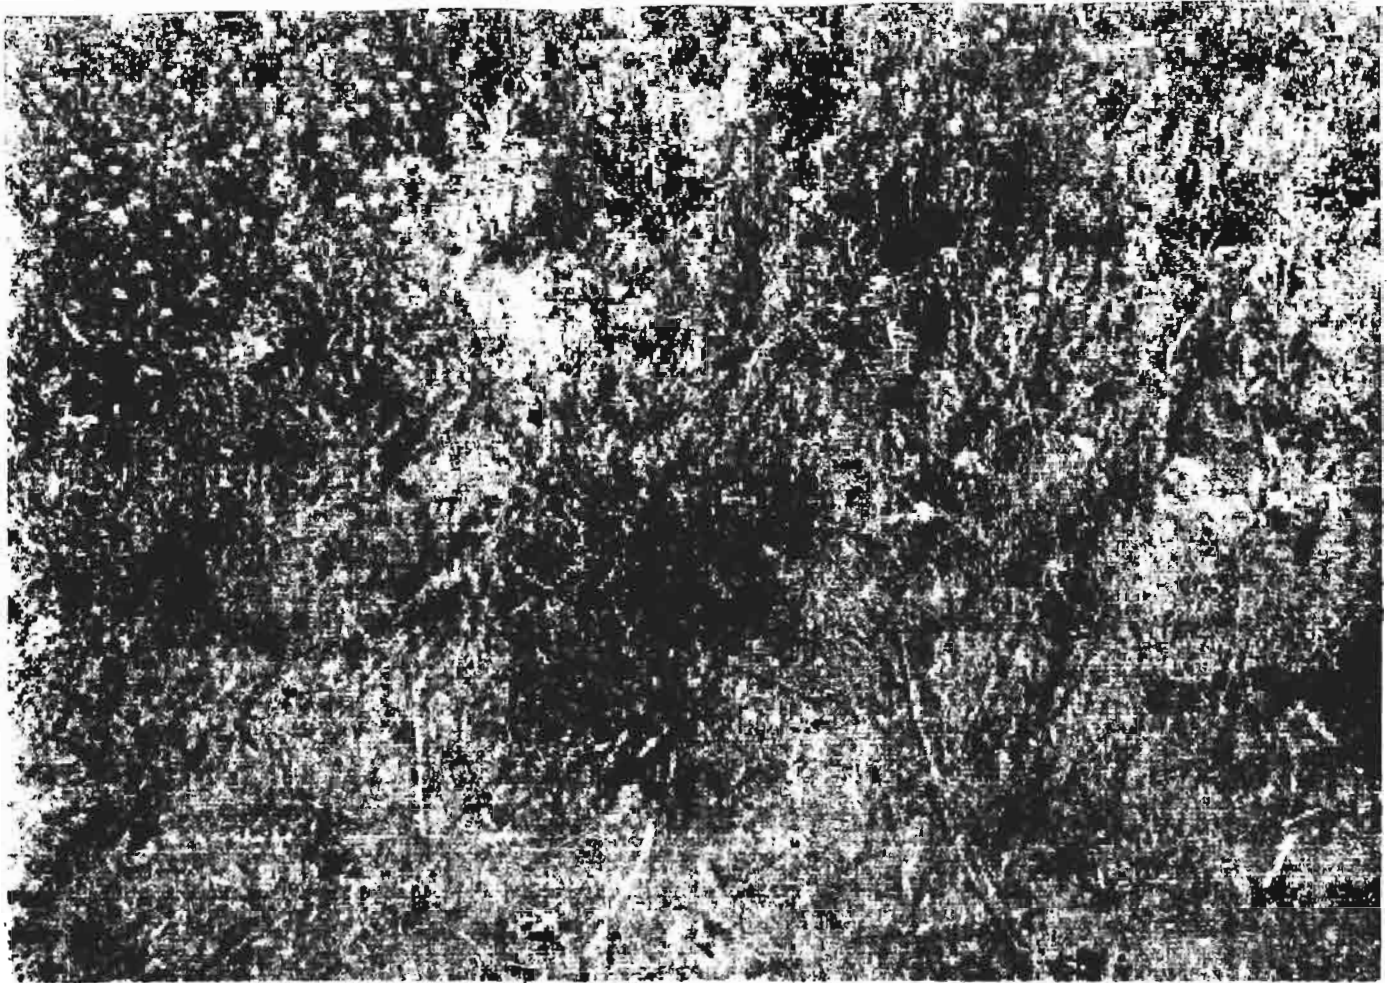
vegetation on cover

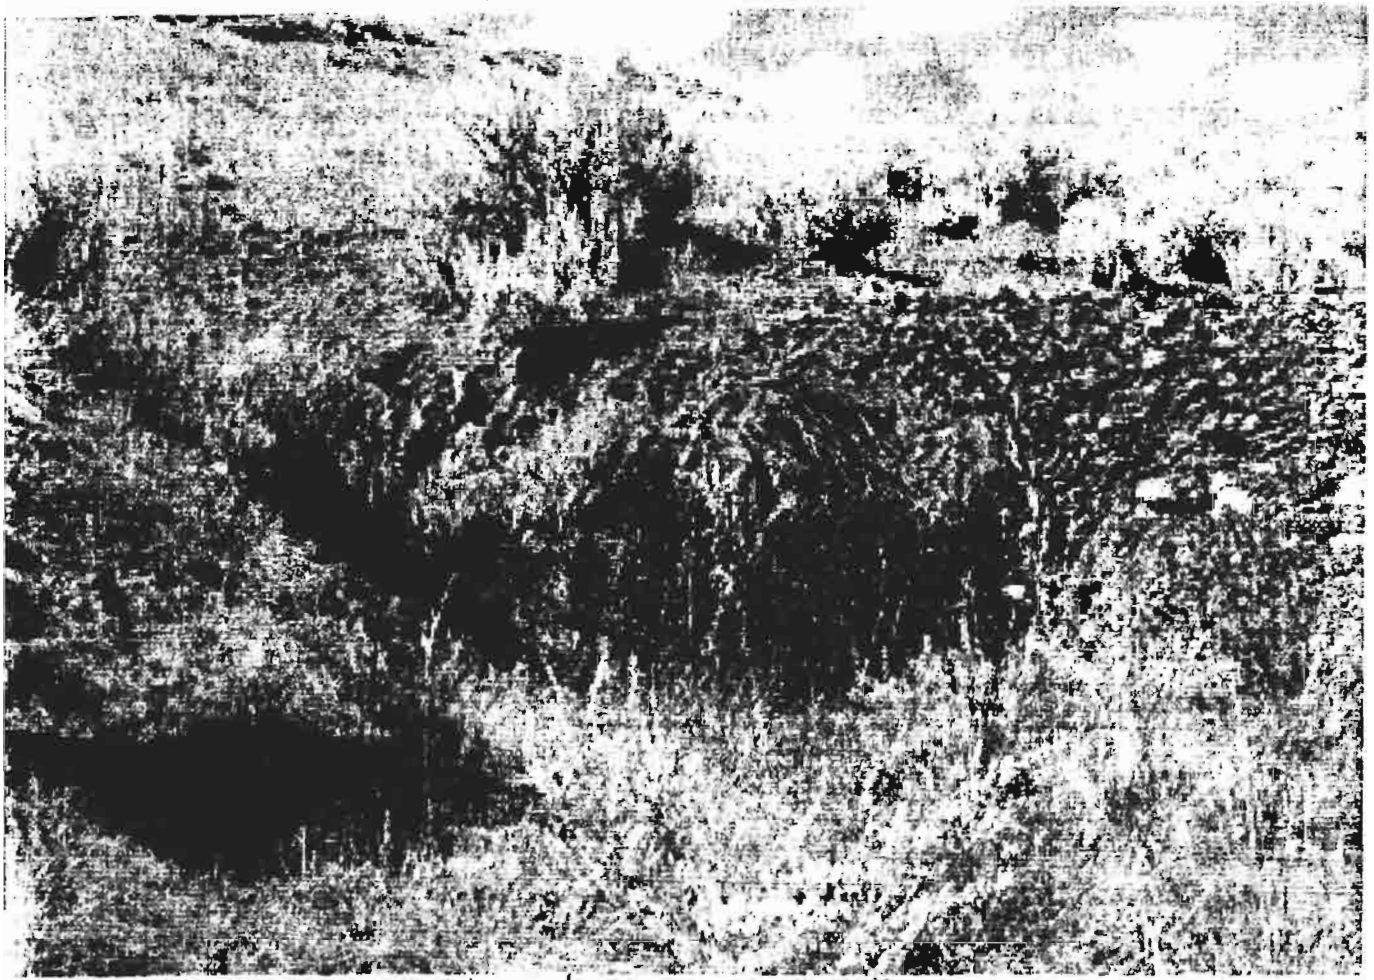
closed mine vert

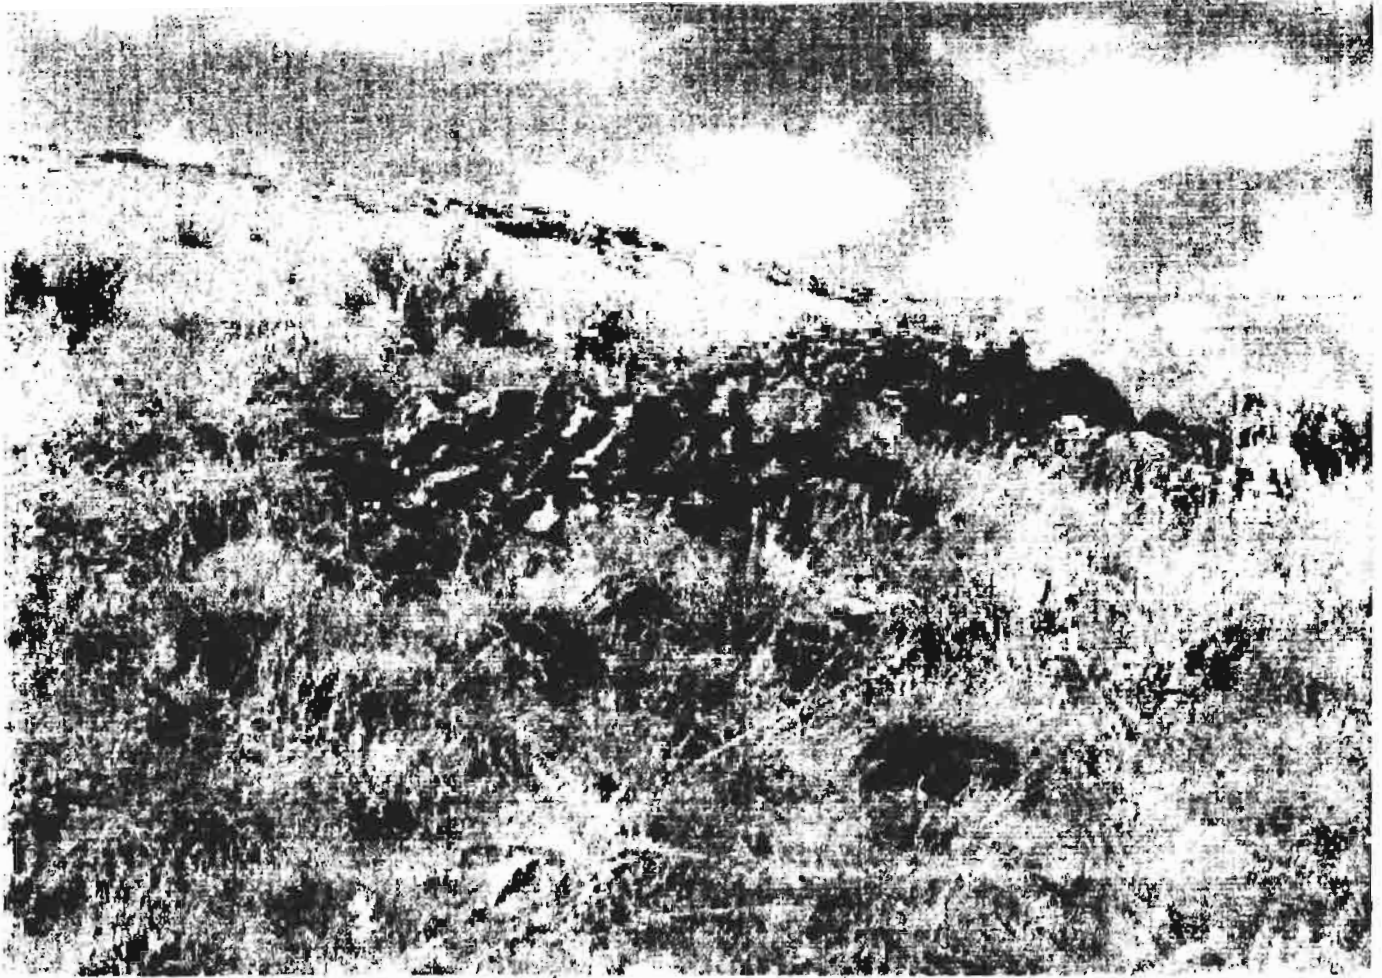
closed mine vent
