**Second Five-Year Review Report for
Priority One and Two Sites,
Fairchild Air Force Base, Washington**

Air Force Center for Engineering and the Environment (AFCEE/ICM)
Brooks City-Base, Texas 78235-5328

CH2M HILL
9 South Washington, Suite 400
Spokane, WA 99201

June 2008

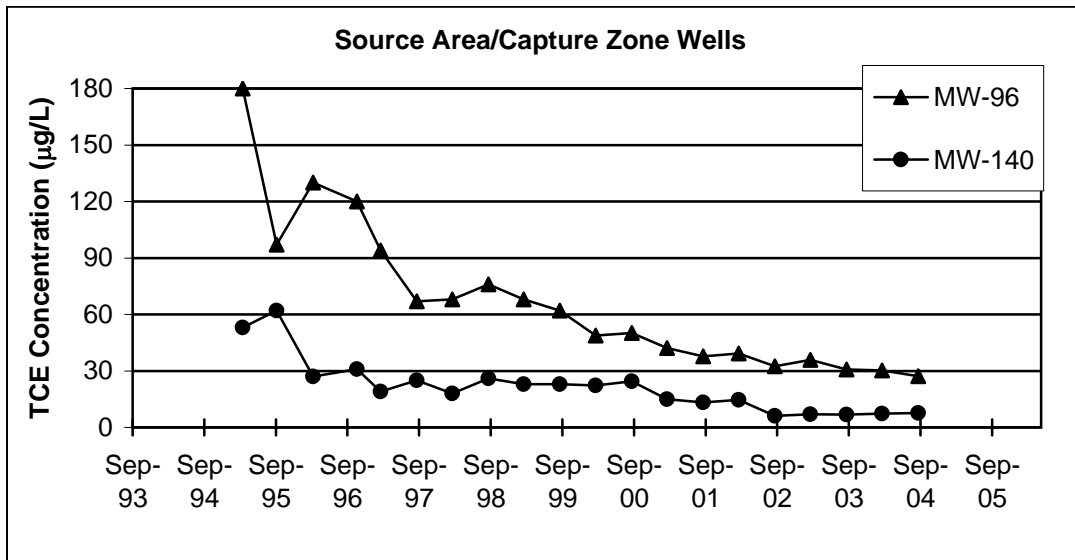
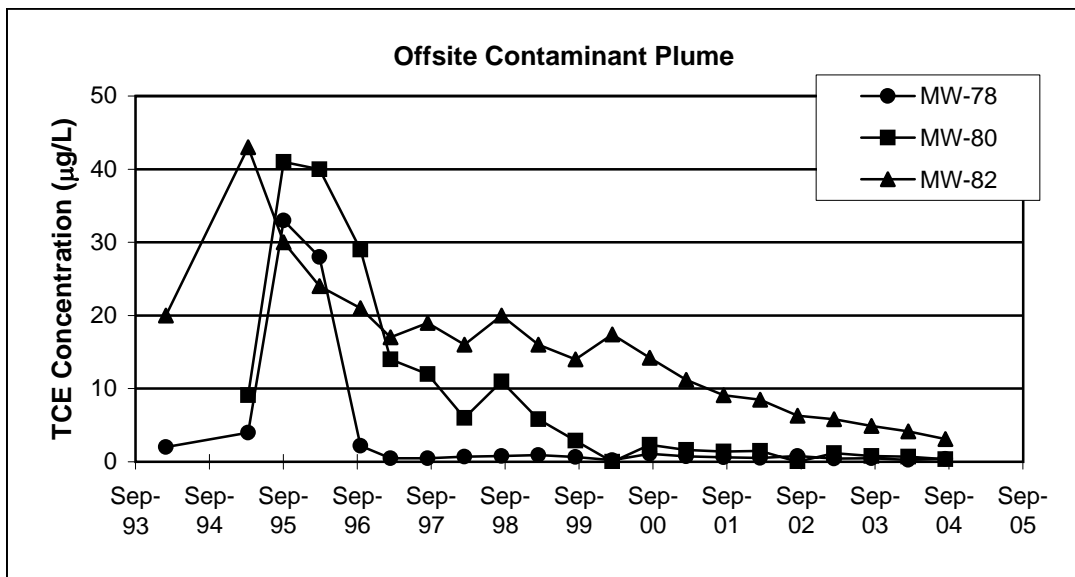
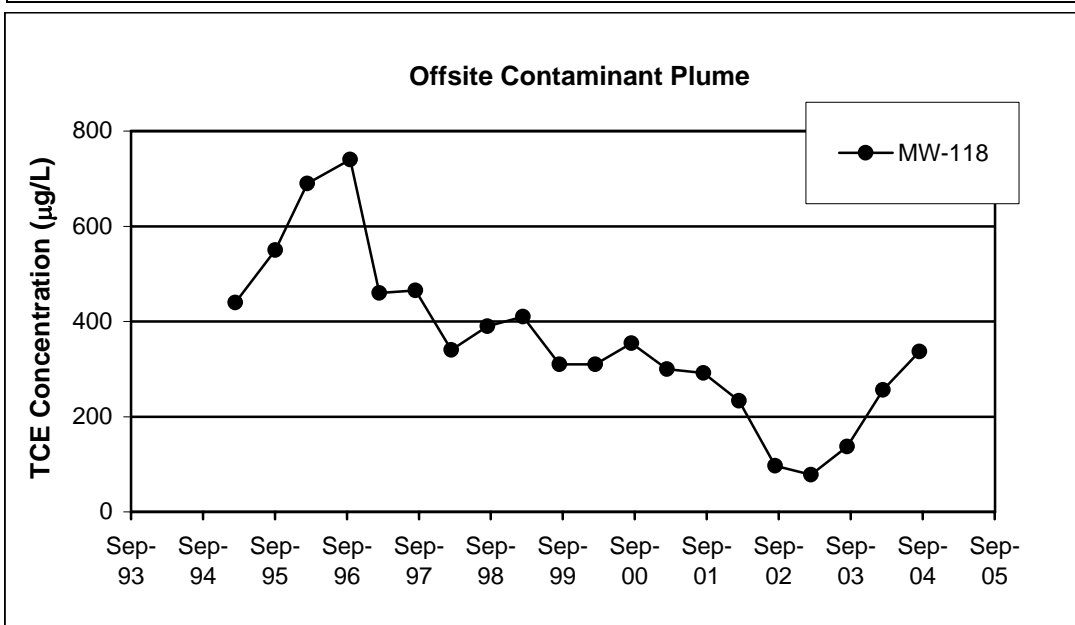
Figure 3-2
Historical TCE Concentrations in Select CRL Wells

In order for the remedy to be protective in the long term, the remedial action objective of achieving cleanup levels in the upper aquifer within the timeframes established by the ROD must be further evaluated. If it is determined that the remedy cannot achieve these goals, alternative remedies may need to be explored to optimize restoration of the upper aquifer.

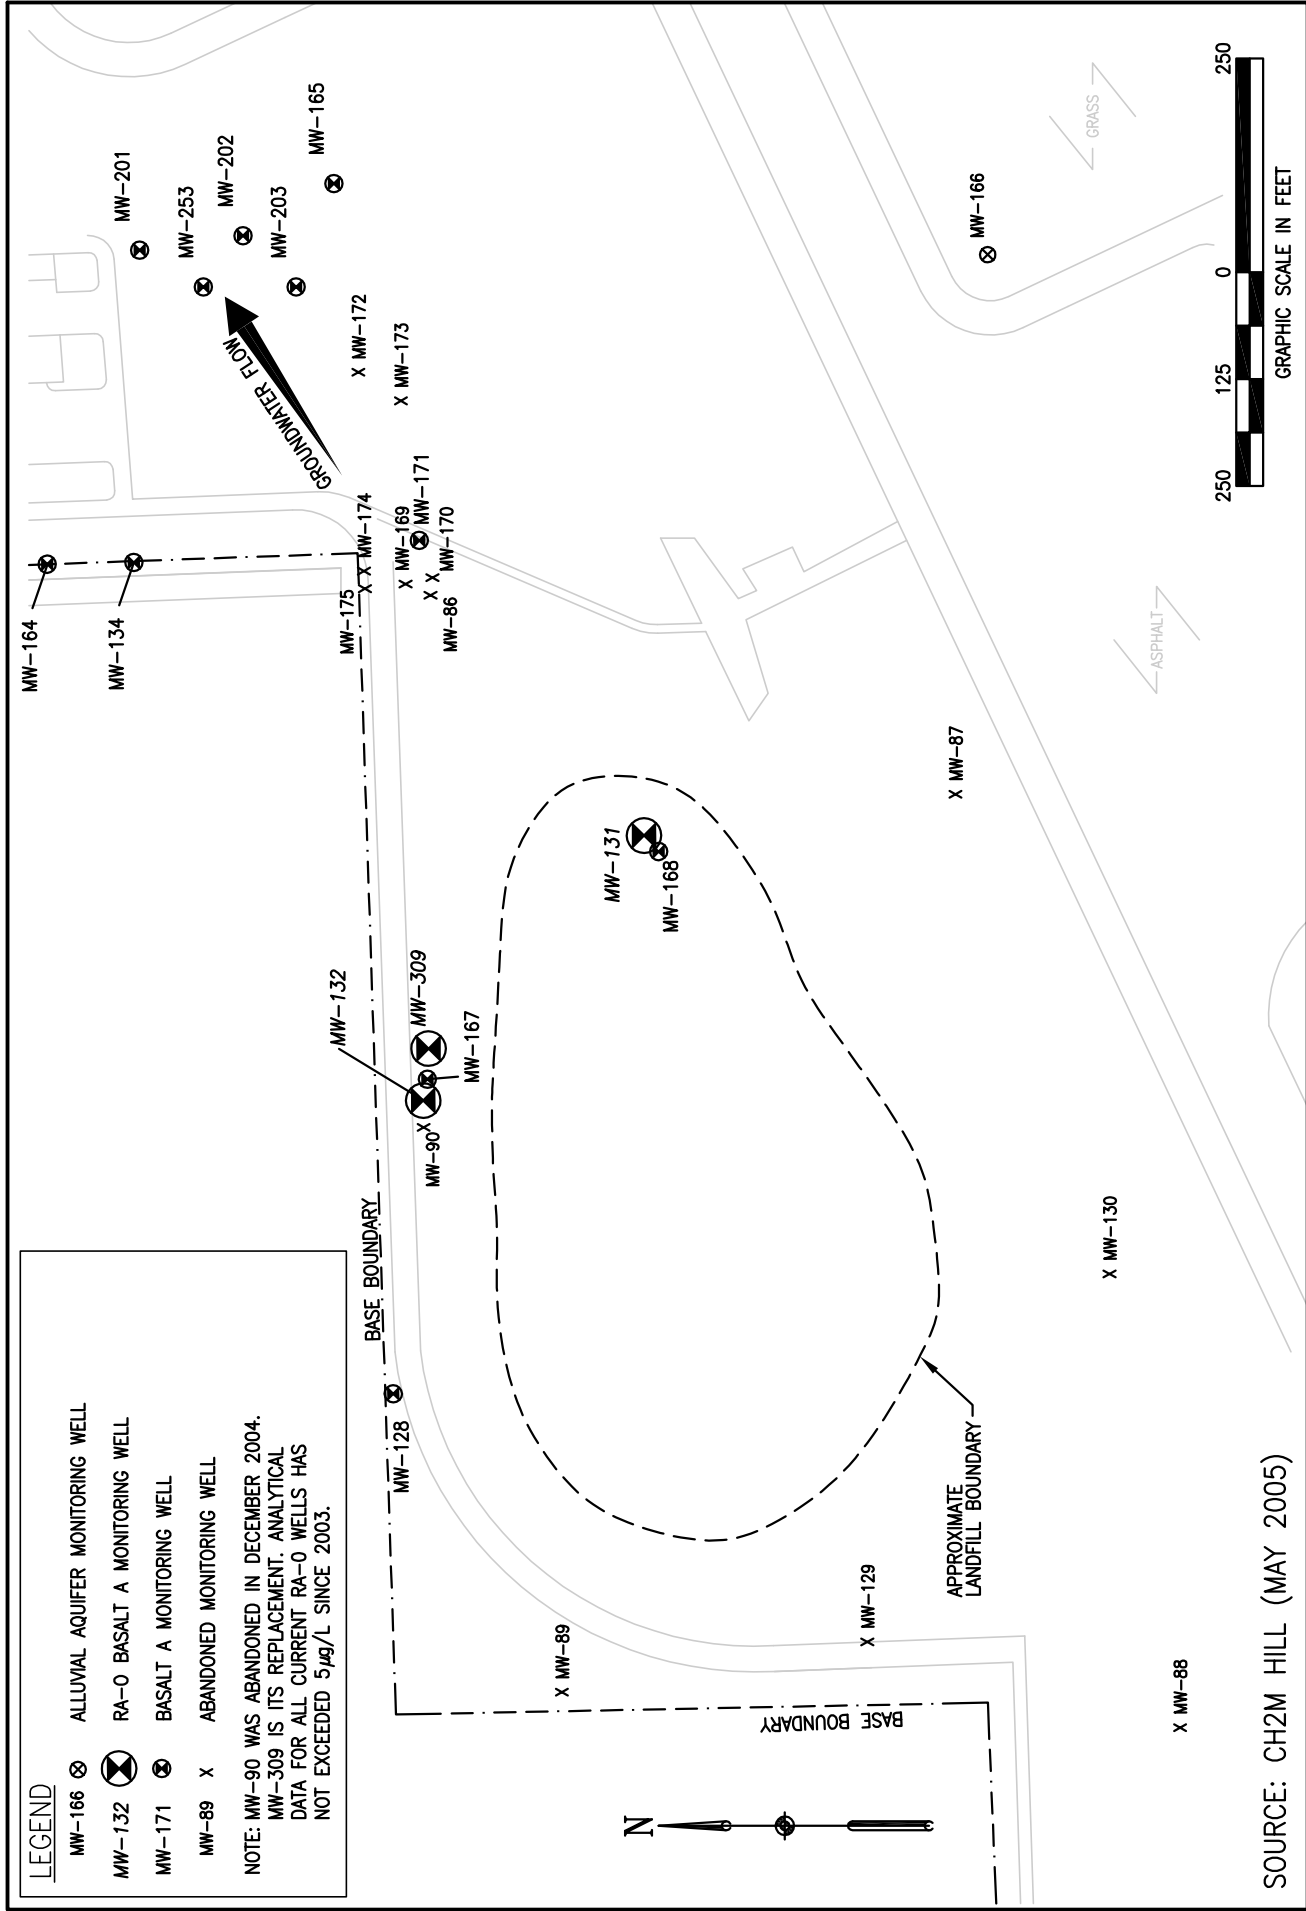
FIGURE 4.1-1: SW-1 SITE MAP

The remedy for site SW-1, the Old Base Landfill, is currently protective of human health and the environment, and it is expected to be protective of human health and the environment upon attainment of remedial action objectives. In the interim, LUCs and institutional controls exist that eliminate current exposure pathways and prevent the potential for completing future exposure pathways.

In order for the remedy to be protective in the long term, the remedial action objective of achieving cleanup levels in the upper aquifer within an acceptable timeframe needs to be further evaluated. If it is determined that cleanup levels cannot be achieved within an acceptable timeframe, then alternative remedies may need to be explored to optimize restoration of the upper aquifer.

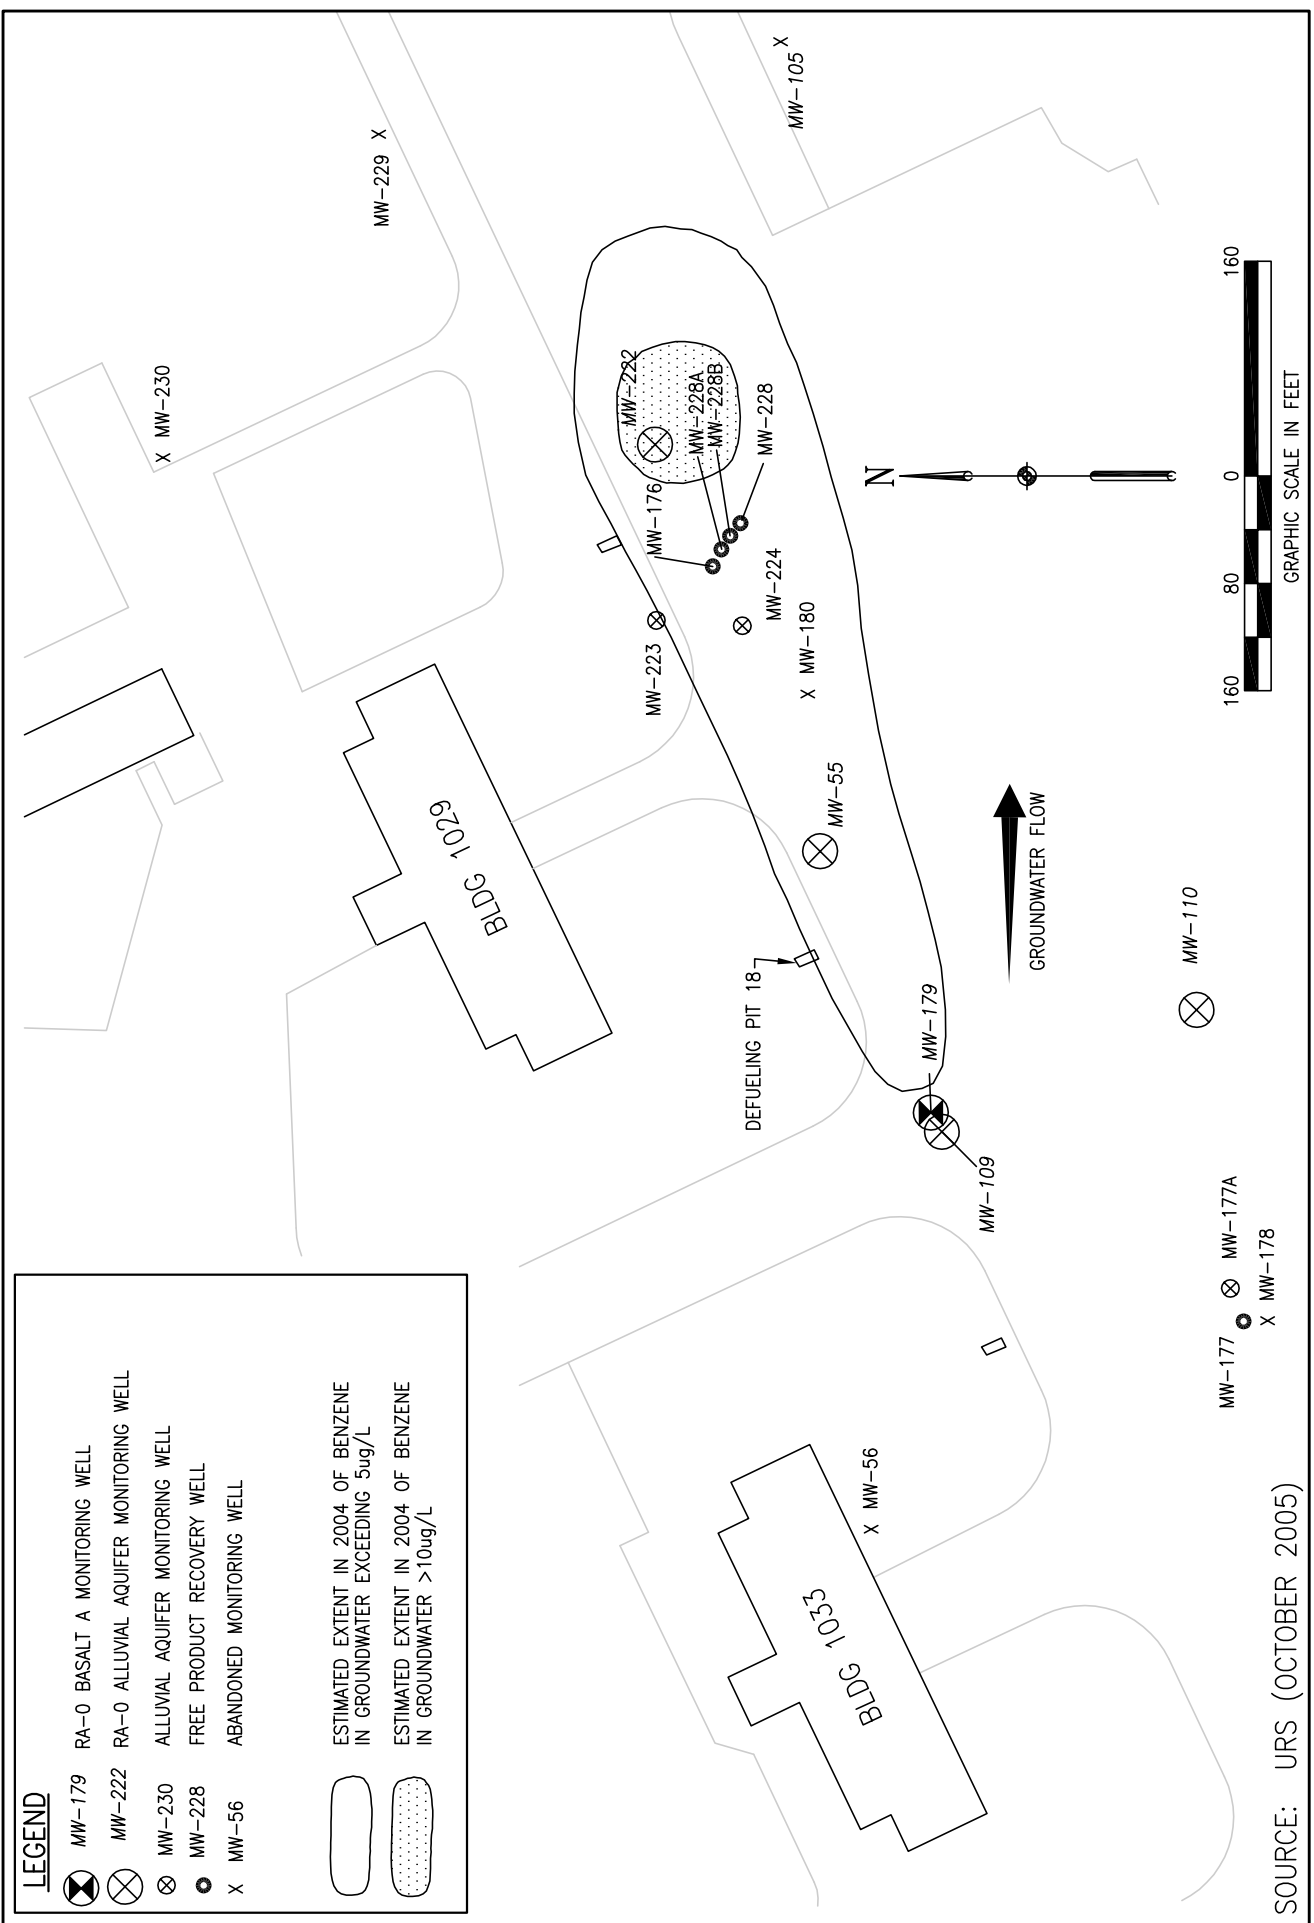
The remedy at site PS-2 is currently protective of human health and the environment, and it is expected to be protective of human health and the environment upon attainment of remedial action objectives. In the interim, LUCs and institutional controls exist that eliminate current exposure pathways and prevent the potential for completing future exposure pathways.

In order for the remedy to be protective in the long term, the remedial action objective of achieving cleanup levels within an acceptable timeframe needs to be further evaluated. If it is determined that cleanup levels cannot be achieved within an acceptable timeframe, then alternative remedies may need to be explored to optimize restoration of impacted groundwater. Additionally, there appears to be sufficient technical justification to install additional downgradient monitoring wells at the site to further evaluate if the plume is migrating or if natural attenuation processes are responsible for the observed decline in benzene concentrations. Because this area is within an active taxiway that is critical to support the base's mission, approval from mission operations command staff will be required but possibly could be denied.

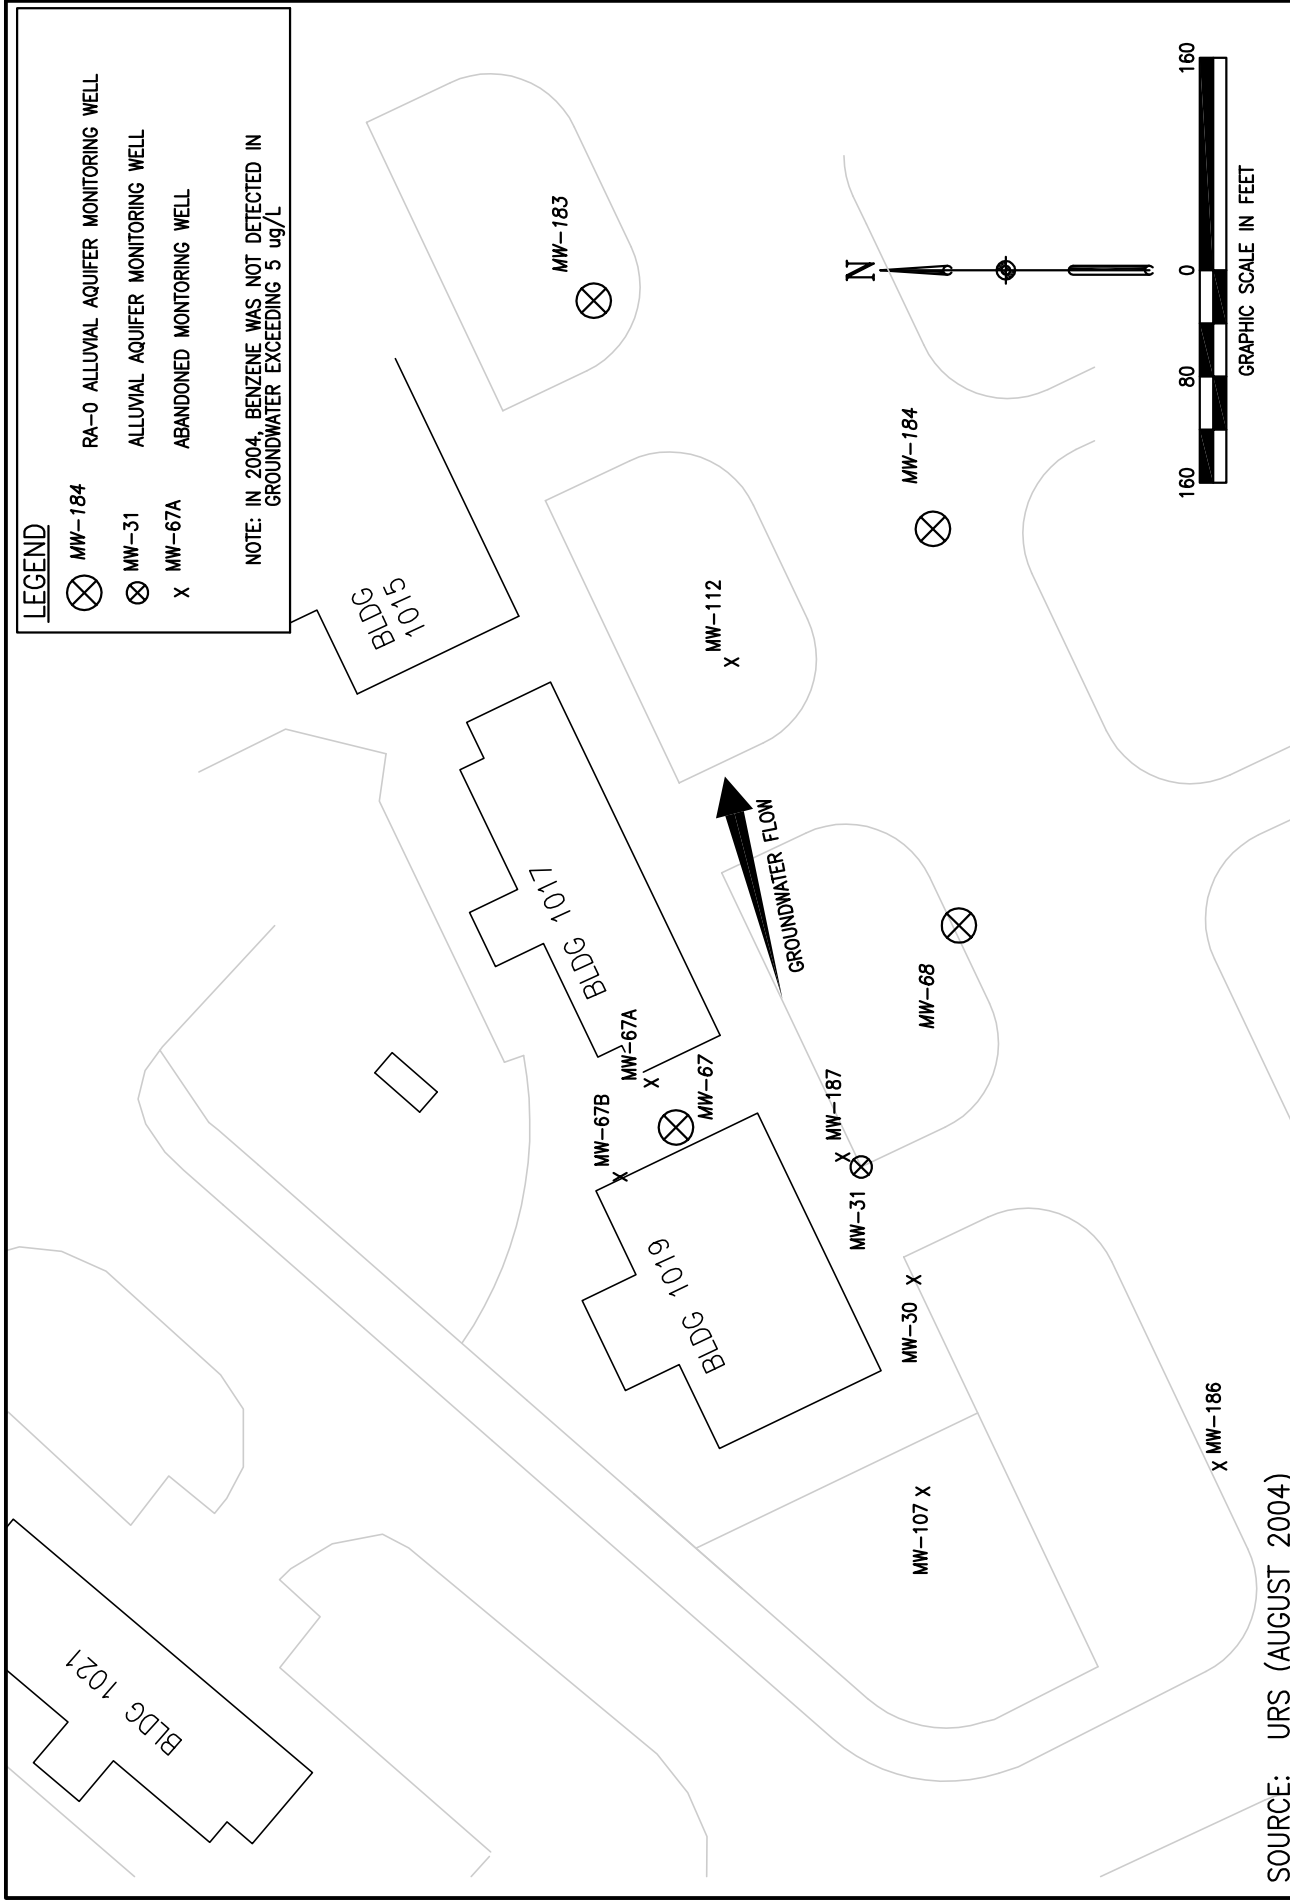
FIGURE 4.3-1: PS-8 SITE MAP

The remedy at site PS-8 is currently protective of human health and the environment, and it is expected to be protective of human health and the environment upon attainment of remedial action objectives. In the interim, LUCs and institutional controls exist that eliminate current exposure pathways and prevent the potential for completing future exposure pathways.

In order for the remedy to be protective in the long term, the remedial action objective of achieving cleanup levels within an acceptable timeframe needs to be further evaluated. If it is determined that cleanup levels cannot be achieved within an acceptable timeframe, then alternative remedies may need to be explored to optimize restoration of impacted groundwater.

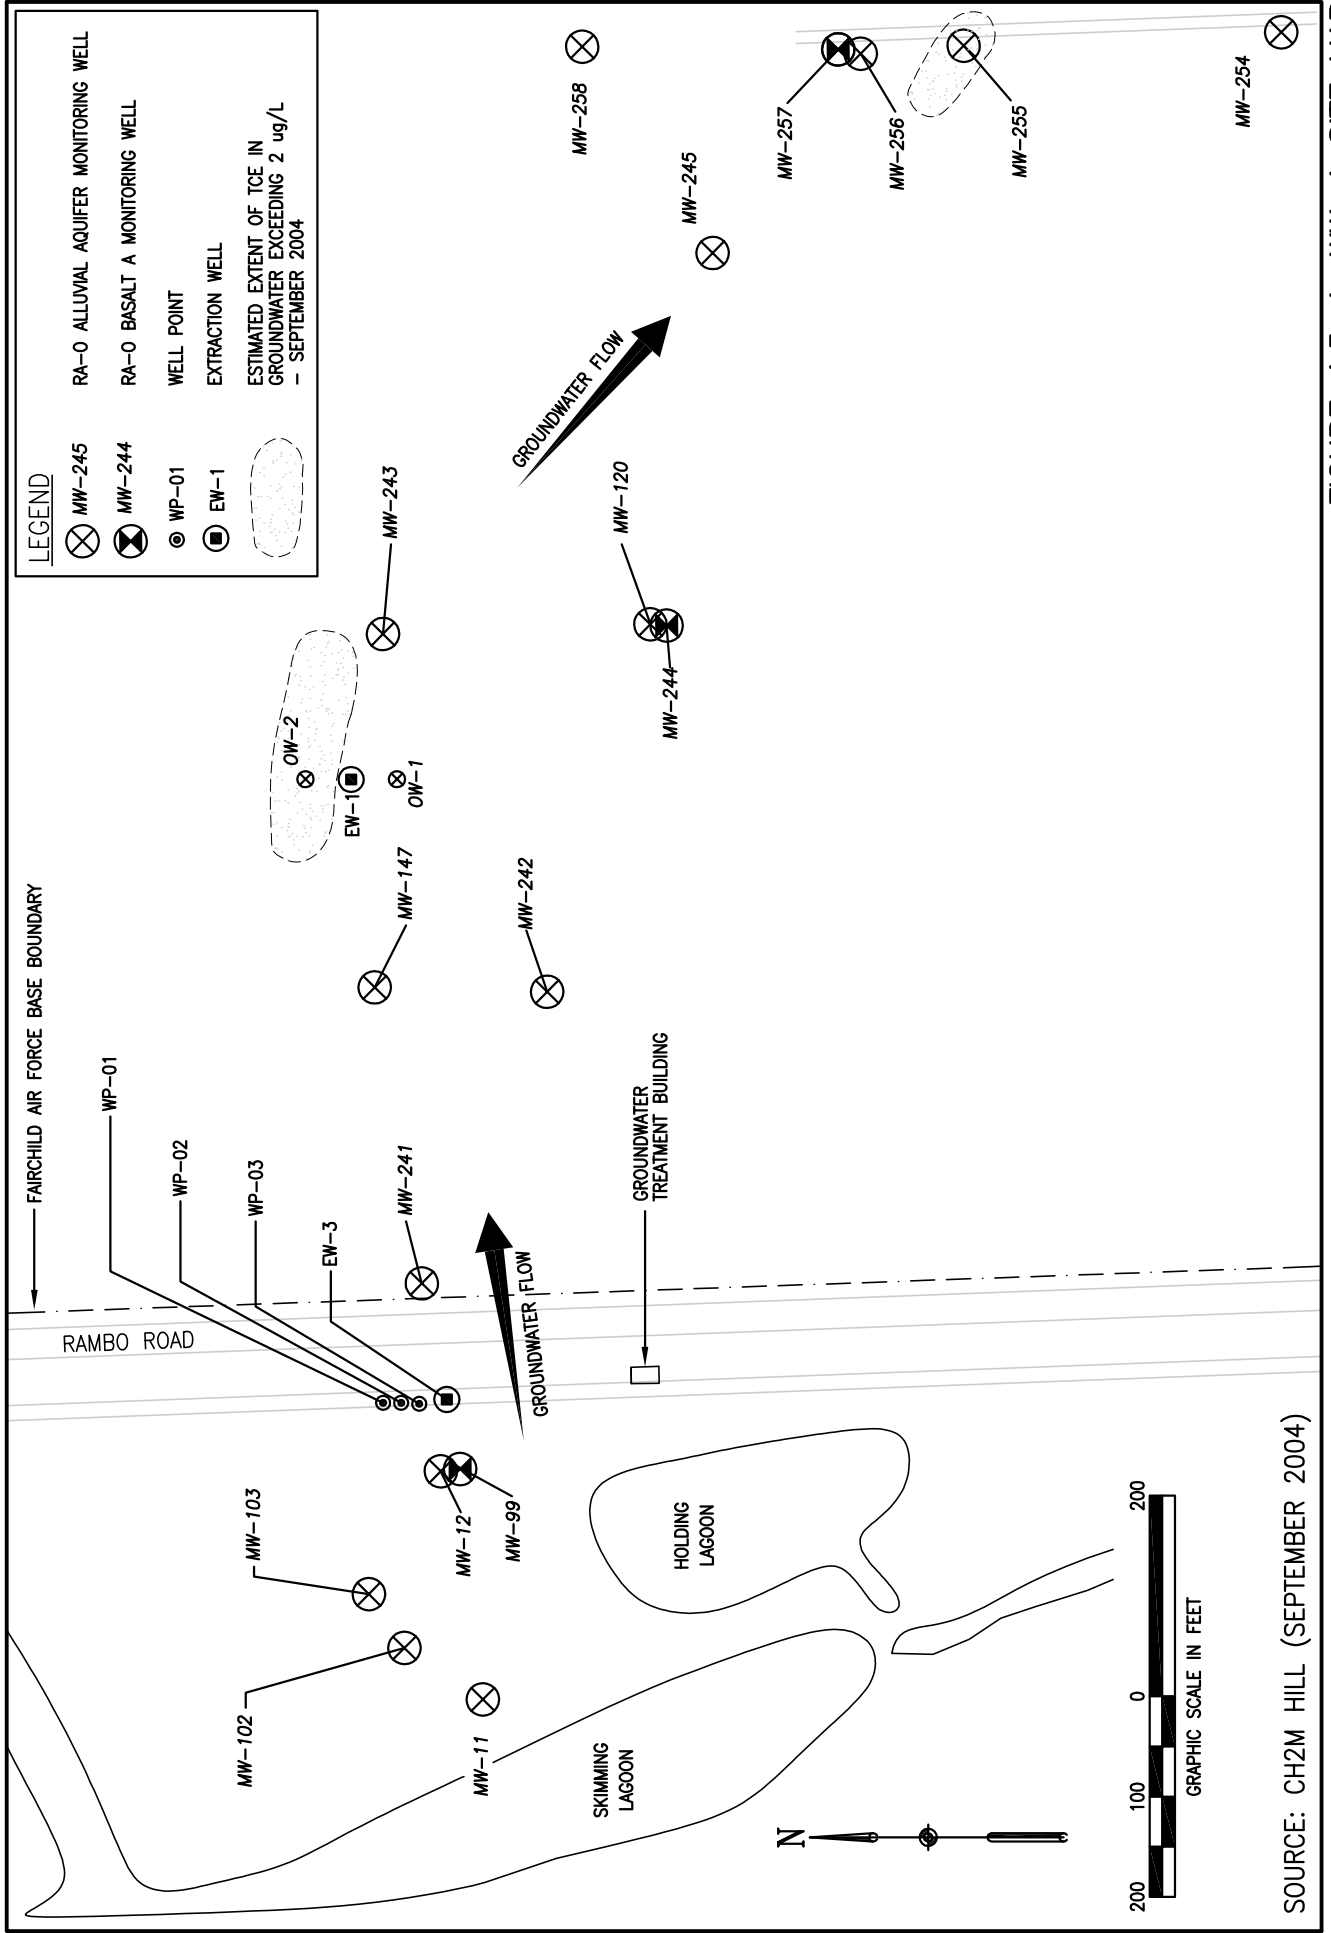
FIGURE 4.5-1: WW-1 SITE MAP

A protectiveness determination for the remedy at site WW-1 cannot be made until further information is obtained concerning arsenic and VC concentrations in groundwater that exceed MTCA Method A cleanup levels and/or federal MCLs. Further analysis of risk from these contaminants may need to be evaluated in order to determine if additional technical or administrative requirements will be necessary. It is expected that a path forward to address these issues may occur by June 2008, at which time a protectiveness determination will be made. In the interim, LUCs and institutional controls exist that eliminate current exposure pathways and prevent the potential for completing future exposure pathways both for both on base and off base locations.

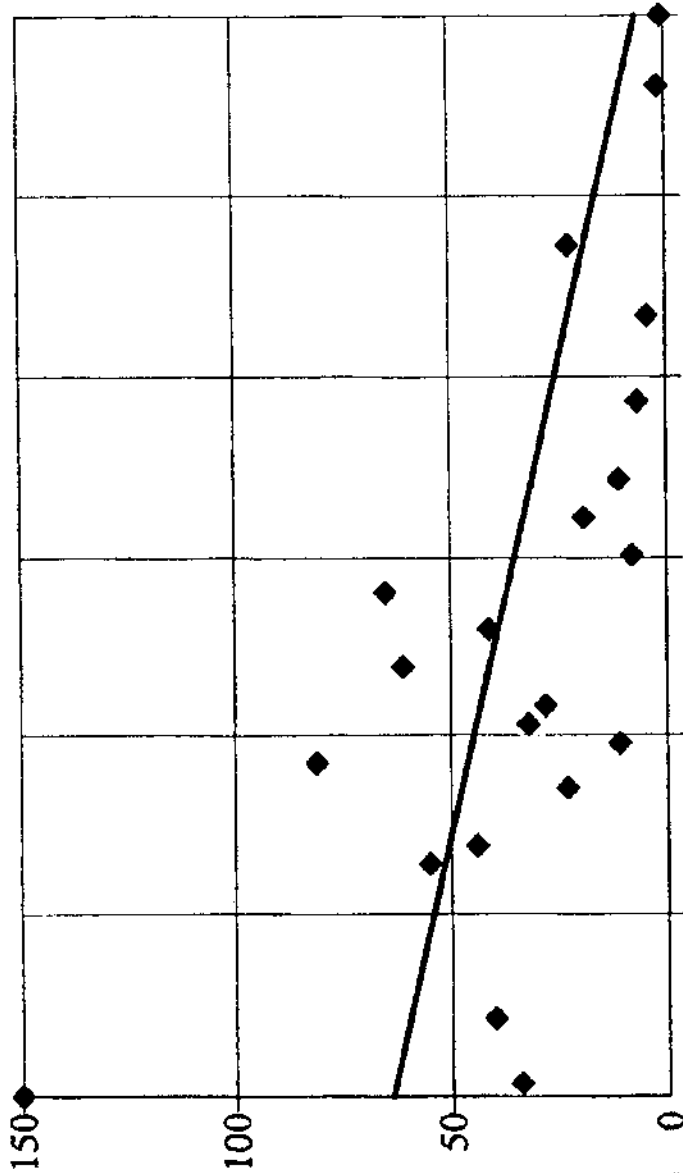
SEN'S SLOPE ESTIMATOR MW-109

n = 21
 Slope = -4.066
 units per year.
 Mann Kendall
 statistic = -115

Alpha	Critical	Signif.
0.01	-87	Down
0.05	-66	Down
0.1	-56	Down
0.2	-44	Down

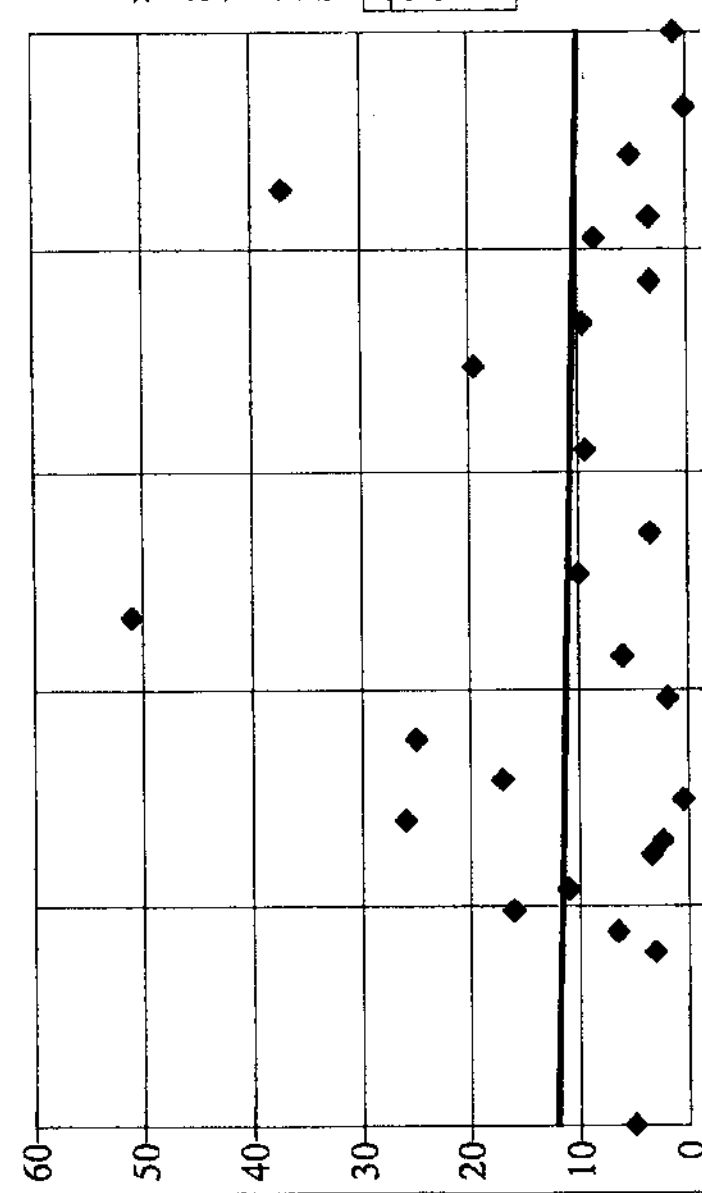
SEN'S SLOPE ESTIMATOR MW-184

n = 26
 Slope = -0.161
 units per year.
 Mann Kendall
 statistic = -23

Alpha	Critical	Signif.
0.01	-118	No
0.05	-90	No
0.1	-76	No
0.2	-60	No

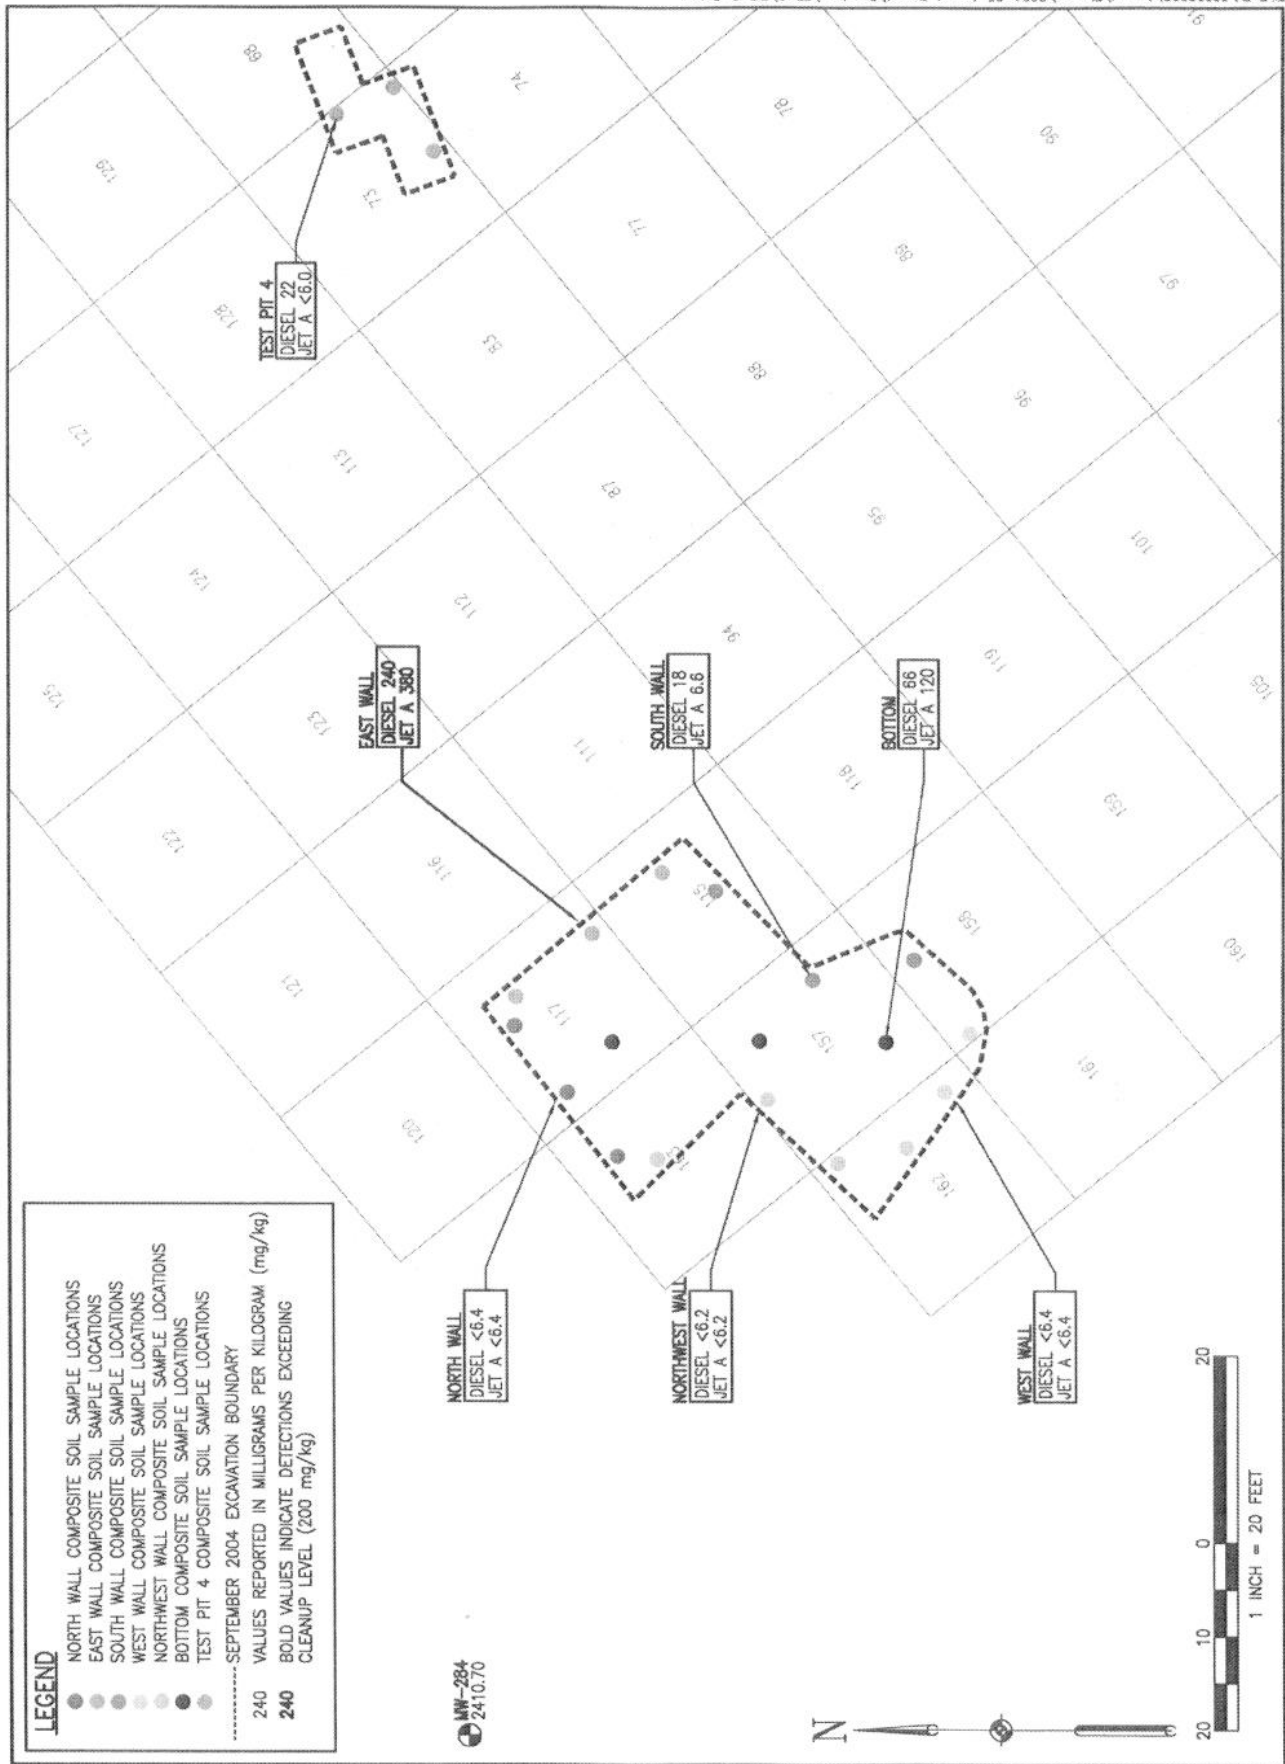
Figure 6-9: Site FT-2 Excavation and Test Pit Verification Soil Sample Locations and TPH-D Concentrations
September 2004

Sample Field Identification	Date Collected	NWTPH-Dx ¹ Jet A (mg/kg ²)	NWTPH-Dx Diesel (mg/kg)	ROD Cleanup Level
FT2LFCOMP1	9/15/05	84	41	200
FT2LFCOMP1	9/15/05	96	97	200
FT2LFCOMP1	9/15/05	280	300	200
