# La Posada Hotel Fire

McAllen, Texas

USFA-TR-001/February 1987

Investigated by: Jeffrey M. Shapiro, P.E.

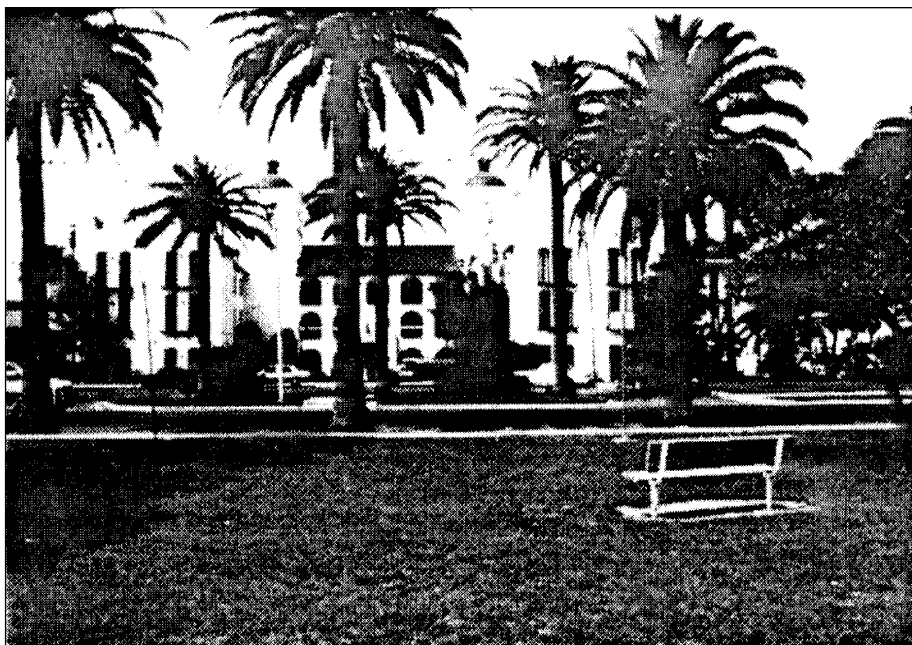
Figure 1. La Posada Hotel (view of the east end main entrance).

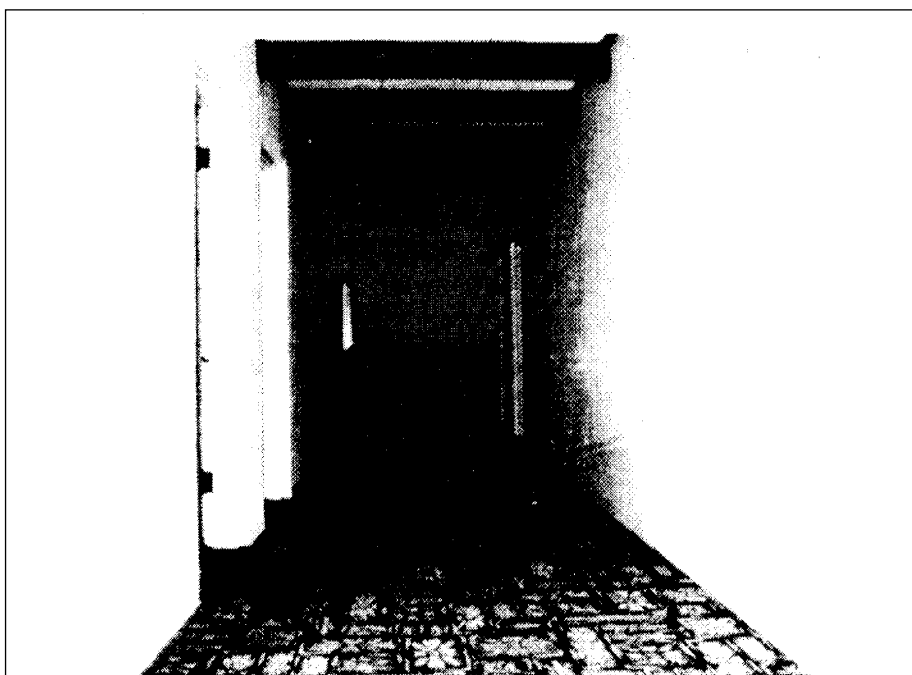
Figure 2. Typical interior corridor.

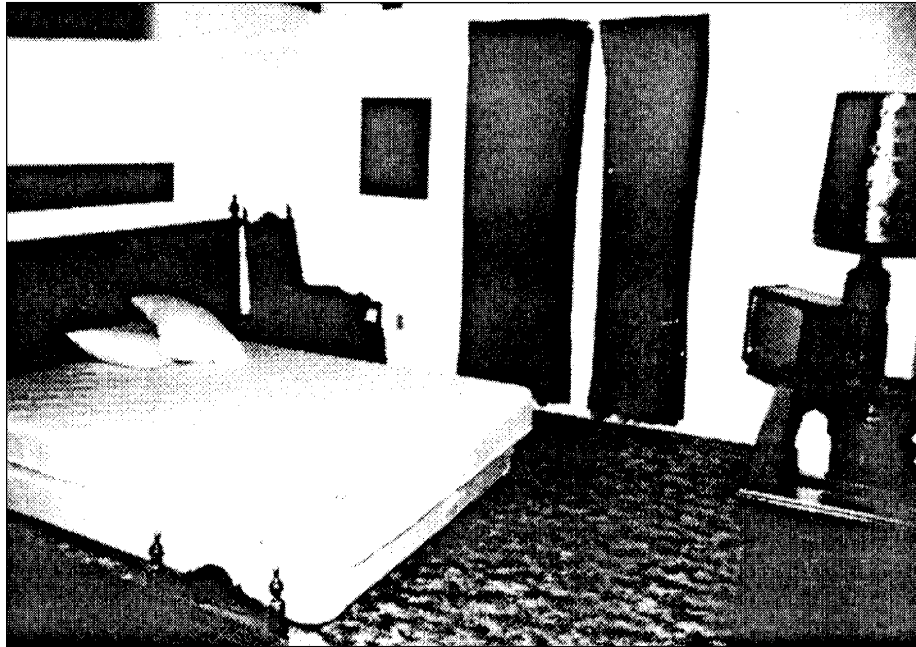
Figure 3. Guest room identical to room of original. Note exterior window and contents.

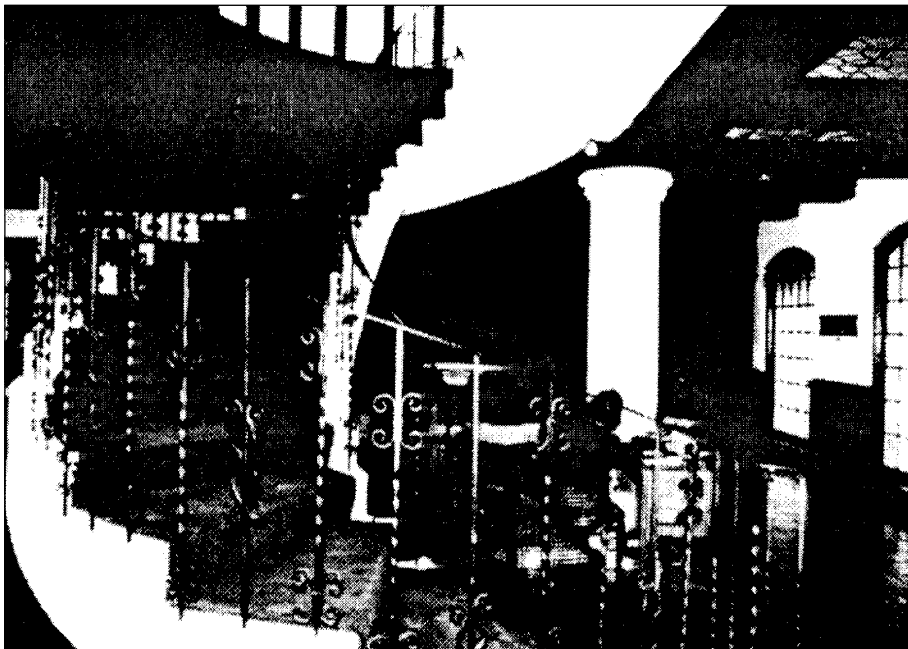
Exiting from the guest rooms was through interior corridors or through an operable window in each room. (See Figures 2 and 3.) The building has four interior exit stairways, all of which are unenclosed or inadequately enclosed, based upon the criteria for new and existing hotels contained in NFPA 101, Life Safety Code. (See Figures 4 and 5.)

Figure 4. Main entry foyer. The front door is to the right. The wall in the rear of the picture was erected after the fire to separate the damaged area. During the fire, smoke traveled past the front desk (visible in the lower portion of the wall behind the telephone operator) and up the "grand" stairway to the upper floor corridors.

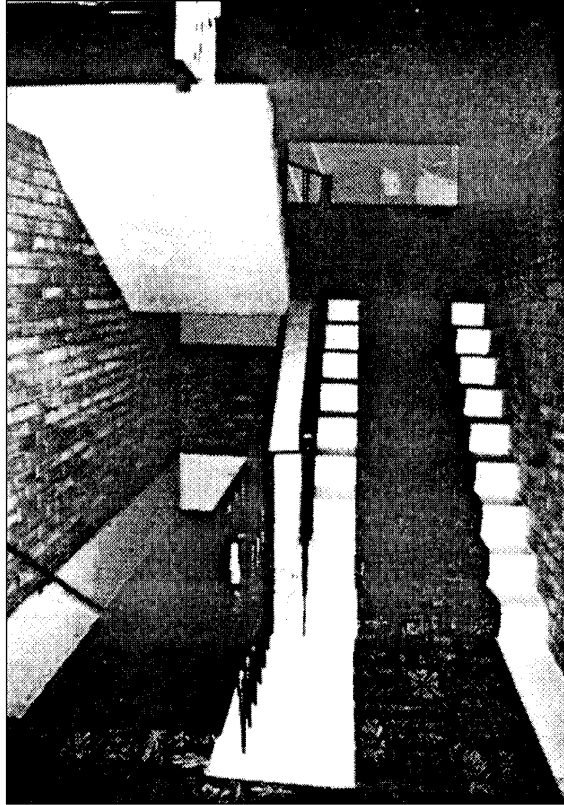
**Figure 5. Typical open stairway (view from a second floor corridor).**

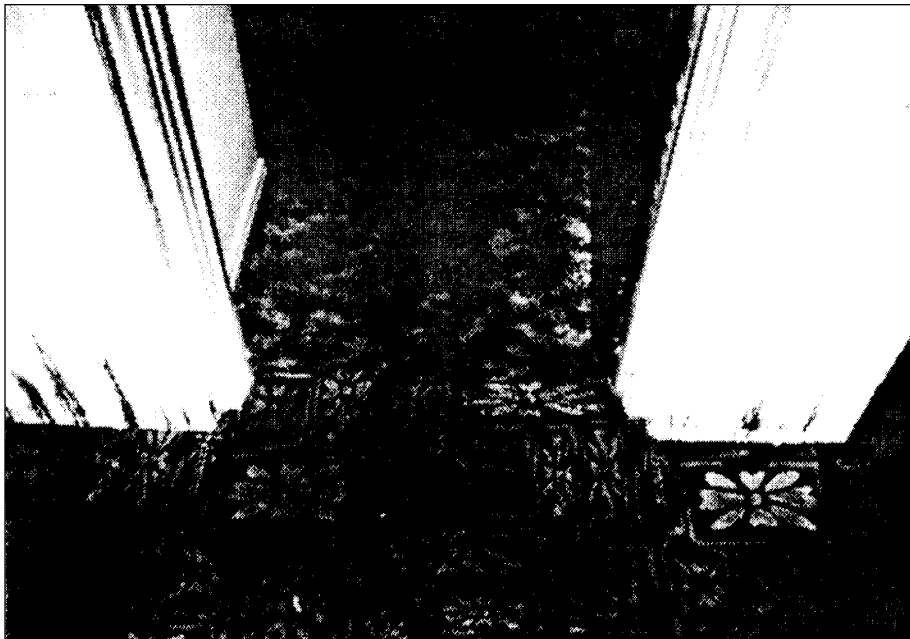
Corridor doors to guest rooms are panel-style wood doors, non-rated, and without closing devices. These doors are hung in solid wood frames.

**Figure 6. Carpeting in interior corridor and guest room. Also note wood panel door without door closer.**

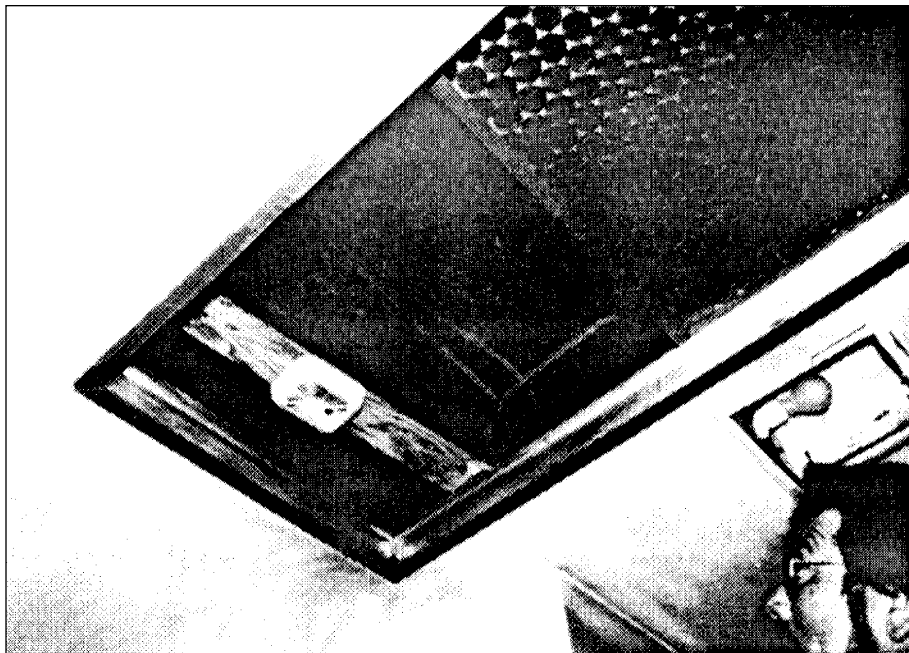
Ironically, the detector was not properly located. It had been installed (as had the other guest room detectors) in the return air plenum, rather than on the ceiling of the room. Moreover, the detector was a battery-operated type, not hard-wired to the electrical system as is preferred for this type of occupancy.

Figure 7. Battery powered smoke detector in adjacent room. All detectors were located in return air plenum above filters and grilles in ceiling.
