U.S. Fire Administration/Technical Report Series

Apartment Complex Fire, 66 Units Destroyed

Seattle, Washington

USFA-TR-059/September 1991

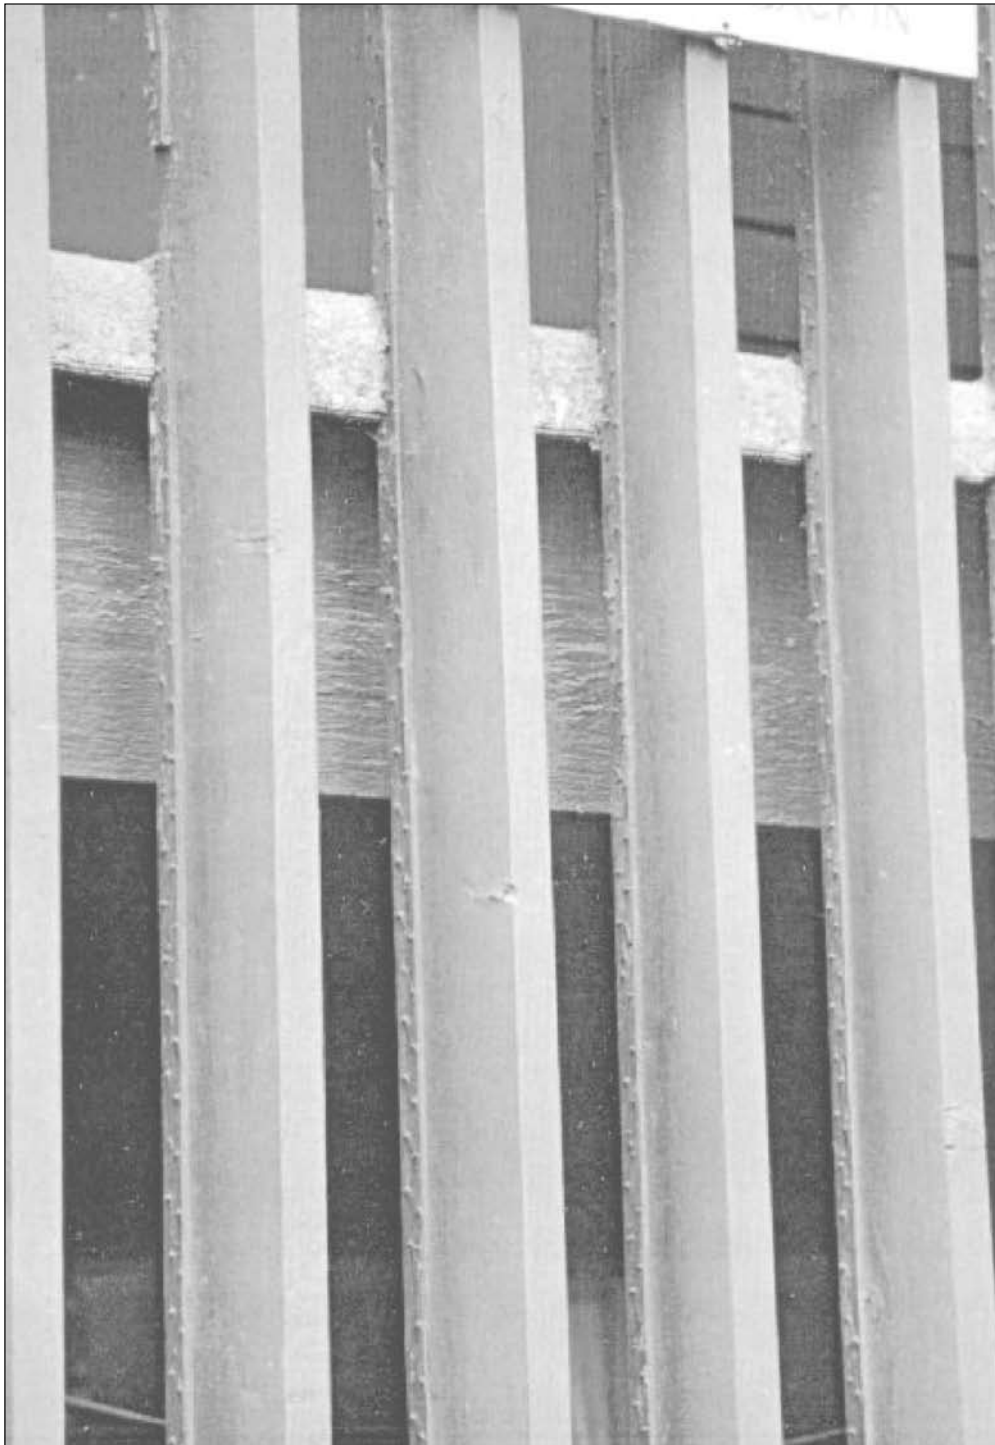
Close-up of the decorative cedar screen on the fronts of the buildings, which served a security purpose as well. Fire could race unimpeded up the wood 2 x 6's. The photograph shows the screen as it passes the outdoor carpeted floor of the walkway above.

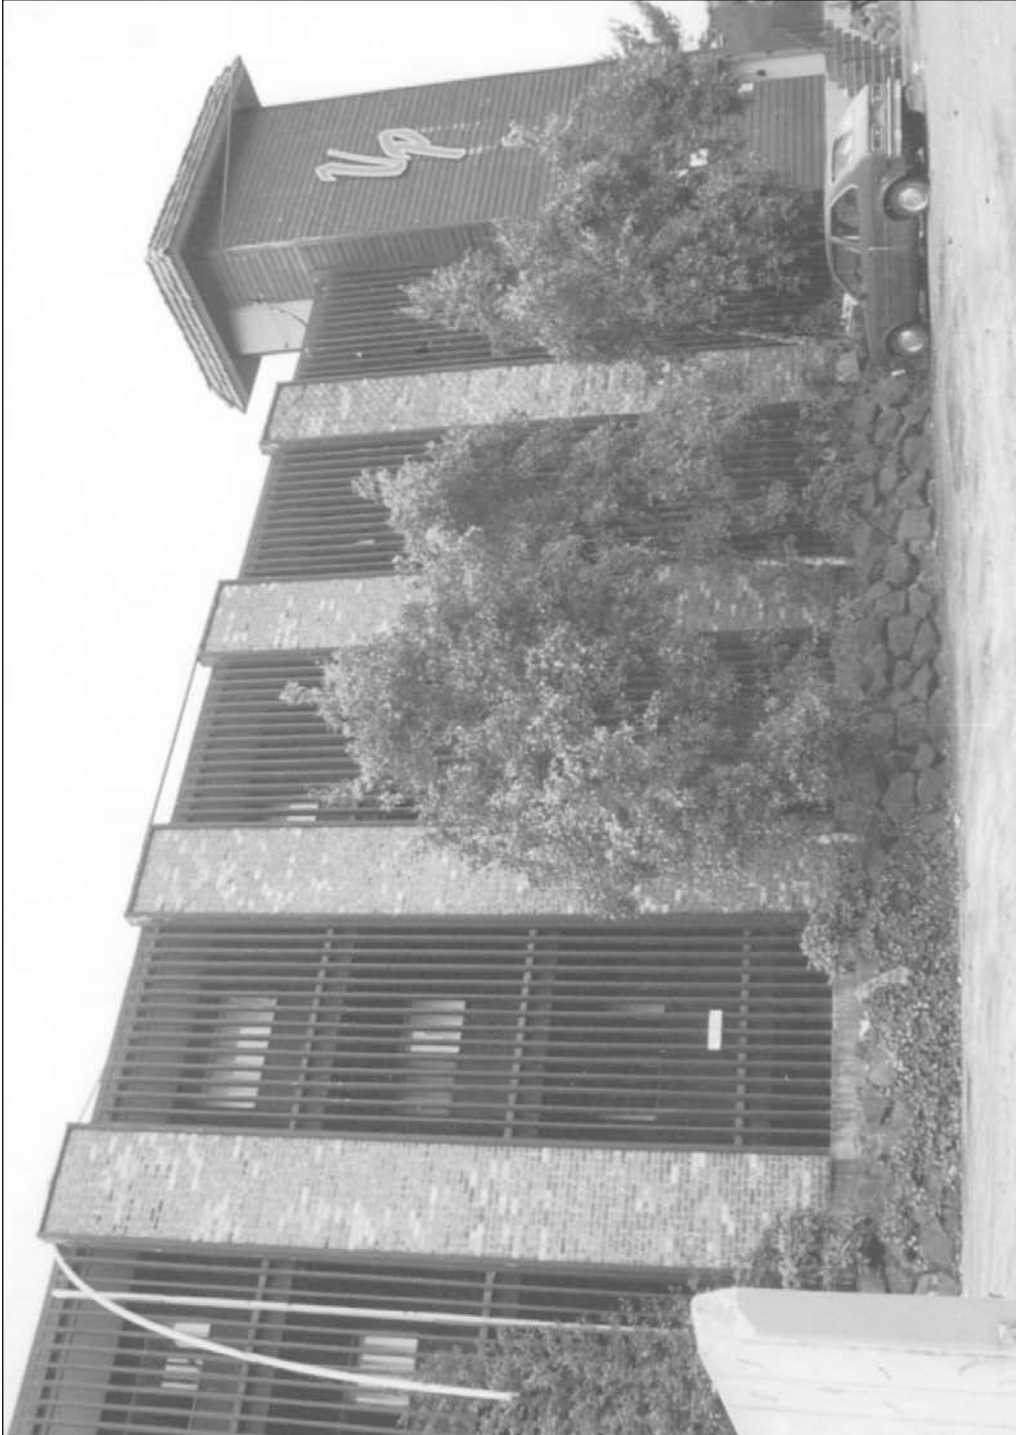
The exterior facades of the walkways on the fronts of the buildings were 4-story high decorative lattices comprised of 2 inch by 6 inch vertical cedar boards approximately on 9-inch centers. (The space between the vertical cedar boards was about seven inches.) The lattices had 10-foot widths separated by 5-foot brick fascia. These lattices were both for aesthetics and security. The wood had been covered with oil-based stain. The wood had dried out in approximately 30 days without rain prior to the fire.

Typical exterior construction, brick fascia with 2" x 6" slated security fencing.

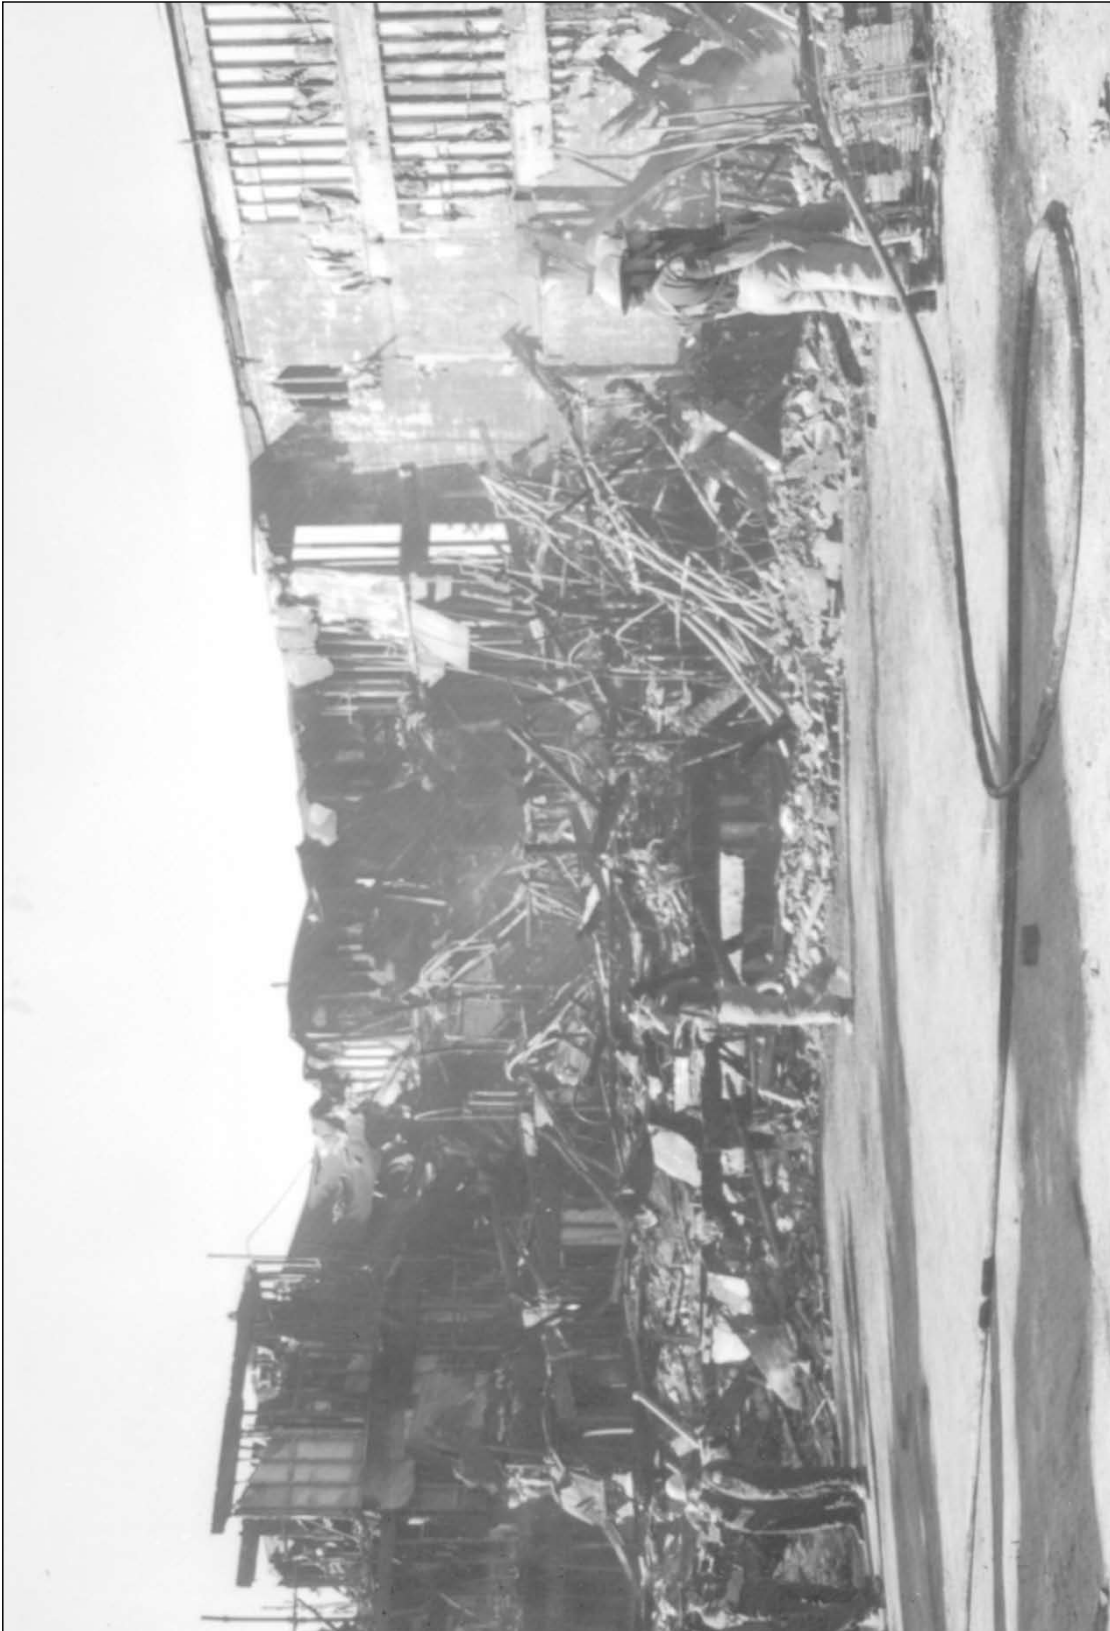
View from the southeast looking northwest.

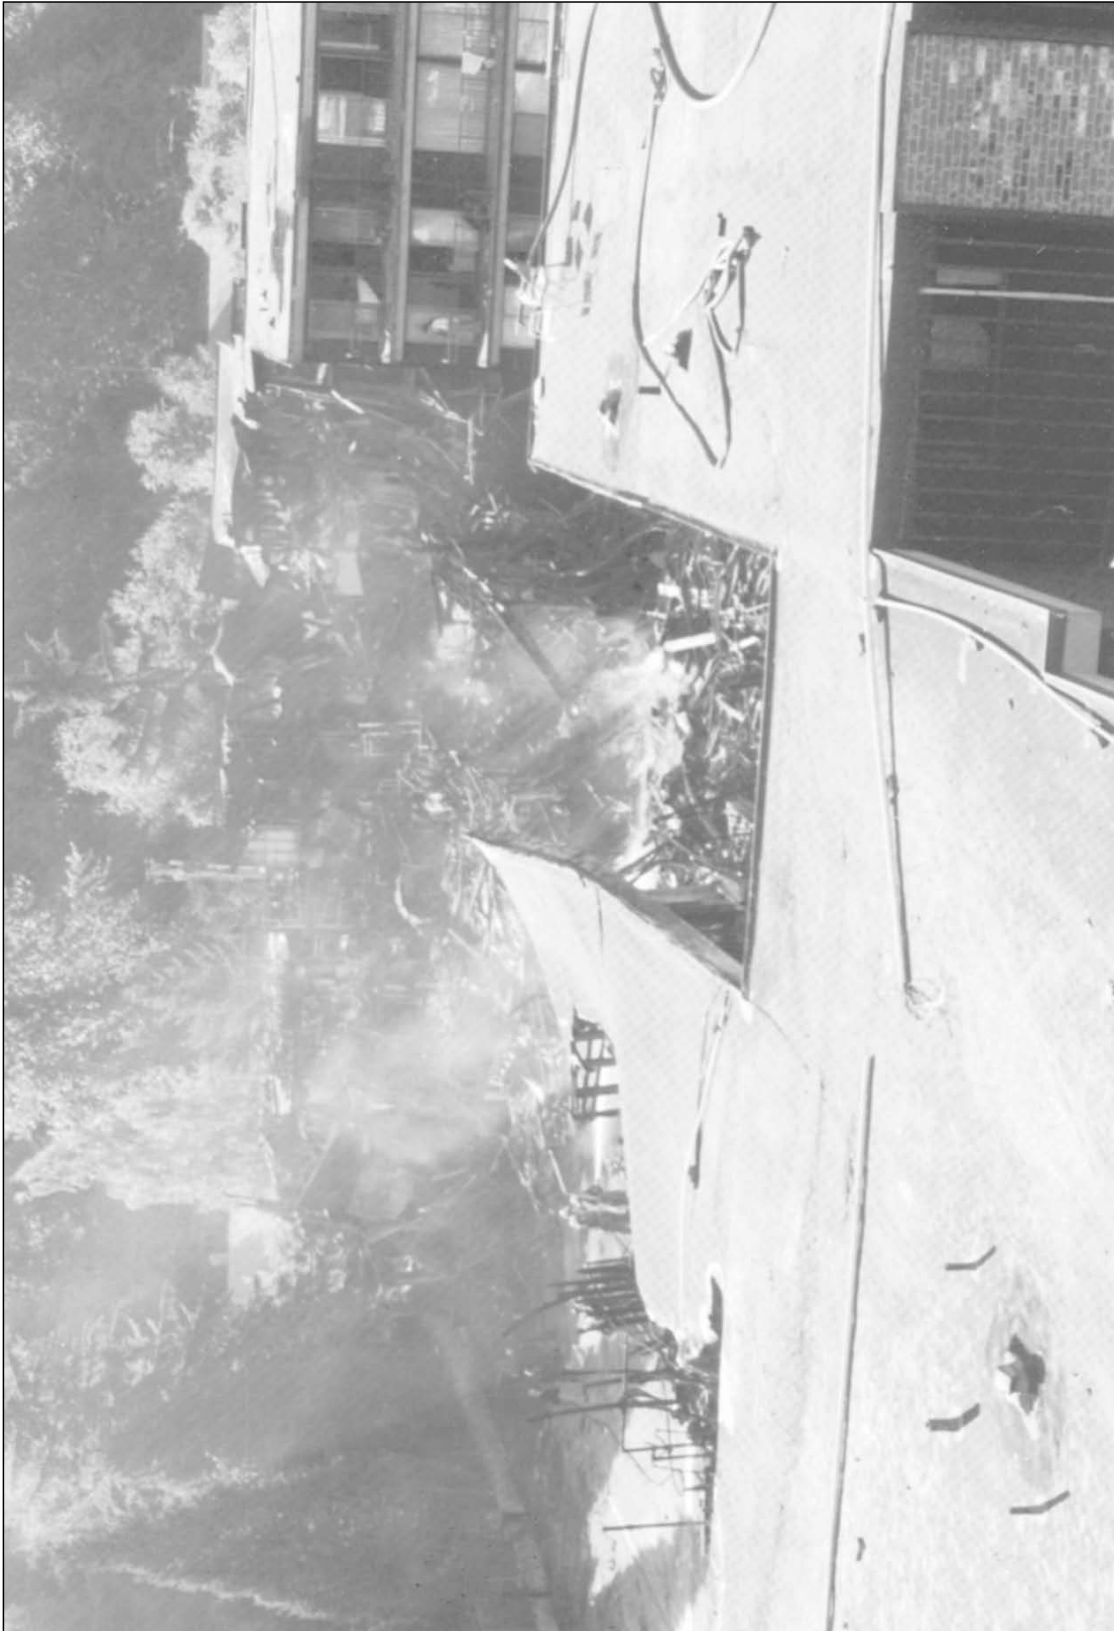
Overview of south wing looking west.

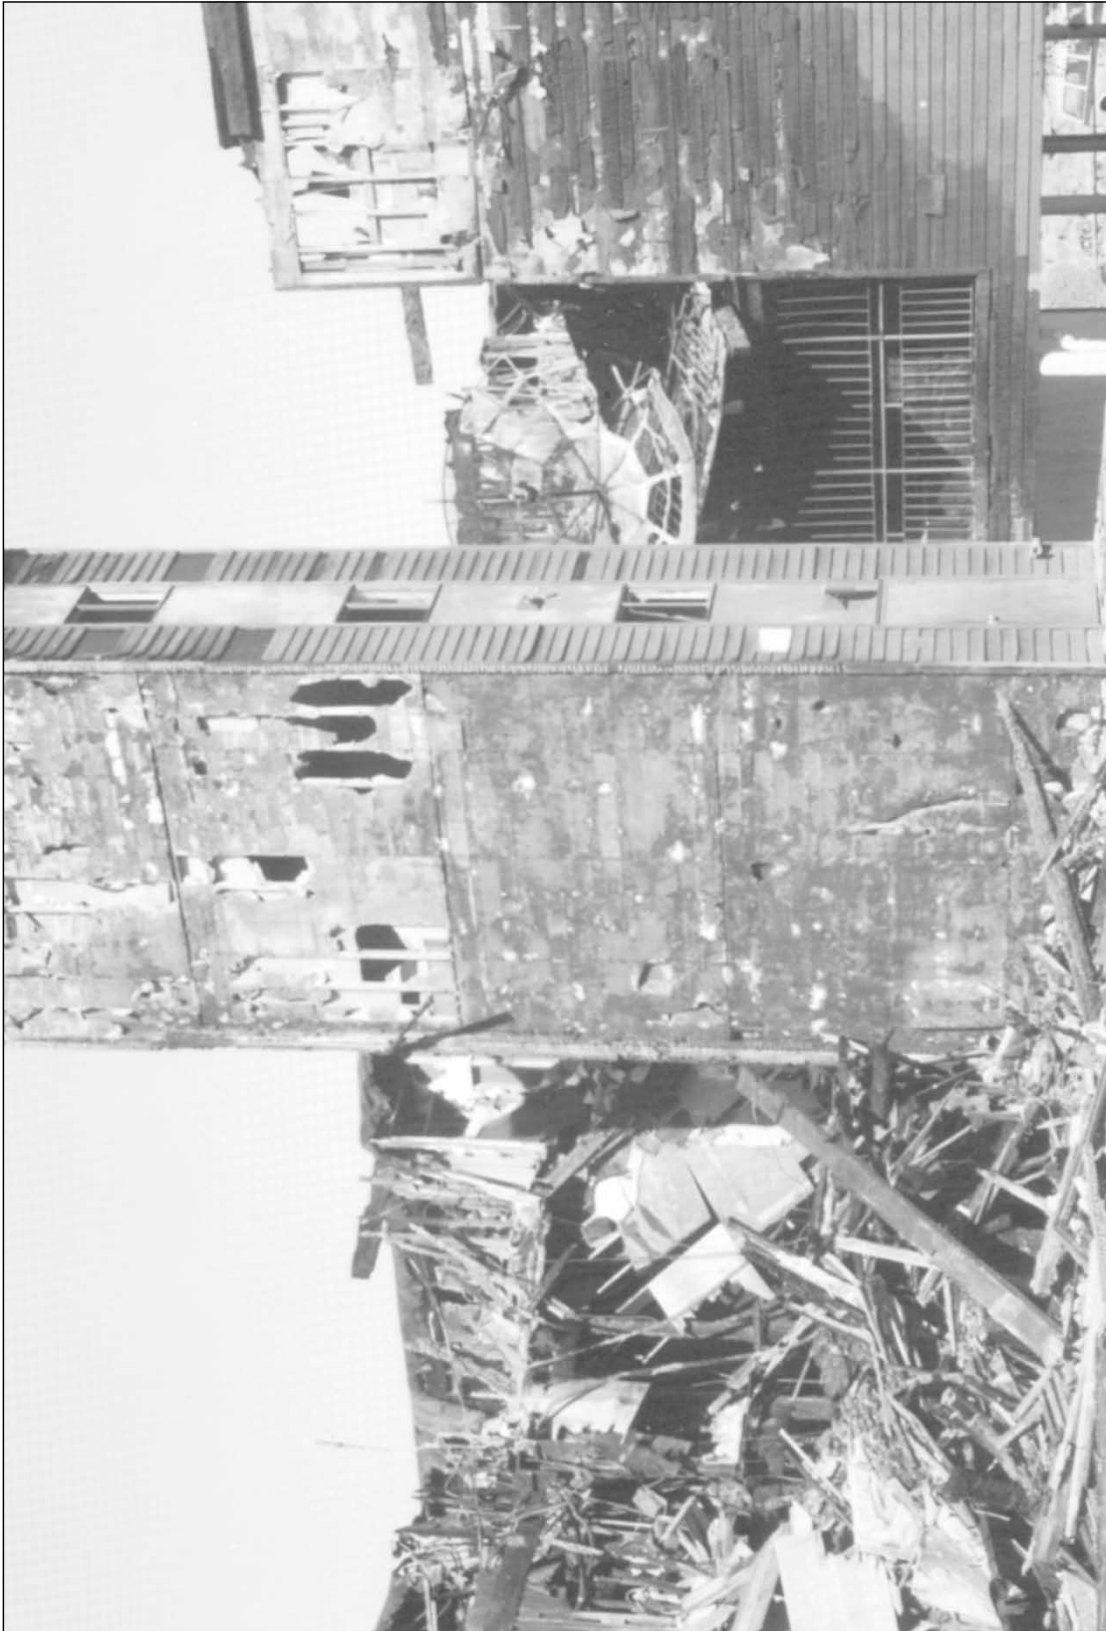
Easterly view showing stairwell enclosure that remained at the east end of the destroyed complex.

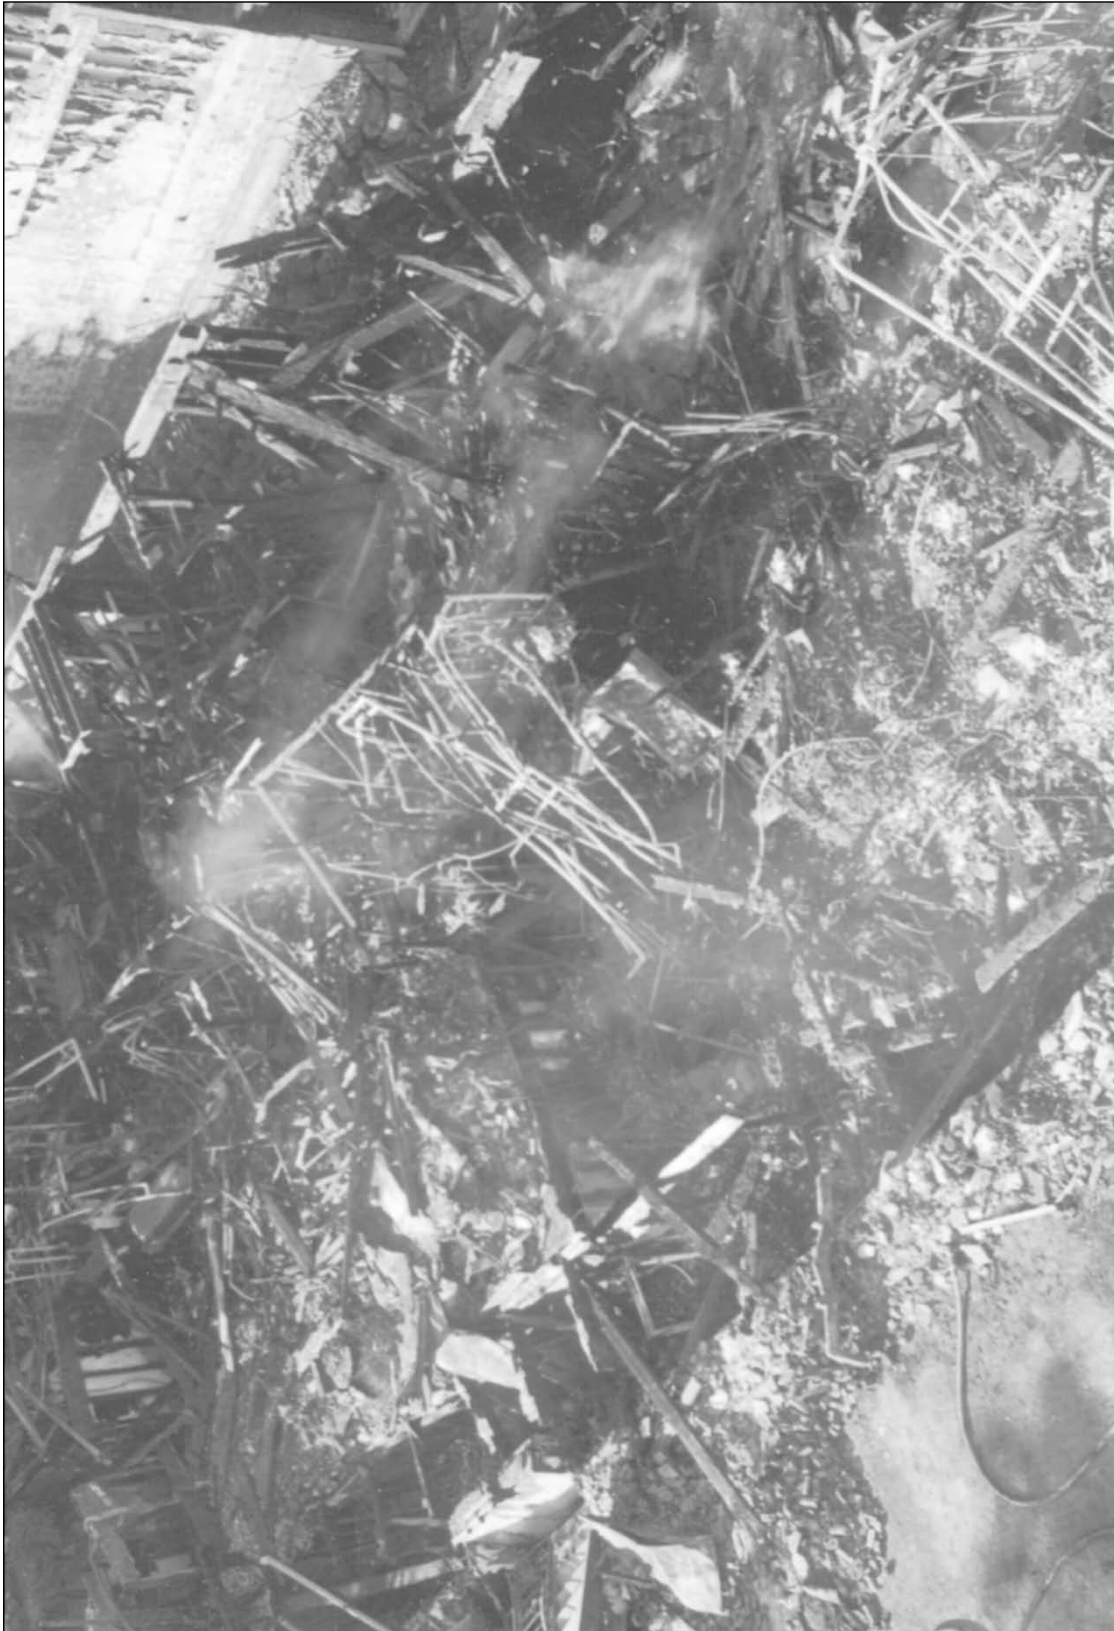
Aerial view of area of origin (Unit 115).

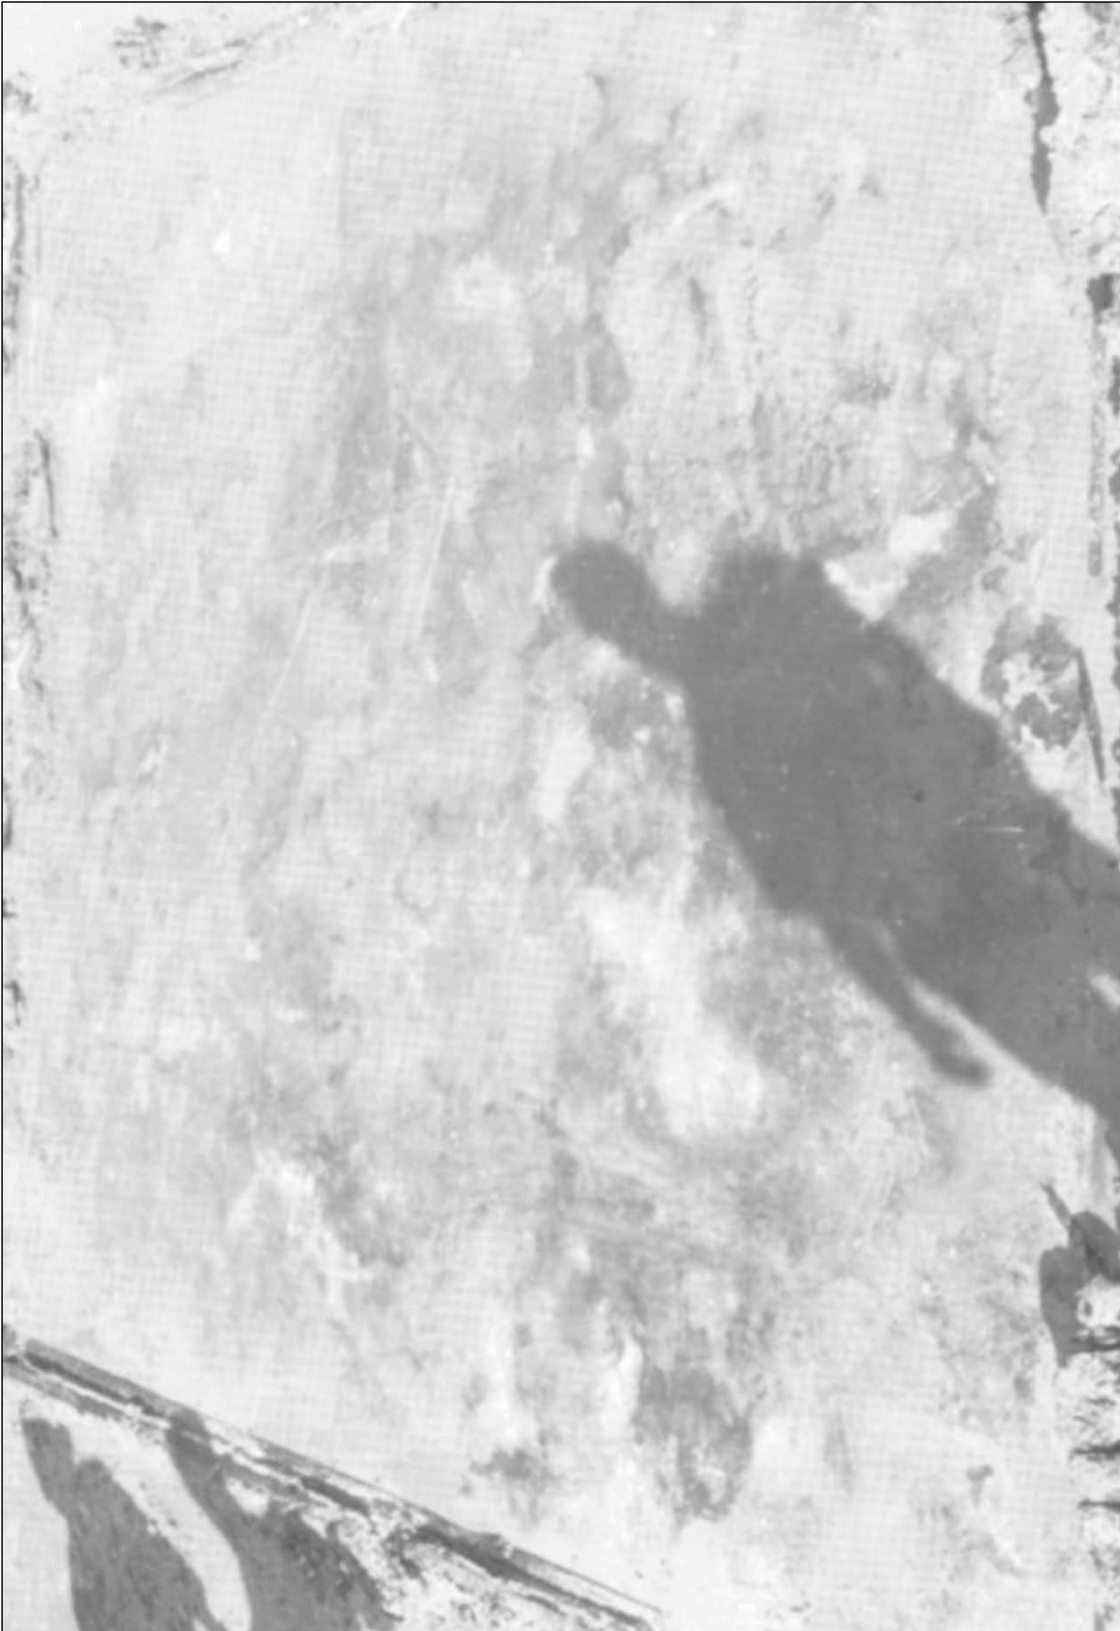
Slab of room of origin, southeast bedroom.

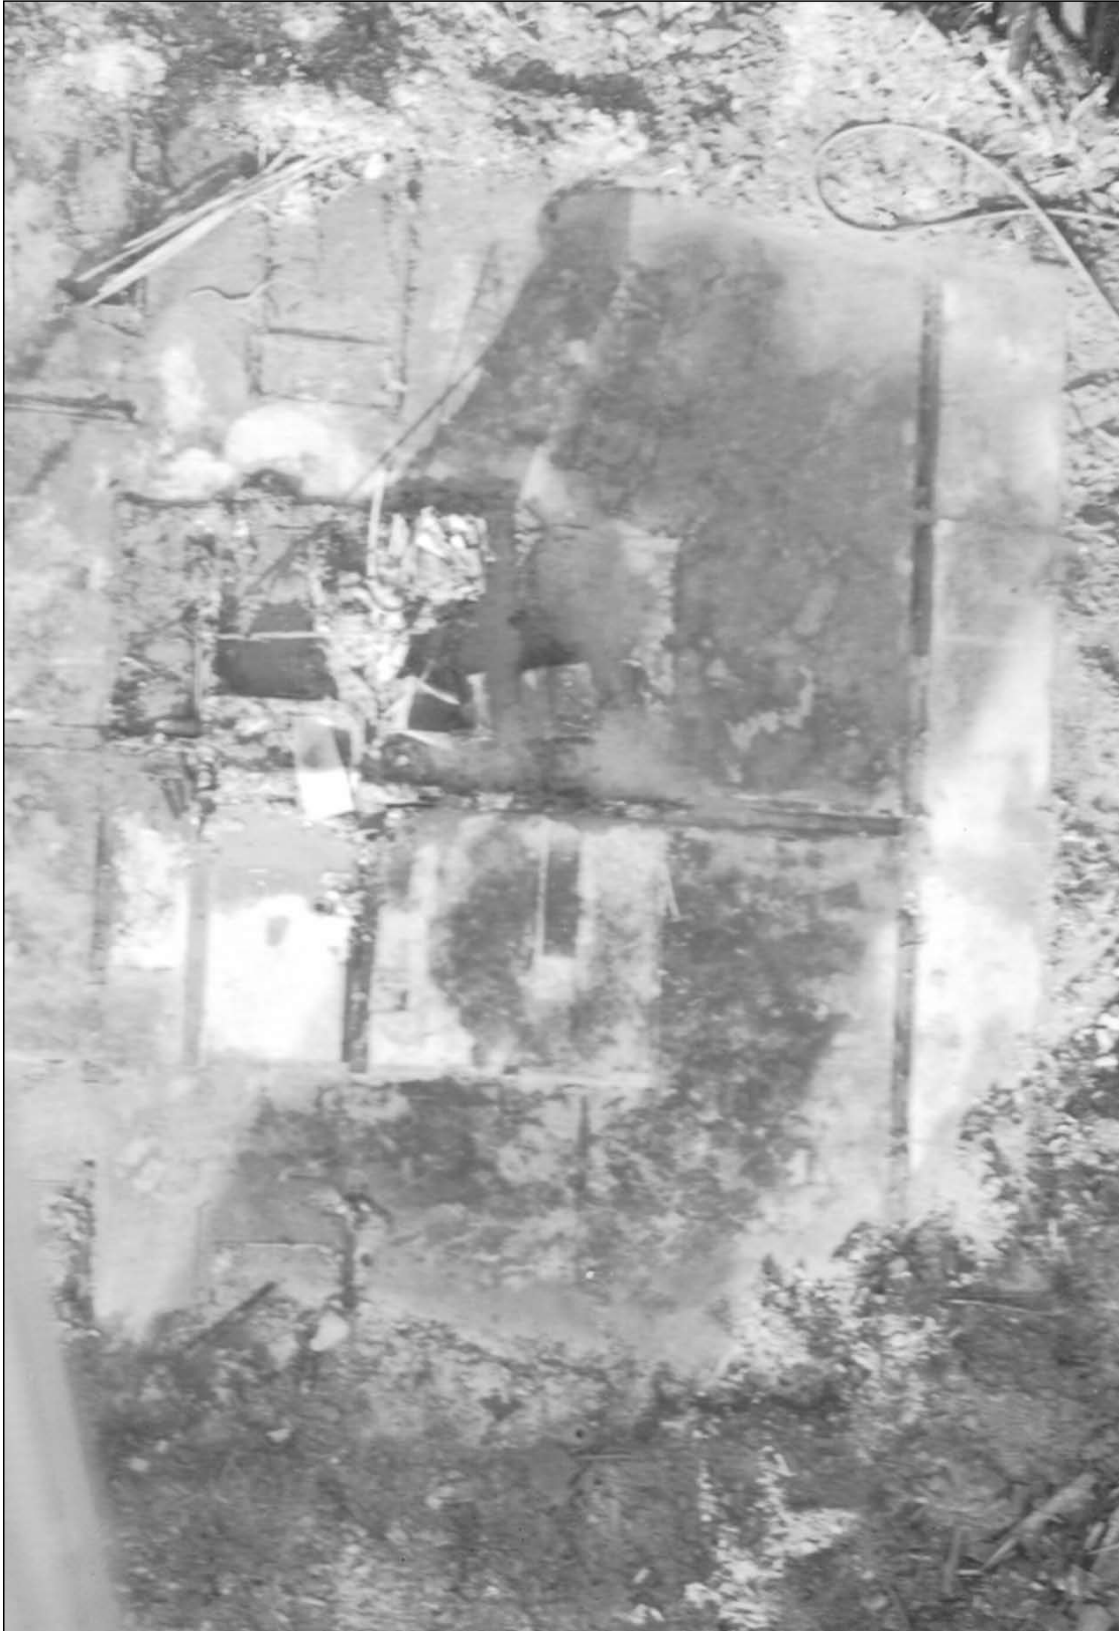
Aerial view showing the unit of origin and adjacent unit on east and slab comparisons.

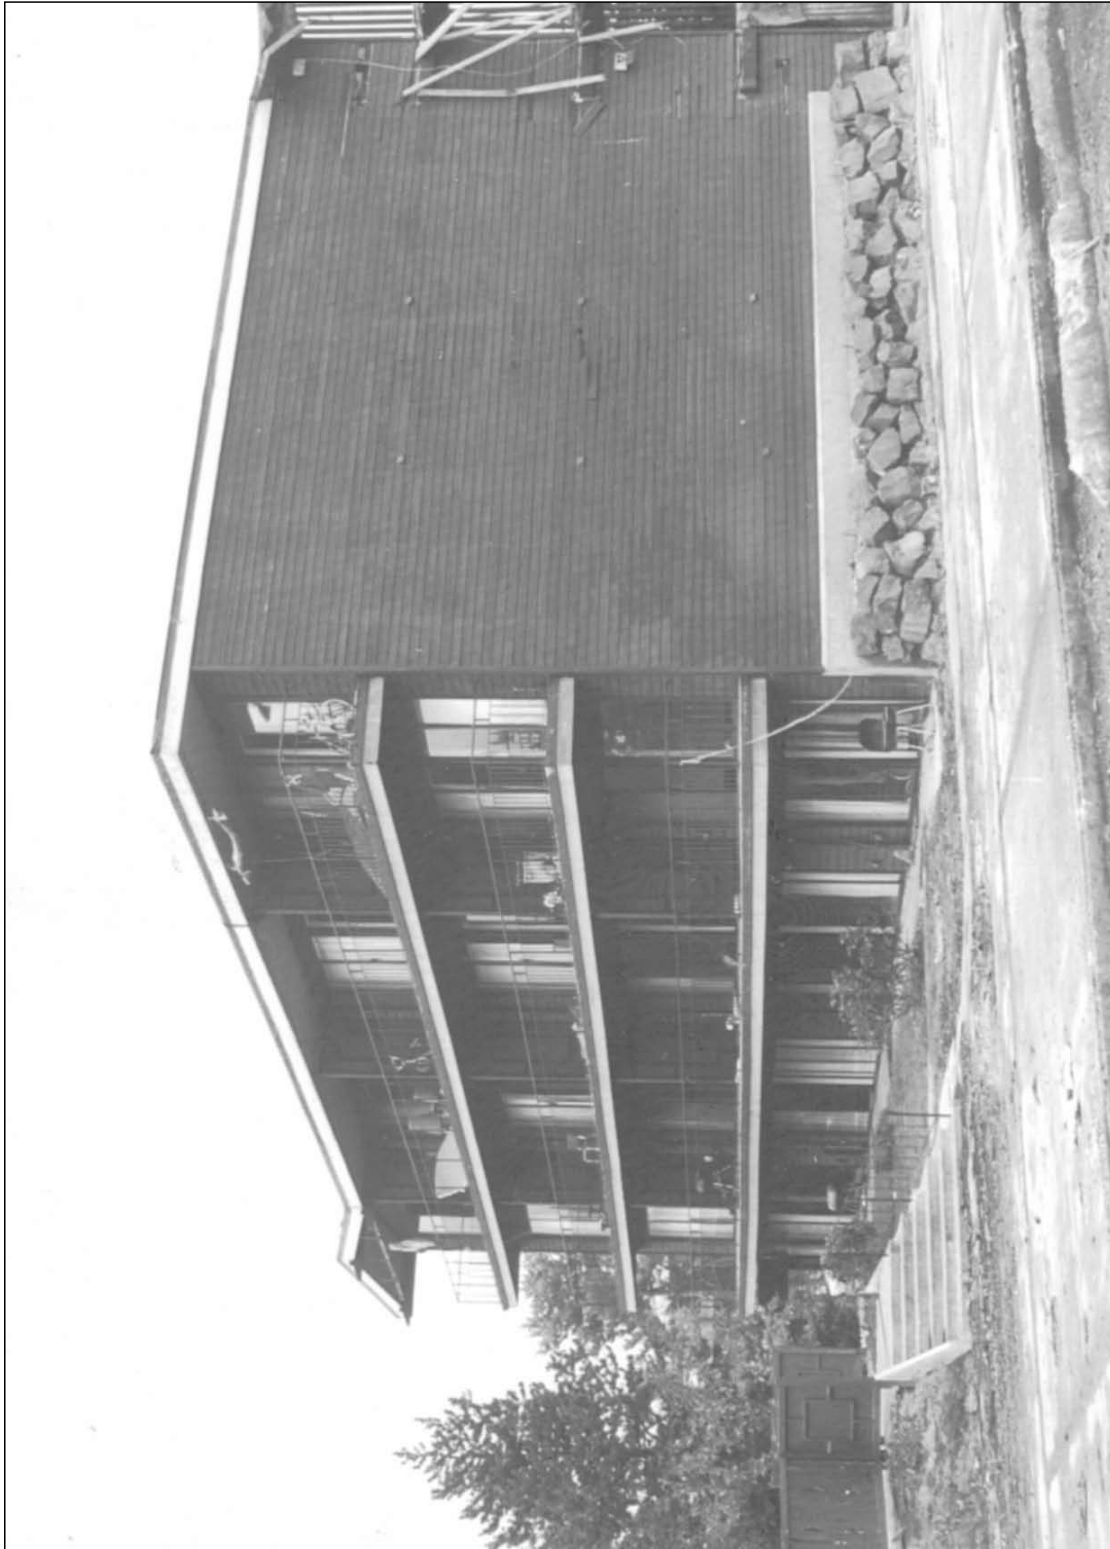
South and west sides of Building E. Note that only a small amount of damage was done to this building, at its southeast corner.

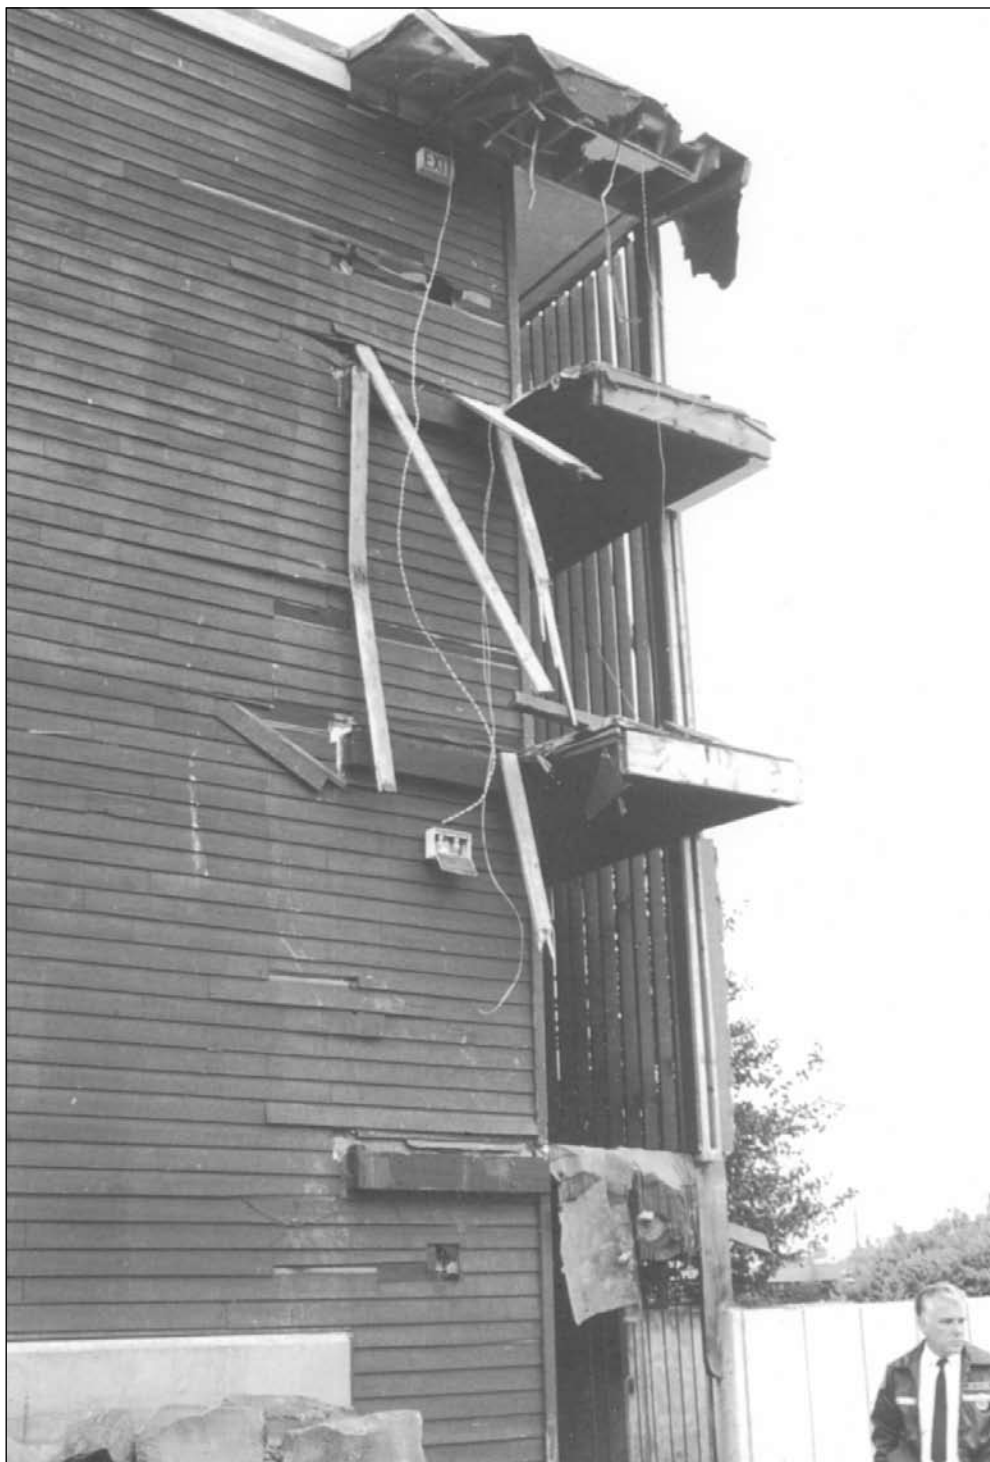
Closer view of damage of southeast corner of Building E. The wooden platforms jutting out on the right were part of the walkway attached to Building D, which was demolished.

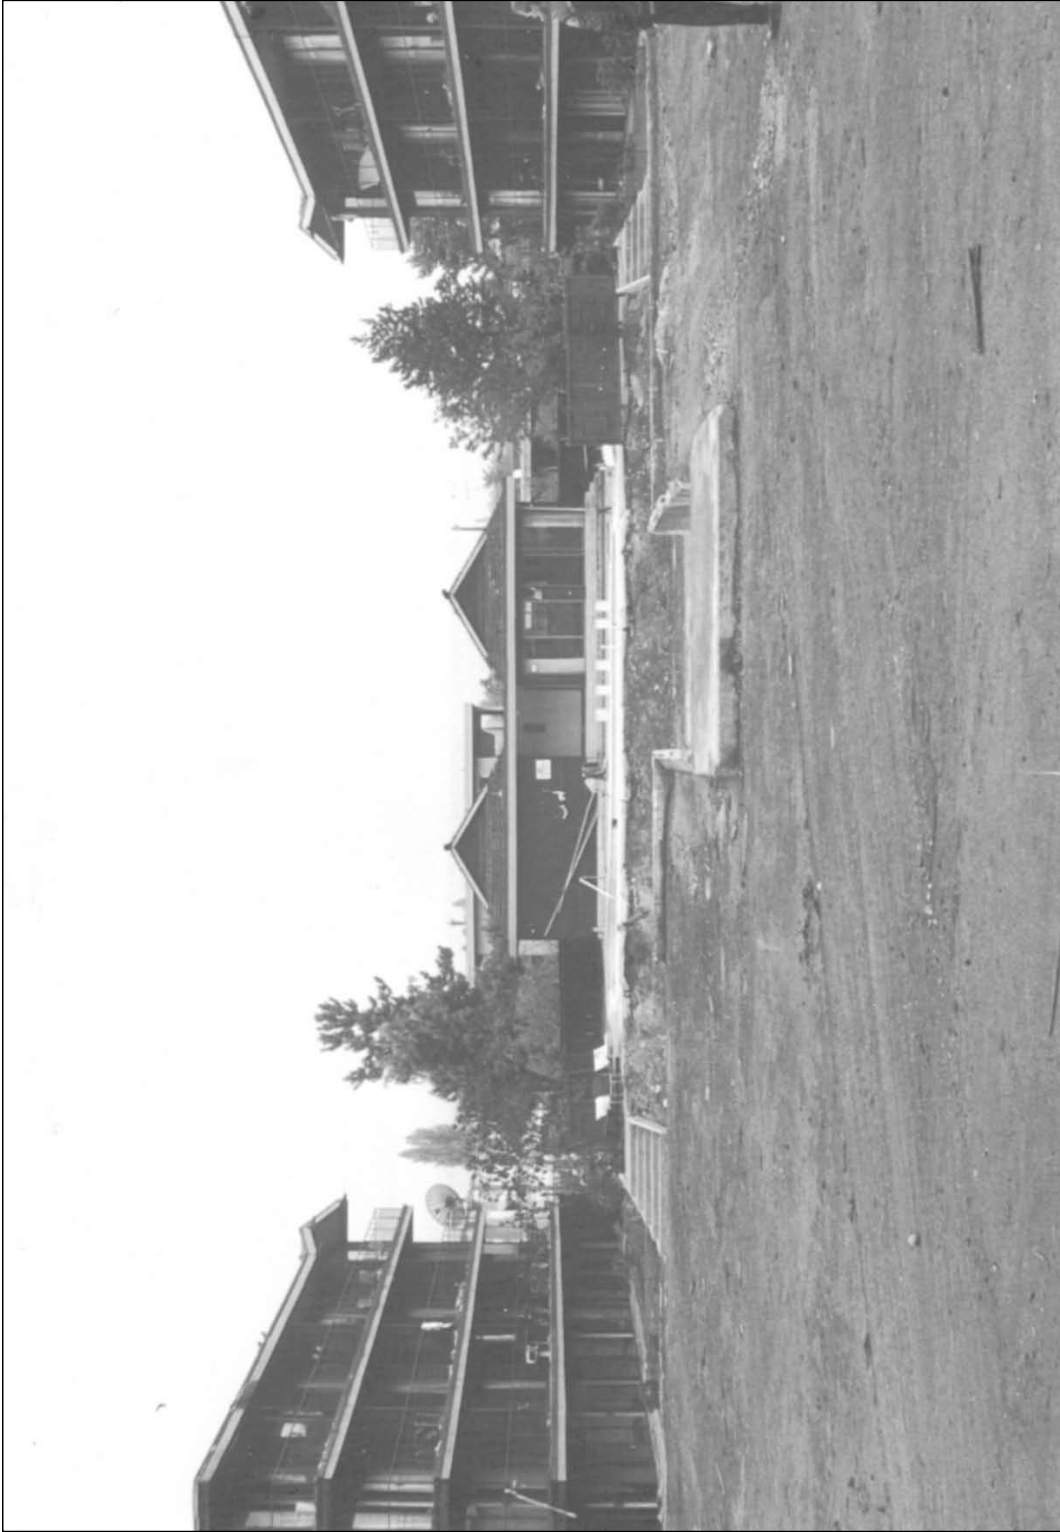
View of complex from south. Building A is on left, Building E on right. The small central building was a pool clubhouse. Buildings B, C and D were demolished and occupied the front (now vacant) space in the bottom third of the photograph.

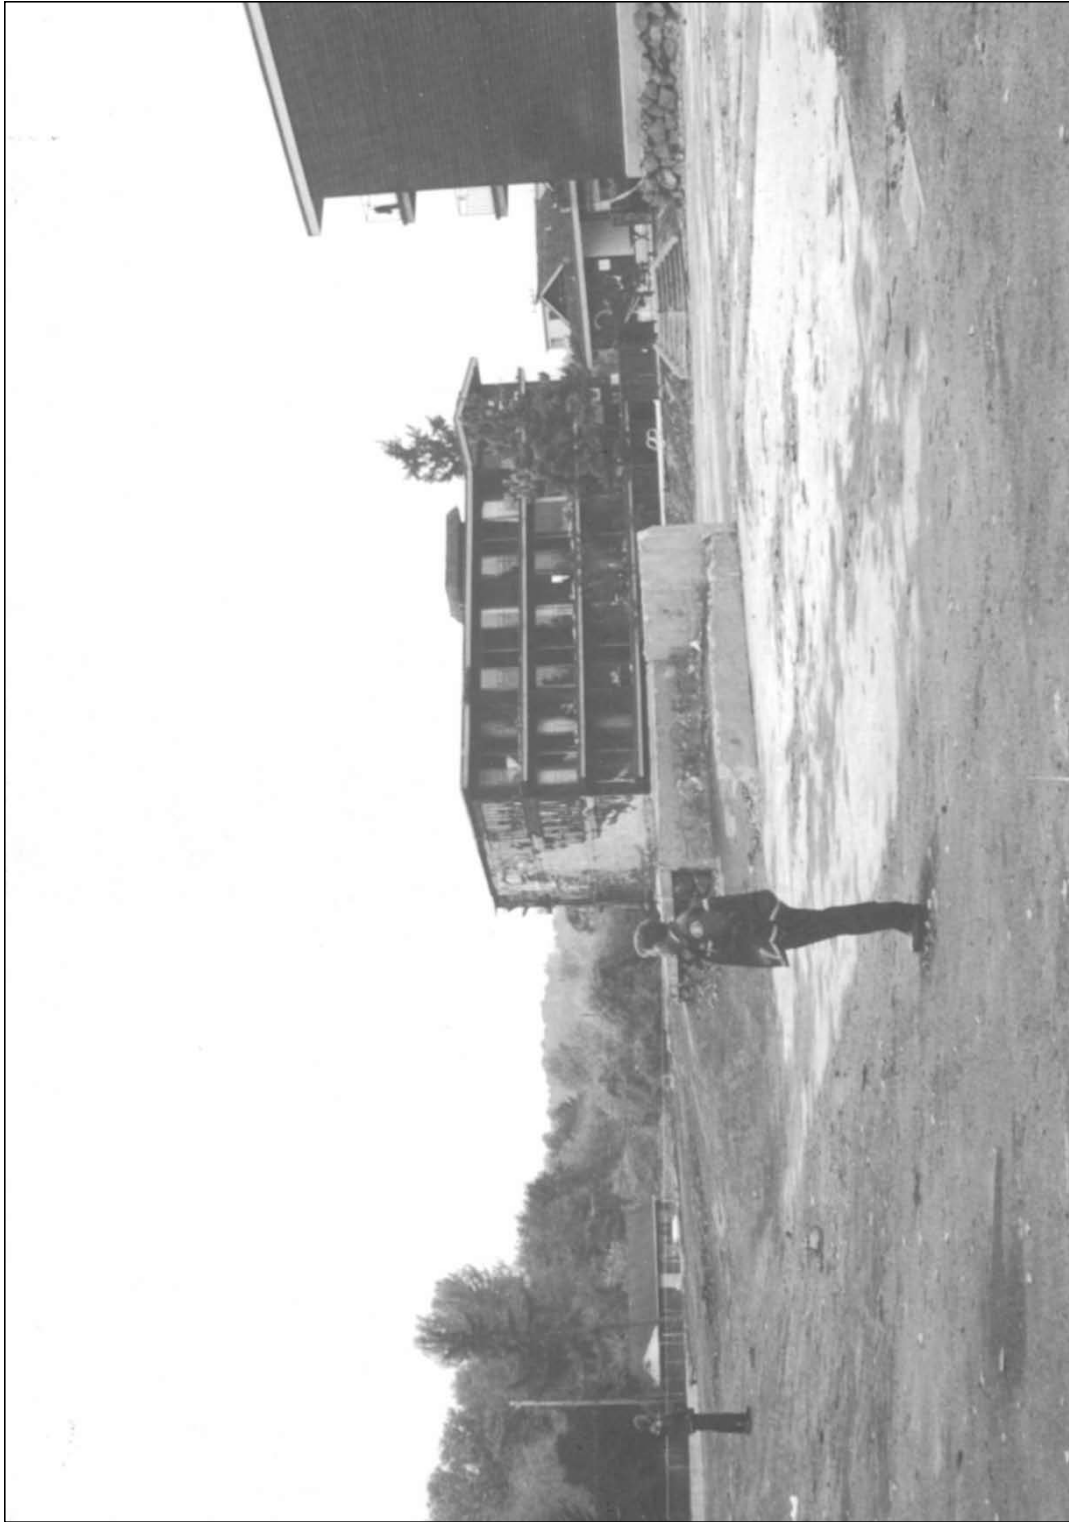
View of complex from southeast corner, looking northwest. The fire officer in the foreground is standing on the building line of what was Building D. The fire officer on the left is standing about where the first line and monitor were put into service by the first arriving engine company.

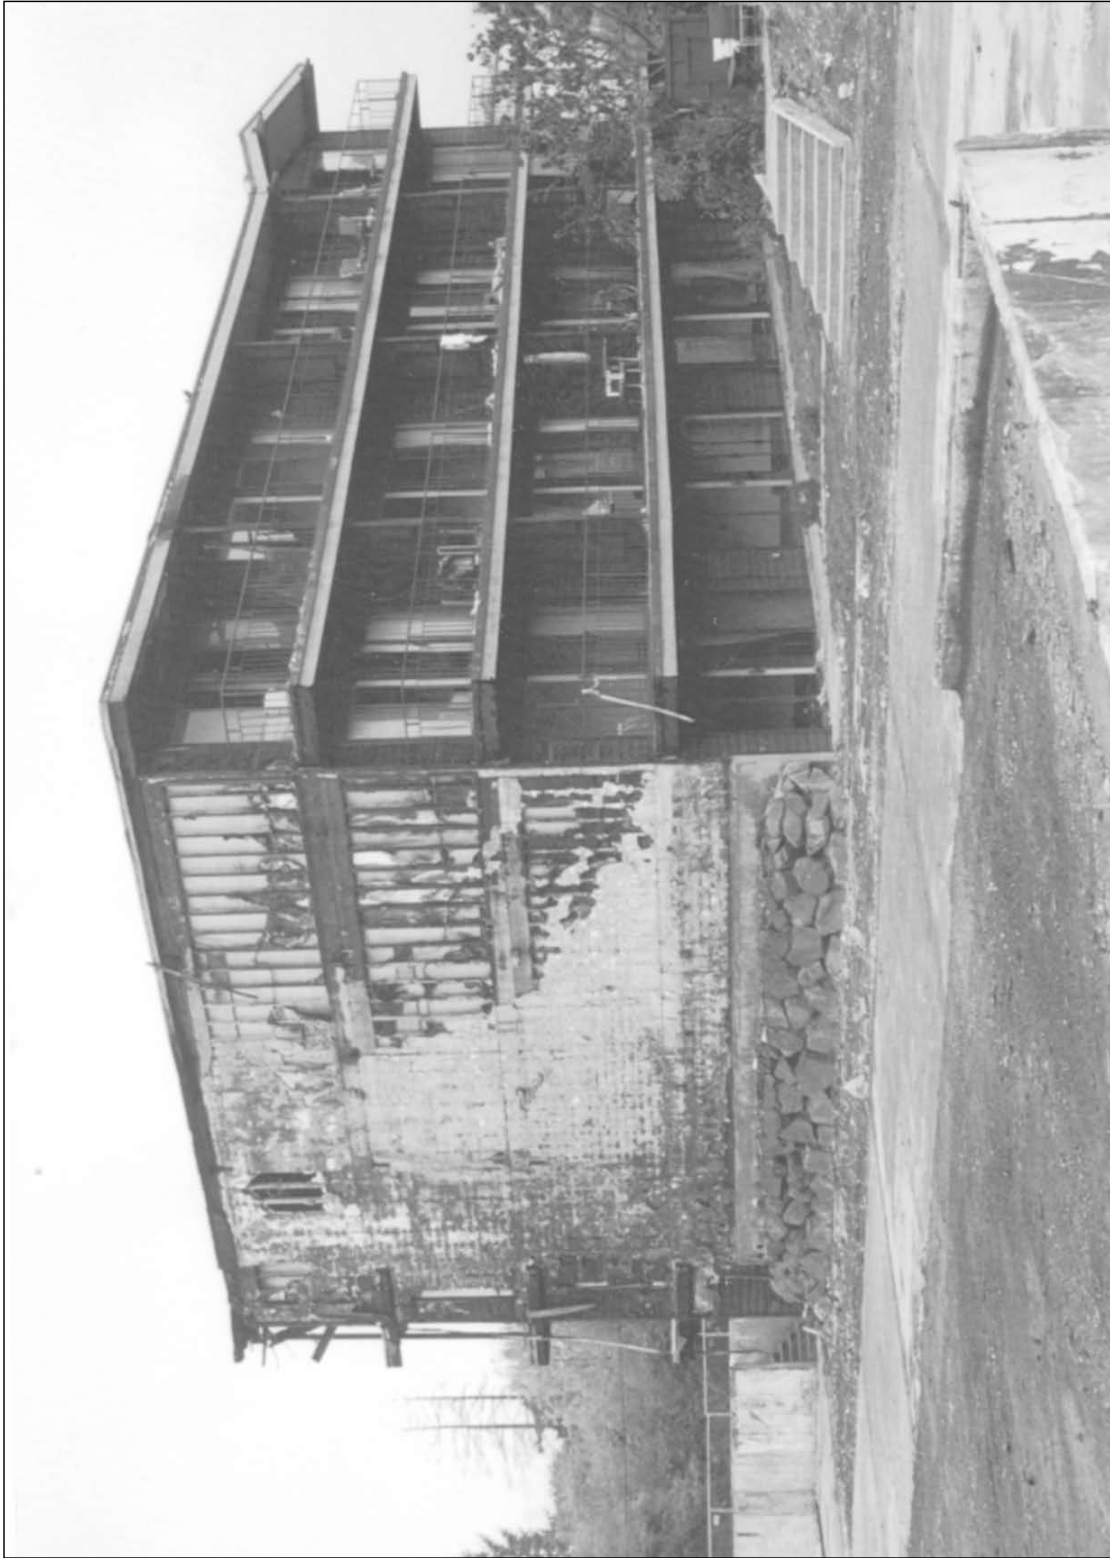
South and east sides of Building A. This building was saved by an excellent exposure defense. Note that it was burning on both its southwest and southeast corners.
