U.S. Fire Administration/Technical Report Series

Apartment Complex Fire, 66 Units Destroyed

Seattle, Washington

USFA-TR-059/September 1991

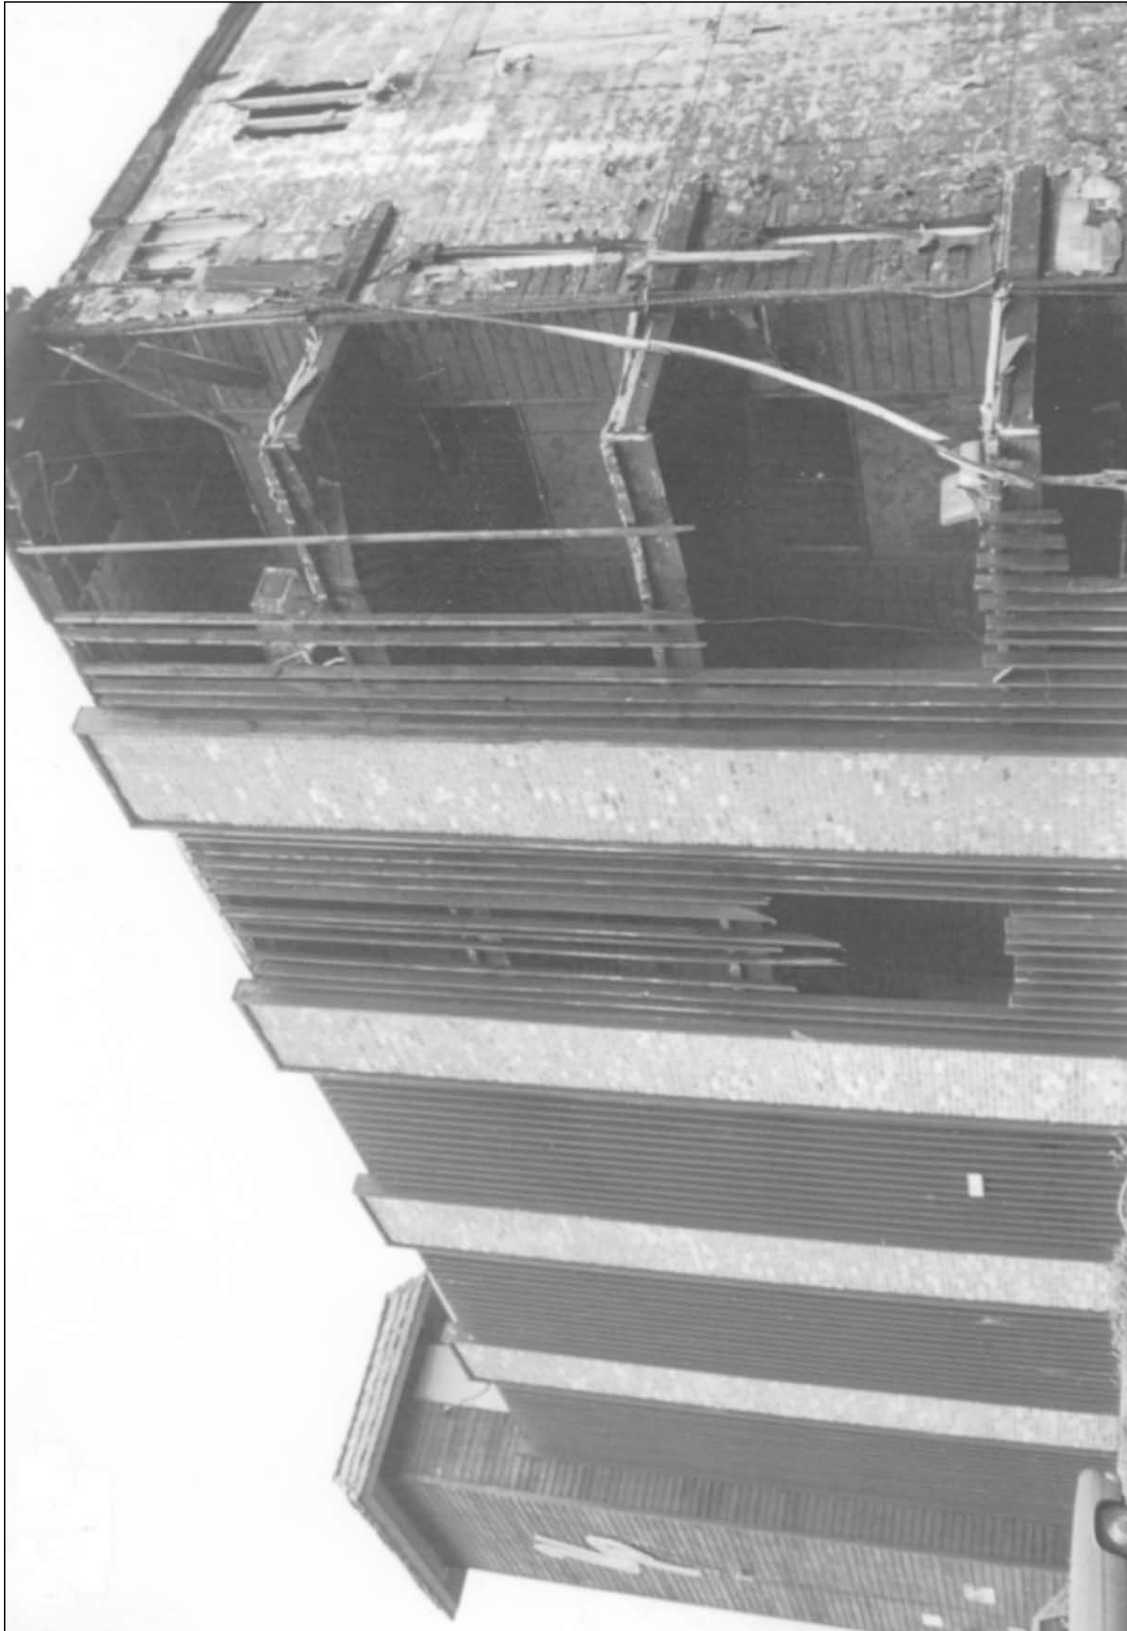
Close-up of west facade of Building A; its southwest corner was damaged.

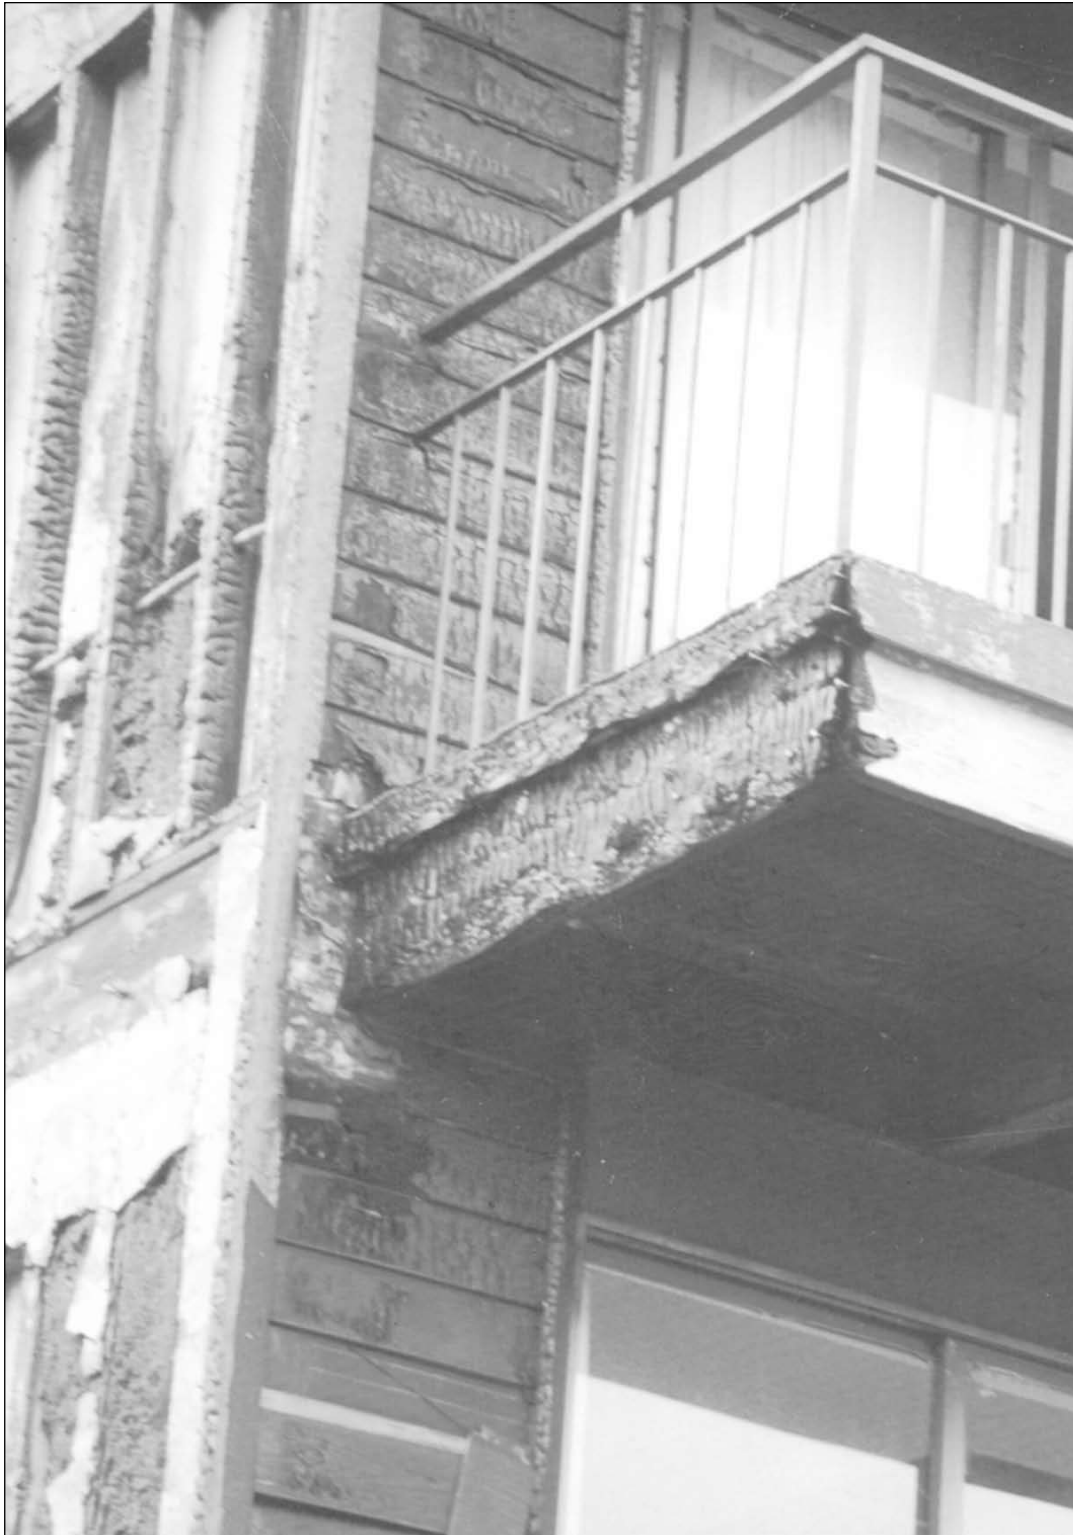
Detail of southeast corner of Building A.

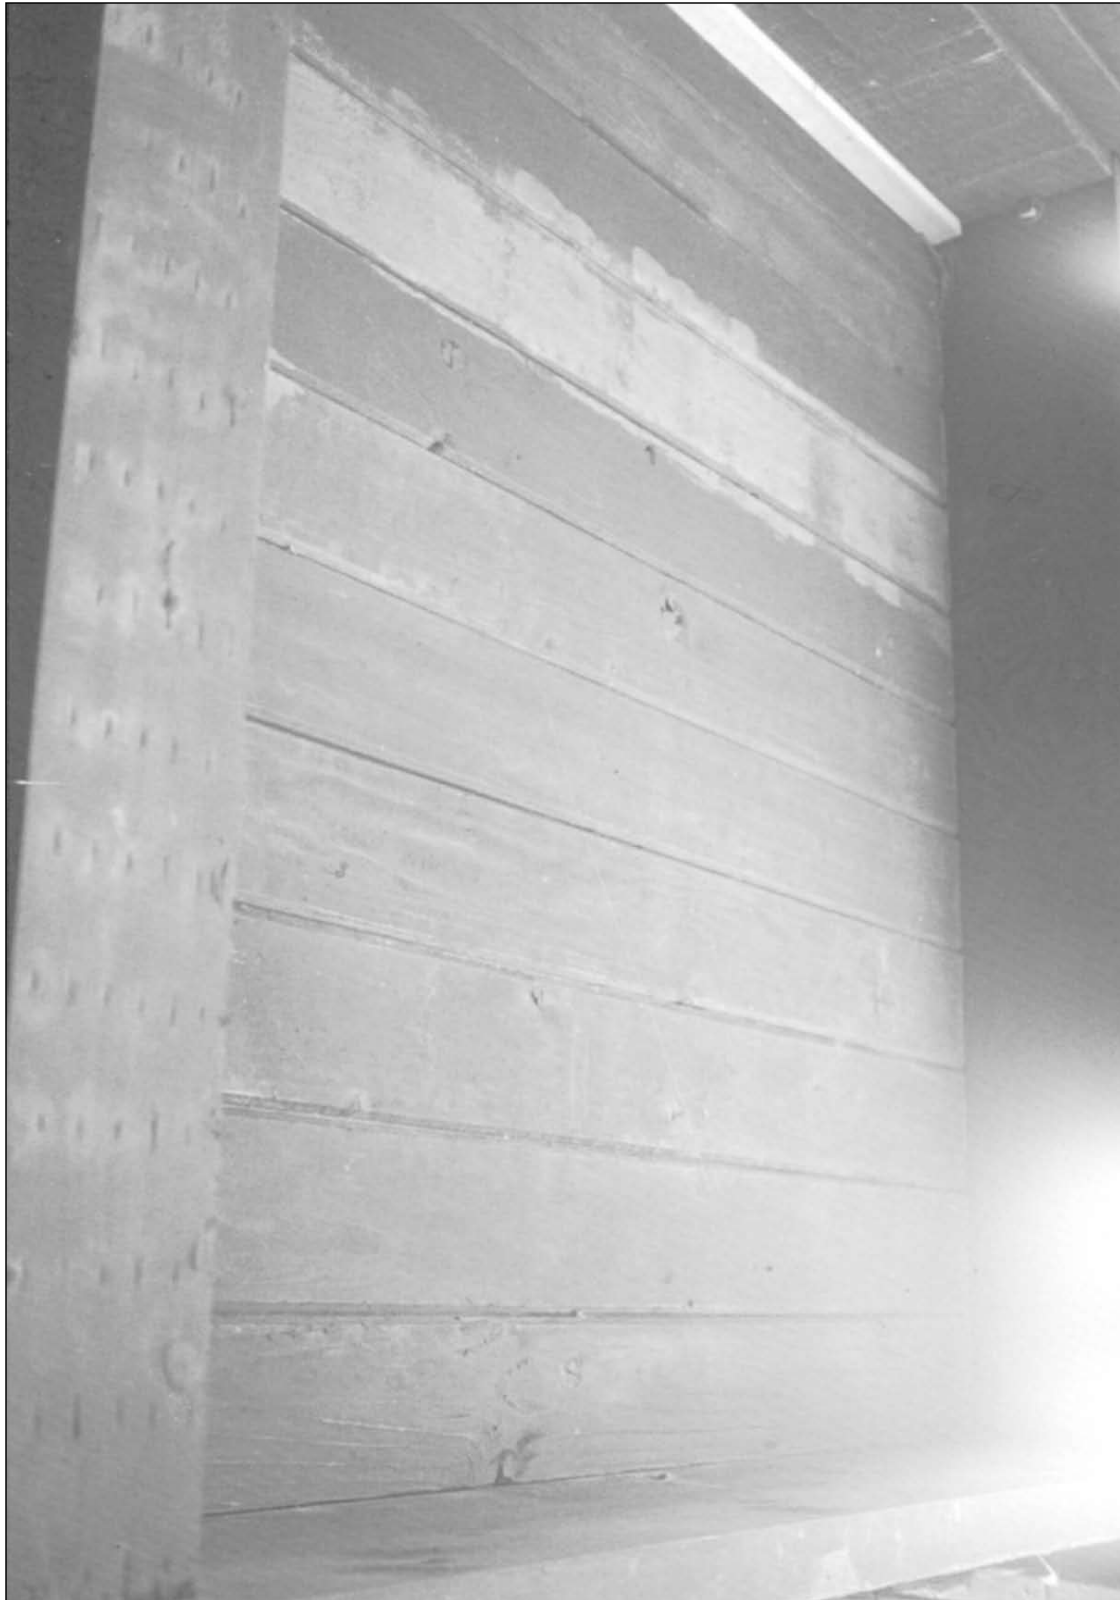
Underside of walkway of basement level of Building E. The underside of all walkways on Floors 1 - 3 were similar and made of cedar. This was one of the avenues of flame spread.

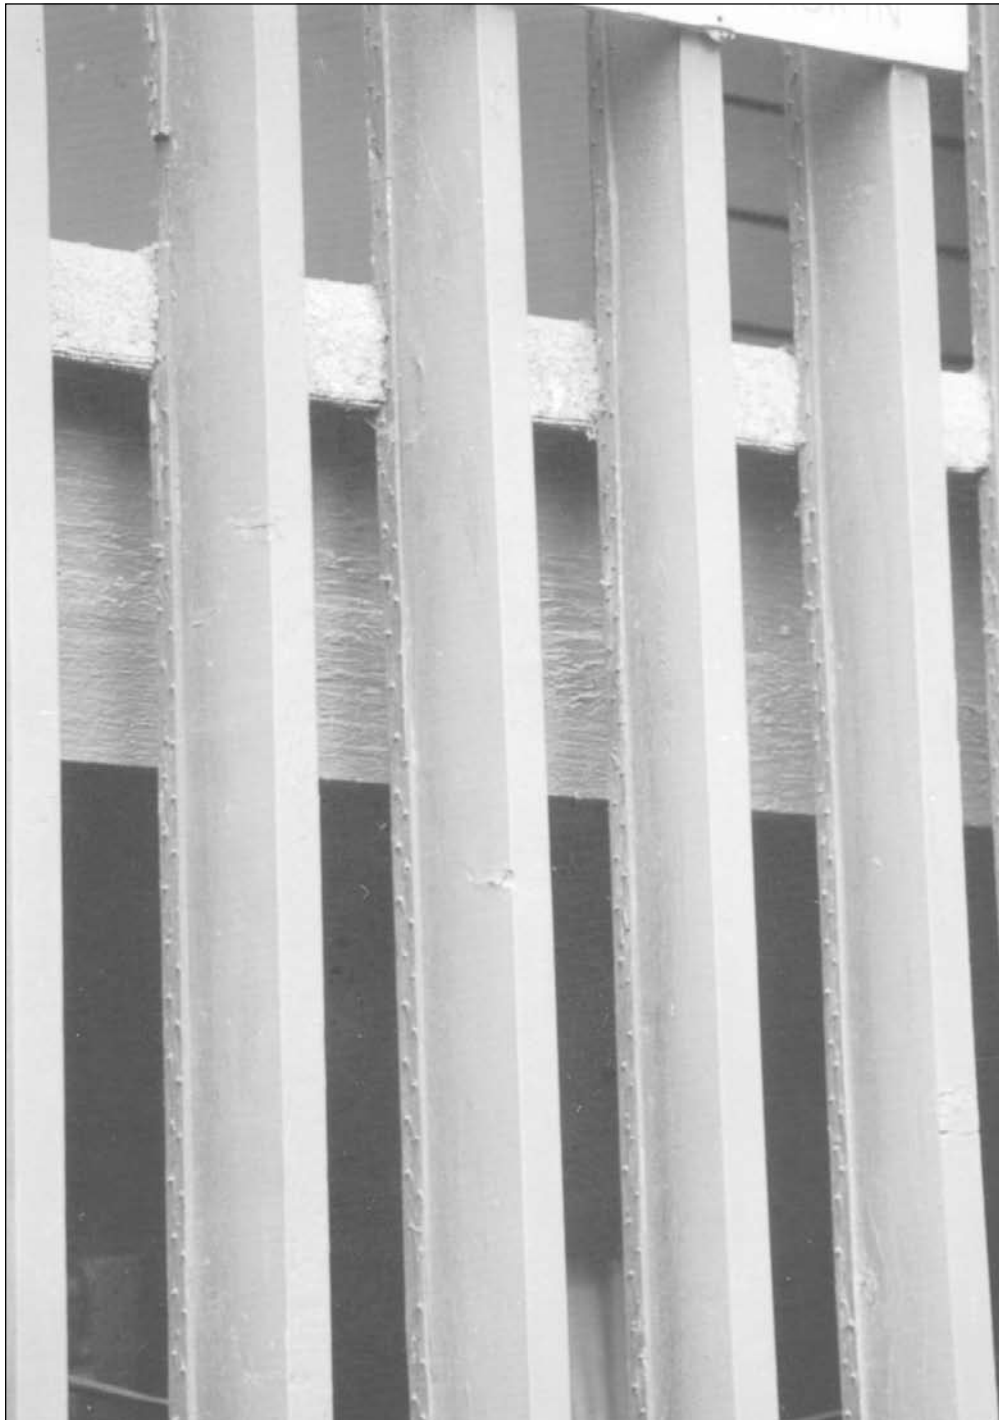
The fire coming out of the broken front bedroom window initially impinged on the base of the brick decorative fascia that separated segments of the cedar screen running up the face of the balconies. The screen was comprised of vertical 2 by 6’s. It soon ignited and acted as a path for the fire to quickly extend vertically up the entire 40-foot face of the screen, and also horizontally across the screen. The fire also quickly ignited the cedar siding and cedar underside of the walkway ceilings. The fire spread both east and west on the face of the building.

Close-up of the decorative cedar screen on the fronts of the buildings, which served a security purpose as well. Fire could race unimpeded up the wood 2 x 6s. The photograph shows the screen as it passes the outdoor carpeted floor of the walkway above.

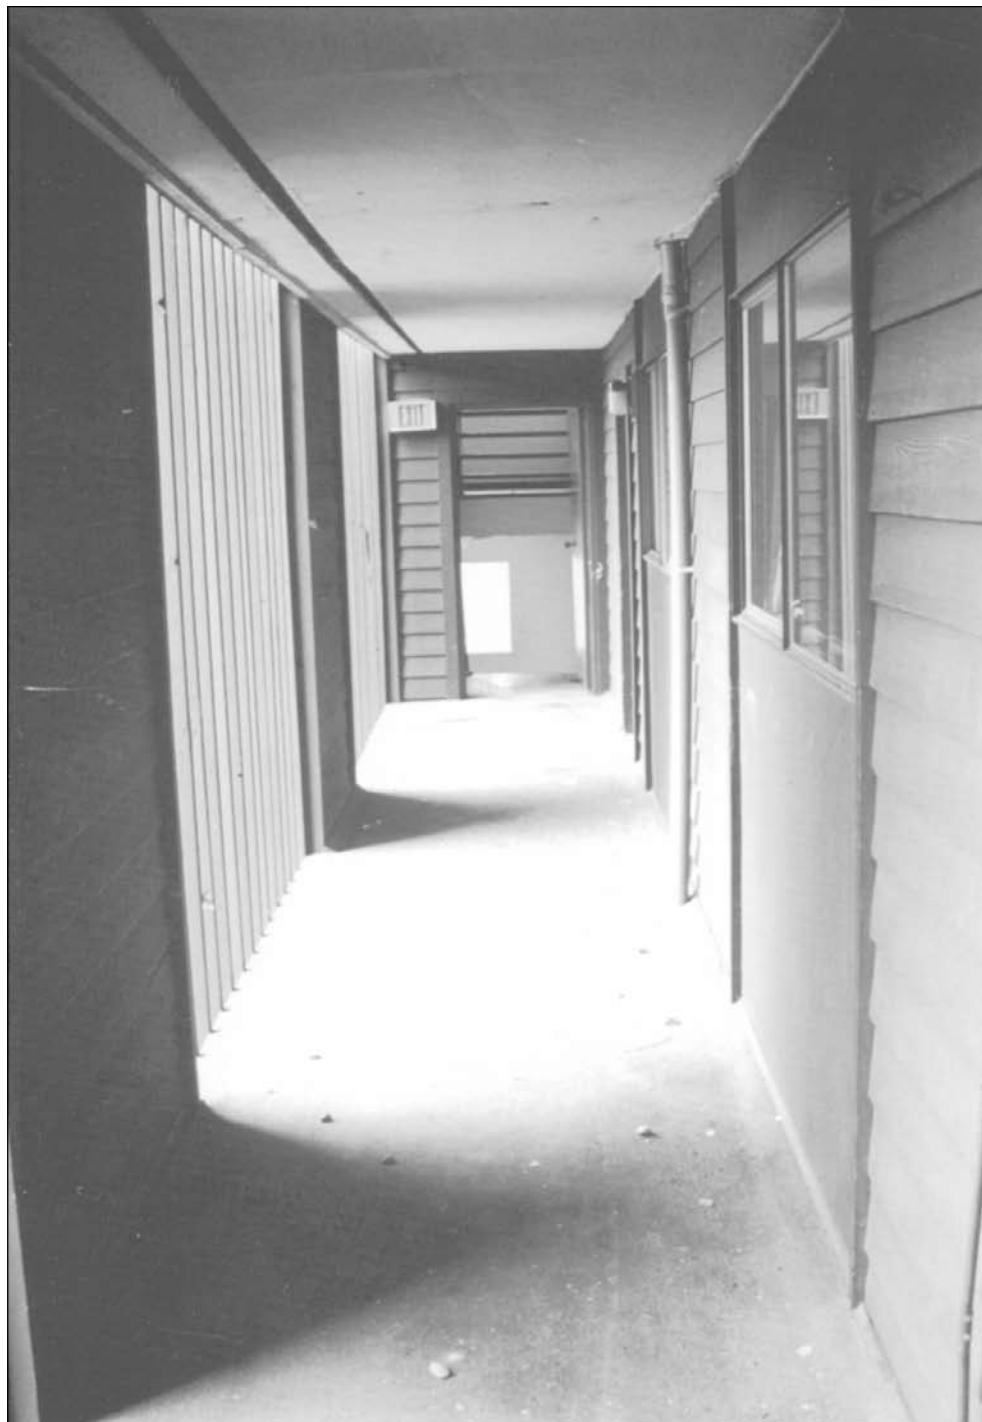
Top (fourth) floor walkway on western exterior of Building A. The ceiling of the fourth level was the only one not of cedar. The window shown is a bedroom window like the one that first blew out in the apartment of origin.

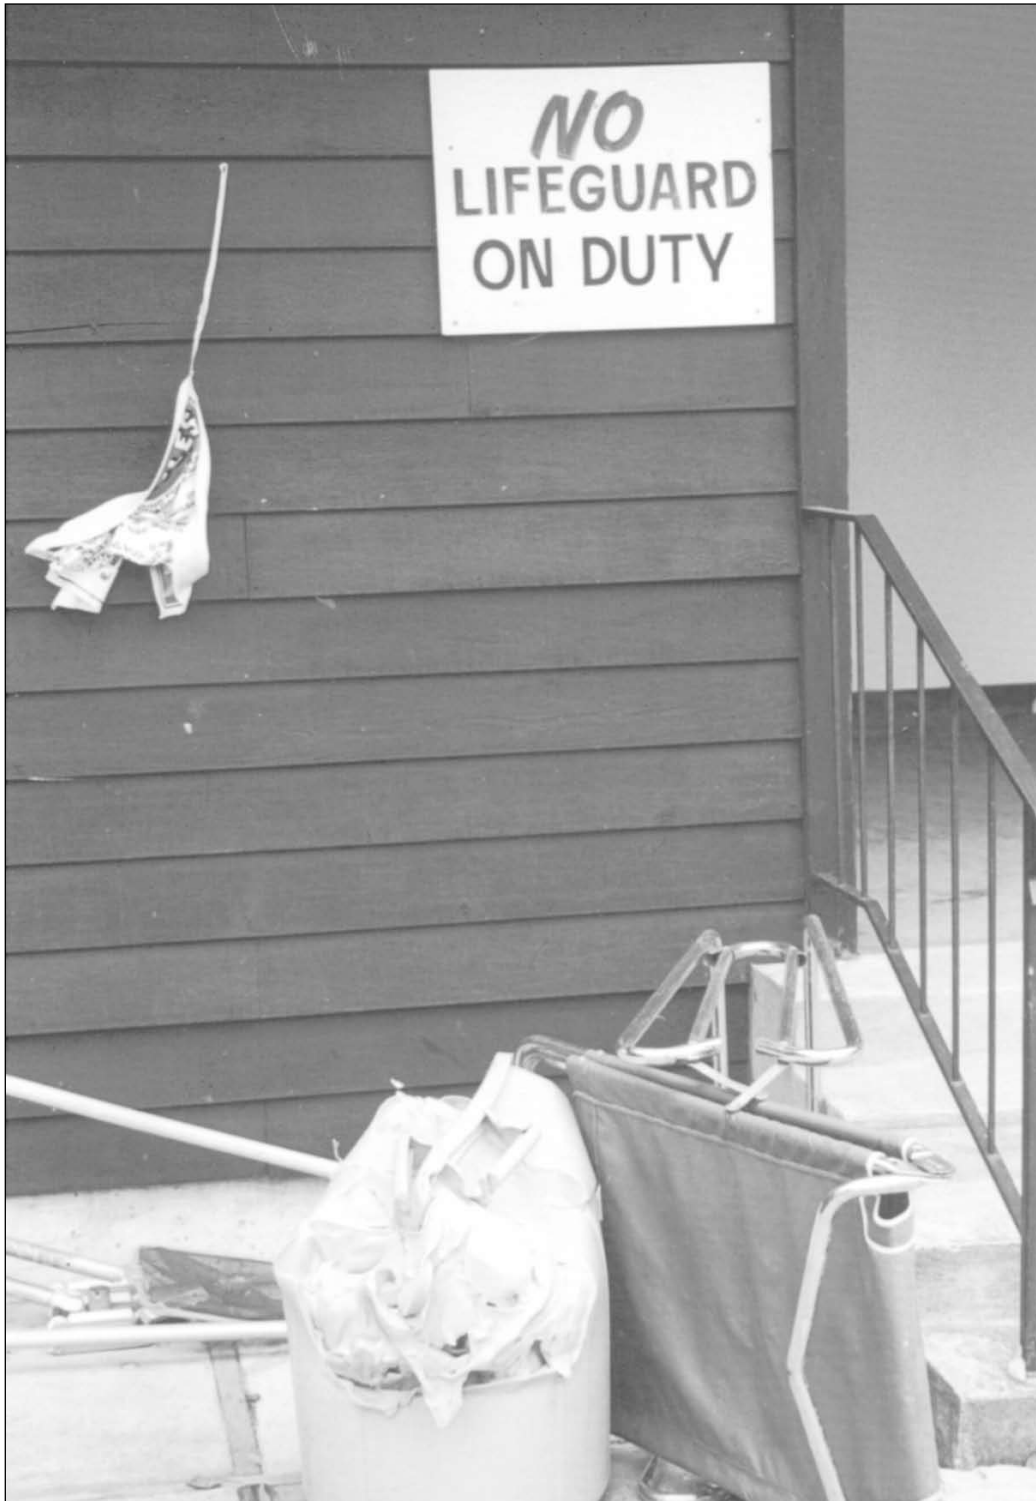
Melted plastic containers behind the swimming pool. Firefighters were operating in this area during the initial stages of the attack.
