U.S. Fire Administration/Technical Report Series

Hospital Fire Kills Four Patients Southside Regional Medical Center

Petersburg, Virginia

USFA-TR-080/December 1994

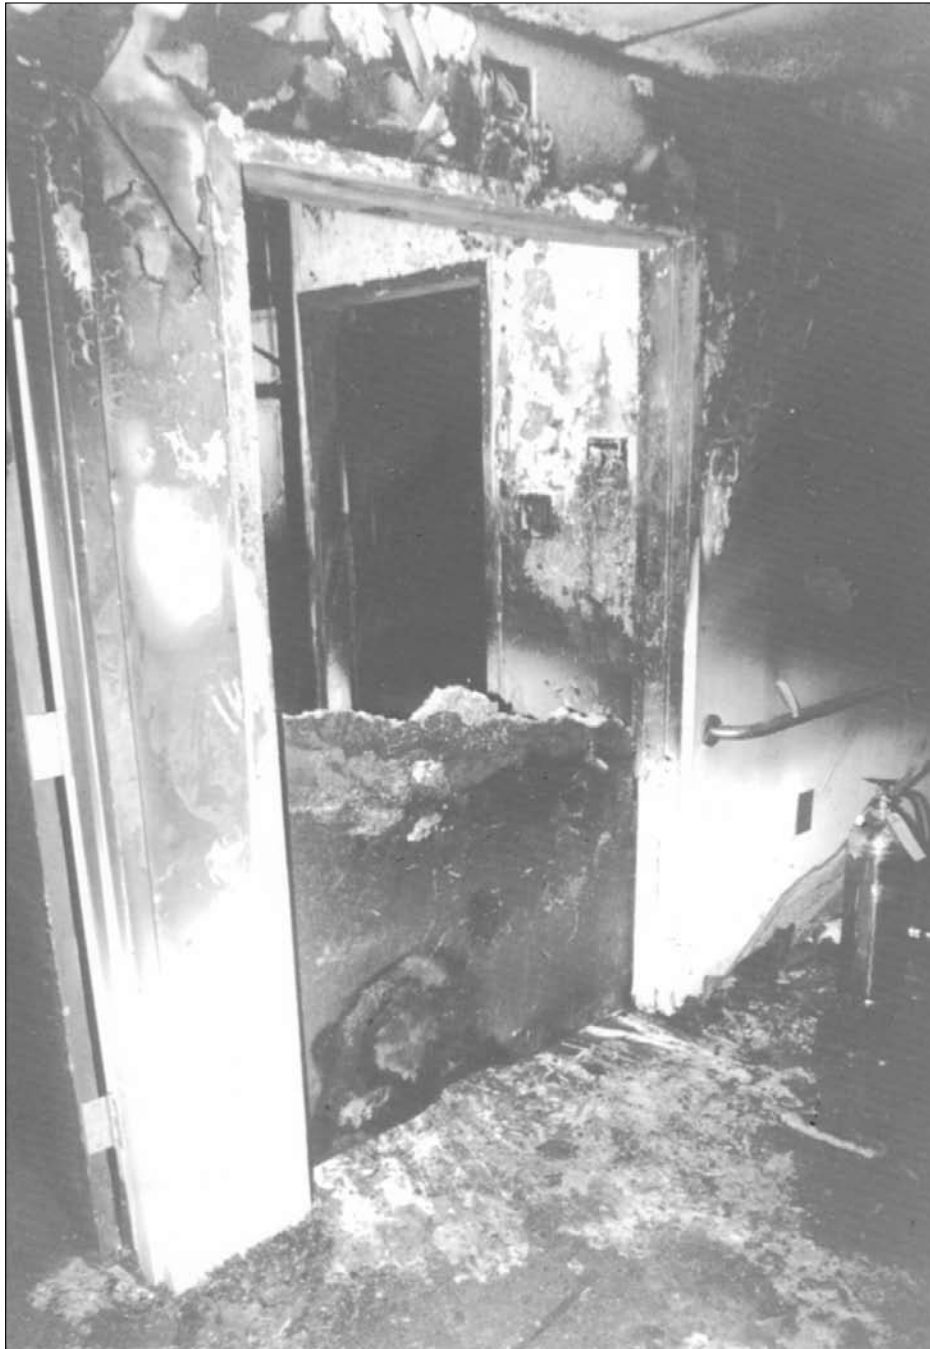
**There was heavy smoke and heat damage around the door to the room of origin.
The top portion of the door burned away in the fire.**

An automatic, self-closing door system on the doors to patient rooms would have been beneficial in this incident. The effectiveness of compartmentation features was destroyed by an open door which allowed smoke and heat spread into the corridor, and which provided a source of fresh air for the fire. The suspended ceiling, which was designed to be fire-rated, failed early in the fire, also destroying the compartmentation effectiveness.

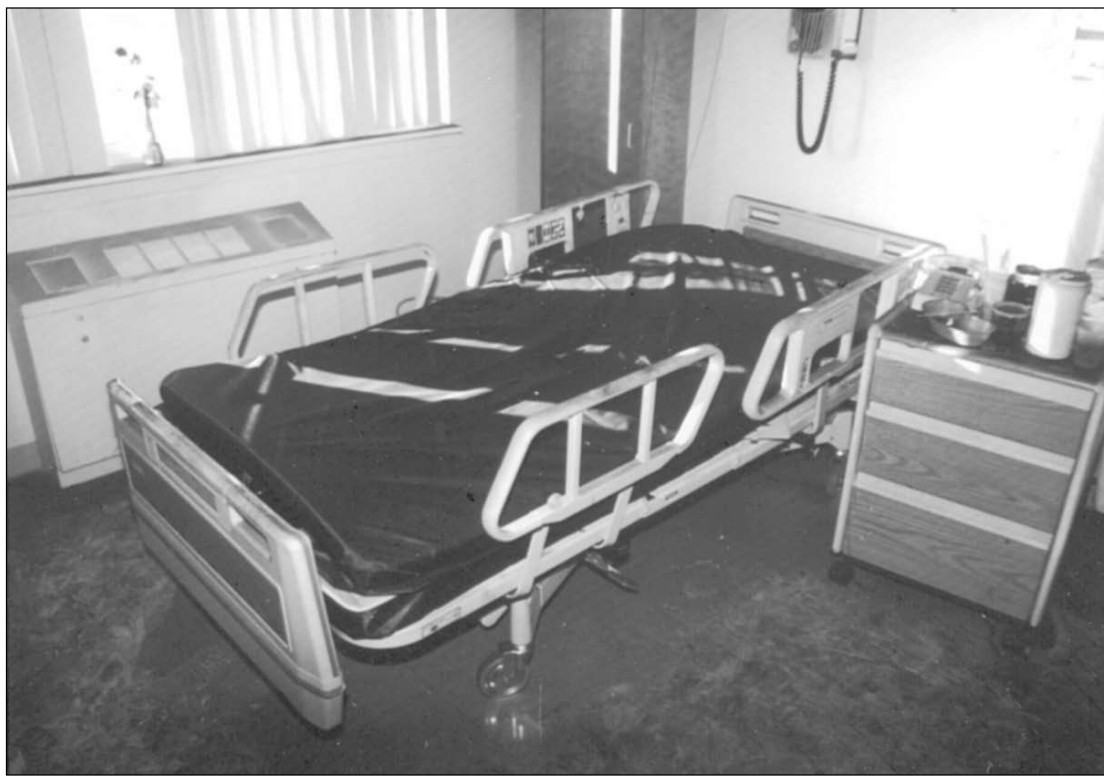
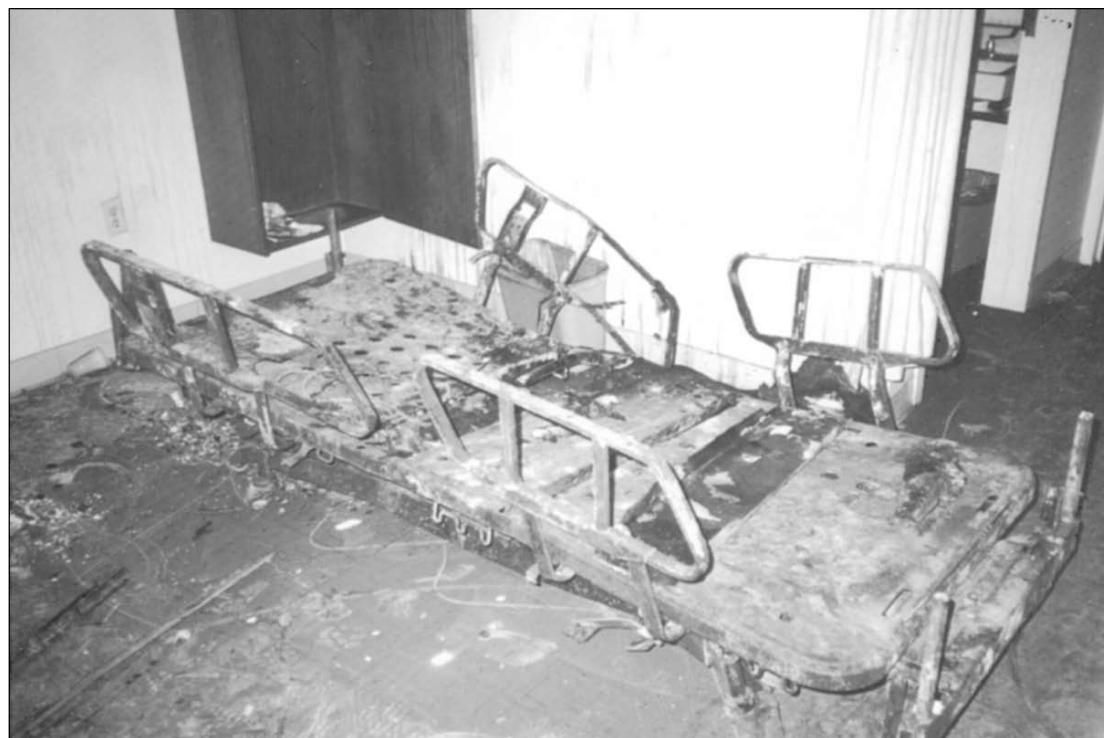
- The beds provided the major source of fuel for the fire. The plastic parts of the bed, particularly the foam plastic in the mattresses provided the fuel for rapid fire growth and heat release, with large volumes of black smoke. The cushions on chairs in the room also contributed to the rapid burning and smoke production.

The beds in the hospital contained heavy amounts of plastic and foam parts. Only the metal frame of the patient's bed was recognizable in the room of origin.

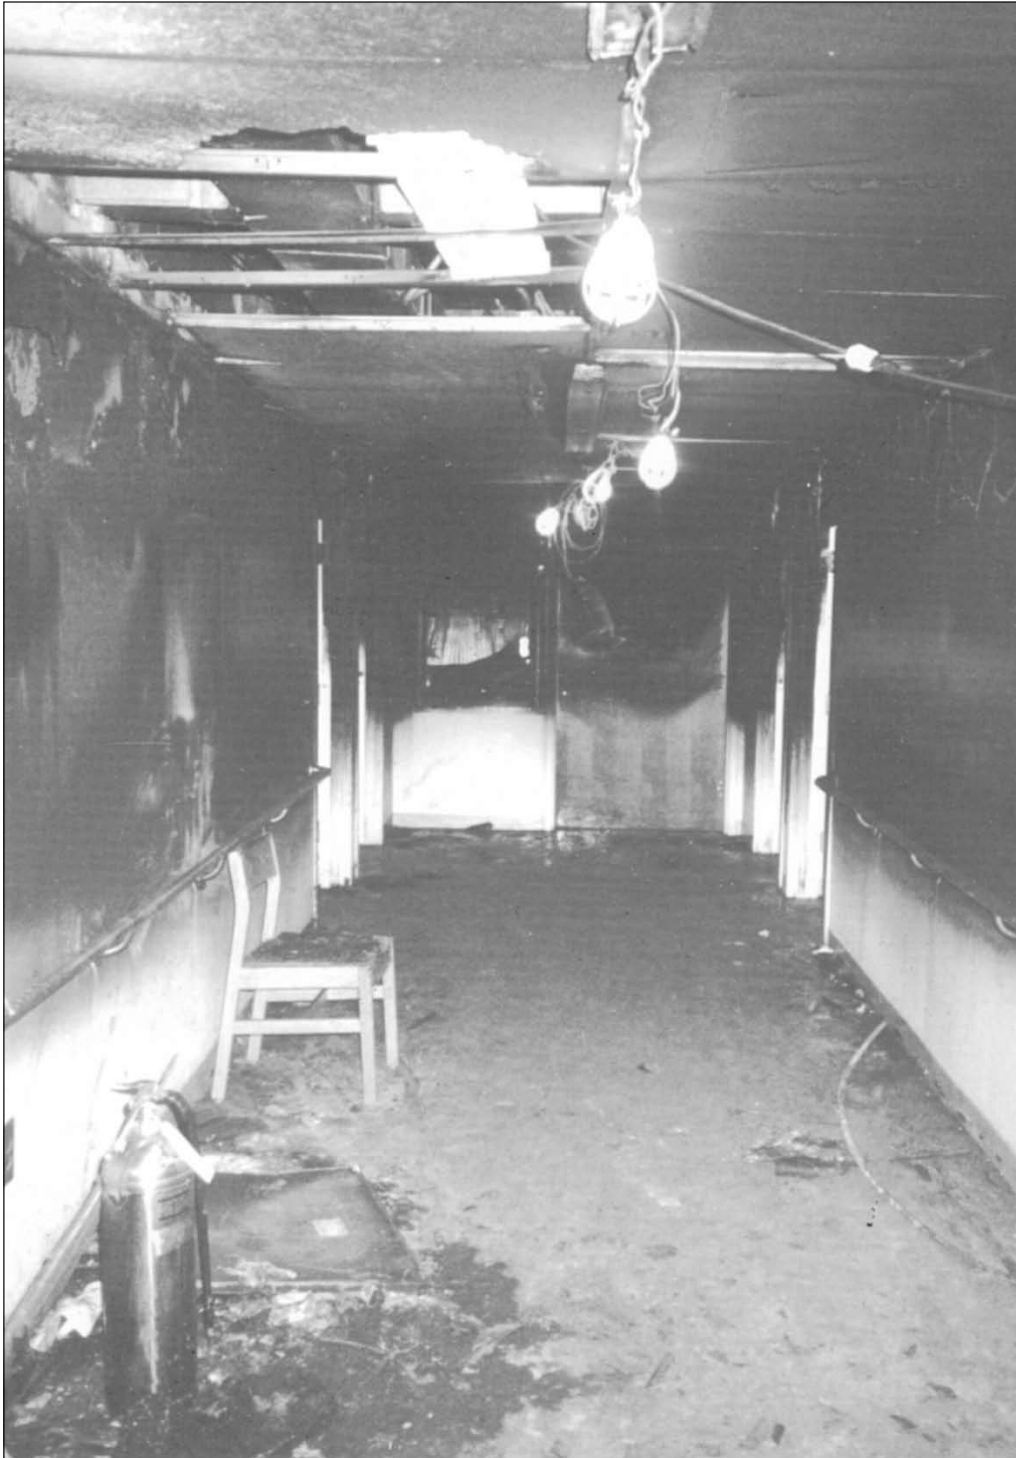
The extent of the smoke and heat conditions was evident after the fire. Heavy smoke stains were evident to within two feet of the floor on the south corridor. The smoke detectors and other plastic fixtures in the corridor melted. The smoke control doors separating the south corridor from the nurses' station protected the rest of the floor from major smoke and heat damage. Witnesses reported that there was heavy smoke in the area of the nurses' station and elevator lobby during the incident, possibly from the opening of the smoke control doors as patients were evacuated from the south corridor.

This photo shows the extent of smoke spread in the south corridor, looking down from the room of origin. At the end of the corridor is an exit, a hose cabinet containing a Class 3 standpipe connection and occupant use-hose, and a fire extinguisher, as well as the manual pull station that was activated by a nurse.

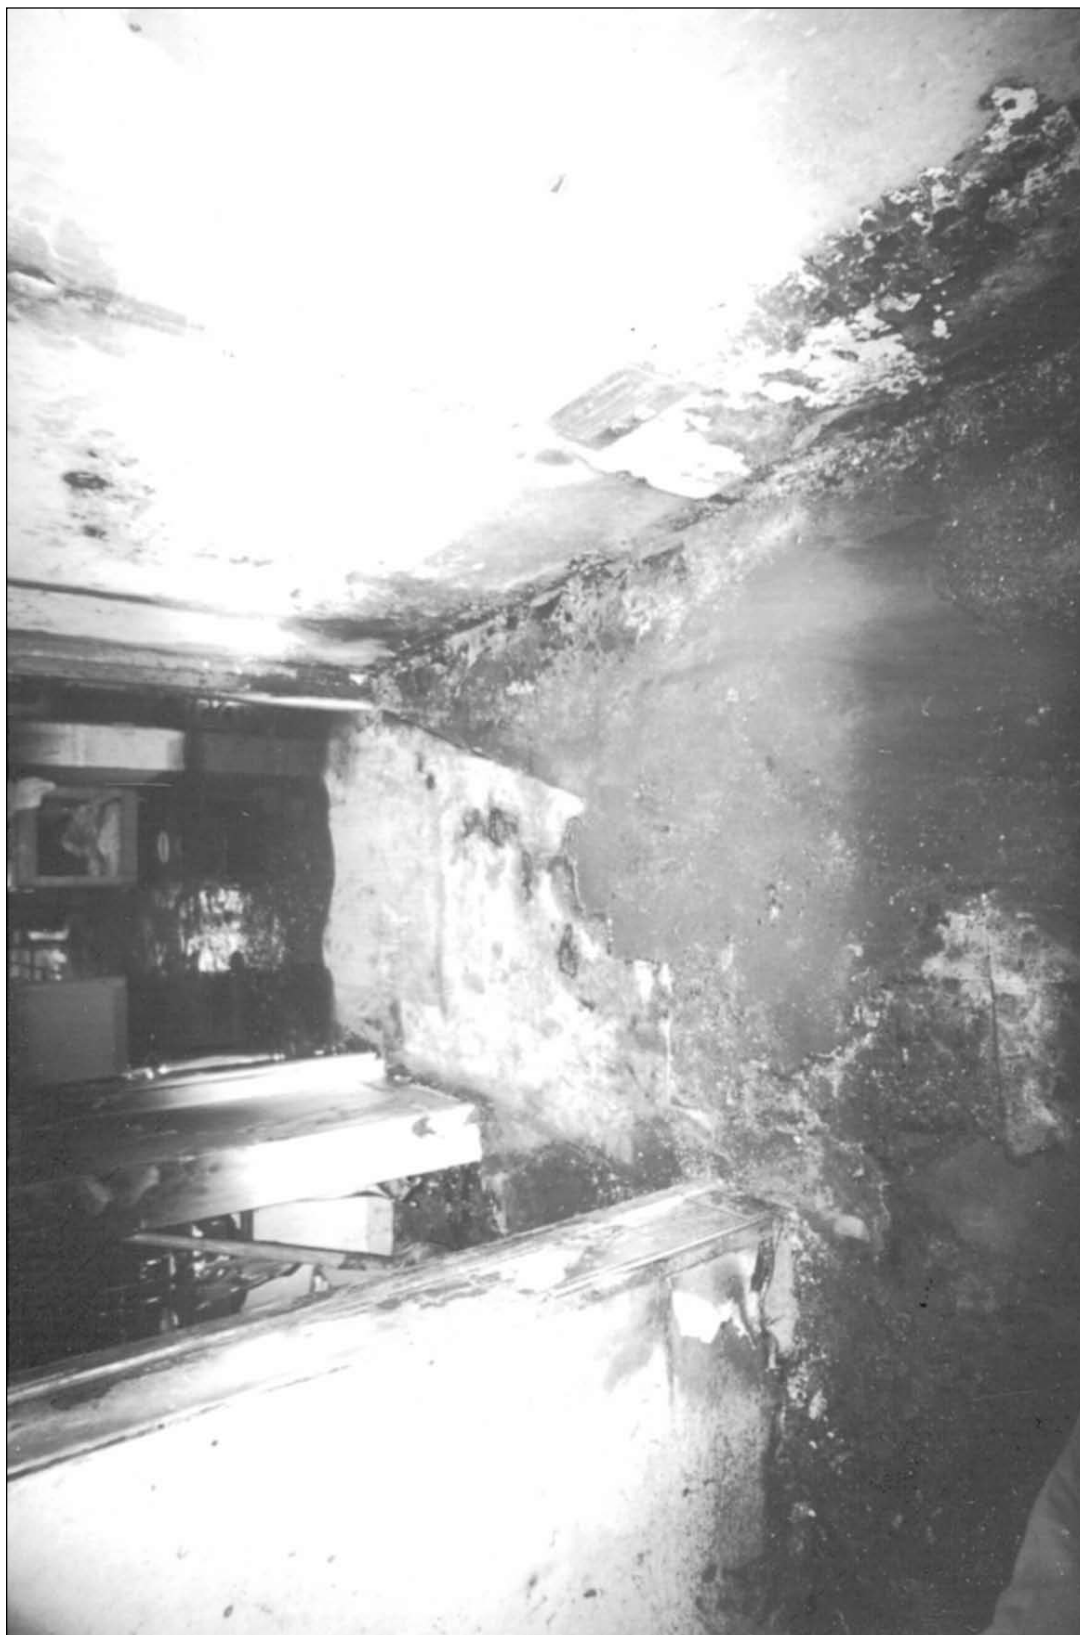
Room 418 and all of its contents were completely consumed. Only the metal frames of the beds and chairs remained. The suspended ceiling in the fire room collapsed during the fire. The unprotected steel trusses and the floor decking immediately above the suspended ceiling sagged slightly. The top half of the door to Room 418 was burned away. With the exception of a small area near the doorway, all of the floor tiles in Room 418 were consumed.

All but a small portion of the floor tile in the room of origin was consumed by the fire. This portion was partially shielded by the door to the room, which was open during the fire. The straight line pattern of burned away tile next to the right side of the doorway indicates the position of the door during the fire.

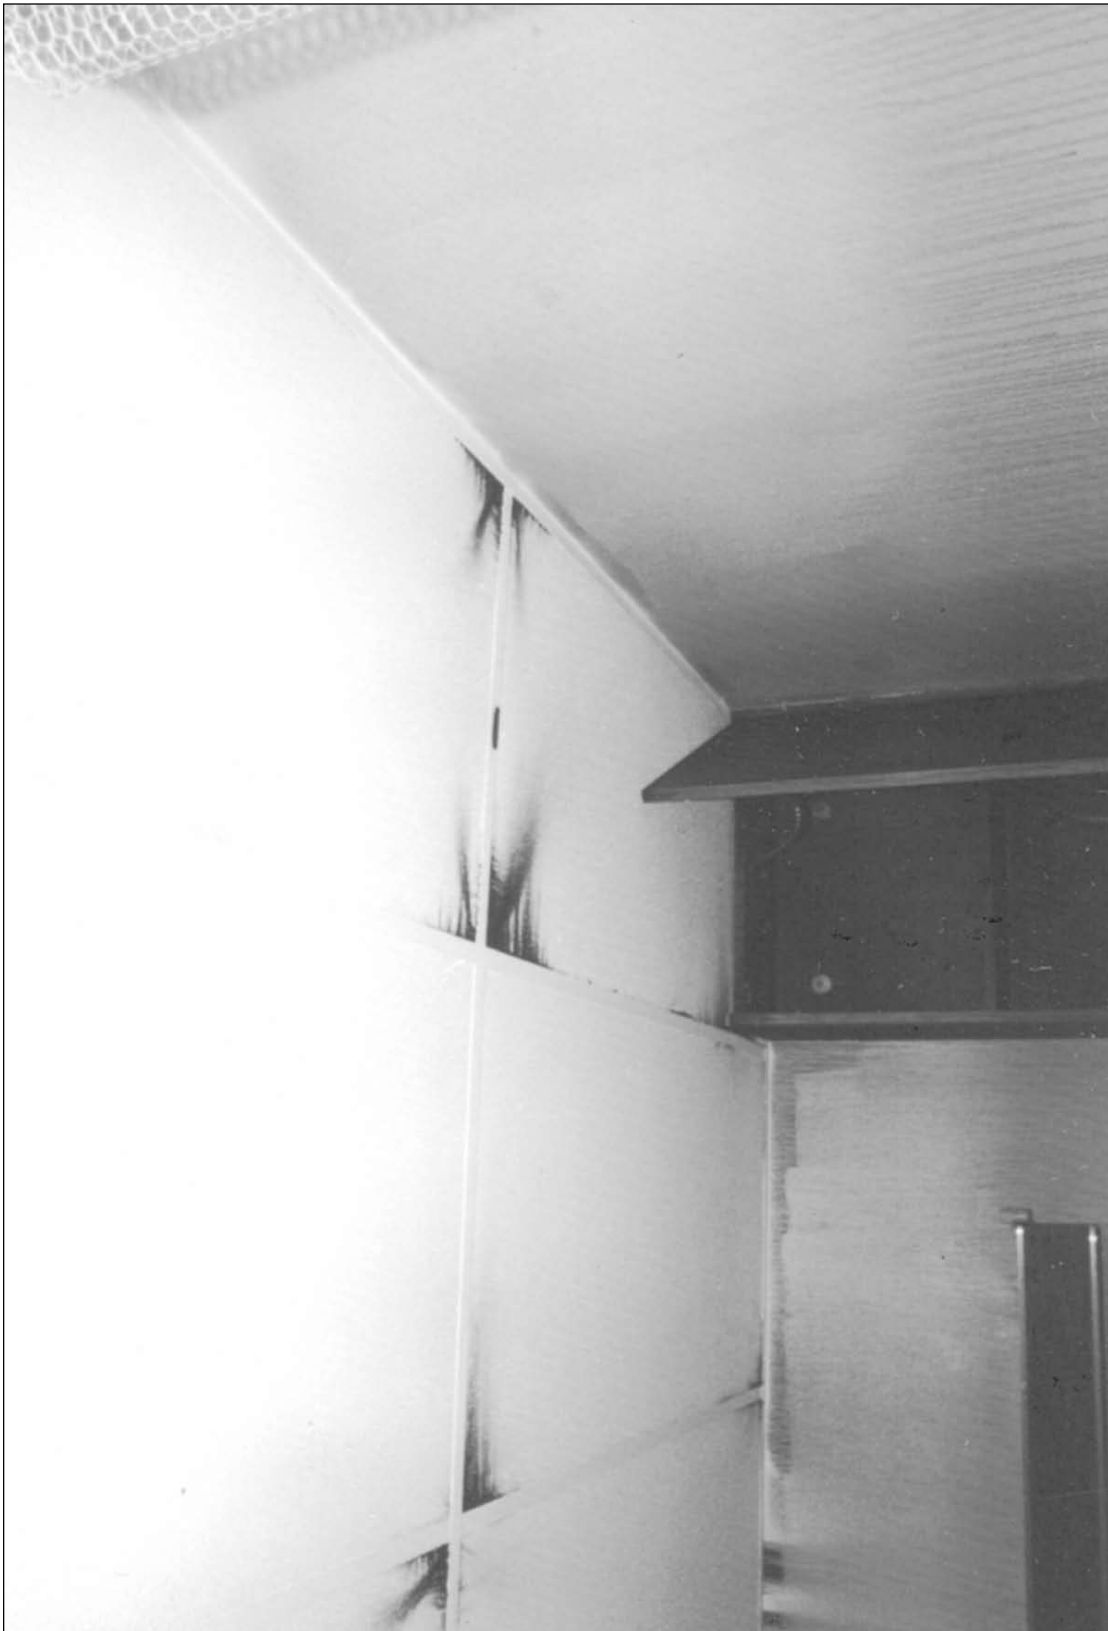
smoke was leaking into the rooms via gaps between the ceiling panels and the suspension system. The ceiling above the fire failed, allowing smoke and heat to enter the plenum area. The smoke then leaked down through the ceilings, under pressure, into the adjacent rooms. The heat damaged some of the lightweight steel members in the floor assembly immediately above Room 418.

Smoke spread very rapidly, through the common plenum space above six rooms on the corridor due to rapid failure of the ceiling in the room of origin. This allowed smoke to fill the plenum space and to spread into adjacent rooms. Common plenum spaces allow for rapid smoke spread. Suspended ceilings should not be expected to contain smoke due to leakage between tiles and the ceiling frame.

Smoke streaks on the ceiling indicate that smoke was entering the rooms adjacent to the fire room through the ceiling suspension system.

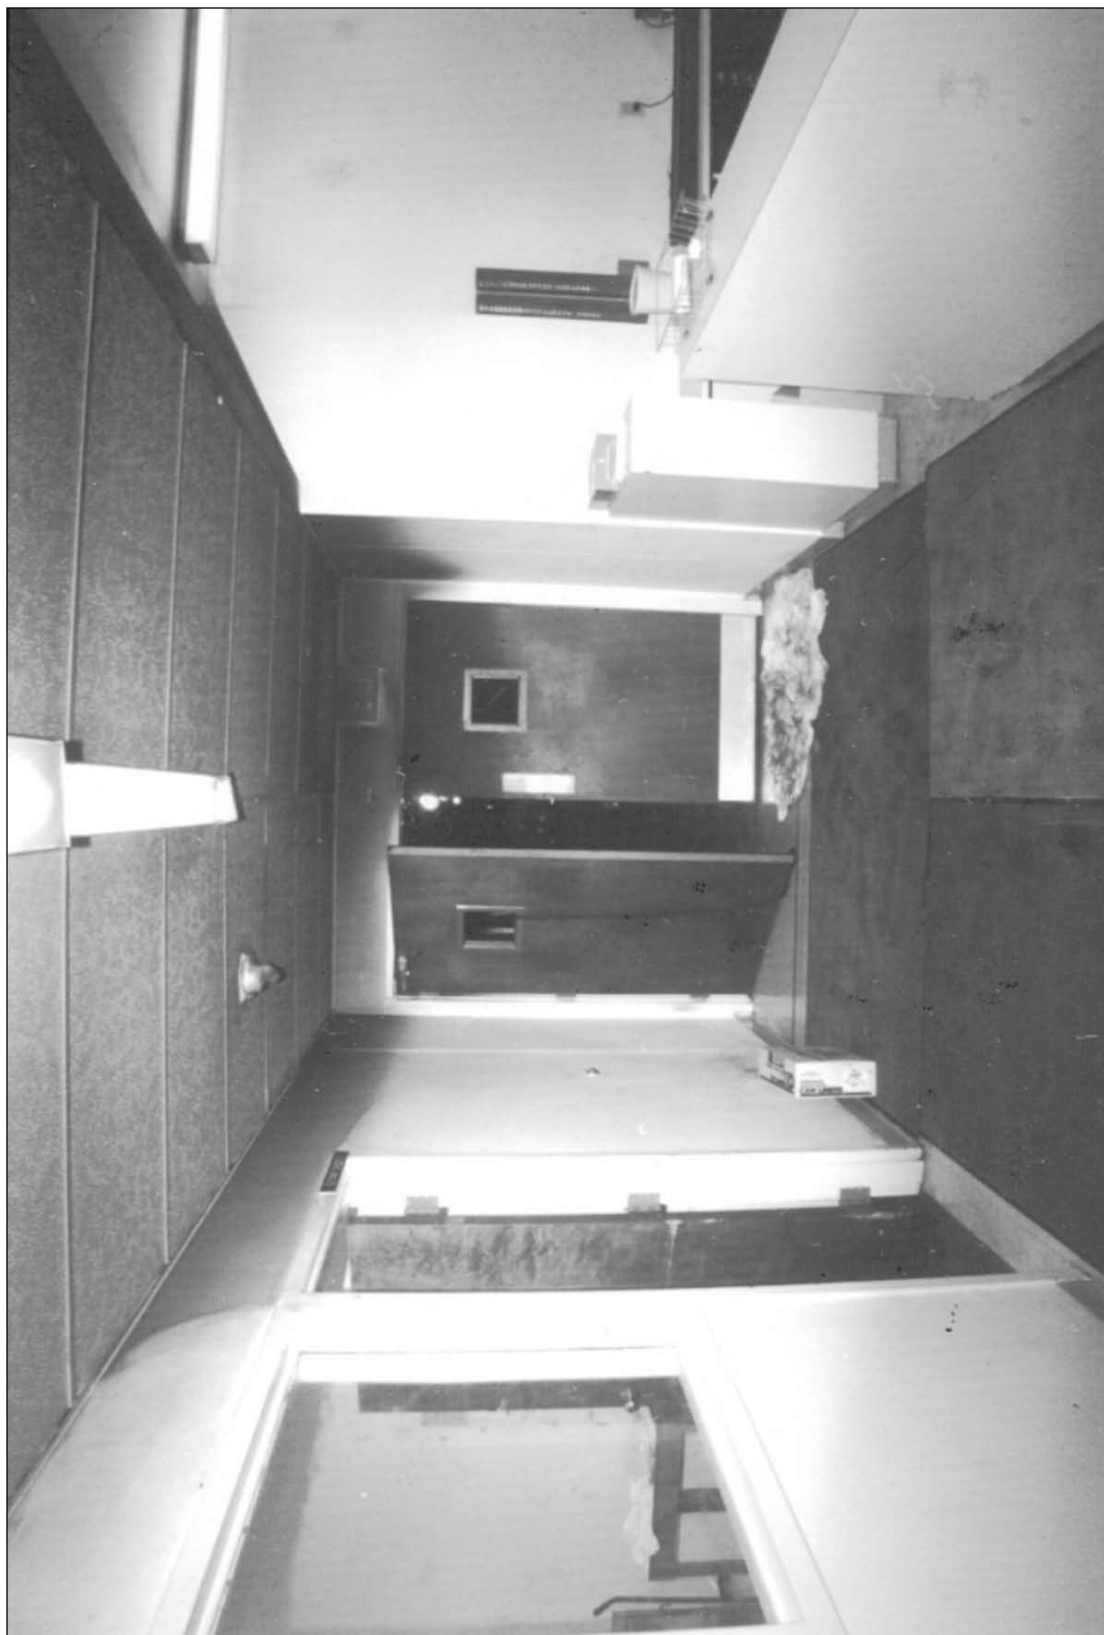
This fire demonstrated that smoke spread can be effectively controlled by smoke control doors and closed doors. Smoke spread via the corridor into other rooms on the corridor was controlled effectively by hospital personnel closing doors to patient rooms. The self-closing smoke control doors at one end of the corridor contained the heavy smoke damage to only one corridor on 4-South wing.

This photo looks down toward the south corridor with the nurses station on the right. The self-closing smoke control doors contained the bulk of the smoke and heat conditions to the corridor of origin, but some smoke escaped into the nurses station area as victims were evacuated through the doors.

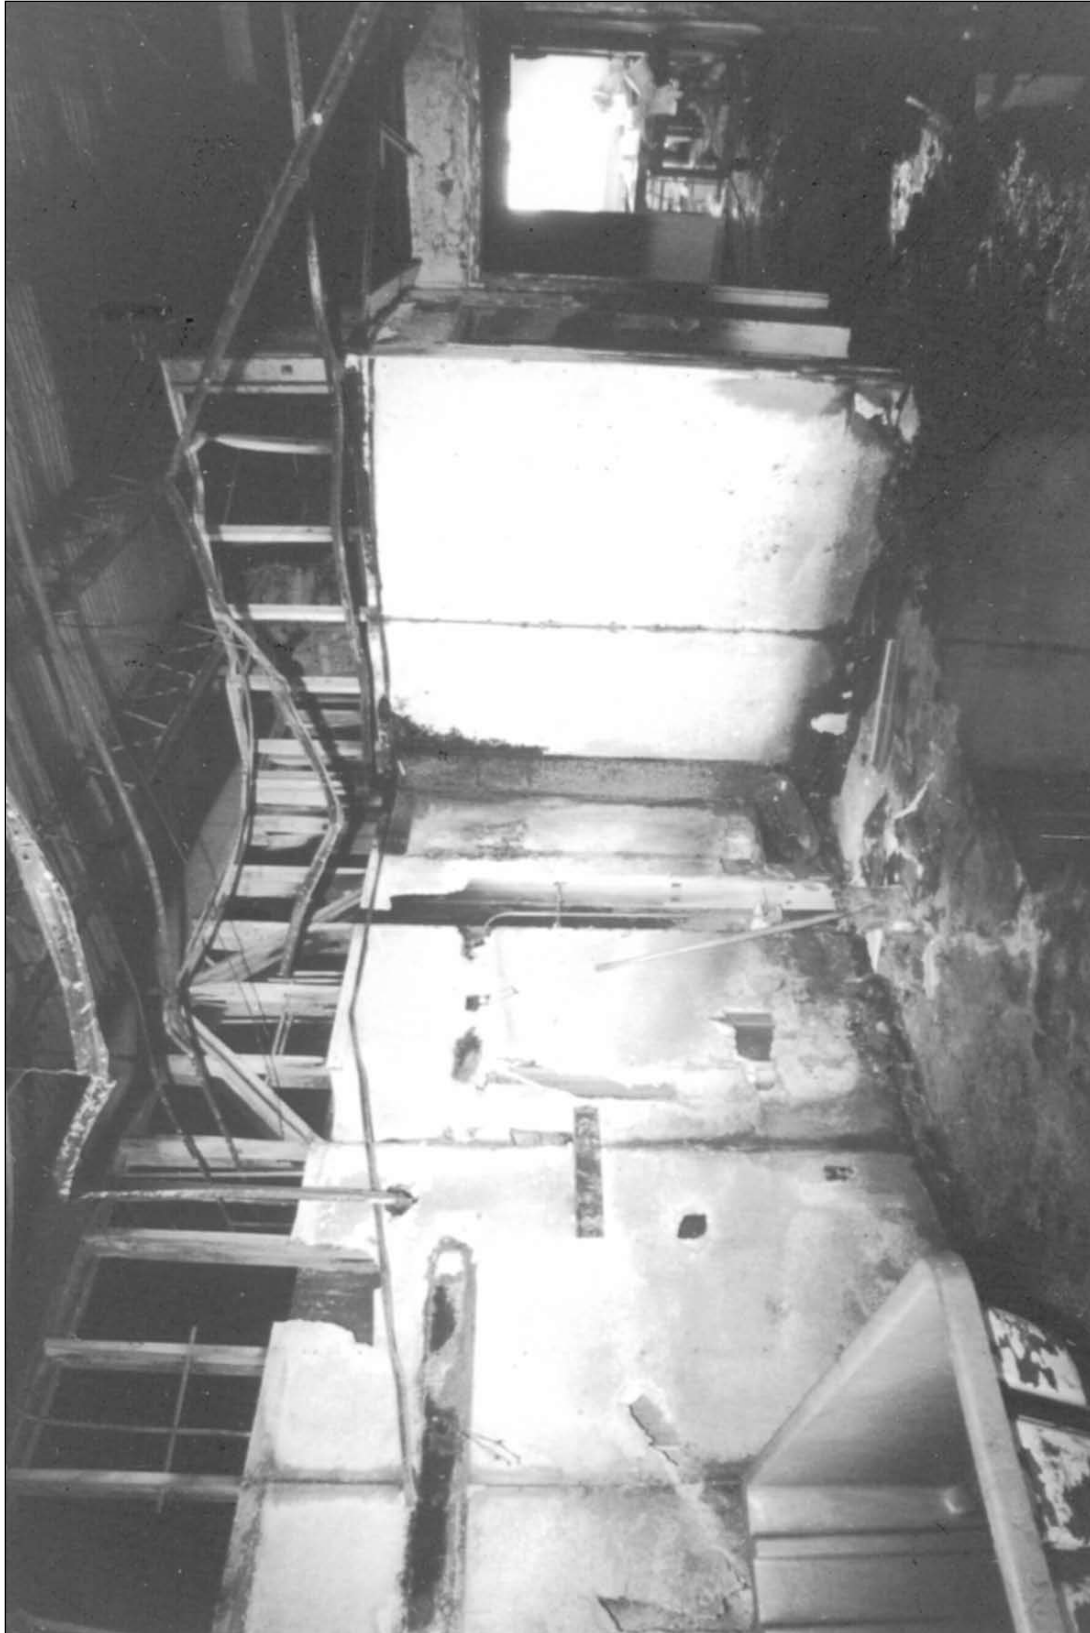
It is unclear why the ceiling assembly failed during the fire. The ceiling was part of a fire resistive floor ceiling system. One or more of the ceiling tiles, which must be secured in place with pins to function properly, may have not been secured, allowing them to be drawn up and out of the frame of the suspended ceiling by air drafts created by the fire. Due to the amount of damage to the ceiling, however, it was impossible to determine whether each ceiling tile was secured in place with clips.

There was very heavy damage to the room of origin. Some structural members were warped by heat after the suspended ceiling collapsed.

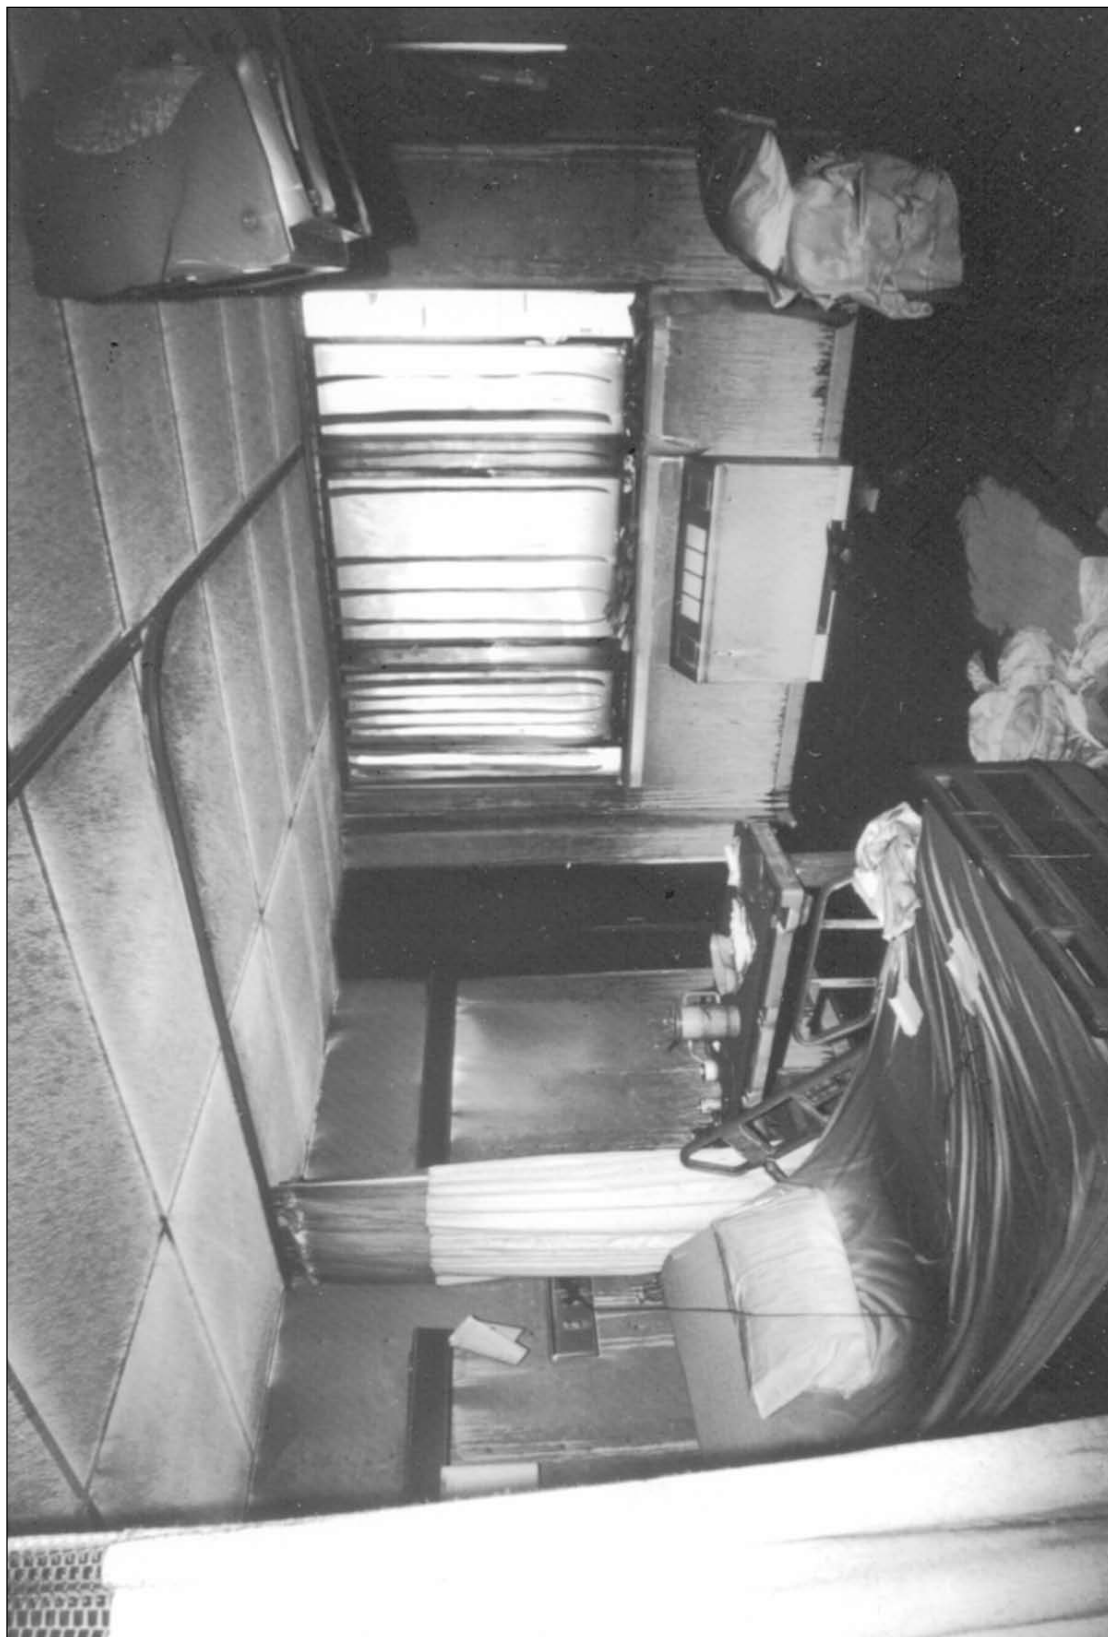
Smoke and heat damage to patient rooms on the south corridor varied significantly. Rooms 411 and 421 suffered heavy smoke damage, indicated by major soot stains on the walls and windows, because the doors to these rooms were open during the fire. The door to Room 411 was not closed by nurses because they had rescued the patient from this room and knew it was empty. The door to Room 421 was closed by nurses, but the patient apparently opened it while trying to escape and collapsed in the doorway.

Room 421 which was located on the south corridor suffered heavy smoke damage. Nurses closed the door to this room, however, investigators believe the patient opened the door while attempting to escape. The patient was found lying in the doorway by the firefighters.

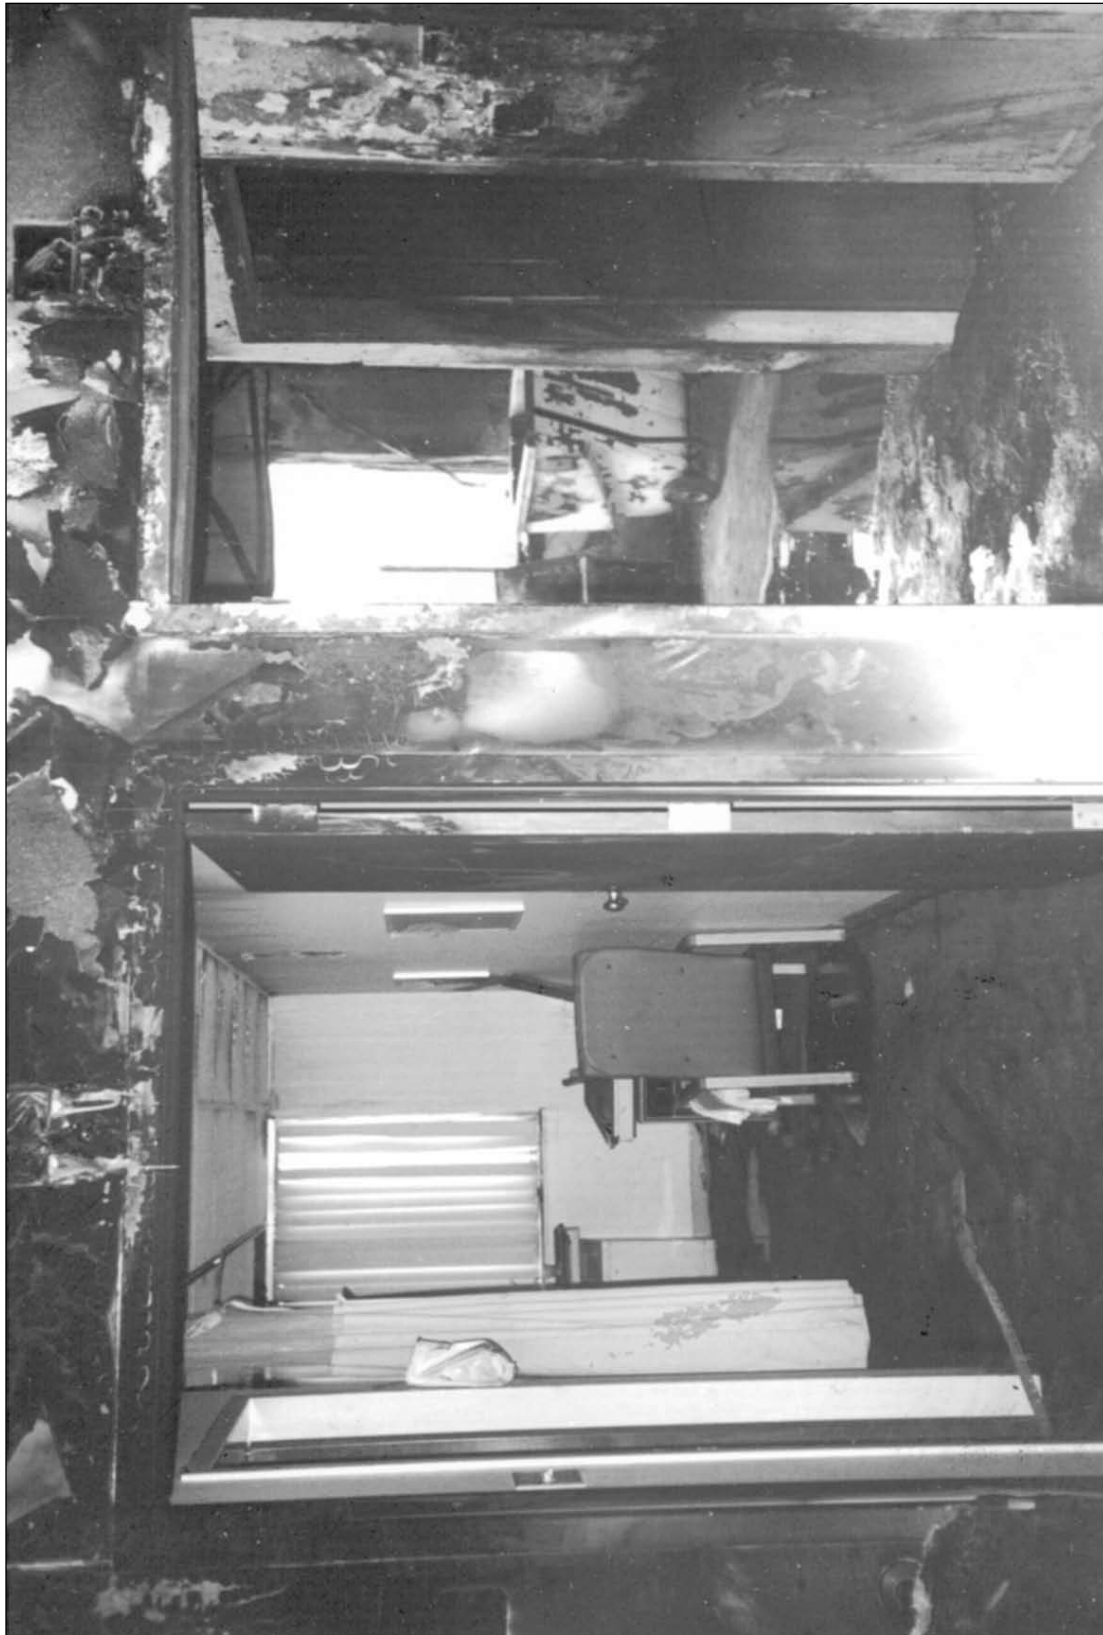
This photo shows the heavy damage to the fire room, Room 418 (on the right), and the adjacent room, Room 419 (on the left). Nurses closed the door to Room 419, but heavy smoke infiltrated the room through the suspended ceiling and cracks around the edges of the door. The patients in both of these rooms died.

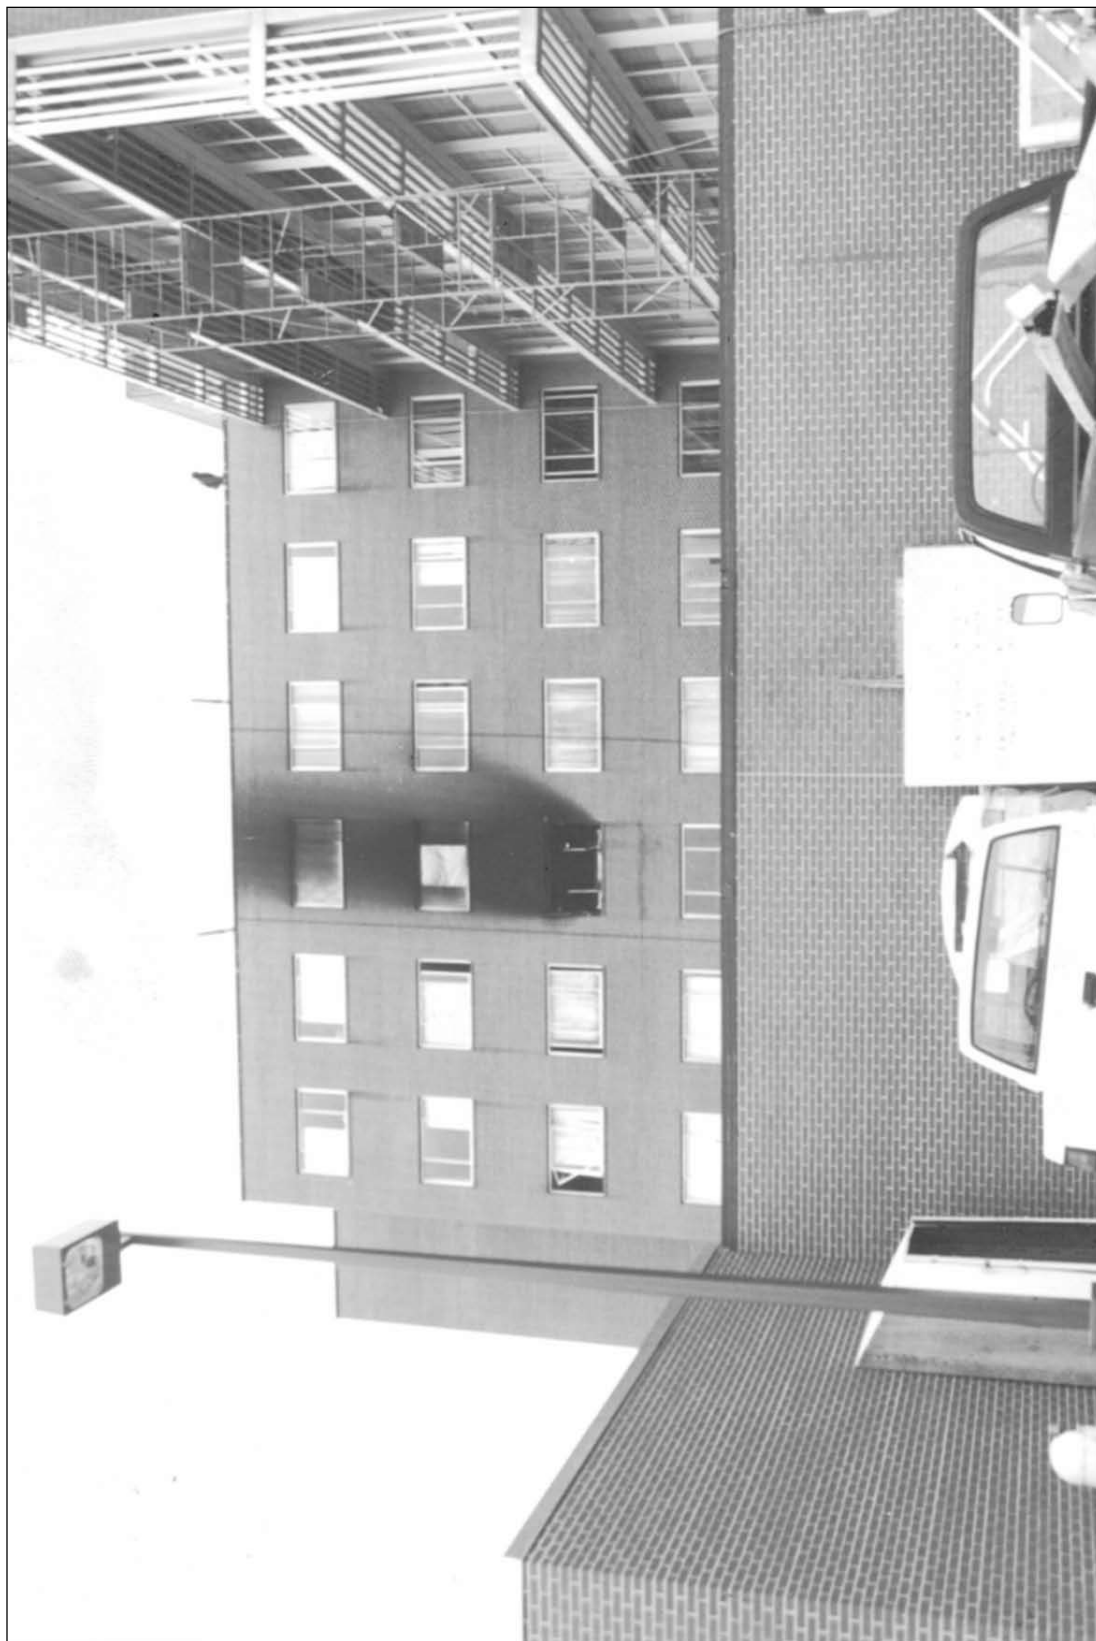
The first floor of the hospital extended out from the upper floors of the building, which blocked access to the fourth floor windows by an aerial ladder. Firefighters used a ground ladder from the roof of the single story wing to rescue a patient from a window located two rooms to the left of the room of origin.
