U.S. Fire Administration/Technical Report Series

I-75 Multiple Vehicle Collision/Mass Casualty Incident

Collier County, Florida

USFA-TR-155/January 2002

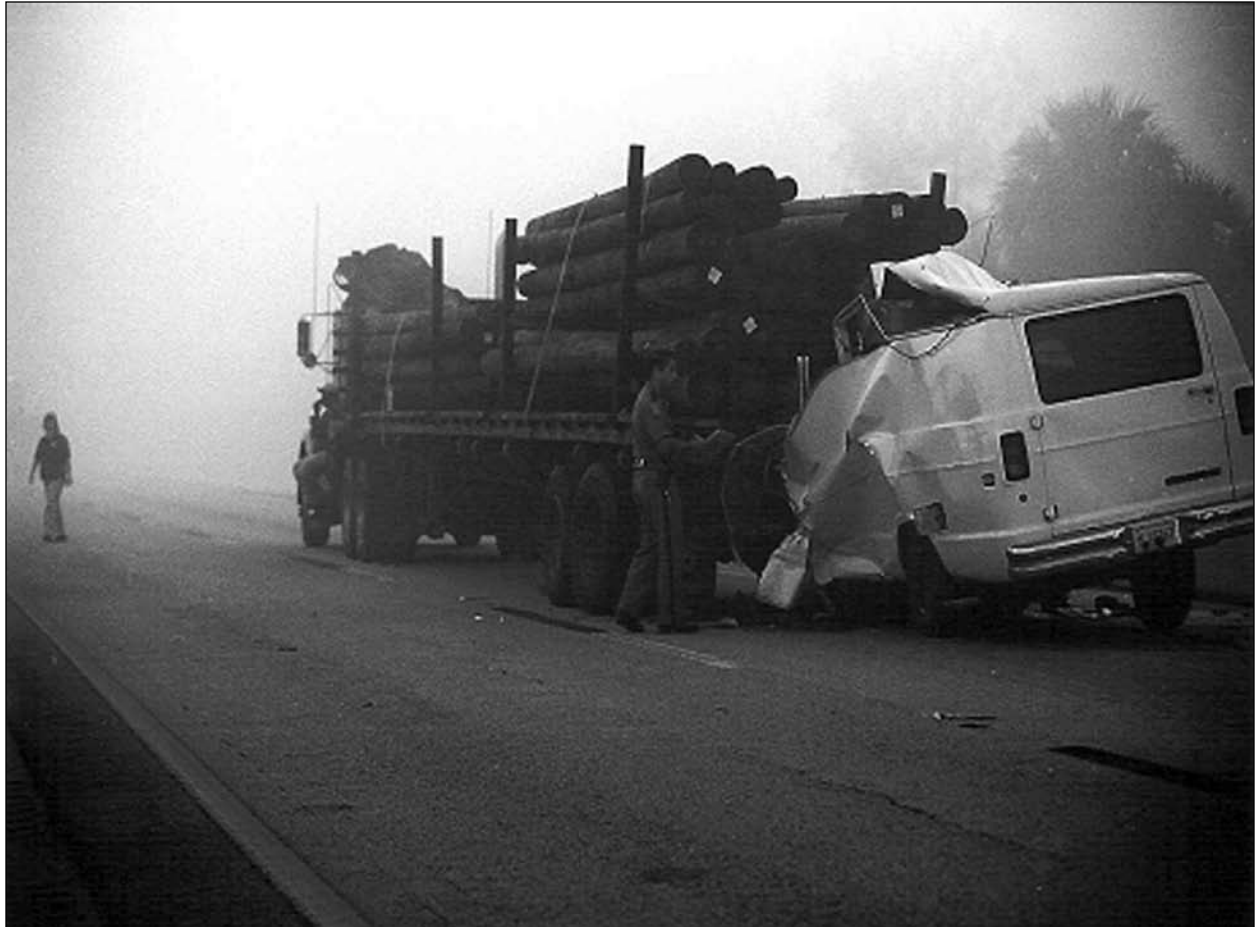
Two occupants of the van in the eastbound lane sustained fatal injuries and were found to have not been wearing the occupant restraint system at the time of the collision, which is a violation of Florida Statutes. Investigators concluded that the driver of the van was the sole cause of the property damage and deaths in the collision and the Medical Examiner's Officer determined that no drugs or alcohol were present in the deceased driver of the van.

1. Florida Highway patrolman investigates van in which two men were killed when their van rear-ended a tractor trailer truck hauling wood in an eastbound lane of Alligator Alley

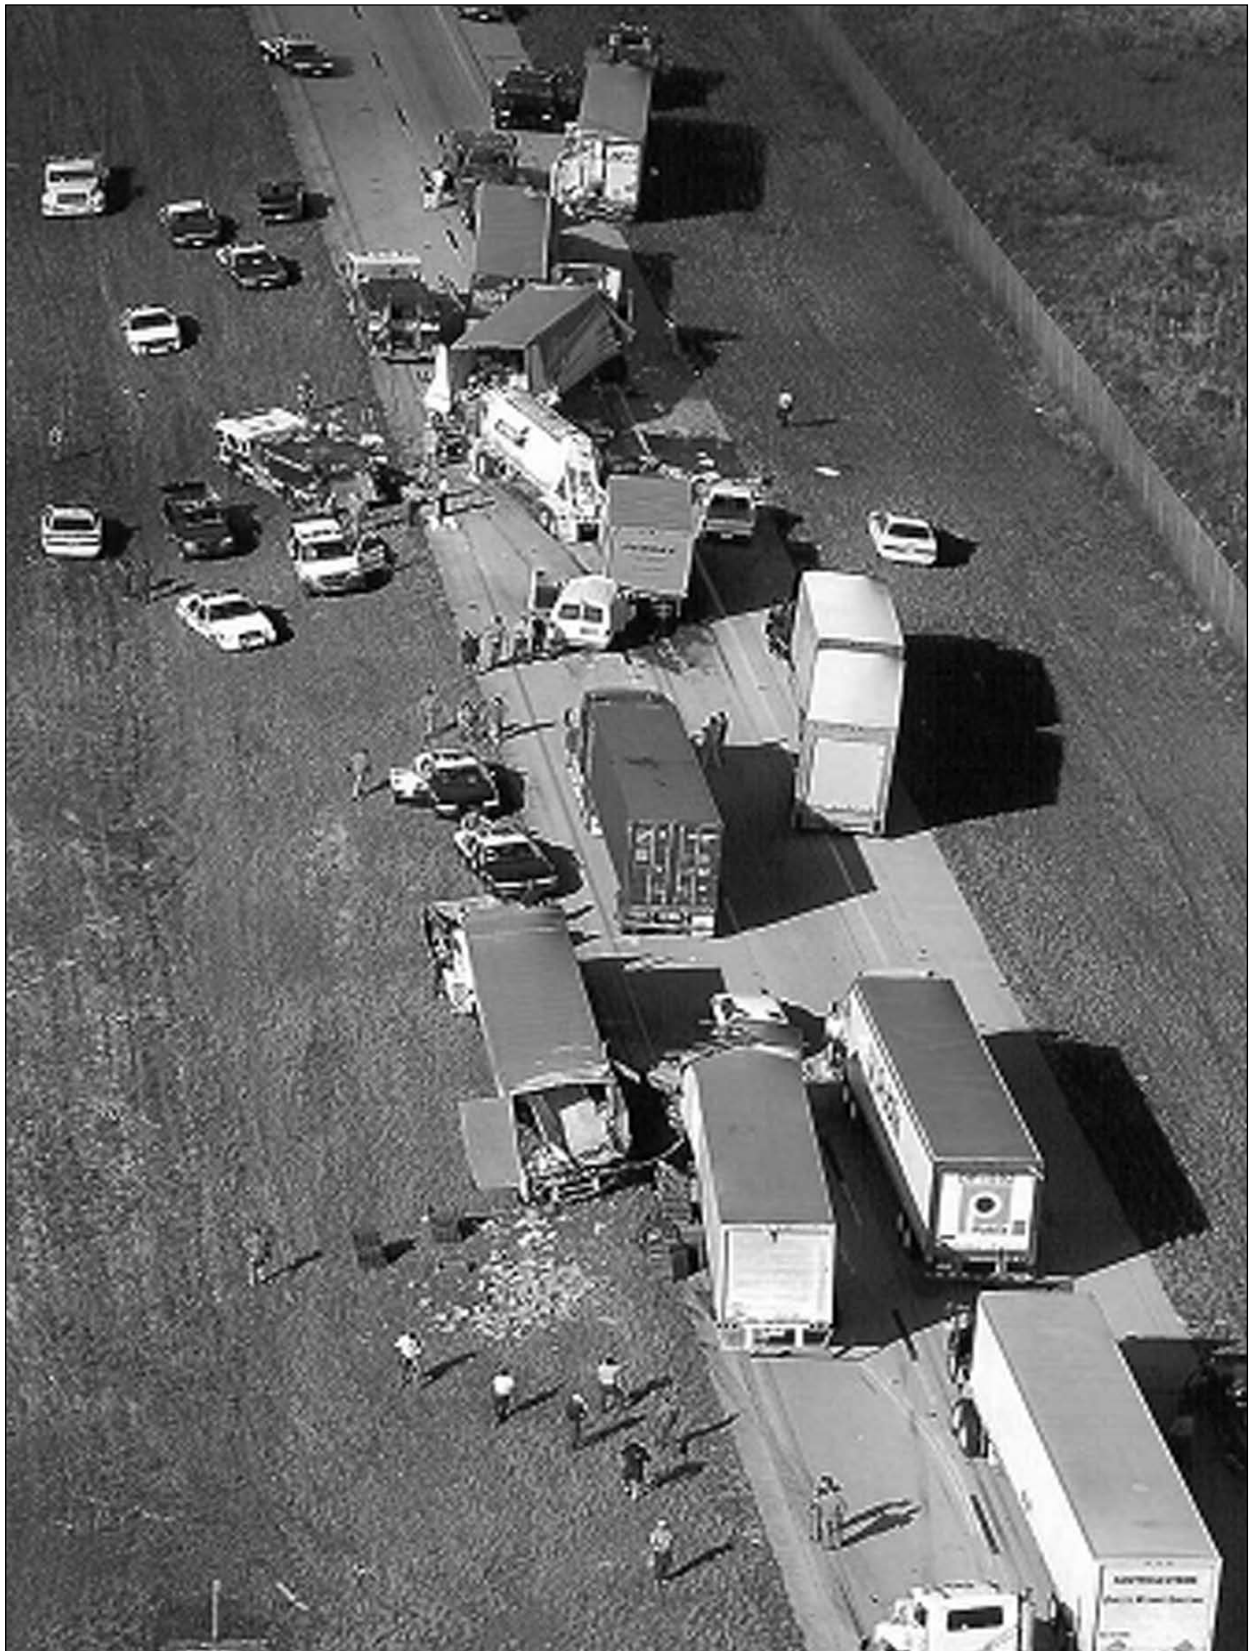
2. Aerial view of westbound lanes of Alligator Alley

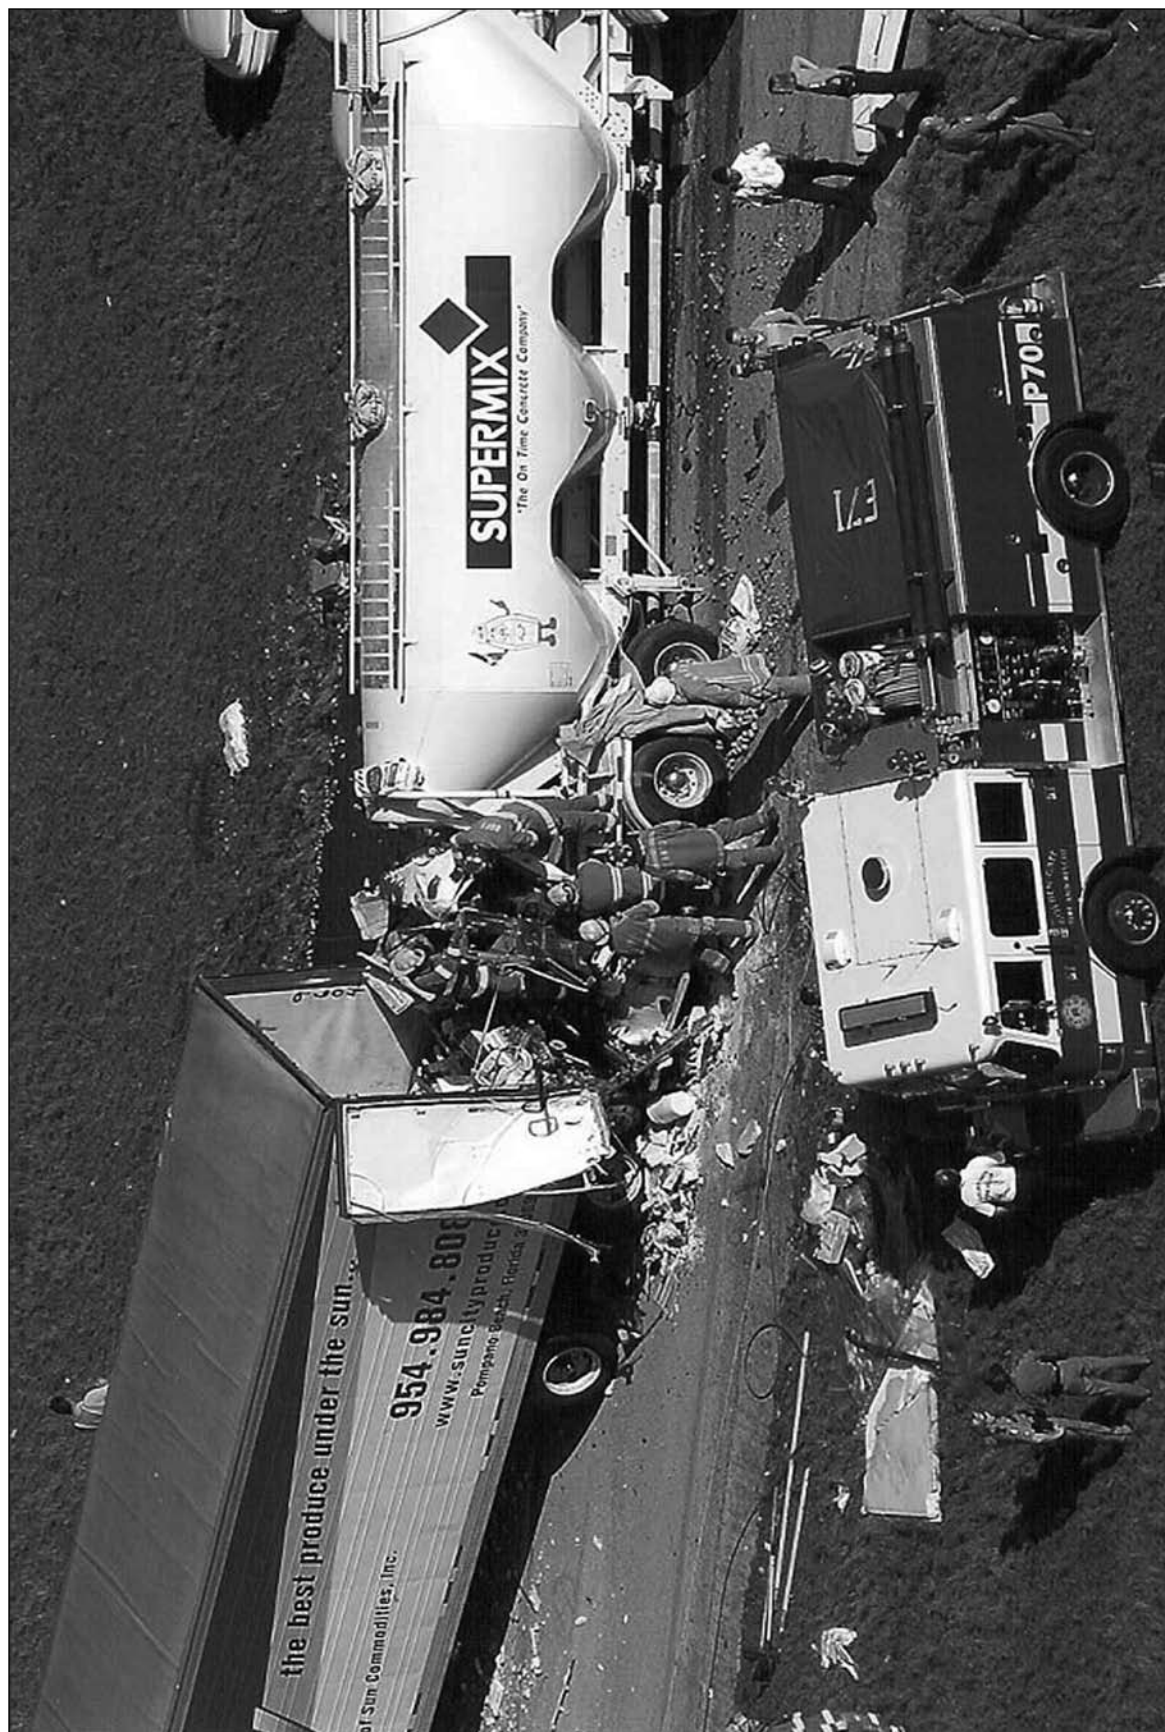
3. Firefighters extricate the body of the driver of a tractor-trailer driver killed in the westbound lane of Alligator Alley

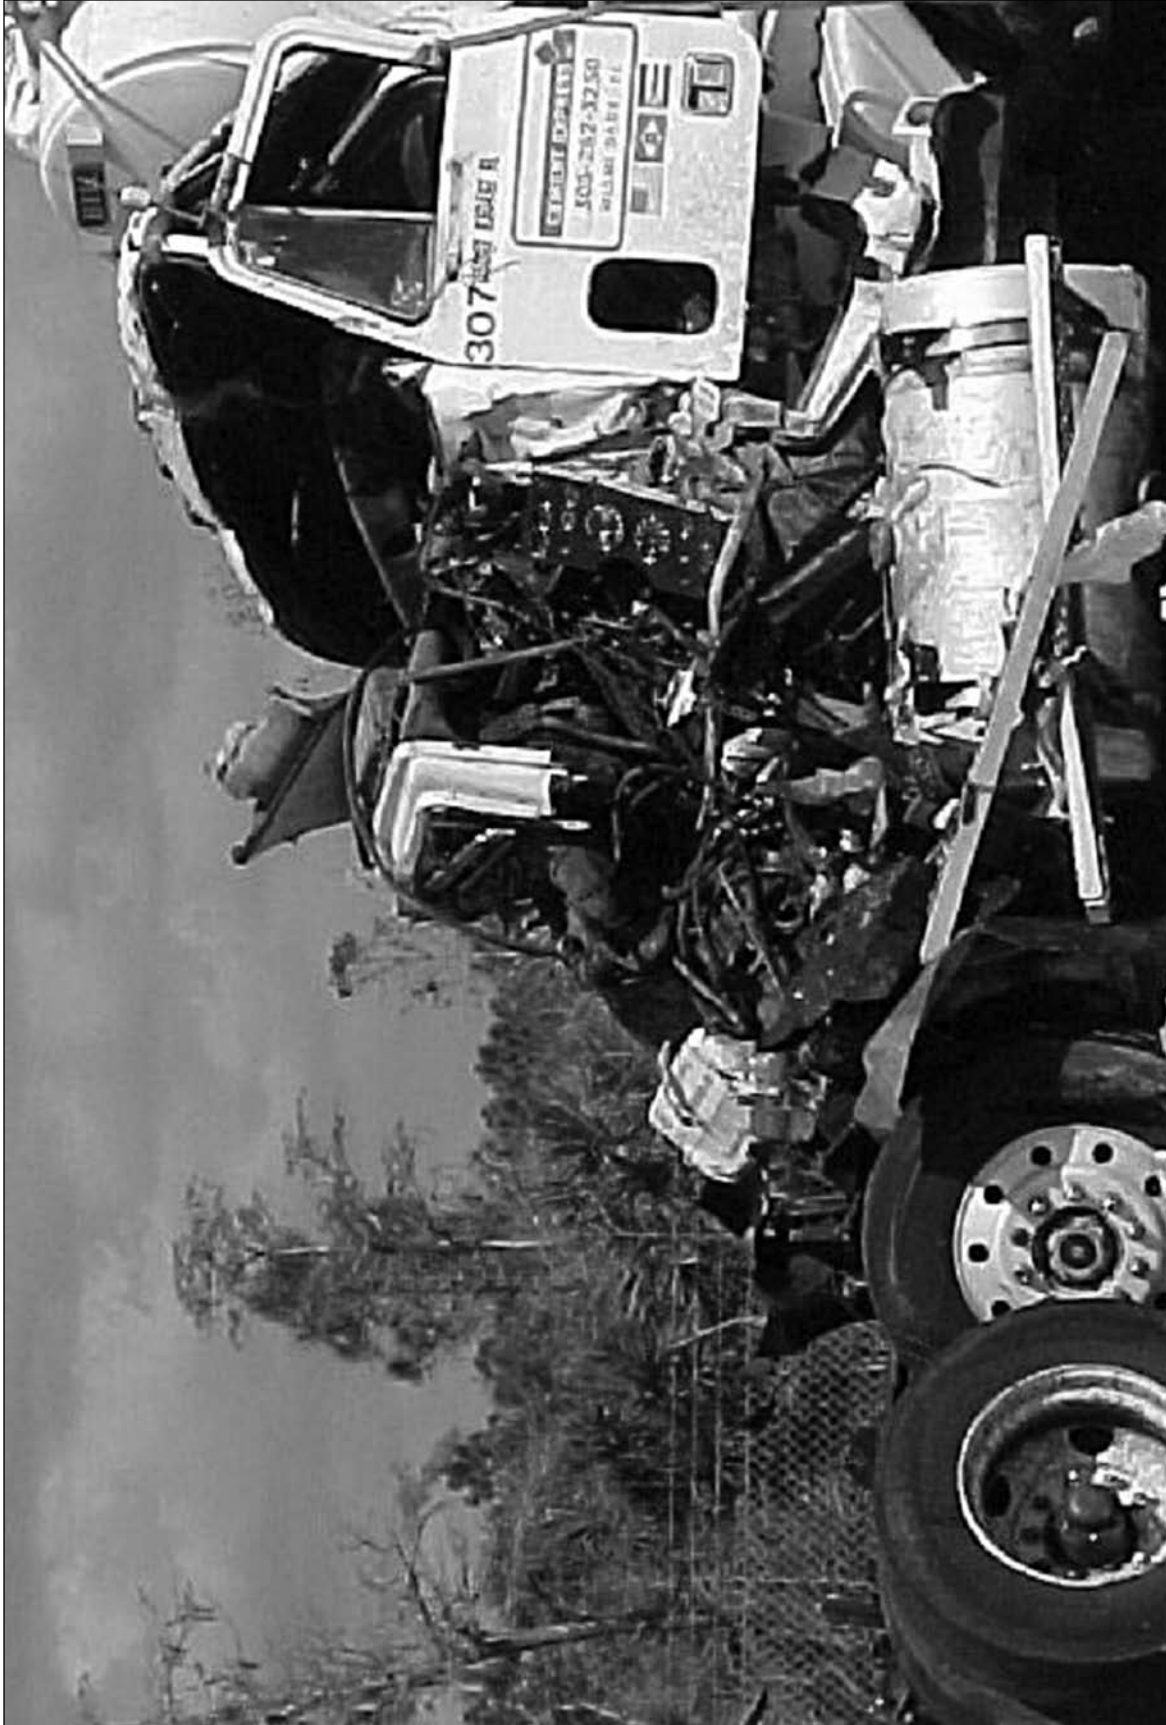
4. Close-up of the cab of the concrete truck in which the driver was killed

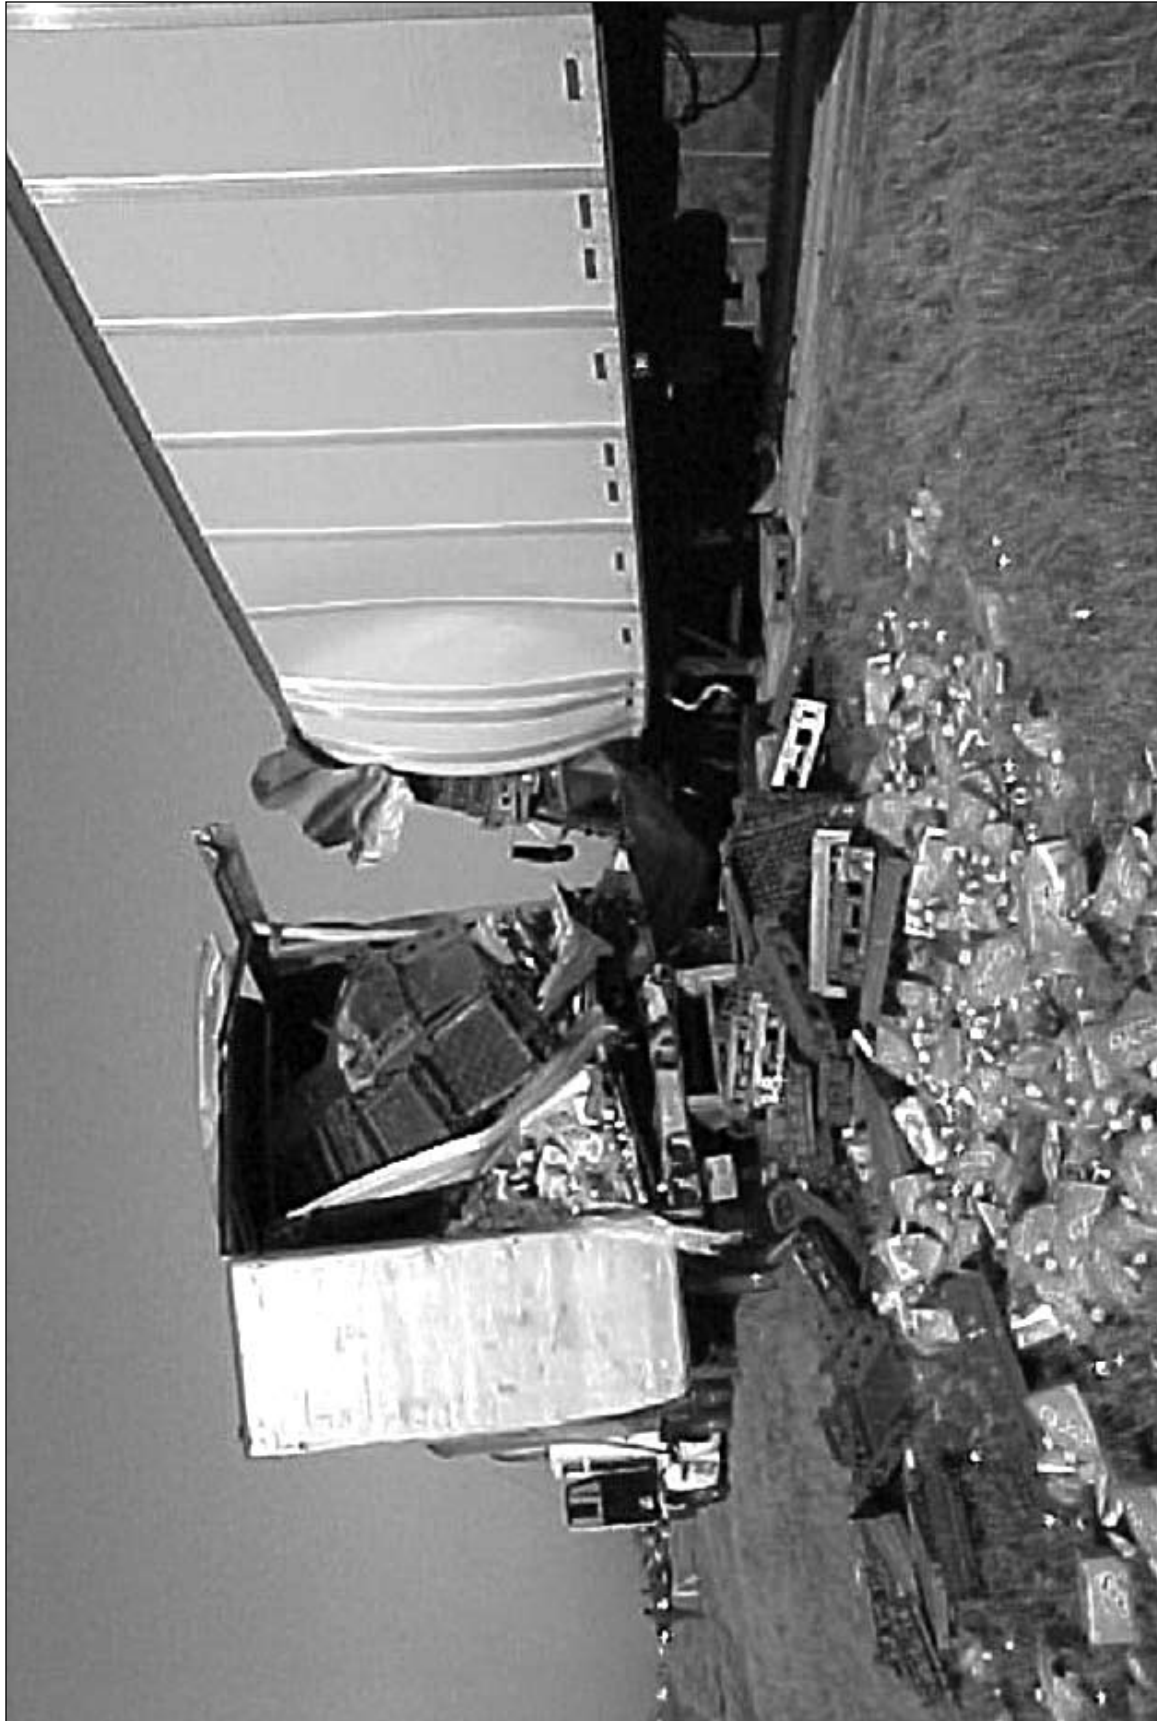
5. Debris spilled during collision

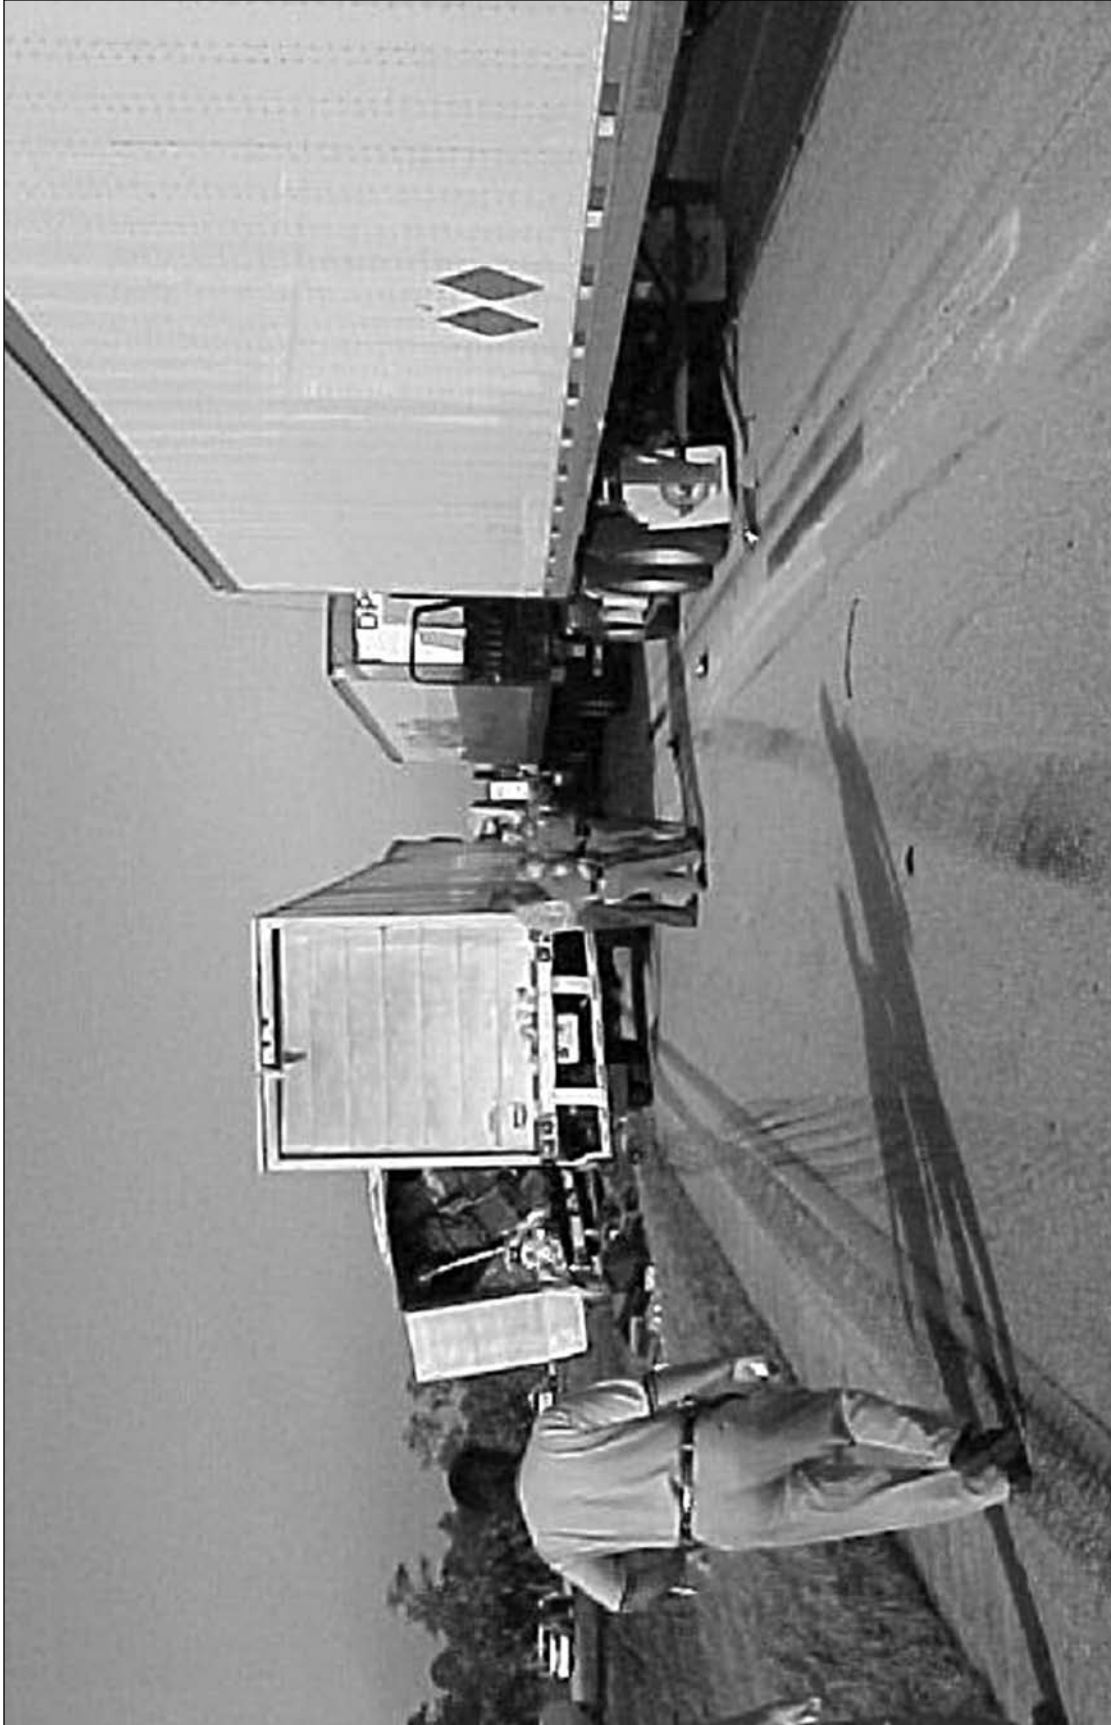
6. Numerous tractor trailer trucks involved in the incident

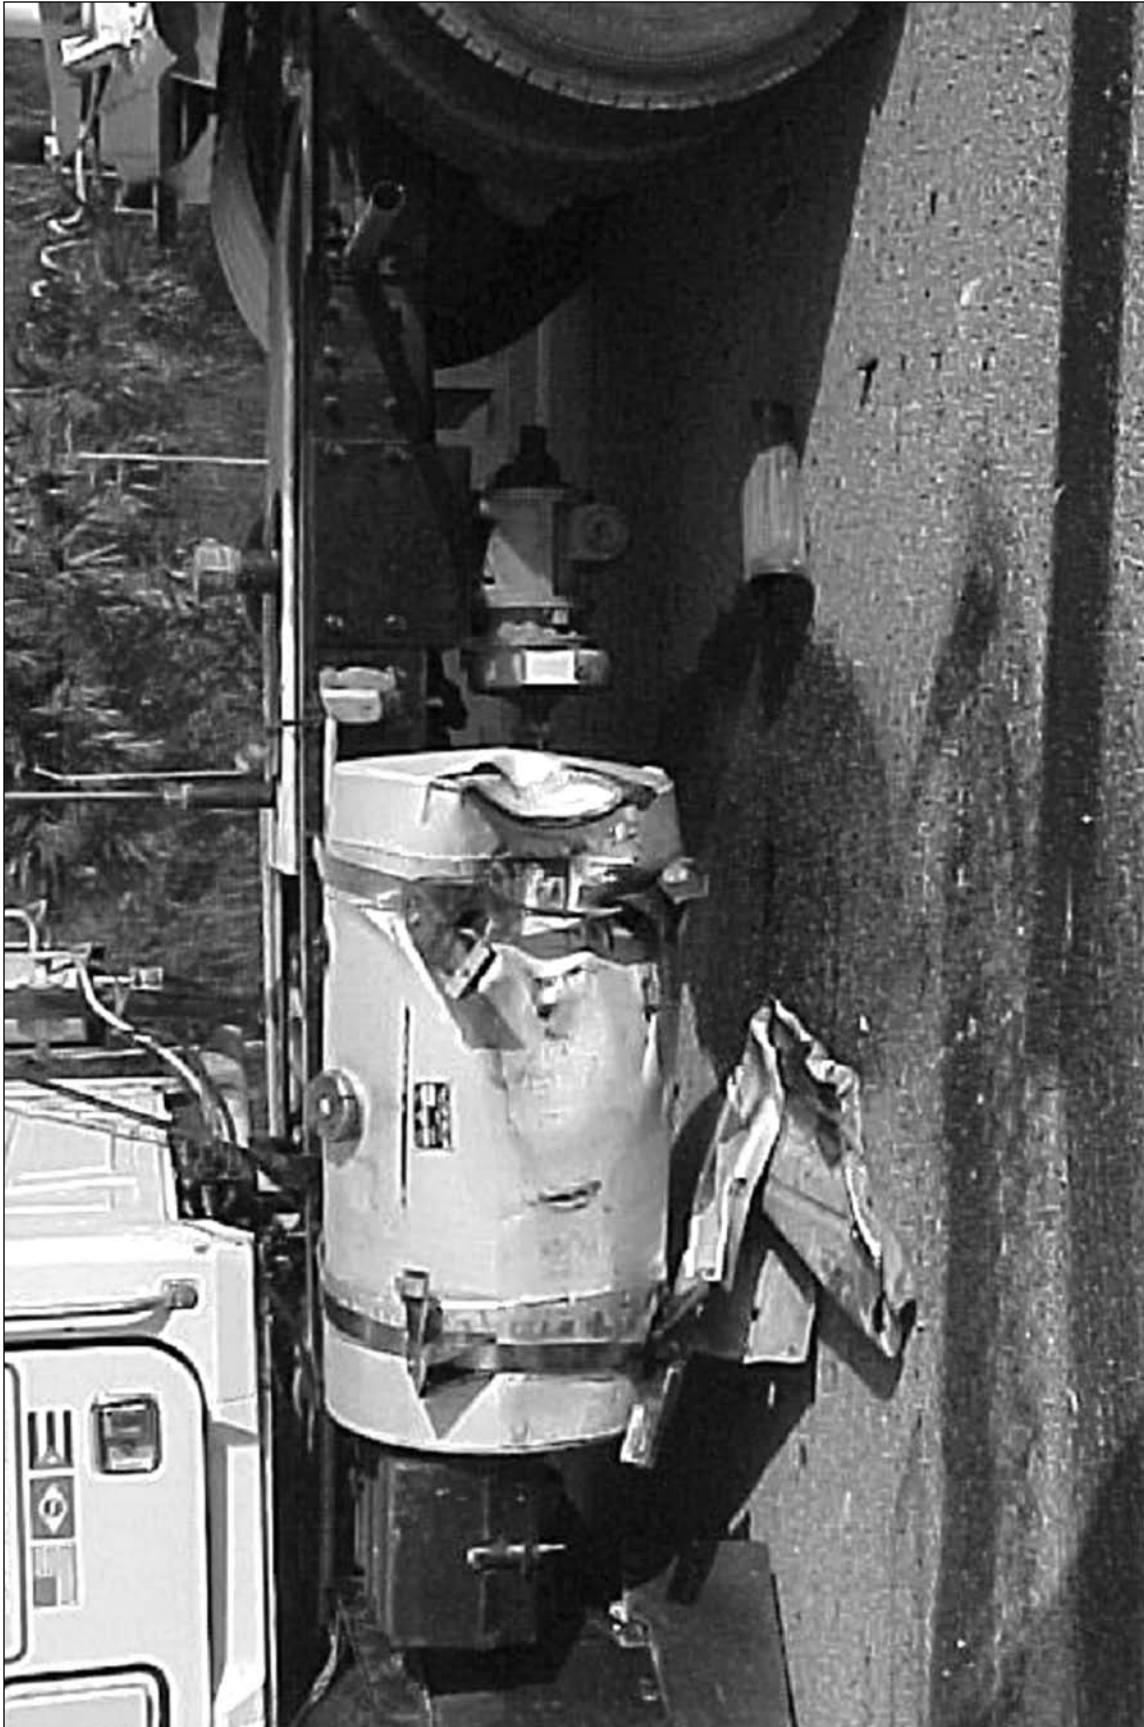
Personnel from the Florida Department of Environmental Protection also responded and managed the 35 gallons of spilled diesel fuel, which was confined to the median. The contaminated soil was removed.

7. Ruptured diesel fuel tank

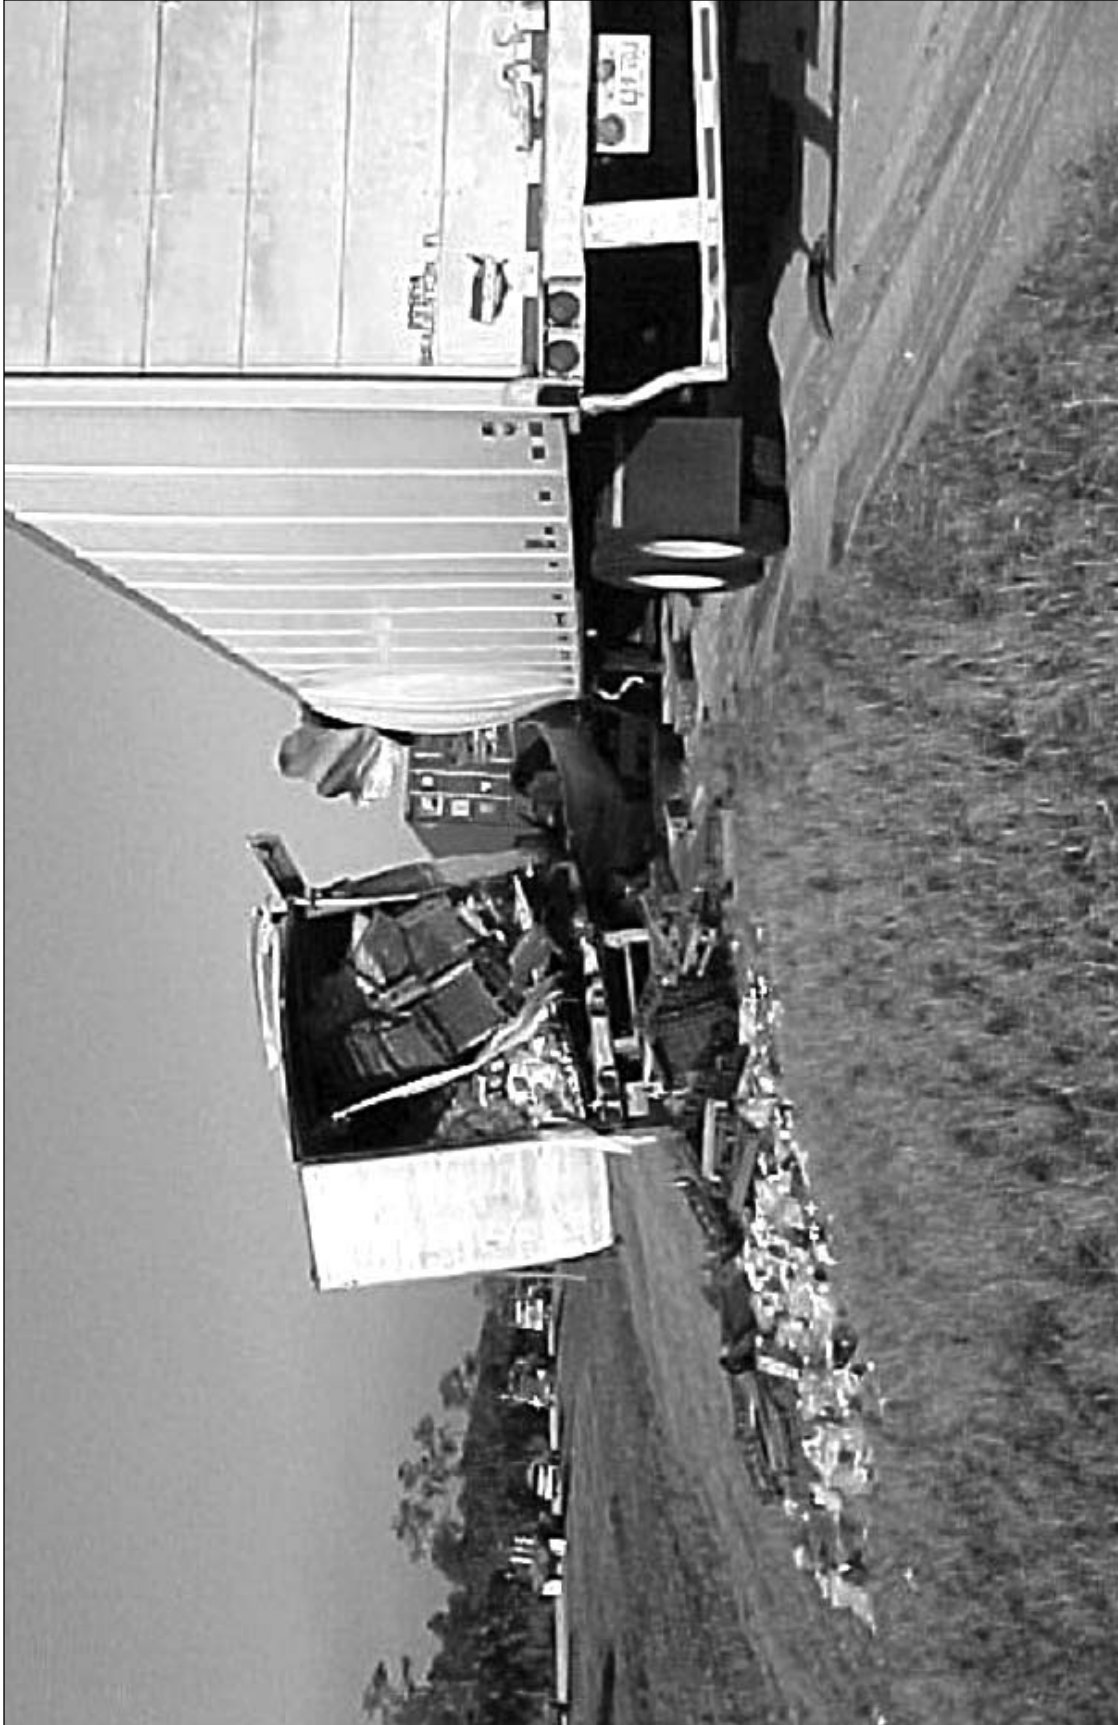
8. Additional view of tractor trailer rigs

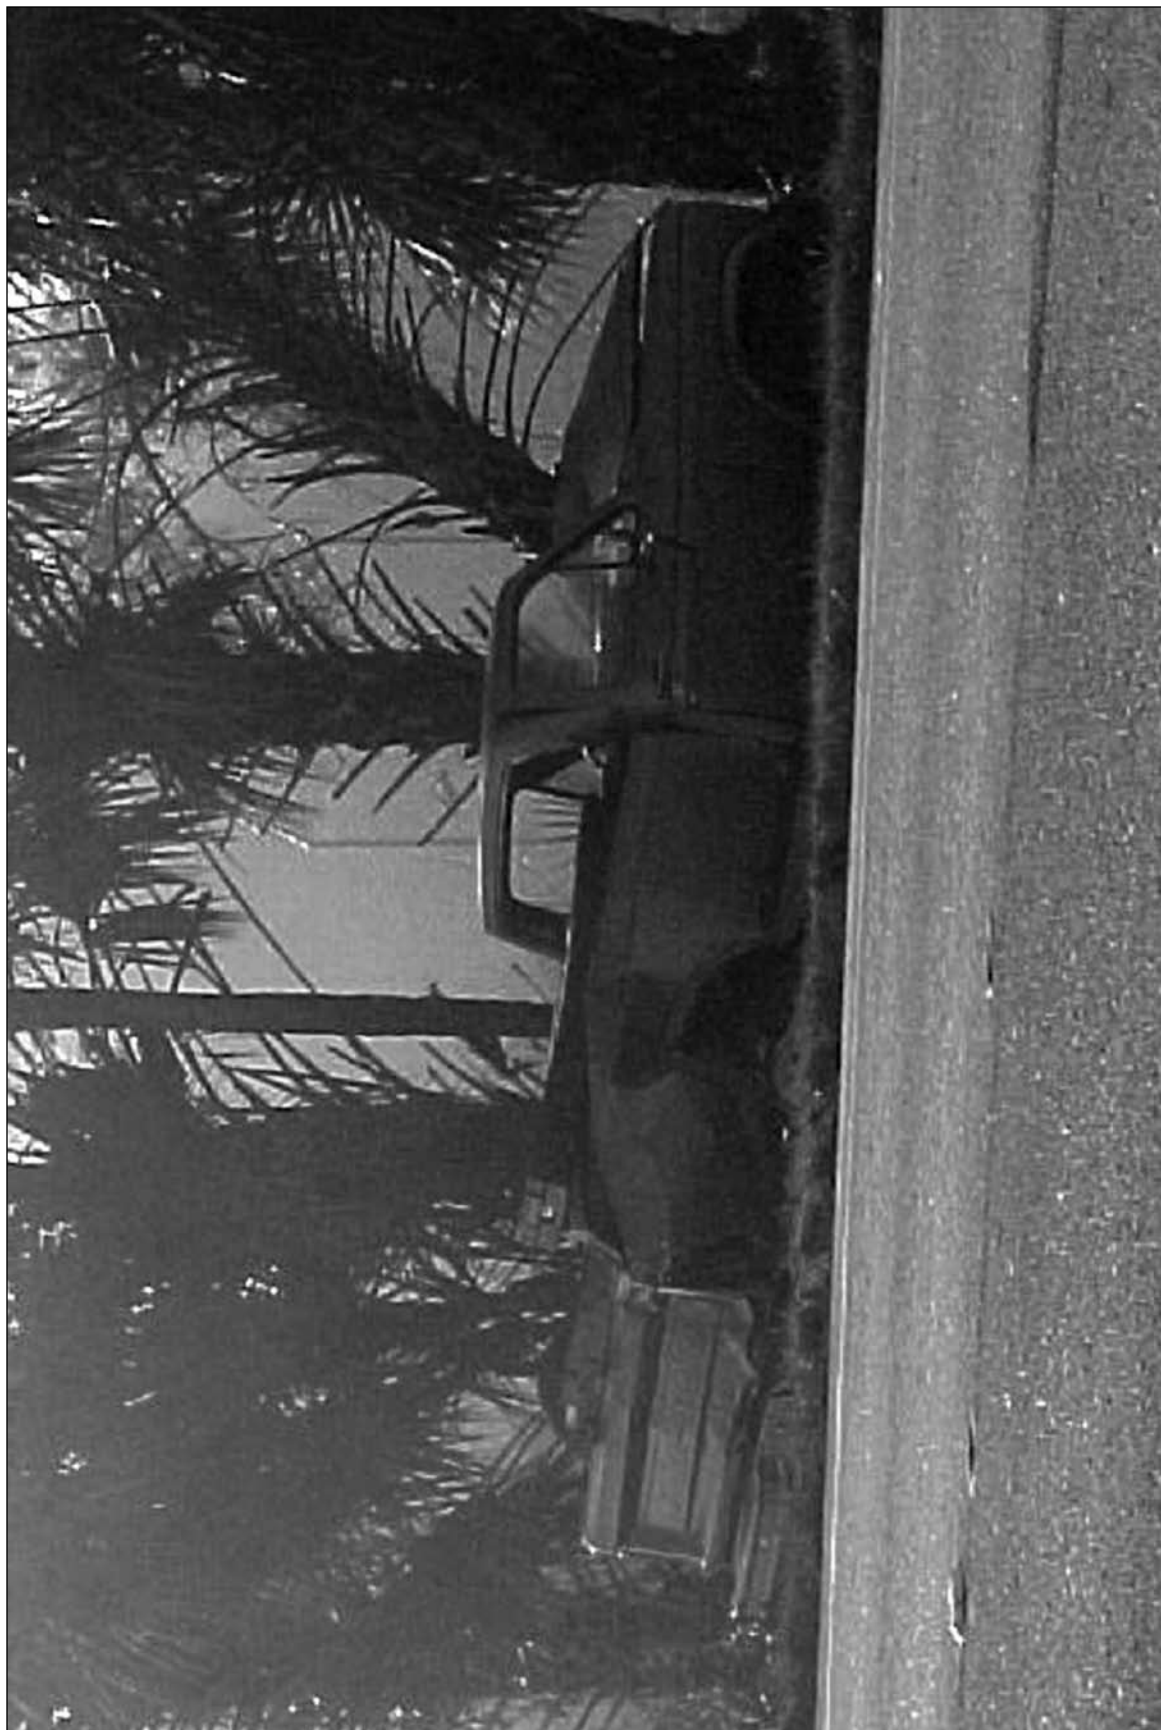
As foggy conditions developed along I-75, the driver of a pickup truck traveling westbound to Naples stopped his truck due to poor visibility. He believed that he had parked on the shoulder of the outside lane. His pickup, however, protruded into the traffic lane and was rear-ended by a tractor-trailer truck transporting automobiles. The truck driver stated that he came upon the stopped vehicle, which had been obscured by the dense fog, and had swerved to miss the pickup, but collided with the right rear corner of the pickup and also hit a car. The car was forced into the eastbound lanes of traffic, which resulted in another collision.

9. Pickup that caused the original collision to occur

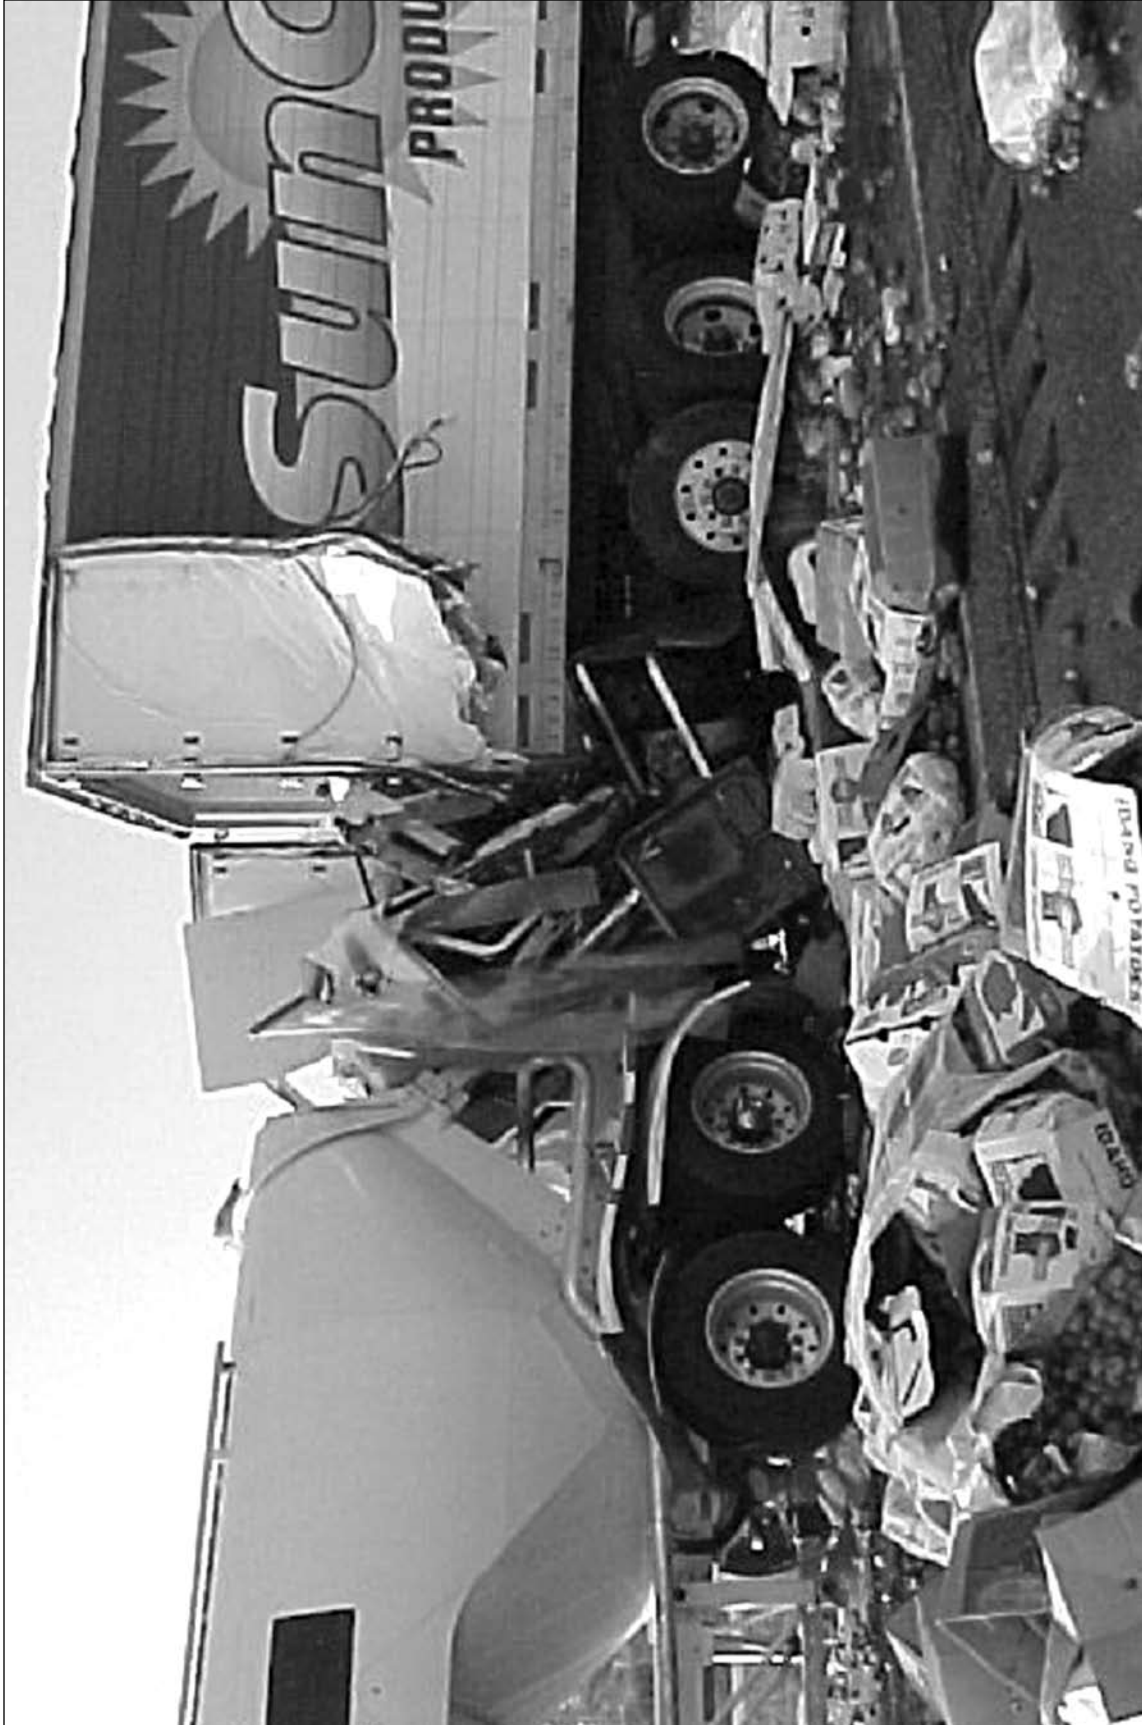
10. Another view of the concrete truck in which the driver was killed

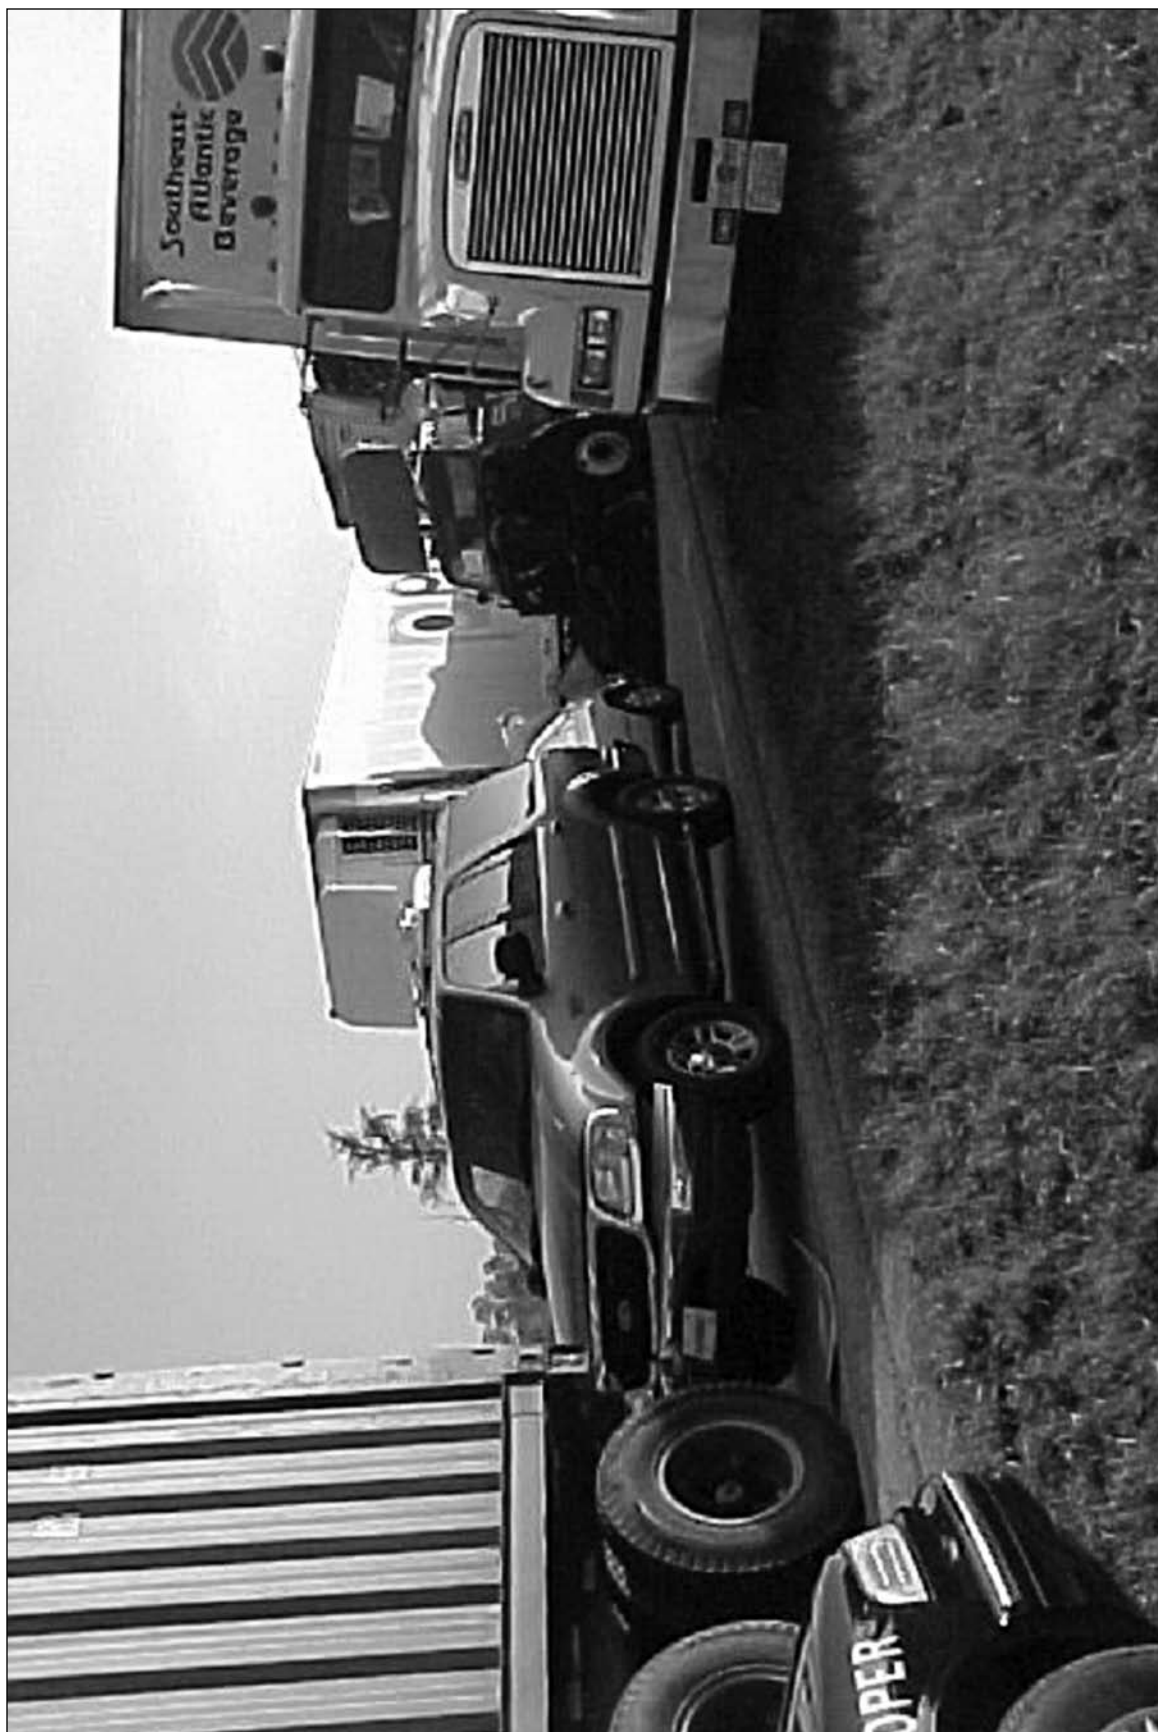
11. Congestion at the scene looking from the road side toward the median
