U.S. Fire Administration/Technical Report Series

I-75 Multiple Vehicle Collision/Mass Casualty Incident

Collier County, Florida

USFA-TR-155/January 2002

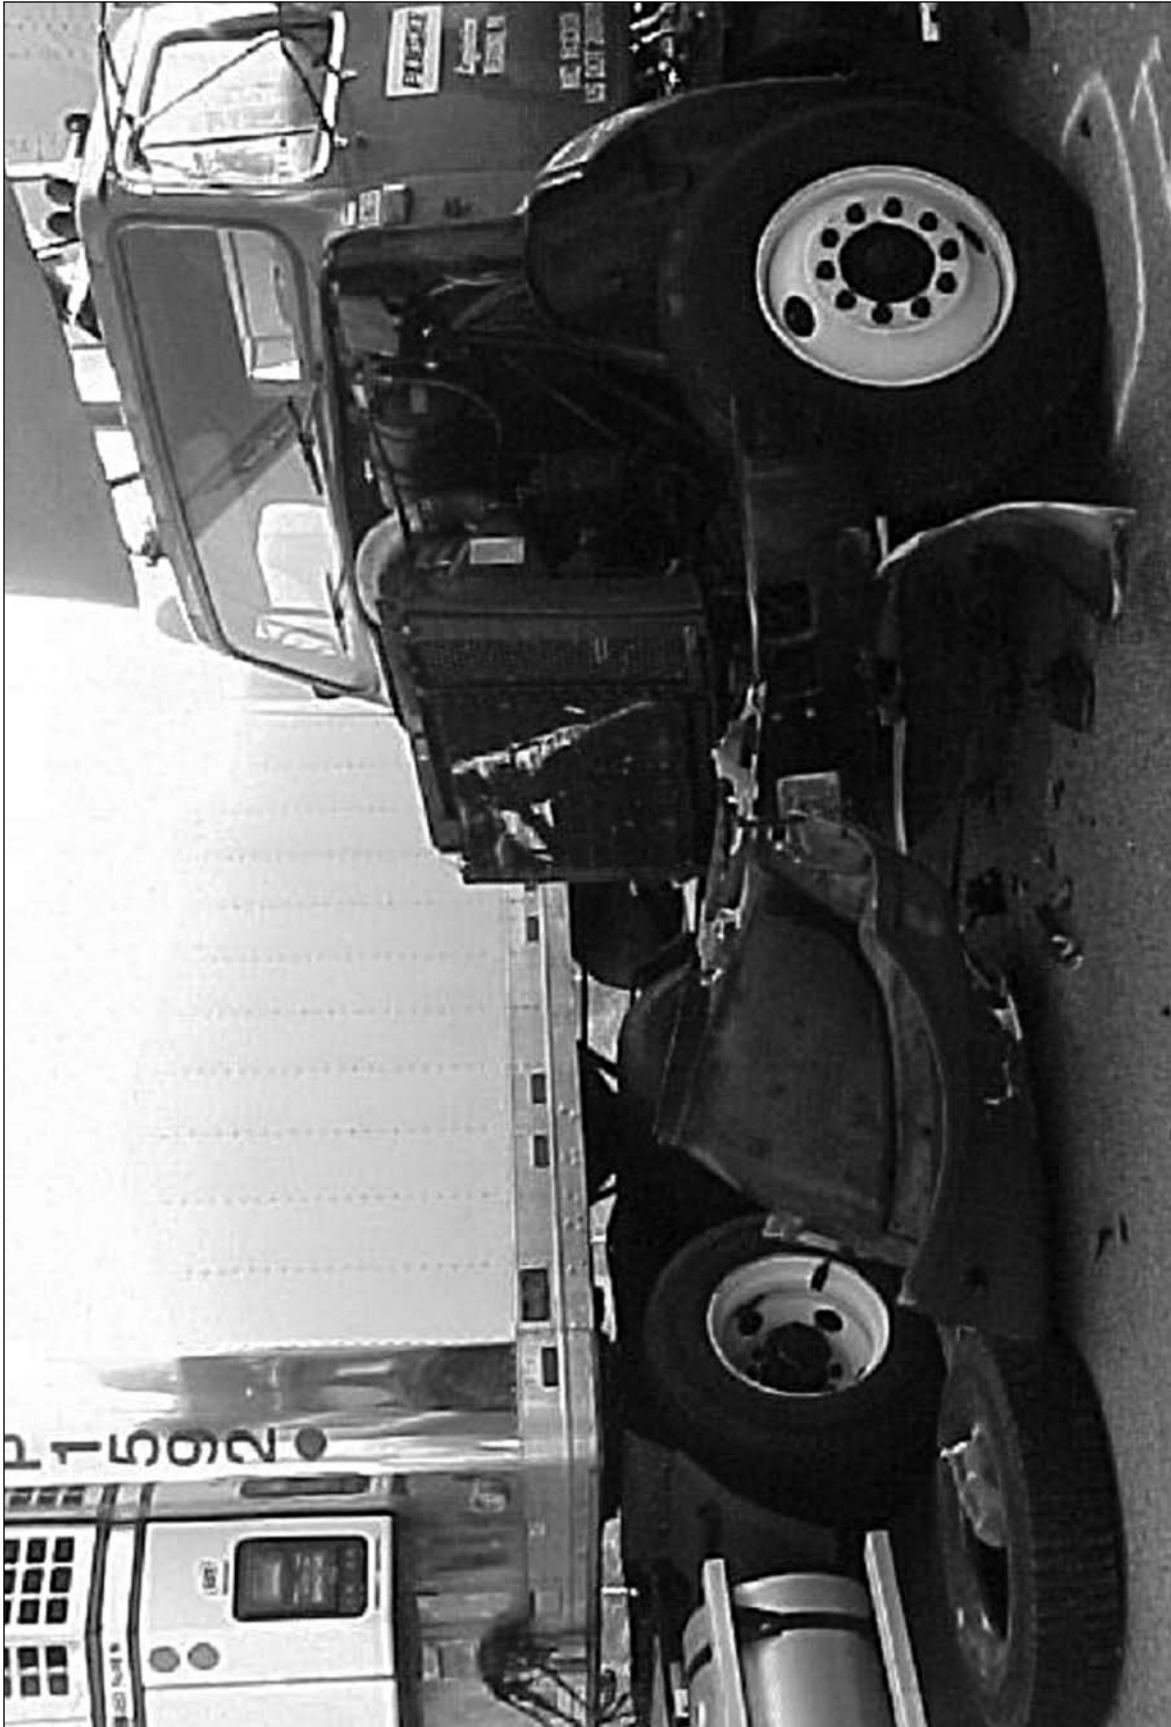
12. Example of the degree of damage

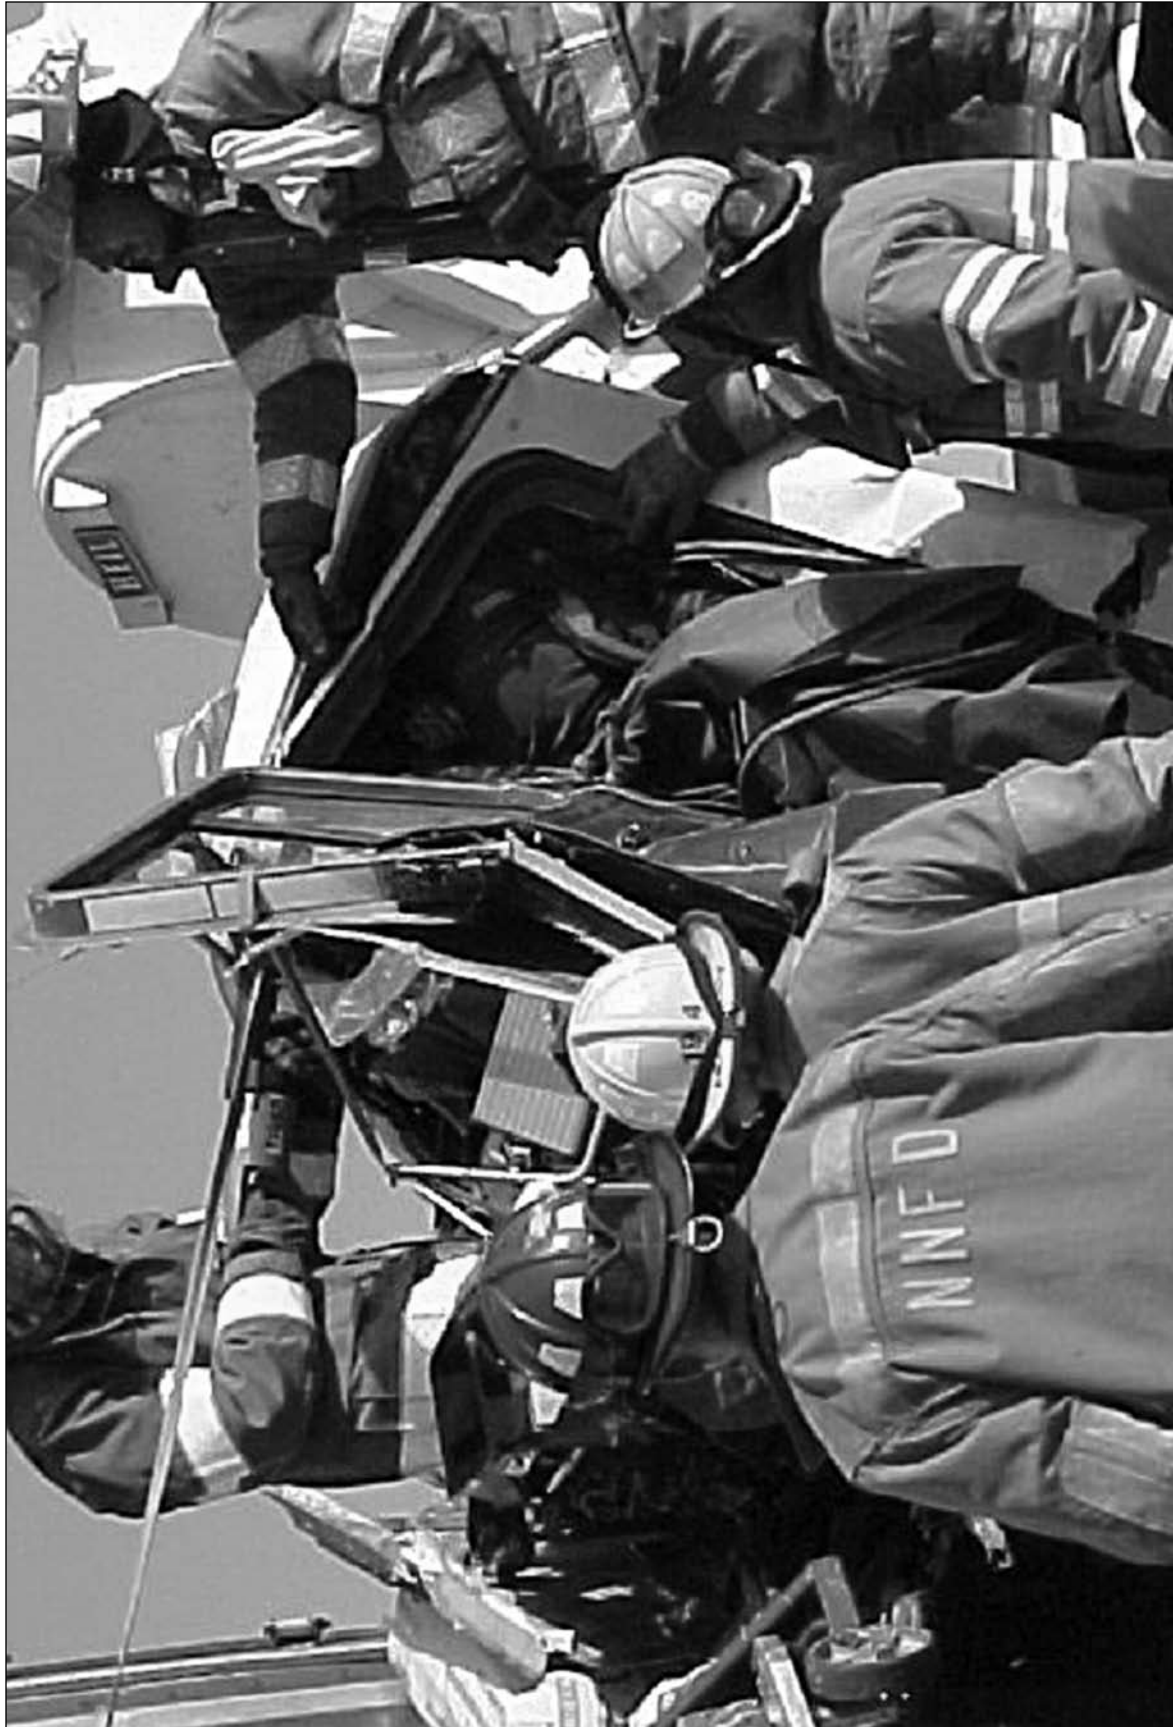
13. Extrication efforts by firefighters to remove the body of the victim from the concrete truck
