United States General Accounting Office

MINE SAFETY

Questions Regarding Enforcement at Wilberg Coal Mine

GAO/HRD-88-30BR

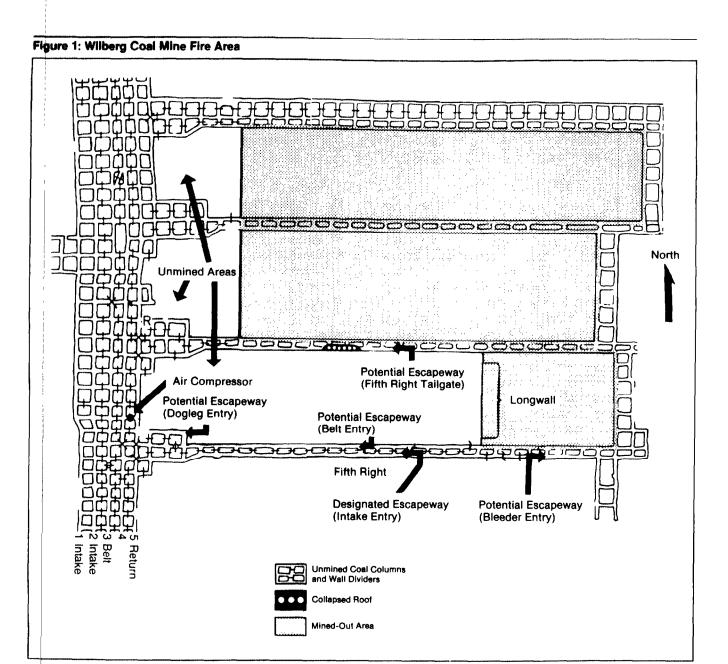
1	Wilberg Coal Mine Fire Area (Including	
	Definitions of Mining Terms)	8

At the time of the fire, the Wilberg Mine operated using two methods of mining, one termed the longwall method (used in the area of the fire) and the other, the continuous miner method. These and other mining terms are used throughout this report to facilitate comparison with other reports on the fire (defined in fig. 1).

Belt entry	 Passageway containing the conveyor belt on which coal is carried out of the section.
Bleeder entry	 Passageway used as an airway exhaust and as ventilation for the mined-out area.
Continous mining	 Mining method in which a mobile mining machine rips coal from the surface of the coal seam and loads it onto conveyors or into shuttle cars.
Dogleg entry	 Passageway with an abrupt, angular change in the course of its direction.
Intake entry	 Passageway by which the ventilating air current enters the area being mined.
Longwall mining	 Mining method in which a mining machine moves back and forth across a wide coal seam (perhaps several hundred feet), removing coal by means of an automated cutting wheel moving along a conveyor belt set against the "longwall" (in one operation).
Tailgate entry	 Passageway at one end of the surface of the coal seam being mined, which serves as a return airway for ventilation.
