Report to Congressional Requesters

October 1987

PHYSICAL SECURITY

Protection of Assets at U.S. Navy Bases

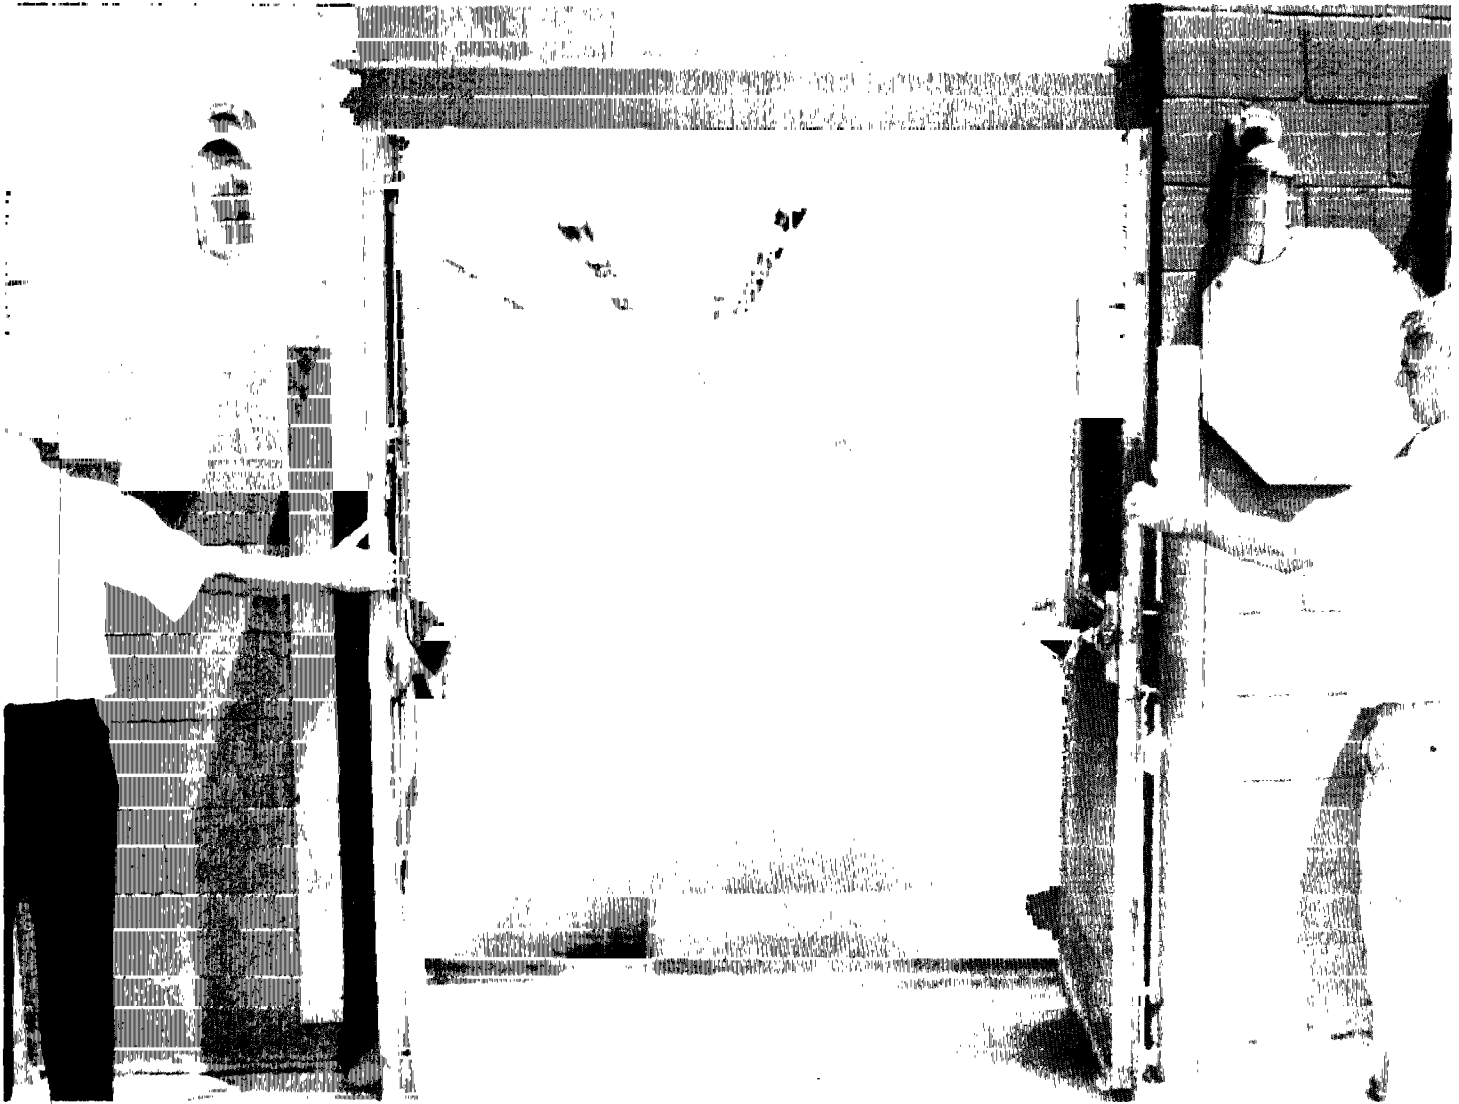
We also found several doors providing access to the classified work area that were not securely locked to preclude entry. These doors were standard metal-clad door assemblies. Even though one door leading to a classified work area was "properly secured," we were able to open it by giving it a hard jerk (see fig. I.1).

Figure I.1: Secure Door Leading to Classified Work Area, Which We Were Able to Open

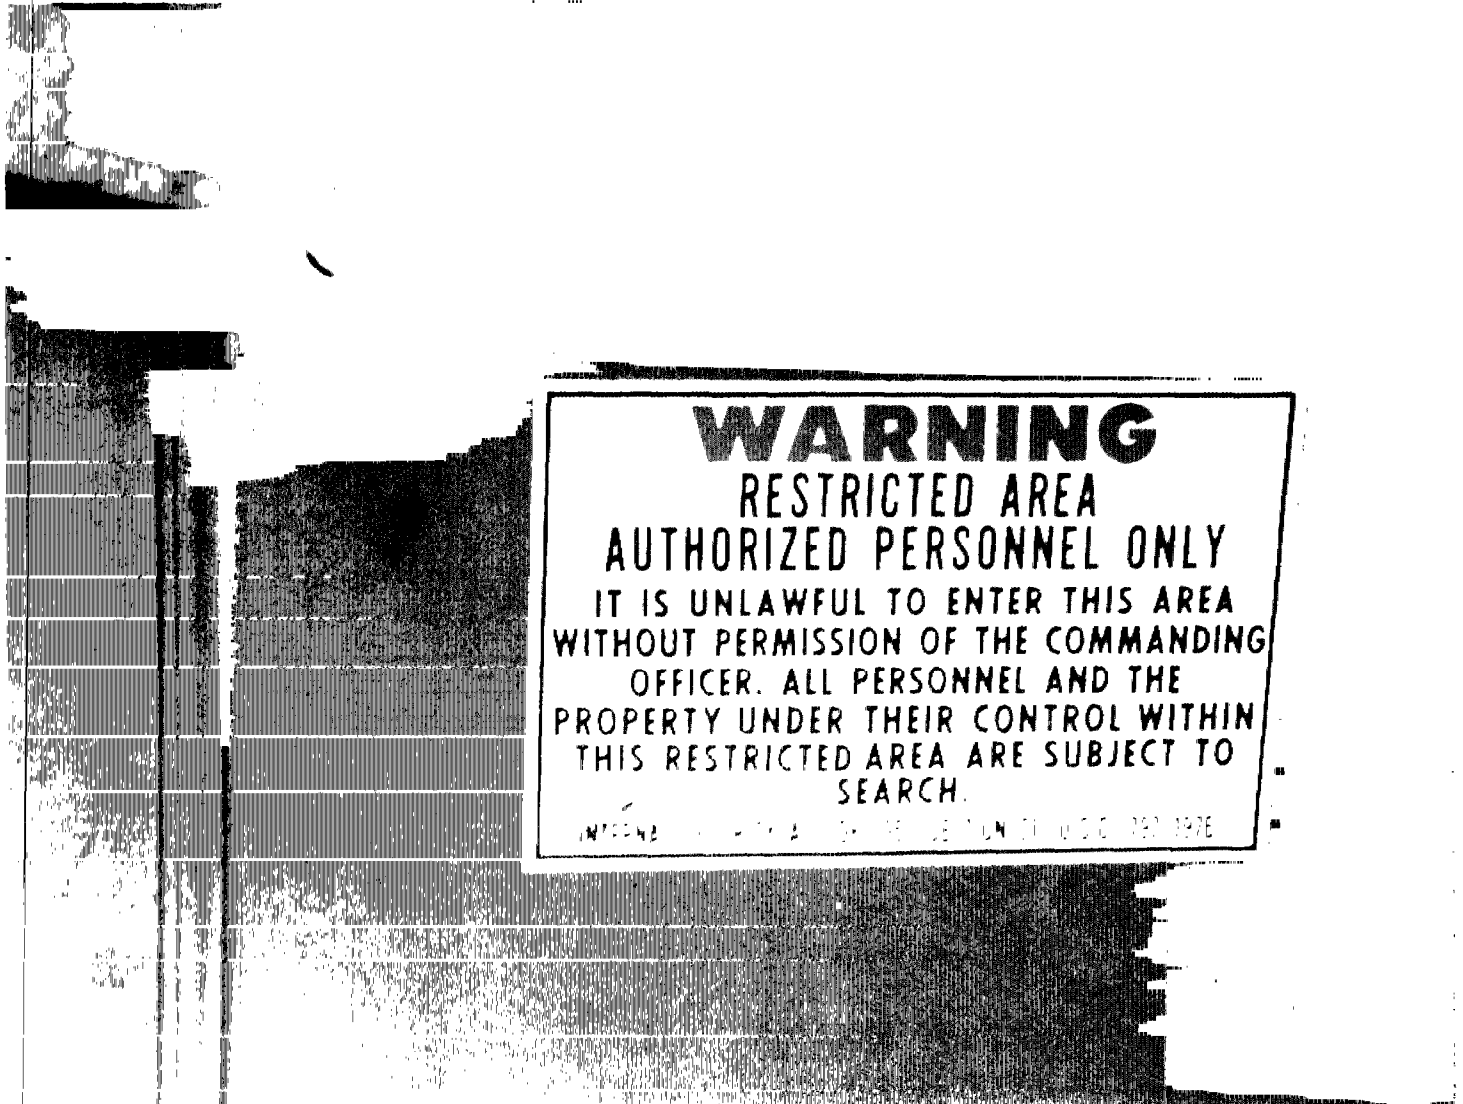
We found two other doors leading to the classified work area that had improvised attachments to defeat the locking mechanisms. One door had been altered to allow opening from the outside by pulling a wire placed through the door and anchored to the crash bar (see figs. I.2 and I.3). Another door had an improvised brace attached to the crash bar, which prevented the door from locking (see figs. I.4 and I.5).

Figure I.2: Outside View of Secure Door Showing Wire That Can Be Used to Open It

Defense stated in its comments on our draft report that the defective locking devices on the exterior perimeter doors have been replaced.

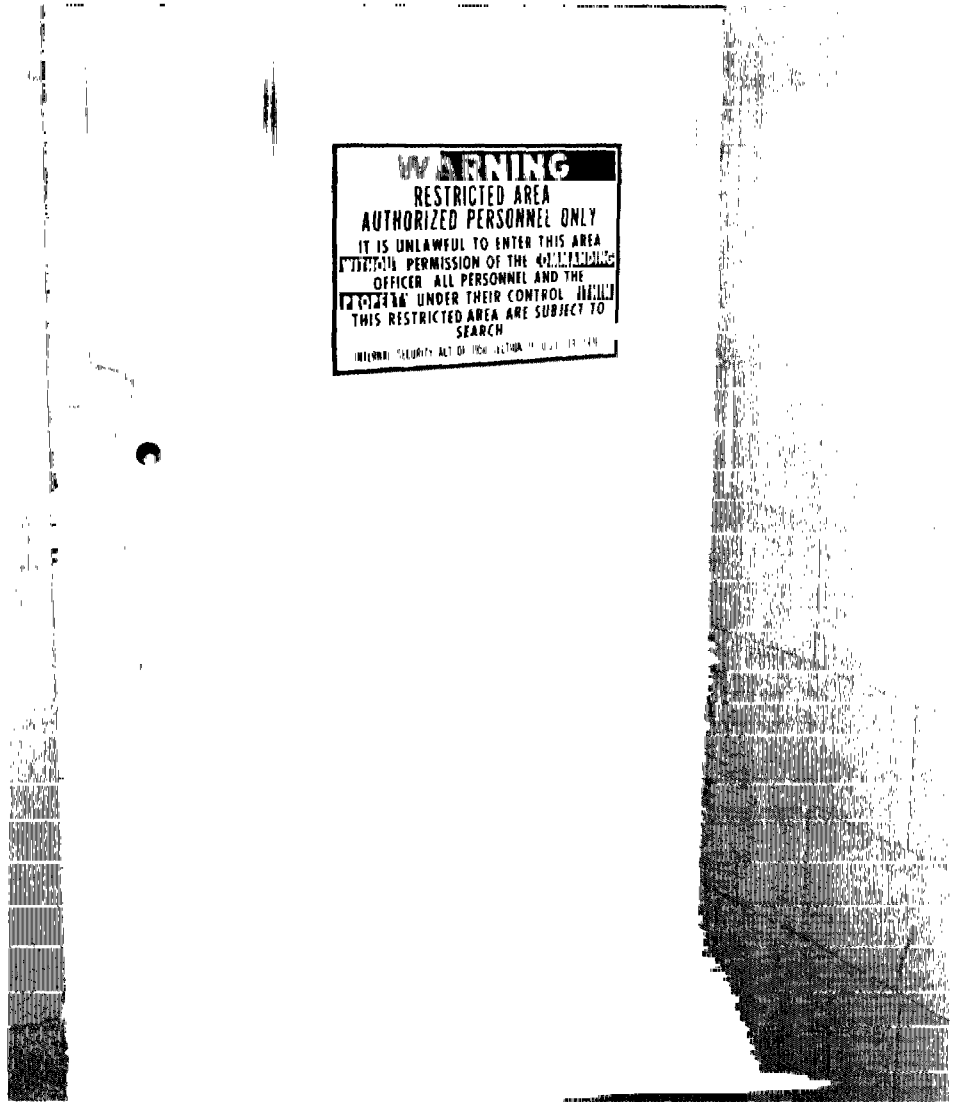
Figure I.4: Outside View of Secure Door That Has an Improvised Brace to Prevent Locking

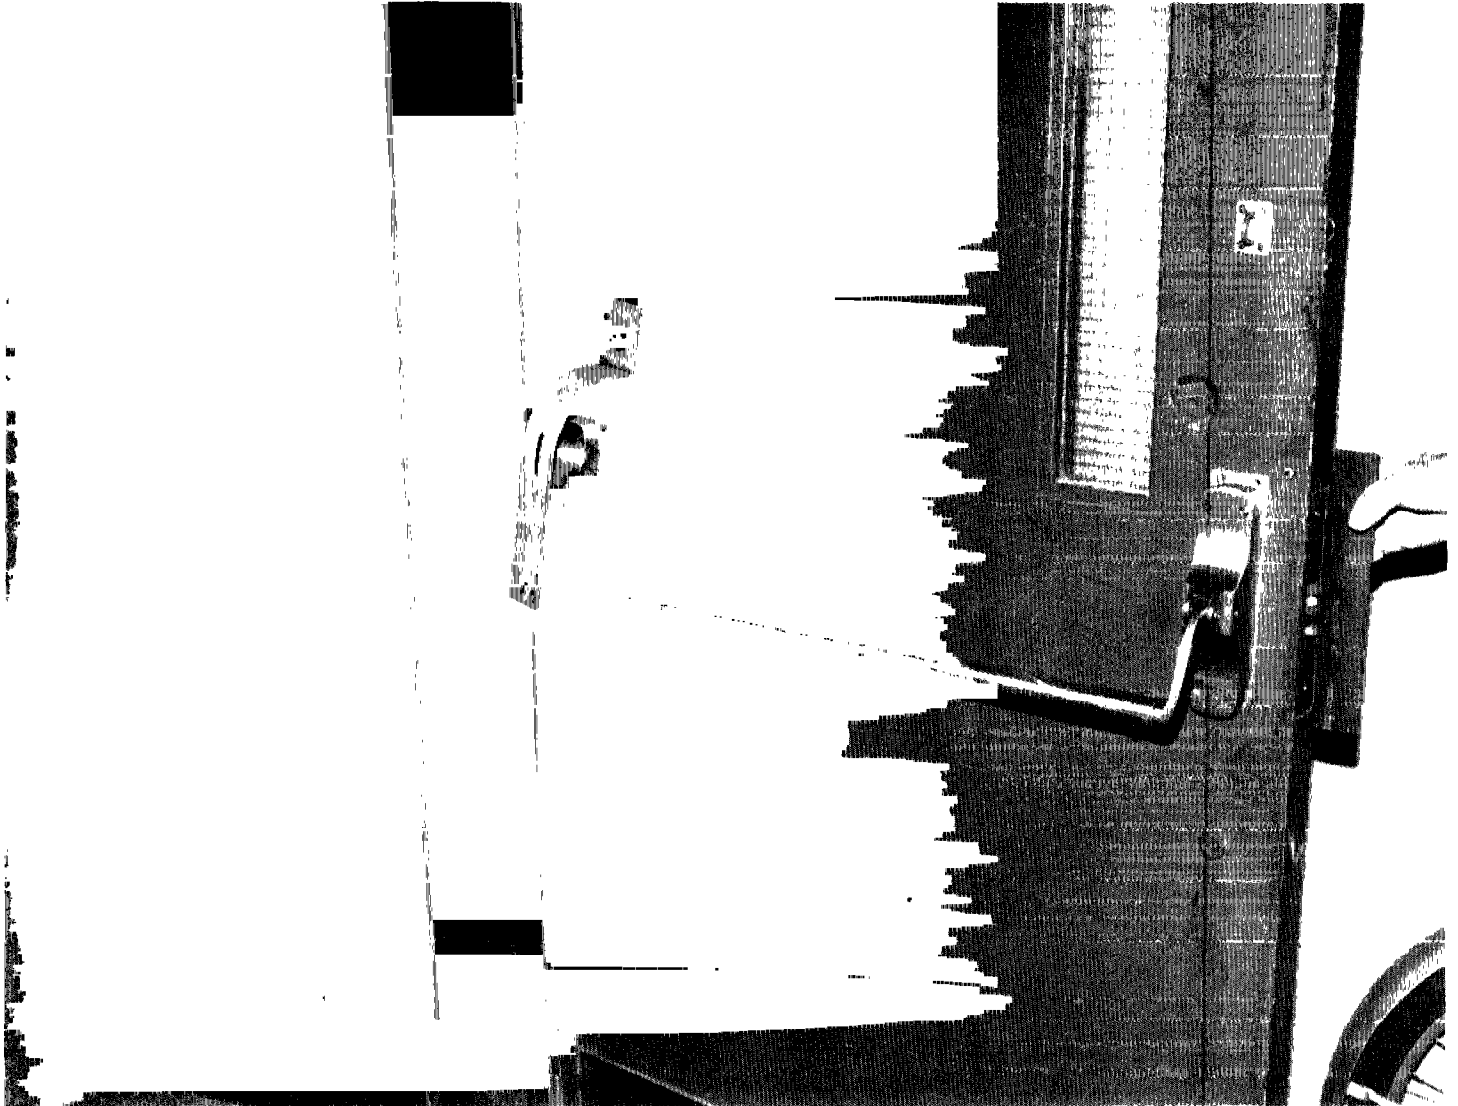
Figure I.5: Inside View of Door With Improvised Brace
