**BRIDGE MAINTENANCE, REHABILITATION, AND REPLACEMENT:
CASE HISTORIES**

Case History 15.1 - In-Place Preservative Treatment of Deteriorating Timber Bridges

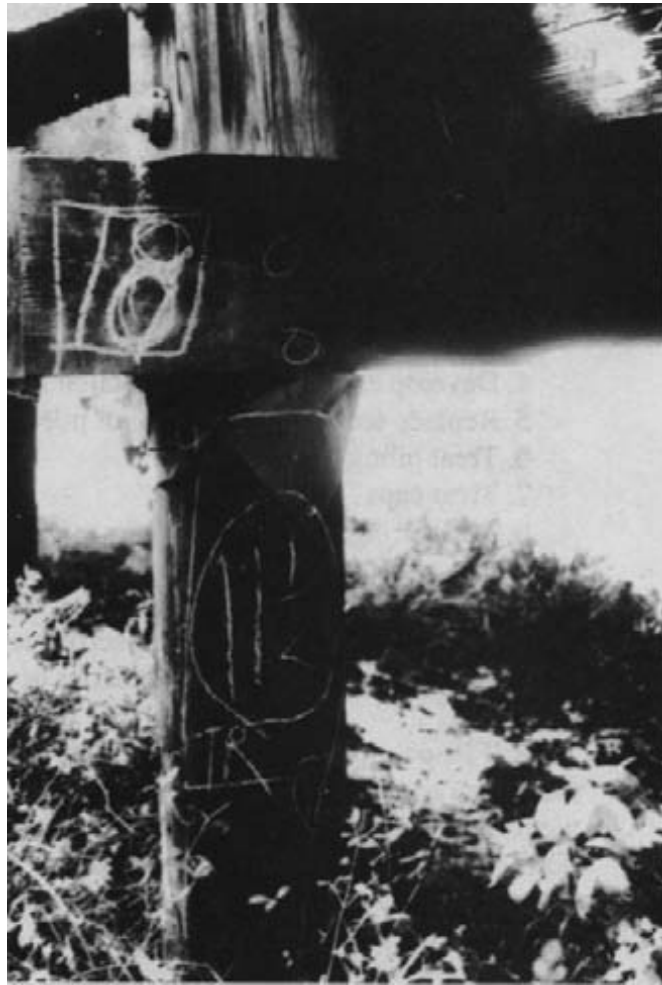
Figure 15-1. - Typical investigative borehole pattern.

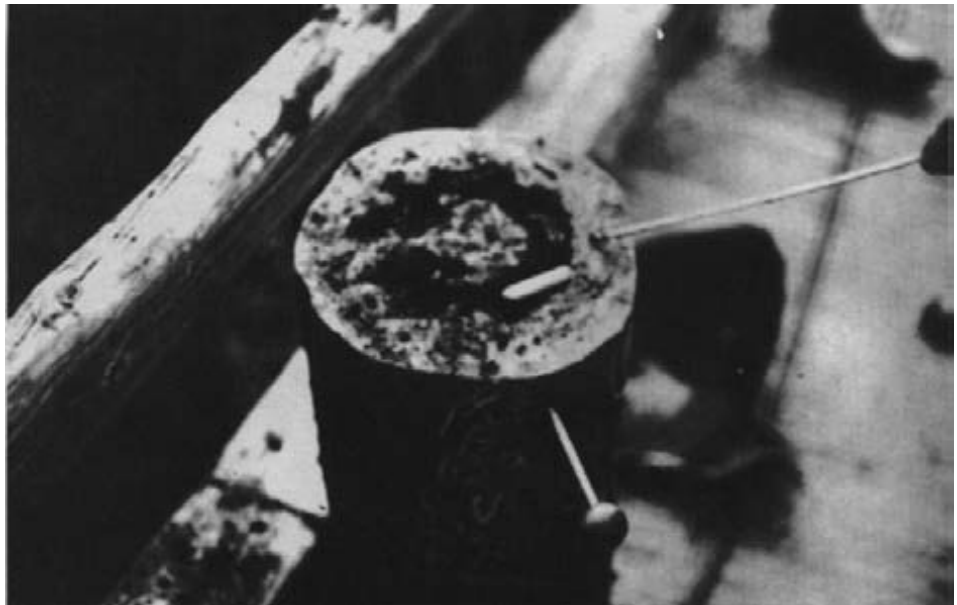
Figure 15-2. - Section of deteriorated pile removed from the structure.

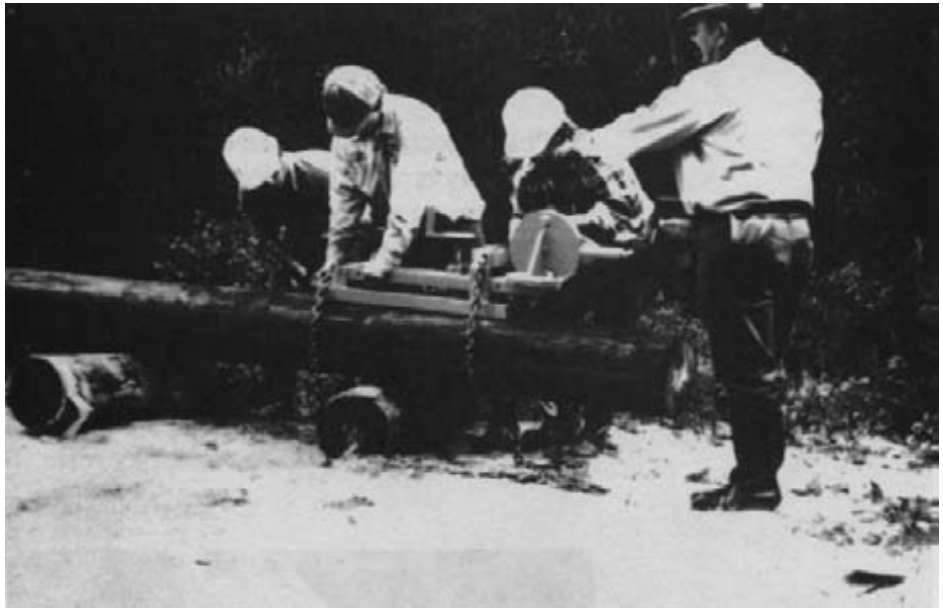
Figure 15-3. - Cutting a replacement pile section using a specially designed pile cutter.

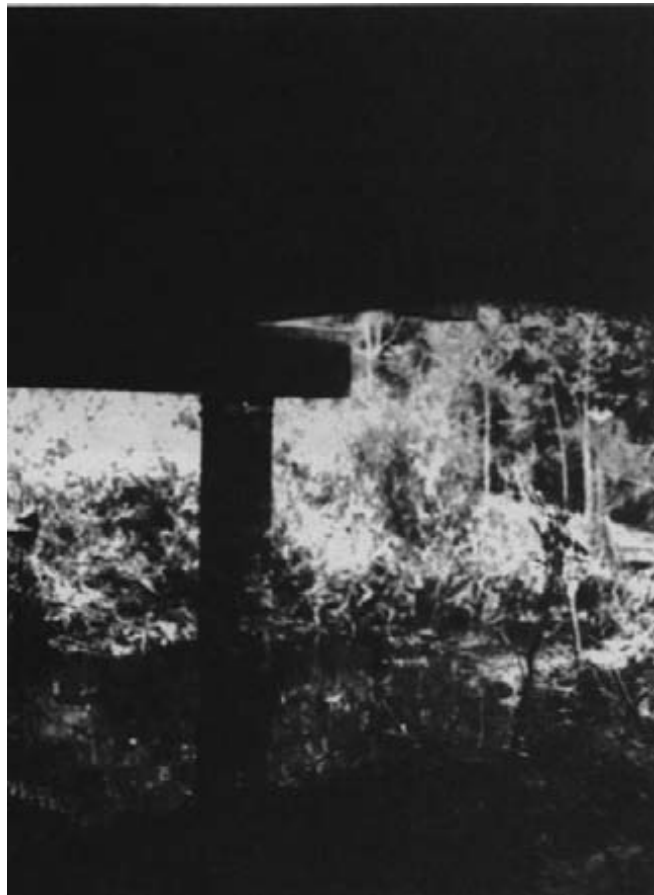
Figure 15-4. - Completed pile posting with protective plastic in place.

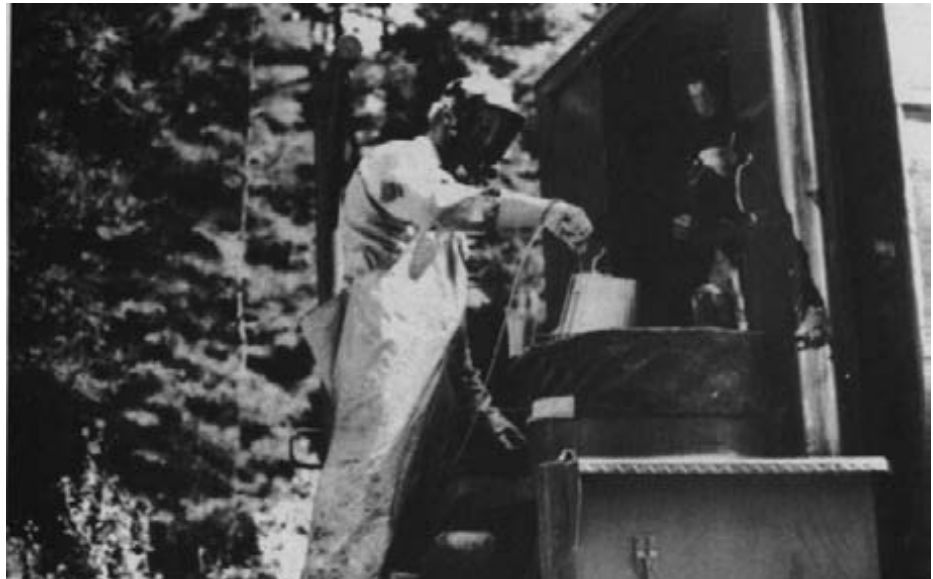
Figure 15-8. - Preparing fumigant vials. Note the required safety mask and gloves.

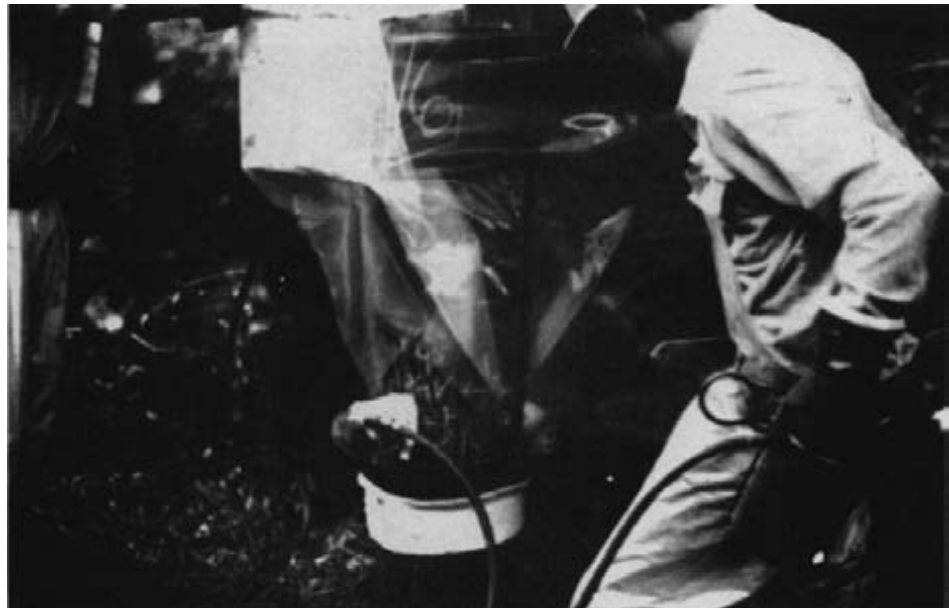
Figure 15-9. - Injection of liquid preservative solution into a timber pile.

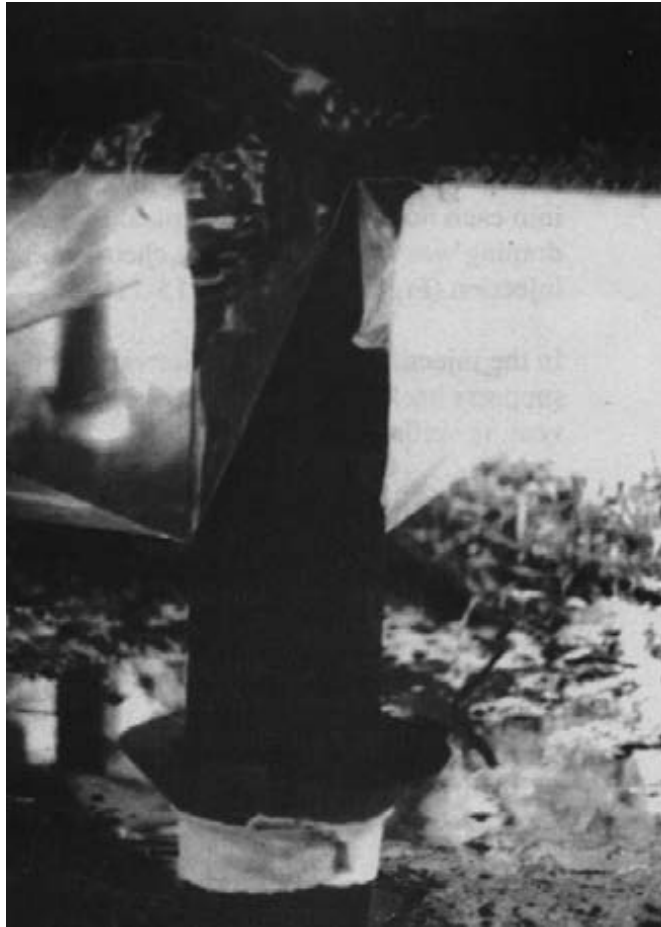
Figure 15-10. - Typical individual cap and pile draping and funnel for protection against leakage of the liquid preservative.

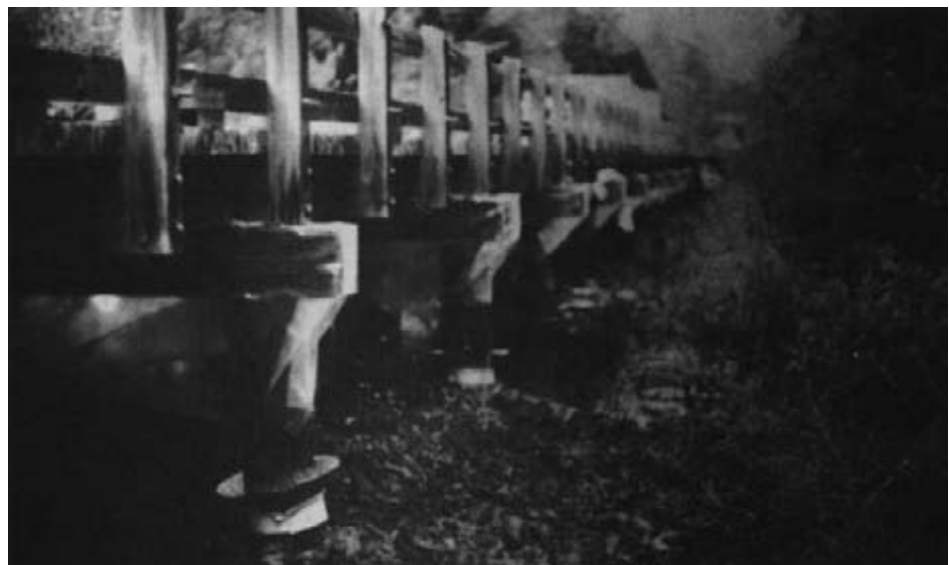
Figure 15-11. - Bridge draping for spillage protection, in place and ready for preservative injection.

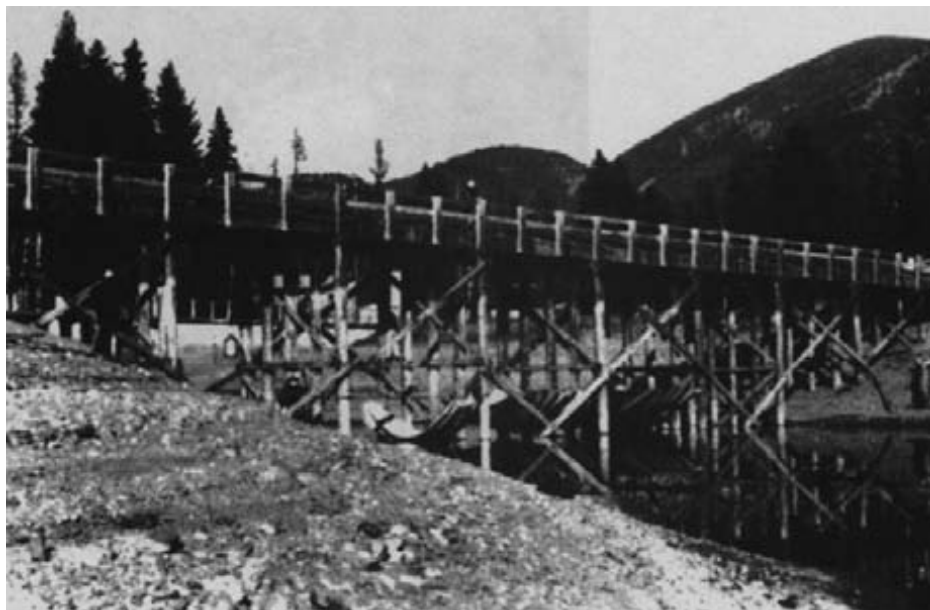
Figure 15-13. - View of the Sullivan Lake Outlet Bridge as in-place treatment was commencing. Note the canvas slings placed under the bridge to prevent water contamination should accidental spillage of treatment chemicals occur.

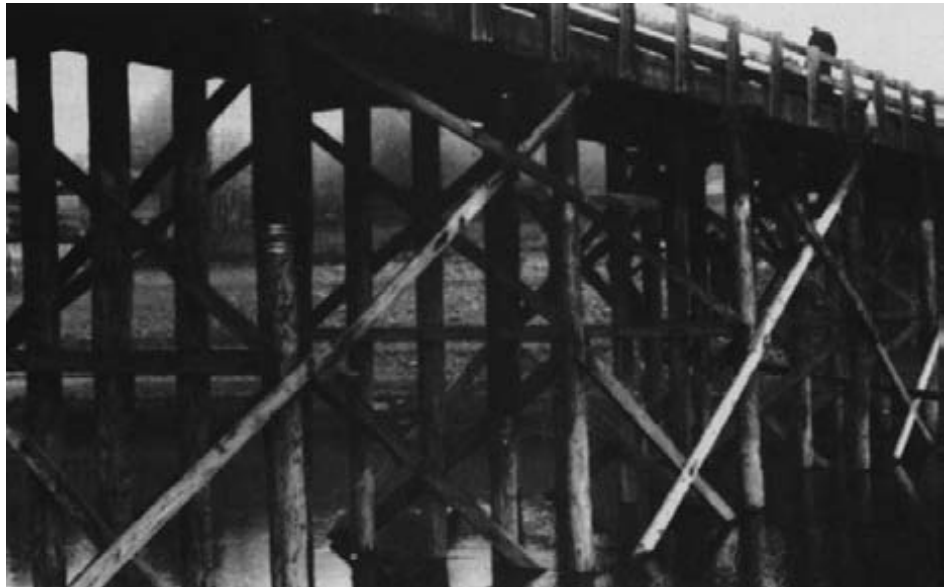
Figure 15-17. - Pile bents after replacement of deteriorated sections by pile posting.

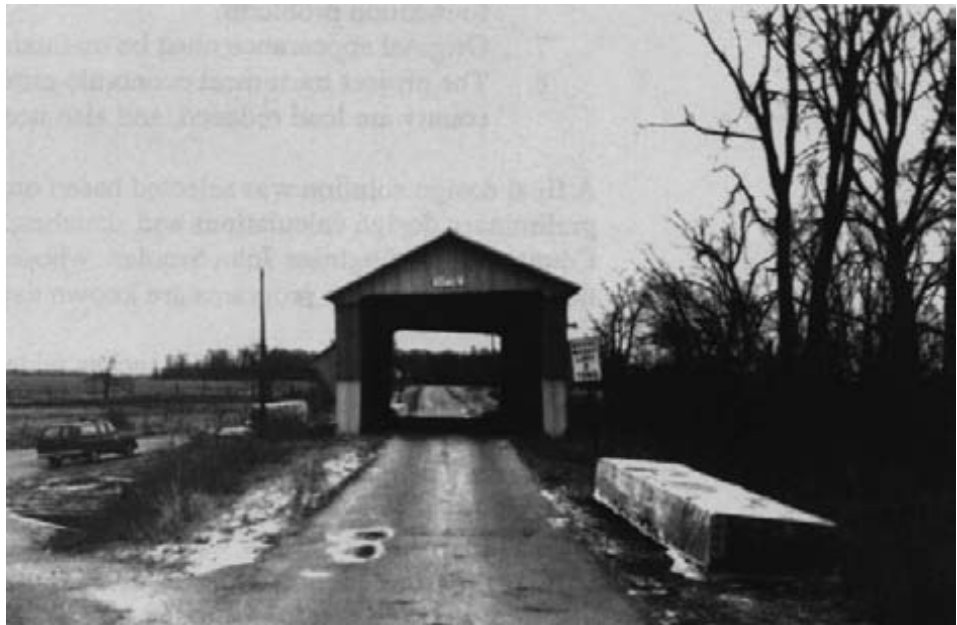
Figure 15-27. - Covered bridge on Winget Road before rehabilitation work began. Note the excessive rack and twist of the truss.

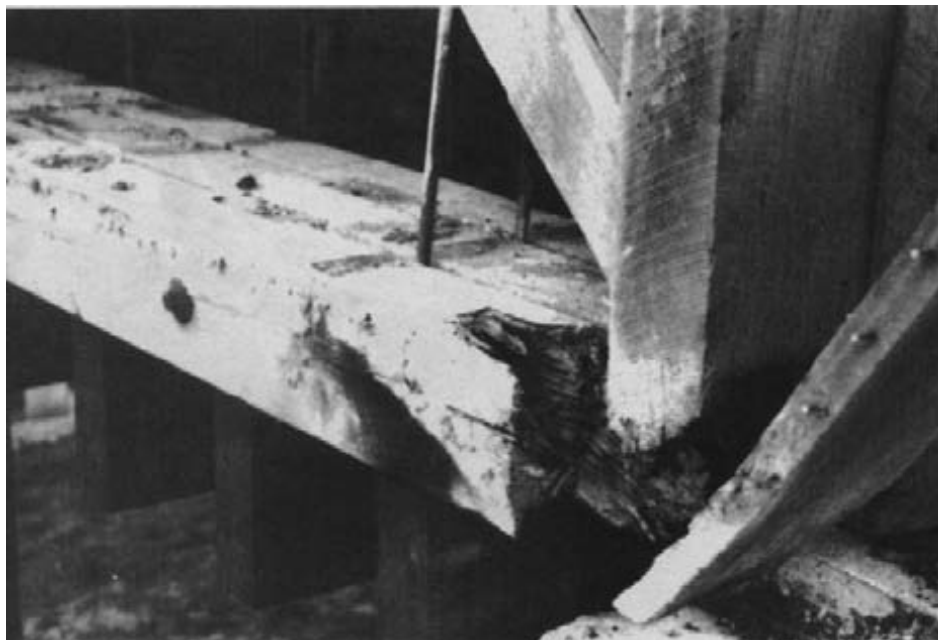
Figure 15-32. - Severe deterioration at each corner of the bridge was one cause of the poor truss alignment. New floorbeams were extended beyond the girders to help support each truss.

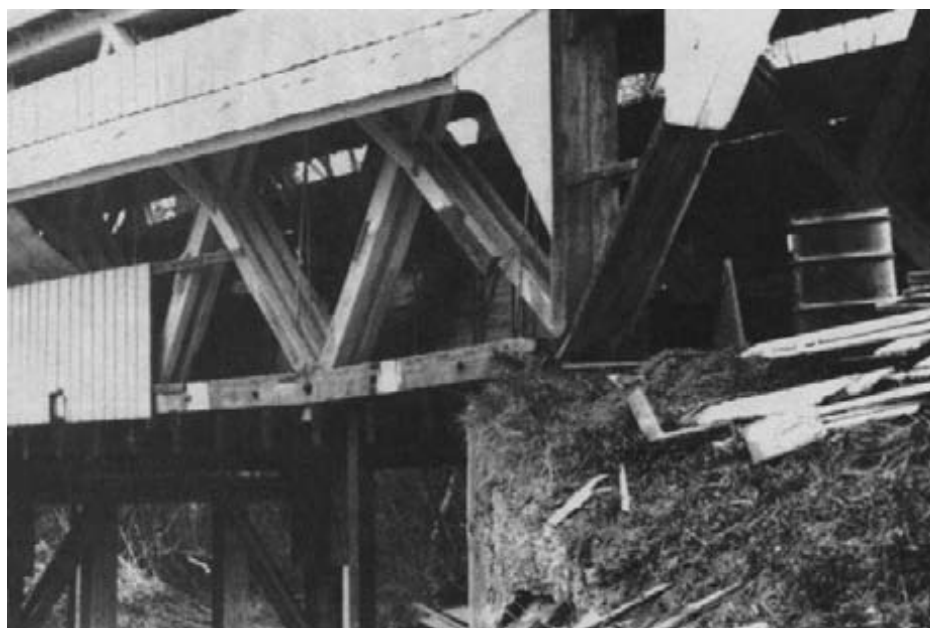
Figure 15-33. - Broken lower chords at two of the four corners prompted the replacement of some existing truss members.

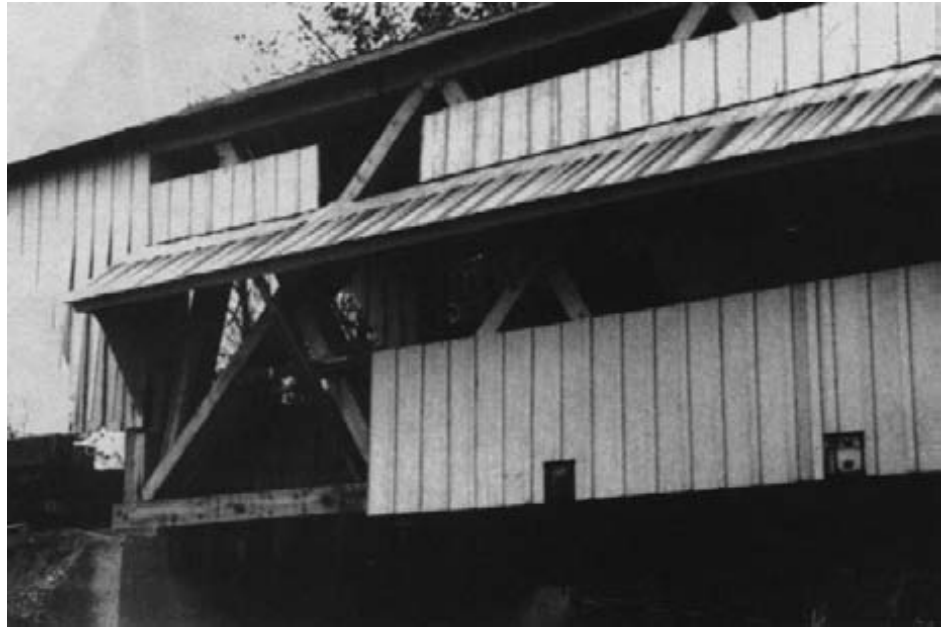
Figure 15-34. - Completed repair of one corner of the bridge, using poplar timbers. Note the closer spacing of the endmost floorbeams to account for the reduced floorbeam load distribution adjacent to the abutment.

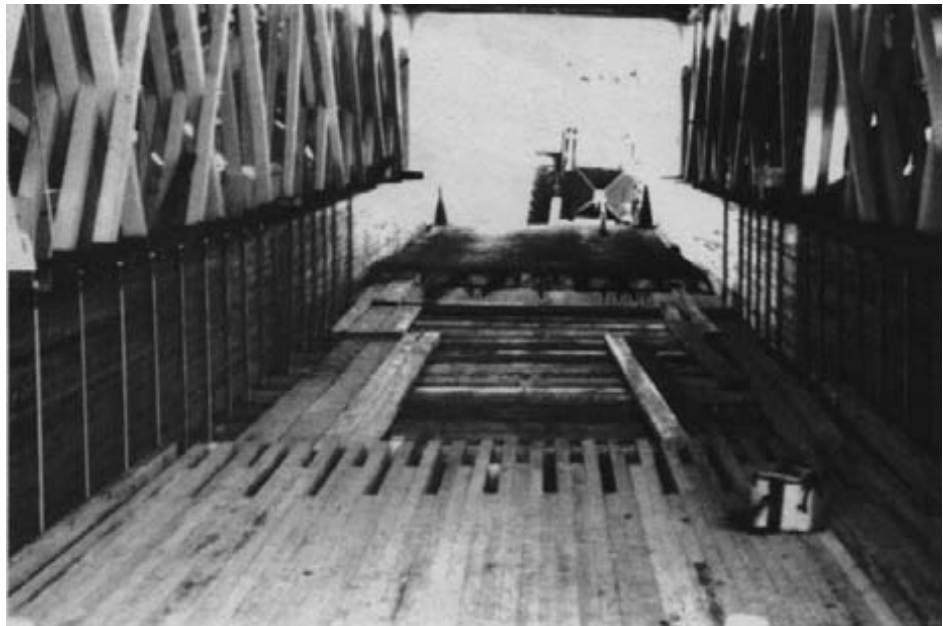
Figure 15-35. - A view inside the bridge showing the glulam girders, floorbeams, and longitudinal nail-laminated lumber floor. The existing floor, still in place at the far end of the roadway, was removed in sections to facilitate construction.

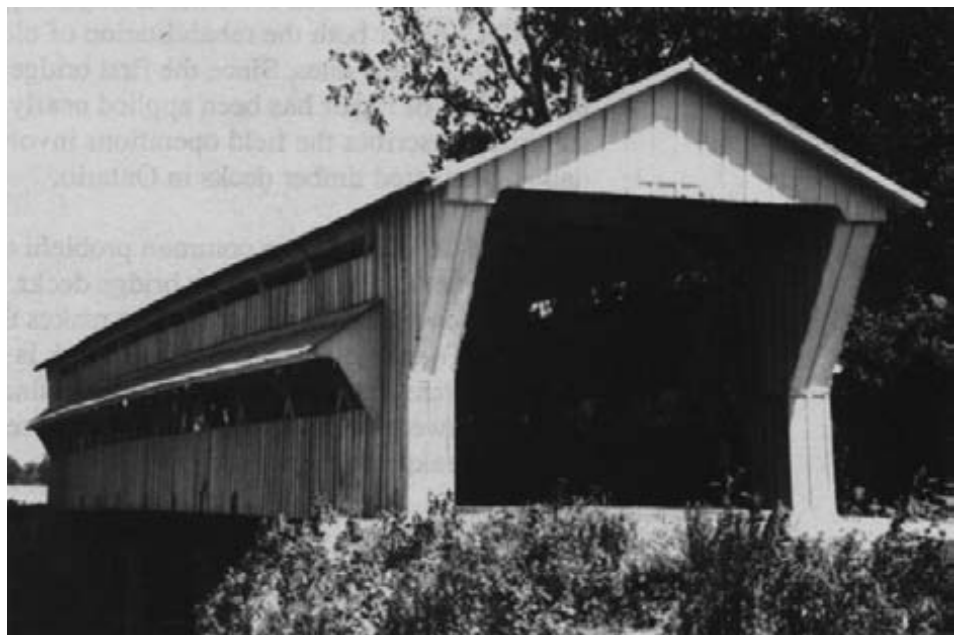
Figure 15-37. - The completed rehabilitation results in a significantly increased load capacity (18 tons), while maintaining the historic bridge's aesthetic appeal.

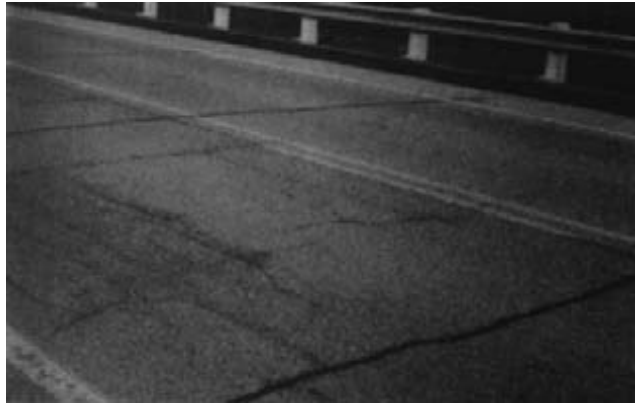
Figure 15-38. - Breakup of asphalt pavement because of delamination of the nail-laminated timber deck.

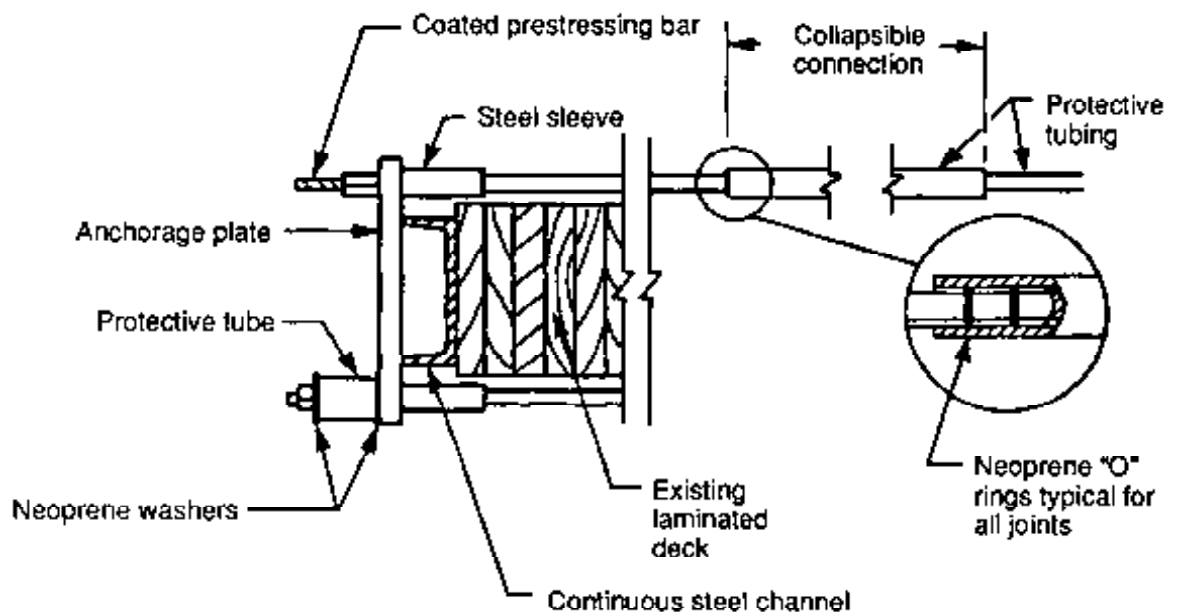
Figure 15-39. - Prestressing detail for rehabilitation of existing decks.

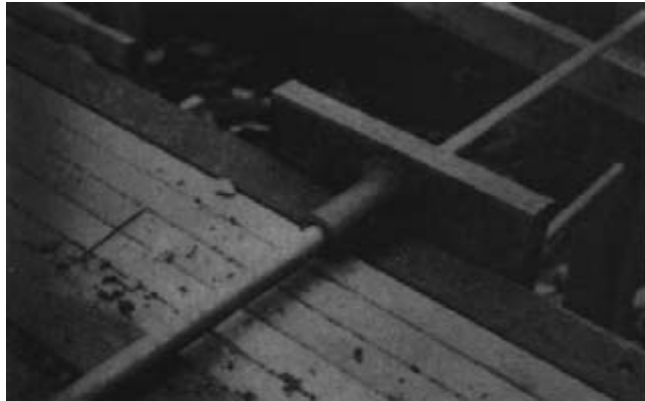
Figure 15-40. - Prestressing anchorage used at the Pickerel River Bridge.

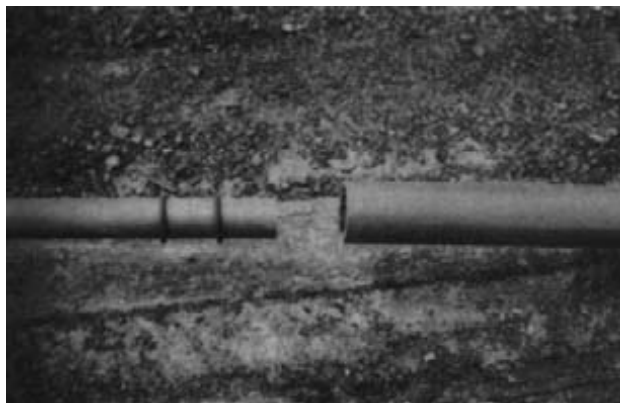
Figure 15-41. - PVC sleeve connection with neoprene O-rings.

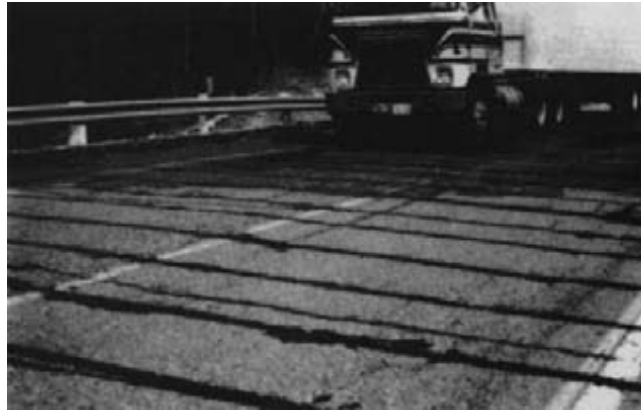
Figure 15-42. - Top prestressing bars installed in grooves cut in the asphalt wearing surface of the North Pagwachuan River Bridge near Terrace Bay, Ontario.

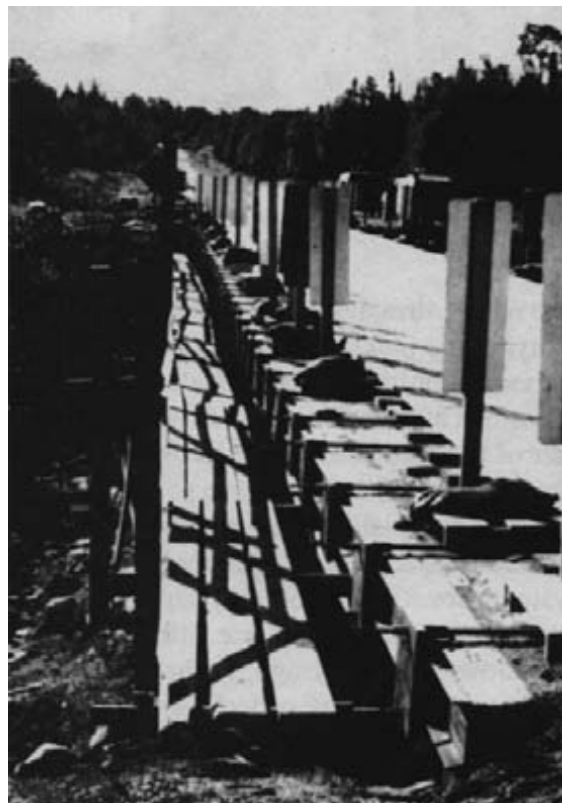
Figure 15-43. - Temporary plank surface placed over prestressing bars during construction at the Pickerel River Bridge.

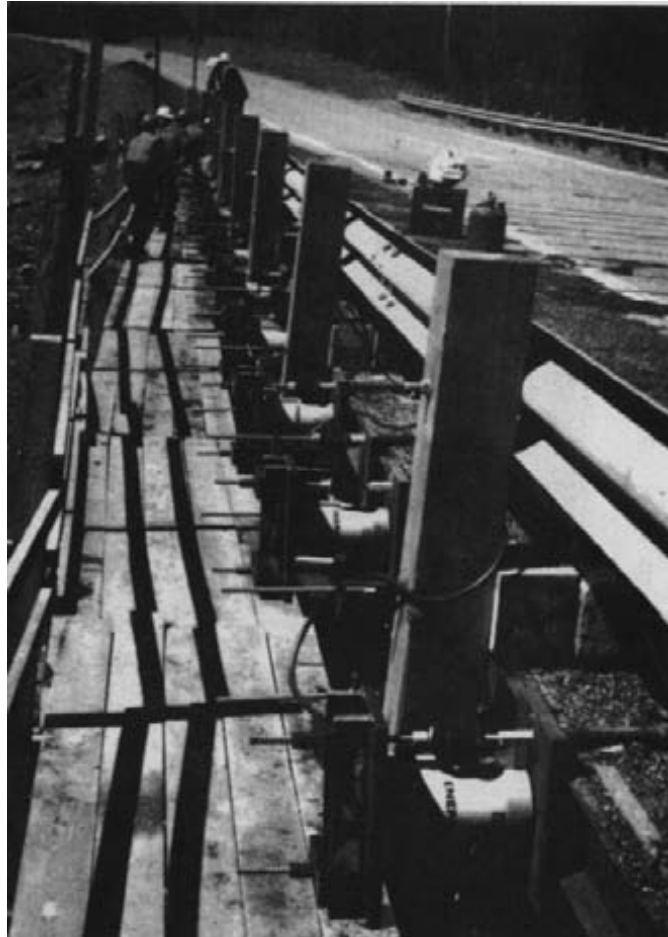
Figure 15-44. - Multijack hydraulic system used at the North Pagwachuan River Bridge.

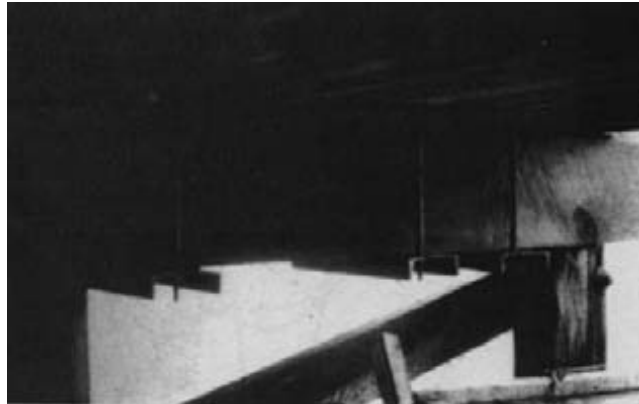
Figure 15-45. - Tie-down of the deck to supports at the Kabaigon River Bridge.

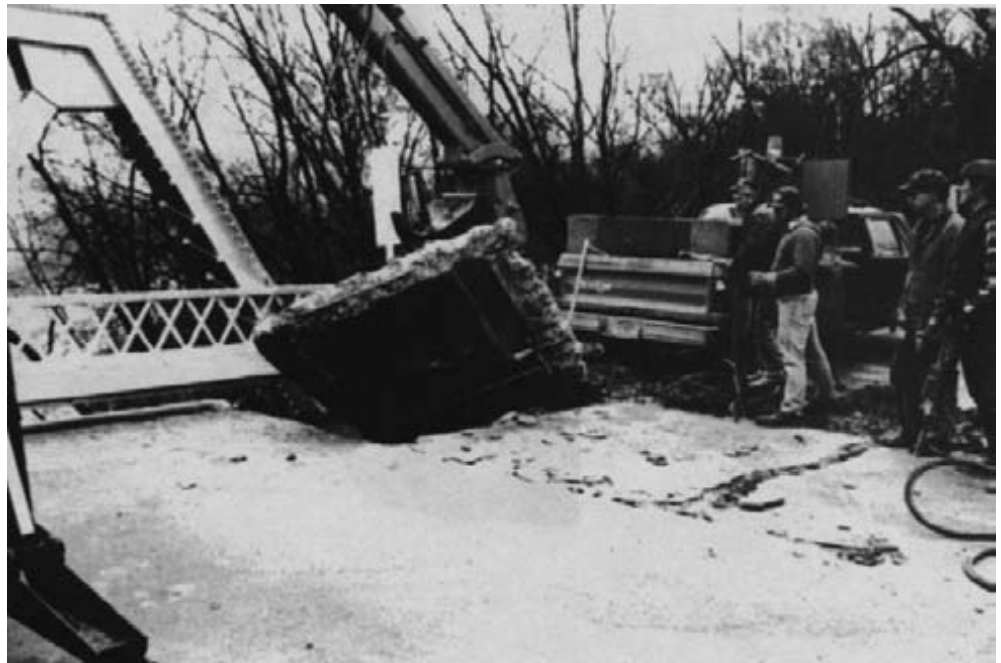
Figure 15-48. - The concrete deck was removed in approximately 5-foot-square sections by the Sauk County Highway maintenance crew. The concrete was broken using jackhammers, and reinforcing bars were flame cut. The sections were lifted and loaded on the trucks with a hydraulic excavator.

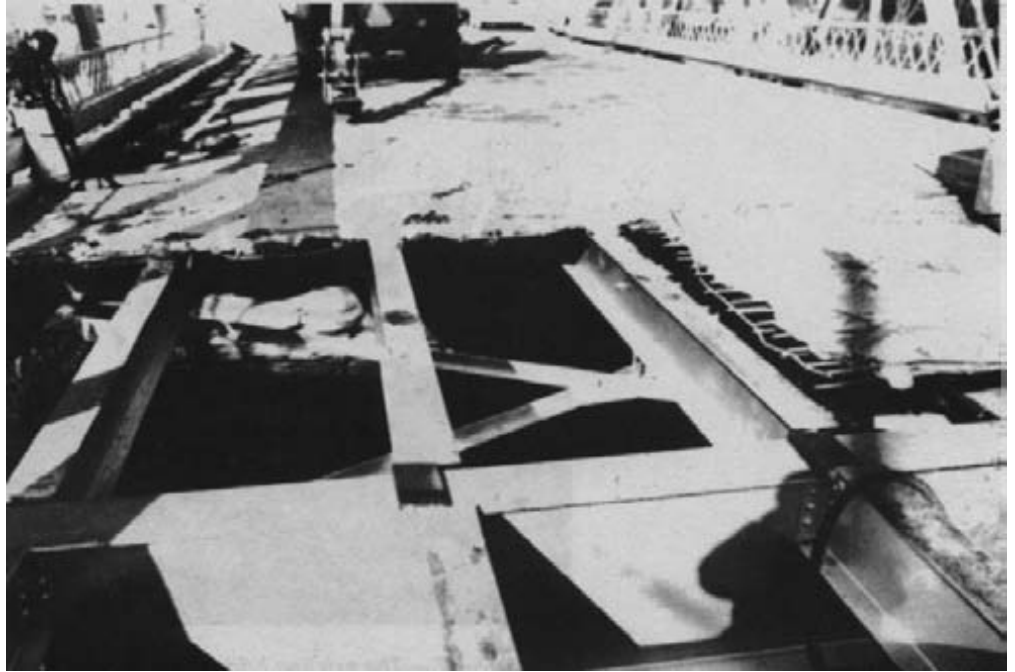
Figure 15-49. - Exposed steel floorbeams and stringers as deck removal proceeds.

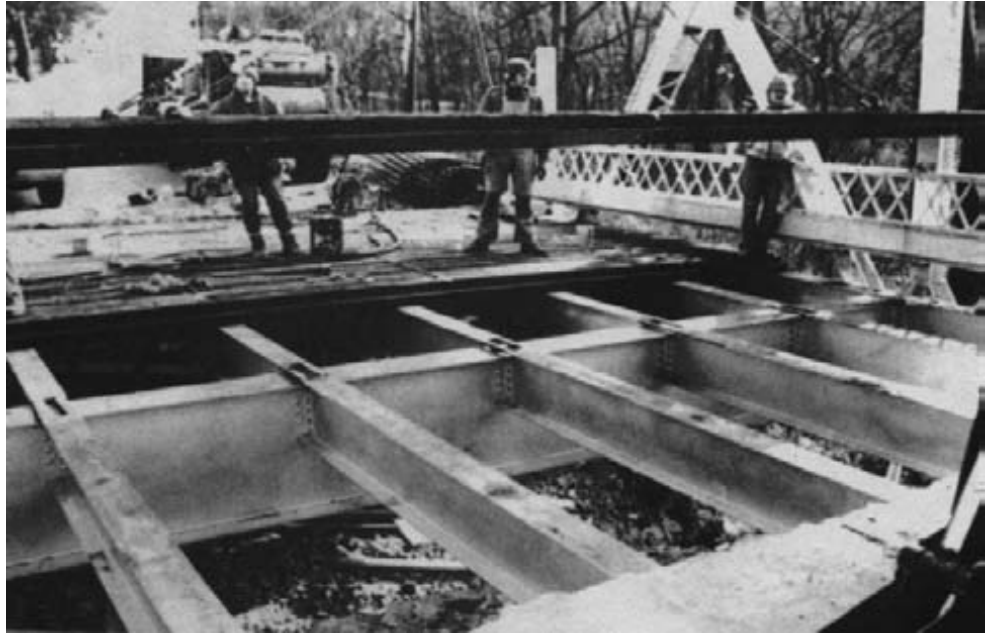
Figure 15-51. - Deck replacement proceeded in stages along the bridge length. After a portion of the concrete was removed, timber deck sections were placed. Steel straps were welded to the ends of the stringers (across floorbeams) to provide continuous support for the timber deck panels.

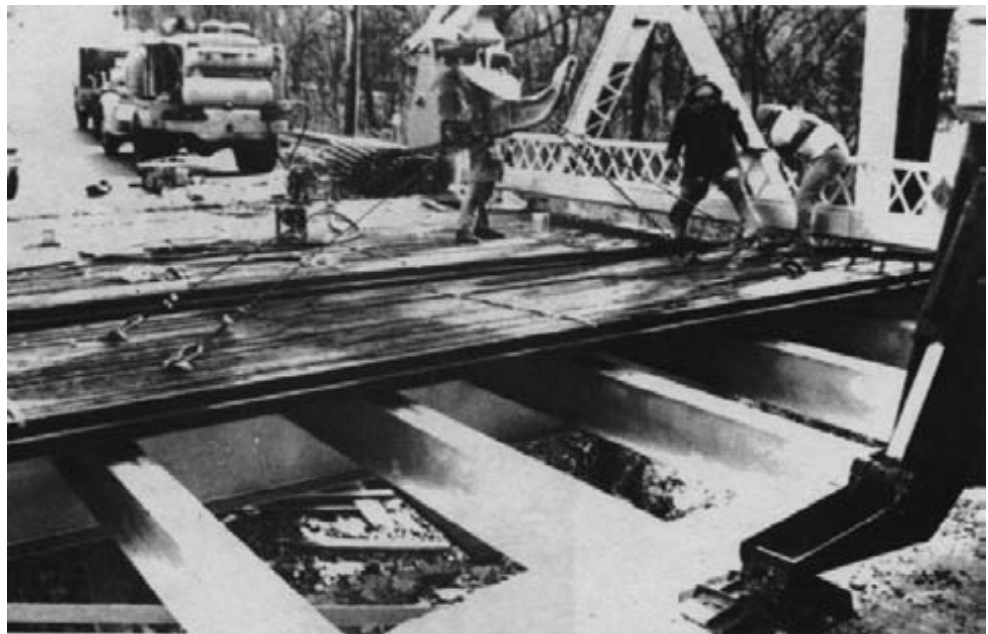
Figure 15-52. - Timber deck panels were provided with four eye-bolts and were banded with straps to facilitate shipping and handling. Panels were fabricated from 3-inch-thick, 6-inch-wide (S1S) creosote-treated Douglas-fir lumber, and were 6 feet 3 inches wide. The individual lumber laminations were laminated together with 5/16-inch-diameter, 8-inch-long ring-shank spikes. Ship-lap-type joints were used between panels, with 1/2-inch-diameter by 5-inch-long drive spikes placed vertically through the joints.

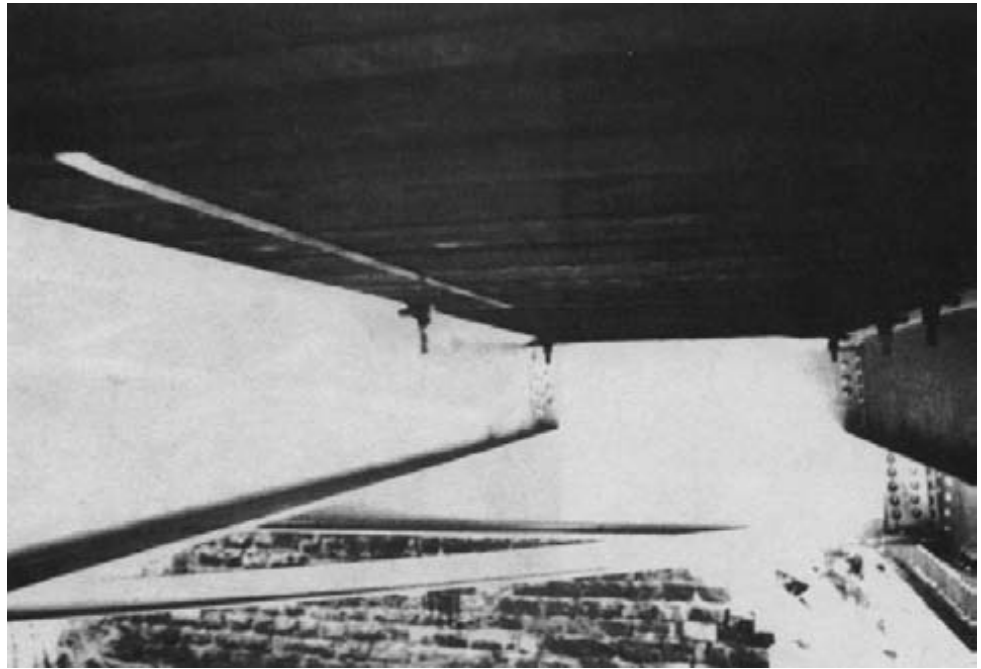
Figure 15-53. - Panels were attached to the stringers with 3/4-inch-diameter by 9-inch-long machine bolts, using a 3/4-inch offset shoe and spring. The offset shoe grips the flange of the stringer, and the compression spring compensates for changes in deck thickness from moisture changes in the timber.

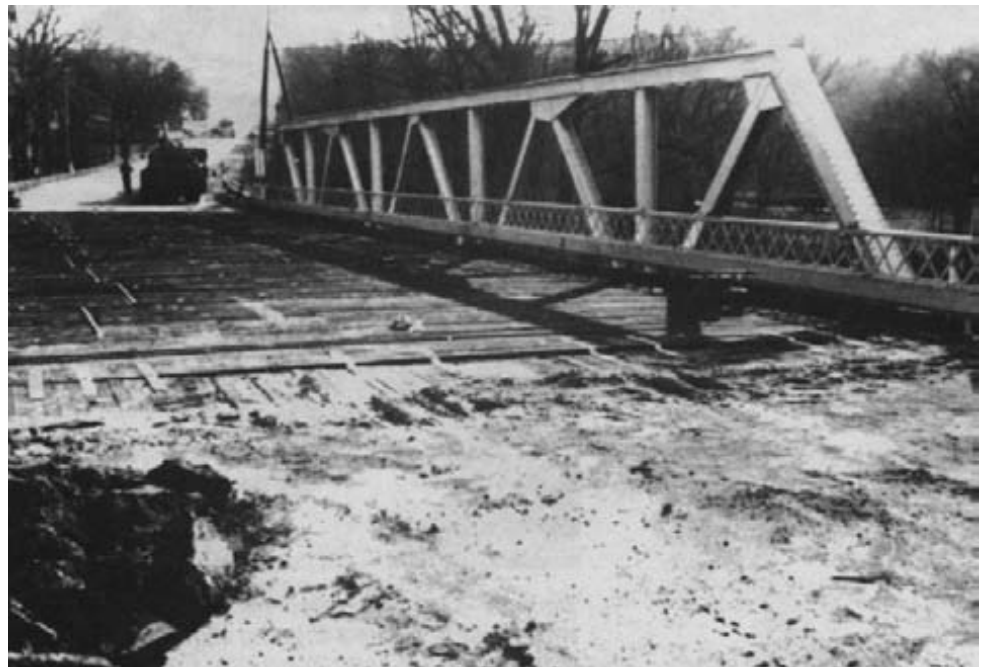
Figure 15-54. - The completed treated-timber deck, before placement of an asphalt-pavement wearing surface.

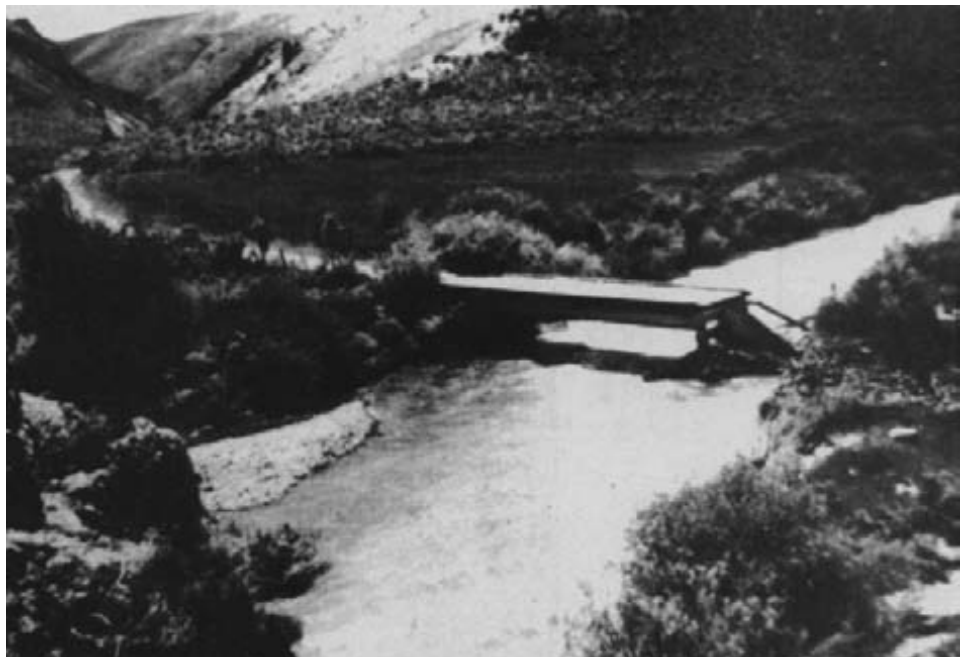
Figure 15-56. - Collapsed span and breached approaches of the existing bridge.

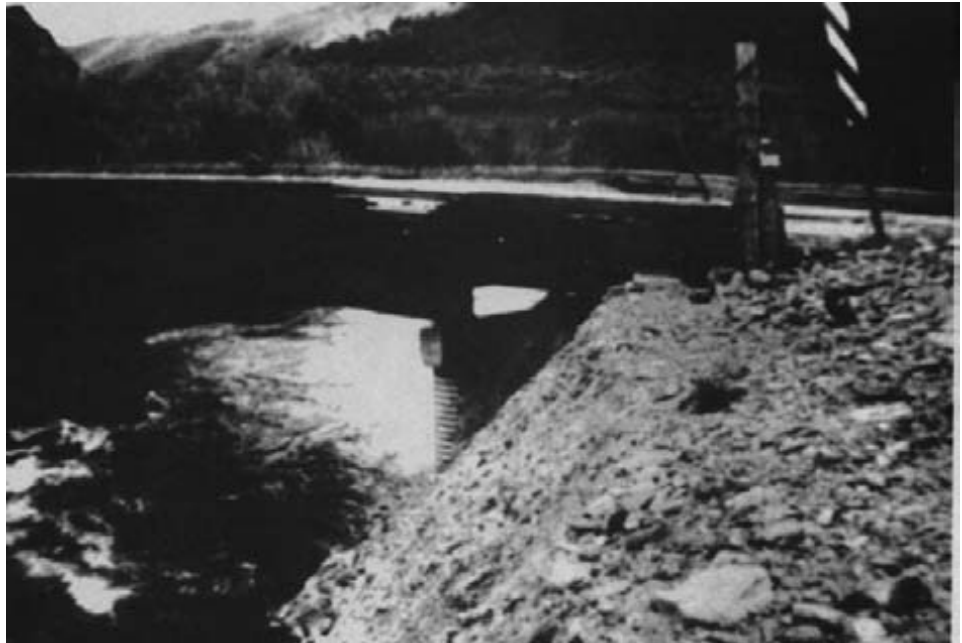
Figure 15-58. - The temporary repair made to the bridge consisted of replacing the approach embankment and lifting the nail-laminated approach span back into position.

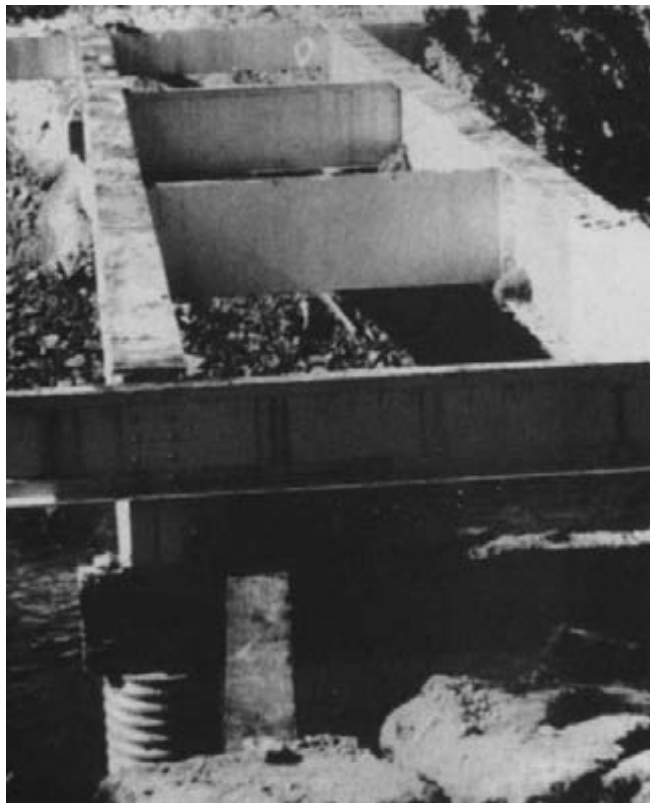
Figure 15-59. - A view of the bridge as rehabilitation began, with the deck, curbs, and timber abutments removed.

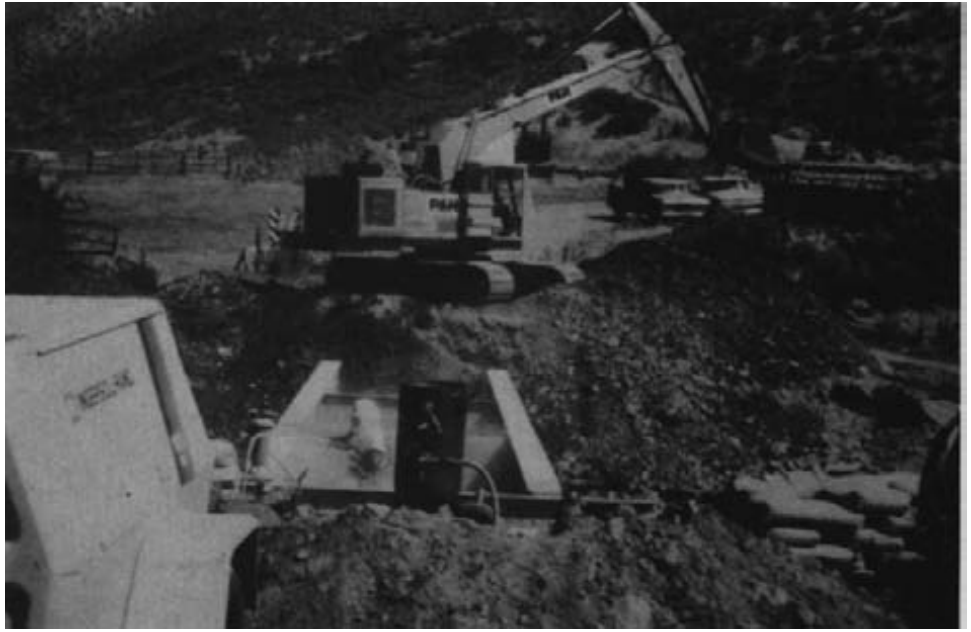
Figure 15-60. - Blast cleaning of the existing steel work in preparation for painting, while a backhoe removes material that was placed for the temporary repair.

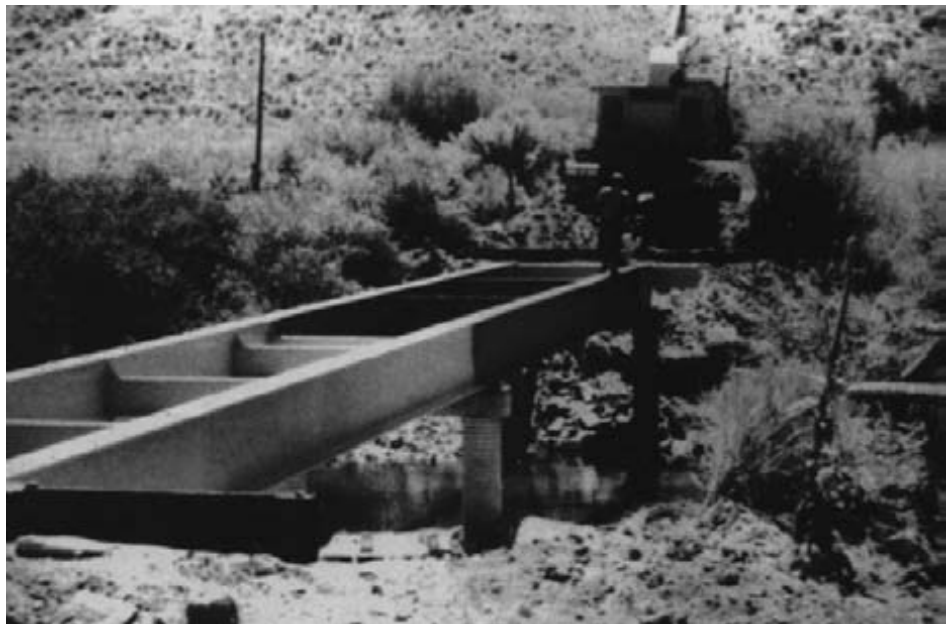
Figure 15-61. - Steel beam extensions in place and pinned to the existing beams.

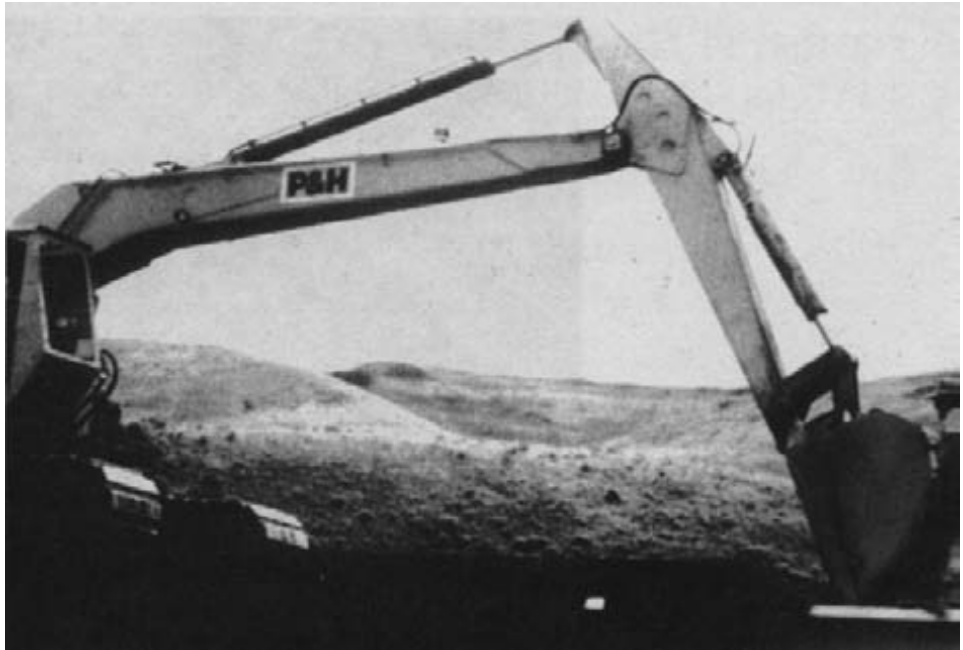
Figure 15-64. - Backhoe pushes panels together after dowels have been aligned. A large timber block was placed across the panel edge to prevent damage from the backhoe bucket.

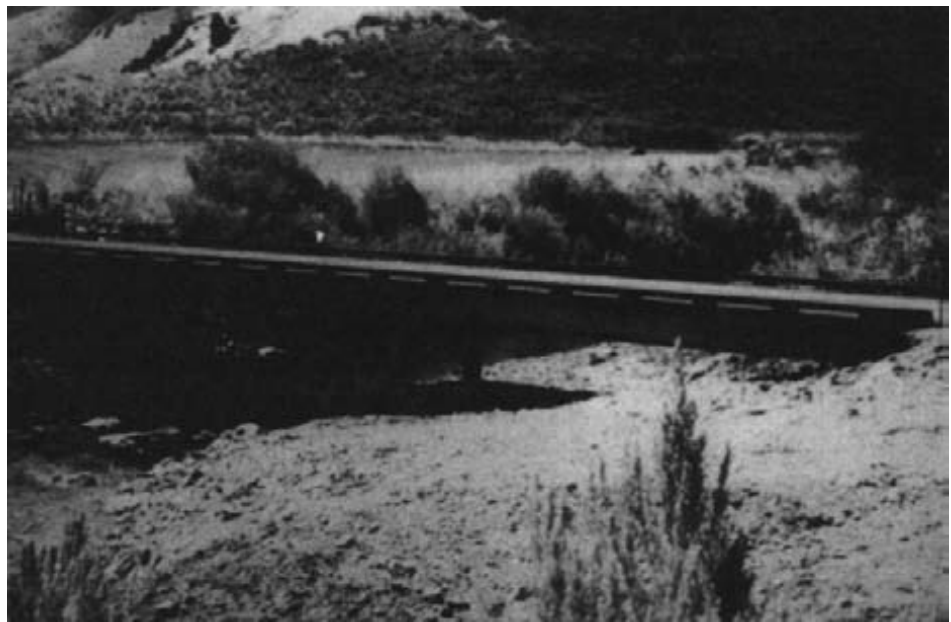
Figure 15-65. - The completed bridge with glulam curb/wheel guards and asphalt wearing surface in place.

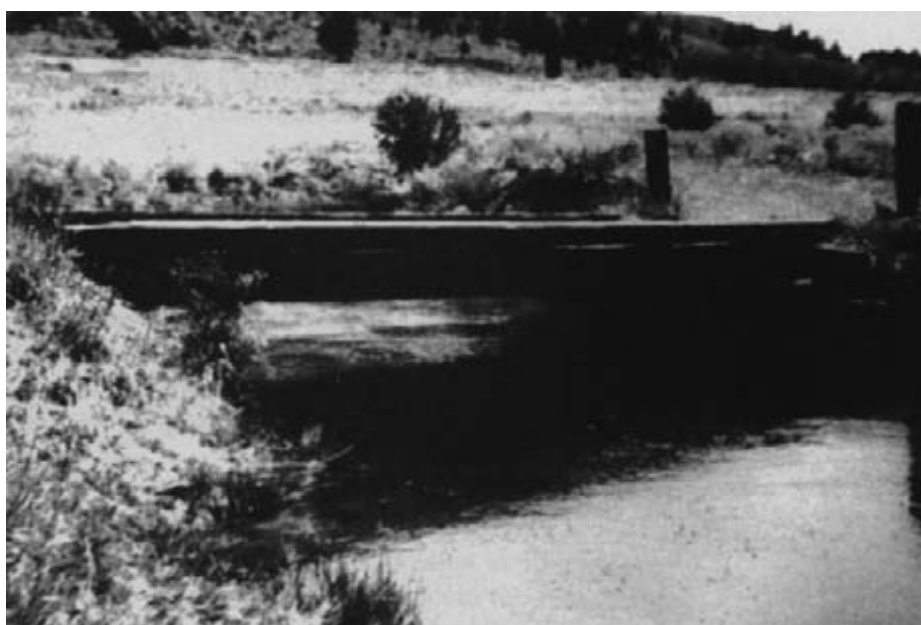
Figure 15-66. - The longitudinal nail-laminated lumber-deck bridge before replacement. The bridge was 26 feet long with a 27-degree skew.
