**BRIDGE MAINTENANCE, REHABILITATION, AND REPLACEMENT:
CASE HISTORIES**

Case History 15.1 - In-Place Preservative Treatment of Deteriorating Timber Bridges

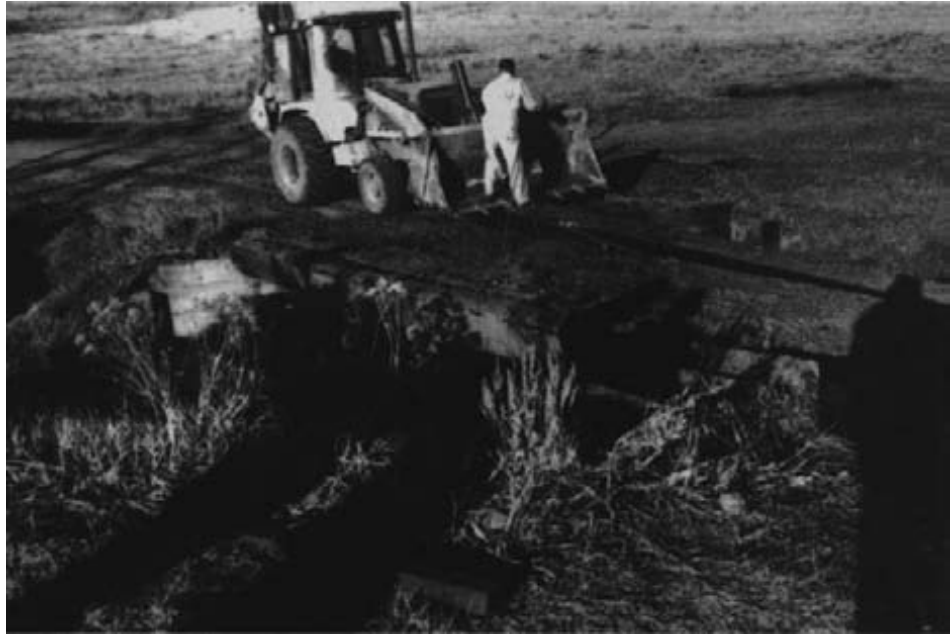
Figure 15-67. - The existing deck was carefully removed in sections to avoid damage to the treated-timber abutment caps.

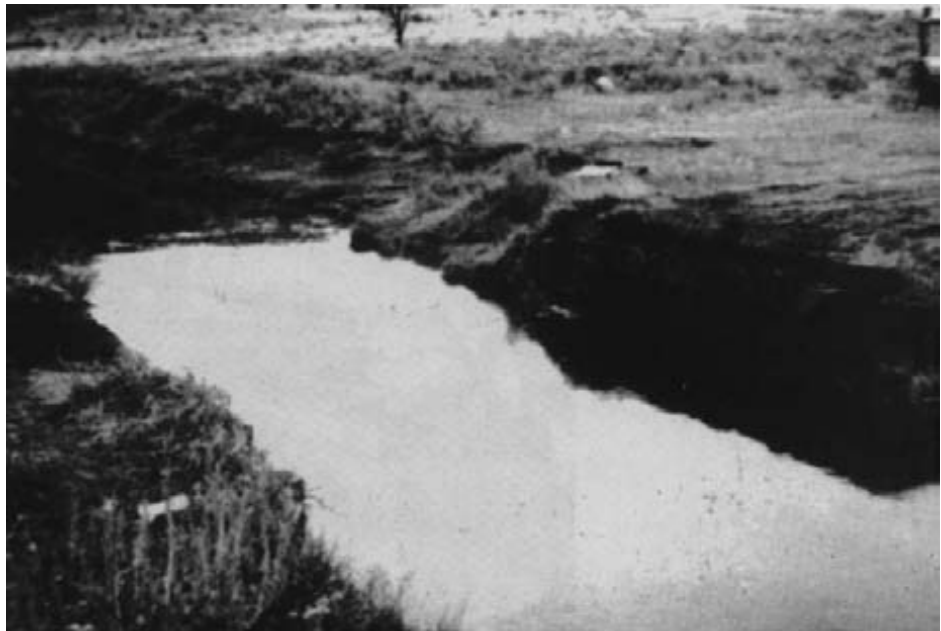
Figure 15-68. - A view of the abutments after the bridge was removed.

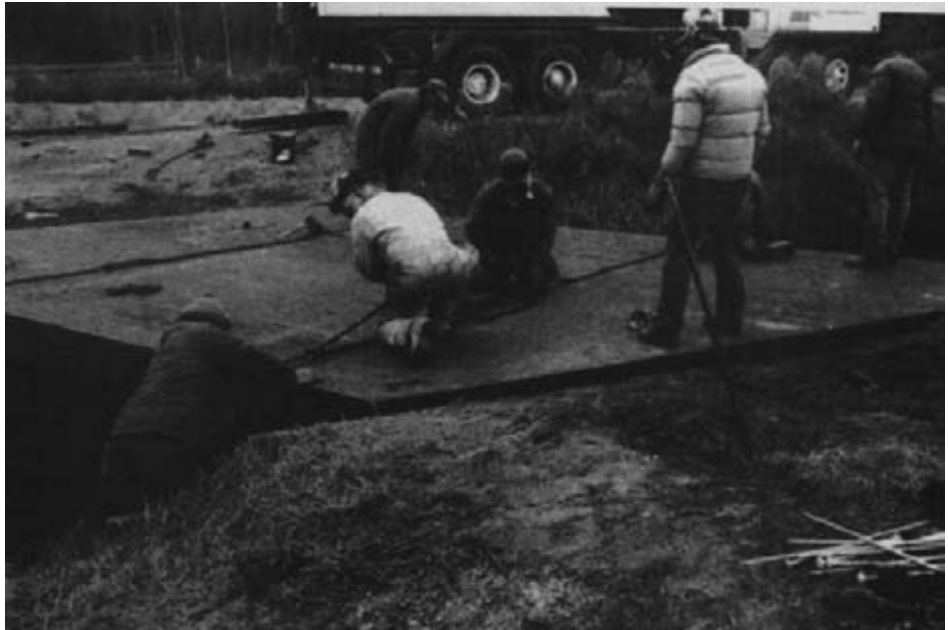
Figure 15-73. - The replacement deck in place.

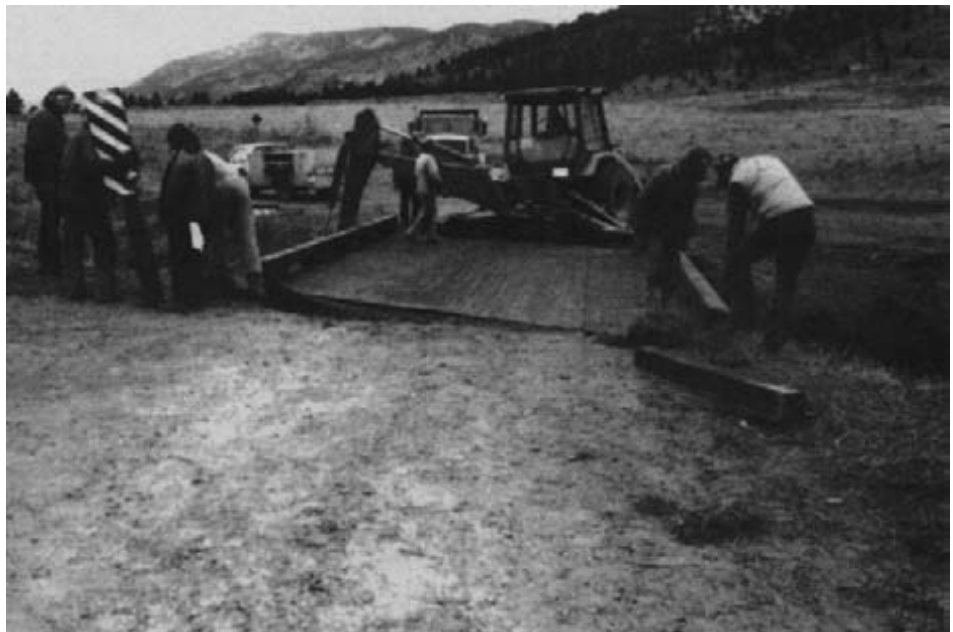
Figure 15-74. - Curbs are attached to the deck.

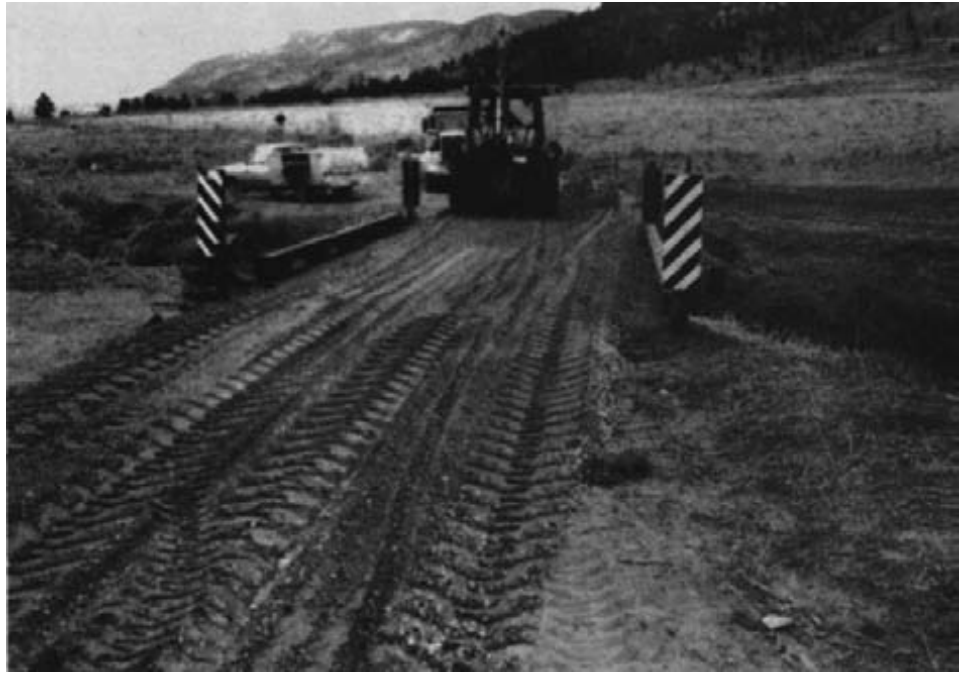
Figure 15-75. - The completed structure with a temporary aggregate wearing surface. The deck was later provided with an asphalt pavement wearing surface.

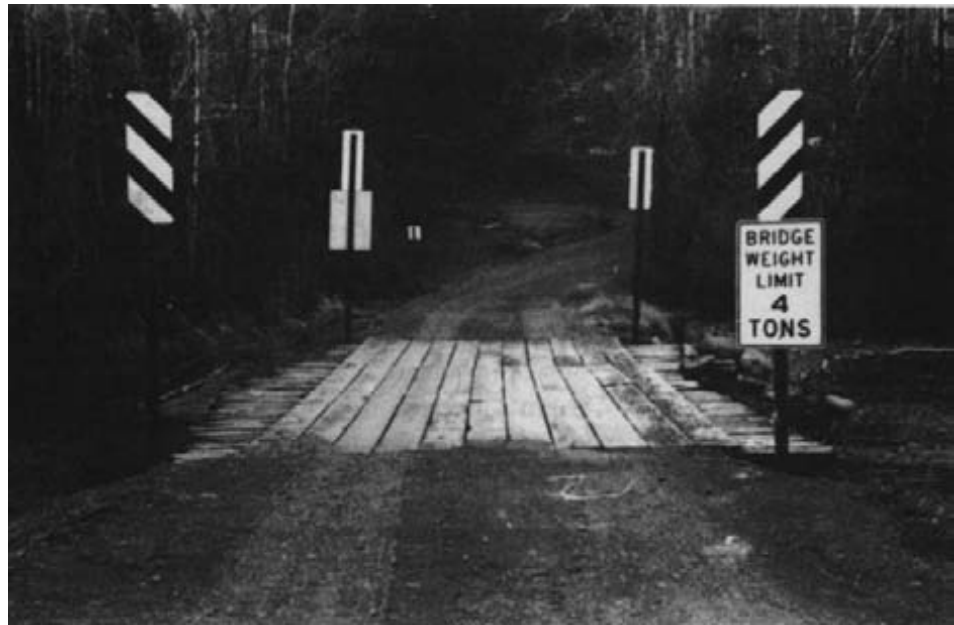
Figure 15-77. - The existing bridge was structurally deficient and load-posted. In addition, it was too narrow and lacked curbs and railing (photo courtesy of Wheeler Consolidated, Inc.).

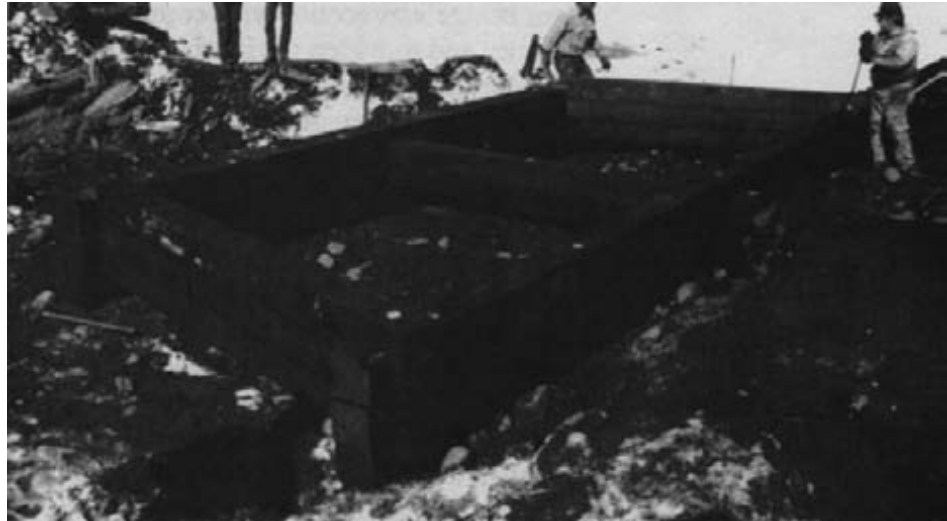
Figure 15-78.-The new crib abutment under construction using precut and creosote-treated Douglas-fir timbers. The only field fabrication involved drilling holes in the timbers for drive spikes used for connections. Such penetration of the protective envelope should have been avoided by drilling before pressure treatment (photo courtesy of Wheeler Consolidated, Inc.).

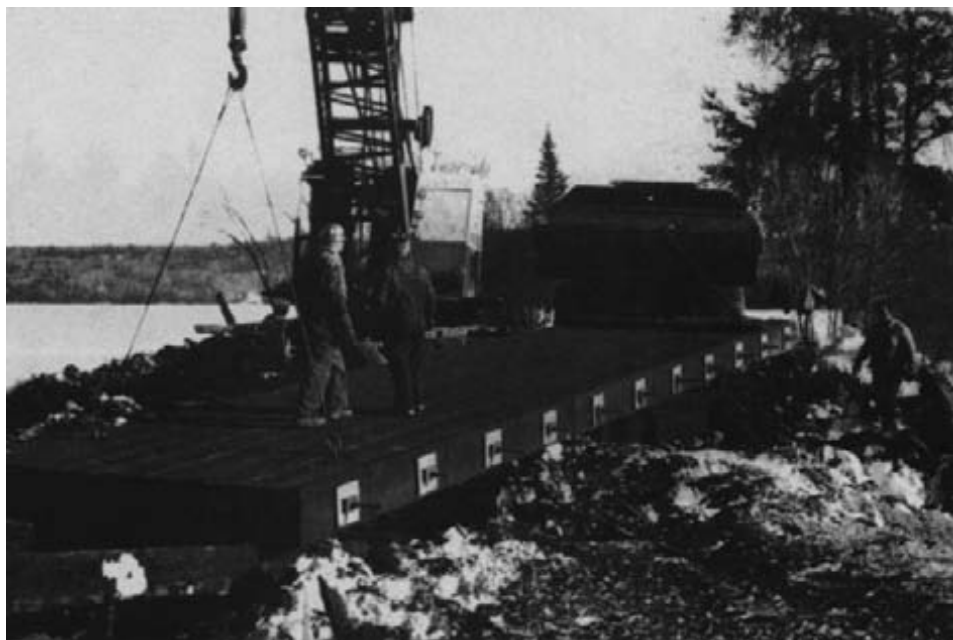
Figure 15-79. - One of the prefabricated, prestressed, bridge deck panels is lifted into position on the treated-timber crib abutments.

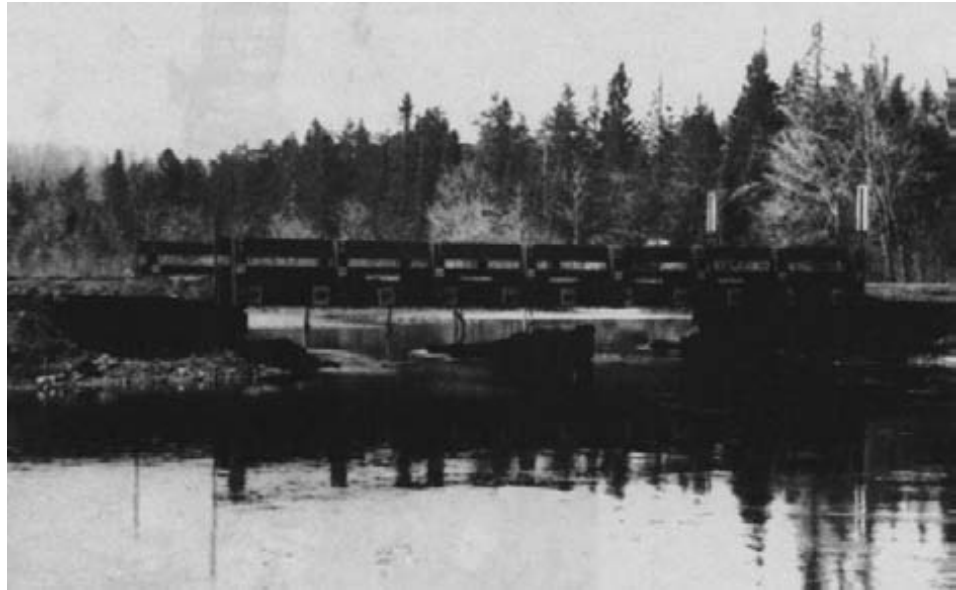
Figure 15-81. - The completed longitudinal stress-laminated deck bridge replaced the existing two-span structure with a single span. The new deck increased load capacity to AASHTO HS 20-44 and included curbs and railing. Remains of the old center support are visible below the replacement structure (photo courtesy of Wheeler Consolidated, Inc.).
