Oregon State Hospital

Framework Master Plan Phase I Report

KMD Architects

May 16, 2005

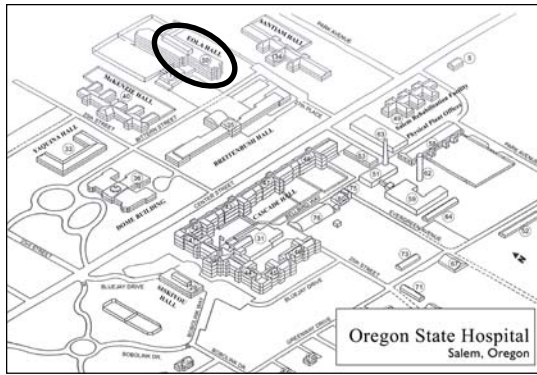
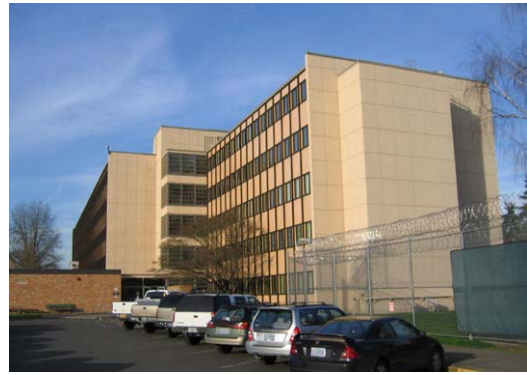
EOLA HALL, BUILDING 50

The newest building housing patients (Building 50, Eola Hall) was constructed of reinforced concrete in the 1950's and remodeled in the 1970's. It might be considered the most likely candidate for reuse. However, if it is remodeled again, current regulations will require that the building be brought into compliance with all current structural, safety and psychiatric hospital codes. This includes structural upgrading to withstand code-determined seismic forces. The exterior glazing, interior walls and ceilings, and plumbing would need to be replaced and the heating, cooling and electrical systems would need to be upgraded. The patient wards that now house up to 44 persons in two-, three- and four-bed rooms would need to be converted into private and semi-private rooms with integral toilet and shower facilities as required by the OAR. This increases the area for patient rooms which will decrease the number of rooms. This suggests that the remodeled building would house about one-third fewer patients.
