BMP Implementation Monitoring – Finger Point Timber Sale; August 28-30, 2006

Summarized by Carol Seitz Warmuth

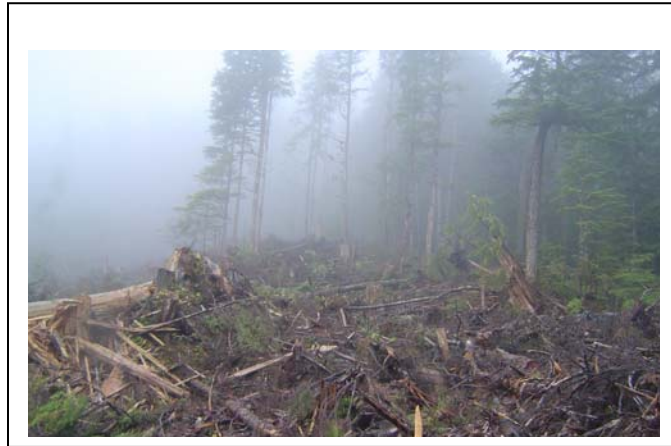
Photo: shows Unit 67

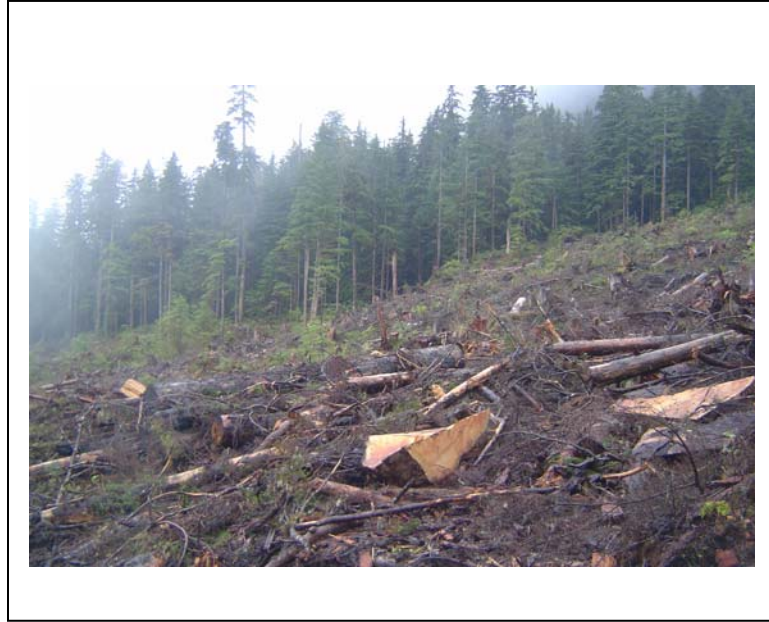
Photo: shows Unit 67; no soil disturbance

- **BMP 13.11/13.14/14.5 Erosion Control Measures- Units, Temporary Roads.** *The team rated this item 5.* Water bars were in place and culverts were pulled. The cut banks were seeded. No water was noted pooling or flowing on the road surface.

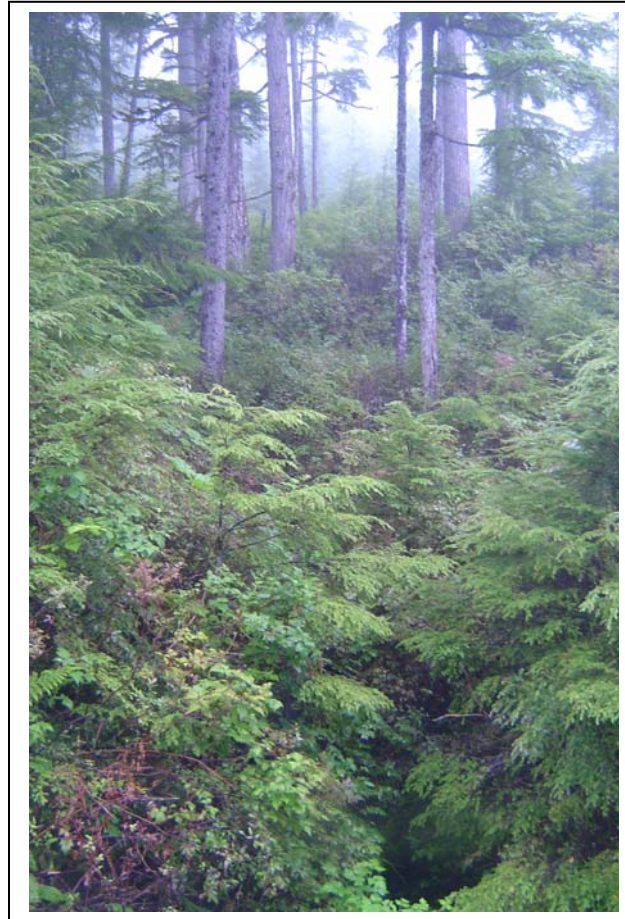
- **BMP 13.16 Stream Channel Protection.** *The team rated this item 5.* The stream protection was implemented on the Class II- III protect stream on the southwest boundary as well as on the Class III stream on the north – northwest boundary. The stream on the north- northwest boundary is highly variable and is marked with conflicting flagging colors. This flagging is probably remnant of various field classification efforts between planning and implementation. This northern stream was prescribed a v- notch buffer and the buffer was implemented. The stream on the south- southwest boundary of the unit was prescribed a 130 foot buffer and the buffer was implemented. This stream was classified as a Class II in the lower reaches and Class III in the upper reaches. Two Class IV streams are shown within the unit. Protection measures were implemented to remove

Photo: shows Class III stream

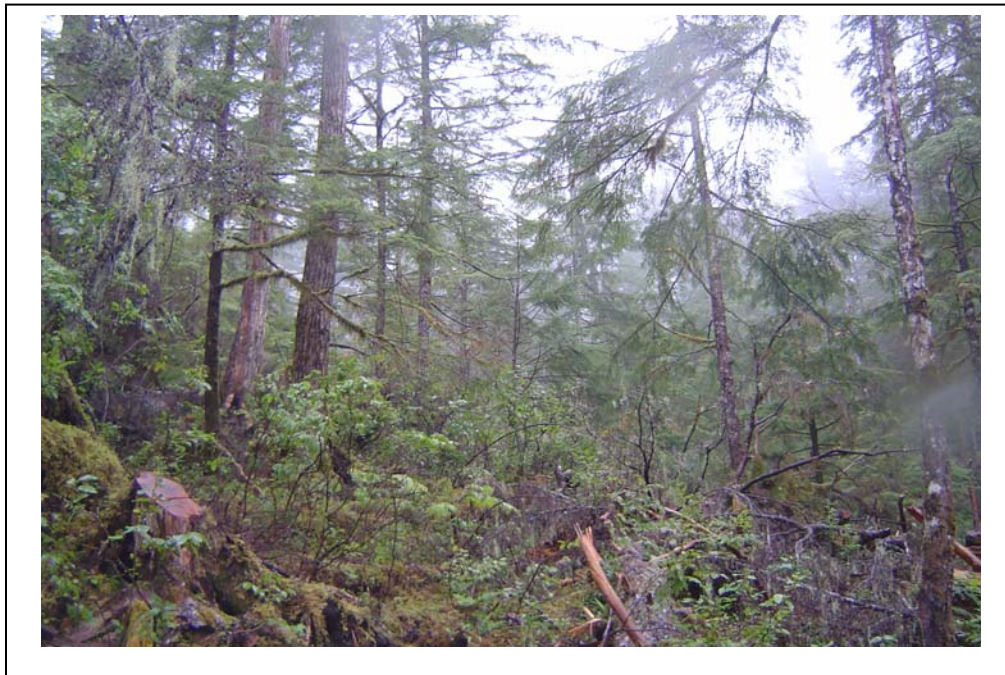
Photo: shows Unit 145

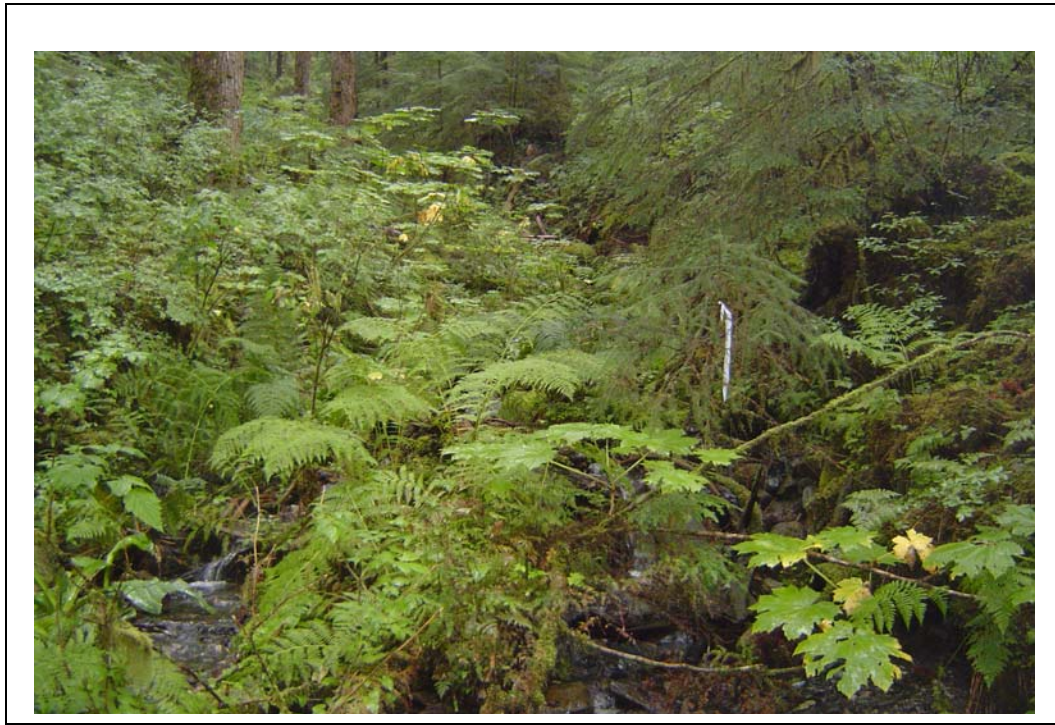
- **BMP 12.6 Riparian Area Designation & Protection/ BMP 12.6a Buffer Zone Design and Layout.** *The team rated this item 5.* A Class III that transitions to a Class II stream is shown on the north side of the unit. A 130 feet buffer was prescribed and implemented on the north boundary of the unit. This 130 feet buffer may have been over conservative in the Class III reaches.

Photo: shows Class II to Class III stream between Units 67 & 145

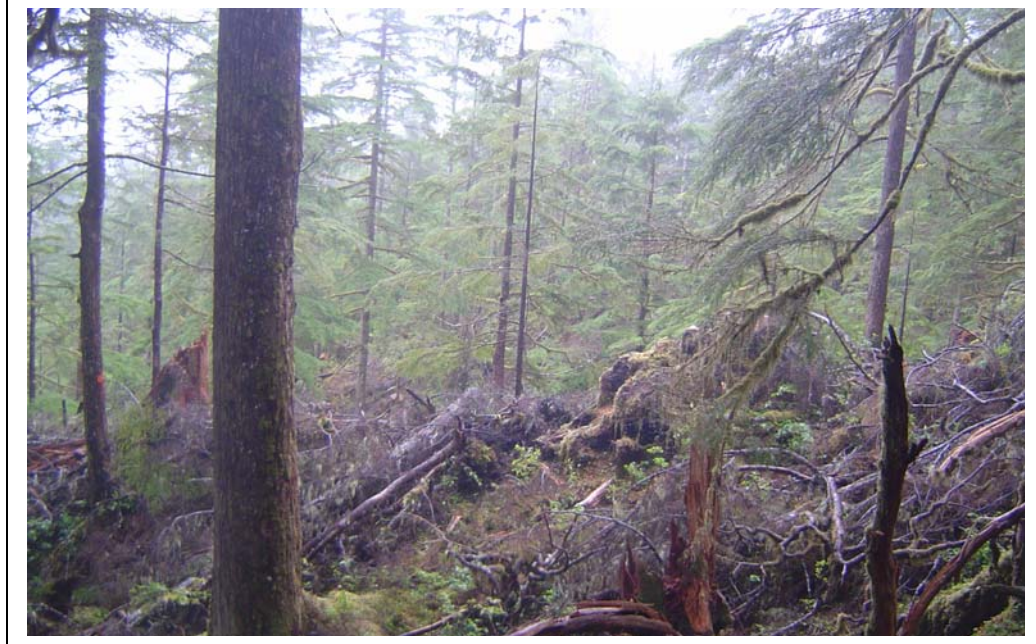
- **BMP 13.11/13.14/14.5 Erosion Control Measures- Units, Temporary Roads.** *The team rated this item not applicable.*
- **BMP 13.16 Stream Channel Protection.** *The team rated this item 5.* The upper Class IV stream was prescribed partial suspension and full suspension was achieved. A log bridged the stream and a wetland area. The log did not appear to be disrupting water flow and was left in place to minimize soil disturbance. The lower Class IV stream has a variable channel and varies between a Class IV and non stream. Full suspension and removal of tree branches from the channel was implemented in the Class IV streams. Reference BMP 12.6 for Class II- III stream description.

Photo: shows Unit 145

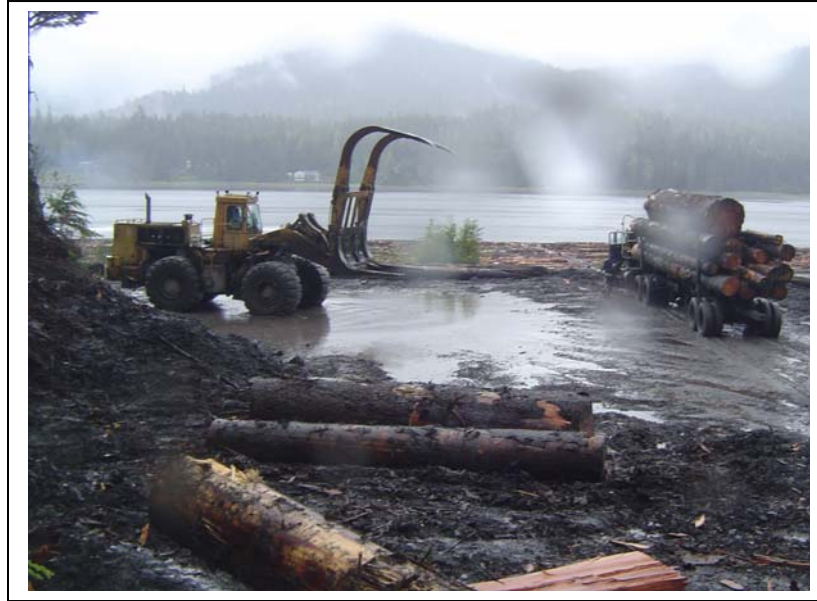
- **BMP 14.26/14.27 LTF Surface Erosion Control Plan Storm Water Pollution Prevention Plan.** *The team rated this item 4.* The NPDES plan was in place. A settling pond was in place in the center of the running surface of the LTF. Site compliance inspection was completed by the environmental engineers June 14, 2006. The loading area should have been retrofitted so the equipment did not run through the settling pond as logs were unloaded and bundled. Rutted soil was noted on the running surface of the LTF with 4- 10” ruts. The SA directed the operator to clean up scrap tree materials and mud and dispose in a designated area. A poor rock source and degrading rock on the surface contributed to the need for continual maintenance at the site. Fuel containment was implemented according to requirements. Secondary containment was shown at the fuel site. The pumps at the fuel site that were secured within the containment. The spill kit was on site. Good housekeeping measures were employed. The fuel tanks were double walled. Fuel records (logs) were kept to show fuel issued verses stored. The tanks were labeled with appropriate placards and fire extinguishers were on site. The LTF was re-surfaced periodically with fresh rock; however, a new lift is needed. A new lift of rock is planned as part of an overall retrofit.

Photo: shows Tonka LTF

There were a few aspects that need follow up action on this timber sale. The sale administrators and engineering representatives worked to limit non-point source storm water discharge at the LTF although the facility design, minimal size of the facility, and poor quality surface rock is limiting the function of the structure. The LTF showed a settlement pond constructed to attenuate sediment transport and logs laid at the edge to hold back surface material. Due to the poor rock quality, low slope of the LTF surface, and timber haul/ transport at the facility, continual maintenance of the facility is necessary and has been directed by the Sale Administrator and Engineering Representative. The deep mud and rutted running surface of the LTF and bundling area may contribute sediment to the ocean. The lack of a functioning settling pond and ditch system at the LTF may contribute to the LTF running surface eroding and sediment transport during major storm events. This LTF facility needs grading, an additional lift of more durable rock, and re-designed to provide for a settlement pond that is outside of the roadway and running surface of the LTF. Recommendations include follow up on these action items immediately to improve the running surface and during the next operating season for the more extensive modification. According to the Timber Sale Administrator and Engineering Representative, the surface was scrapped of mud and some rock was spread following this monitoring trip. Additionally a retrofit design has been prepared with reconstruction work scheduled for 2007.

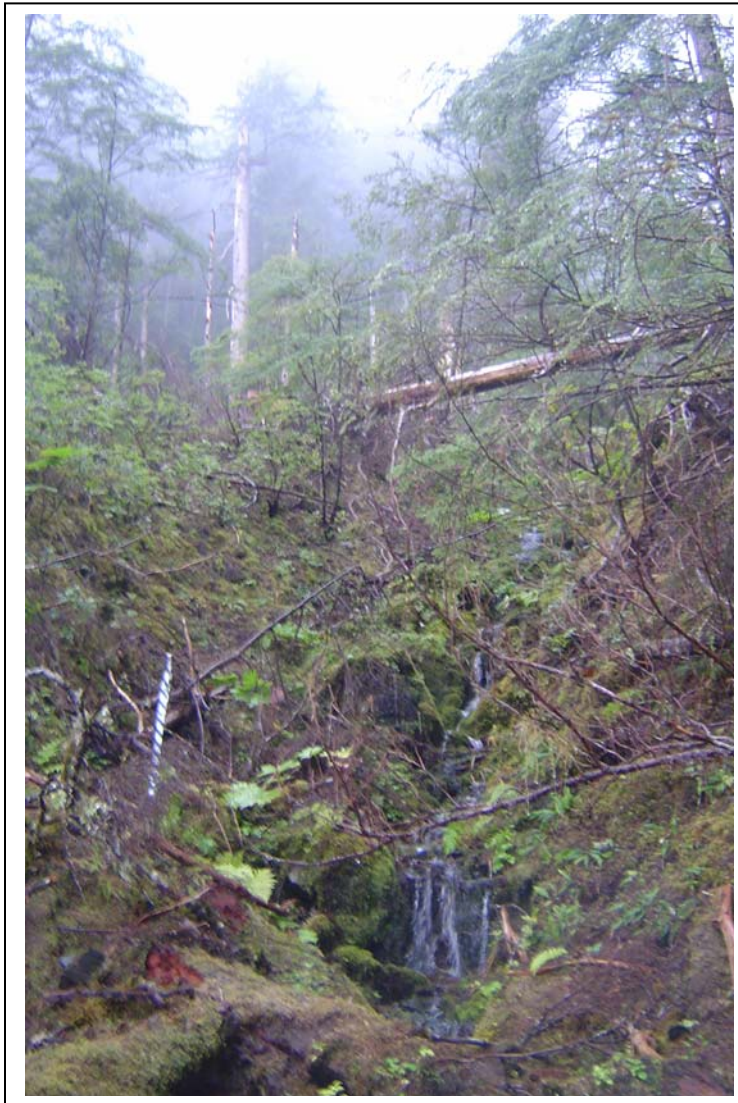
Unit 145 shows two Class IV streams in addition to the Class III stream discussed above. The Class IV stream channels showed bank full widths of 1-5 feet and incision depths of 0- 10 feet in the 5 transects measured. Some of the stream channel shown on the lower drainage was a wet area without an established channel. This area was relatively flat and there was no distinct flow. The lower reach of the one Class IV stream may have been a non-stream. In some reaches of the northern channel and the southern channels the bed load was angular sand to cobble size material. In a few reaches the bed load was primarily organic soils. There was vegetation shown in the channels and moss growing on the rocks.

Photo: shows Class IV stream in upper edge of Unit 145
