# **Best Management Practices Implementation Monitoring Trip Report**

## **Thomas Bay Fish Passage Improvements Culvert Replacement Project**

September 6<sup>th</sup> and 7<sup>th</sup> 2006

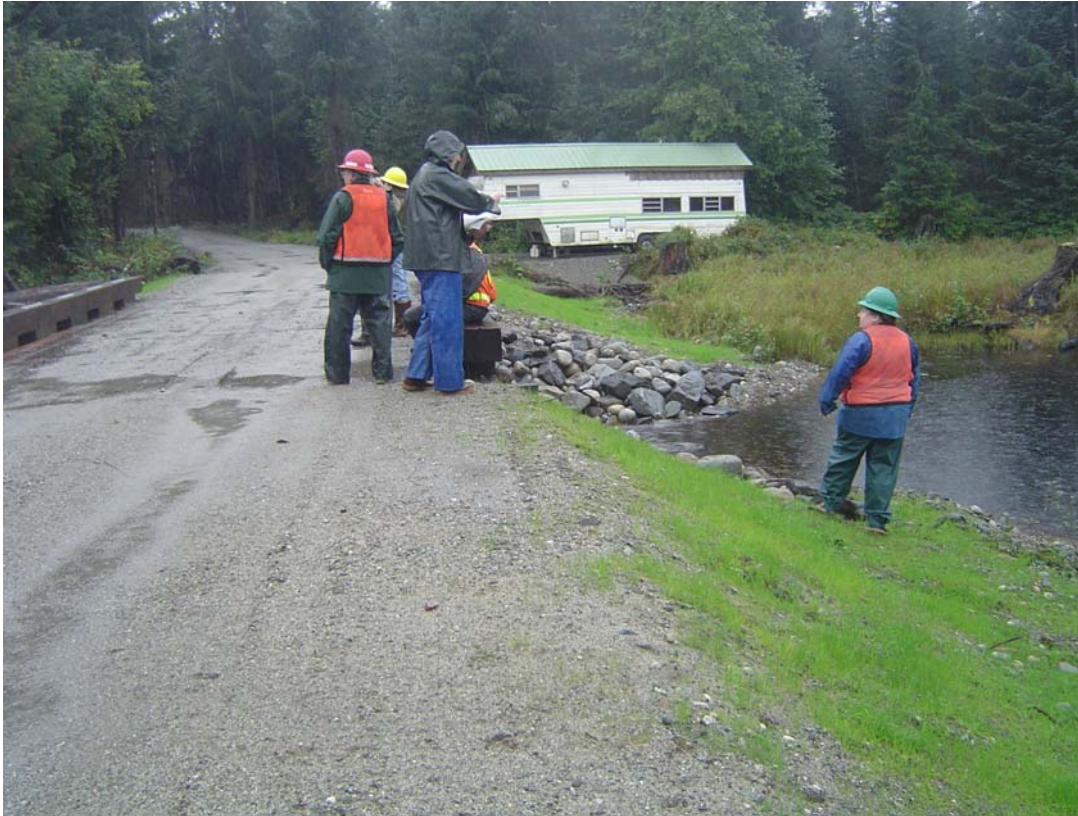
This BMP applied to all sites. All sites monitored are slough-like and act as connections between the main slough and Muddy River. Flow here can be ground water dependant and the road prism does interfere with flow and has probably created the pond and wetland condition in some locations. All sites maintained the pre-construction water levels and wetlands upstream with the exception of site C and D. At site C, a minor reduction in the pre-construction pond level to allow consistent flow through the culvert and at site D the pre-existing pond level was lowered 1 foot to achieve a lower gradient and slower flow through the pipe per design.

Contract Daily Diaries documented seeding within specified timing window. Vegetation was established at all sites (see Photo 1). This BMP received a rating of five, reflecting full implementation.

Photo 1. Site E, Bridge at Road 6256 MP 3.543. Photo taken looking towards Thomas Bay. Note well-established vegetation (BMP 14.8). Note placement of riprap along banks (BMP 14.17), and rock weir partially visible was used to maintain the preconstruction pond elevation (BMP 12.5).

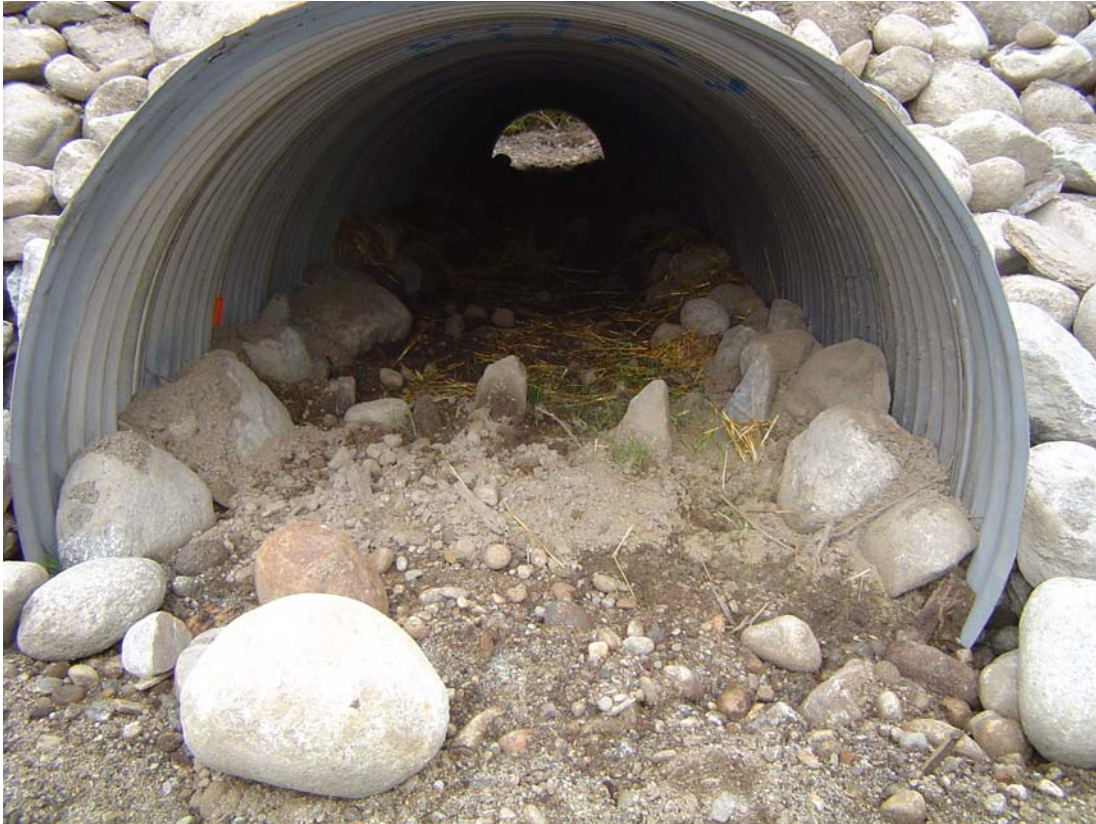
material at culvert inlets were functioning and maintaining upstream water levels. Site C had yet to receive surface flow so there was some question as to the design elevation of this structure.

Photo 2. Culvert inlet at Road 6256 MP 3.244. Dry Channel, note the rock weirs, channel banks and rip rap.
