Submarine Division of the Naval Safety Center Factual Lines About Submarine Hazards

Jul-Sep 08

Table of Contents

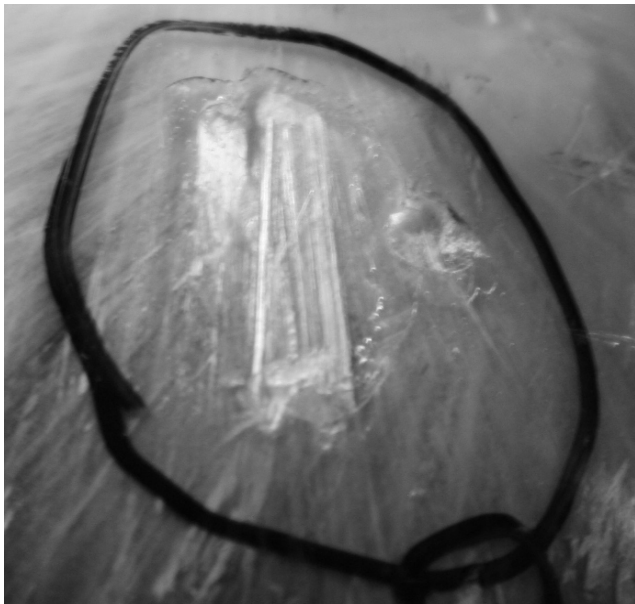
SCBA BOTTLE DAMAGE

After surveying more than 50 ships this past fiscal year, I have noticed a growing trend in the number of SCBA bottles that meet the requirement of the 5519/016 R-2 MRC to have the bottles repaired. After numerous discussions with the DCPOs and their commands, I have found that there is not a clear idea on where to get the bottles repaired or hydrostatically tested. The 5519/016 U-1 MRC has the following website link that will give you a listing of the fifty

http://hazmat.dot.gov/sp_app/approvals/hydro/hydro_retesters.htm. On that list, some of the companies are also authorized to perform repairs to the SCBA bottles also. The following companies from that list are authorized to perform SCBA bottle repairs.

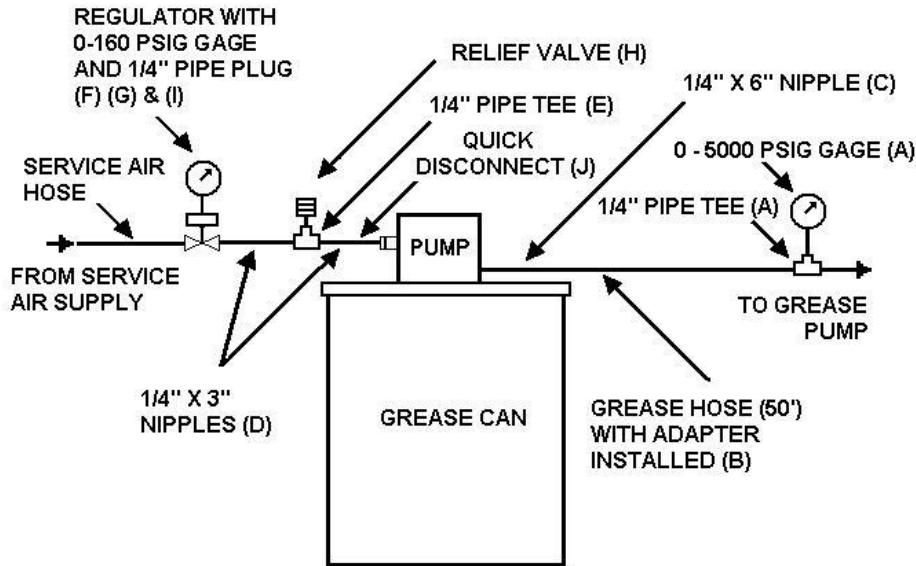
Extract from Ref b

Yes, those dreaded, monstrosities that we drag out periodically to grease the steering and diving system, torpedo tube system and other equipment. Too often they are **broken** out, used, and thrown back out of the way without being checked out correctly. Broken is the key. Our safety surveys reveal more than 90% of the pneumatic grease guns did not meet the requirements of the Submarine Greasing Handbook, NAVSEA T6350-AA-HBK-010.

Gauges are smashed, regulators don't work, or they are not even installed.

Figure (1) from reference (a) shows the correct configuration for the grease gun. It is important to rig it correctly to ensure the safety of the operator and to prevent the grease lines from rupturing due to over pressurization. You can find guidance on setting up your pneumatic grease gun based on gun type and supply air pressure on page 2-7 of reference (b). Each

- (A) Gage (2-12" Shatterproof 0-5000 psig)
 - (B) 50' Grease hose (with 1/4" NPT x 1/2" 27 NS taper male adapter)
 - (C) 1/4" x 6" pipe nipple
 - (D) 1/4" x 3" pipe nipple
 - (E) 1/4" pipe tee (2)
- Note: Refer to Table 4-1 for NSNs

- (F) Low pressure air regulator
- (G) Low pressure gage (0-160 psig)
- (H) Low pressure air relief valve
- (I) 1/4" pipe plug
- (J) Service air quick-disconnect type fittings

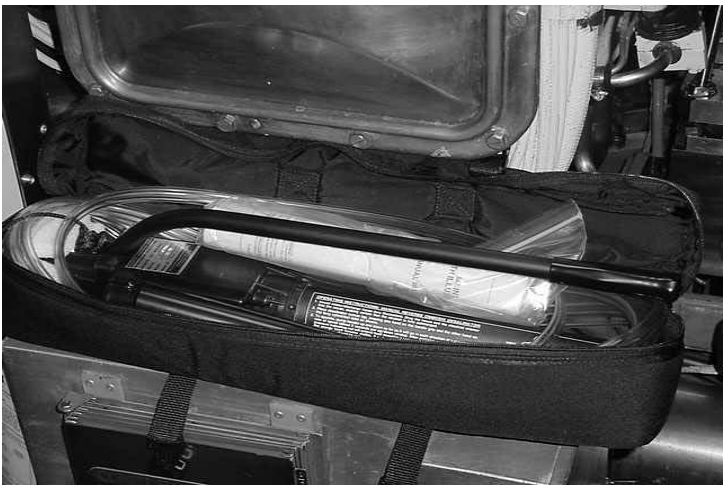
Desalinator kit

you complete the 48M-1 on all of your desalinators upon receipt. The reason, the majority of the boats with the SEIE suit modification have desalinator kits that were manufactured at least six years ago. Completing the PMS now, versus 48 months from now, will ensure the equipment functions properly when needed.

Don't wait until you need it to find out the SEIE suits have problems and the desalinators do not function properly. Besides, if there are problems with either one, it's better to identify them now.

Next is the 48M-1. The 48M-1 details a test maintenance procedure. I strongly recommend
