Submarine Division of the Naval Safety Center Factual Lines About Submarine Hazards

March 2006 Top Deficiencies of 2005

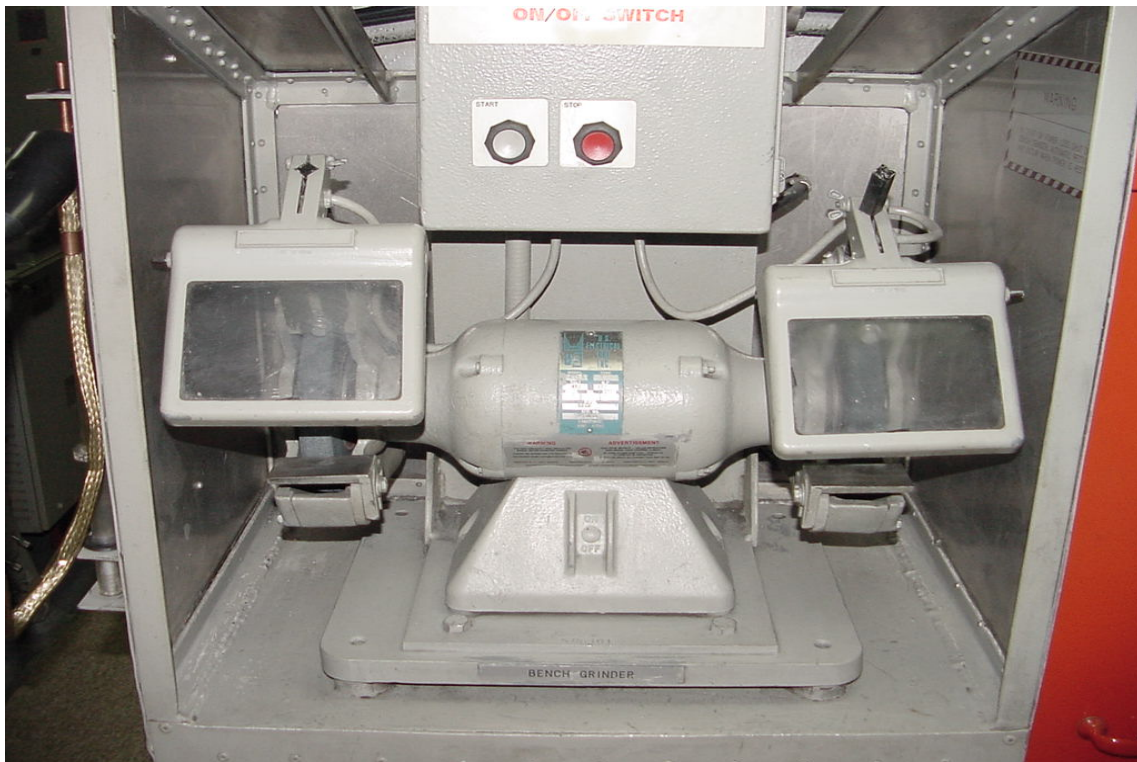
Bench Grinder Set Up Correctly

75% percent of submarines surveyed in 2005 had mechanically unsafe bench grinders. Noted discrepancies included **65.6%** misaligned/missing tool rests, **75%** broken /missing point of operation guards (chip shield), and **54.8%** worn grinding wheels most with embedded non-ferrous materials. Embedded metals in grinding wheels can cause them to fly apart at high RPMs. Usually the embedded materials are non-ferrous, and should not have been allowed to be tooled on the grinder. These conditions could lead to serious personnel injury.

Inspect your bench grinder to ensure it is safe for operation. Attention to detail in performing MIP 6603/001 is paramount. Chapter D8 of [OPNAVINST 5100.19D](#) and MIP 6603/001 provide guidance on the maintenance required to ensure a safe working environment. Identifying and accomplishing PMS correctly is not only a requirement, but also a time-tested, proven method to keep your bench grinder safe.

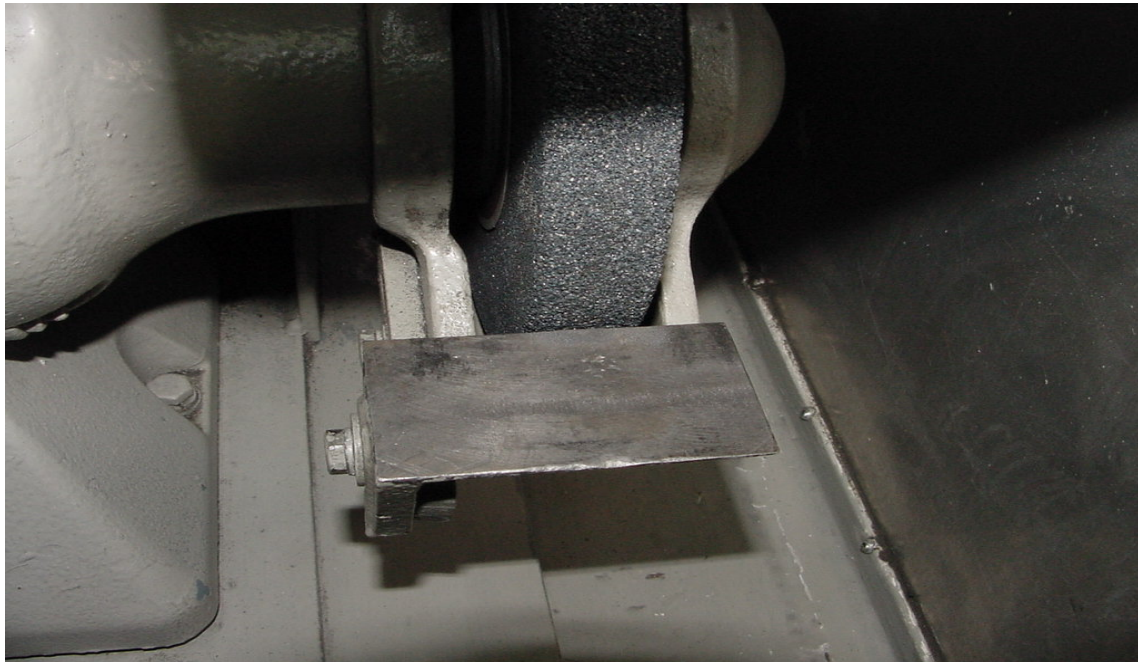
Tool Rest Correctly Adjusted

- A. Using a dressing tool to eliminate grinding wheel imbalance and possible disintegration.
- B. Adjusting tool rests to within 1/8th of an inch of grinding/wire wheels.
- C. Adjusting the grinding wheel hoods facing the operator to not less than 25 degrees

and not more than 65 degrees from a vertical line drawn through the spindle center.
