U.S.S. IOWA
EXPLOSION

Sandia National
Laboratories' Final
Technical Report

**SANDIA NATIONAL LABORATORIES
REVIEW OF THE USS IOWA INCIDENT**

AUGUST 1991

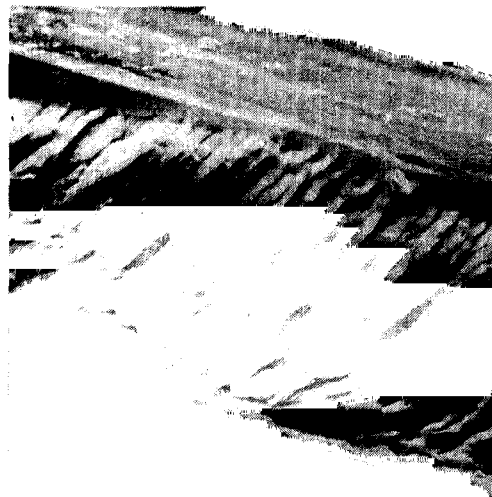
Conclusion: The physical appearance of fibers found in the cannellure is not consistent with that expected of fibers exposed to temperatures above the melting point. The relative absence of steel wool in the cannellure following full scale field tests using a chemical ignition device to initiate an explosion is consistent with ballistics modeling that predicts the general flow of gases away from the cannellure. These and other results regarding fibers suggest that the steel wool in the rotating band of the center gun projectile was present before the explosion and is unrelated to its cause.

Figure 8. A photograph of an iron fiber.

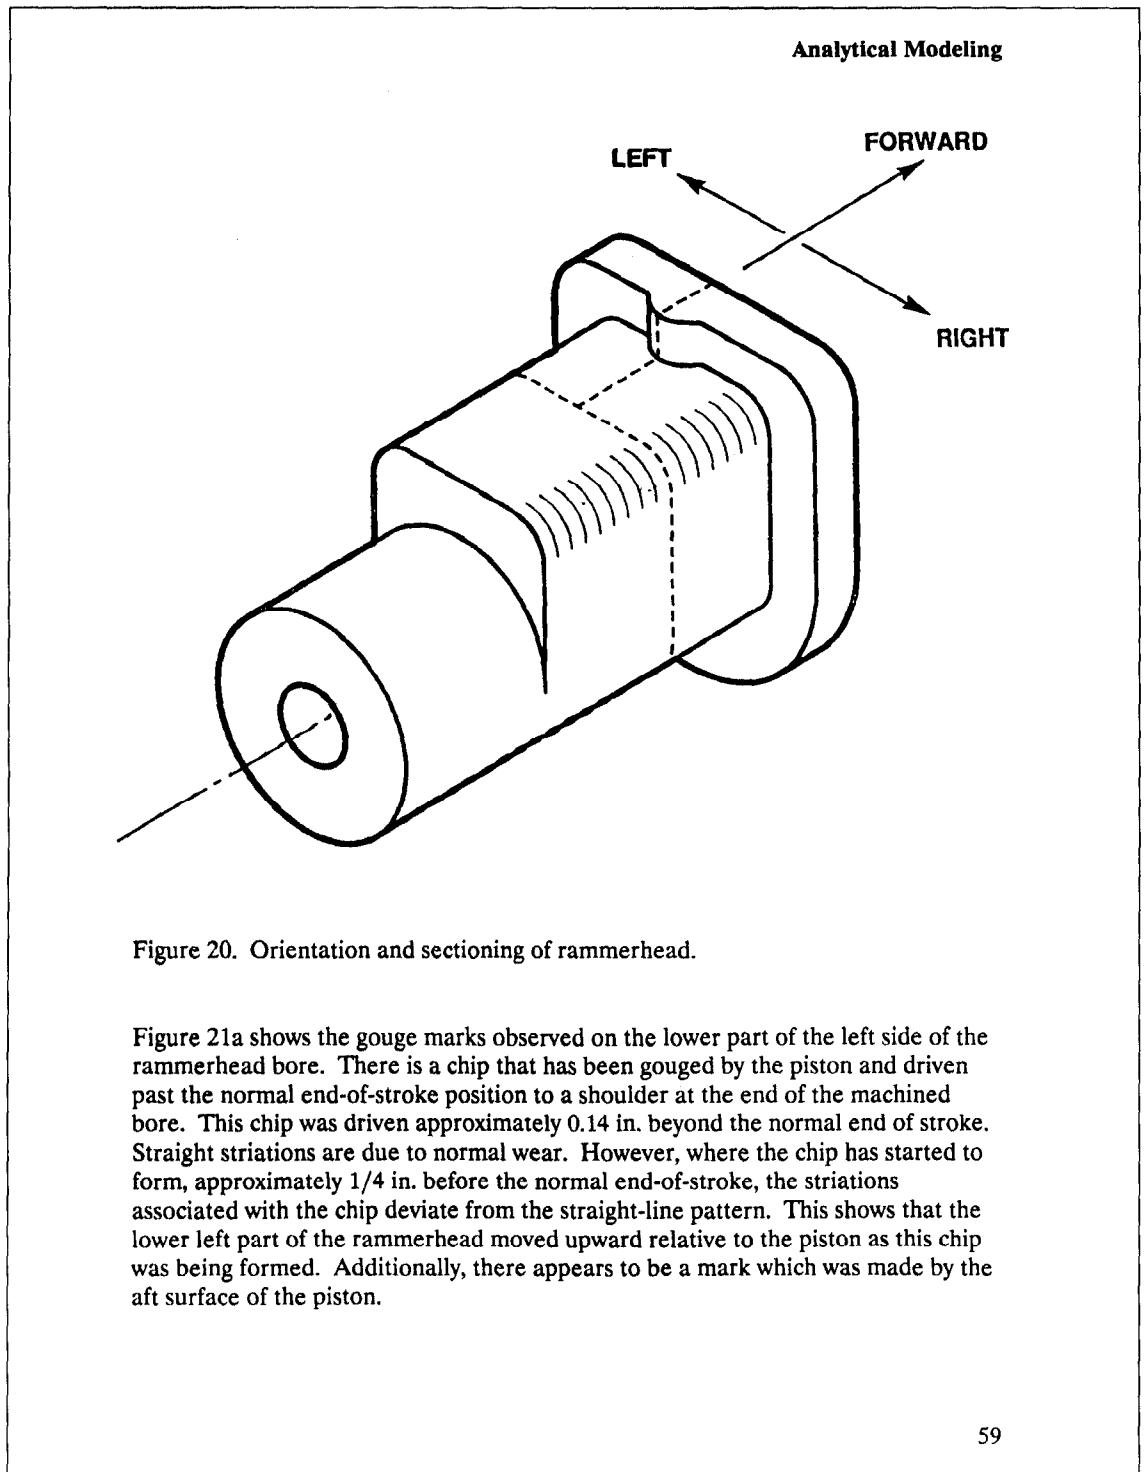
It was reasoned that the rammerhead might exhibit marks that would indicate the position of the rammerhead buffer at the time of the incident. To investigate this, the rammerhead was sectioned, as is shown in Figure 20. The forward section on the left side of the rammerhead was also cut horizontally near the center of the bore. Examination of the bore of the rammerhead buffer (Figure 21) showed two gouges.

It is concluded that these gouges and chips were produced during the incident and were not the result of ordinary wear, for two reasons. First, the chip on the left side has clearly been raised beyond the normal limit of buffer stroke. This requires that the spring break and, by a lateral offset of the broken ends, allow slightly more axial travel of the rammerhead relative to the piston. Second, the constant churning of fluid in the buffer should ultimately have caused the relatively delicate chips to bend, fatigue, and break off if they had been formed at an earlier time.

Figure 21. Photographs of gouges on (a) left side and (b) right side of rammerhead buffer cylinders.

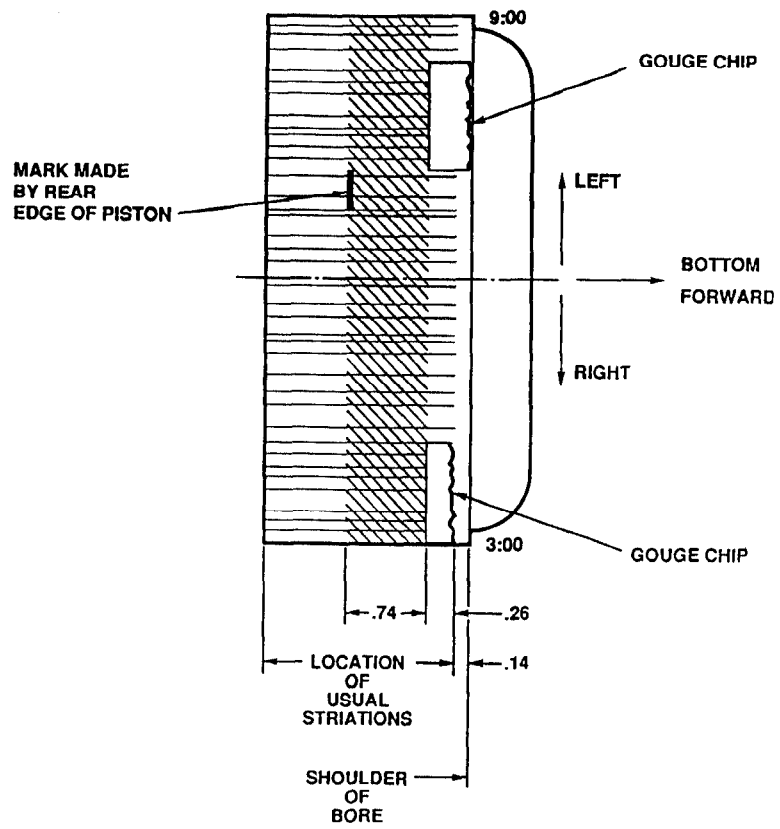
Examination of the front of the rammerhead shows that the right side of the buffer had received considerable damage caused by the impact with the bulkhead. On this side, the marks clearly show that the upper right side of the rammerhead impacted the small buffer located on the bulkhead. It is reasonable to associate the formation of the chip on the right with the impact of the rammerhead into the bulkhead, and the chip on the left with the initial blast force.

Figure 22. Developed surface of lower half of rammerhead bore.

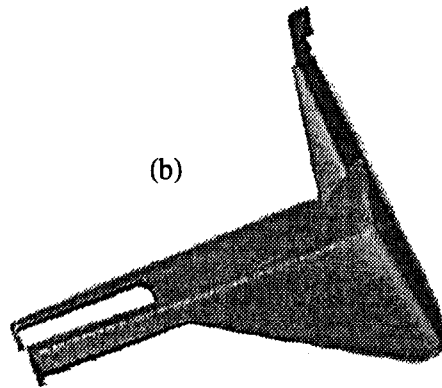
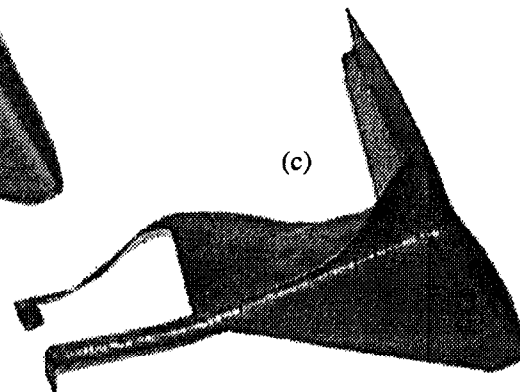
Figure 24. Photograph of:
(a) deformed rammerman's seat
(b) scale model of "as-designed" seat and
(c) scale model of "as-built and bent" seat

The top aft edge of the "as-built" seat also differs from the "as-designed" in that about one-half of the inboard side of the mounting flange had to be removed to clear piping mounted on the bulkhead. Figure 25 shows the location on the rear gun bulkhead where the seat mounting flange was secured by two 1/2 in. bolts. Directly outboard of the seat is a sheet metal mounting clip that secures two pipes in the corner of the gun room. Since this clip is undamaged, it can be concluded that the seat motion could not be directly outward since this would have crushed the clip and pipes. The rammerman foot rest also constrains the motion of the seat in the forward direction. The aft face of this foot rest on the USS IOWA was located 25 in. forward of the rear bulkhead. This permits about 5 1/4 in. of forward motion before the forward leg (which according to Figure 24a is virtually unbent) of the seat strikes the foot rest.

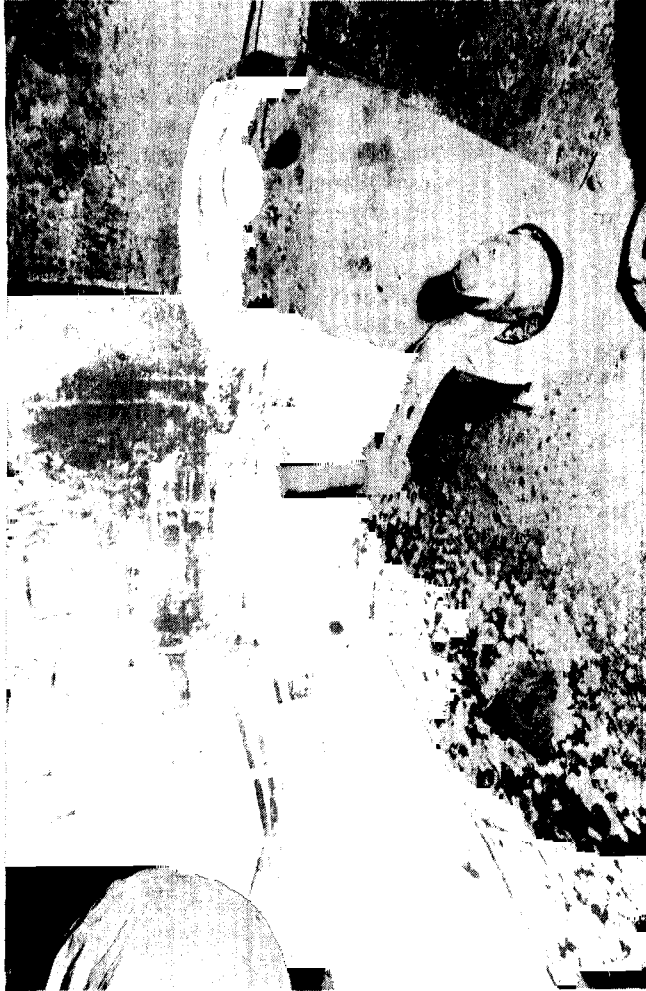
Figure 25. Photograph of rear corner of gun room with seat removed showing undisturbed piping in corner and bent, dislodged quadrant.
