**HURRICANE KATRINA:  
WHY DID THE LEVEES FAIL?**

COMMITTEE ON  
HOMELAND SECURITY AND  
GOVERNMENTAL AFFAIRS  
UNITED STATES SENATE

\_\_\_\_\_  
NOVEMBER 2, 2005  
\_\_\_\_\_

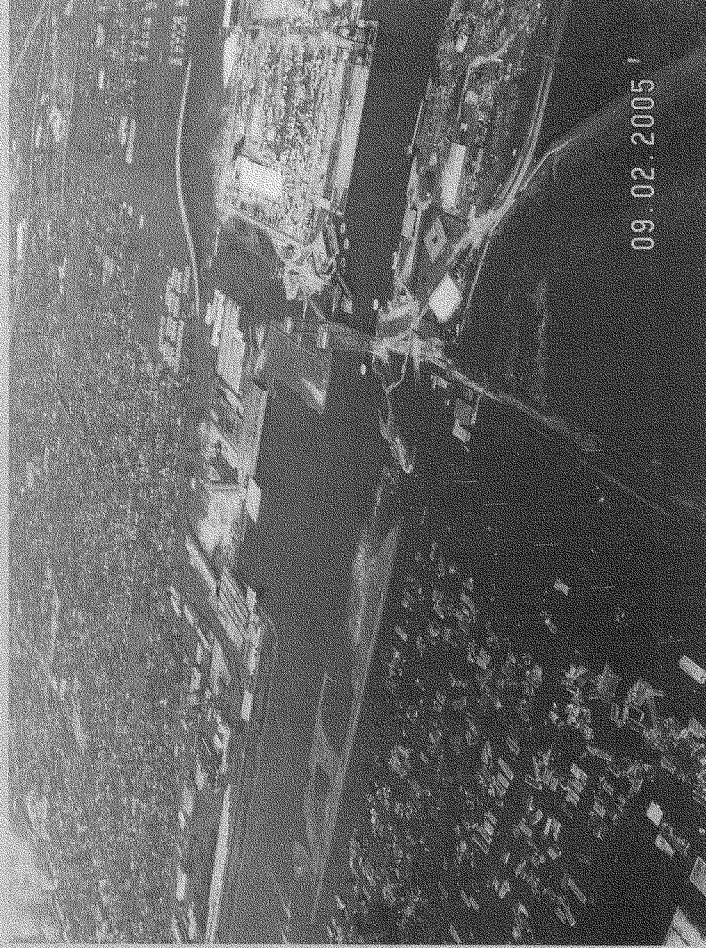
Levee Failure on East Side of Industrial Canal

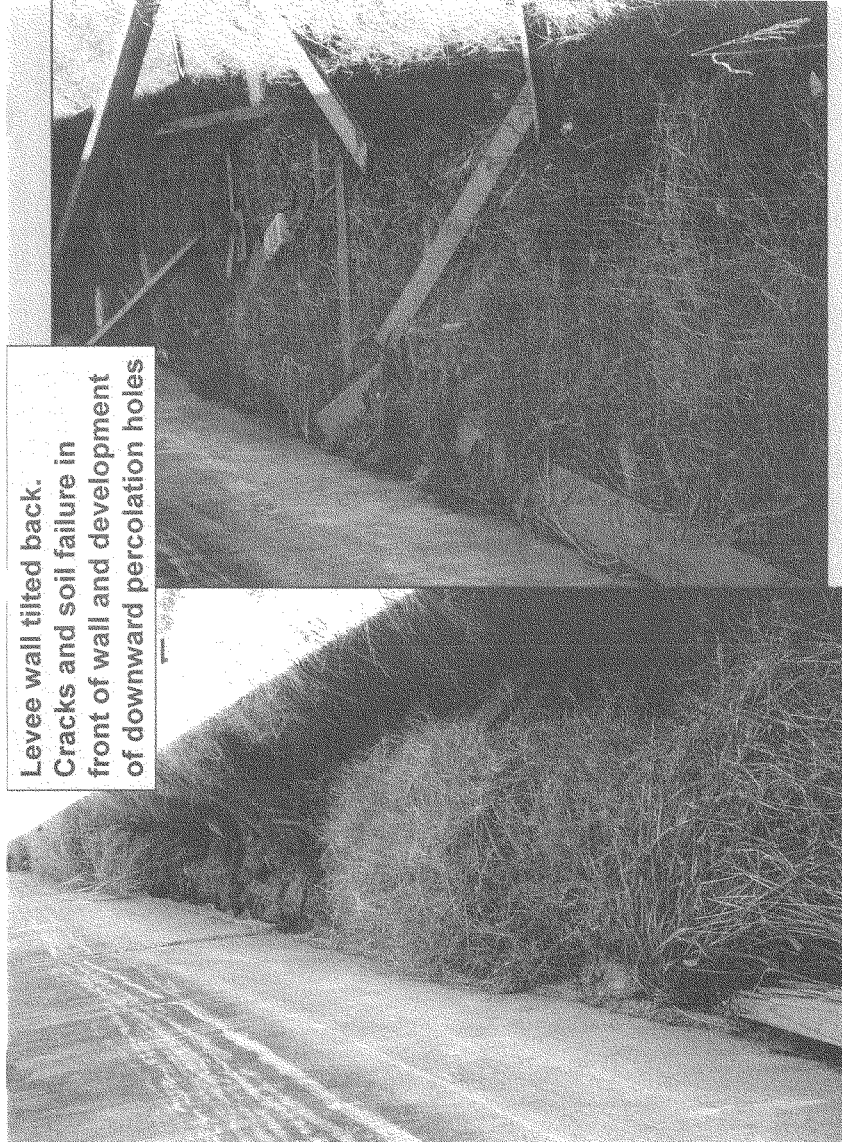
Levee wall tilted back.  
Cracks and soil failure in  
front of wall and development  
of downward percolation holes

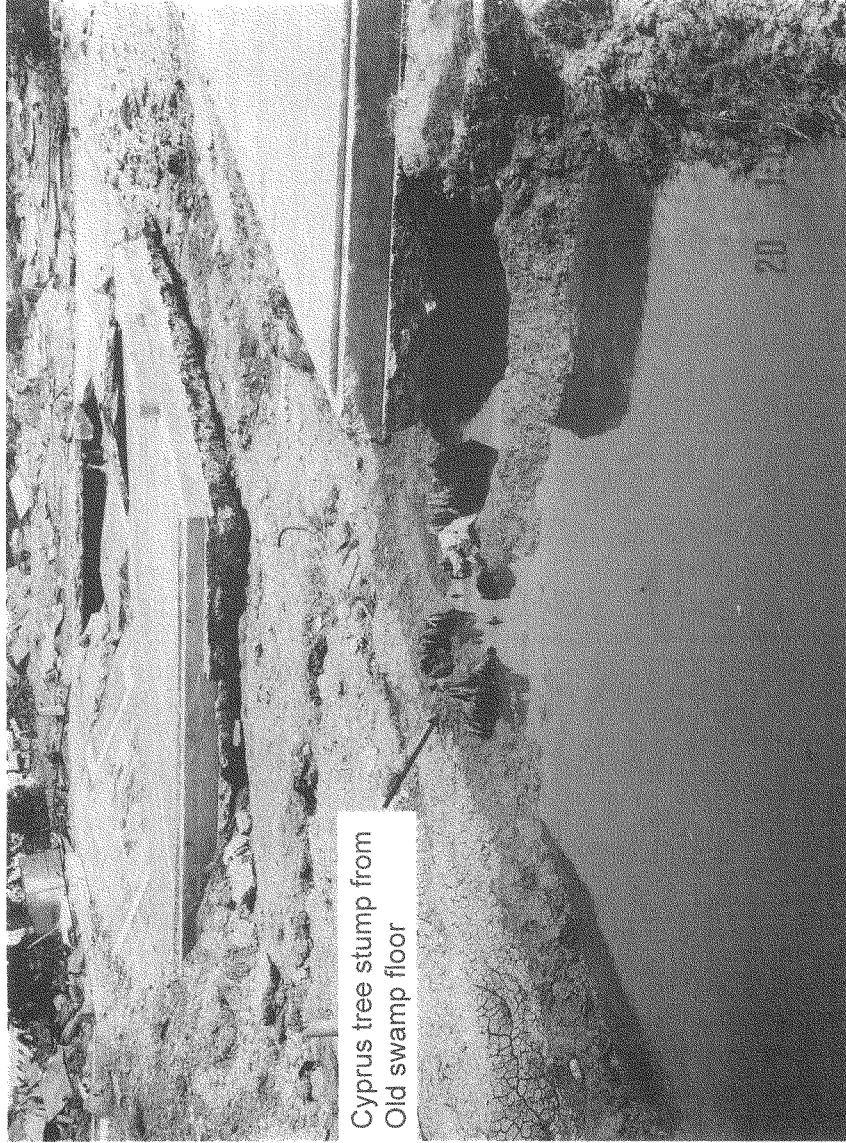
Cyprus tree stump from  
Old swamp floor

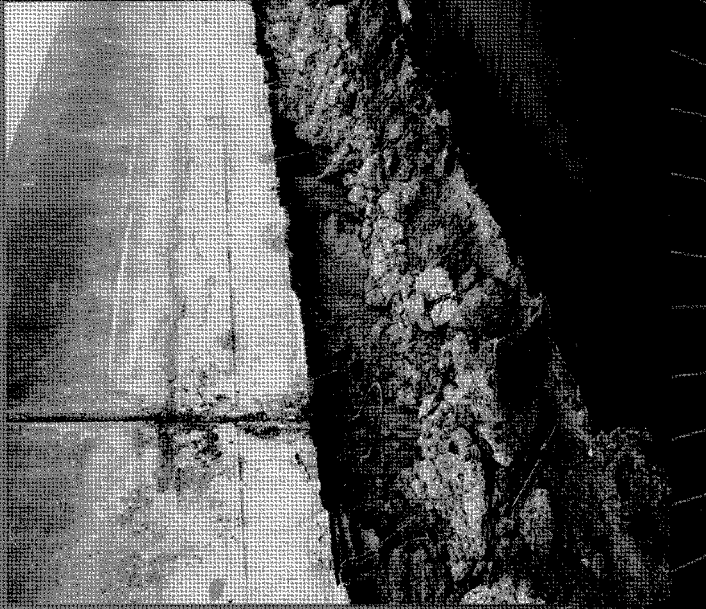
**MRGO, North Bank (New Orleans East):  
Floodwall Overtopping Failure**

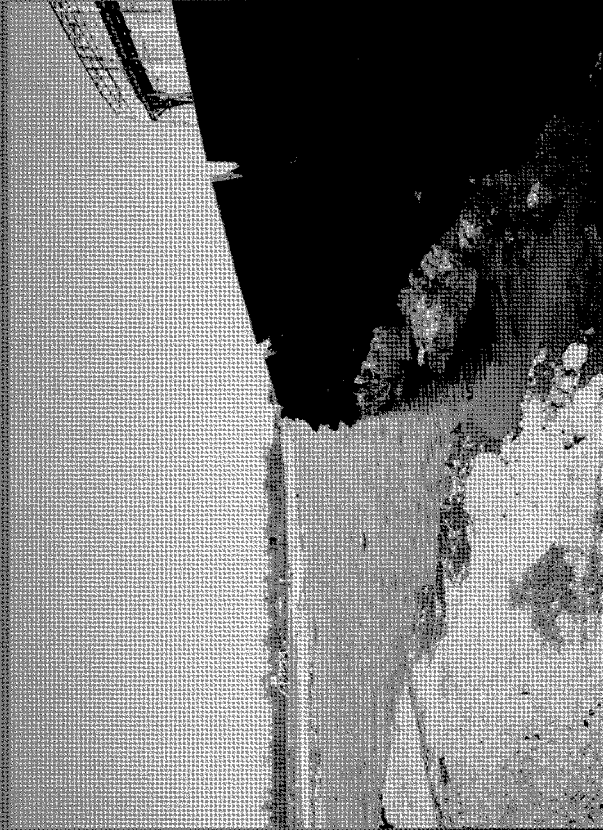
Common Transition Problems

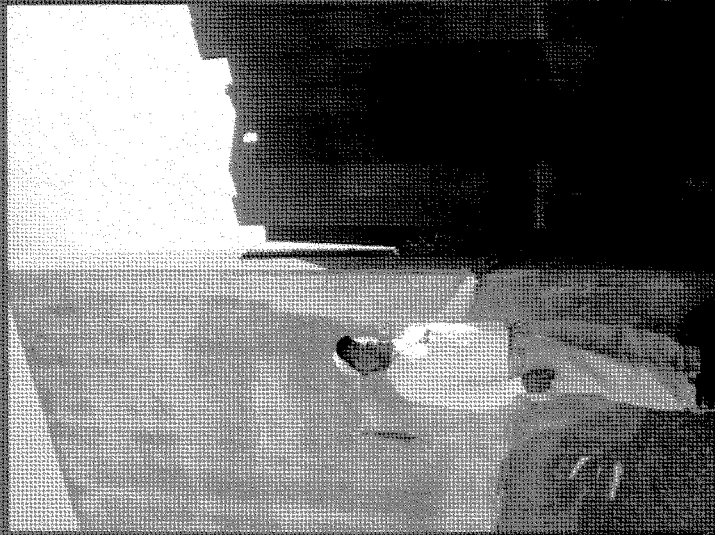
Common Transition Failures

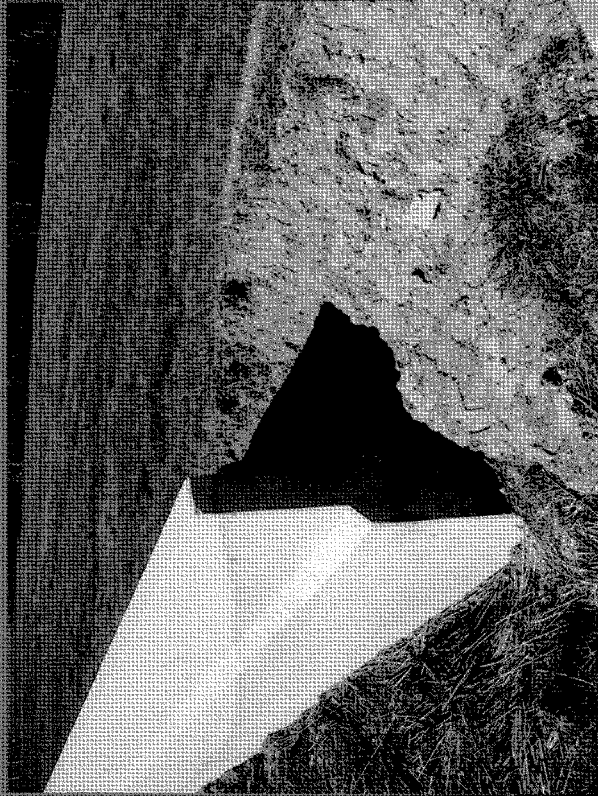
Common Transition Failures

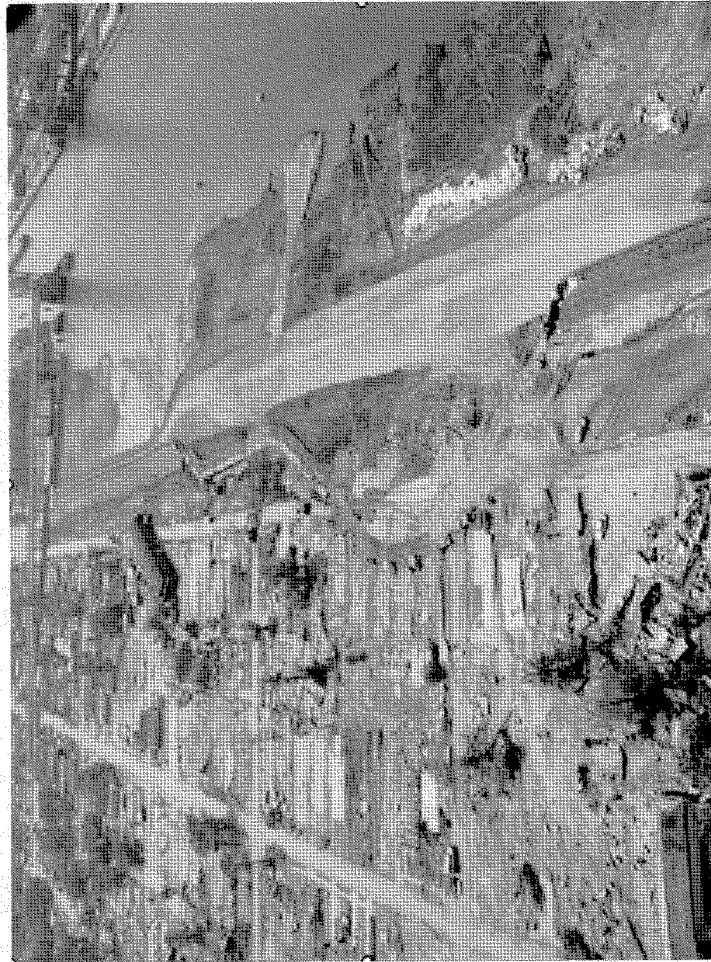
Figure 1.9: Oblique view of the (south) levee break at the Inner Harbor Navigation Canal into the lower Ninth Ward.

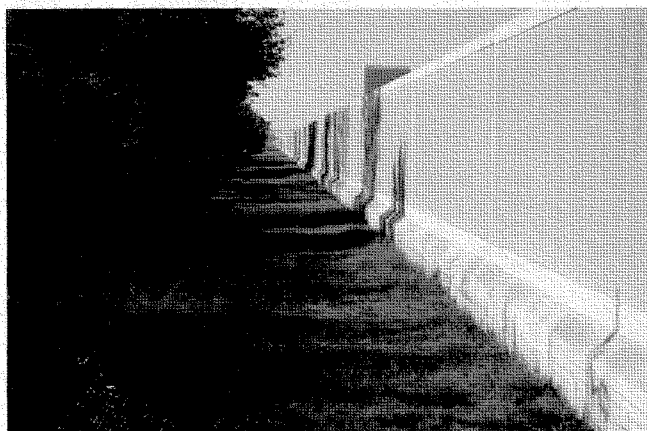
Figure 2.11: Typical conditions at the inboard side of floodwalls along the 17<sup>th</sup> Street Canal showing no scour of soil at the toe of the wall.

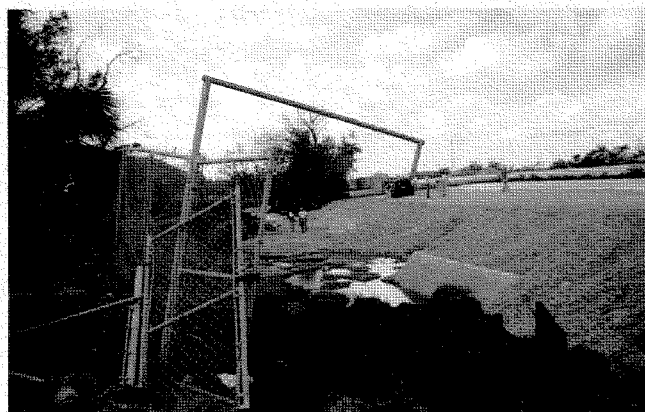
Figure 2.12: Temporary closure section embankment on October 3rd, 2005.

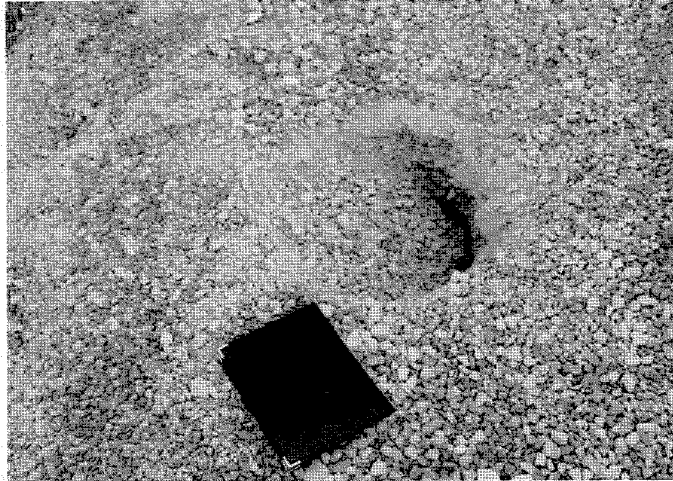
Figure 2.13: One of four sinkholes noted at the front lip of the crest of the temporary closure section embankment.

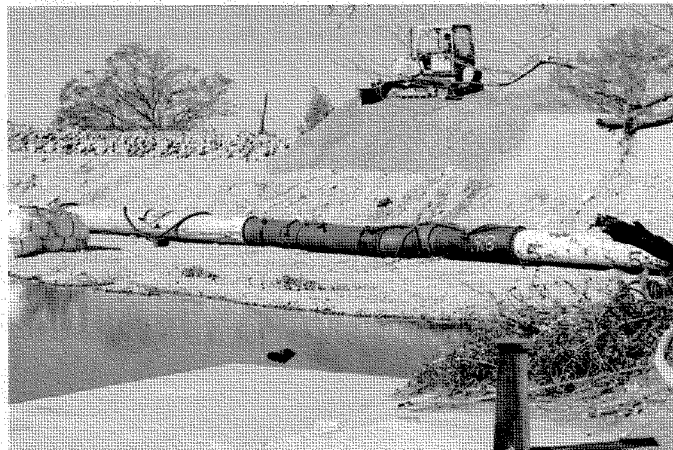
Figure 2.14: Placement of silty sand fill at the crest and on both the inboard and outboard faces of the temporary embankment closure section on October 6, 2005.

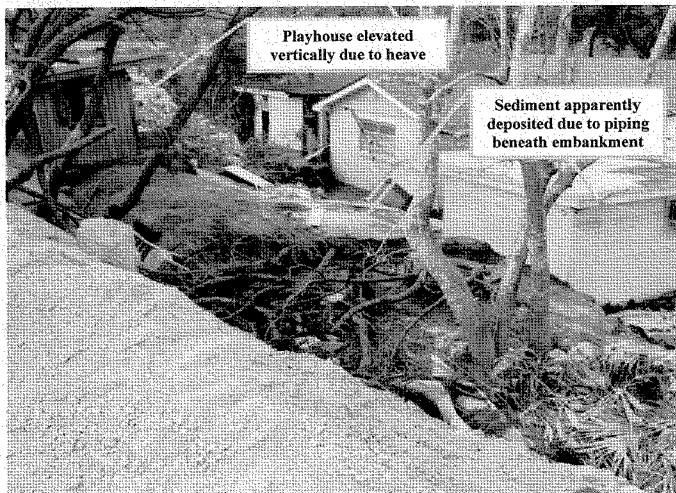
Figure 2.16: Conditions at the inboard toe of the London Avenue Canal (North) breach section.

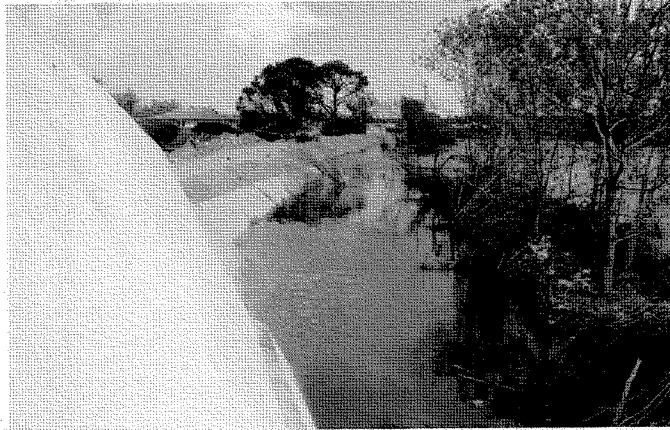
Figure 2.17: The toppled floodwall/sheetpile walls at the London Avenue Canal (North) breach site.

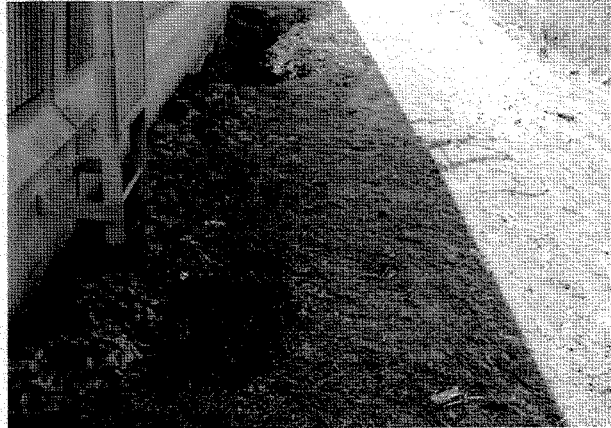
Figure 2.21: Closeup view of sinkholes at the inboard toe of the floodwall, at the location of the engineer wearing a red shirt in Figure 2.20.

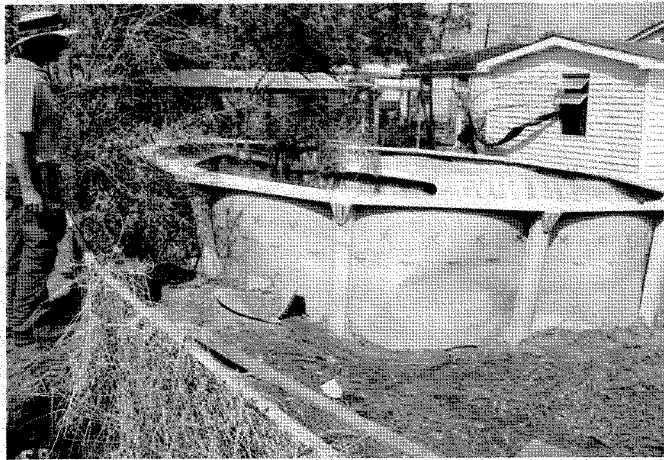
Figure 2.22: View of conditions at the inboard toe, immediately inboard of the locations shown previously in Figures 2.21 and 2.22. Note the bulged and hummocky ground, the laterally displaced chain link fence, and the piping boil ejecta.

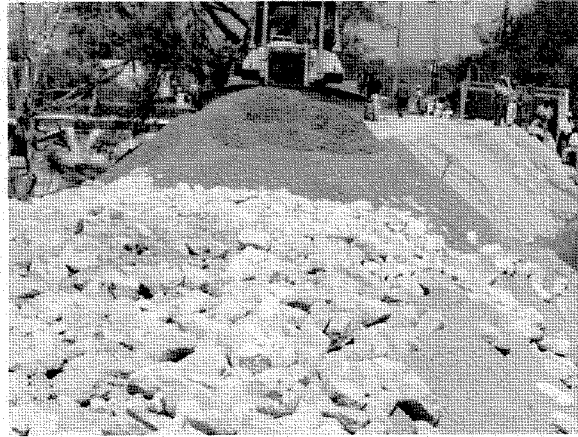
Figure 2.23: Photo during construction of the emergency breach repair embankment at the London Avenue Canal (North) breach site.

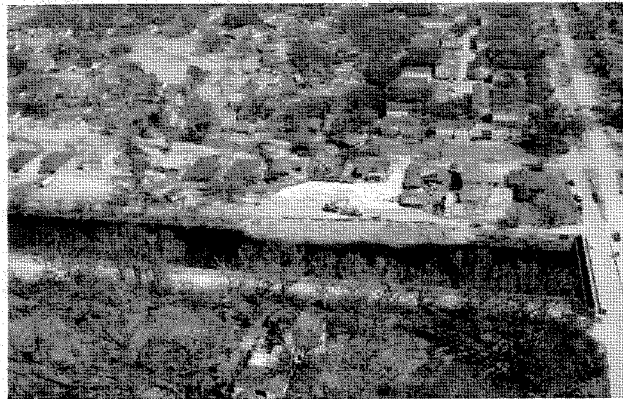
Figure 2.24: Aerial view of the breach section at London Avenue Canal (South).

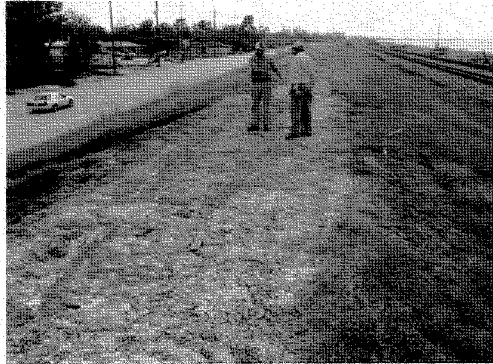
Figure 3.6: Wave overtopping of lakefront earthen levee at low spot in structure did not cause serious damage (N 30° 03' 47.8", W 89° 58' 13.1)

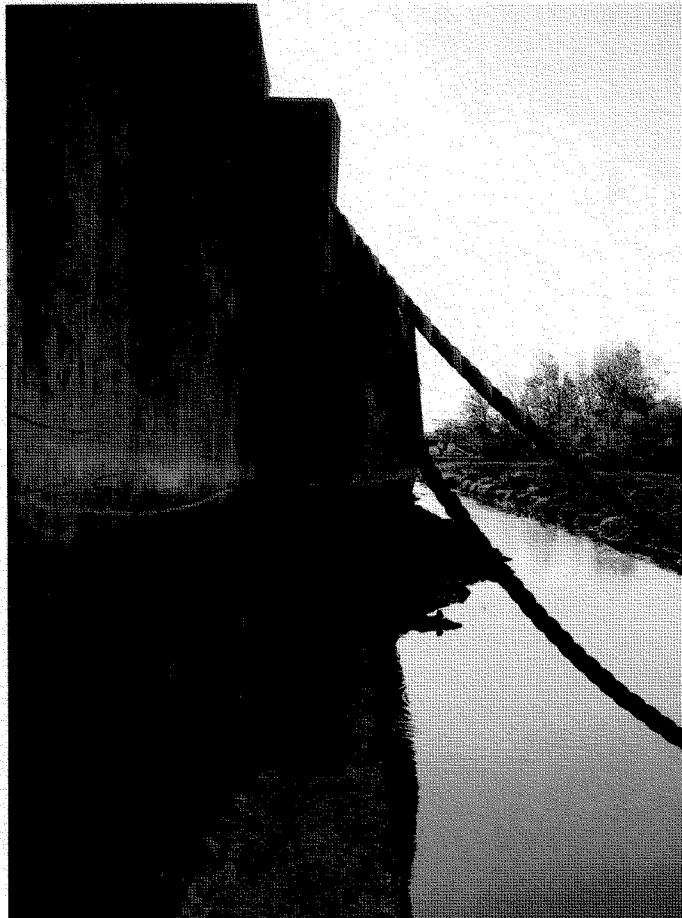
Figure 3.10: Undamaged T-wall in foreground and damaged I-wall in background along the IWW/MRGO. Severe scour on the landside and distress of the I-wall (N30.00030 W89.99459).

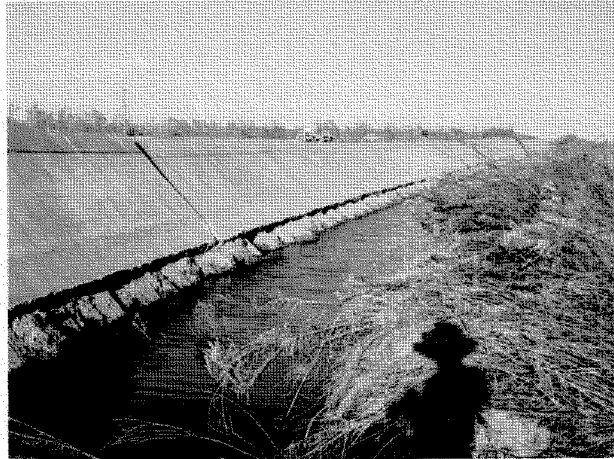
Figure 3.11: Severely distressed I-wall after overtopping from the water side along the IWW/MRGO.

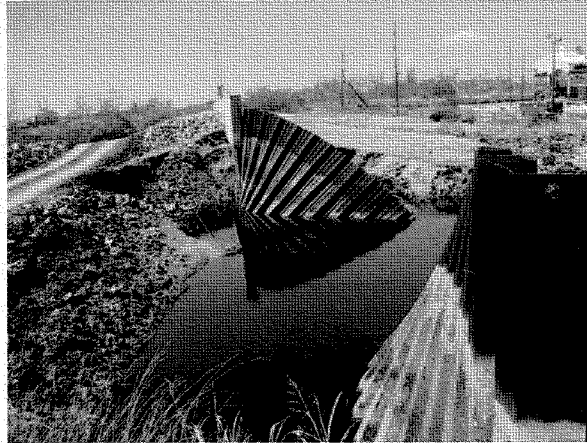
Figure 3.13 Failure of sheetpile wall adjacent to higher and stronger concrete topped I-wall on the north side of the IWW.

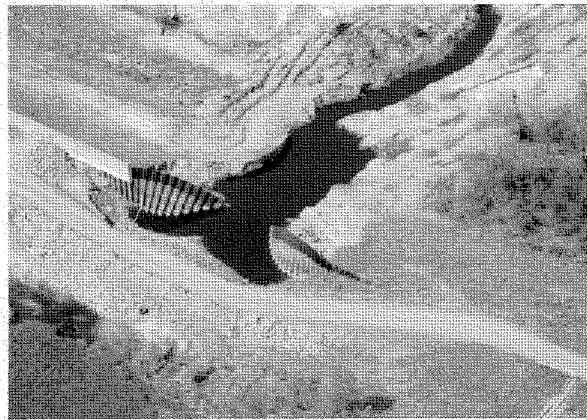
Figure 3.14: Aerial view of the failed wall section shown in Figure 3.13

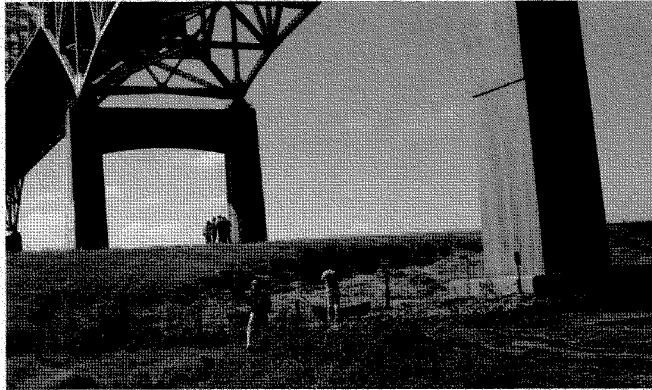
Figure 3.17: Earth levee beneath the north abutment of the Route 47 Bridge over the IWW/MRGO, next to the Entergy Michoud Generating Plant, looking south. Despite considerable damage, the levee performed satisfactorily during and after overtopping.

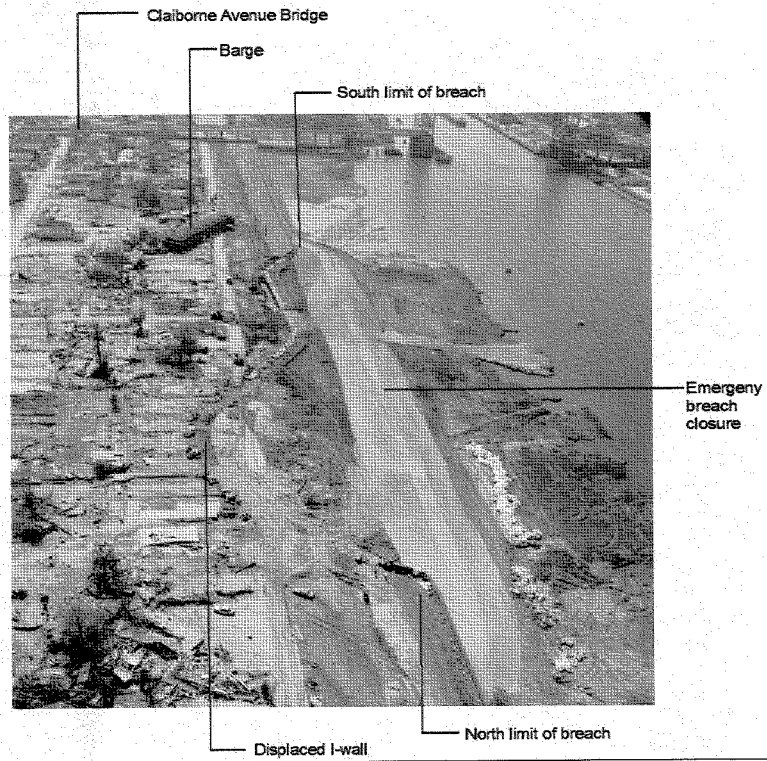
Figure 4.2: Aerial view of the south breach at the Lower Ninth Ward (L. Harder, October 14, 2005).

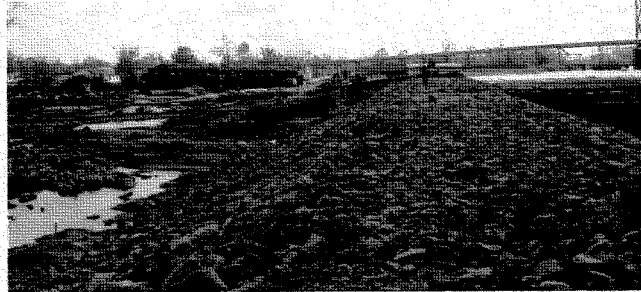
Figure 4.6: South view of the south breach repair at the Lower Ninth Ward (J. Wartman, October 4, 2005).

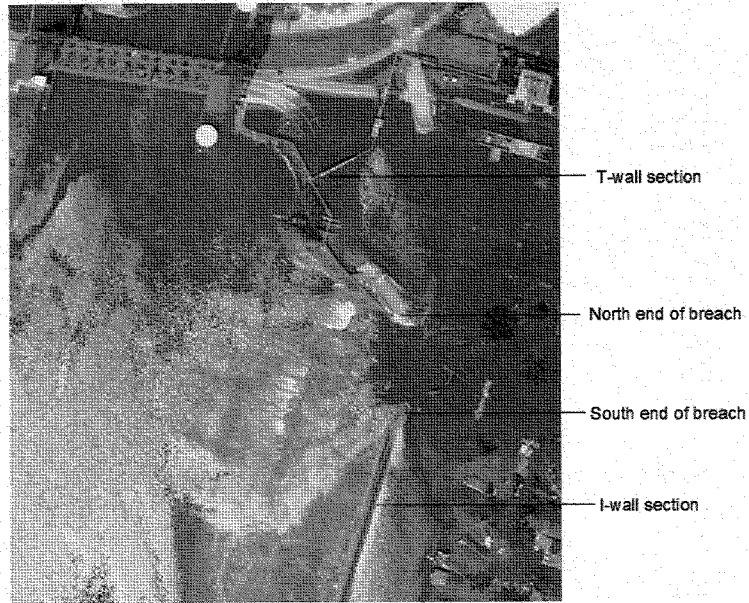
Figure 4.7: Airborne digital imagery of the north breach at the Lower Ninth Ward. Water is shown flowing back into the IHNC (courtesy NOAA, August 31, 2005).

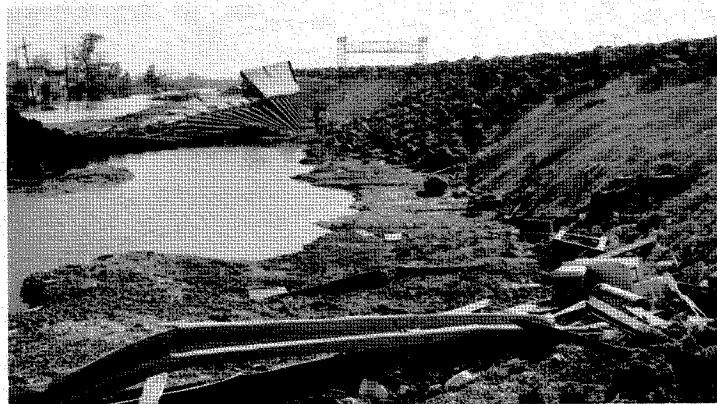
Figure 4.11: Looking south along the north breach repair at the Lower Ninth Ward (J. Wartman, October 4, 2005).

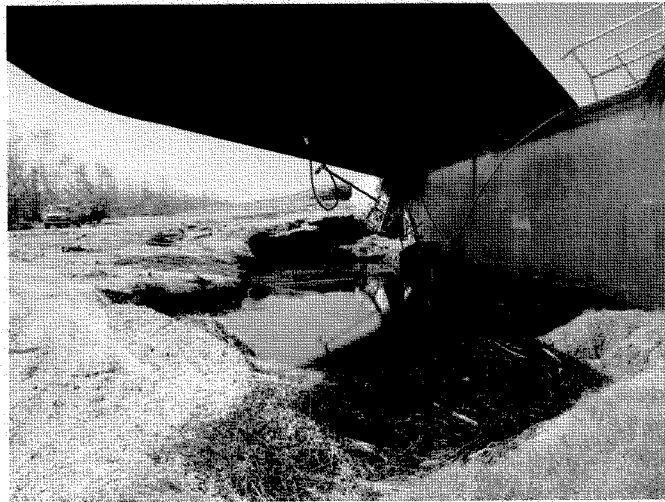
Figure 4.14: Scour near barge damage at the Bayou Bienvenue Gate site (J. Wartman, October 5, 2005).

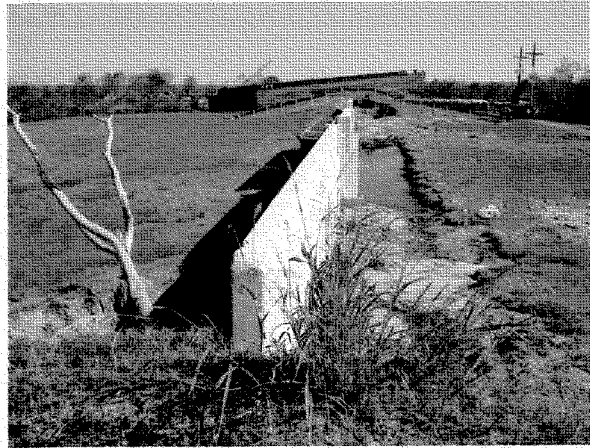
Figure 4.15: Scour near Bayou Bienvenue Gate site (L. Wooten, October 5, 2005).

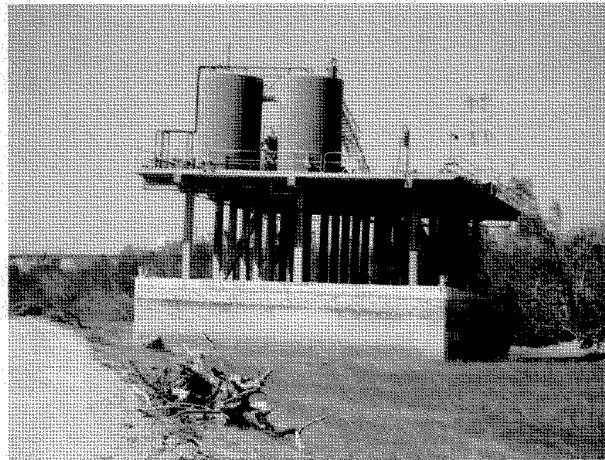
Figure 4.18: Various barges and other floating structures made contact with the earth levees without causing significant damage. Photo shows a gas processing barge (F. Silva, October 1, 2005).

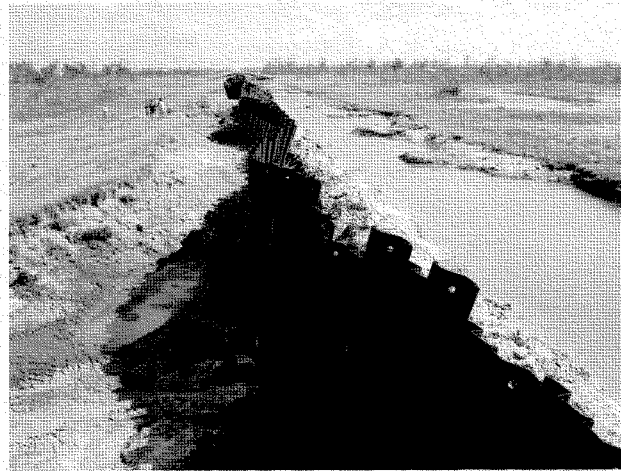
Figure 4.20: Failure of earth levee with steel sheetpile barrier on the southeast bank of the MRGO. Note severe erosion and scour (L. Wooten, October 6, 2005).

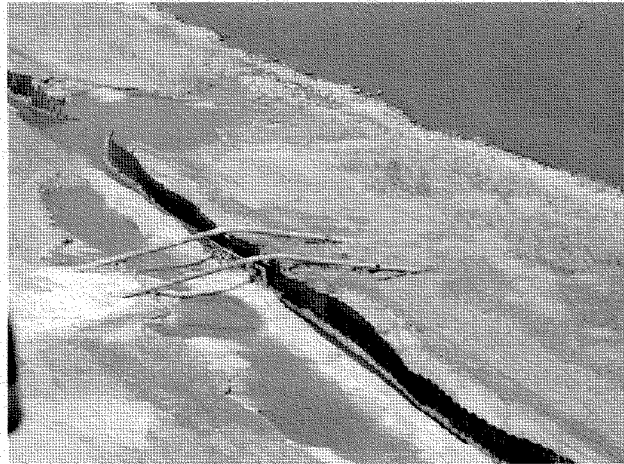
Figure 4.21: Levee failure on southwestern bank of MRGO between Bayou Bienvenue (where barge is aground on I-wall) and Bayou Dupree. Note severe erosion and scouring (L. Harder, October 14, 2005).

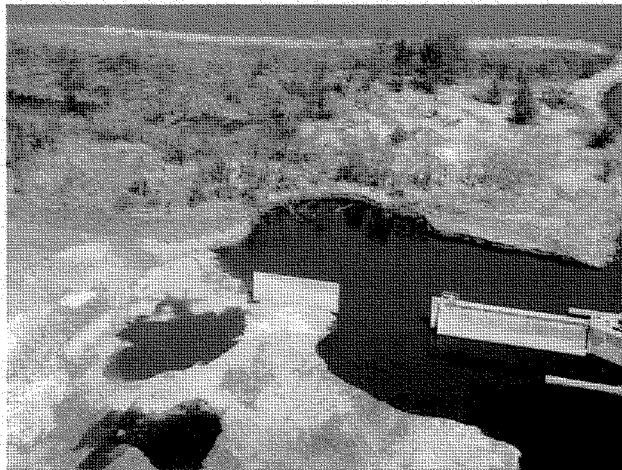
Figure 4.22: Levee failure on southwestern bank of MRGO at Bayou Dupree. Note concrete sheetpile and levee transition washouts (L. Harder, October 14, 2005).

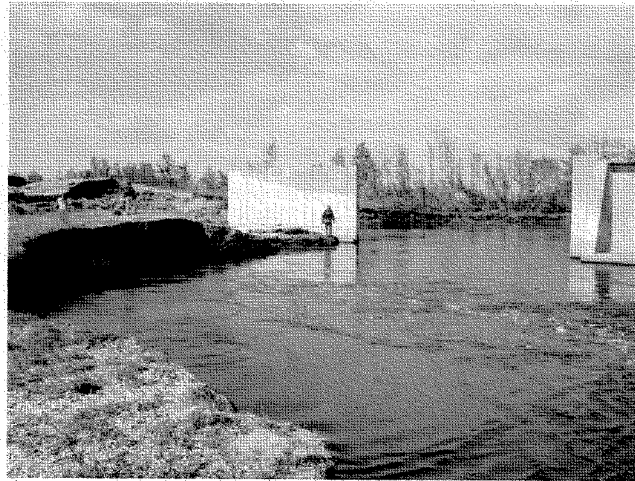
Figure 4.23: Ground perspective of Bayou Dupree gate abutment failure (L. Wooten, October 6, 2005).

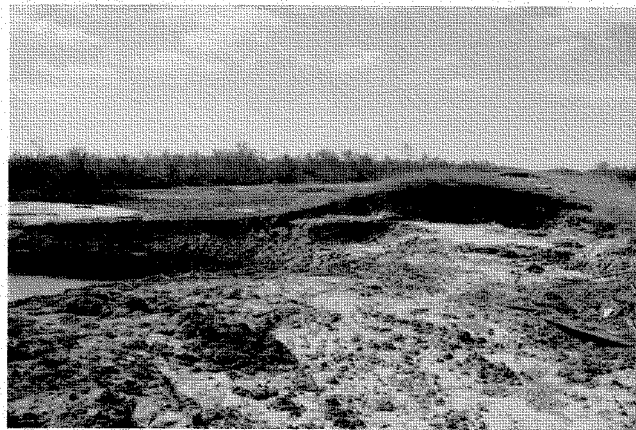
Figure 4.24: Failure of earth levee on southwest bank of MRGO adjacent to the Bayou Dupree gate (L. Wooten, October 6, 2005).

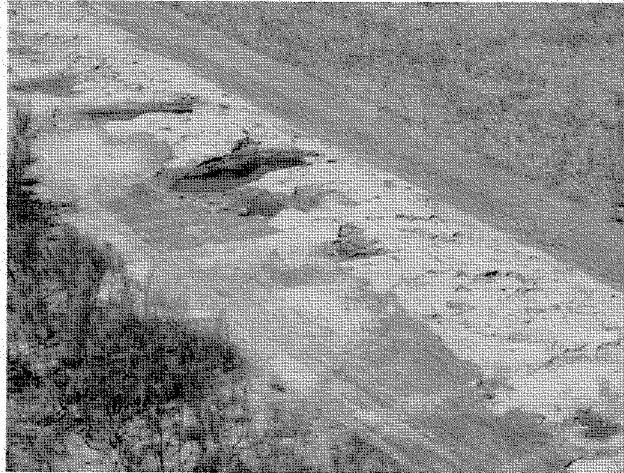
Figure 4.25: Overtopping obliterated earth levee along southwestern bank of MRGO, within two miles southeast of Bayou Dupree. Note deep scour at the levee foundation level (L. Harder, October 14, 2005).

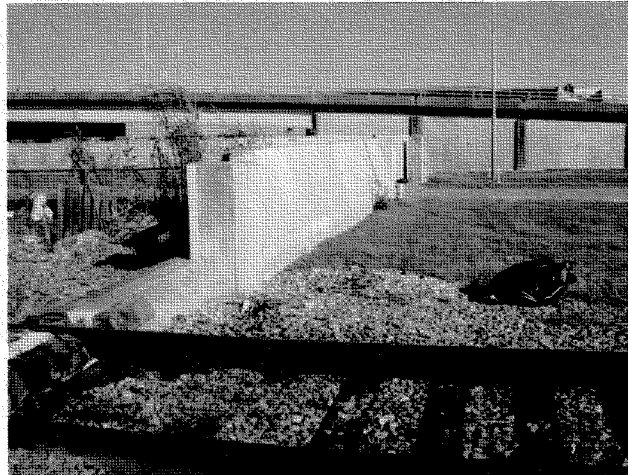
Figure 6.2: Lack of a floodgate at the railroad line crossing resulted in scour around the railroad tracks. No overtopping was observed the floodgate across the adjacent roadway.

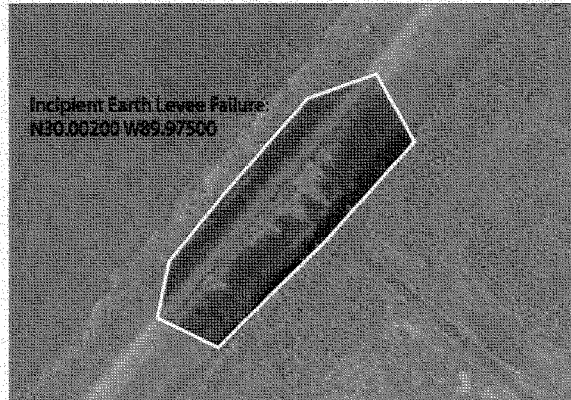
Figure 7.11. Incipient Earth Levee Failure at N30.00200°, W89.97500°

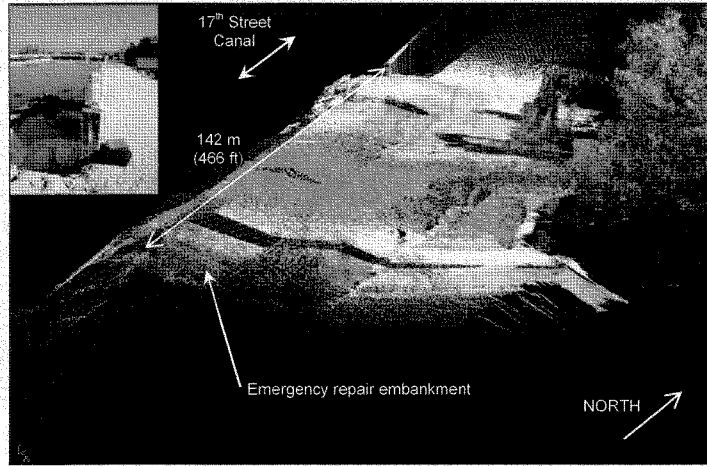
Figure 7.19. An oblique close-in image of the as built replacement levee at the 17<sup>th</sup> Street Canal breach from the south. The remaining I-wall is visible on either side of the earthen embankment.
