NASA Technical Memorandum 85706

VERTICAL DROP TEST OF A TRANSPORT FUSELAGE
CENTER SECTION INCLUDING THE WHEEL WELLS

M. SUSAN WILLIAMS
ROBERT J. HAYDUK

OCTOBER 1983

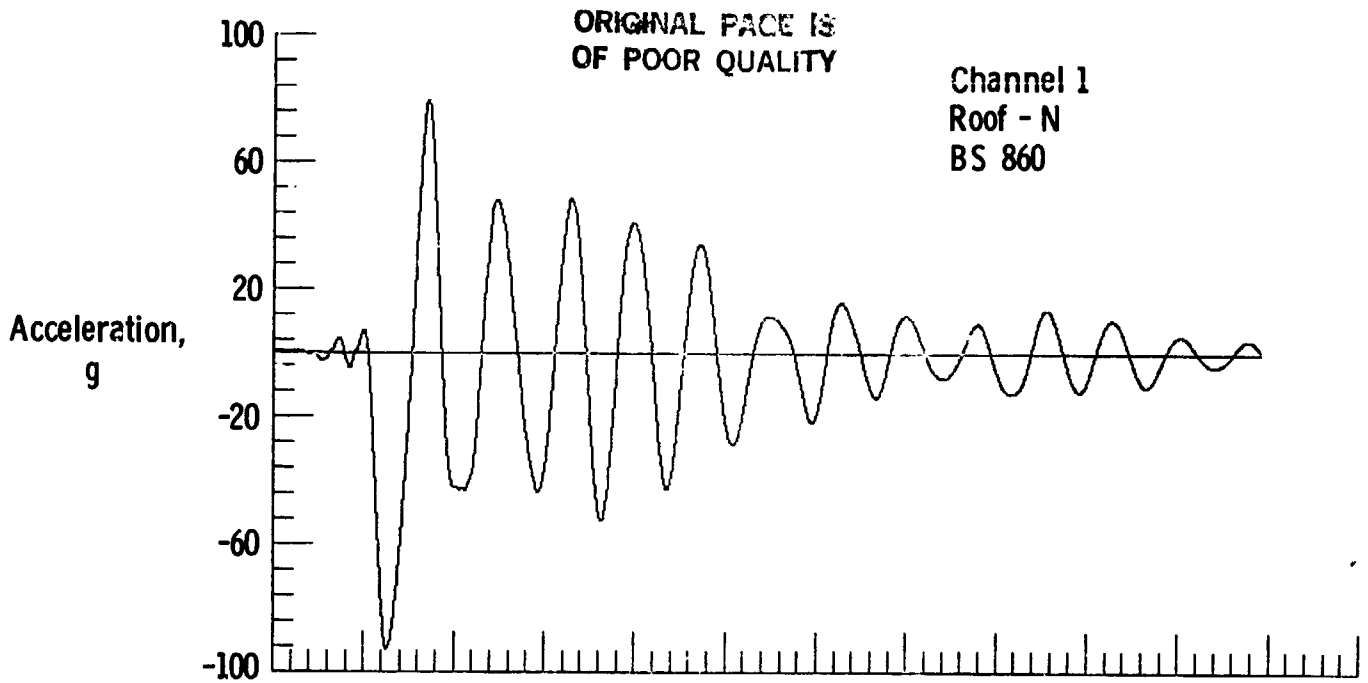
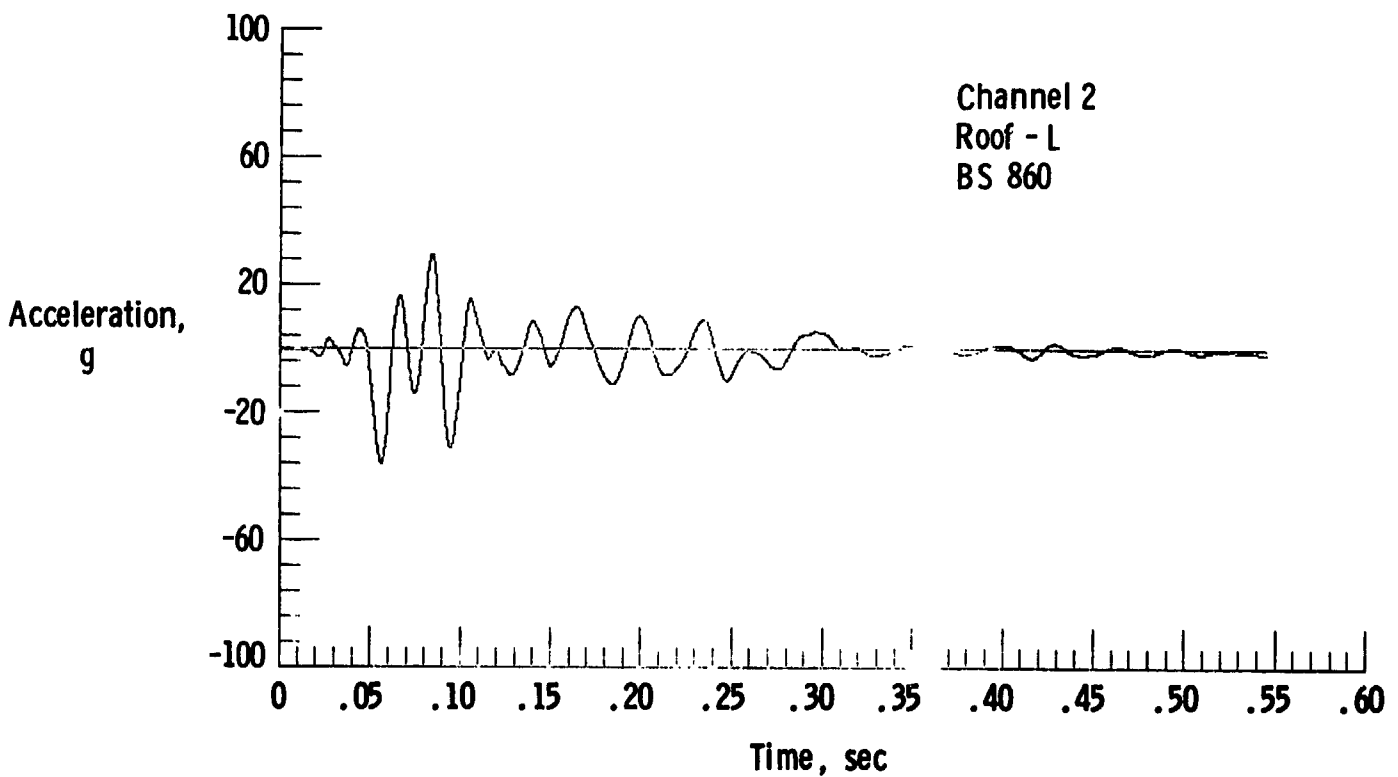
The maximum normal acceleration level measured at the roof was similar in magnitude to that at the floor beam / frame location. However, the roof normal accelerometers at BS 860 and 920 (Figures 9a and 9b) show an oscillatory rather than pulse response, as exhibited on the floor and undercarriage. Nearly 93 g (60 Hz filter) for 0.024 sec was measured during the first half wave at BS 860. The oscillatory response at the roof is in the 24 to 27 cycle per second range.

(a) Structural acceleration time histories.

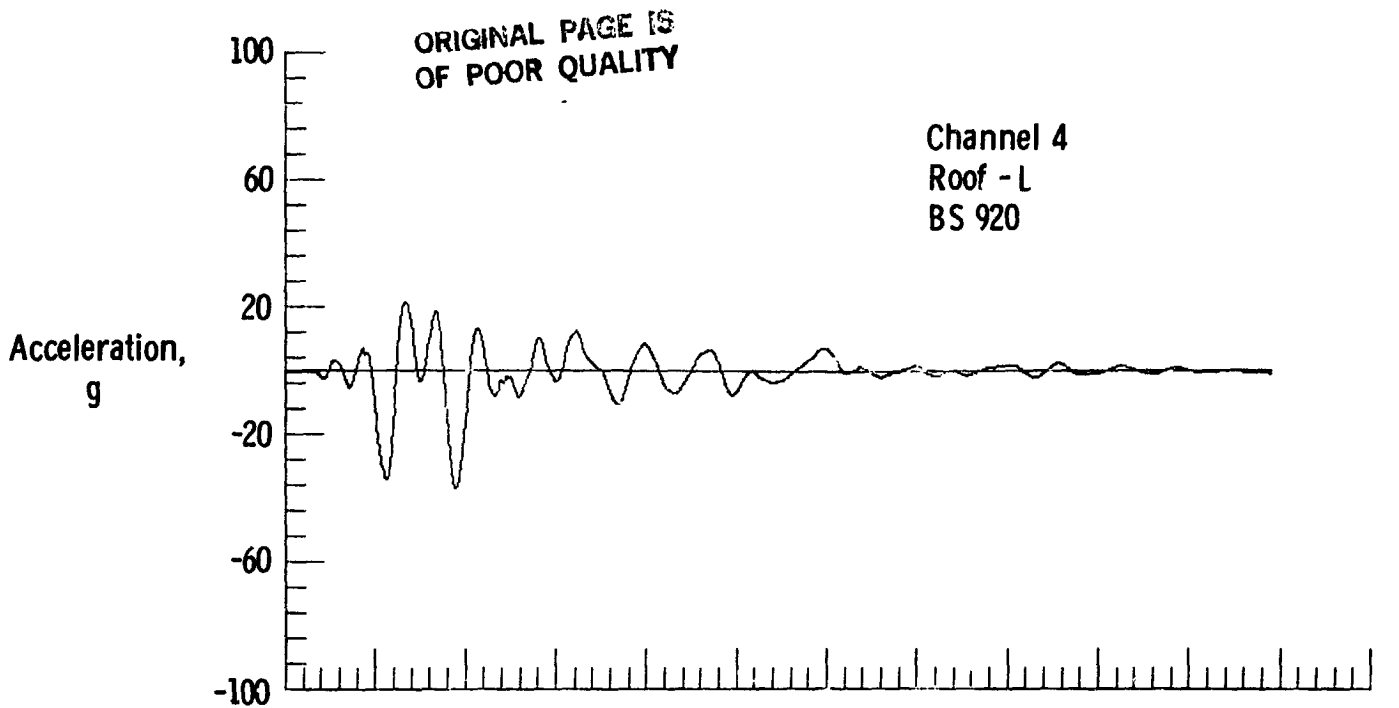
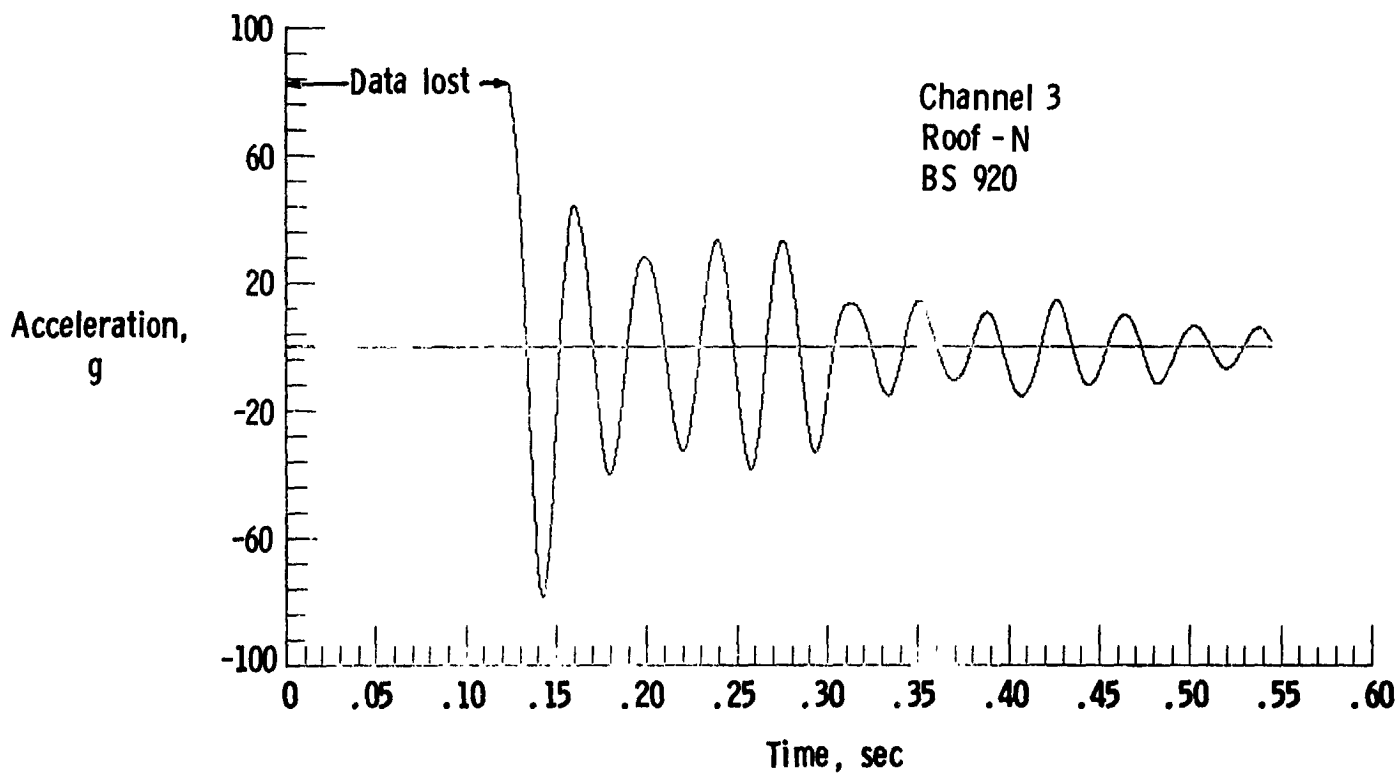
(b) Structural acceleration time histories.

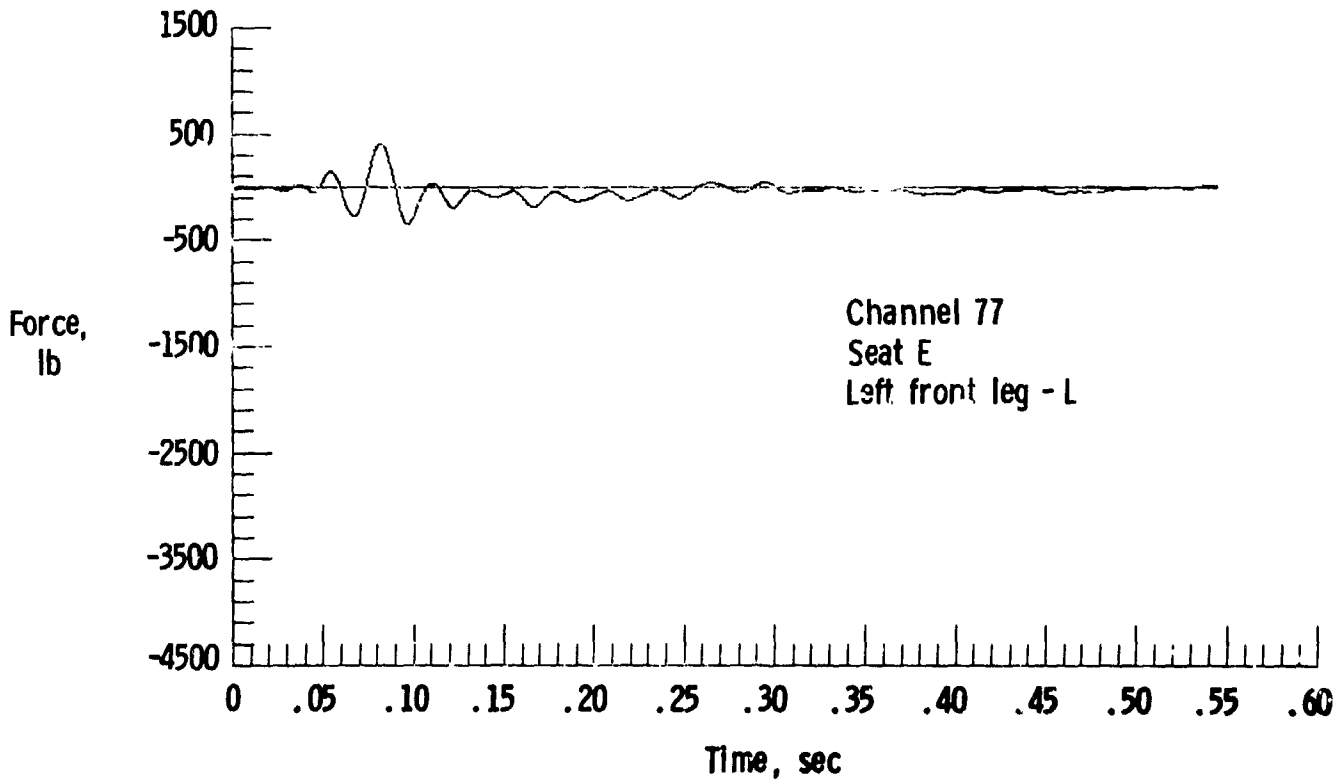
Figures 11a through 11d show forces measured by load cells at the seat attachment points of seat E. Compressive forces at the front legs ranged from 3200 to 4200 lbs in the normal direction. Since the front legs are mainly vertical, little force was applied in the longitudinal direction for a vertical impact. In contrast, the rear legs are angled and normal forces in the legs ranged from 2140 to 2860 lbs (compression) and longitudinal forces ranged from 960 to 1320 lbs.

(a) Reaction forces at left front leg.

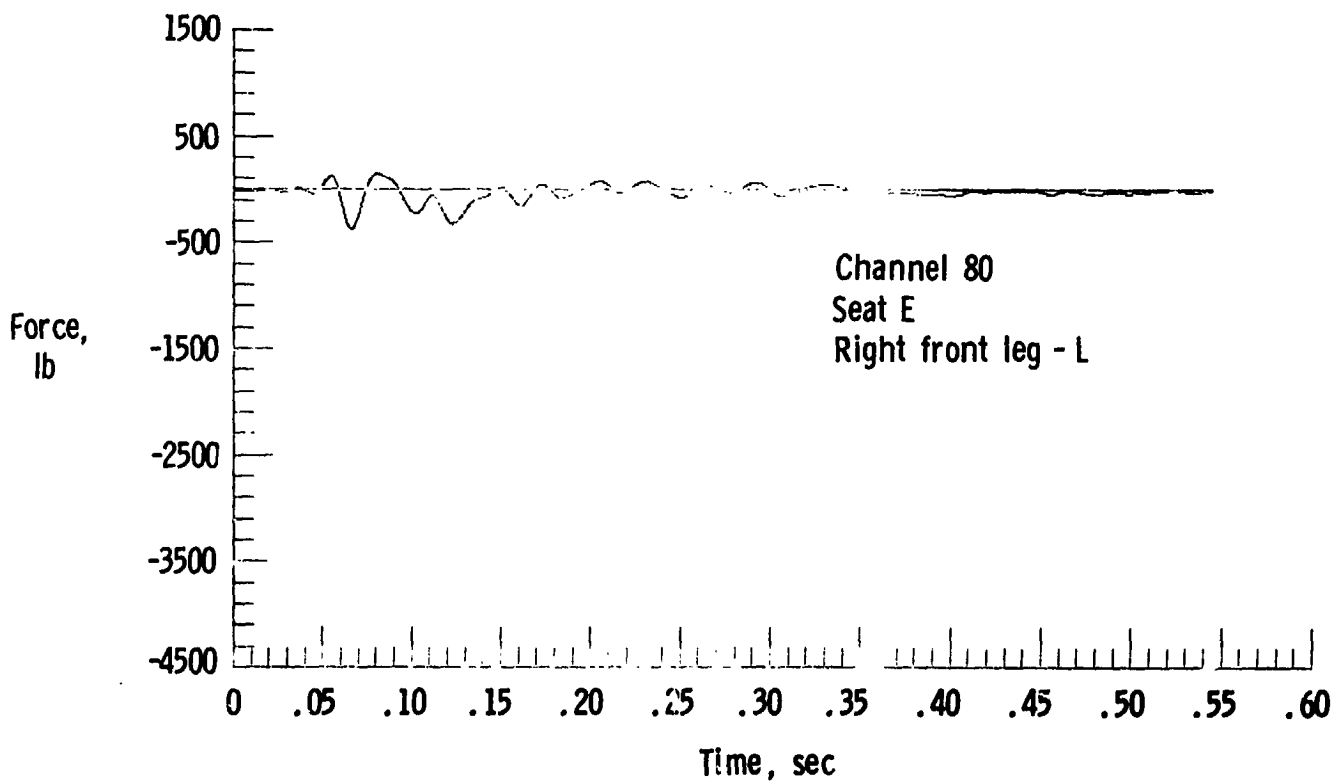
(b) Reaction forces at right front leg.

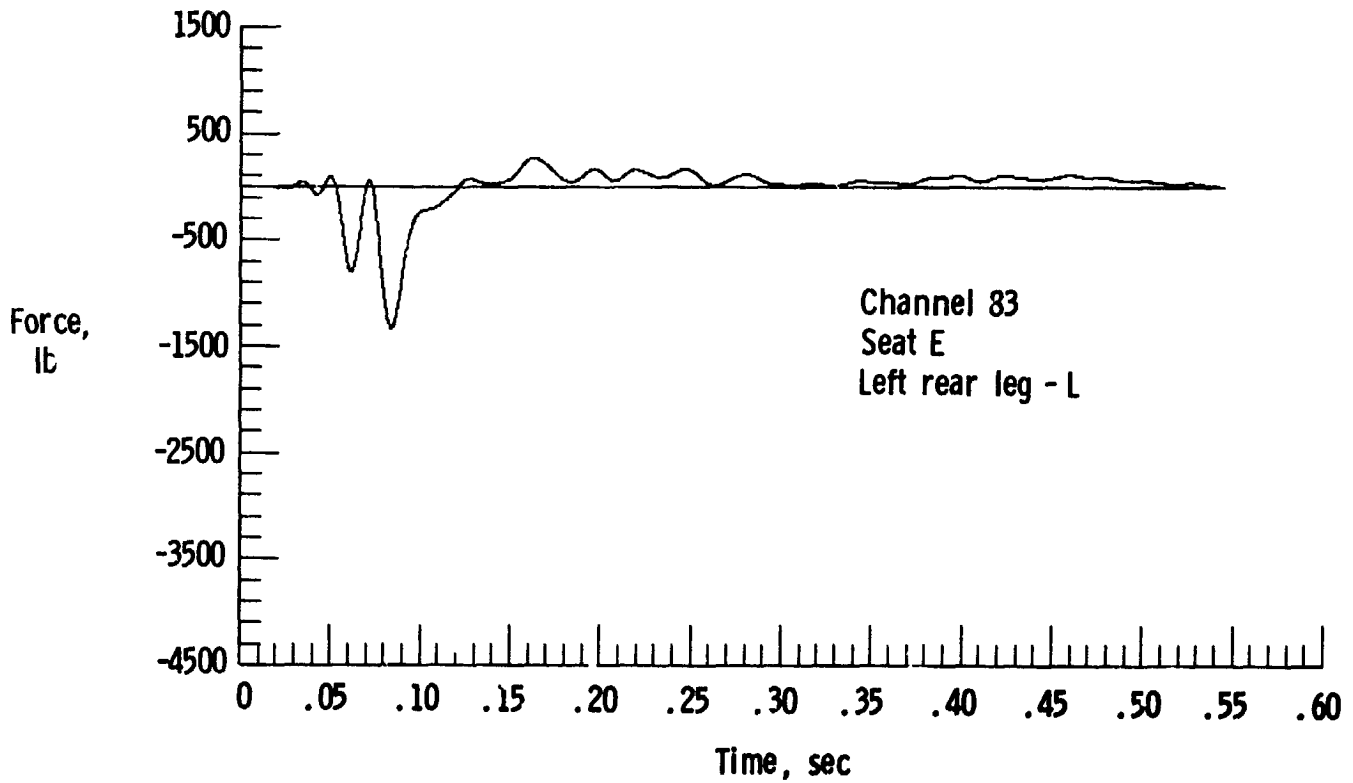
(c) Reaction forces at left rear leg.

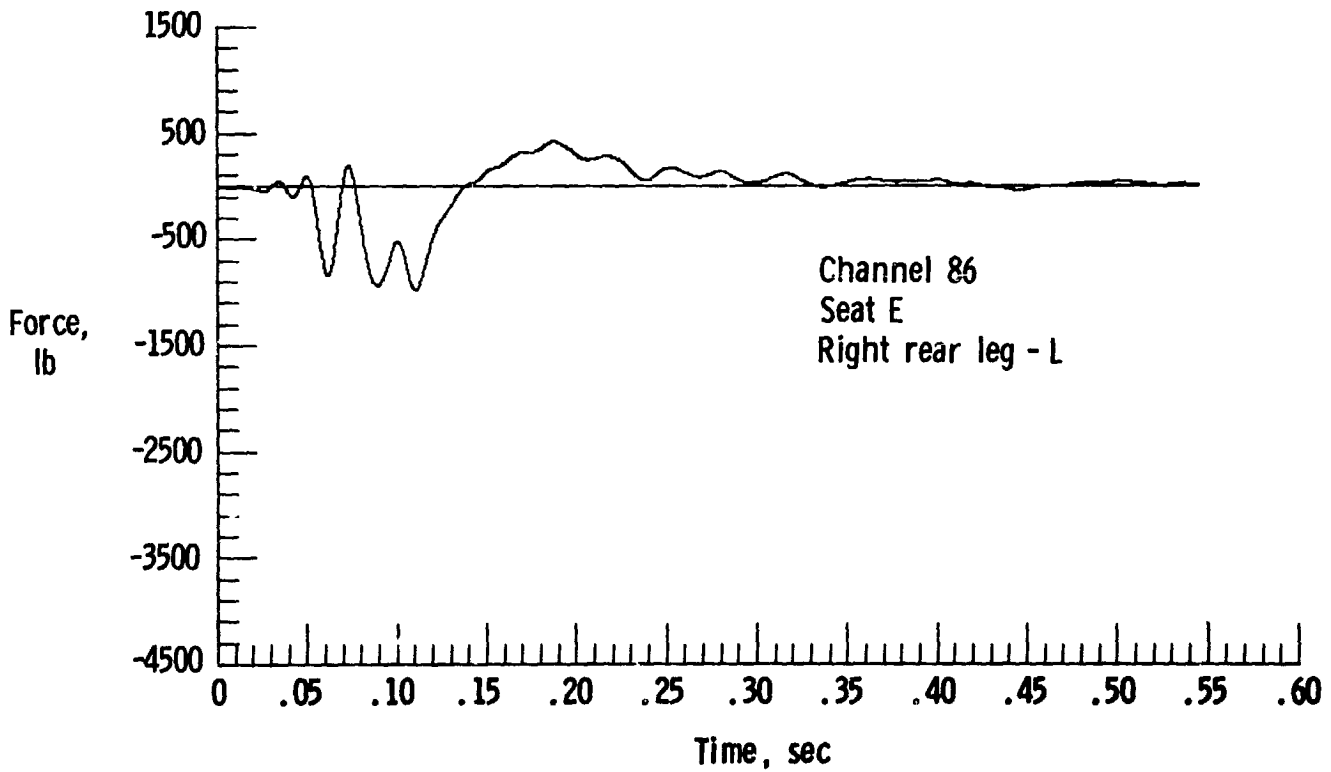
(d) Reaction forces at right rear leg.
