1966 BEECH BARON

CASE 1-1

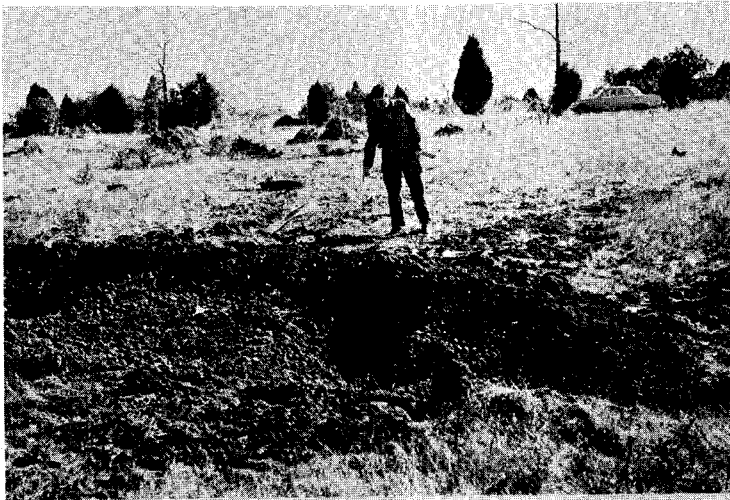
A. Crater formed by aircraft impact
38' long, 12' wide, & 4' deep.

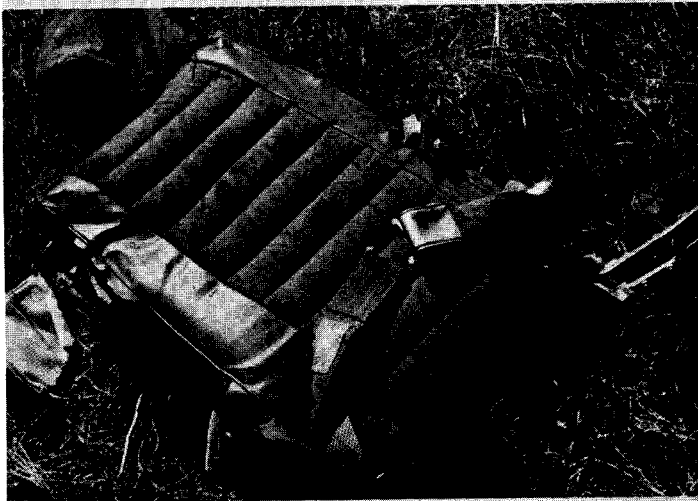
C. Part of copilot's seat showing failure
of tongue half of seat belt buckle.

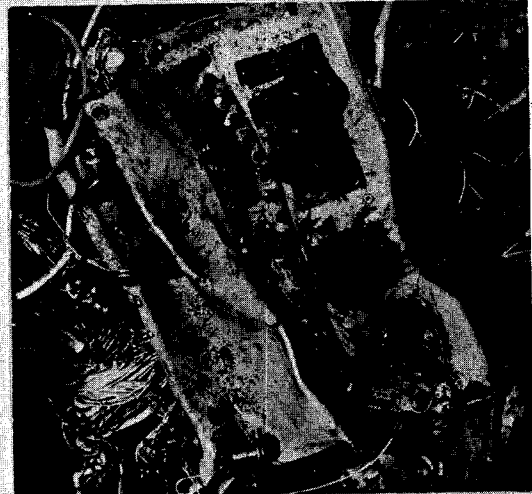
D. Portion of instrument panel,
broken, deformed & covered
with tissue.

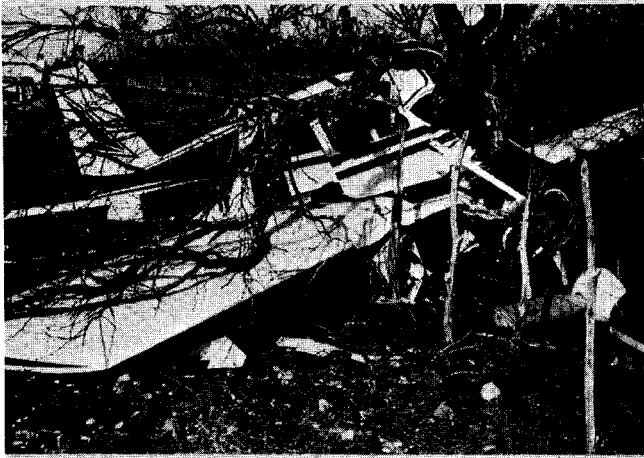
A. Overall view of aircraft impact with tree.

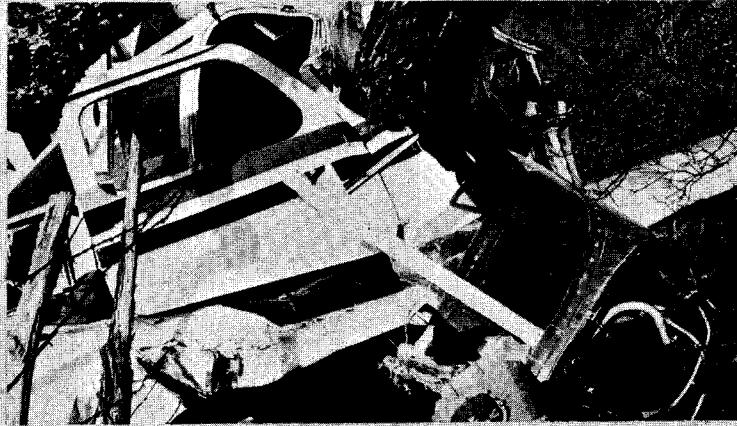
B. Close-up showing relative size of tree & depth of its penetration into the aircraft.

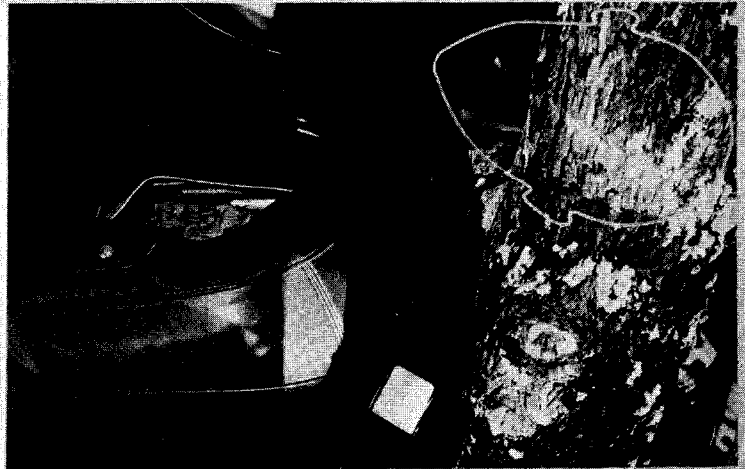
C. Inside the cabin, the tree is almost touching the front edge of the pilot's seat. An outline of a head indicates head impact area on the tree.

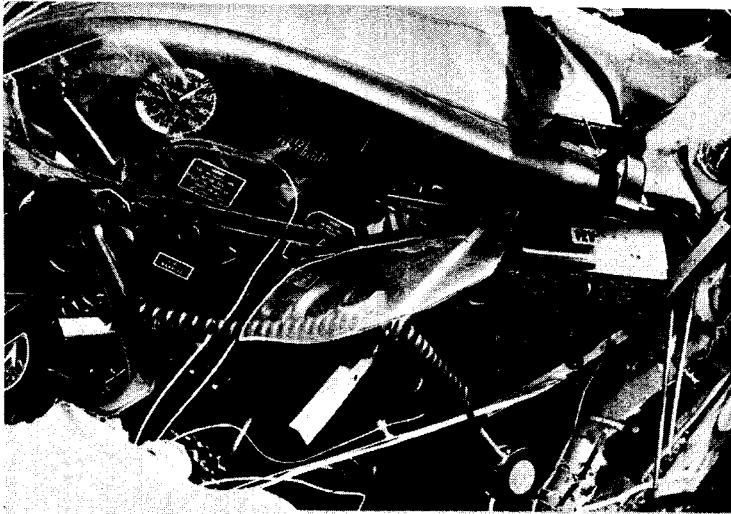
D. Left half of the instrument panel shows no signs of body impact. Note broken pieces of plastic windshield in the cockpit.

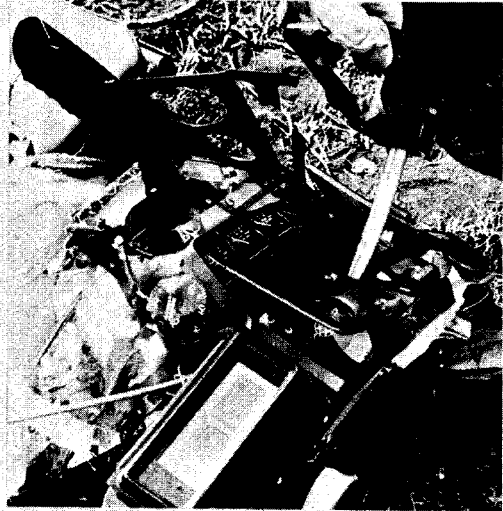
E. Right half of instrument panel sheared off by tree penetration.

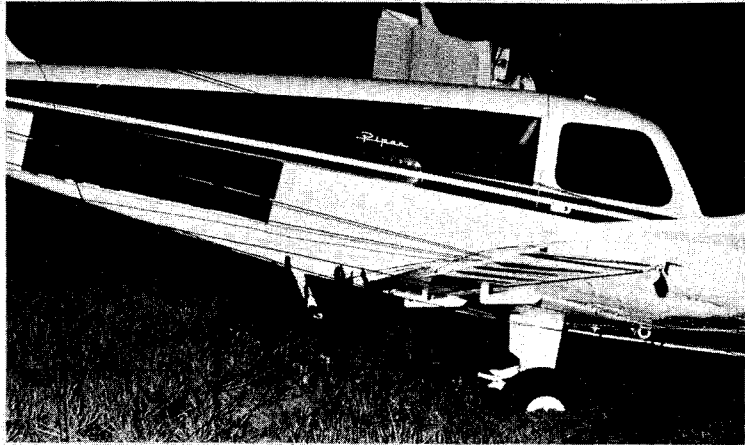
B. Five strands of steel telegraph wires stretched taut along sides of the fuselage.

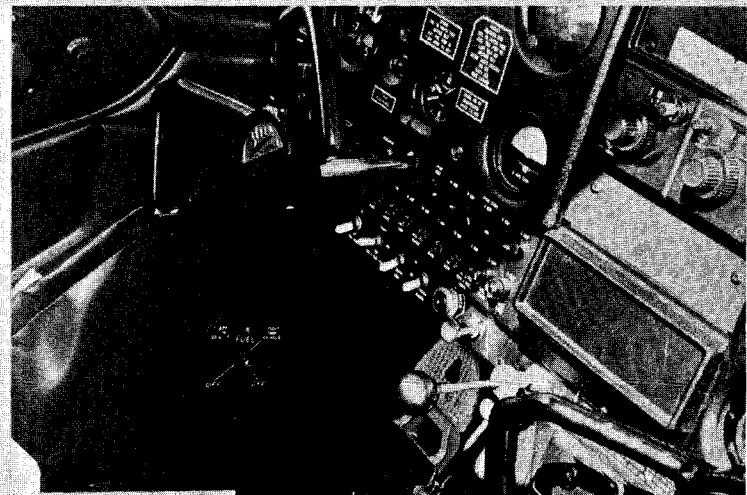
F. Lower left instrument panel. No damage from knee impact.

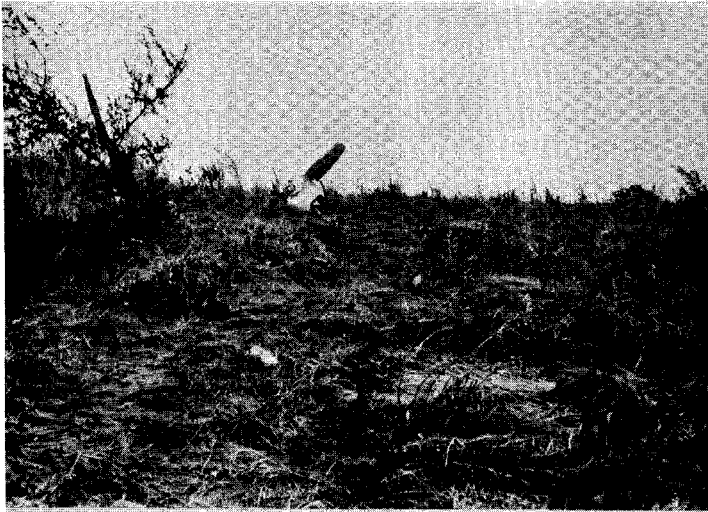
A. Path taken by aircraft during 305-foot deceleration.

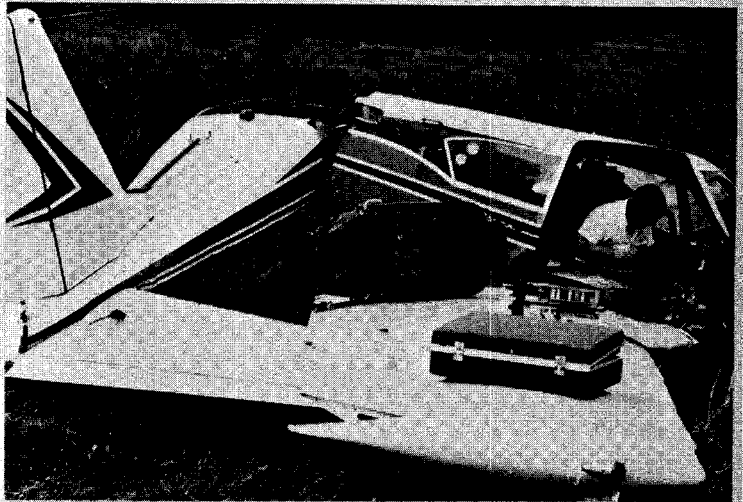
B. Final attitude of aircraft. Tail section separated at the rear of the cabin & turned 90°.

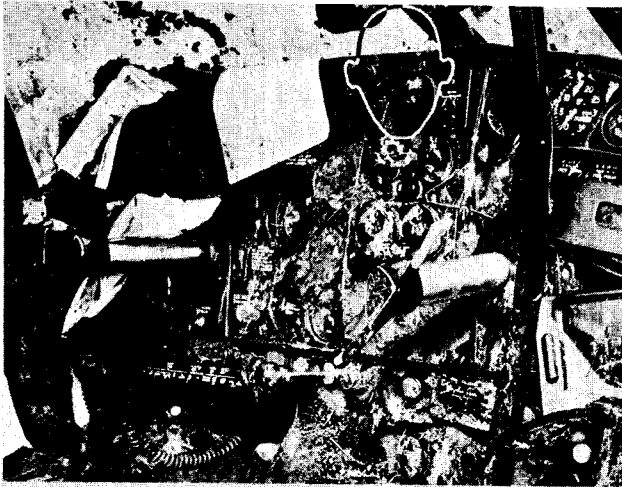
2.5 "g" (reference Case 4), probably during initial impact where the aircraft was changing direction. More severe facial injuries were probably not sustained since the pilot's head hit a relatively flat arc of the instrument panel (Case

5 C), and since a significant portion of the forward force of the head and trunk was dissipated when the chest struck the control yoke fracturing several ribs as well as the horns on the yoke.

C. Left half of instrument panel showing head impact and broken control wheels.

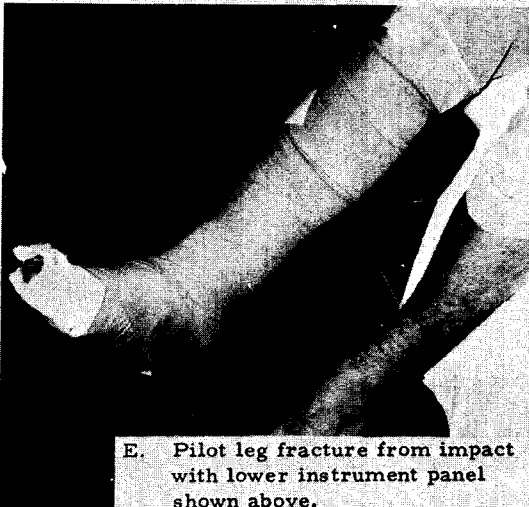
E. Pilot leg fracture from impact with lower instrument panel shown above.

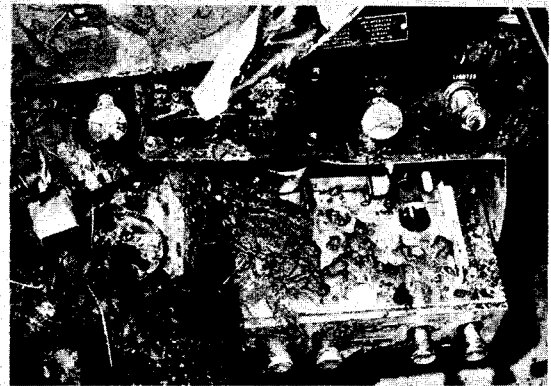
F. Lower left instrument panel. Heavy radio fractured right leg of copilot shown below.

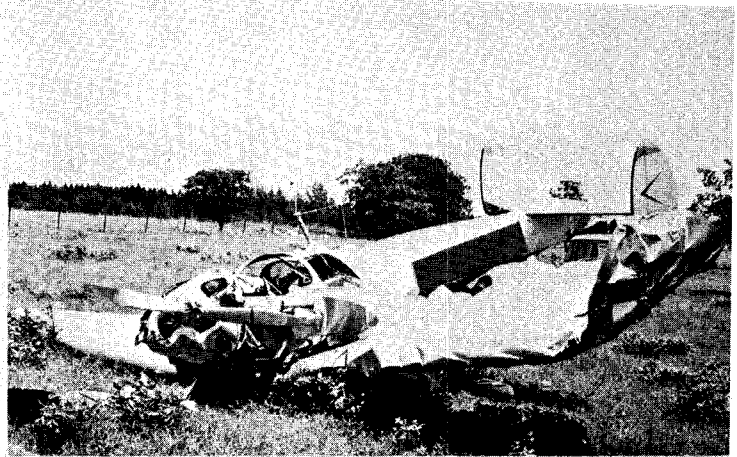
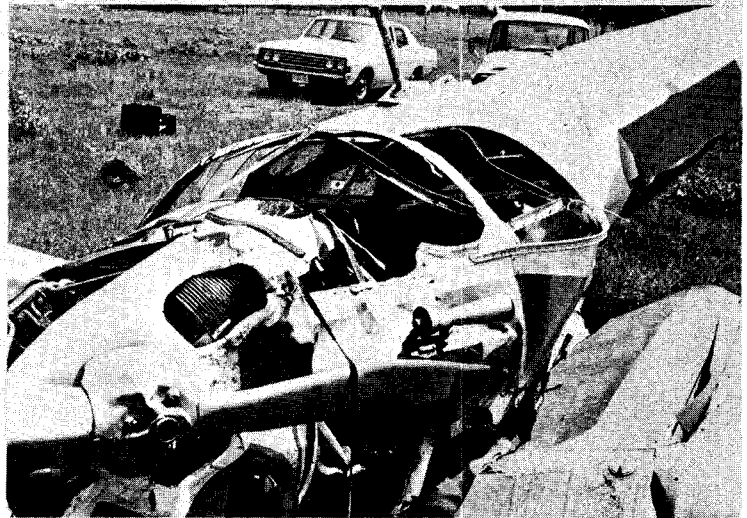
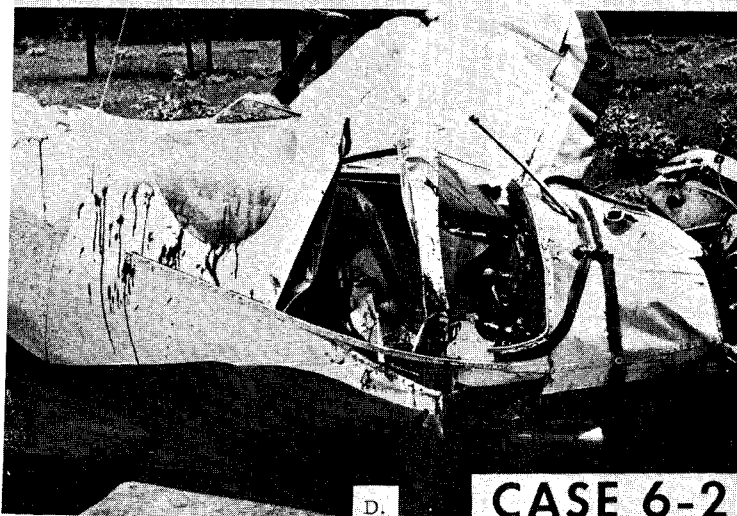
Close-up views of the exterior of the aircraft. The cabin maintained its integrity. The plastic windshield disintegrated & some outward buckling of the sides of the cockpit may be noted.

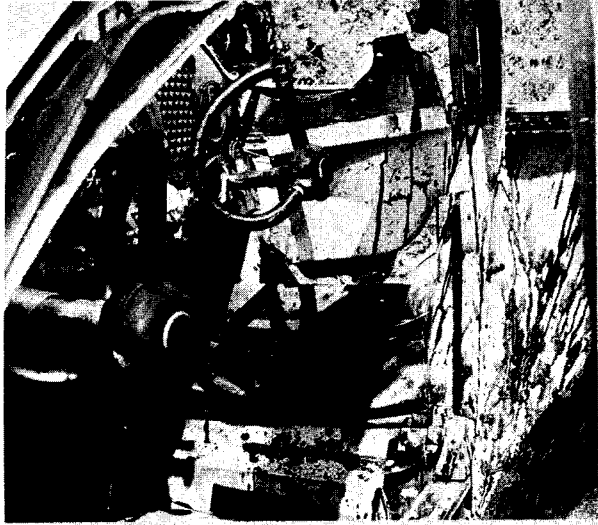
E. Internal view of cockpit. Note control wheel rims bent forward.

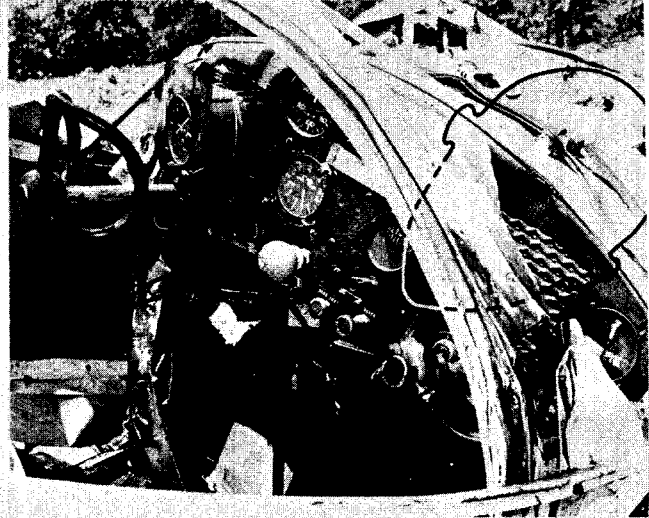
F. Head outline & dent in upper right instrument panel indicate head impact of copilot.

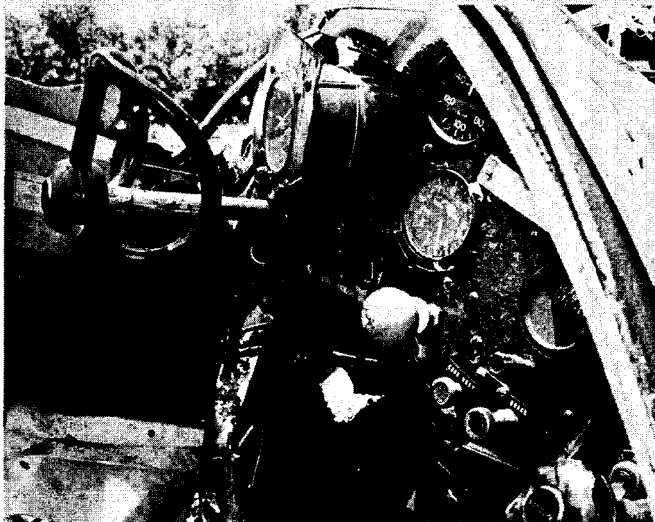
G. Area of body impact of pilot.

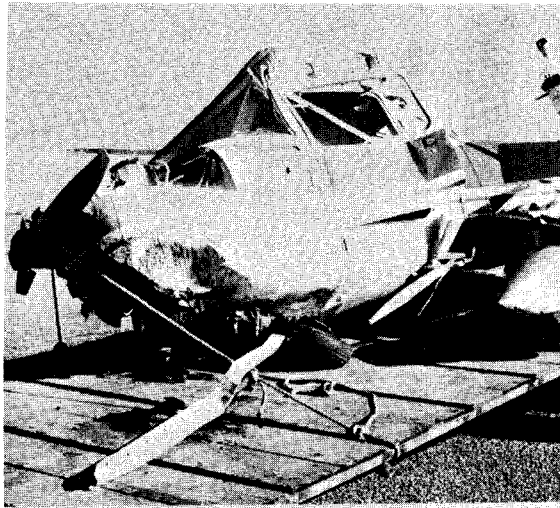
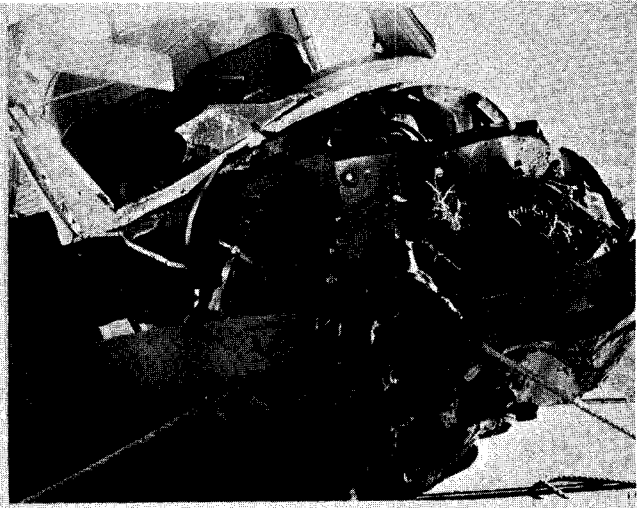
A & B Slight damage to the motor & cabin are indicative of a minor crash impact.

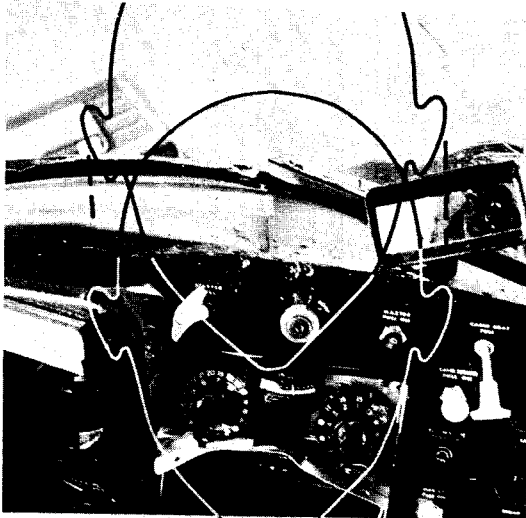
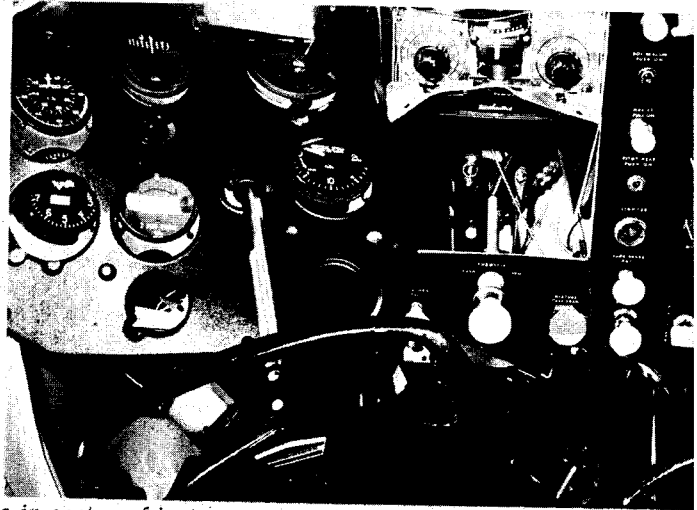
right and down with only a slight contusion of the chest and right shoulder (Case 7 F) and slowing his head velocity to a point (estimated 18 ft./sec.) that he survived with very severe facial injuries. Especially worthy of note at this point is the needless deep laceration (8 inches long) across the chin and right cheek inflicted when his face slid down and engaged the thin cover plate over the radio (Case 7 E). Teeth marks in the same figure indicate that his upper teeth and hard palate were destroyed when he impacted the top edge of the instrument panel just above the key insert.

E & F Area in center of instrument panel where pilot's head struck. Note teeth enamel above key insert and sharp edge of radio cover plate.

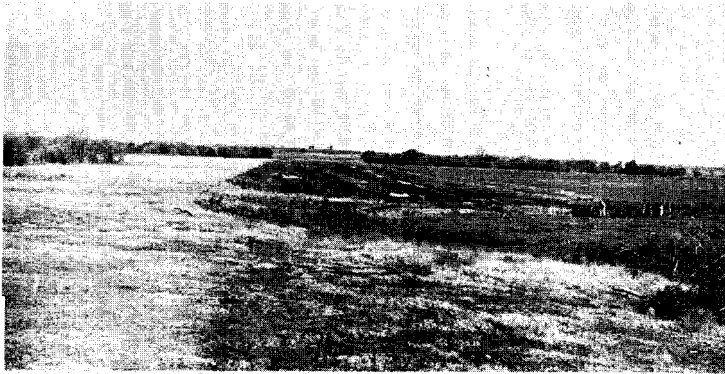
A. Blacktop landing strip with 4' fence across the end. Landing gear of aircraft hooked fence on take-off.

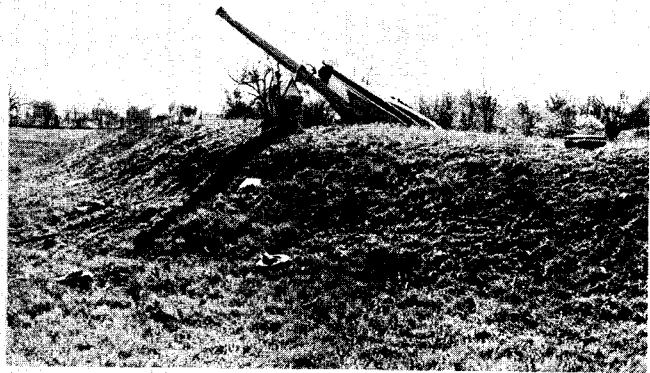
B. After traveling 420 feet in the air, aircraft impacted this dirt embankment, tore off its gear, and slid over into the pond.

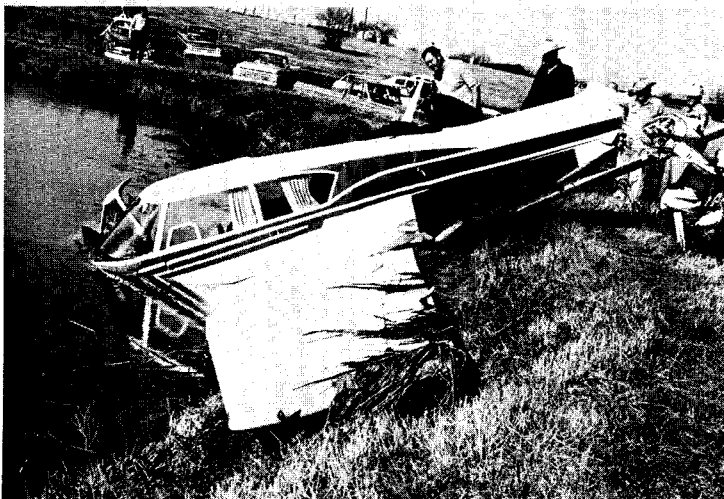
C. View of the aircraft as it was pulled out of the pond. Note cabin is entirely intact.

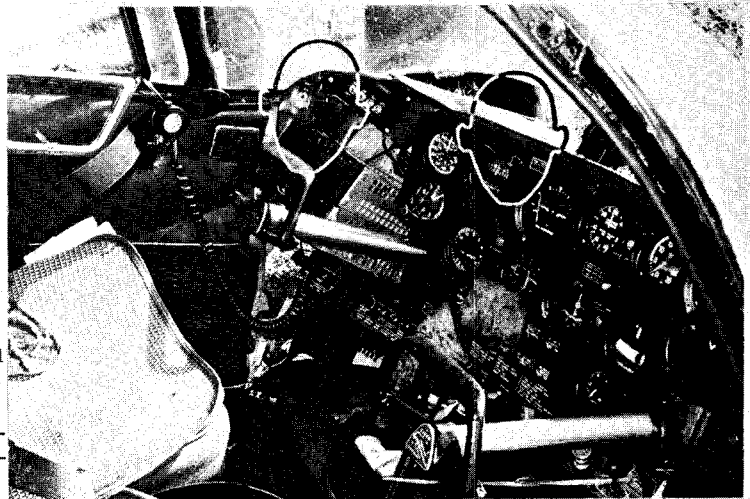
E. Head outlines indicate dented areas at top edge of the instrument panel produced by head impacts of two front seat occupants - all were knocked unconscious & drowned.

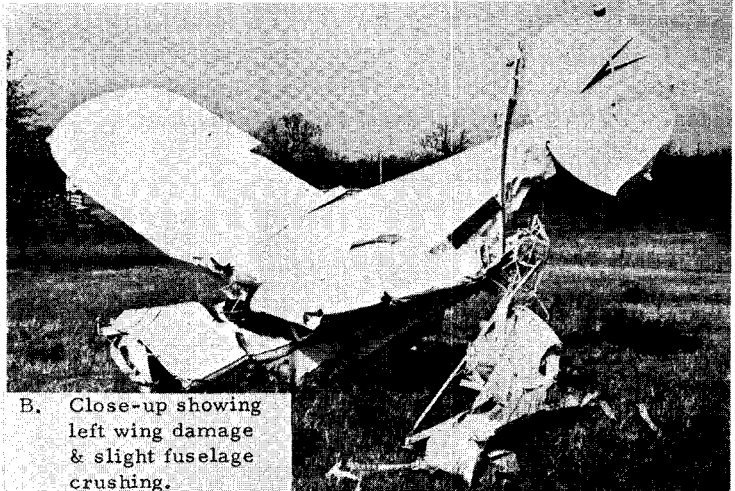
B. Close-up showing left wing damage & slight fuselage crushing.

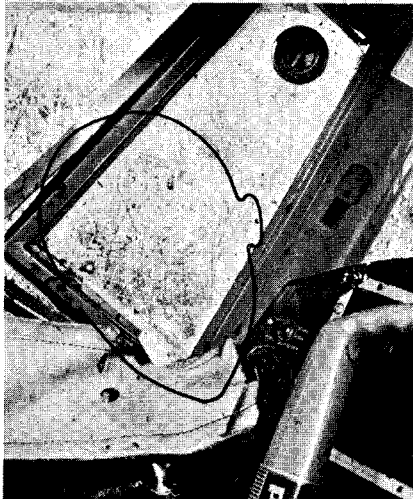
C. Area of pilot's head impact.

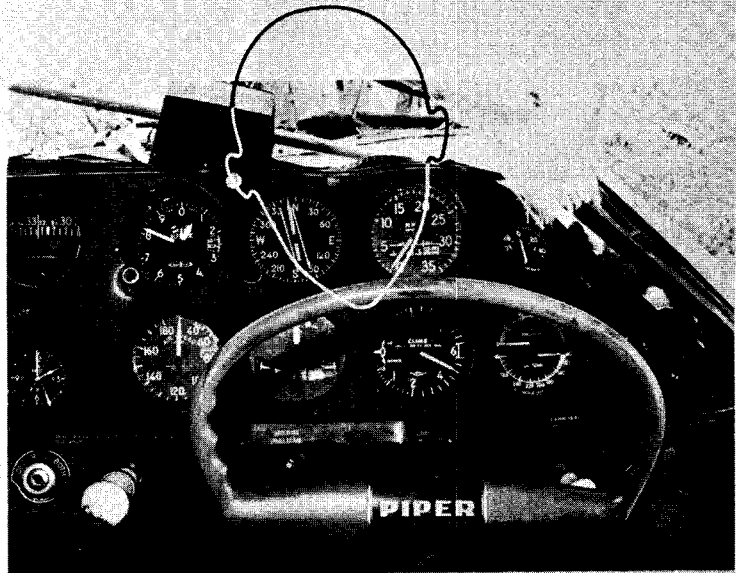
D. Dent at the top edge of instrument panel caused by copilot's head impact.

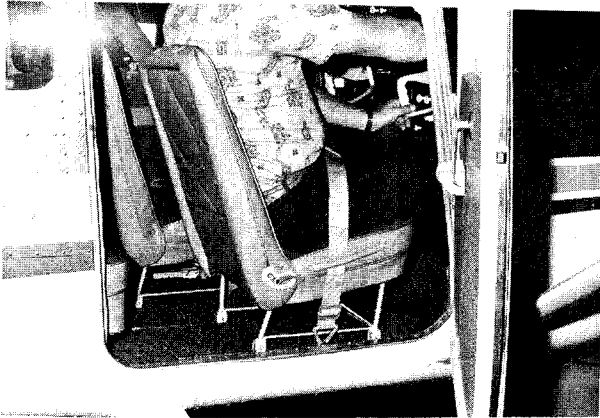
FIGURE 3. Subject wearing seat belt in 1968 Cessna 150.

the lap belts applied around the pelvic structure. The lap belt, if worn and if it does not fail, restrains only the pelvic area and allows the rest of the body to continue in motion until stopped by impacting some portion of the container. In a number of cases in this study it was noted that even the lap belt is an ineffective restraint because of faulty installation. In numerous aircraft the lap belt goes across the thighs and straight down to the floor (Figures 3 and 4) instead of across the iliac crest and then back at a 45° angle to the floor.

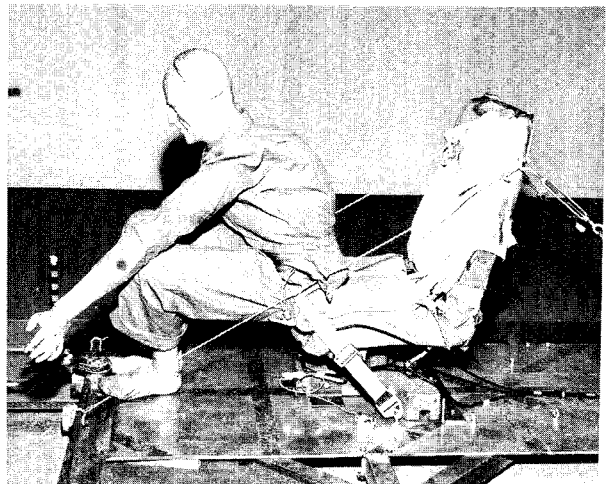
During deceleration the occupant is free to move forward until the belt is at nearly a 45° angle with the floor before the belt offers any restraint. By this time he is sliding off the front edge of the seat (Figure 5) and the forward motion added to belt stretch allows him to penetrate the firewall.

FIGURE 5. Position of dummy after crash test. Extreme forward motion is allowed by improper seat belt installation.
