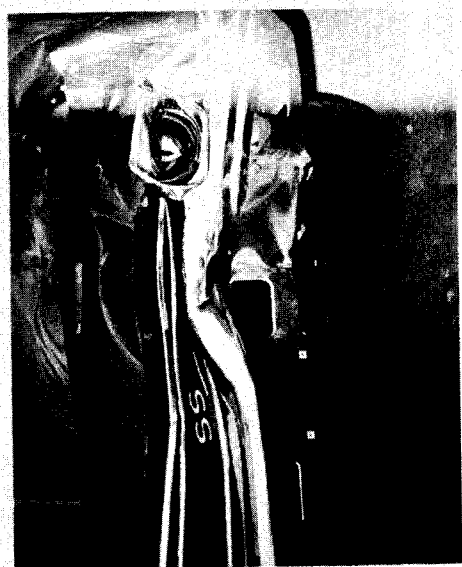
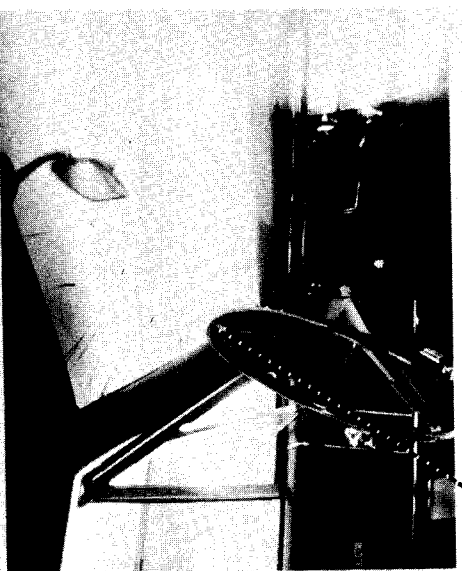
FIGURE 7. Automobile accident in which driver was subject to 7 "g" forward deceleration.

Note: Hood hinge penetrated windshield

Cervical strain, pain in trapezius muscles, pain in left arm and upper chest

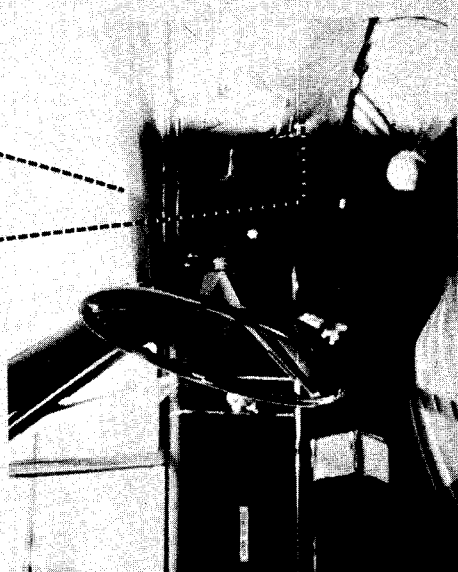
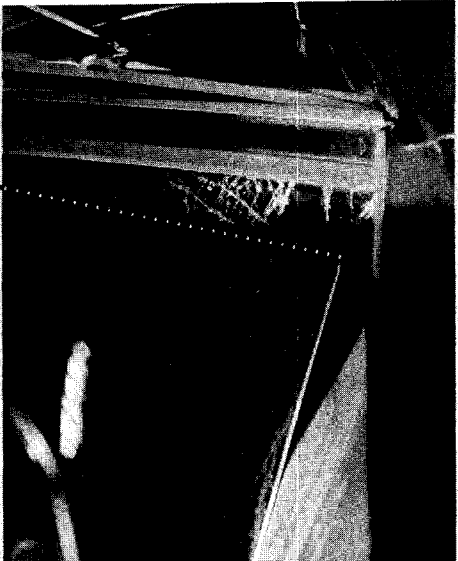
FIGURE 8. Automobile accident that subjected driver to 9 "g" deceleration.

Complained of neck pain — no fracture  
Pain in (R) knee and (L) elbow, no fracture, no lacerations

Note: hood penetrating windshield

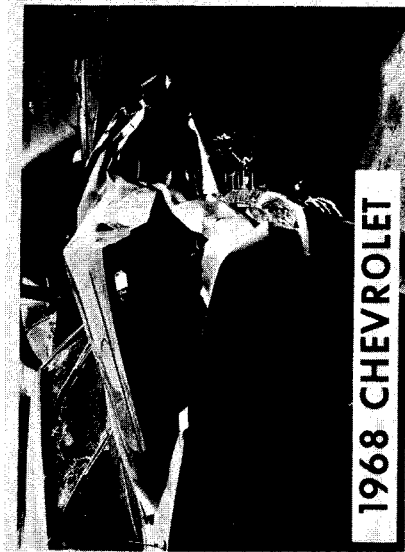
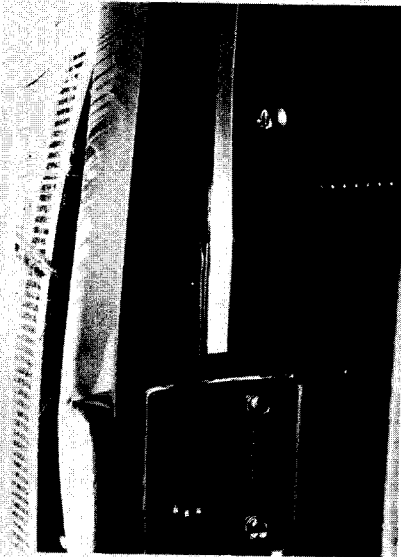
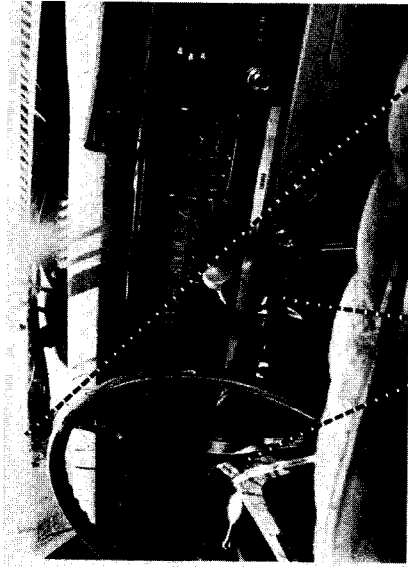
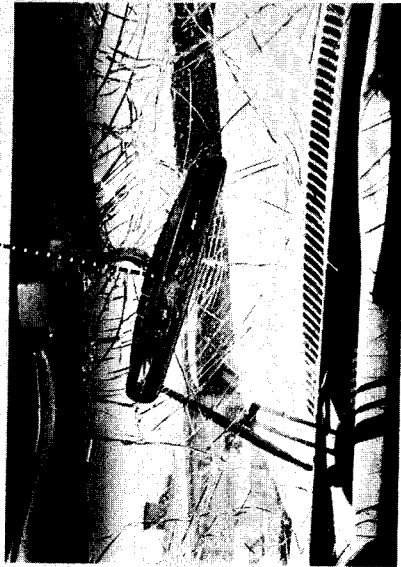
FIGURE 9. Effects on occupants in a 10.5 "g" automotive crash.

① DRIVER  
 Minor lacerations on forehead  
 Laceration of (R) knee  
 Sore chest

③ RIGHT FRONT  
 Fractured nose (severe) and nasal spine of maxilla, cut over left eye  
 (L) hip and (R) hand painful but no fractures

⑥ RIGHT REAR  
 Lacerations of both lower legs anterior

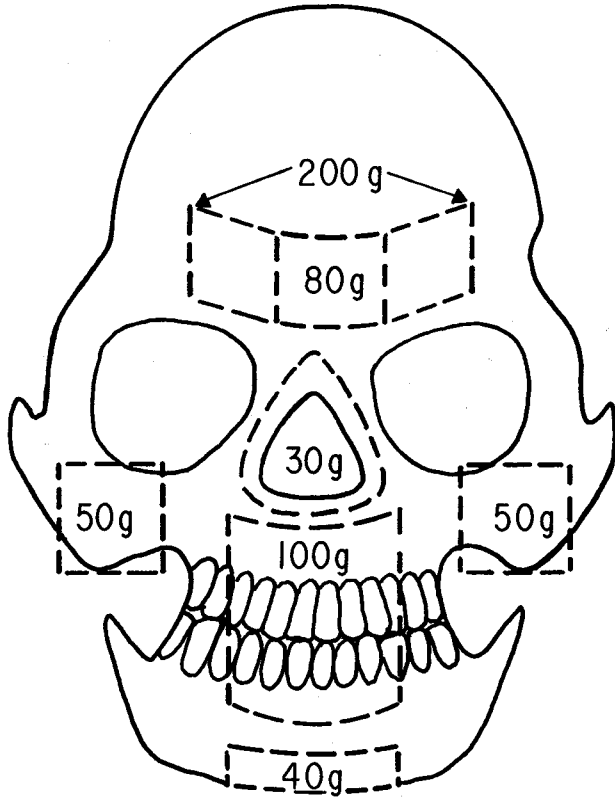
FIGURE 12. Tolerances of the human head to crash impact.

that a single square inch of the forehead is capable of withstanding an 80 "g" impact without fracture—*PROVIDED* the force is evenly distributed over the contour of the area impacted. If this area of contact is increased to 3 square inches, the frontal skull of most adults can withstand 200 "g" without fracture. Other portions of the face explored include the zygomas, nasal area, maxilla, and mandible and tolerance limits are shown in Figure 12.

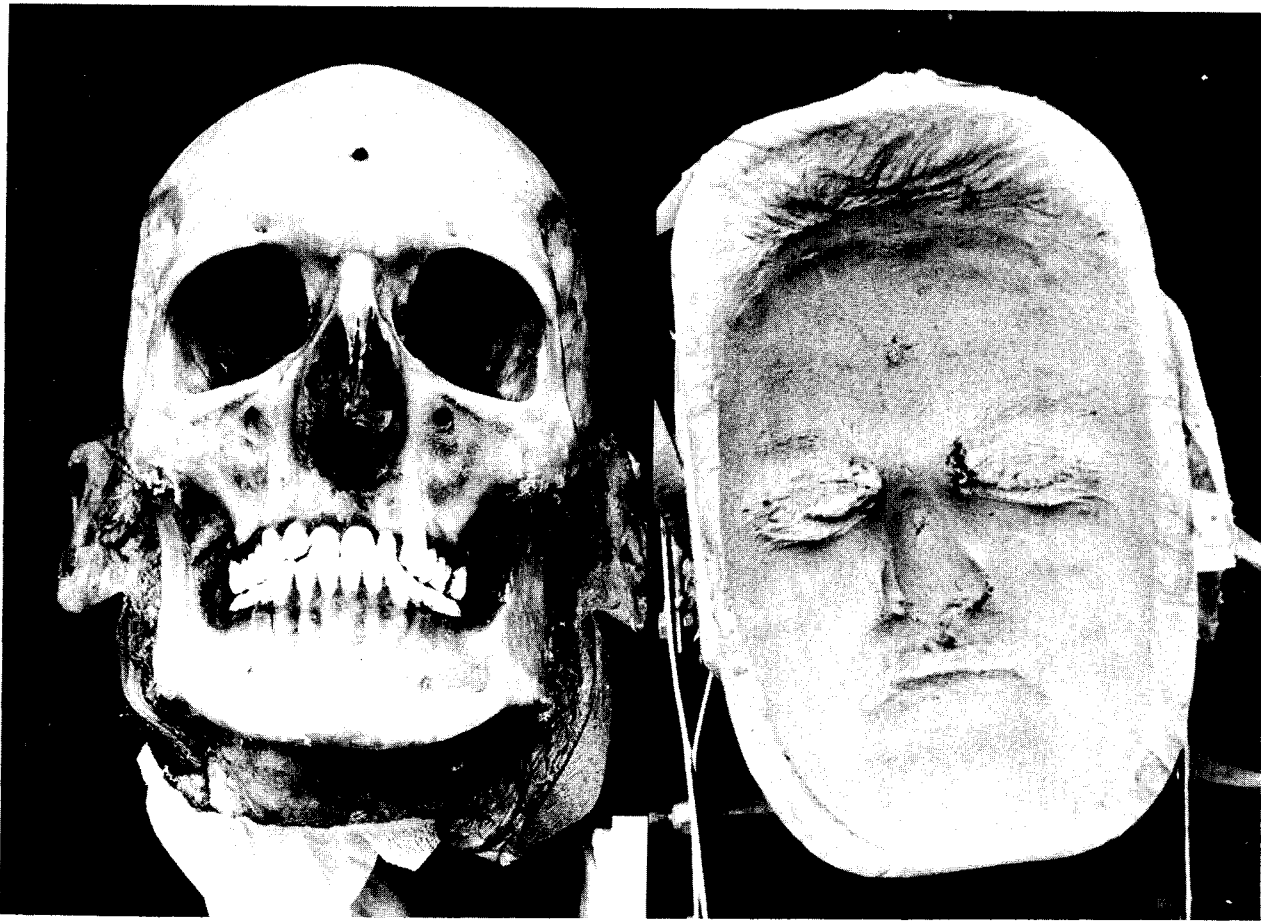
FIGURE 13. Full-face (maximum area) crash test exceed 300 "g" deceleration.

He then became curious as to whether or not these impact tolerance areas were additive. A rigid cast was made for one cadaver head to provide even distribution of force over the entire frontal face and forehead. Impact tests exceeding 300 "g" produced no signs of soft tissue laceration or bone fractures. Every tooth and even the thin turbinate bones of the nose remained undamaged (Figure 13).

This study shows conclusively that it is possible through engineering design of the inside of the container to completely eliminate lacerations and fractures of the head and face during head impact of extremely high forces (over 300 "g").

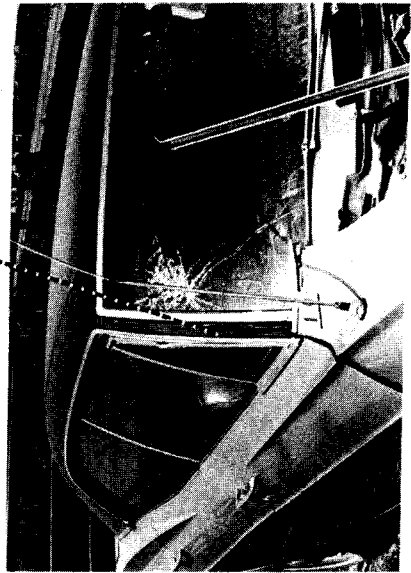
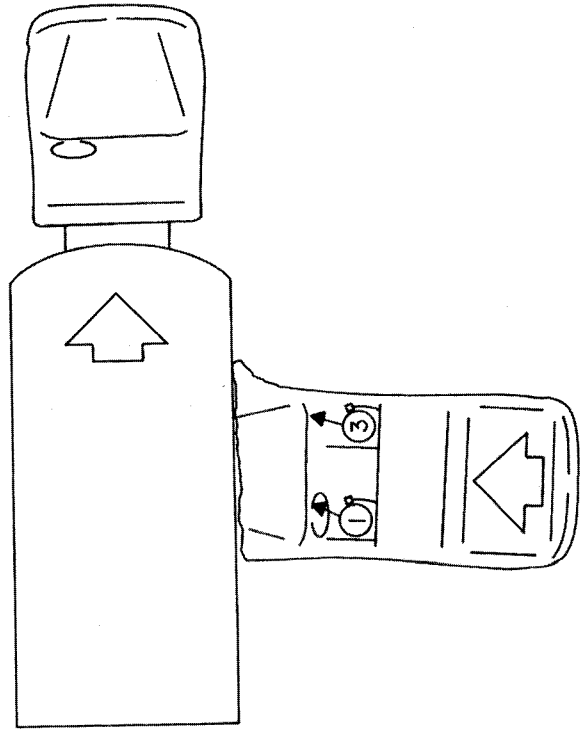
FIGURE 21. Deceleration = 28 "g".

① DRIVER

Laceration (R) leg below knee

③ RIGHT FRONT

Fracture (R) clavicle

Dislocation (R) shoulder

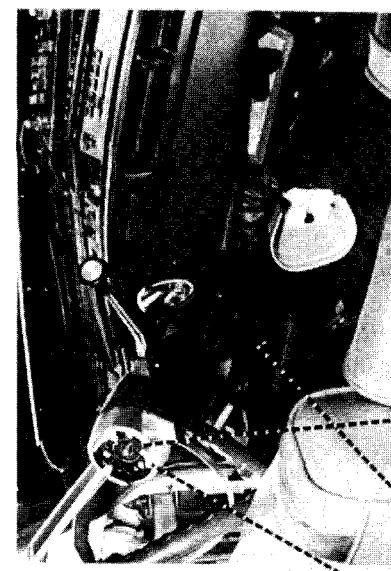
FIGURE 25. Deceleration = 38 "g".

① DRIVER

- Fracture nose, cerebral concussion
- Fracture (R) fibula
- Fracture humerus (R)
- Laceration (R) knee

No chest injury

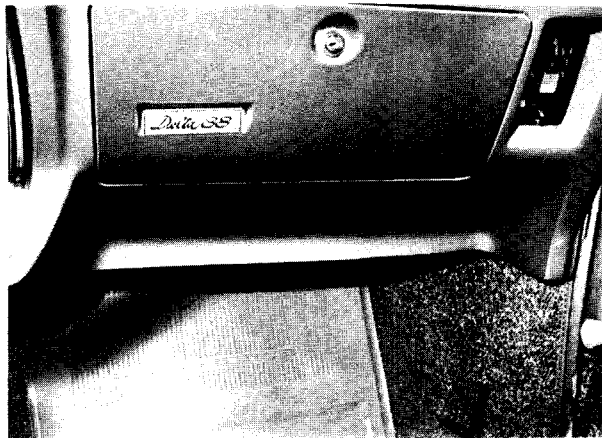
FIGURE 27. Knee impact area in late-model automobile.

pellor controls, etc.) on the lower left instrument panel (Case 11 E and G) were directly responsible for a fractured arm, fractured pelvis, and dislocated hip and knee in this accident. The author feels that the manufacturers of general aviation aircraft could significantly reduce leg and pelvic injuries by copying the design trends of the automobile manufacturers (Figure 27).

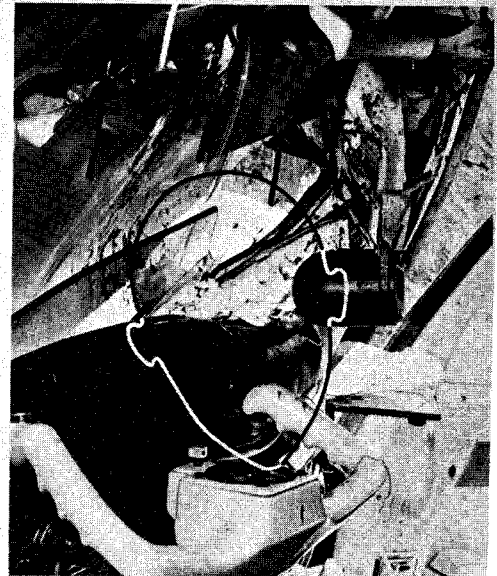
D. Pilot's head struck the broken plexiglass windshield, the heavy compass, & right horn of the control wheel.

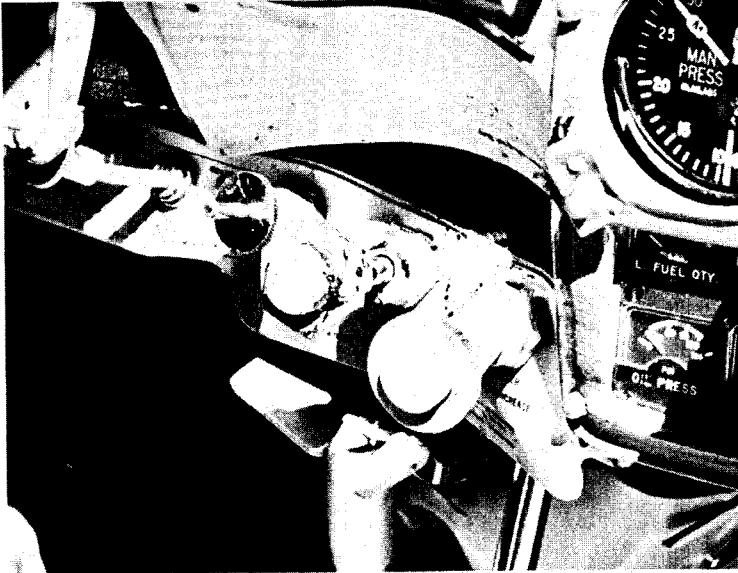
E & G Lower left instrument panel showing knobs bent and broken by pilot's legs.

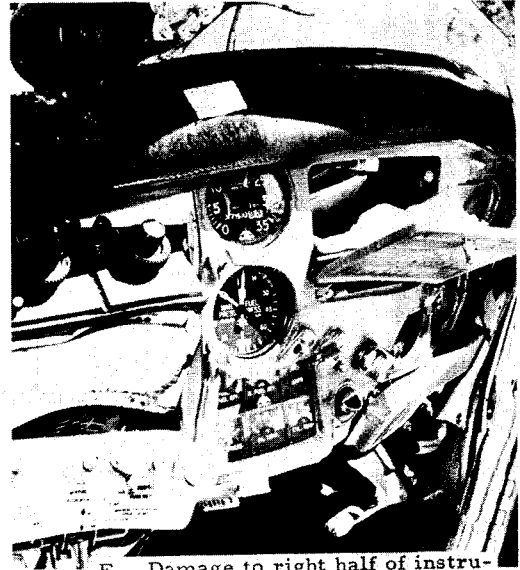
F. Damage to right half of instrument panel from unrestrained stretcher.

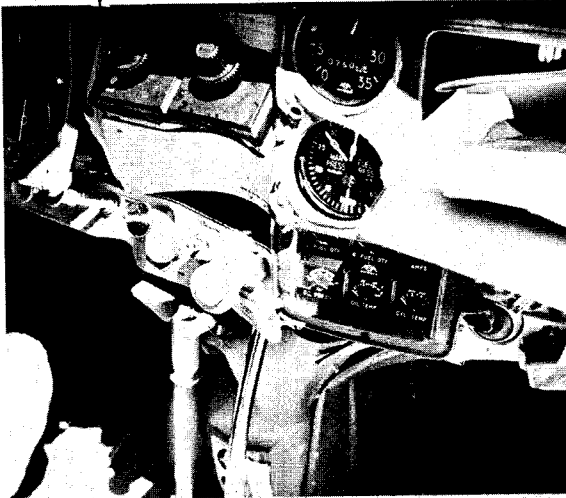
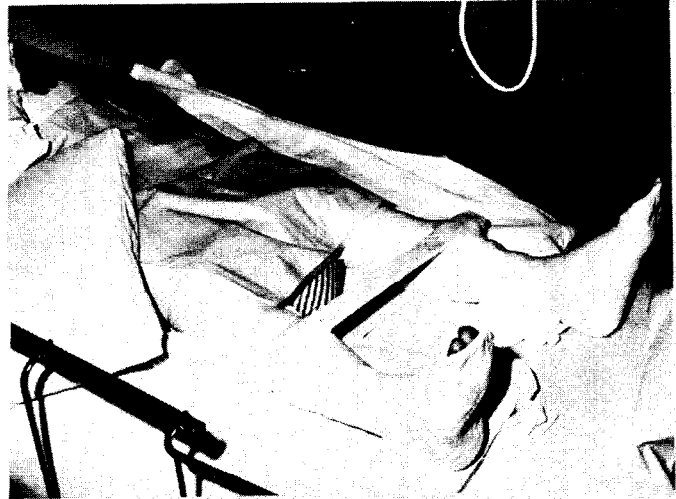
H. Pelvic & lower leg injuries.

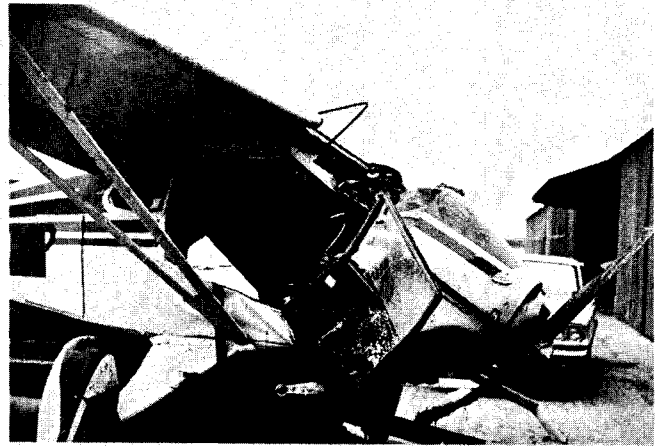
In Case Number 12 there has been a complete separation of the cabin structure at both ends of the instrument panel (Case 12 B and C) as a result of the impact. Since this 1955 Piper Tri-pacer PA 22-150 has doors on both sides, the only structure preventing the engine and instrument panel from being pushed back into the faces of the front seat occupants is the "A" post on each side of the windshield. The inboard half of each seat belt was attached to the seat while the outboard half was attached to the fuselage. Attaching lap belts to seats loads the seat tie-down attachments unnecessarily, often causing them to fail and the package contents are no longer even partially restrained. Seat attachments in this case did fail (Case 12 I, J, K and L), allowing the two front seat occupants to smash their faces into the formidable structure of the upper instrument panel and their knees and legs into the prong-studded lower panel (Case 12 D). Facial injuries were more severe in this case than in Case 11, partially because there was no padding on the instrument panel and partially because the crash impact force was slightly greater as attested to by the significant increase in lower leg injuries. The bare survival of these two oc-

C. Close-up of right side of aircraft shows complete failure of right "A" post. (Only structure resisting backward displacement of motor & instrument panel on that side).

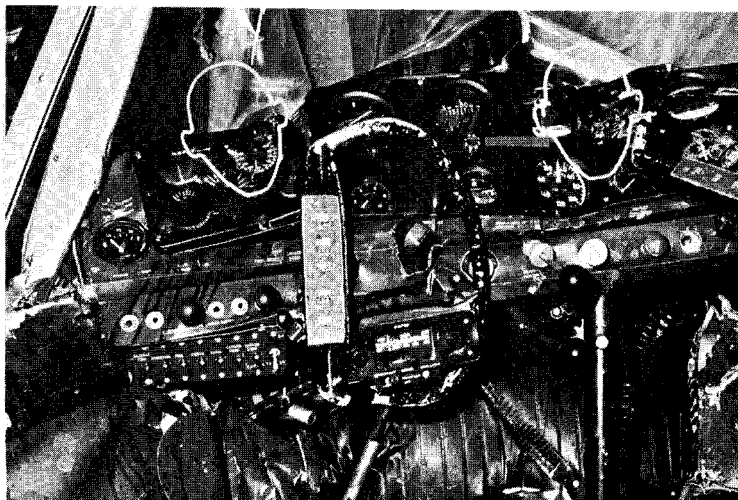
D. Head outlines indicate instrument panel depression areas produced by head impacts of the two front seat occupants. Note control wheel crushed into instrument panel.

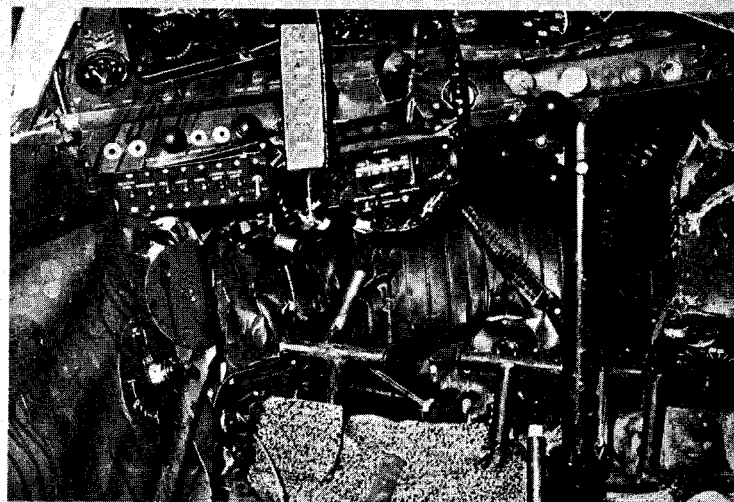
E. Lower left instrument panel conglomerate, responsible for numerous leg and ankle fractures & lacerations.

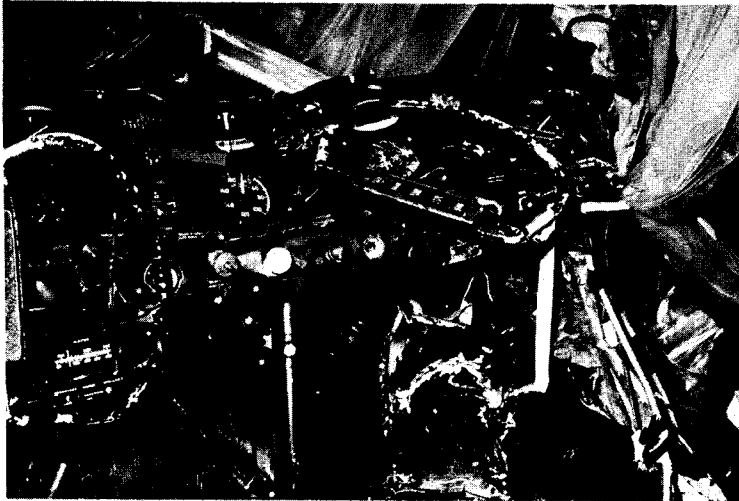
F. Right half of instrument panel.

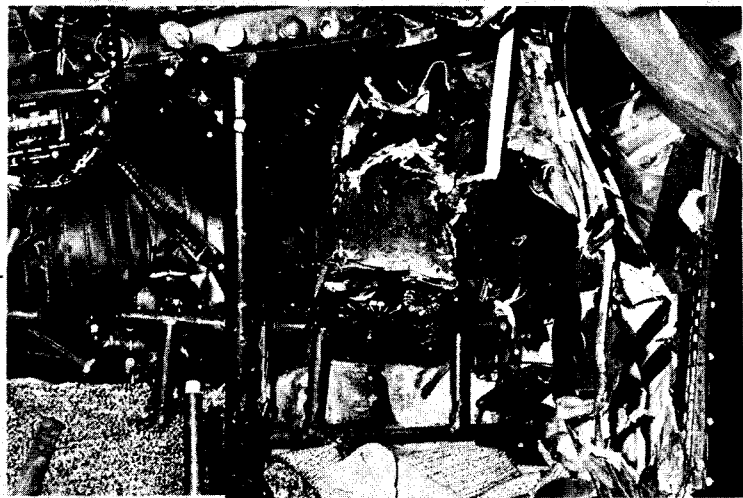
The total weight of the radio equipment in this aircraft was approximately 30 pounds. Radio equipment incorporating miniaturization technology is available today. By substitution of this new equipment, communication weight could be greatly reduced and the pounds saved utilized to strengthen the forward areas of the cabin as Beech Aircraft Corporation did so successfully nearly 20 years ago.

H. Close-up of heavy radio structure on copilot's side causing four lower limb fractures.

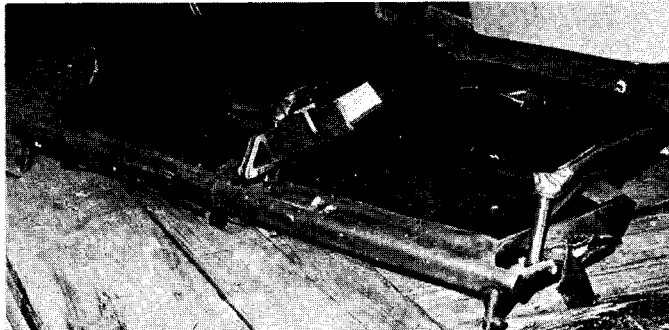
I. Inboard halves of seat belts were attached to the seat in this aircraft, transferring heavy belt loads to fragile seat tie-down structure.

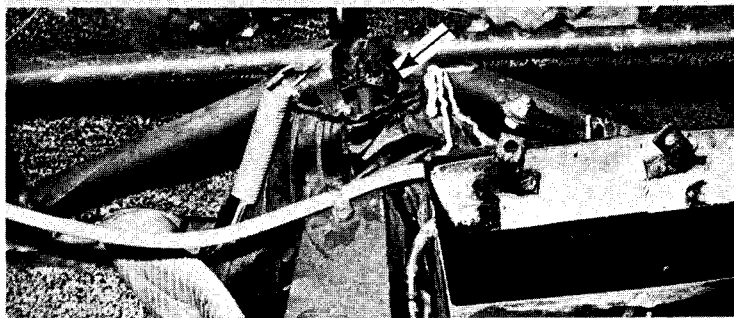
K. Adjustment pin & center tie-down flanges. Notice that the thin tie-down flanges are spread open, allowing the seat to leave the track.

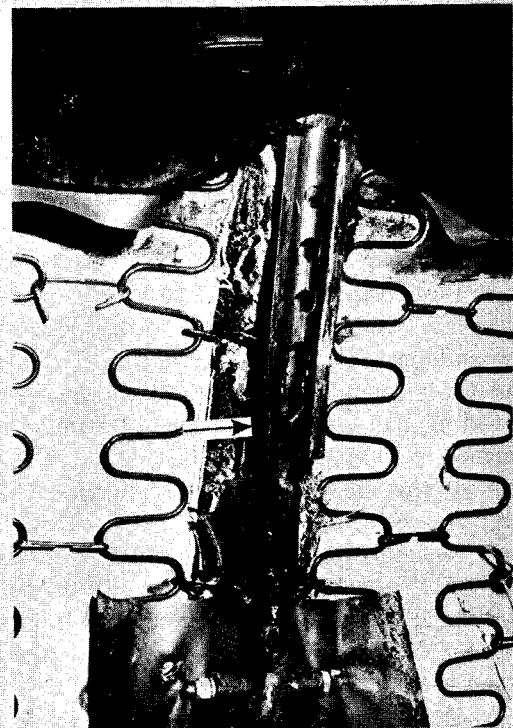
L. Tie-down & adjustment structure on bottom of seat. The thin metal on either side of the adjustment holes bent & allowed seat to tear loose.

of two occupants and the weight of the seat could fail with only one occupant in such a minor deceleration. It is possible, since this aircraft was nearly 15 years old, that deterioration of the seat attachments may have been a factor. However, since general aviation aircraft keep on flying until they disintegrate in a crash, seat tie-down attachments should be designed for long usage. If the restraint system fails under these minor conditions, certainly it is of little or no benefit in even a hard landing, let alone a minor crash.

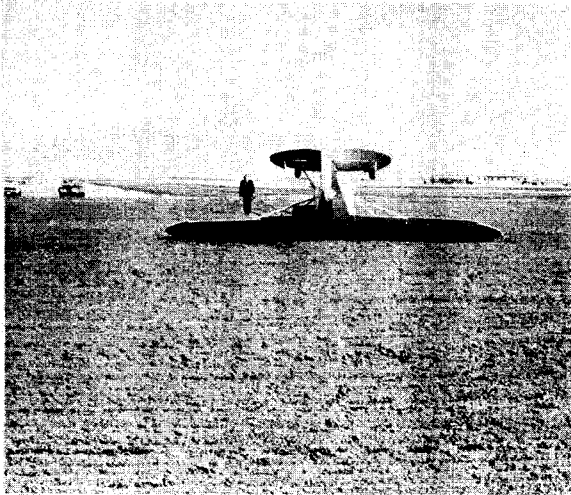
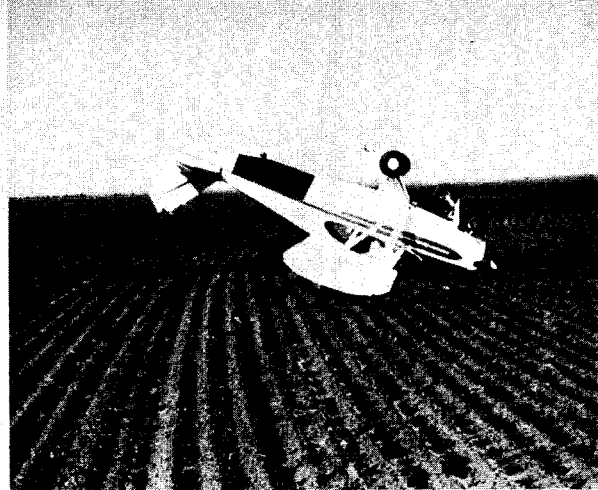
A & B Two views of aircraft that simply flipped over onto its back without damage.

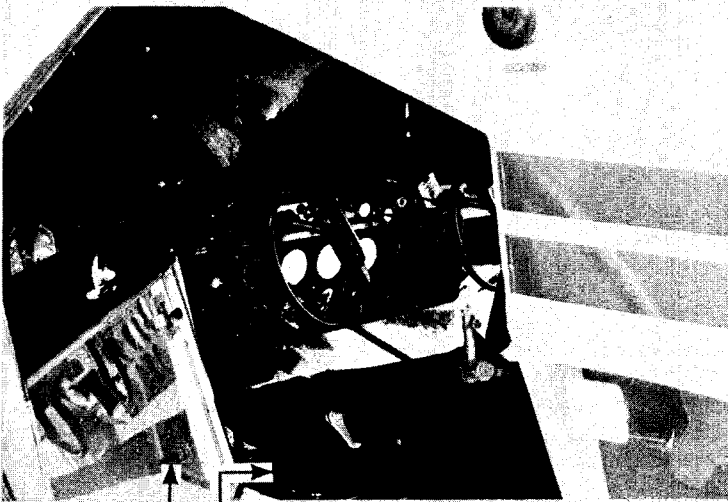
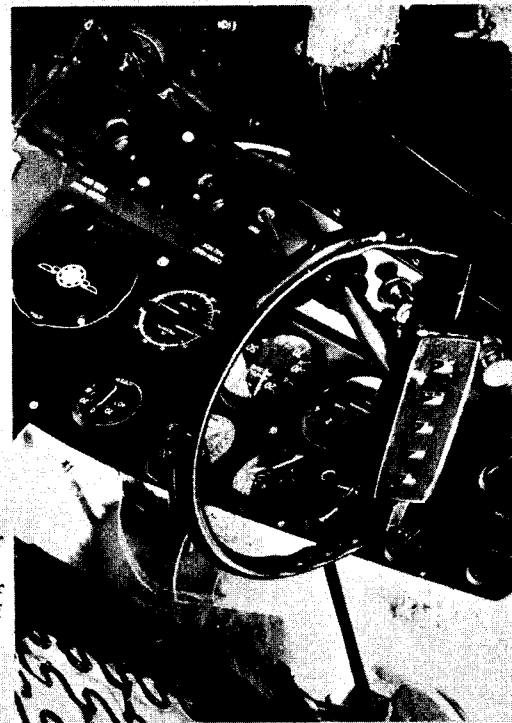
C & D Views of instrument panel and control wheels show no signs of damage & indicate deceleration forces were not of sufficient magnitude to cause pilot to be thrown forward. However note seat has torn free & is lying in the top of the aircraft.

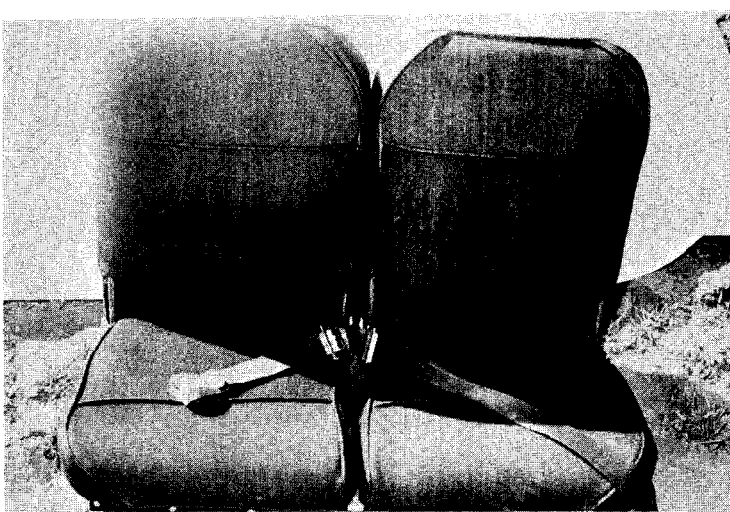
E. Seats failed in this minor incident (1) because seat belts were attached to the seat.

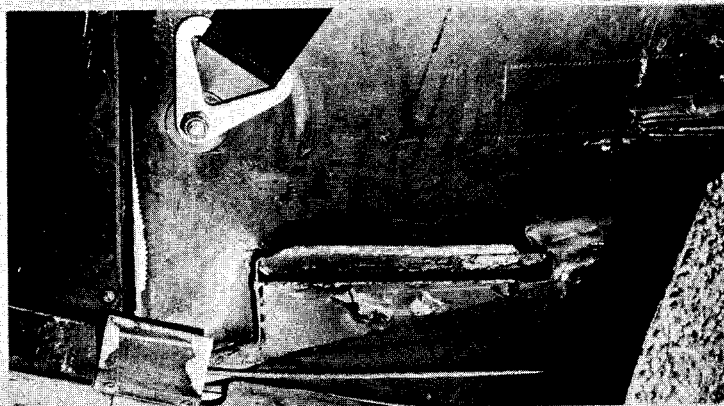
F. (2) wall track for end of seat allows seat to slip out.

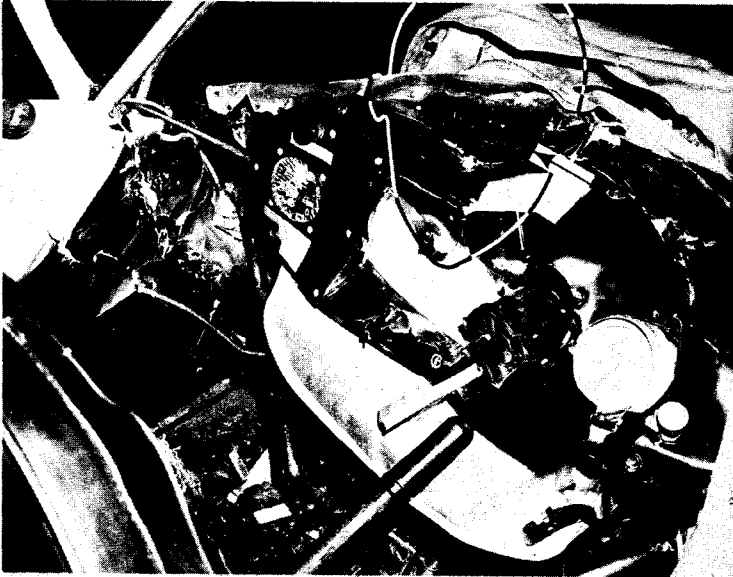
C. Impression in the top center of the instrument panel that caused fatal head injuries.

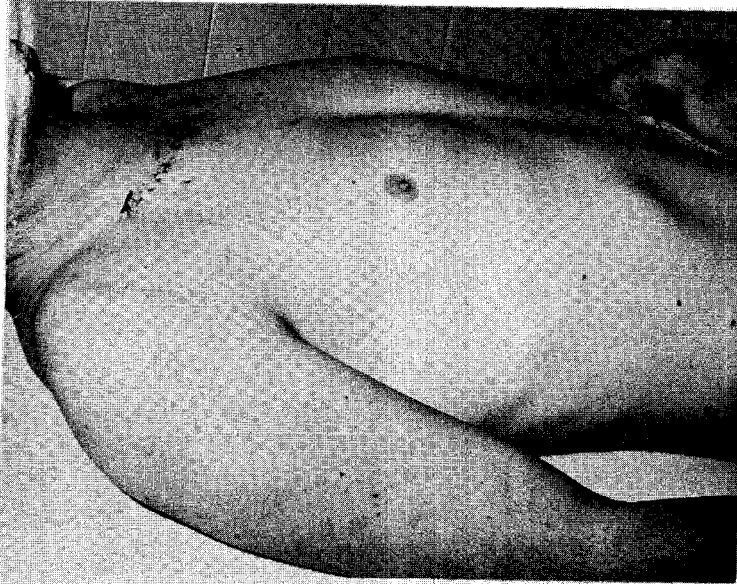
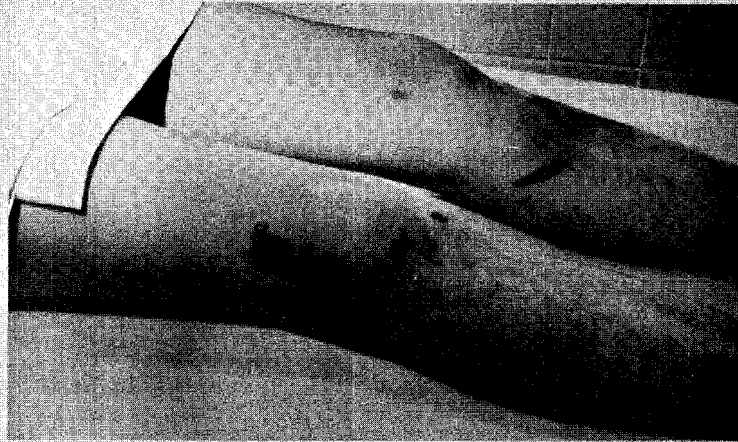
E, F & G Body pictures to show complete lack of body injuries with the exception of a broken ankle.

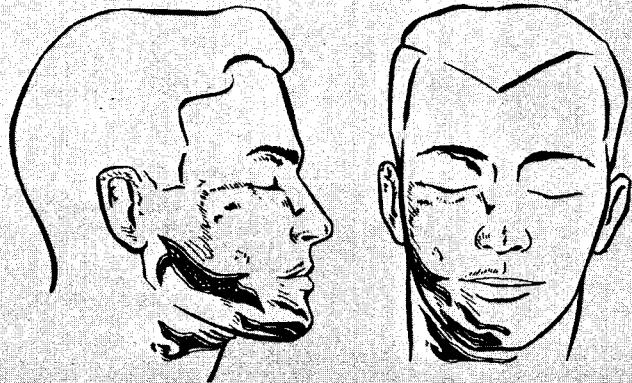
E. Pilot (rear seat) head injuries. Note lacerations from broken windshield.

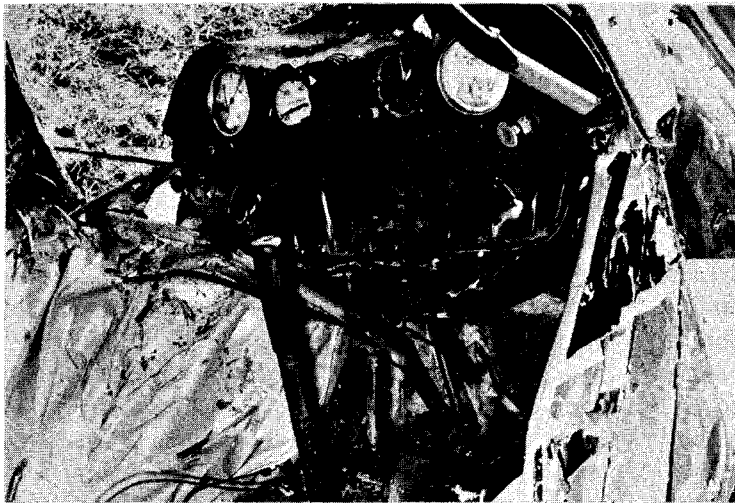
The rear seat lap belt failed at its attachments allowing the occupant of this seat to be thrown forward over and on top of the front seat occupant. His body weight may have added to the force of head impact of the front seat occupant. The fatal head injuries of the rear seat occupant were inflicted by the broken windshield and rigid edge for attachment of the windshield (Case 15 E). Failure of the rear seat belt attachments cannot be taken as indicative of severe crash forces since the ends of the seat belt are fastened by  $\frac{3}{32}$  inch wire loops to a  $\frac{3}{4}$  inch floating tube running through the canvas seat bottom. Ends of this tube are in turn fastened to the fuselage by similar wire fasteners. Failure of these latter attachments allowed the seat belt attachments to slip off the end of the tube. As in Case 14, the front seat occupant received a severe fractured ankle, almost severed (Case 15 G) from the tubular cross brace (Case 15 F) in the lower cockpit.

F. Lower instrument panel showing tubular cross brace that passes over the ankle.

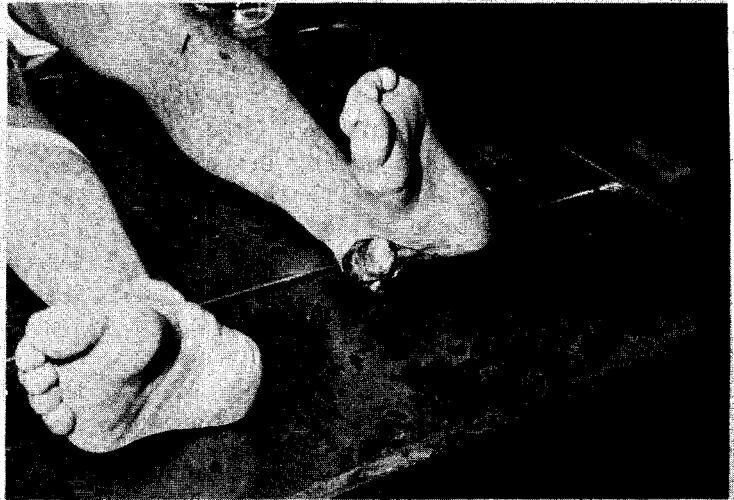
G. Typical ankle fracture from cross brace.

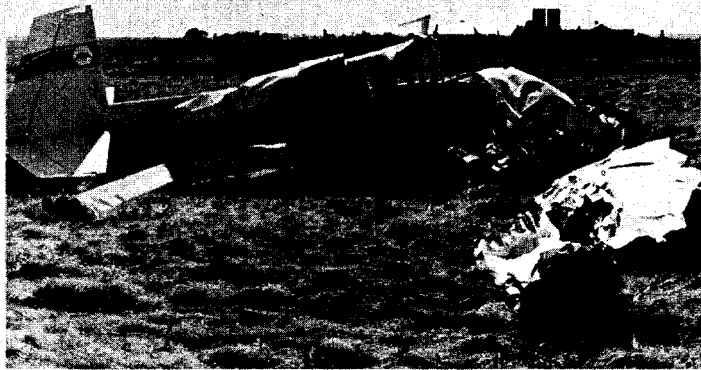
B. Right view shows cabin structure failed & opened up.

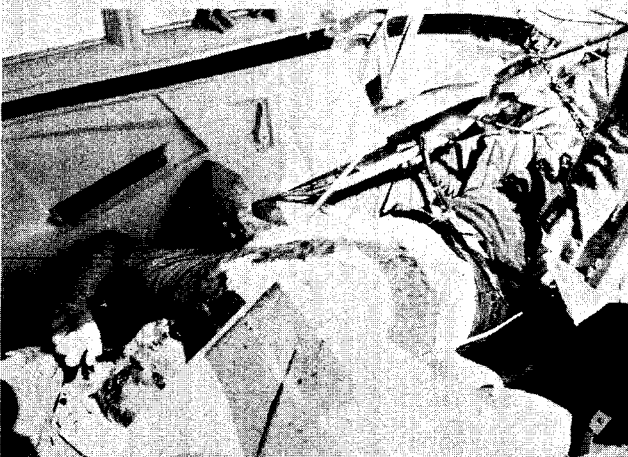
C. Pilot's body still retained by seat belt.

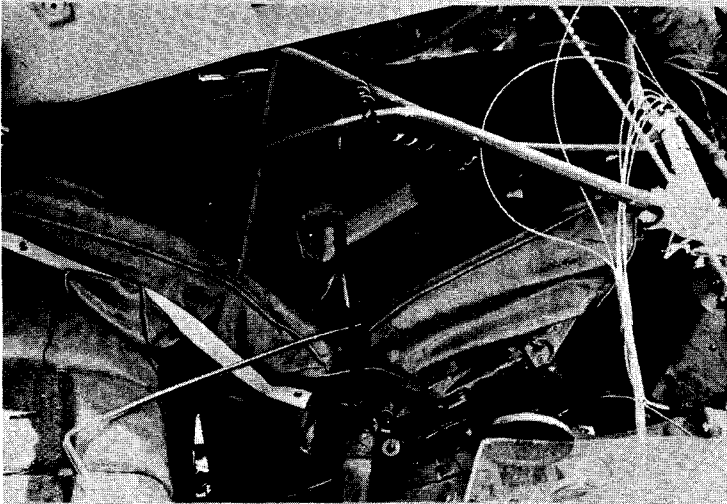
G. Seat track pulled loose from floor.

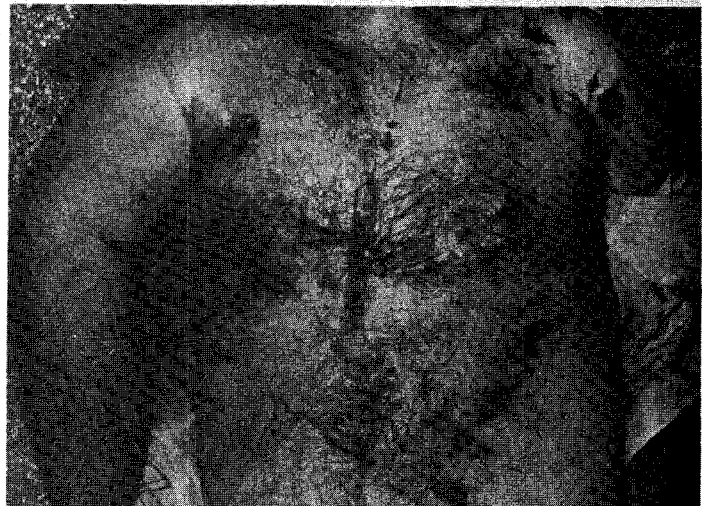
N. Chest injuries from control wheel horns & broken column.

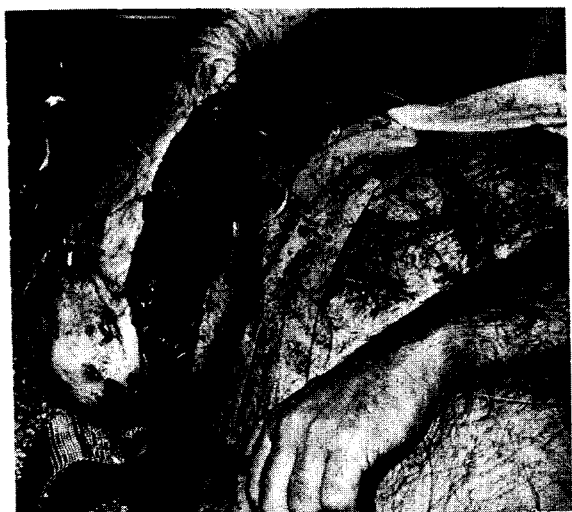
P, Q & R Severe lacerations & fractures inflicted when arms & legs flailed into broken structures.

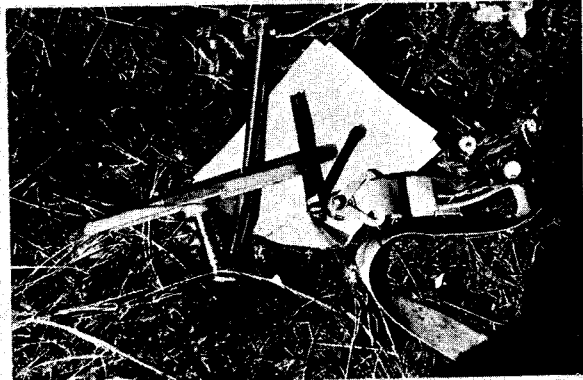
E. Pilot received massive puncture of all major body viscera when control column bent to form a spear after seat belt attachment failed.

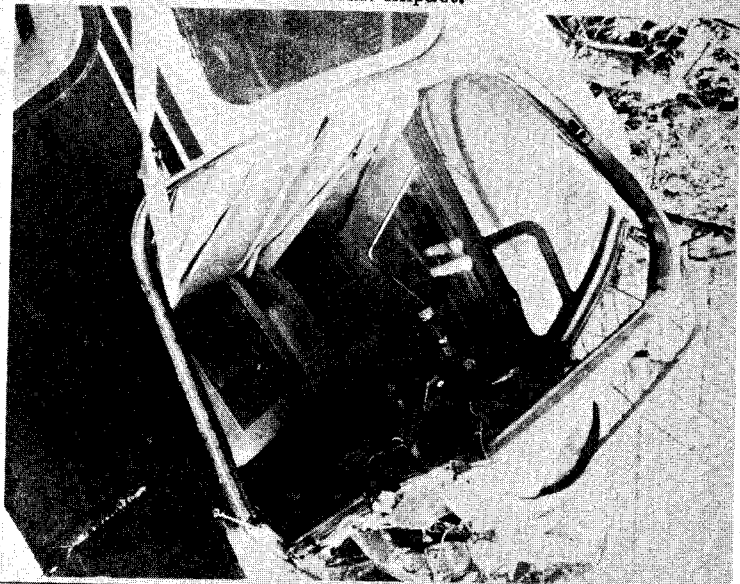
C. Close-up showing cabin integrity.

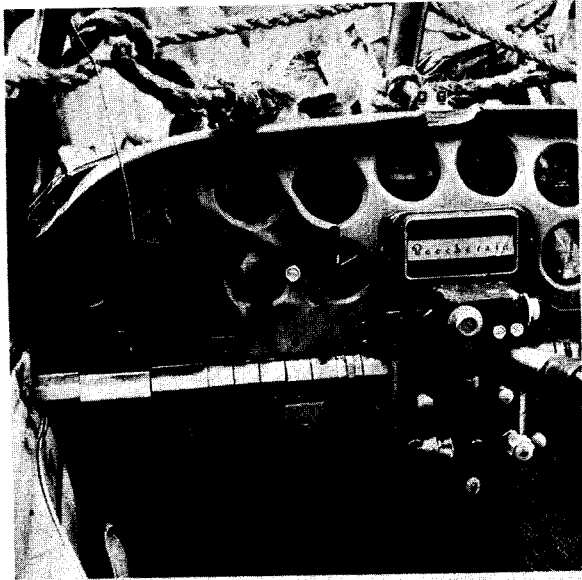
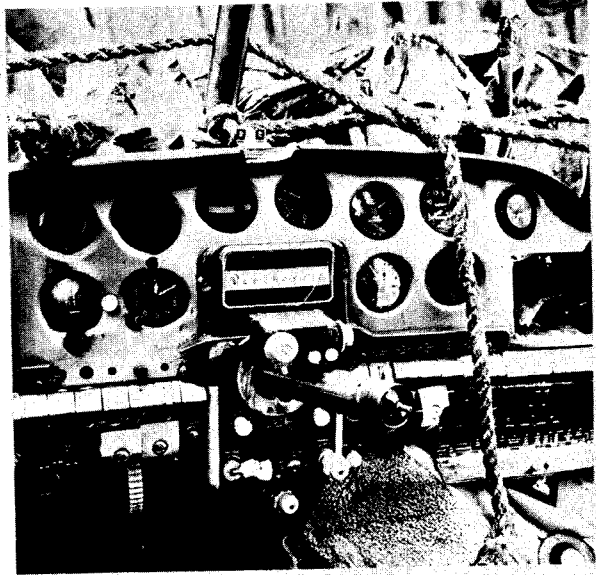
D, E & F Views of instrument panel  
& cabin interior.

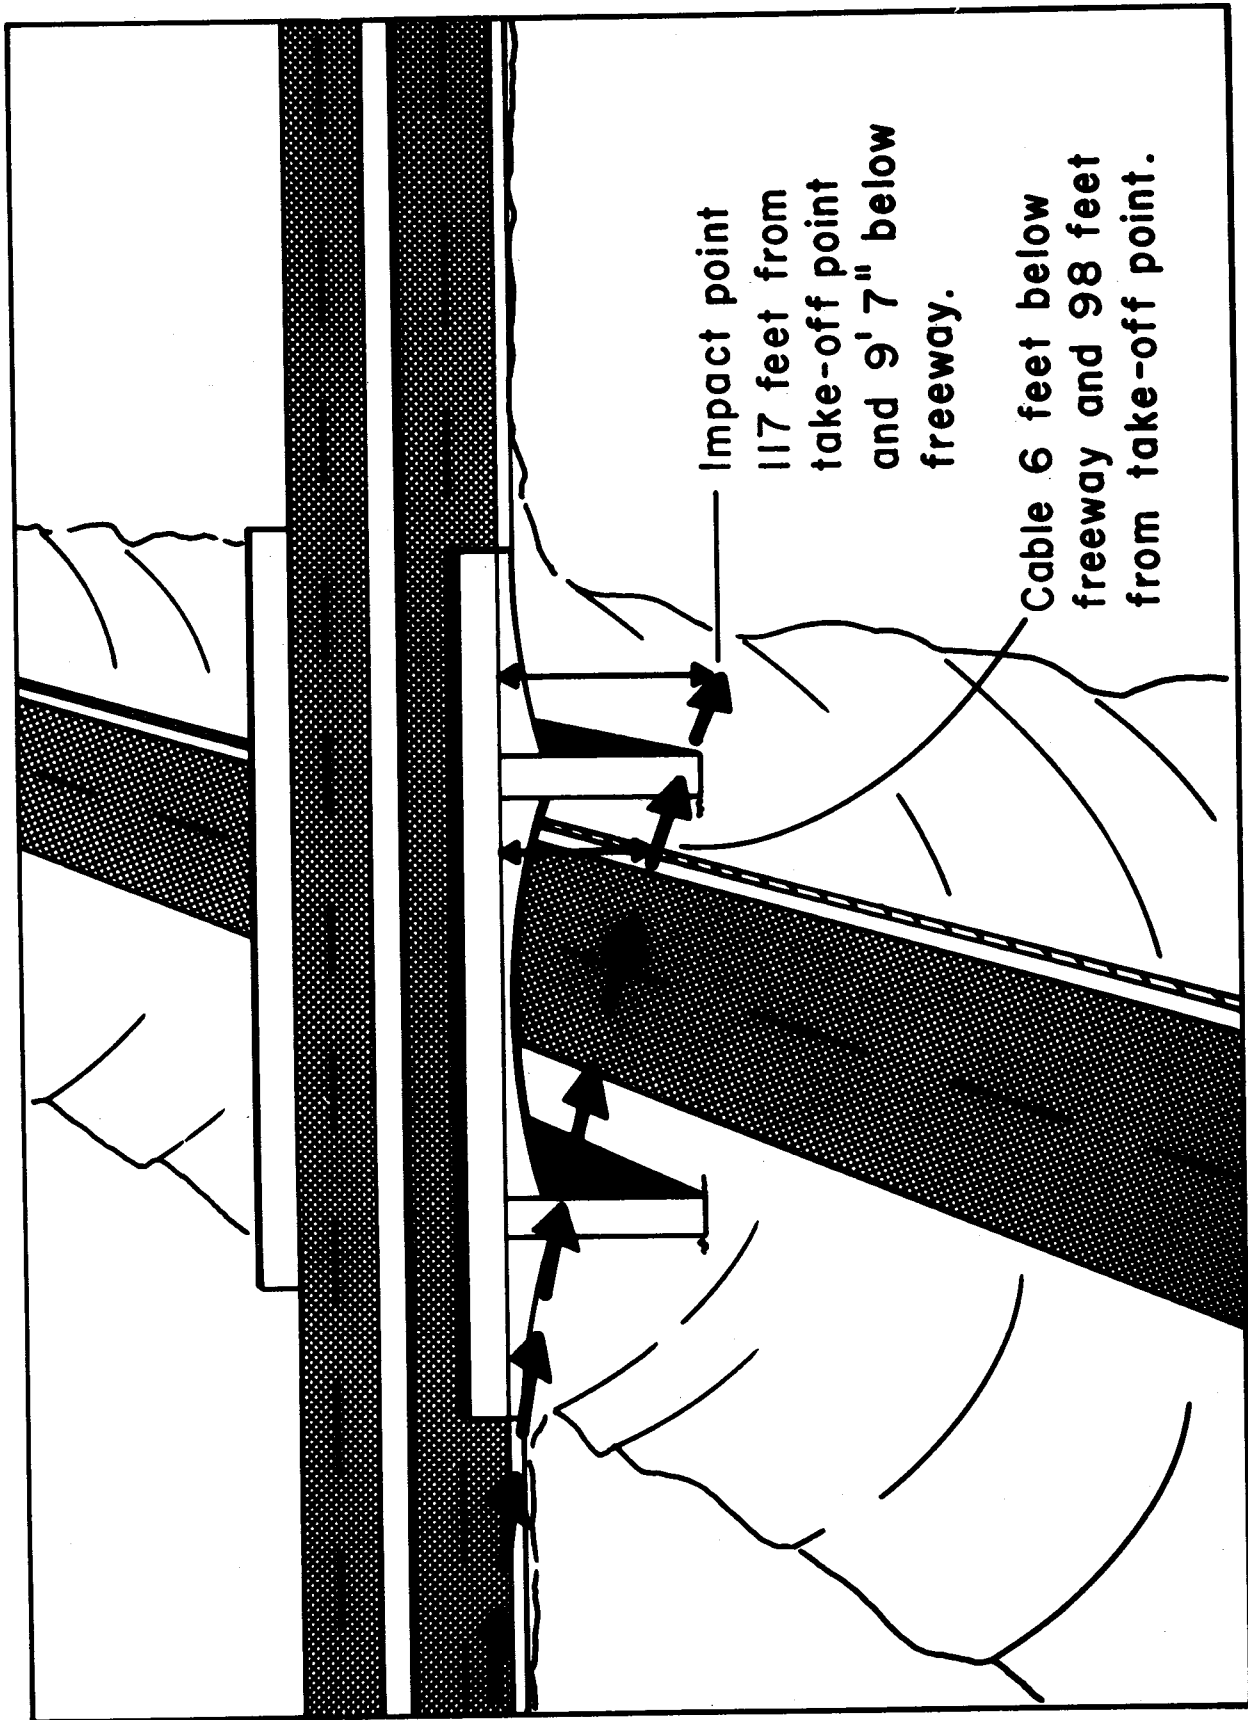
FIGURE 29. Trajectory of an automobile traveling at high velocity after it ran off the freeway.

ing 6 feet below the bridge and about 98 feet from the take-off point. Acceleration due to gravity caused a drop of only 9 feet, 7 inches, during its 117-foot flight. In this instance, one can easily calculate with accuracy that the flight velocity of this vehicle must have been slightly over 100 miles per hour. Crushing of the front of the vehicle was approximately 5 feet (Figure 30) and the depression in the hard earth embank-

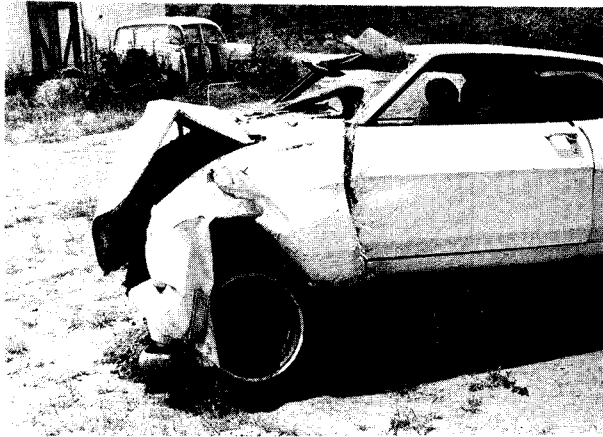
FIGURE 30. Side view of vehicle showing crushing of front end during deceleration.

ment measured 8 to 12 inches. Hence, it can be calculated that the average deceleration of the car was in excess of 50 "g". Even with these very severe impact forces, the shipping container maintained its integrity and the heavy motor was pushed back under the floor board and not into the cabin. While it is doubtful if light aircraft cabins can be designed to withstand "g" forces of this magnitude, their interior certainly could be modified to incorporate some of
