1968 CESSNA 150

ACCIDENT INVESTIGATED BY:
GALE BRADEN AND DON ROWLAN
CAMI

CASE 20-1

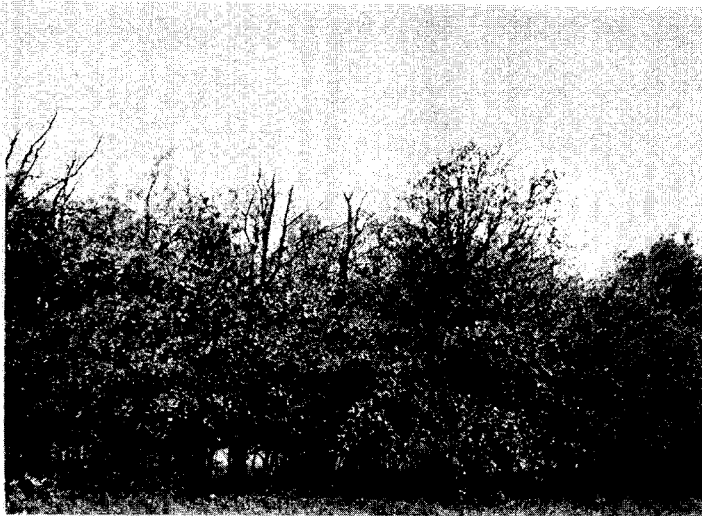
A. Tree tops clipped by inverted aircraft just before it crashed.

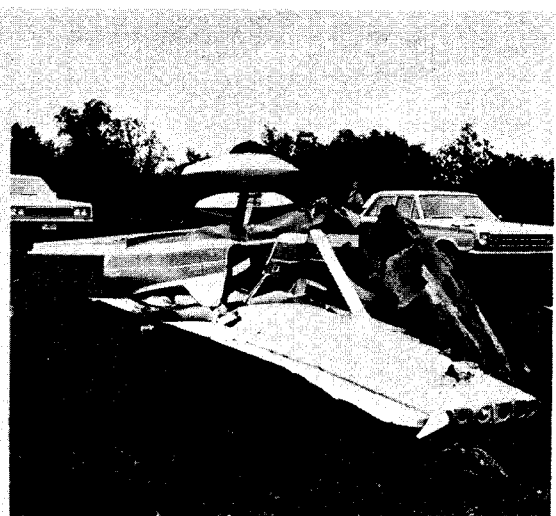
B. Forward motion of the aircraft was stopped when motor plowed under a large flat rock.

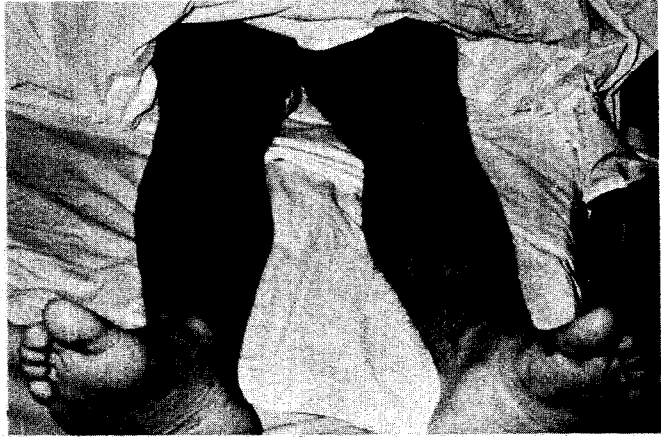
H & I Matching photographs of knee abrasions of copilot & lower instrument panel push buttons.

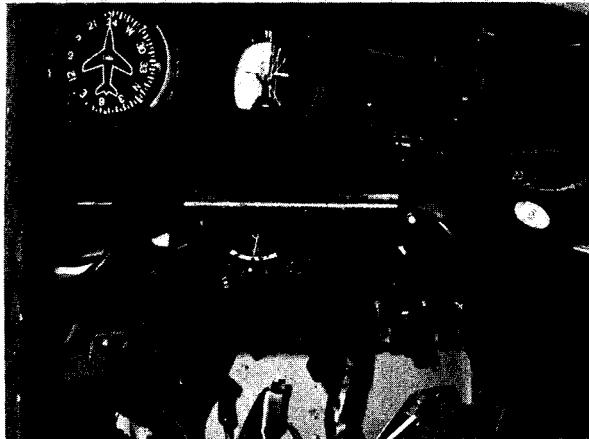
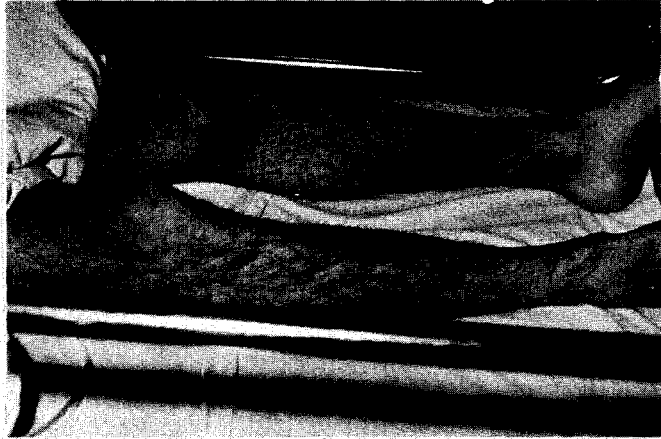
J & K Matching photographs of pilot's knees & lower left instrument panel.

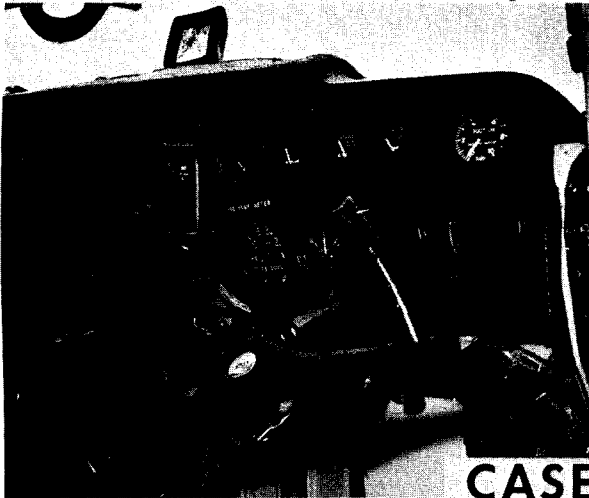
L. Head impact with upper instrument panel was prevented since both occupants heads dragged along the ground.

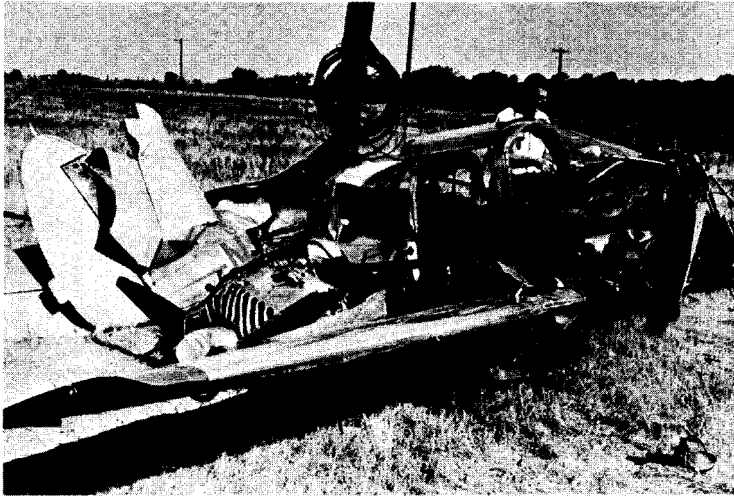
A. Telephone pole is completely buried in fuselage after side impact by aircraft.

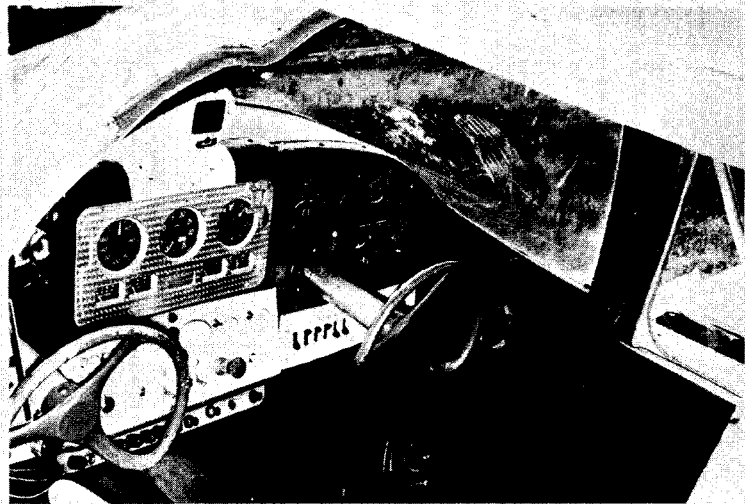
B. Since both occupants were thrown to the side, the instrument panel is unmarked.

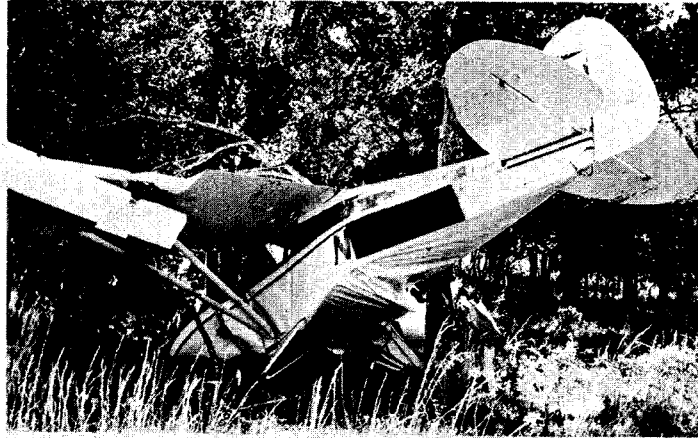
B. Rear view of aircraft after tree impact & 90° change of direction.

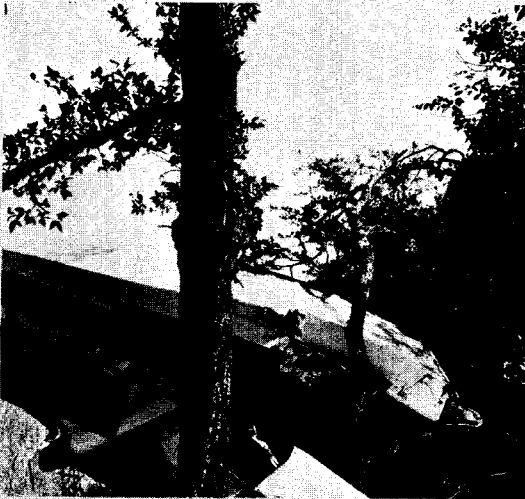
C. Right side of aircraft. Note bark missing from tree & snagged control cable about 5 feet above the ground.

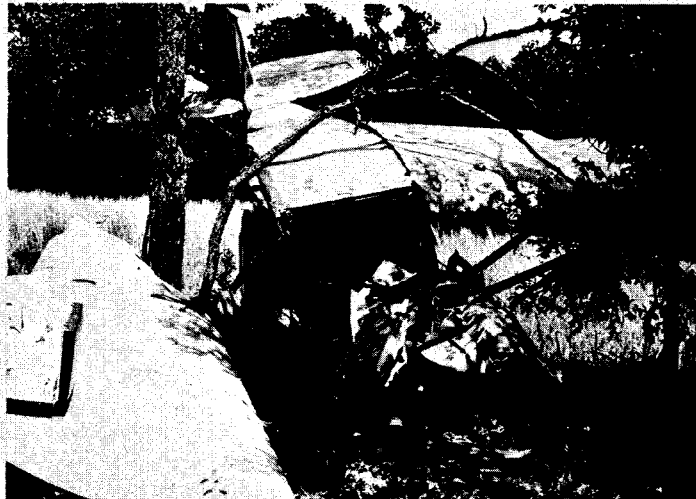
D. Front of aircraft showing complete separation of motor & instrument panel.

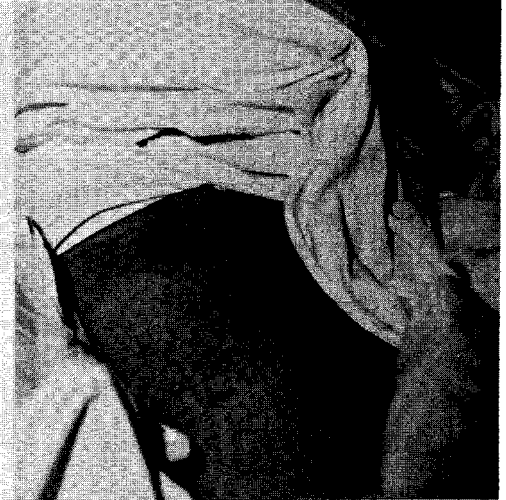
F. Seat belt abrasion on copilot.

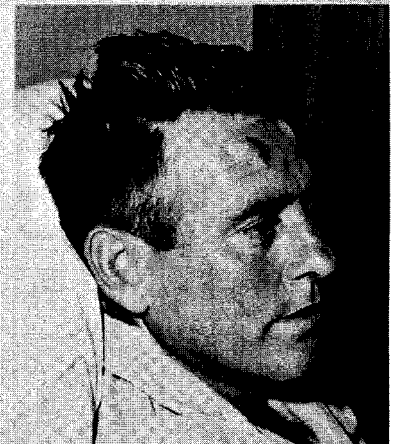
H. Pilot with minor laceration of forehead.

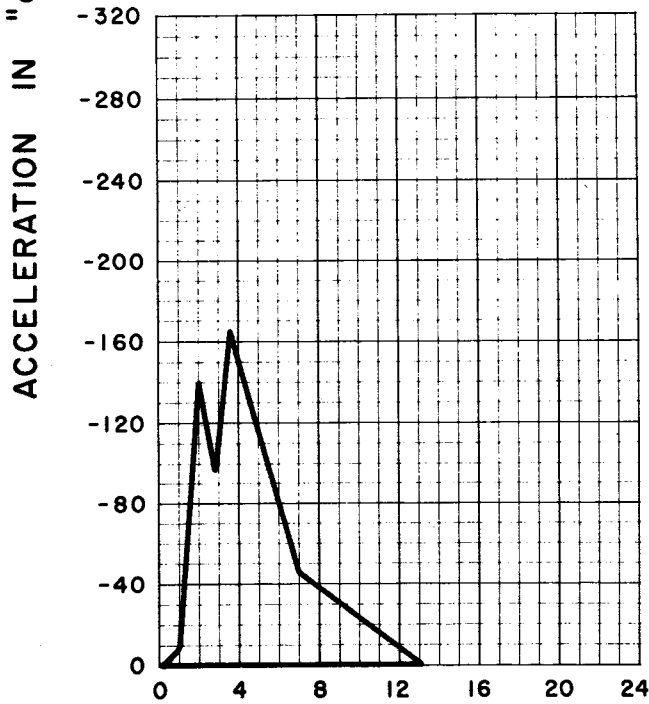
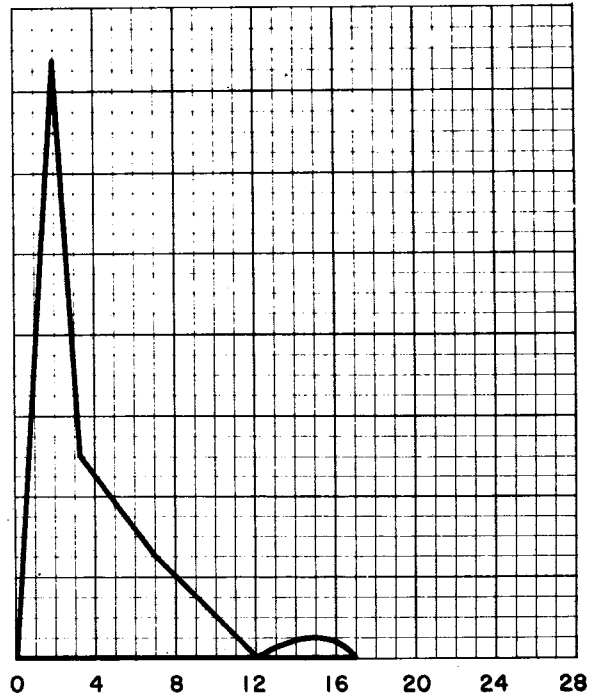
FIGURE 36. Comparison of test results of head impact tests against the Piper Pawnee aluminum $\frac{1}{2}$ cylinder (Case 1), and one of the common rigid instrument panels in general aviation aircraft (Case 2).

similar data for impacts against a rigid instrument panel in common use in general aviation aircraft, are presented in Figure 36. Note that not only does the aluminum roll reduce the peak "g" force at 15 ft./sec. from 160 to 30 "g", but also extends the time for deceleration from 12 milliseconds to nearly 24, while at 30 ft./sec. im-

pect velocity it reduces the force of head impact from 300 "g" to 110 "g" with a doubling of the deceleration time. Decreased impact forces and extended duration times are most important for preventing head injuries, but of even more significance was the distribution of the load over a greater surface area. As the light aluminum

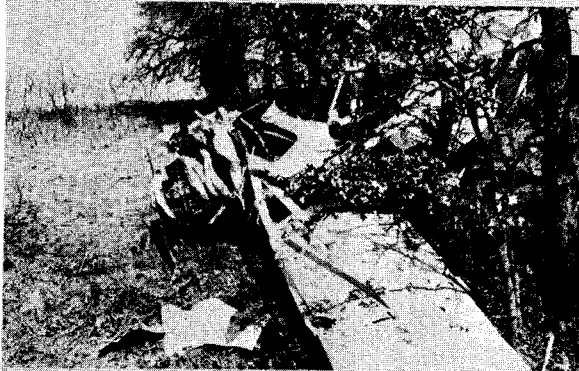
C. Crash design causes motor to fold under the aircraft.

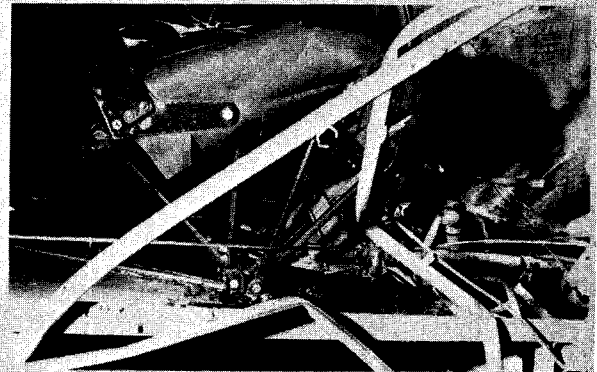
D. Seat attachments held since belts & harness were attached to fuselage.

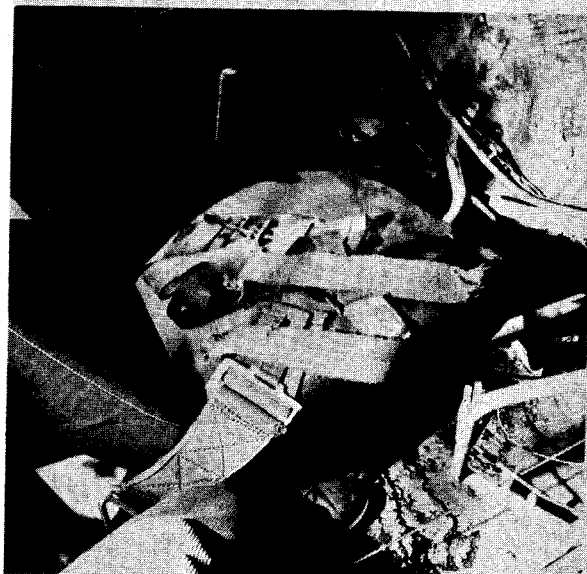
E. Shoulder harness & 3" seat belt broke.

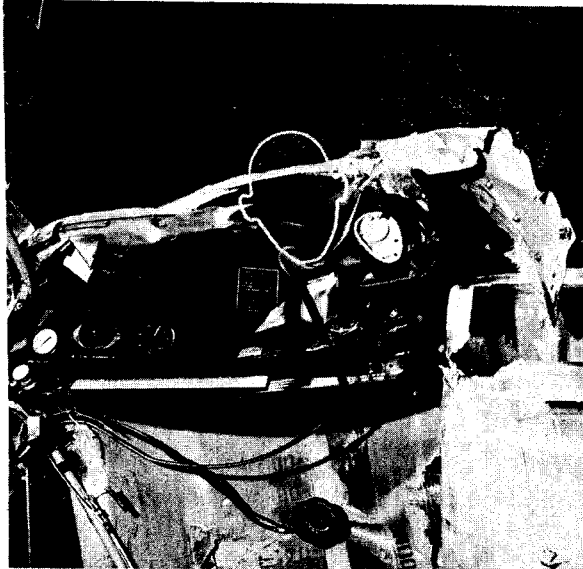
F. Head outline indicates area of head impact on light aluminum cylinder.

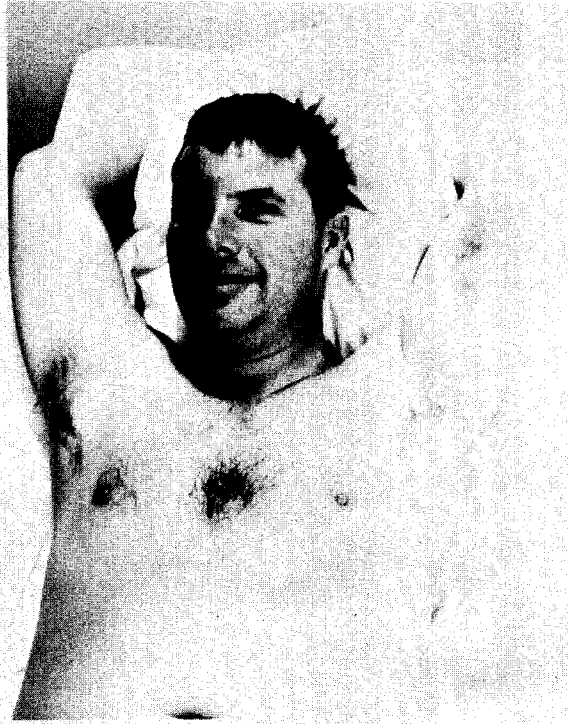
G. Pilot with minor bruises & facial lacerations 4 days after crash.

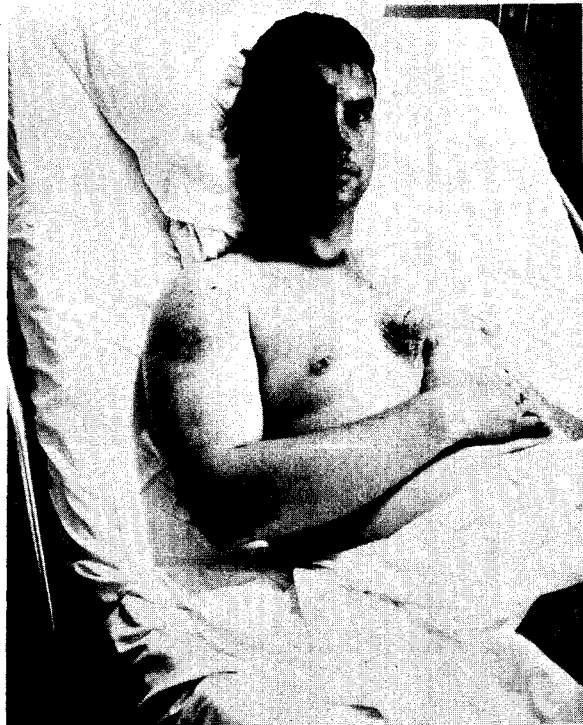
H. Bruise on right shoulder from contact with microphone.

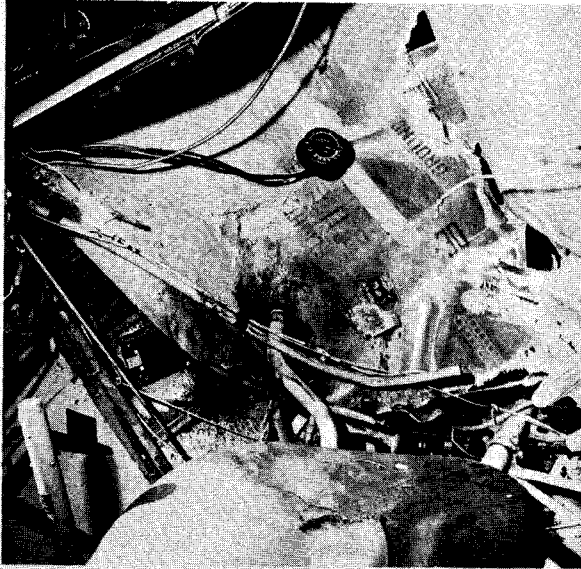
I. Knees penetrated fiberglass hopper without serious injury. Left ankle was fractured in pedal area.

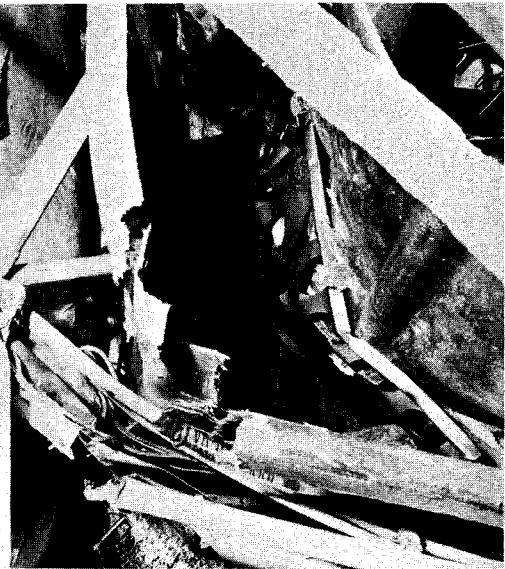
J. Perforated aluminum hopper liner served as good decelerator for knees.

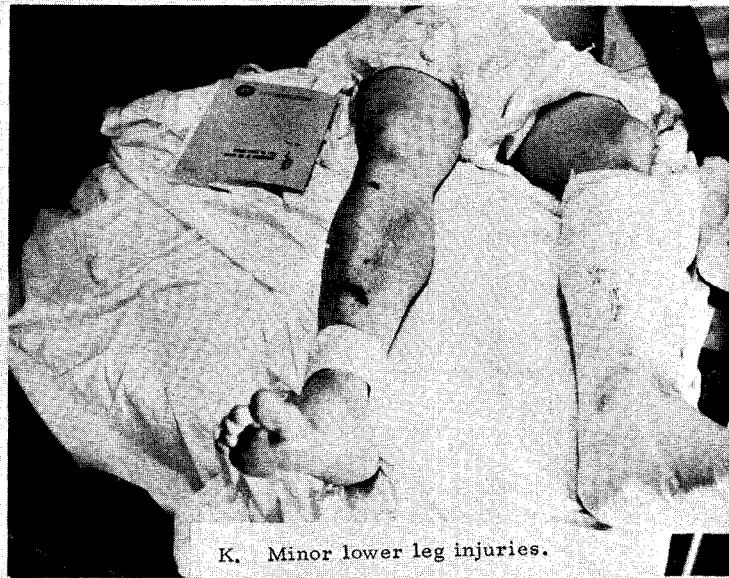
K. Minor lower leg injuries.

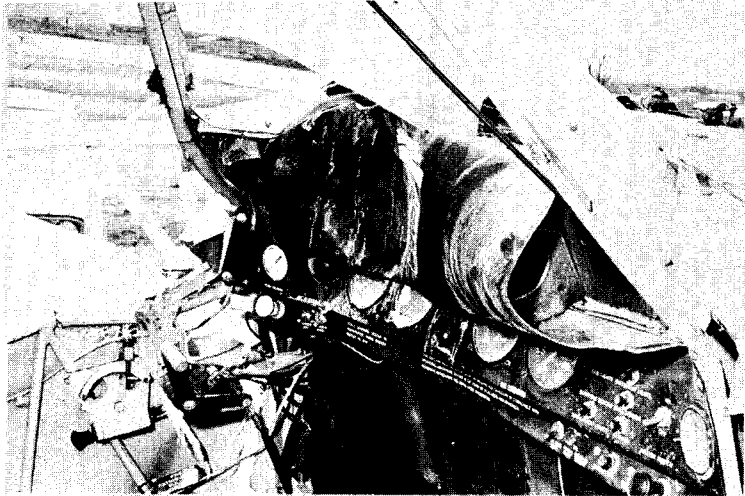
E. Side view of light aluminum cylinder at the top of the instrument panel designed to reduce head injuries.

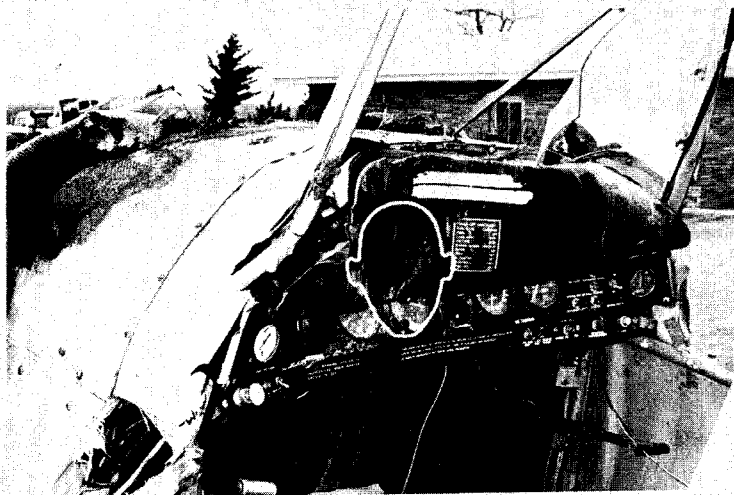
F. Outline showing area of pilot's head impact on aluminum cylinder. Note chin slipped down & contacted reset knob on altimeter.

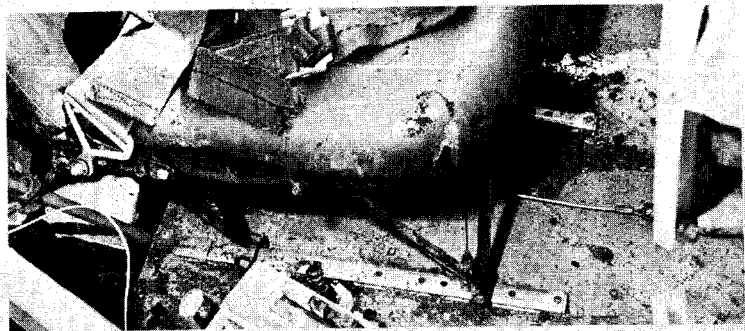
G. Shoulder harness failed in webbing but seat & seat belt held.

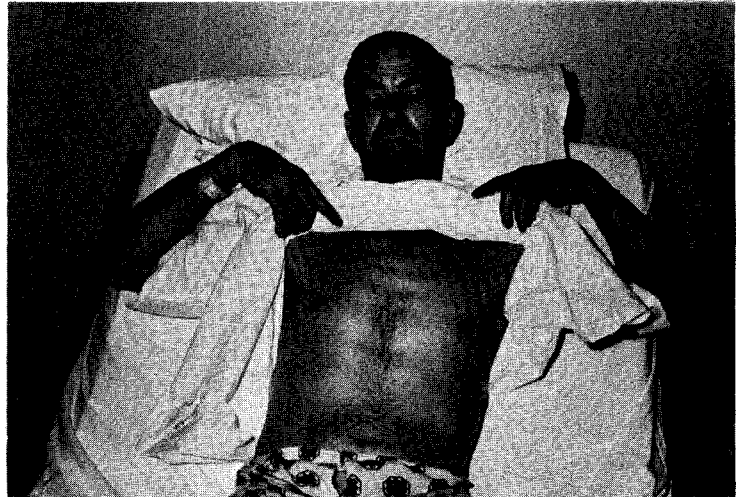
I. No chest injuries.

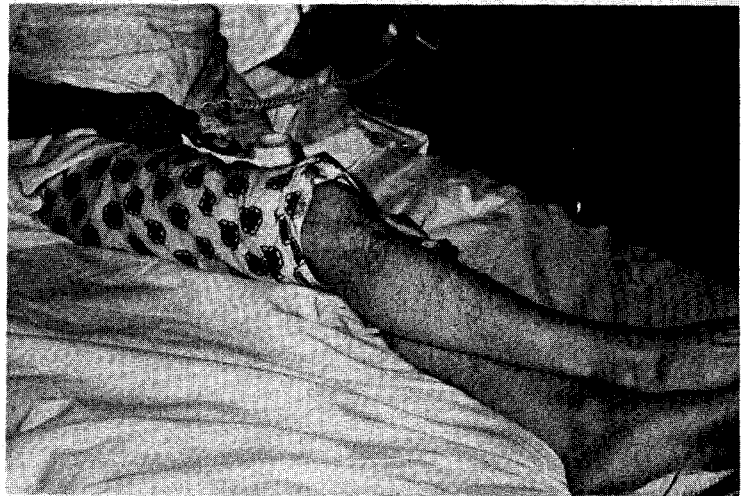
K. Practically no leg injuries.

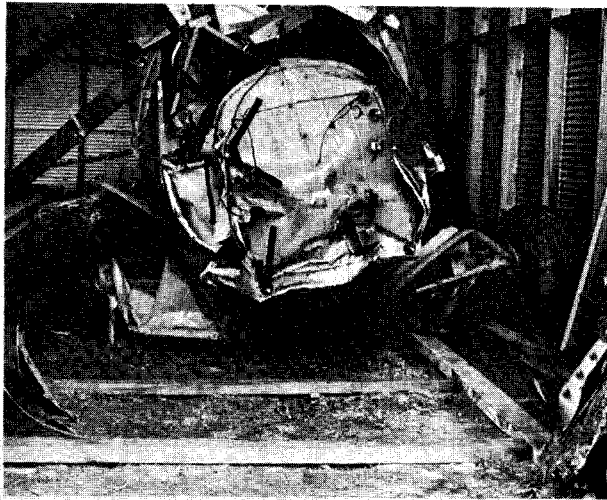
A. Upward bending of landing gear indicates heavy vertical crash forces.

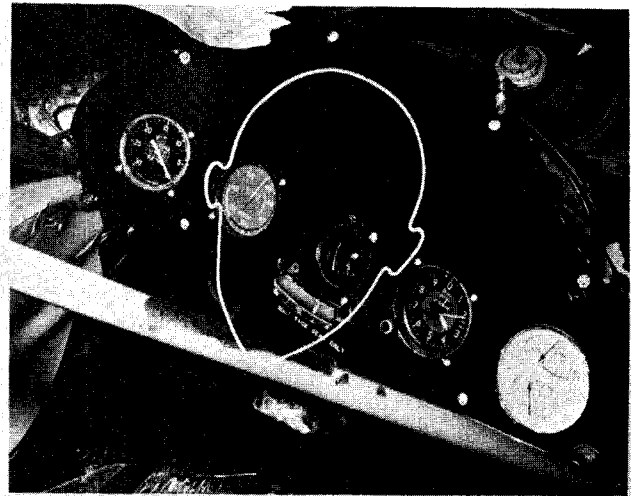
B. Outline indicating area of head impact.

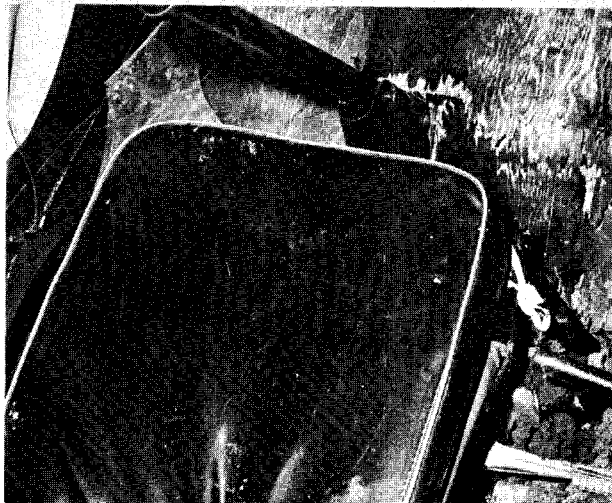
C. Upward buckling of floor structure further indicates vertical forces.

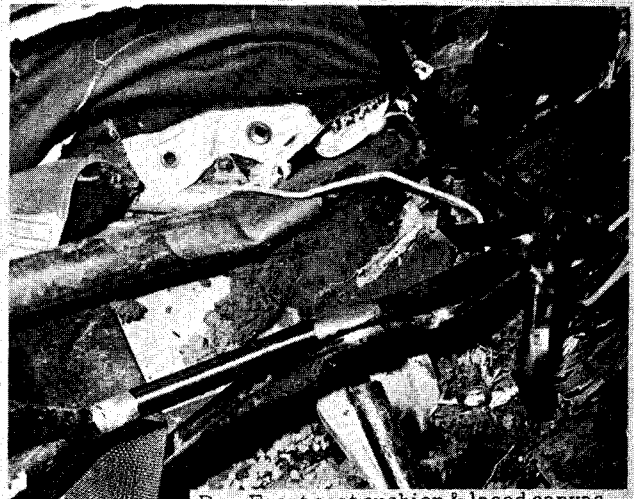
In Case 25 (a 1940 Piper Cub J-3C-65) numerous serious vertebral fractures resulted from vertical impact forces on a seat constructed of a cushion placed on top of a sheet of canvas laced to the sides of the seat structure. This flimsy structure gave way readily, allowing the buttocks of the front seat occupant to impact the heavy tubular structure under the center of the seat (Case 25 D). The forces involved in the crash of the 1964 Beech Musketeer A-23 presented as Case 26 were not all vertical as indicated by the pilot's receiving a brain concussion when his head hit the unpadded "A" post (Case 26 E) and the copilot's receiving a similar head injury from impact with the compass (Case 26 F) mounted on top of the instrument panel. However, the vertical component was significant as attested by the engine breaking straight down (Case 26 B and C) and the buckling of the legs of the front seats (Case 26 H and I). The fact

D. Front seat cushion & laced canvas removed to show tubular structure under seat that was responsible for vertebral fractures.

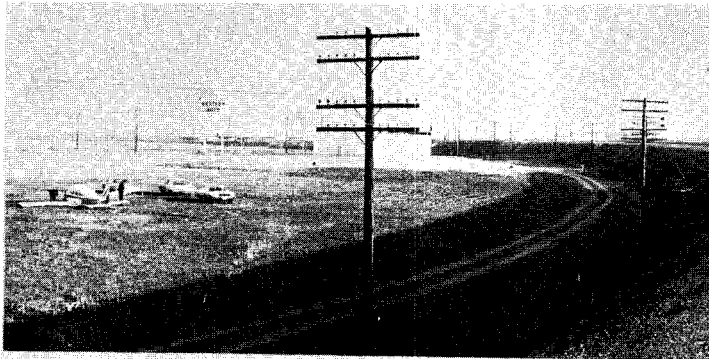
A. General view of crash site.

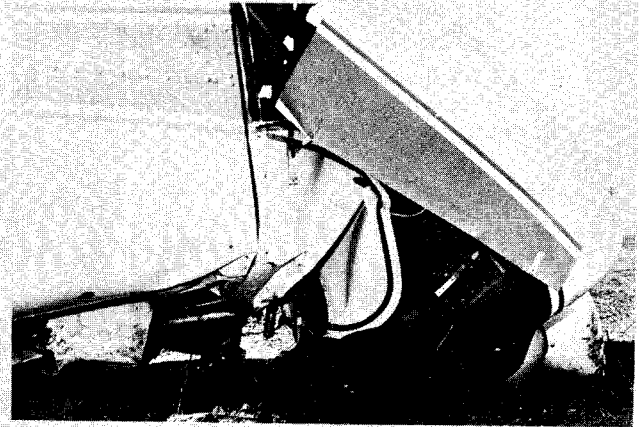
B & C Short 6-foot gouge mark under the aircraft, upward bending of the landing gear, & downward bending of motor all indicate that the aircraft crashed nearly flat with heavy vertical loads.

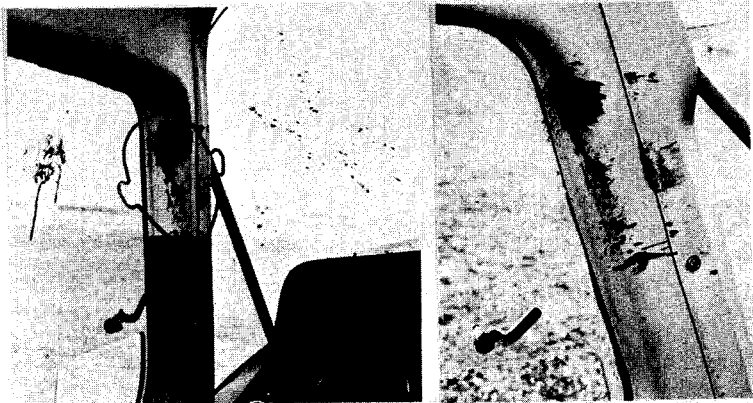
E. Pilot was thrown slightly to the left & his head hit the rigid "A" post.

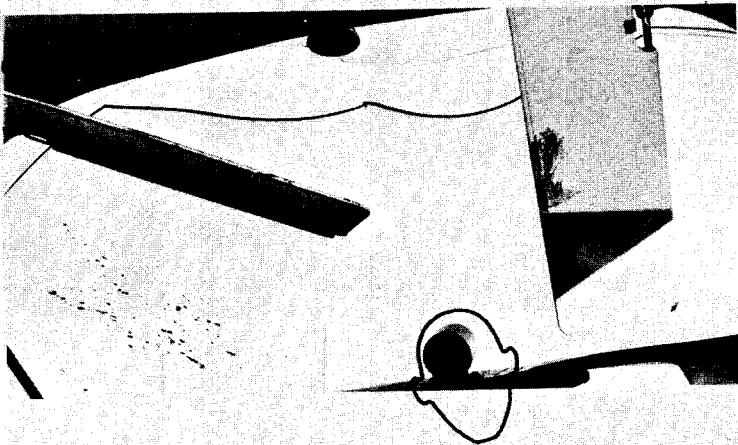
F & G Copilot's head struck compass & top center edge of instrument panel.

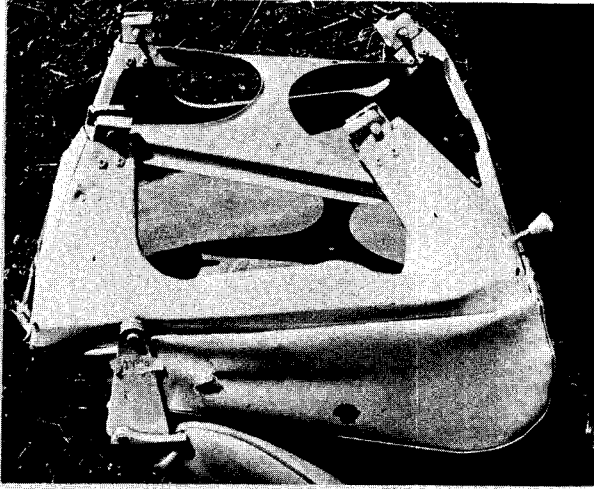
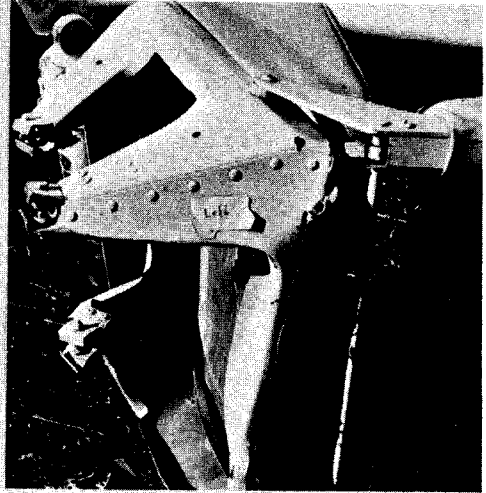
that the legs did buckle to a degree probably prevented more serious back injuries of these two occupants. Fractures of L1 for both front seat occupants would have been avoided in this case if only one or two additional inches of vertical attenuation had been provided. It is interesting that the single occupant of the rear seat escaped without vertebral injury or even a back sprain. The rear seat cushion (3-inch-thick foam) is not mounted on a rigid seat pan and rigid legs as is the case with the front seats, but instead lies on top of lightweight aluminum stringers perforated with 5½-inch diameter holes. The attenuation offered by this type of construction, offering up to 9 inches of crush distance, was sufficient in this case to prevent vertebral fractures.

H & I Heavy seat legs buckled from vertical forces. Vertebral fractures could have been prevented by attenuation in seats.

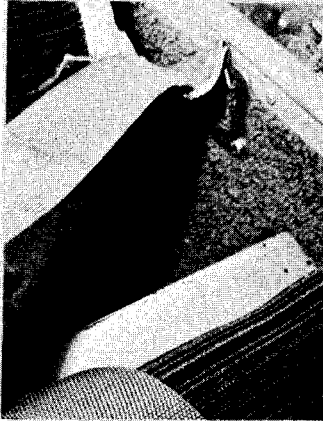
J. Outboard belts fuselage-attached.

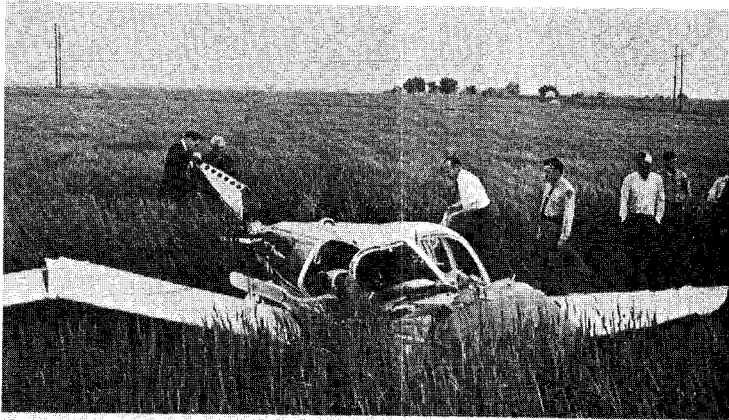
A. Aircraft crashed flat in a tall wheat field. Note wheat all around aircraft is undisturbed.

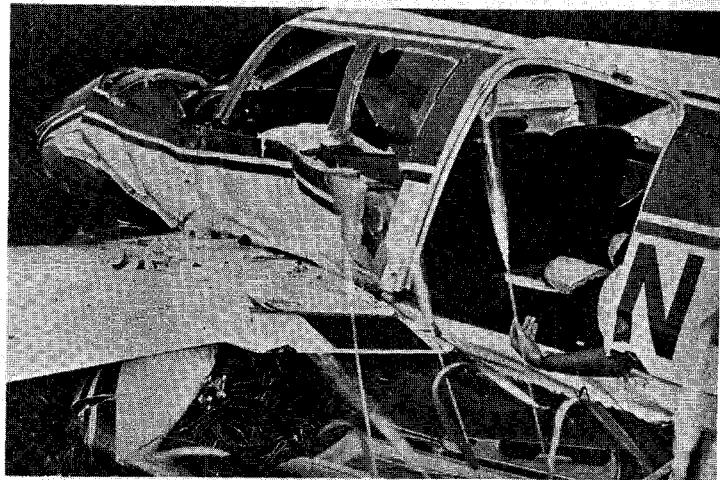
B. Motor is bent downward, landing gear pushed up into wings, instrument panel completely undamaged & rear passenger appears to be sitting flat on the ground.

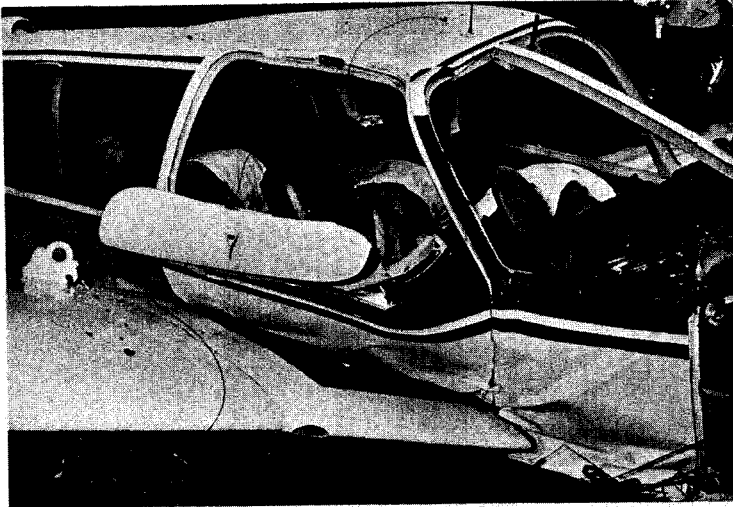
C & D Front seat occupants appear to be uninjured & asleep.

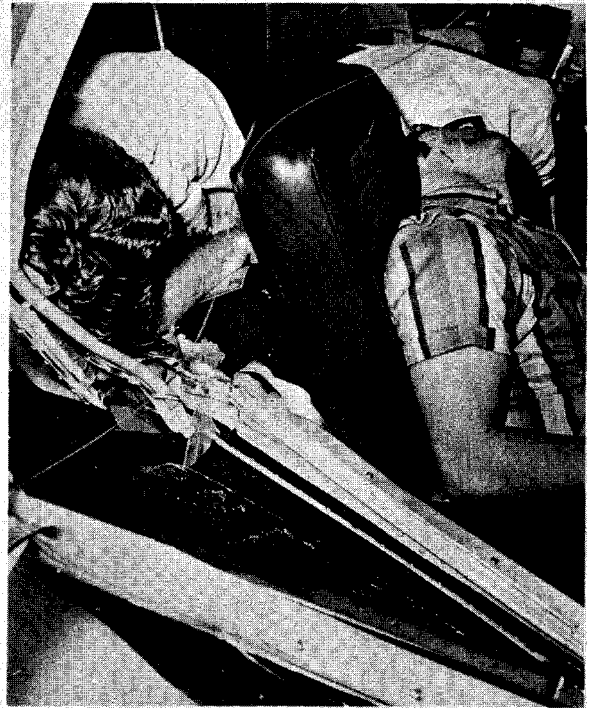
E & F Views of right front & center seat occupants.

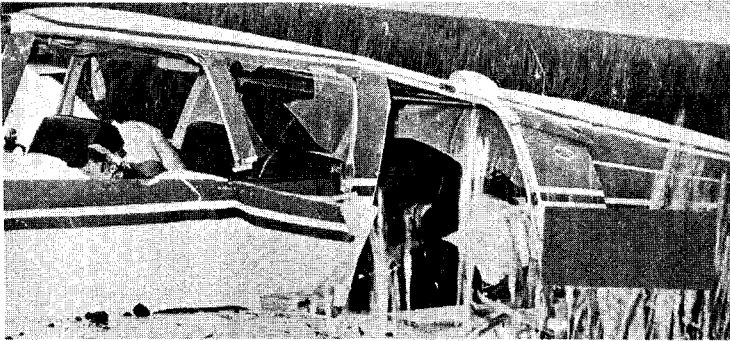
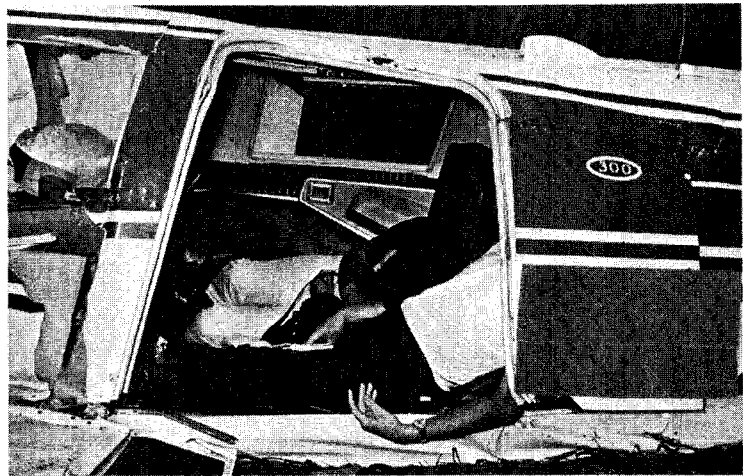
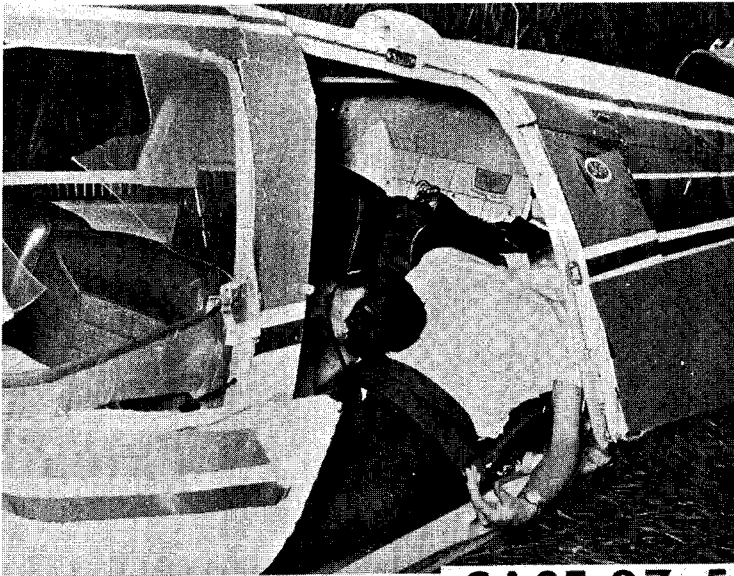
G, H & I All occupants have seat belts fastened, appear to be sitting on the ground, & died from severe internal injuries produced by vertical forces.
