# 737 GRAPHITE COMPOSITE FLIGHT SPOILER FLIGHT SERVICE EVALUATION

**EIGHTH REPORT  
MAY 1981 THROUGH DECEMBER 1984**

**Prepared under Contract NAS 1-11668 by  
BOEING COMMERCIAL AIRPLANE COMPANY  
July 1985**

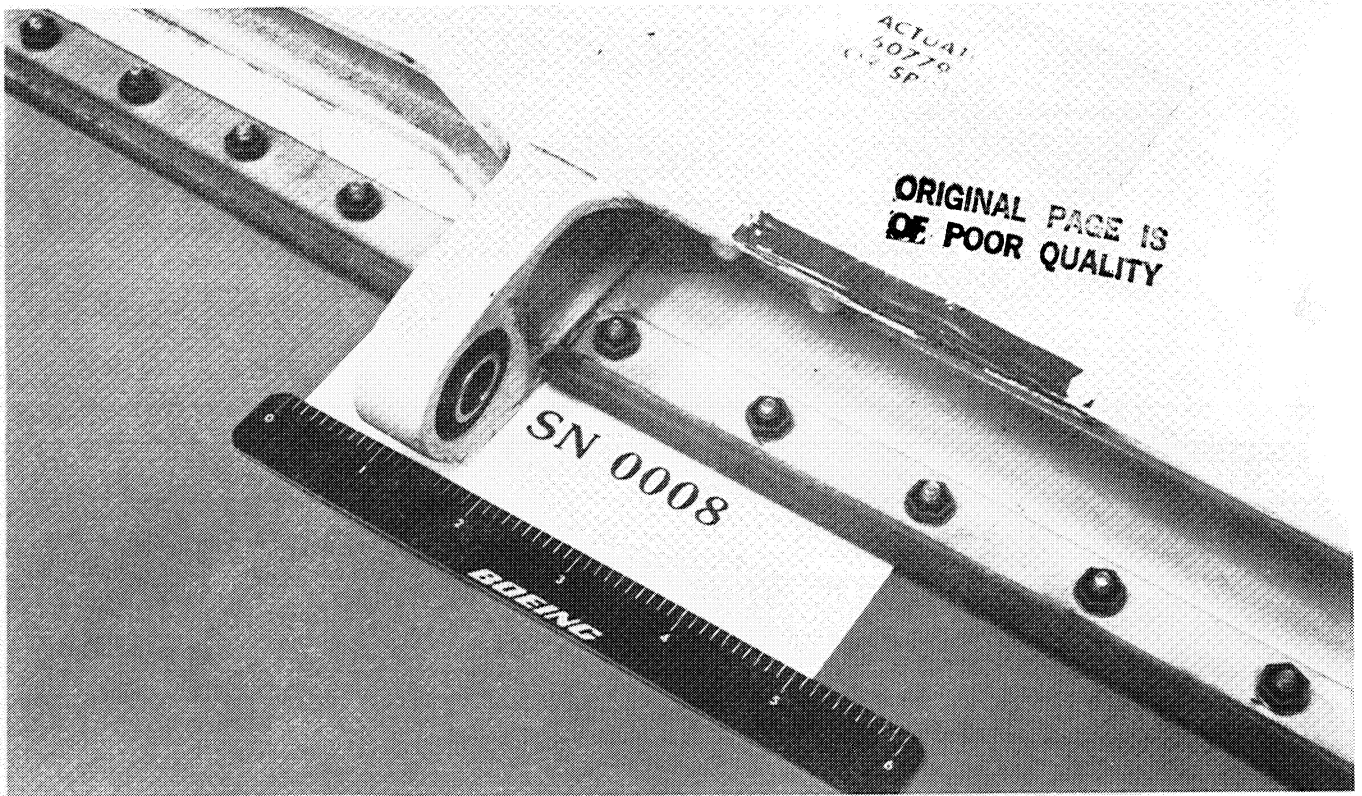
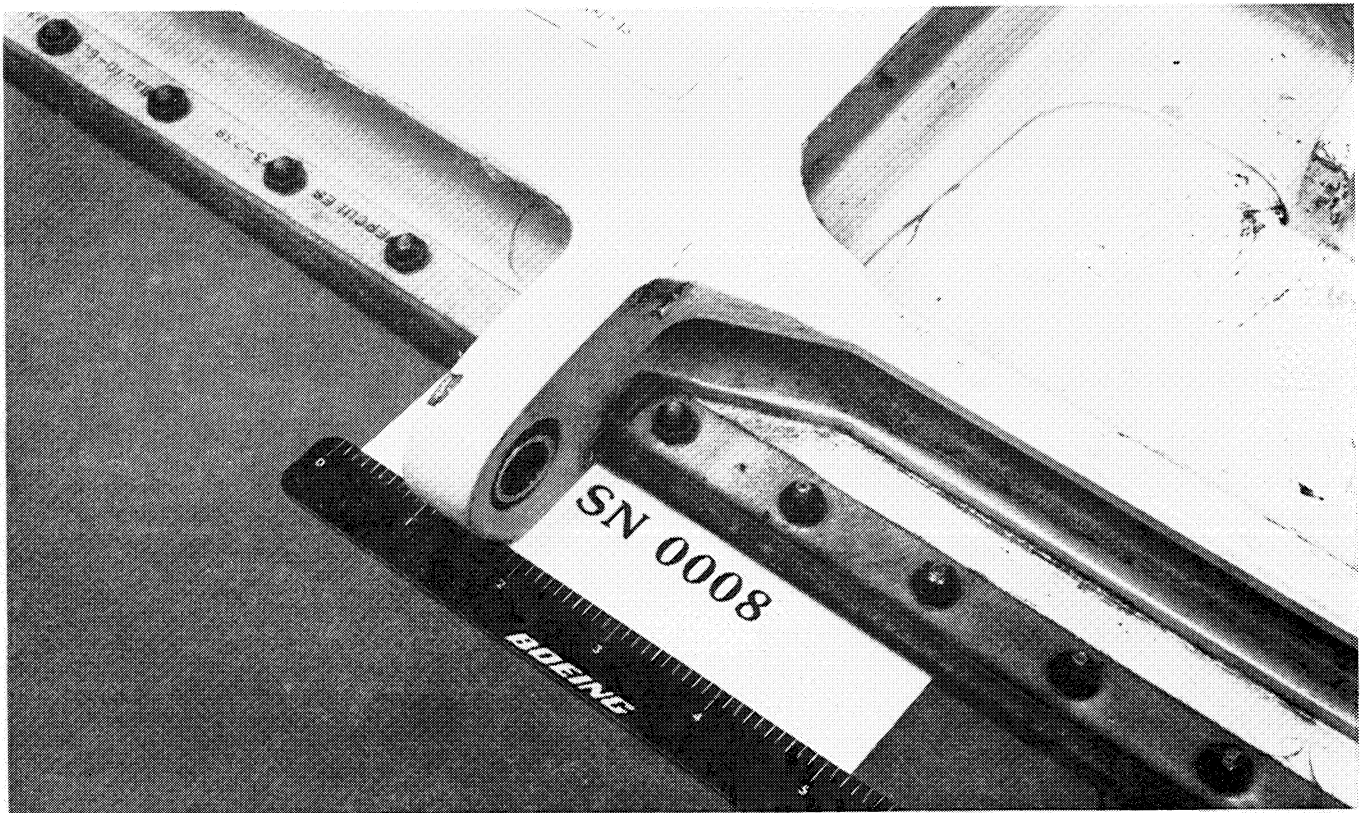
Following selection for test, the units were photographed. Figures 2 and 3 show the upper and lower surfaces of spoiler S/N 0008 after 7 years of service, respectively. The damage on this unit is shown in Figures 4 and 5. Figure 4 shows an exfoliation corrosion blister at one spar to center hinge fitting splice, and Figure 5 shows a similar but less severe exfoliation corrosion blister at the opposite side.

Figure 4. Hinge Detail of Spoiler S/N 0008 After 7 Years of Service

Figure 5. Hinge Detail of Spoiler S/N 0008 After 7 Years of Service

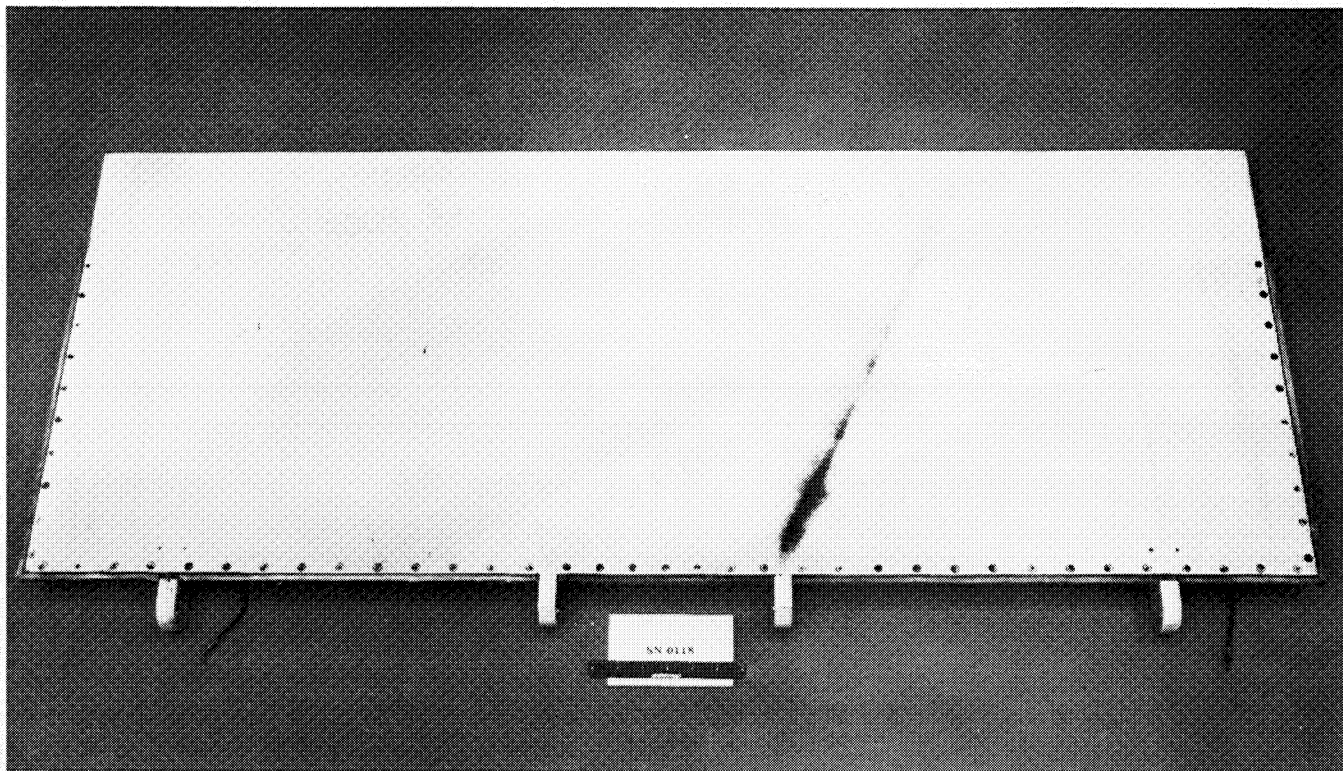
Figure 6. Upper Surface of Spoiler S/N 0118 After 7 Years of Service

Figures 6 and 7 are photographs of the upper and lower surfaces, respectively, of spoiler S/N 0118 after 7 years of service. The upper surface shows evidence of paint erosion although no damage to the graphite skin was apparent. Figures 8 through 10 show the damage found on this unit. Figure 8 shows earlier minor doubler corrosion that had been dressed down and repainted by the airline. This condition was also found on the opposite side. An edge delamination on the corner of the panel is also shown. These two defects are shown on Figure 9. The initial stages of exfoliation corrosion at one spar to center hinge fitting splice are shown on Figure 10.

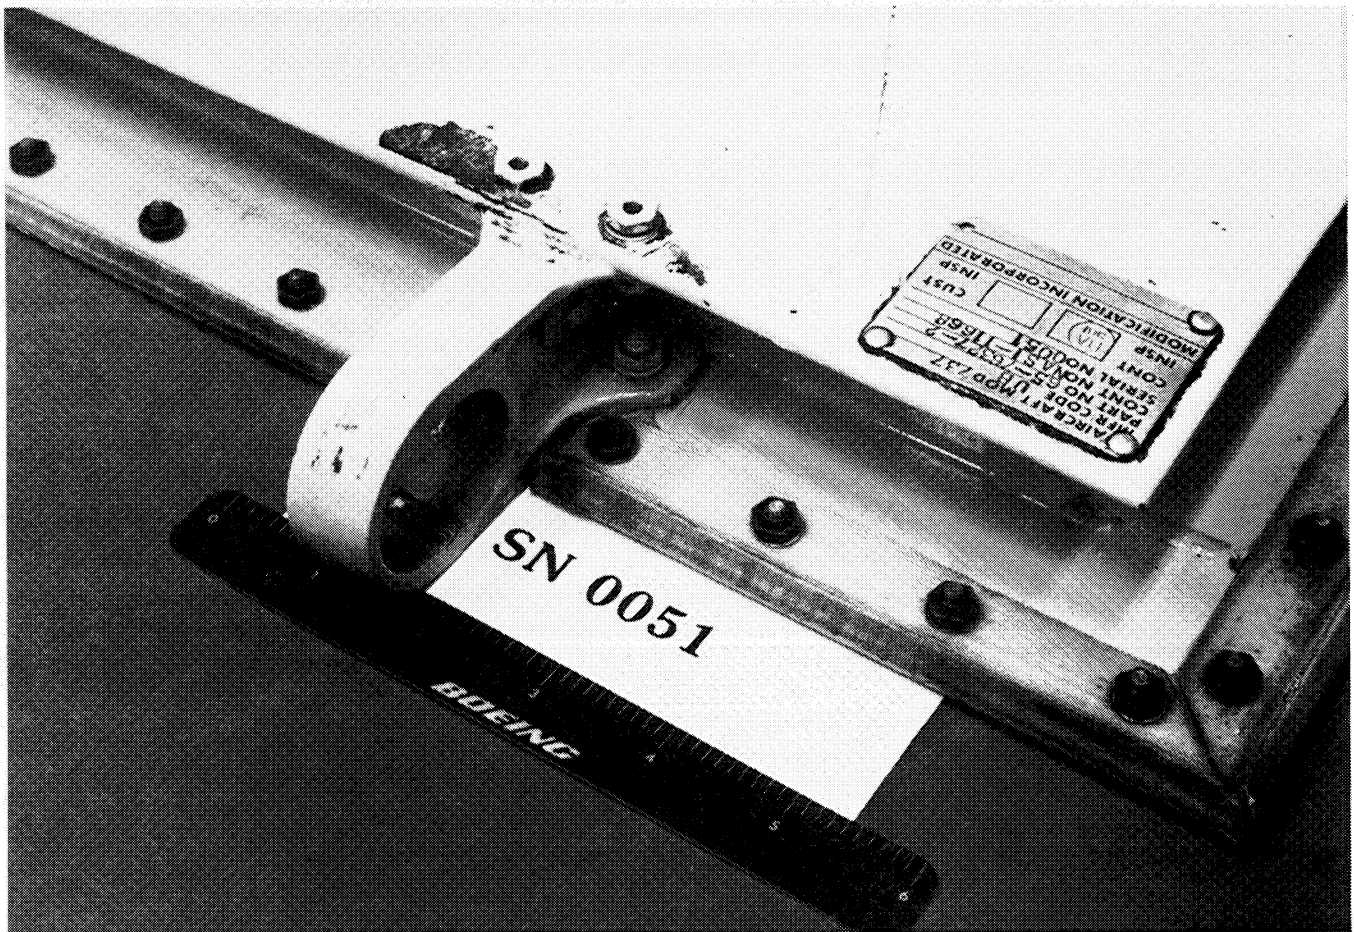
Figure 19. Corner Detail of Spoiler S/N 0051 After 8 Years of Service

Figures 17 and 18 show the upper and lower surfaces of spoiler S/N 0051 after 8 years of service. This unit was relatively clear of damage. The only detectable damage was some minor doubler corrosion as shown in Figure 19.

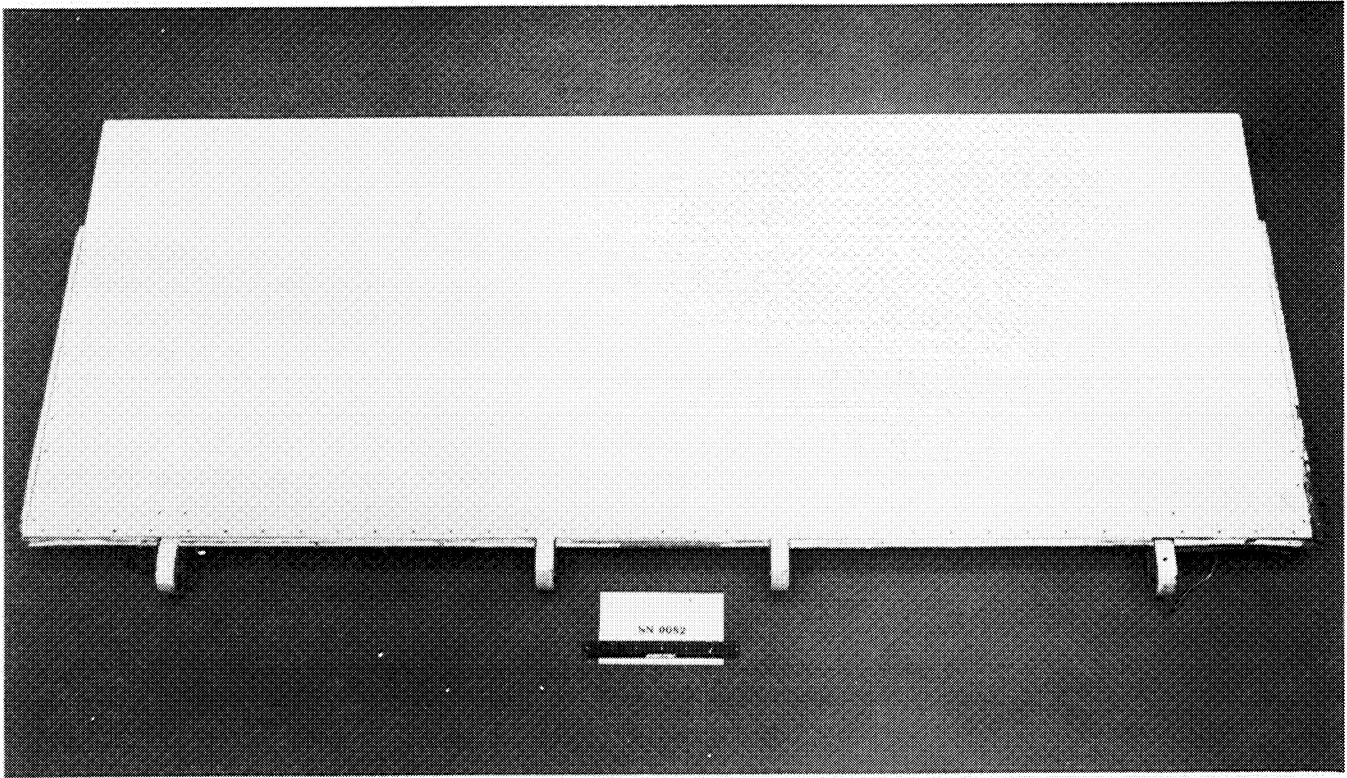
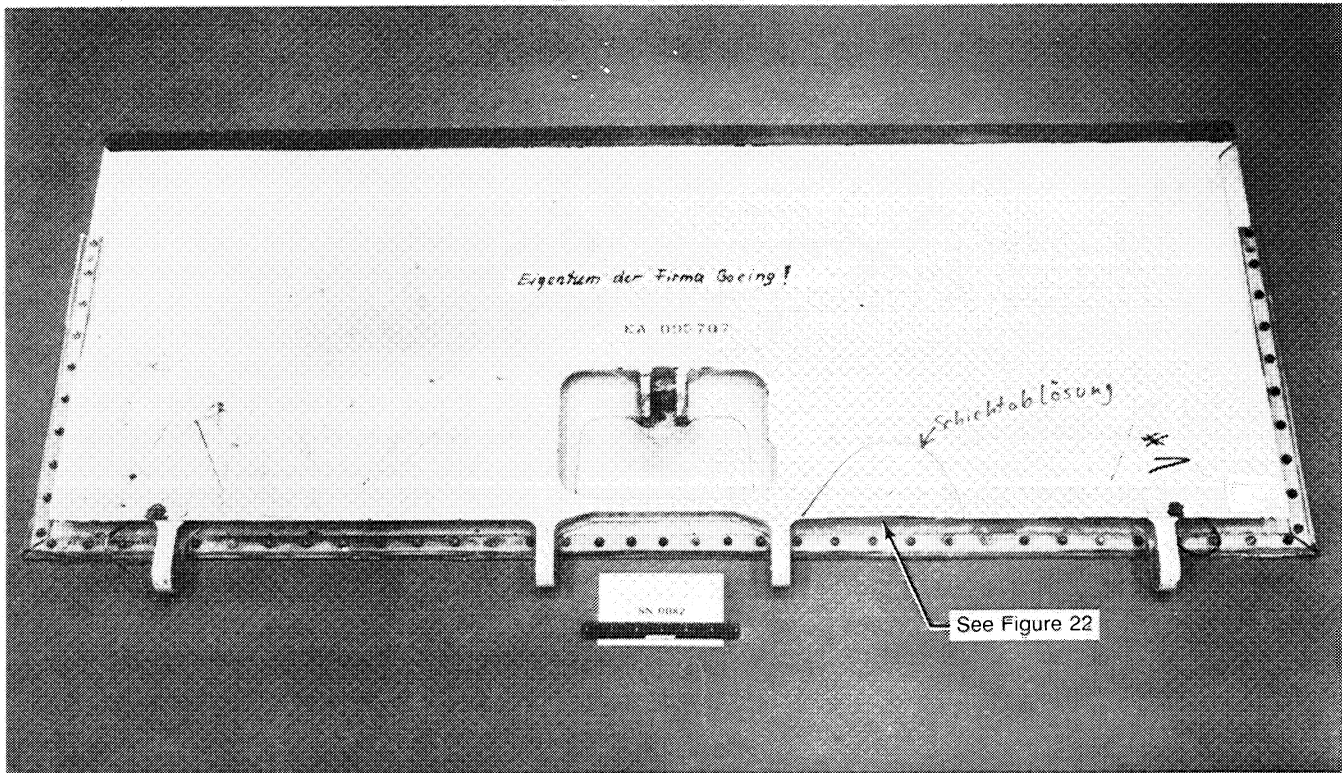
Spoiler S/N 0082 with 8 years of service was returned with significant damage. Figures 20 and 21 show the upper and lower surfaces, respectively. A massive blister had developed over one spar to center hinge fitting splice as shown on Figure 22.

Figure 20. Upper Surface of Spoiler S/N 0082 After 8 Years of Service

Figure 21. Lower Surface of Spoiler S/N 0082 After 8 Years of Service

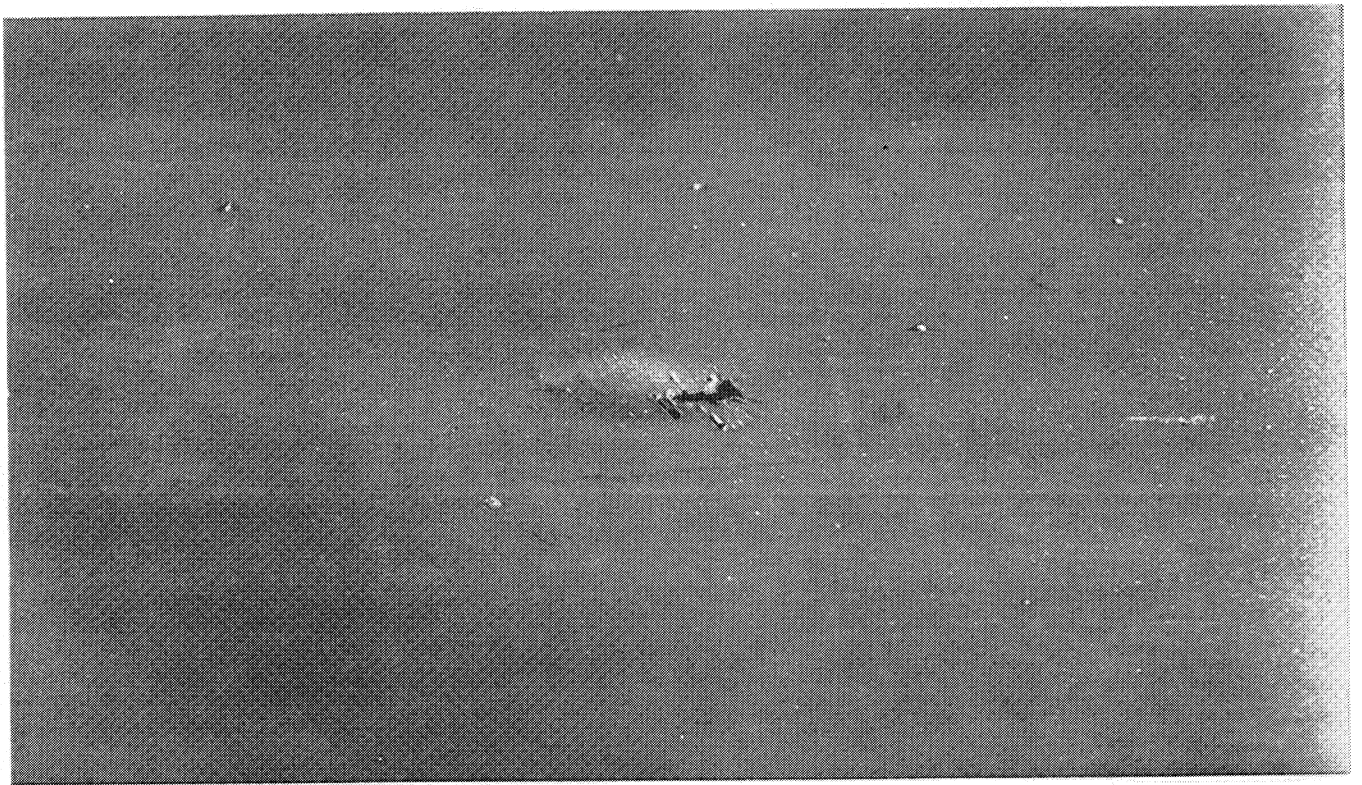
Figure 27. Blister Detail of Spoiler S/N 0029 After 9 Years of Service

The upper and lower surfaces of spoiler S/N 0029 after 8 years of service are shown on Figures 25 and 26, respectively. Flap track rubbing on the lower surface was covered with a thick application of teflon paint. The only major damage is a blister over the center hinge fitting. A closeup of this is shown on Figure 27. This was the second blister at this location. The first blister was repaired previously.

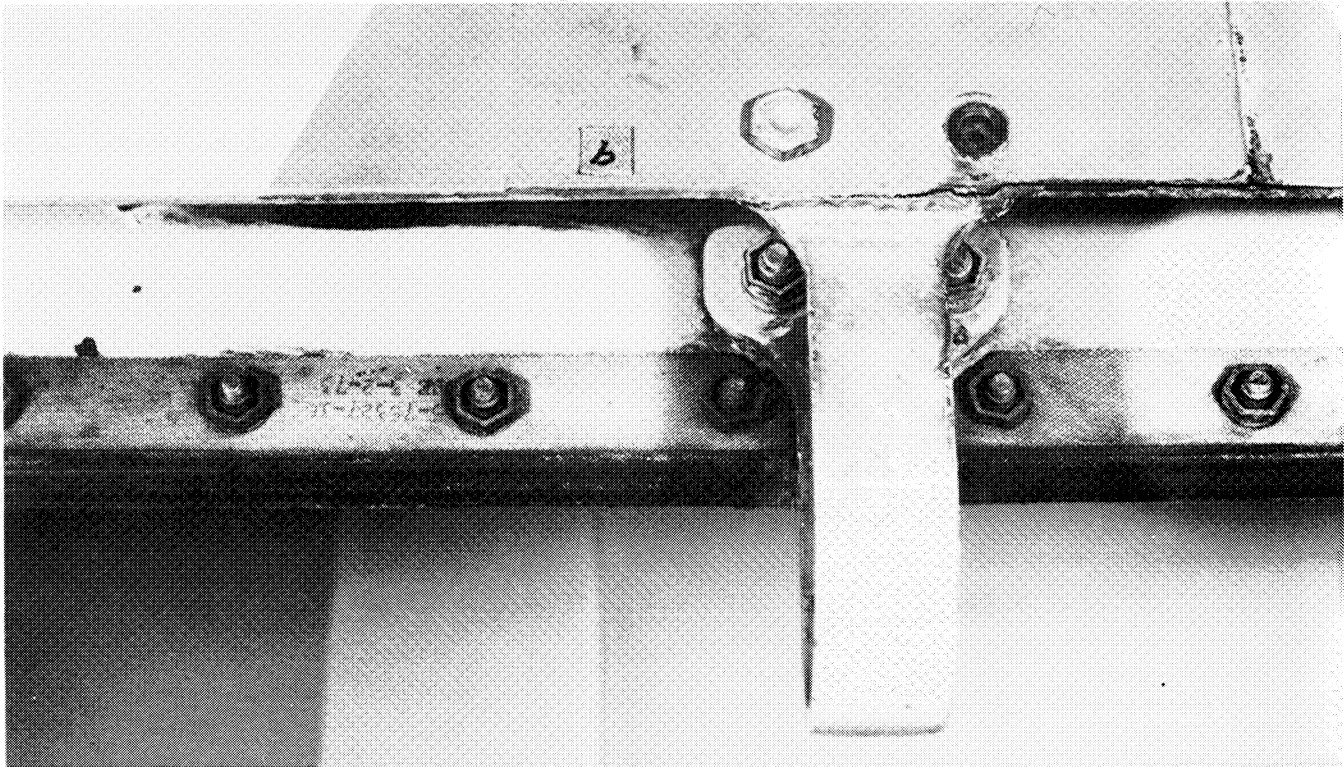
*Figure 29. Outer Hinge Detail of Spoiler S/N 0038 After 9 Years of Service*

Spoiler S/N 0038 after 9 years of service is shown on Figures 28 through 31. Corrosion was evident on both lower skin aluminum doublers and on the doubler in the center hinge fitting. One doubler had delaminated as shown on Figure 29. This photograph was taken after the spoiler had been tested to failure.

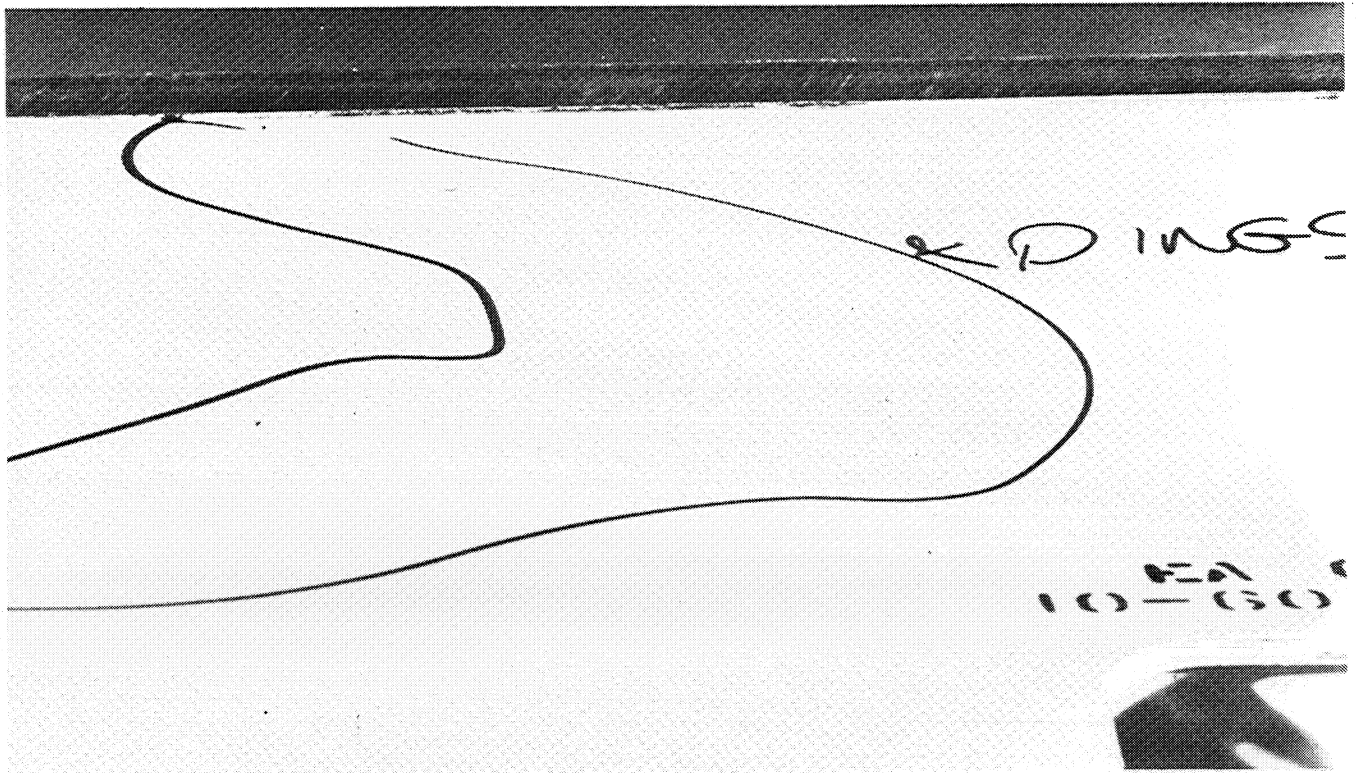
Figure 34. Surface Detail of Spoiler S/N 0064 After 9 Years of Service

Photographs of spoiler S/N 0064 after 9 years of service are shown on Figures 32 through 35. This spoiler had evidence of mechanical impact damage on the lower surface as shown on Figure 34. A blister was evident over the center hinge fitting as shown on Figure 35.

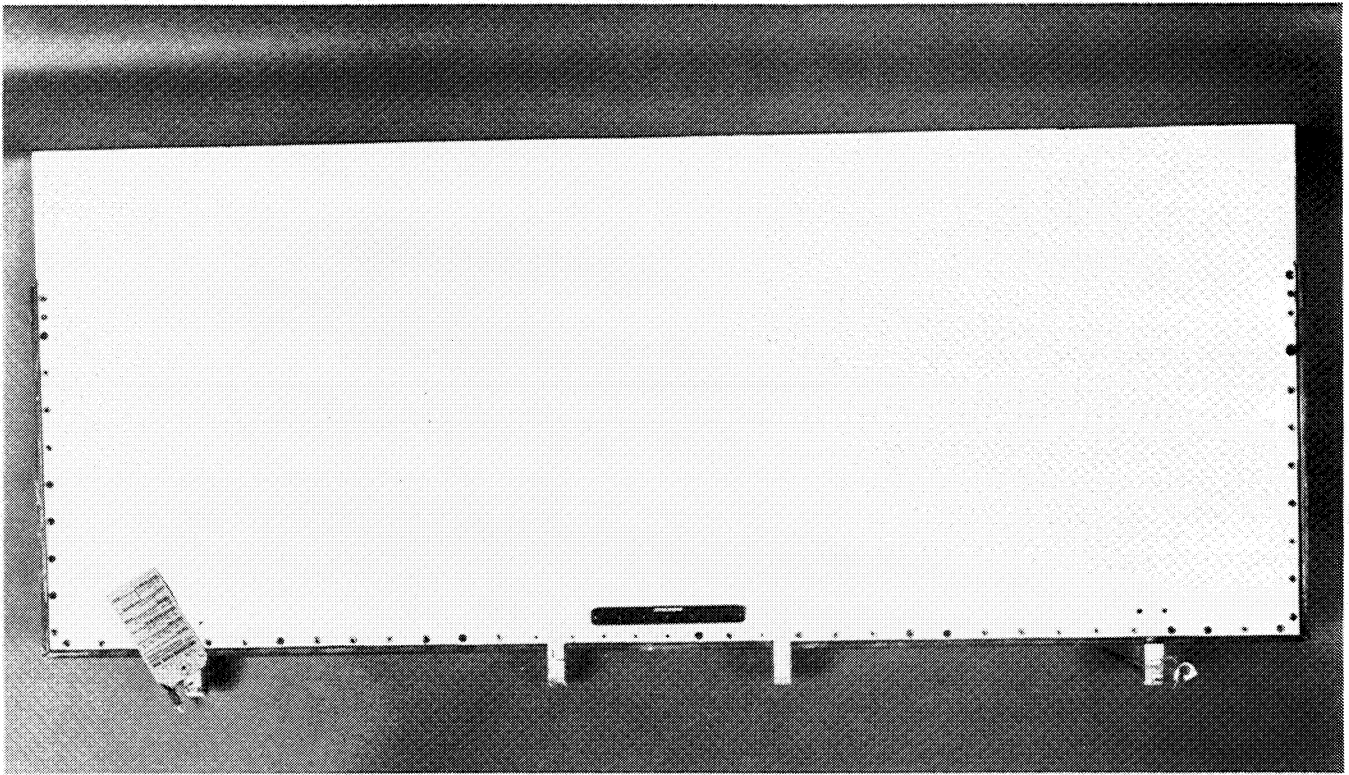
*Figure 36. Upper Surface of Spoiler S/N 0102 After 9 Years of Service*

The upper surface of spoiler S/N 0102 after 9 years of service is shown on Figure 36. There is no photograph available of the lower surface. The general condition of this panel was good with the exception of some paint wear on the lower surface due to flap rubbing.

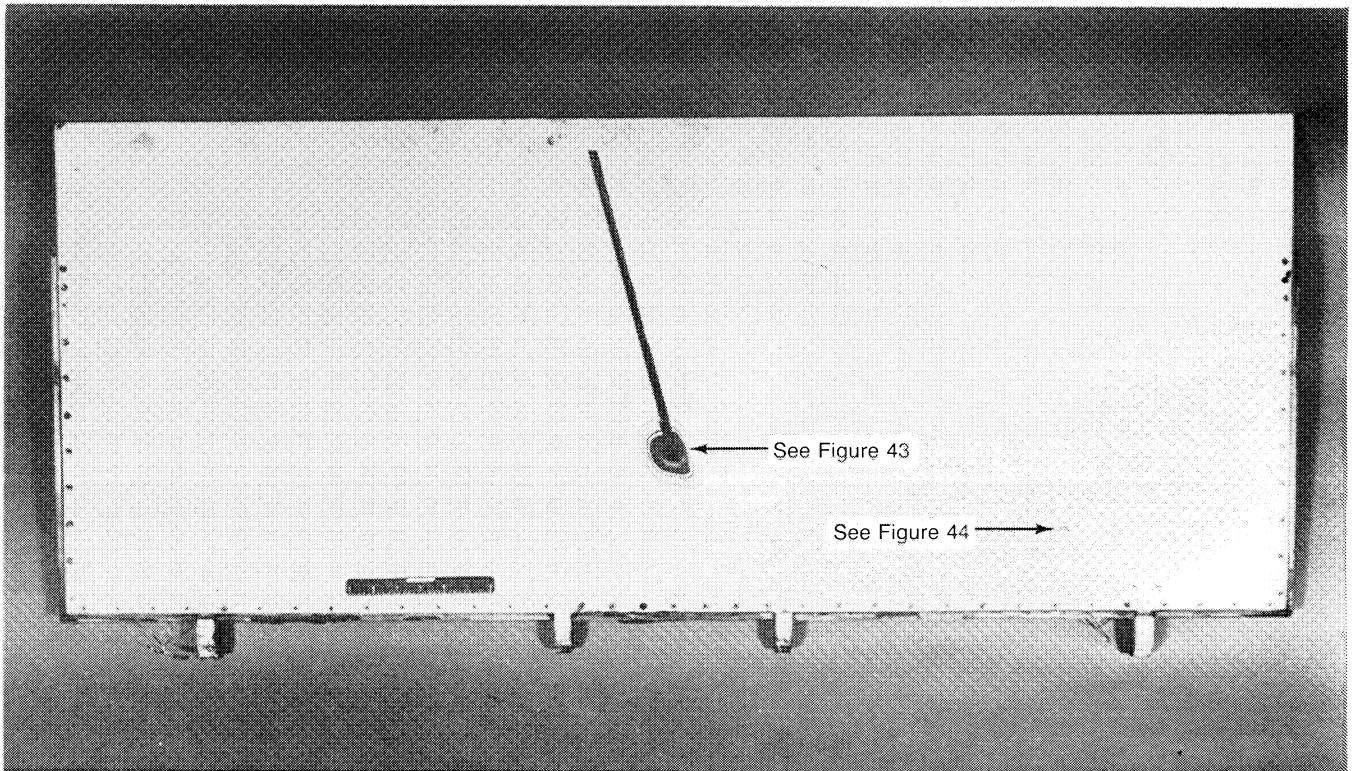
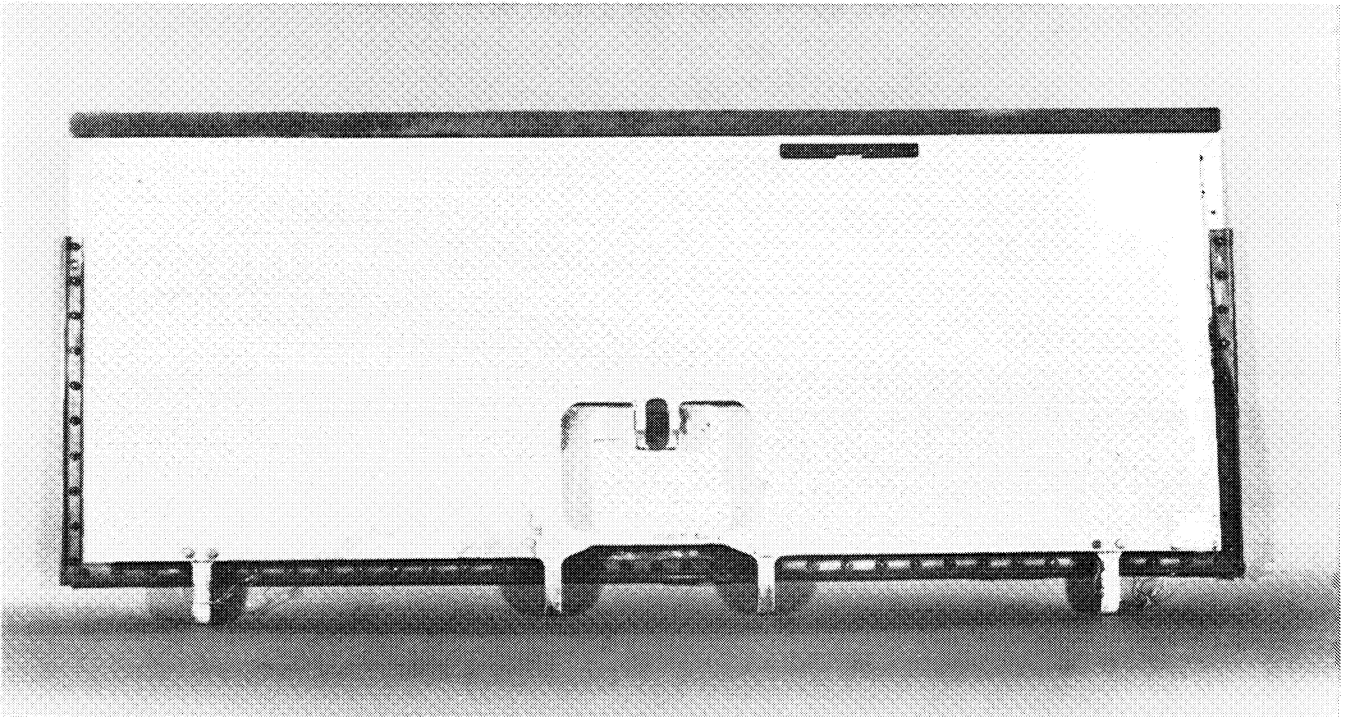
Spoiler S/N 0044 with 10 years of service was returned with a delamination over the center hinge fitting. This is shown in an overall view on Figure 41 and in detail on Figure 42. The outer ply has been removed in a strip in the chordwise direction. The delamination area has been sanded down, removing the paint for better clarity. The lower surface overall view is shown on Figure 43. A small mechanical impact in the upper surface is shown on Figure 44. This impact was most likely caused after the panel was removed from the aircraft.

Figure 41. Upper Surface of Spoiler S/N 0044 After 10 Years of Service

Figure 42. Lower Surface of Spoiler S/N 0044 After 10 Years of Service

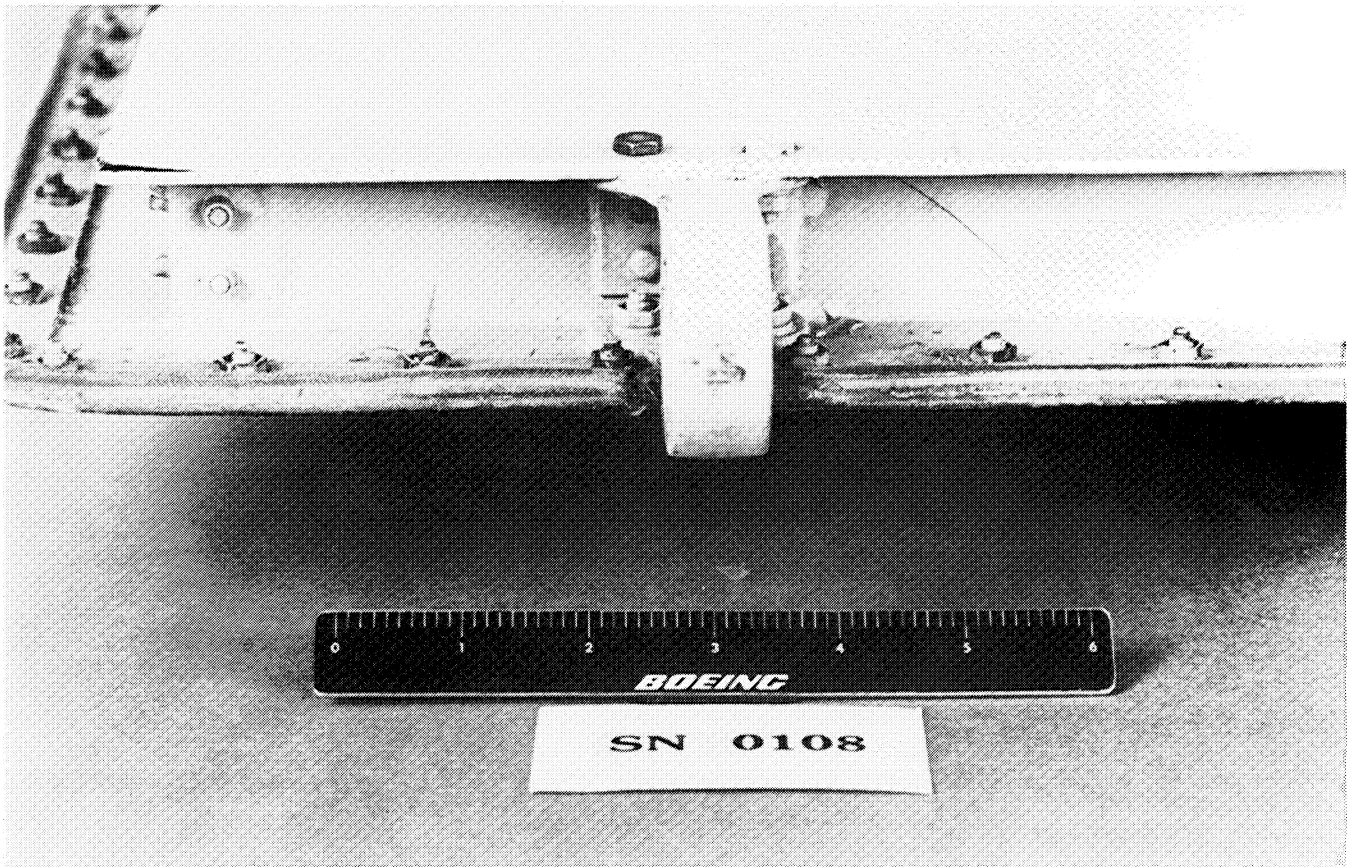
*Figure 48. Corner Detail of Spoiler S/N 0108 After 10 Years of Service*

The overall views of spoiler S/N 0108 after 10 years of service are shown on Figures 45 and 46. Some interference rubbing with the flaps on the lower surface has been treated. A substantial blister on one spar to center hinge fitting location is shown on Figure 47. This blister has progressed to the point where corrosion products are visible. This blister is one of the most severe found in the program. A minor corner delamination was also found on the forward lower surface. This delamination is shown on Figure 48.

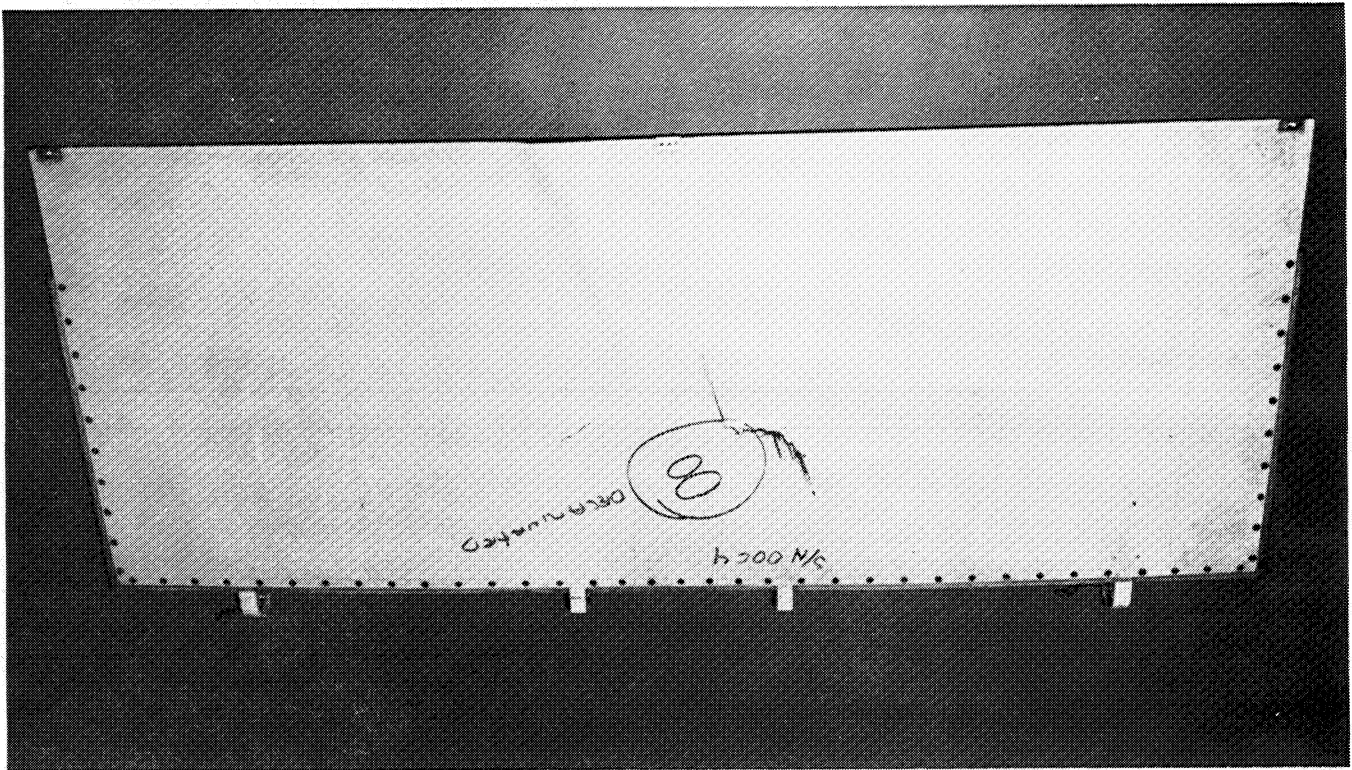
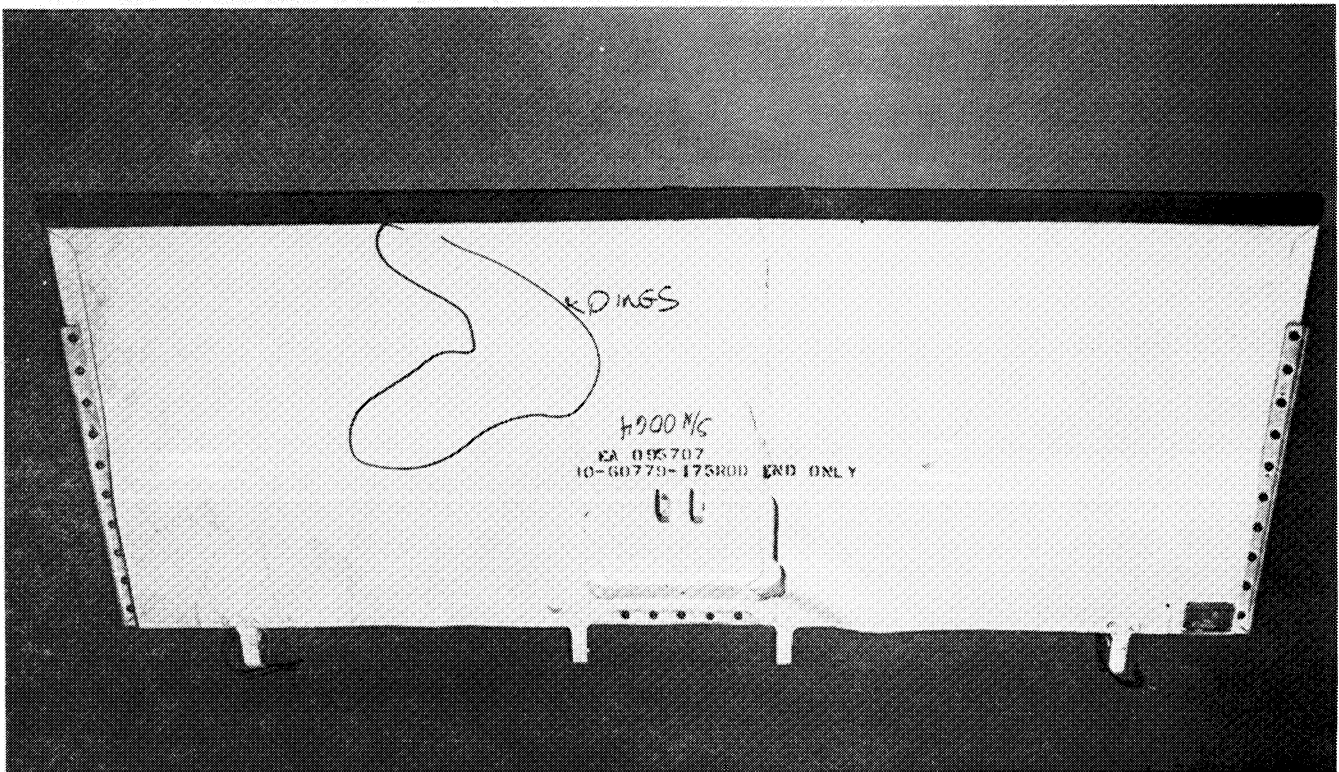
Figures 65 and 66 are photographs of a typical spoilers after testing. A typical failure would be initiated through a hinge fitting splice location. Often the center hinge fitting is pushed through the upper surface upon failure.

Figure 65. Upper Surface of Spoiler S/N 0064 Following Residual Strength Test

Figure 66. Lower Surface of Spoiler S/N 0064 Following Residual Strength Test
