AC NO: AC 20-64

ADVISORY CIRCULAR

SUBJECT: MAINTENANCE INSPECTION NOTES FOR LOCKHEED L-188
SERIES AIRCRAFT

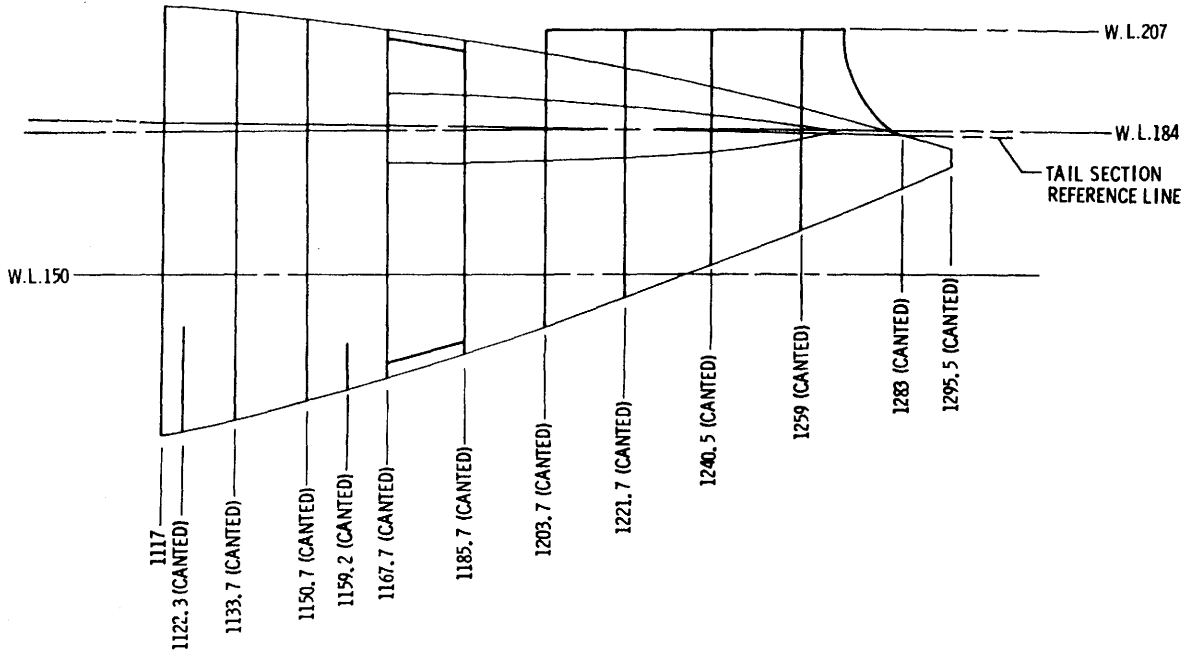
FIGURE D-4. FUSELAGE CANTED SECTION

- g. Canted Fuselage Frame Upper Web. Cracks have been
Found in the canted frame upper web, station 1167.7.
(See figure D-4 in appendix 4, page 4.)

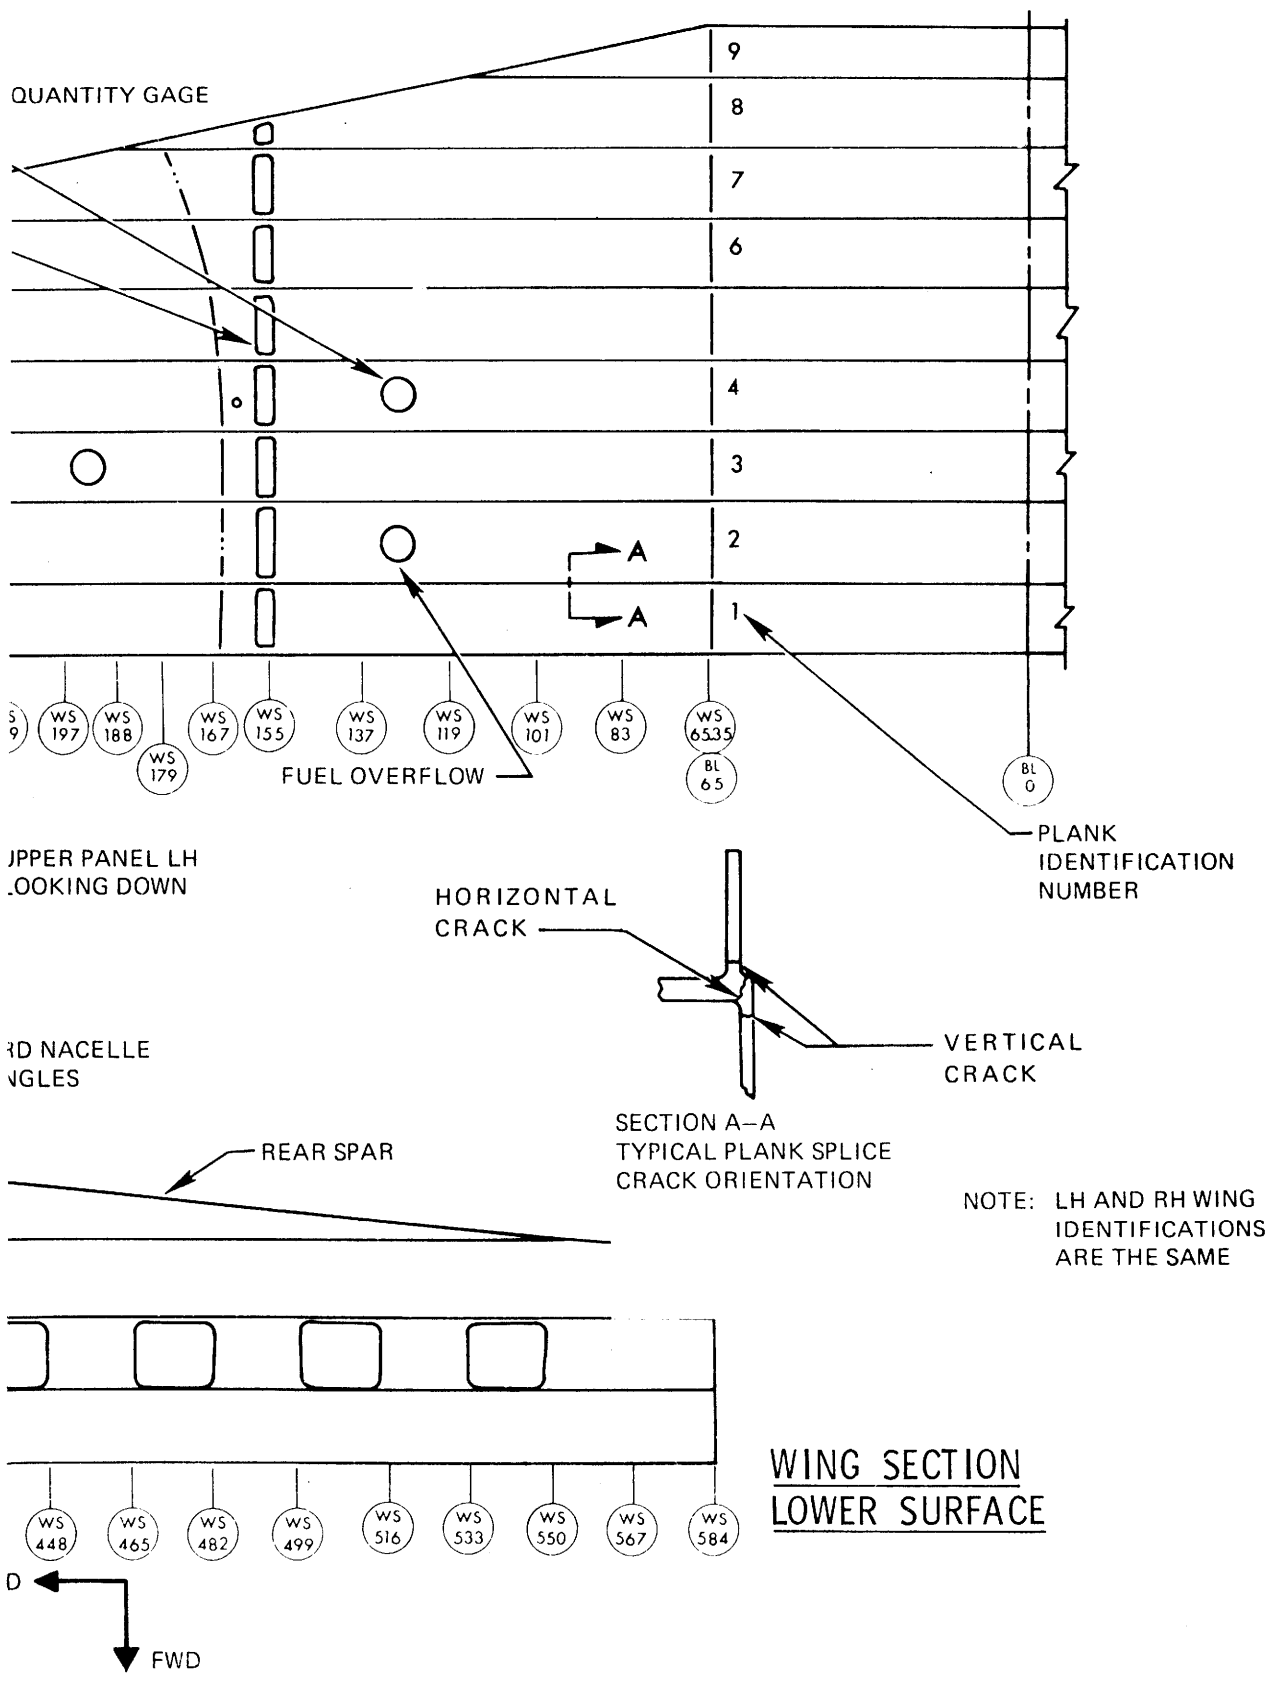
FIGURE F-3. SERVICE PROBLEM AREAS

1 NO.	2 MAJOR ASSEMBLY	3 ITEM	4 SERVICE HISTORY	5 PAGE REF. FOR ILLUSTR.	6 S/N CODE
W-30	Wing Center Section B.L. 65 L/R	Upper and Lower Wing Surfaces at B.L. 65 Splice Area	Corrosion damage has been reported in upper and lower wing surfaces at B.L. 65 where center section joins outer sections.	42 57	⚠
W-31	Outer Wing Front Spar W.S. 209	Upper cap and spar web	Cracks have occurred in the spar web at the MLG rib attach bolts thru the rib tee, spar web, upper spar cap and nacelle attach fitting.	51	⚠
W-32	Outer Wing and Center Section B.L. 0 to W.S. 584	Upper and Lower Wing Surfaces, B.L. 0 to W.S. 584	Corrosion damage around plank splice fasteners has occurred on both the upper and lower wing surfaces.	43	⚠

7	8		9	10
RECOMMENDATIONS				
METHOD OF INSP.	FREQUENCY OF INSPECTION	TYPE OR METHOD OF REPAIR	PREVENTIVE ACTION	
V i s u a l	Inspect at next periodic with repeat inspections at every major structural inspection interval.	Repair in accordance with LAC Service Bulletin 88/SB-678A.	P e r i o d i c inspections and application of corrosion protection coatings.	
Visual, Eddy current	On aircraft having 20,000 hours or more inspect within 625 ft. hours. Repeat inspection at 1250 ft. hour intervals until preventive reinforcement or repair which eliminates repeat inspections is installed.	Repair in accordance with LAC Service Bulletin 88/SB-682B, paragraph 2.F. DRAWINGS 841802 841804C	Service Bulletin 88/SB-682B, paragraph 2.E. Ref: Drawing 841800C	
V i s u a l	Normal wing structural maintenance inspection interval, but in no case shall interval exceed that required by LAC Service Bulletin 88/SB-620.	Repair in accordance with LAC Service Bulletin 88/SB-685, paragraphs 2.C and 2.D. DRAWINGS 841867 841872	P e r i o d i c inspections and application of corrosion protection coatings.
