# Broward Marine Fire

Ft. Lauderdale, Florida

USFA-TR-101/September 1996

This is Report 101 of the Major Fires Investigation Project conducted by Varley-Campbell and Associates, Inc. under contract EMW-94-C-4423 to the United States Fire Administration, Federal Emergency Management Agency.

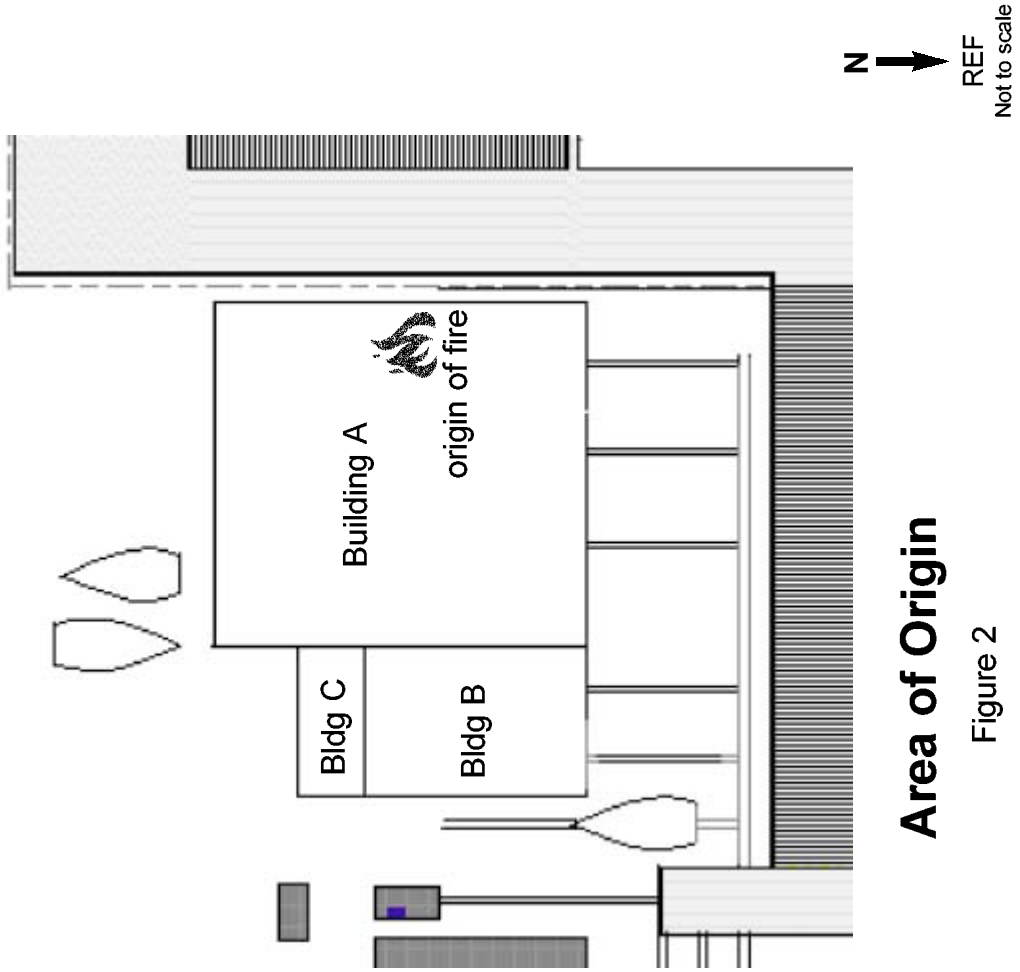
**Area of Origin**

The teams worked until September 9, when a final meeting was held and the team attributed the cause of the fire to an electric short in the west central end of Building A. The intensity of the fire was considered increased because of poor housekeeping practices. The multiple spot fires were determined to be the result of flying embers from the fully developed fire and subsequent radiant heat.

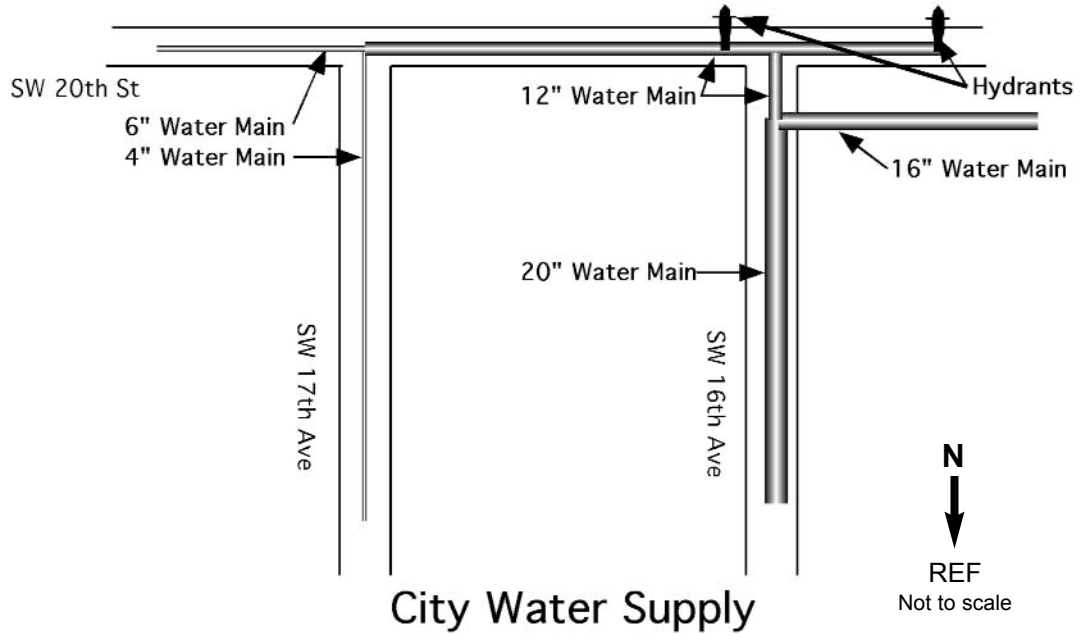
Figure 3

The hydrant located at the intersection of Southwest 20th Street and Southwest 15th Avenue had a static pressure of 72 psi and a residual pressure of 65 psi at a flow of 1300 gpm. This hydrant is supplied through approximately 150 feet of 12-inch underground pipe, which is connected to a 20-inch city water main located under Southwest 15th Avenue. This 20-inch city water main also supplied a 6-inch loop to the west, which ties back into the 20-inch water main to the south. (See Figure 3)

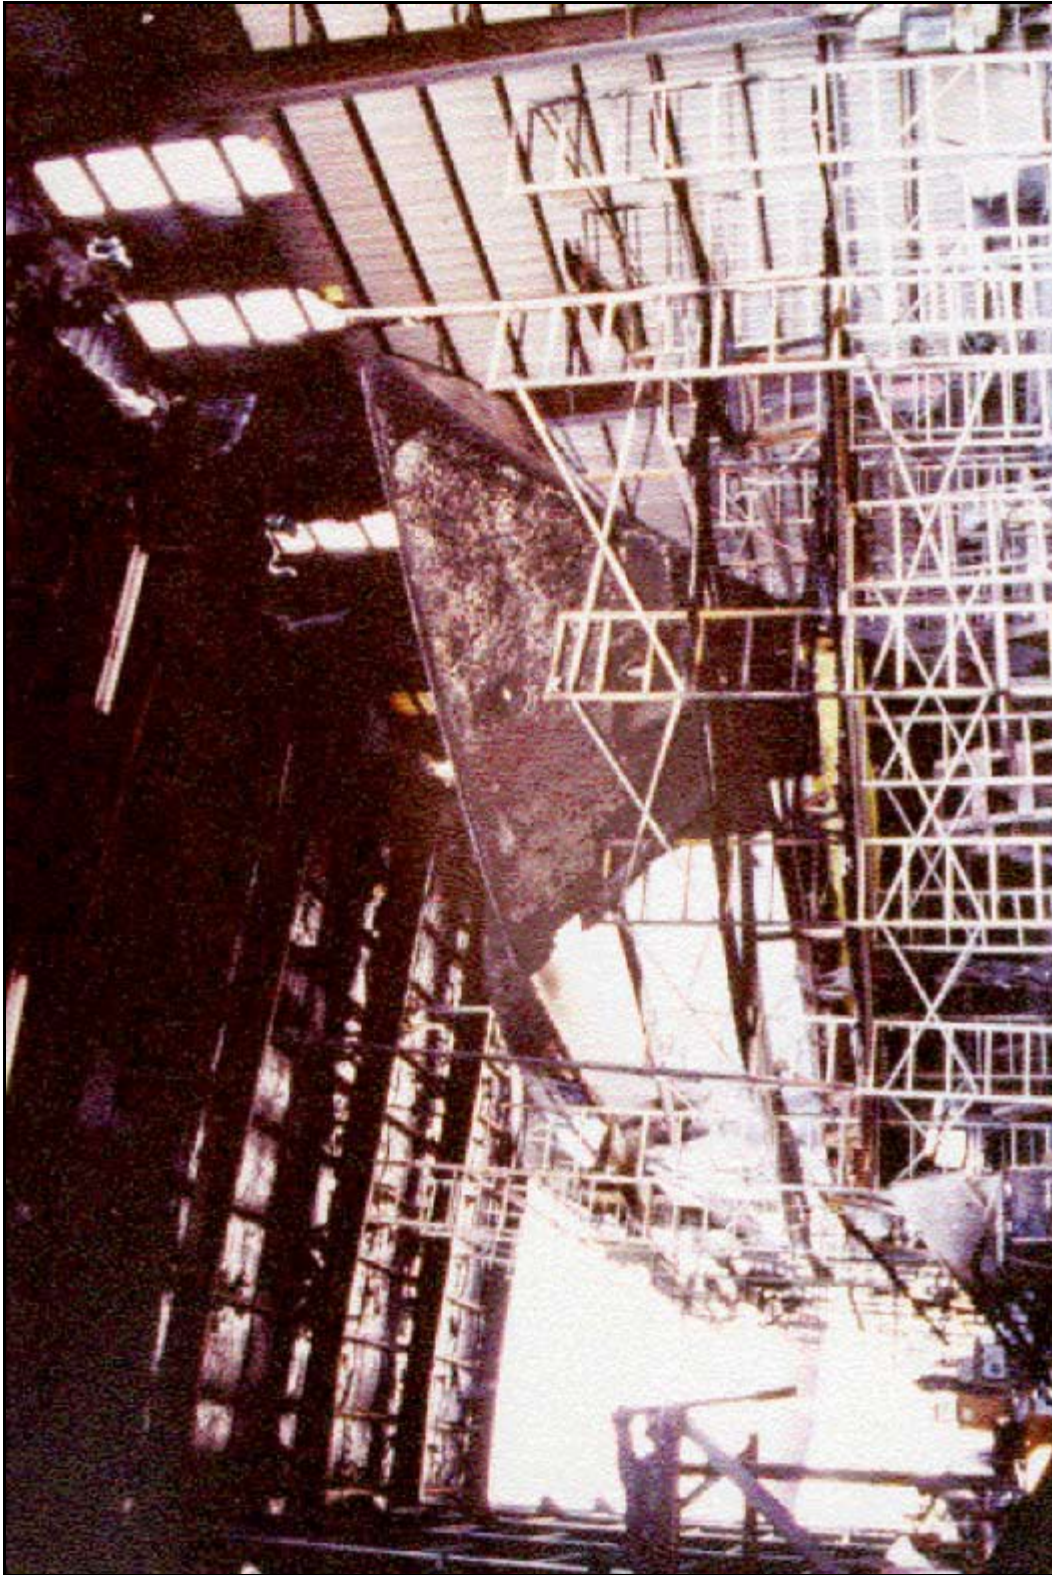
1. View of yacht under construction in Building B. Scaffolding constructed around the yacht hindered the firefighting efforts.

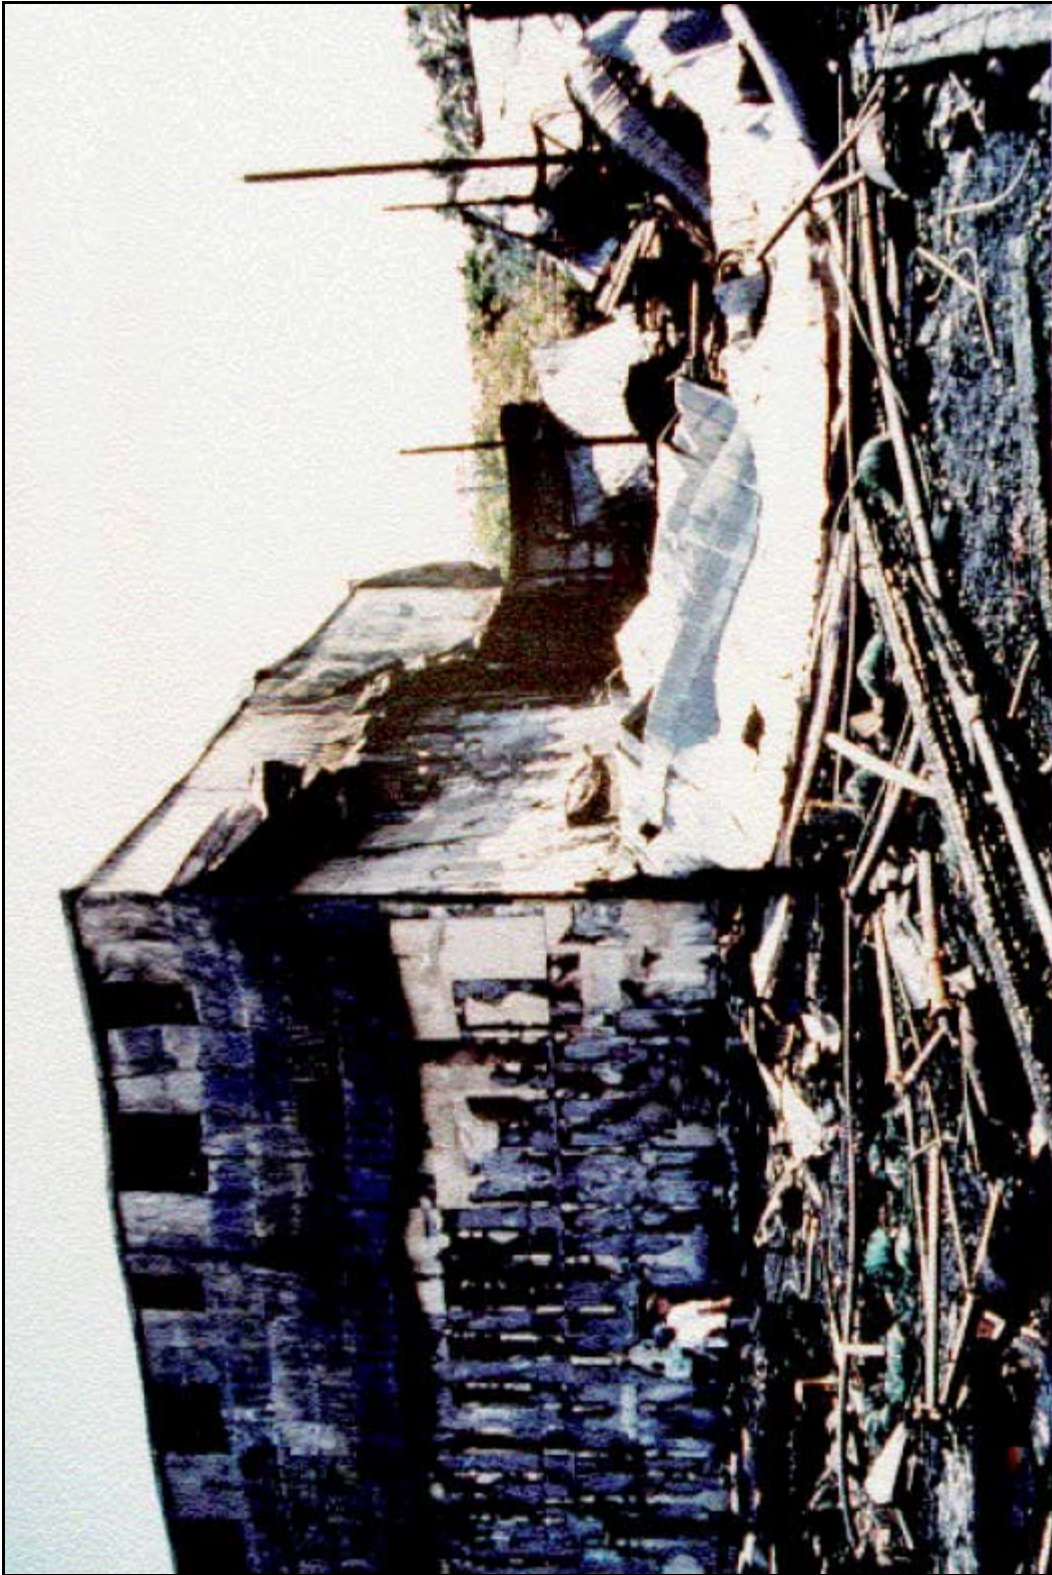
2. View looking east from Manufacturing Building (Building A) towards the destroyed Office Building (Building C).

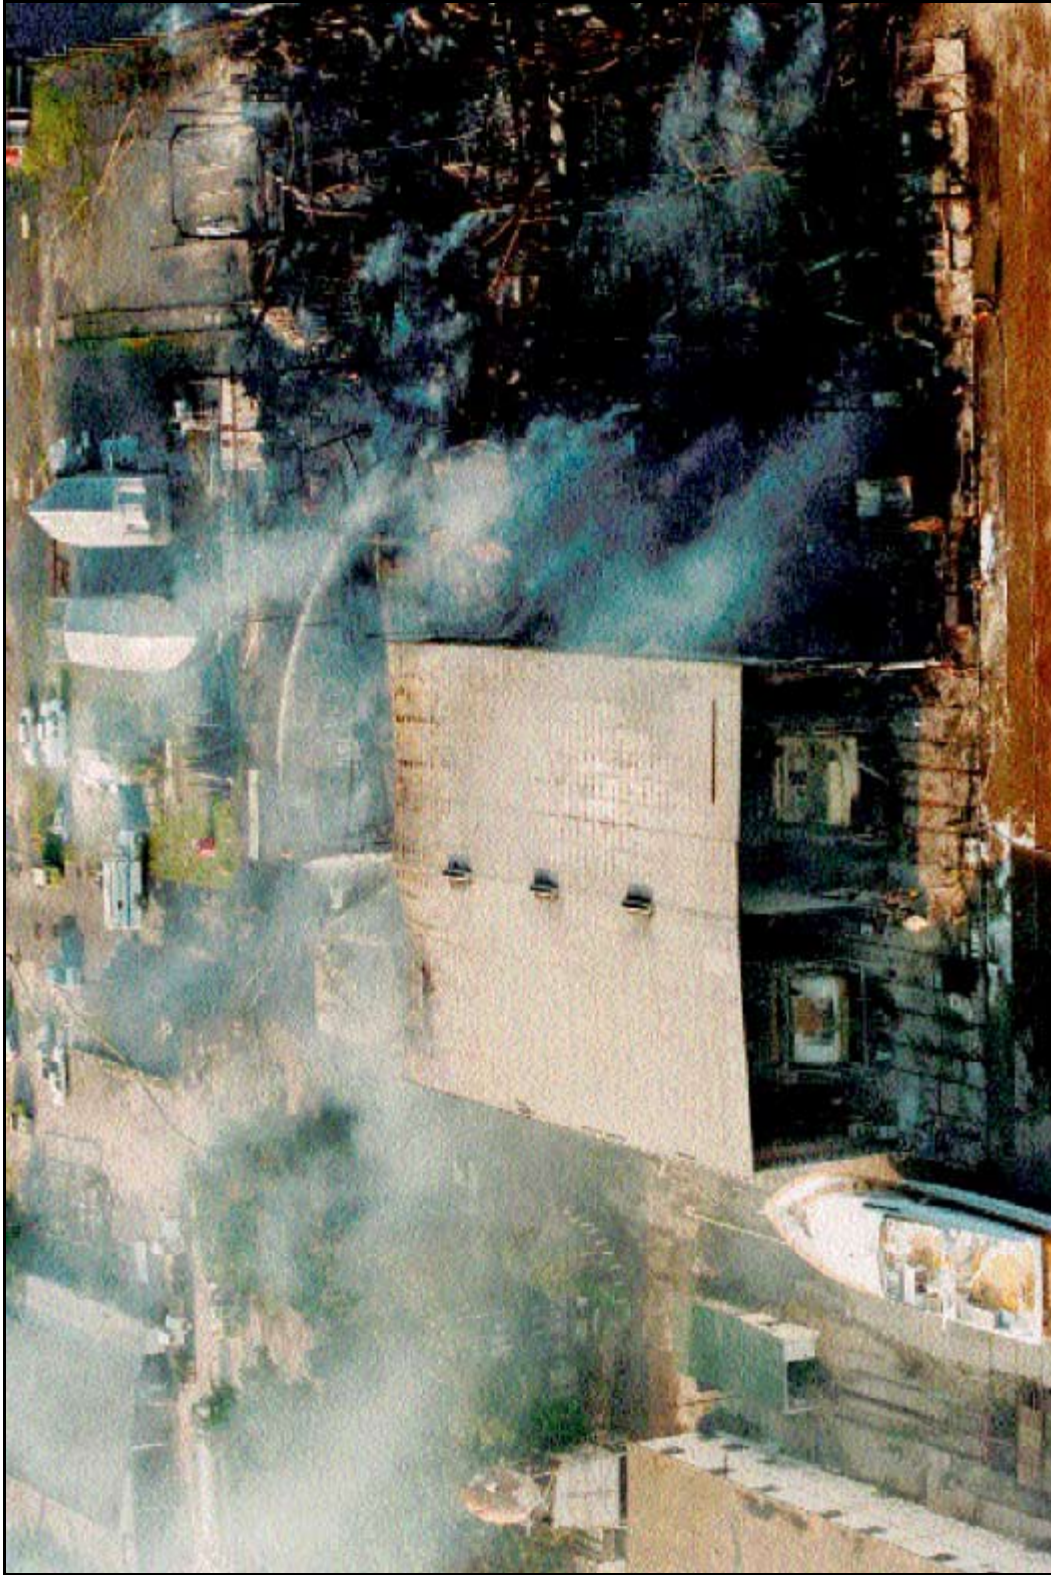
3. Aerial view of fire scene; the two boat hulls located at the top of the photograph are situated south of Building A.

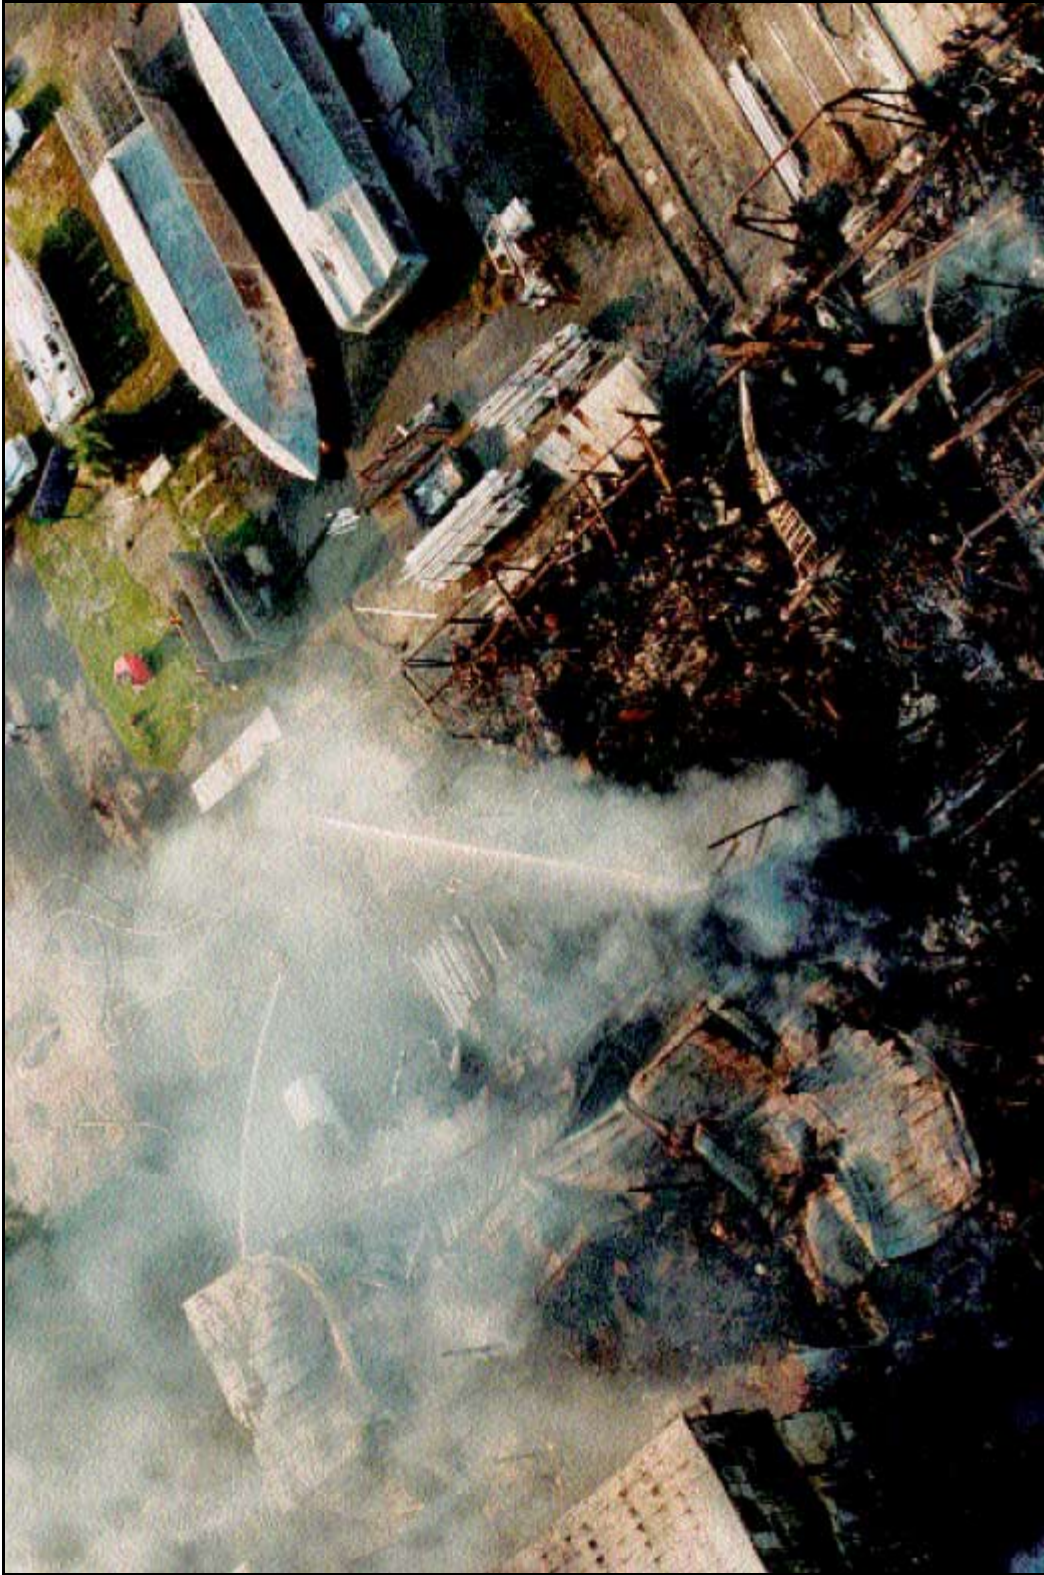
4. Aerial view of the south corner of the collapsed Manufacturing Building (Building A).

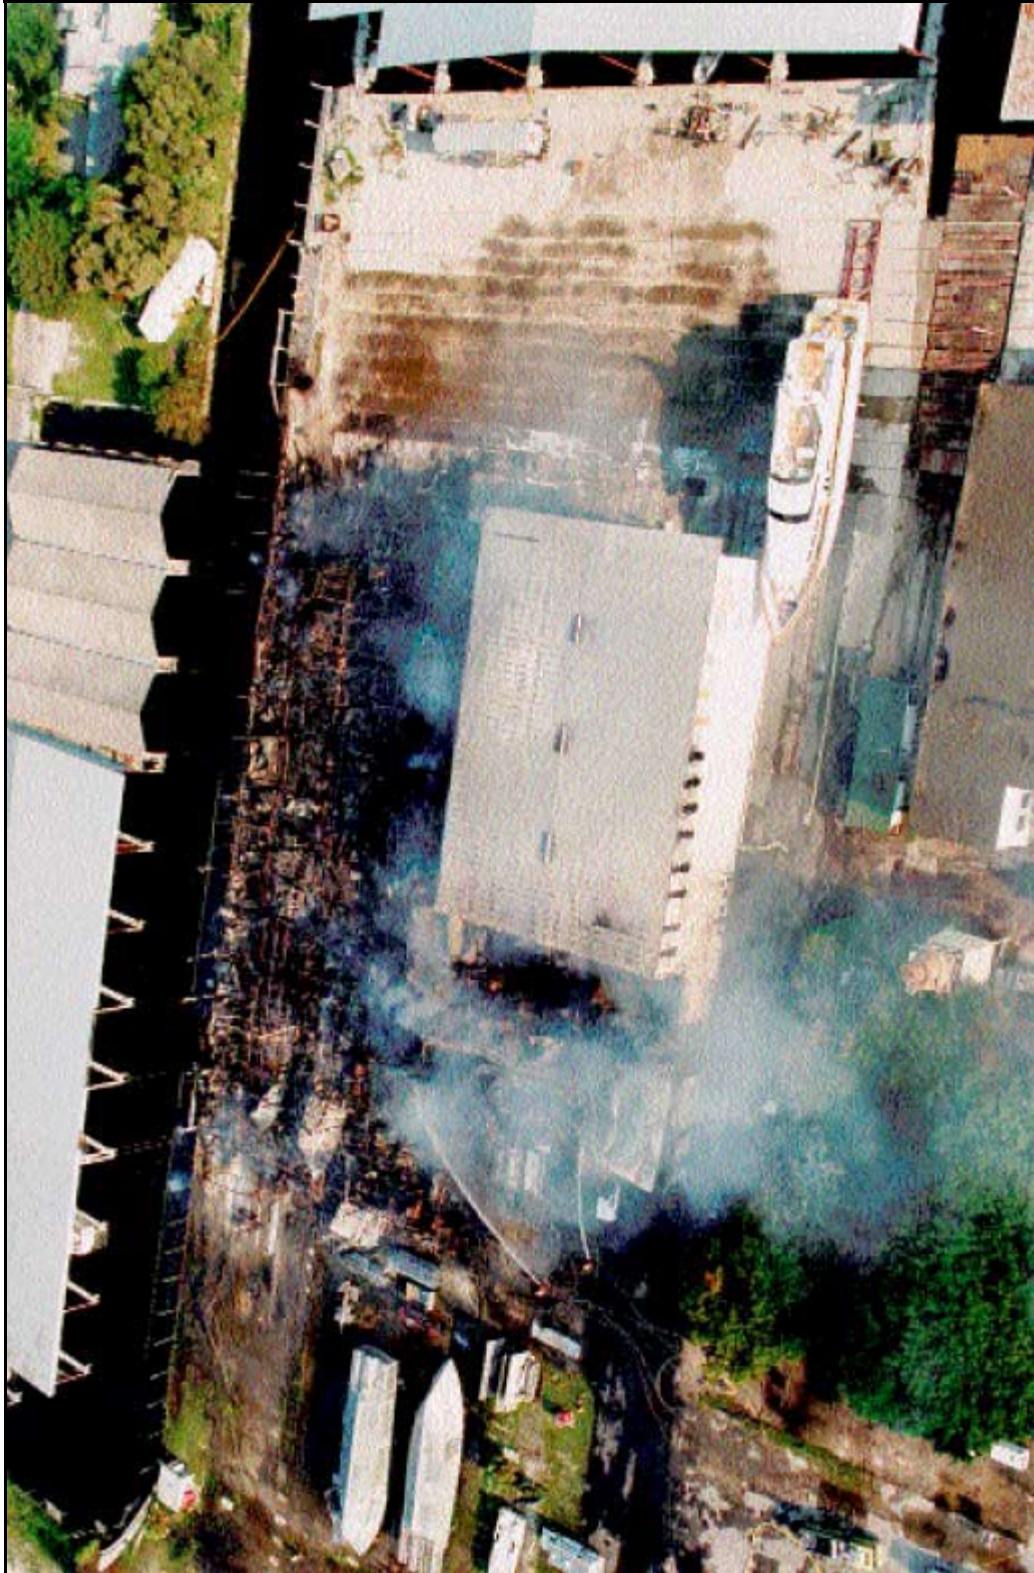
5. Aerial view of the fire scene, with the canal and neighboring covered boat slips (to the west) at top of photograph.
