U.S. Fire Administration/Technical Report Series

Chicken Processing Plant Fires

Hamlet, North Carolina

USFA-TR-057/June/September 1991

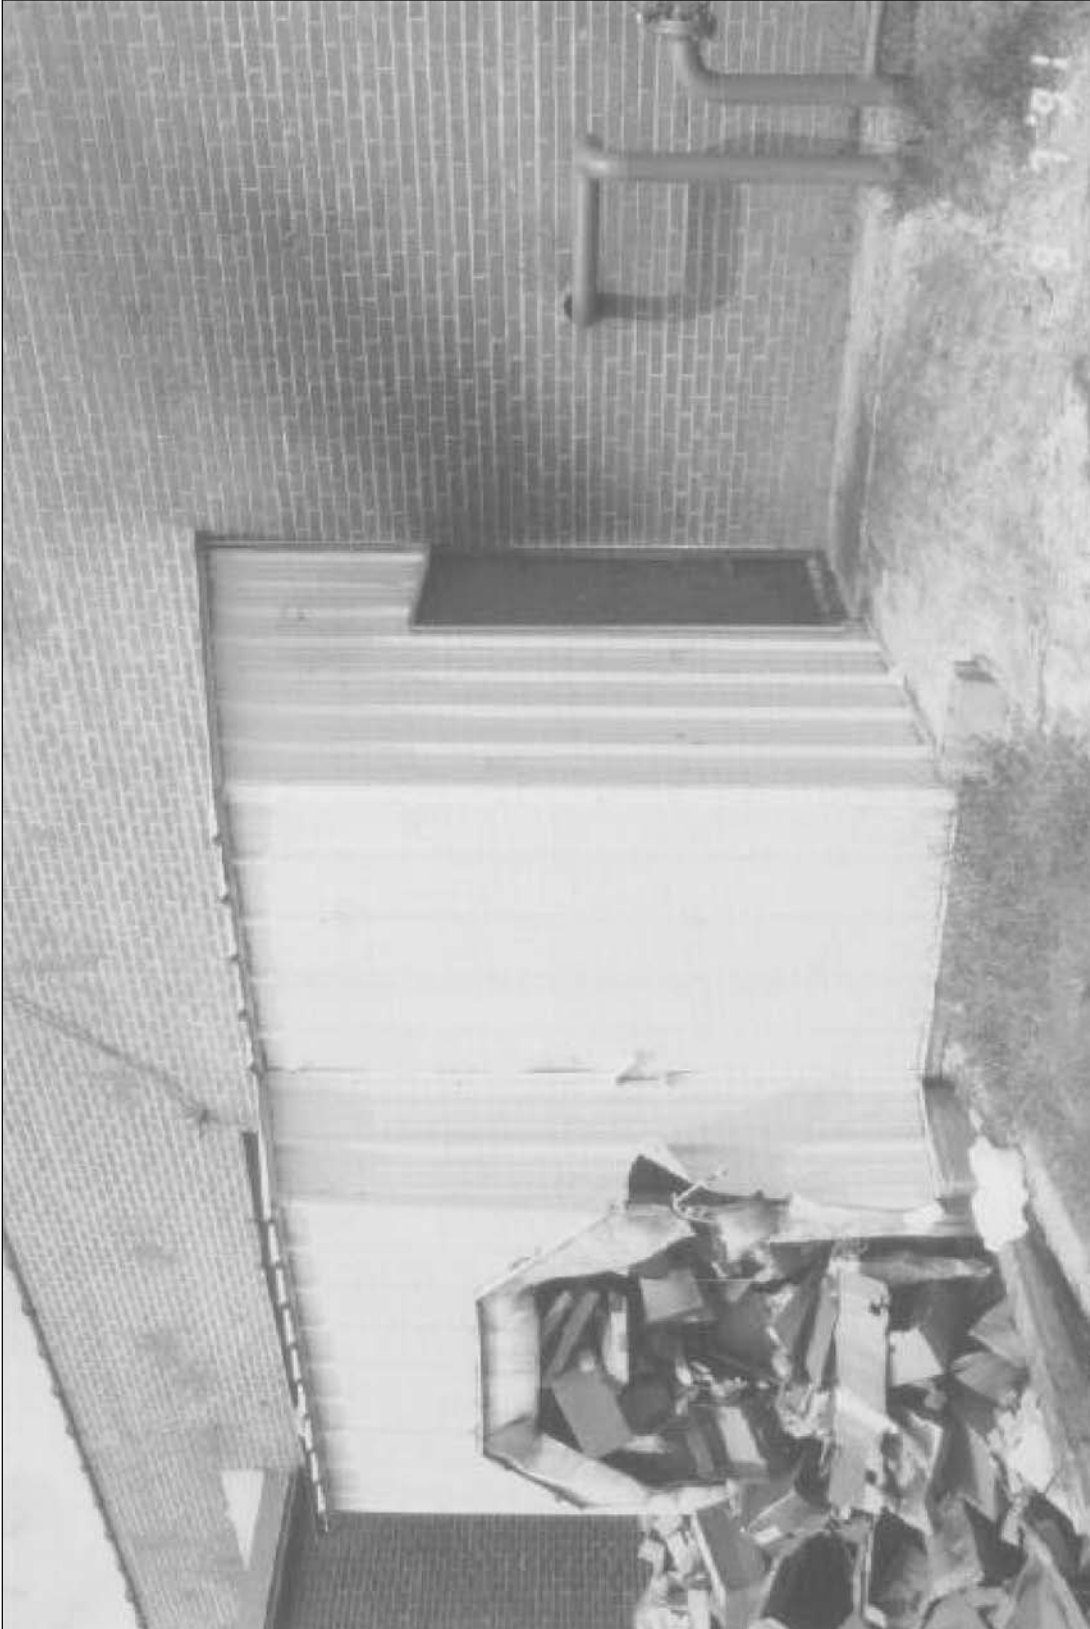
The compactor area and one of the exit doors that was locked.

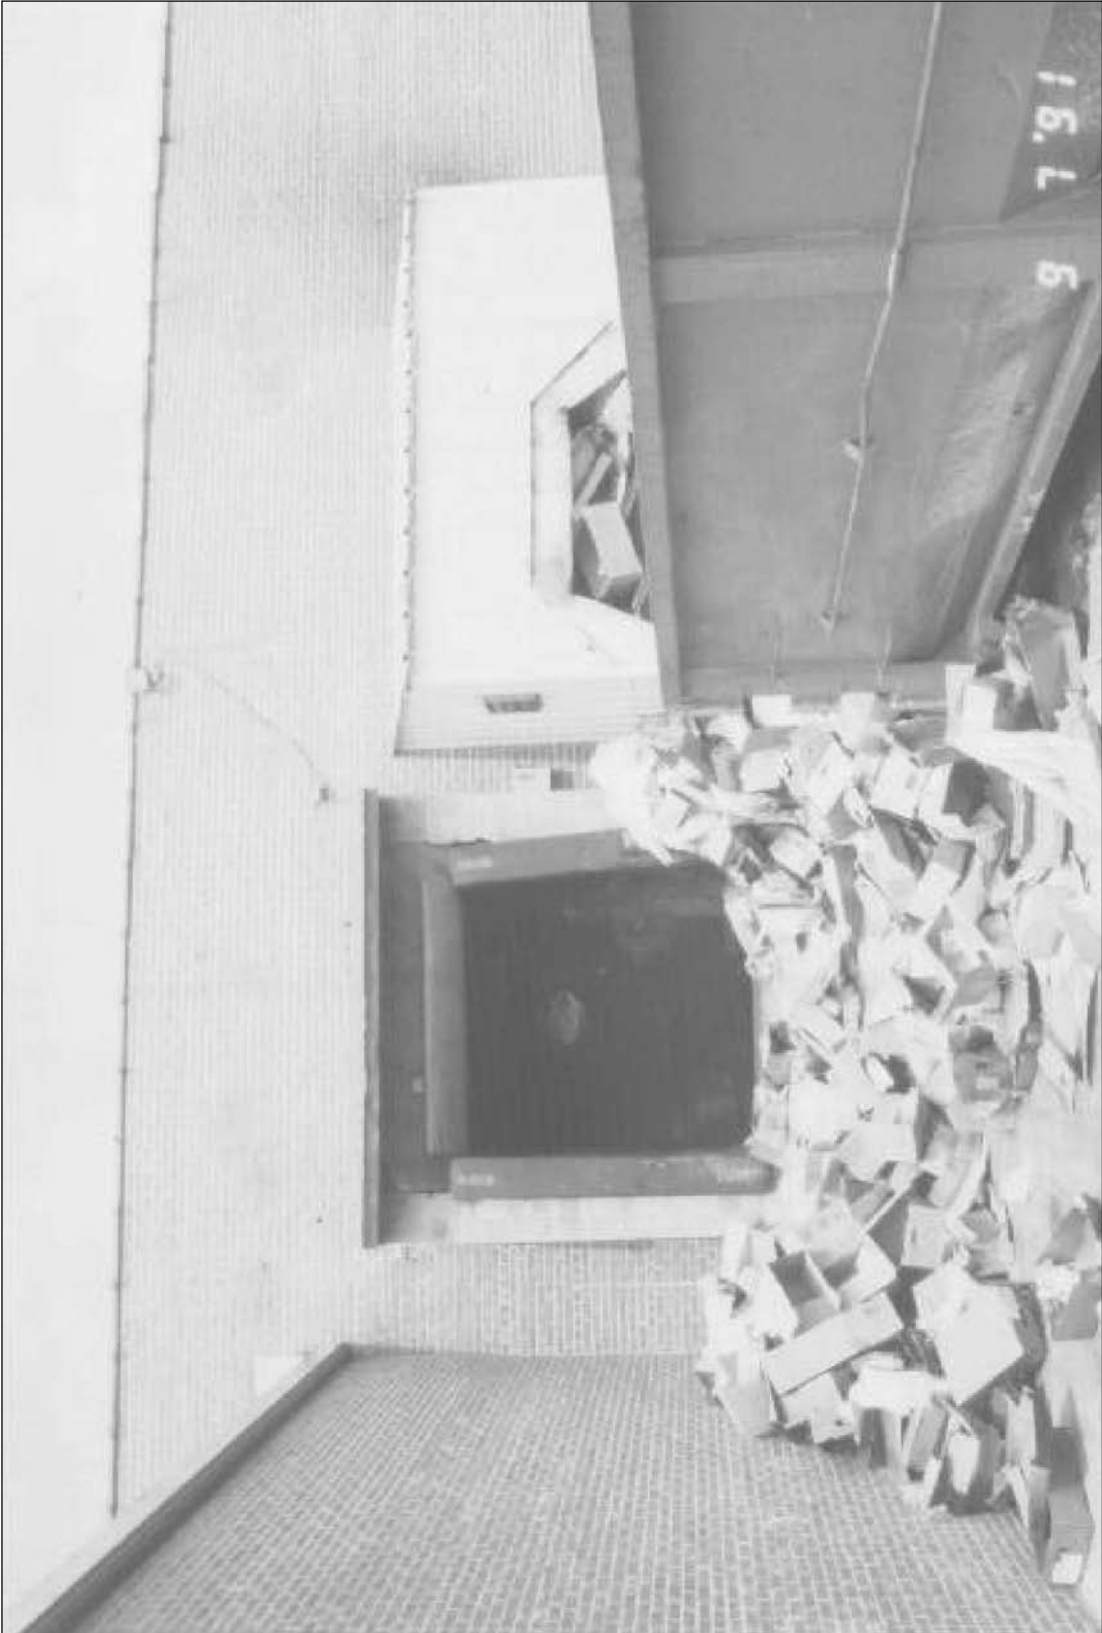
The loading dock area and sealed doors next to the compactor. The pads around the doors are designed to form a seal when the trailer backs into this dock.

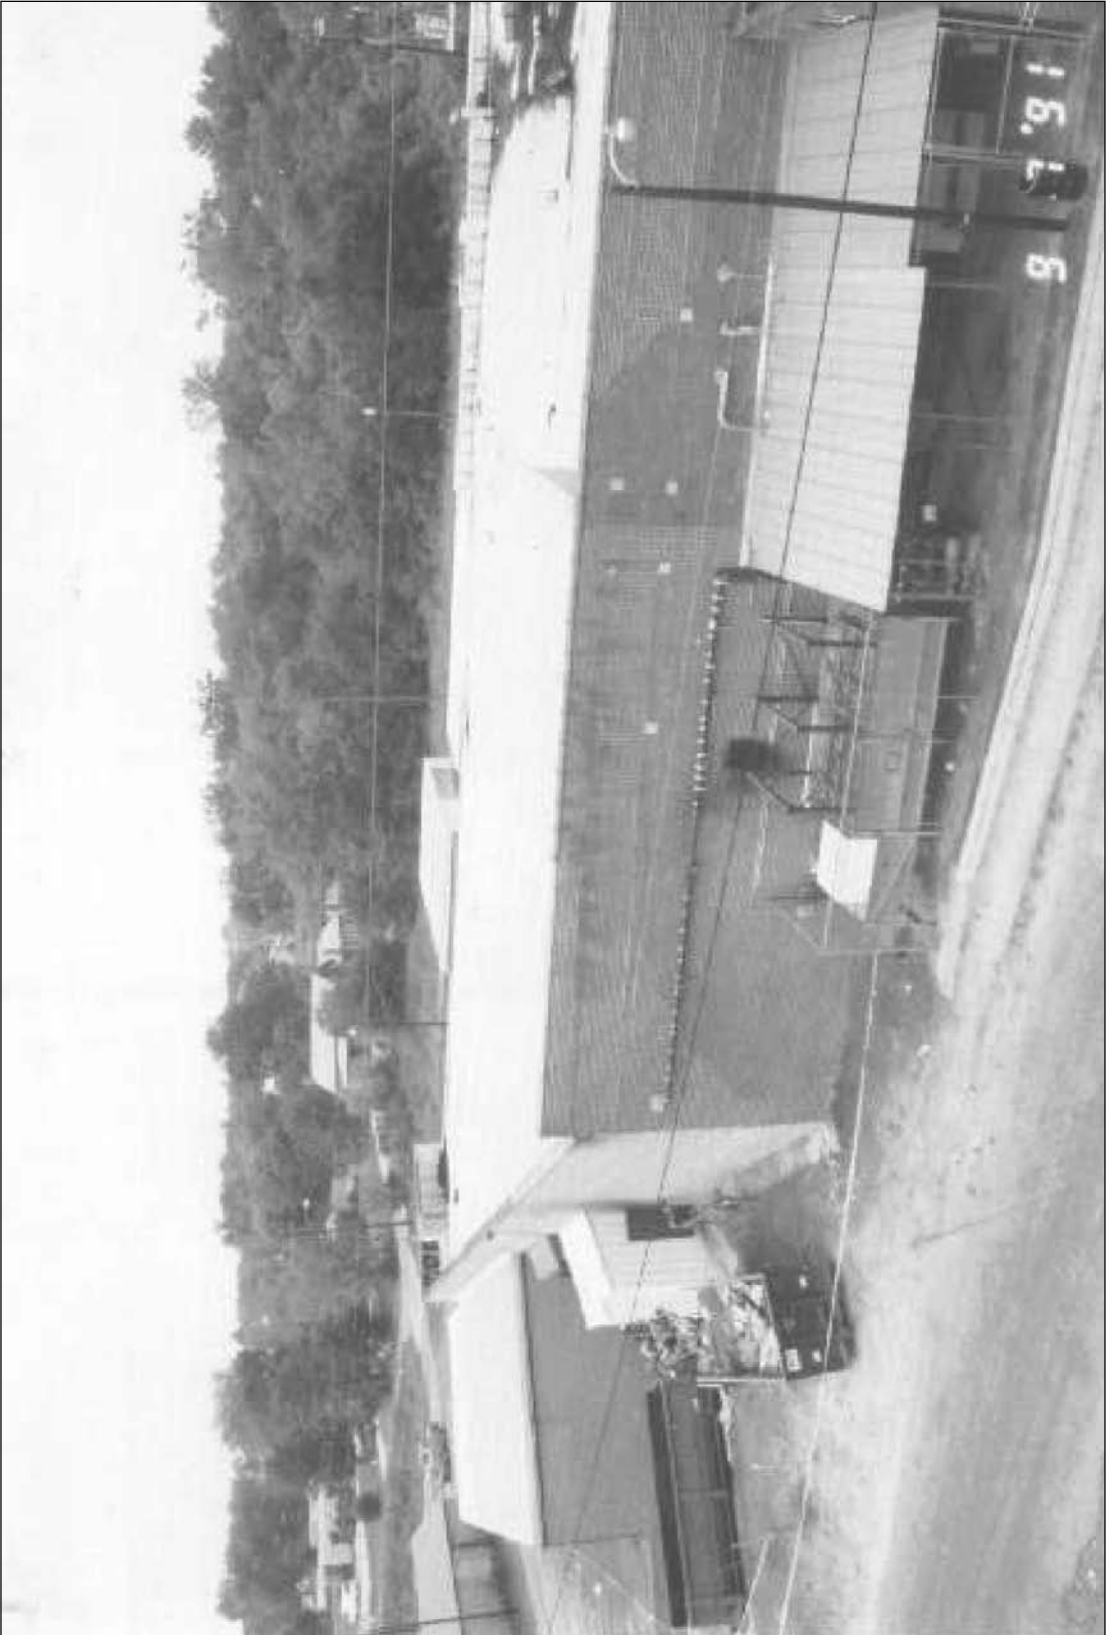
A view from an aerial ladder from the east looking southwest. Some roof damage is visible at the extreme right.

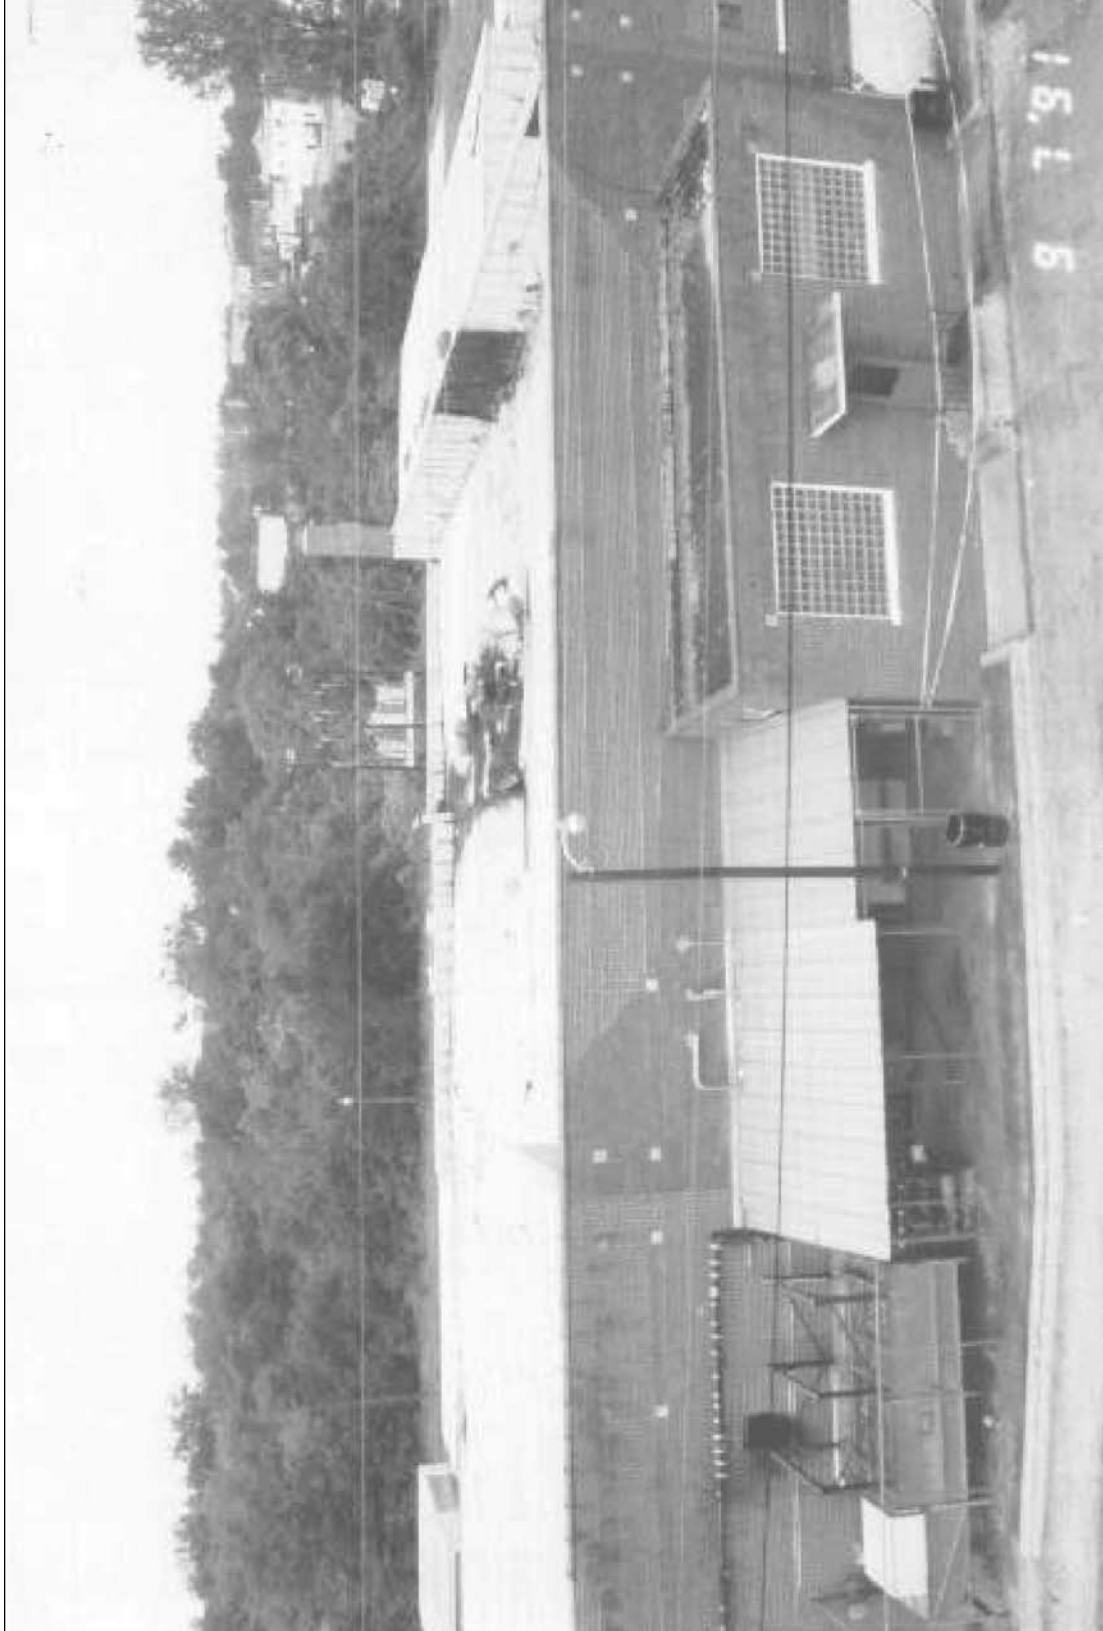
Another view from the aerial ladder from the east looking west, shows the portion of the roof collapsed over the area of origin.

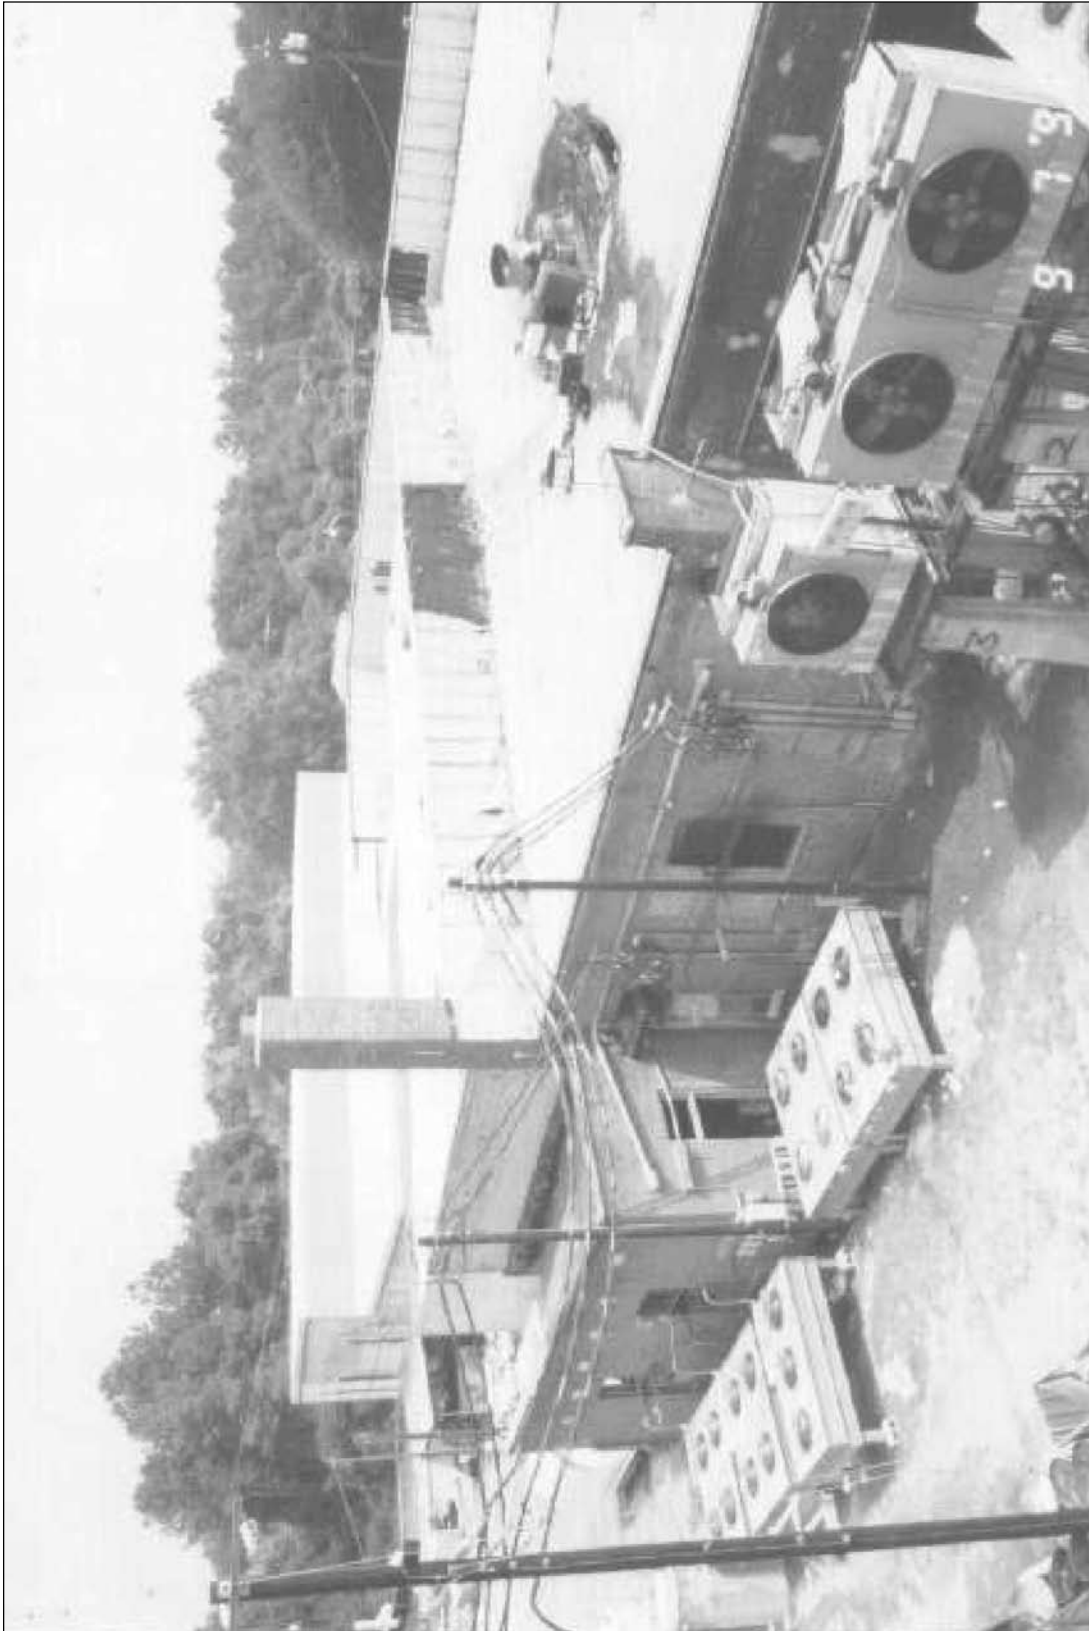
A view from the aerial ladder from the west side looking to the northeast. The roof collapse can be seen on the right, refrigeration compressor equipment is seen on the ground in the lower left.

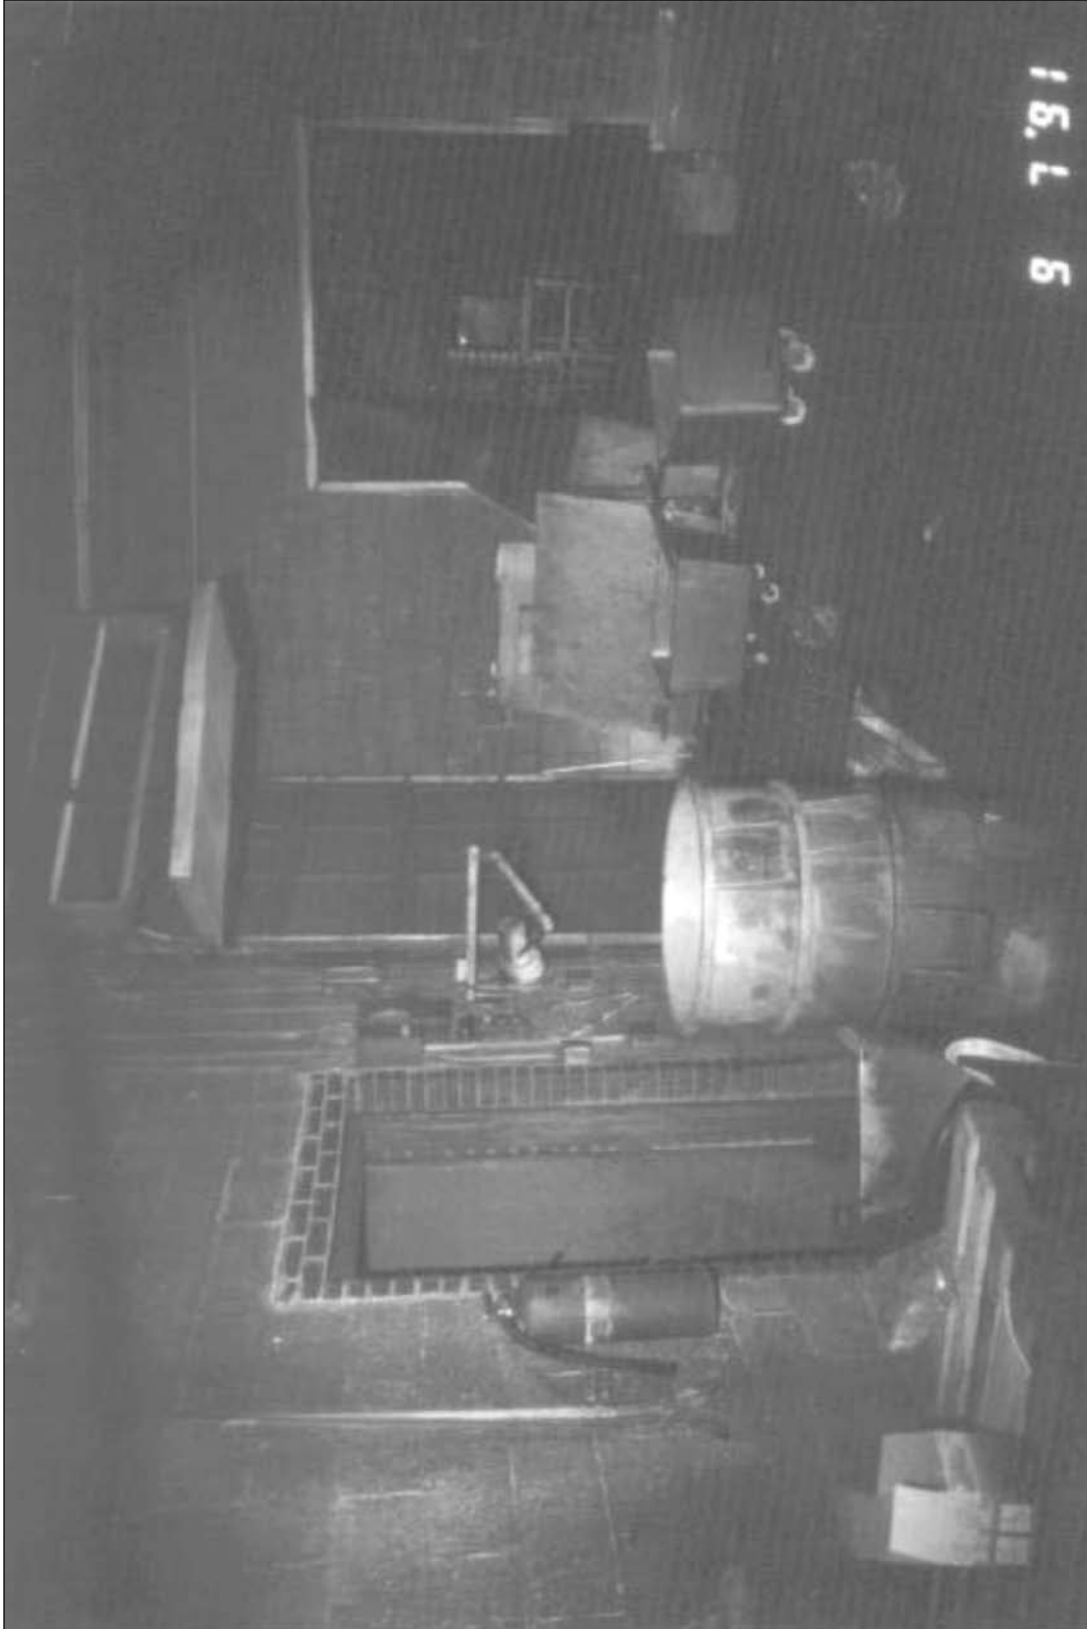
The trash and loading dock area. It was into this compactor area that several people tried to escape only to find the door to the outside locked. Upon coming back out of this area, they went through the large doors at the right which ultimately led to the large walk-in cooler where the largest fatality count was found. View is from the east toward the west southwest.

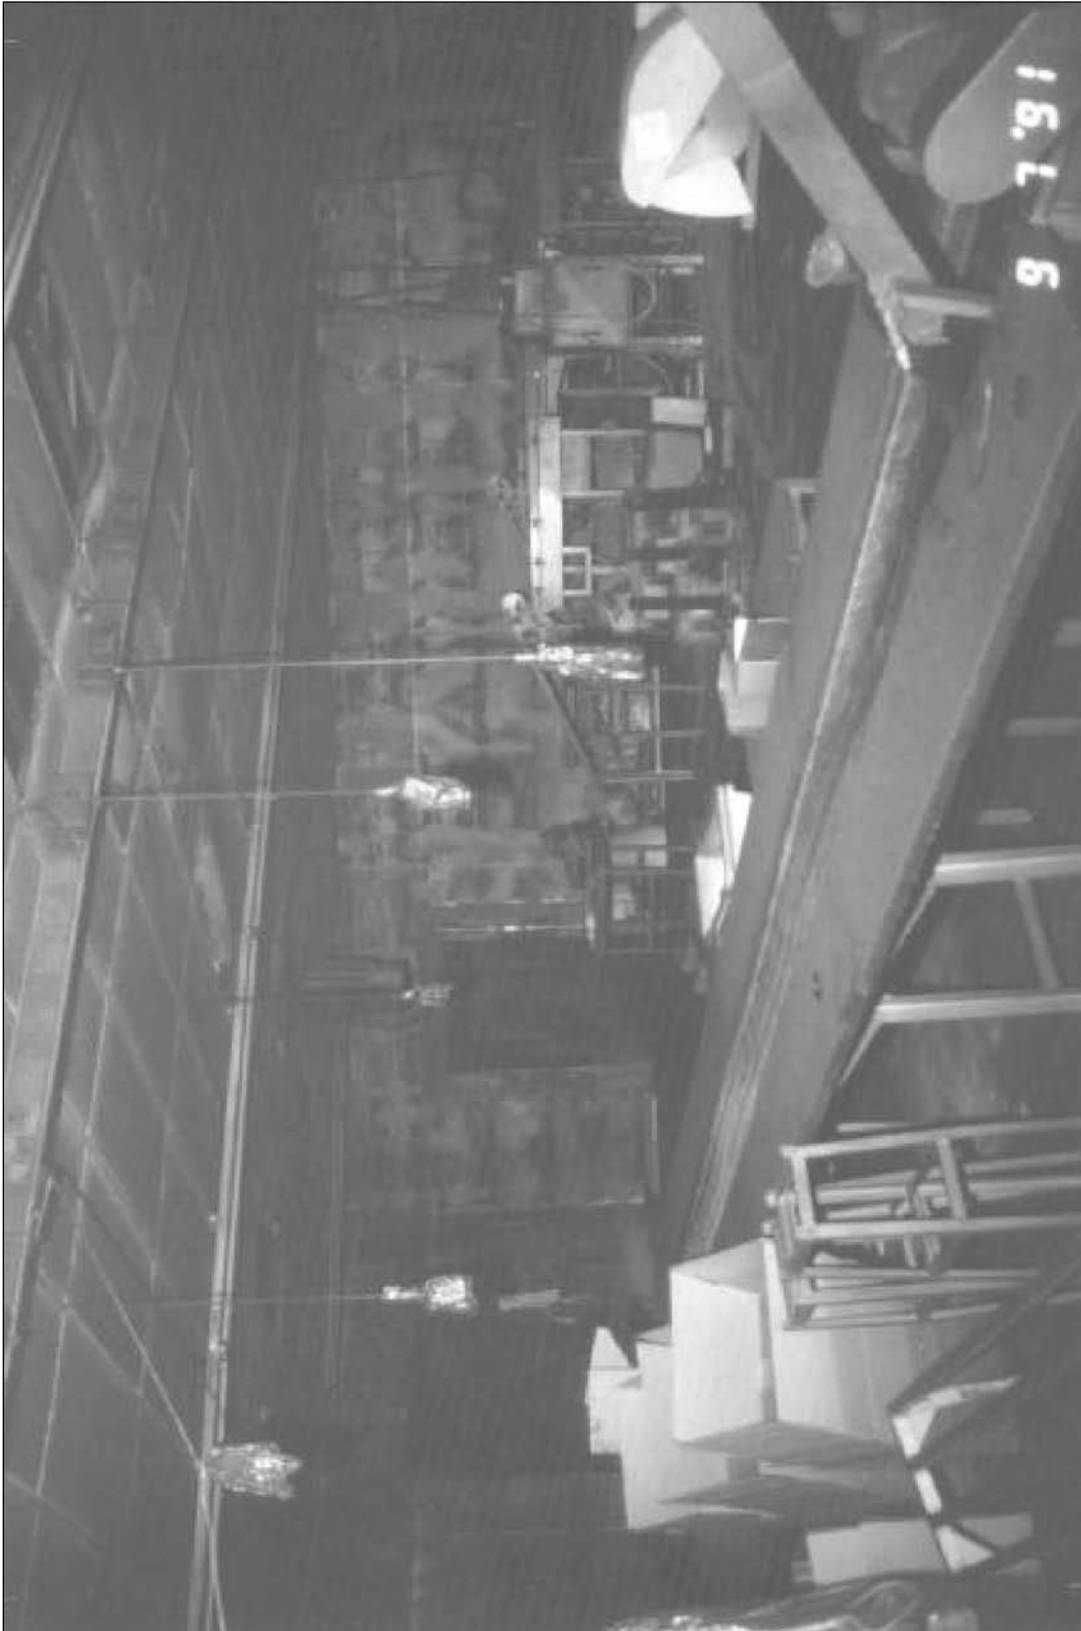
View showing the trim roof as seen from the west center looking to the southeast. This view is looking toward the door to the cooler where the highest fatality count was located.

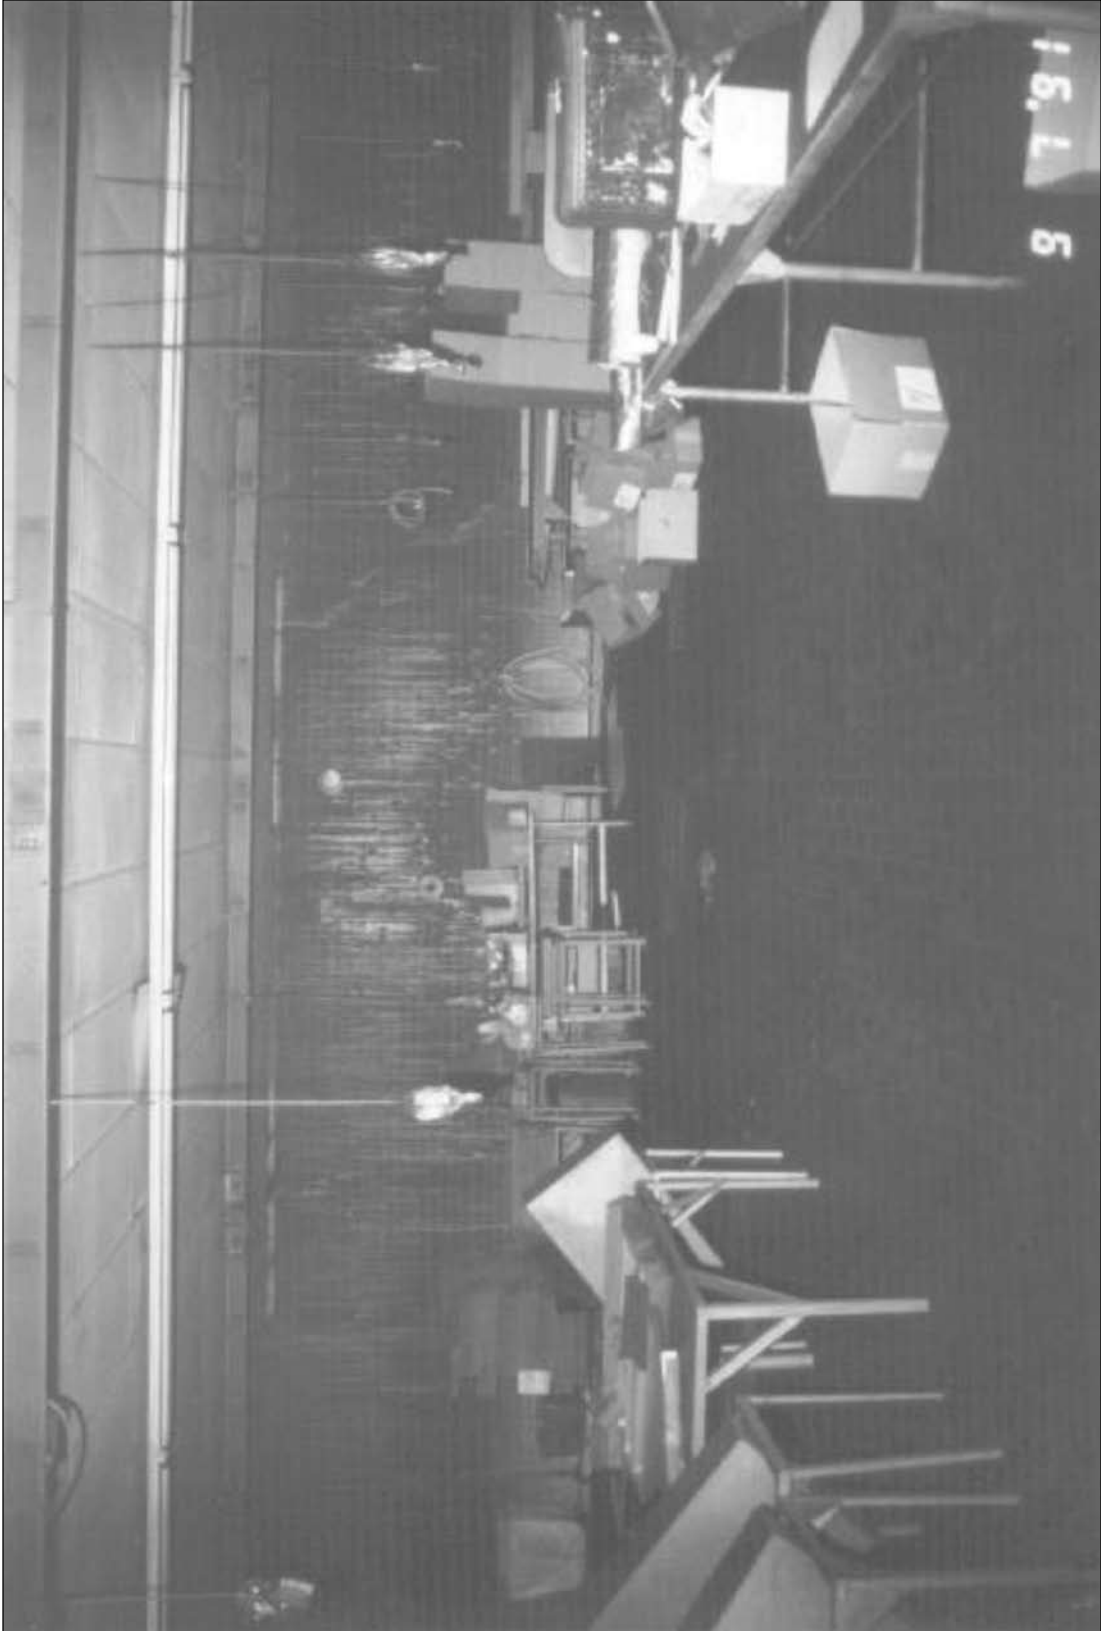
**Inside the marinating and cutting room; no direct flame impingement actually entered into this area.
View is from the east to the west.**

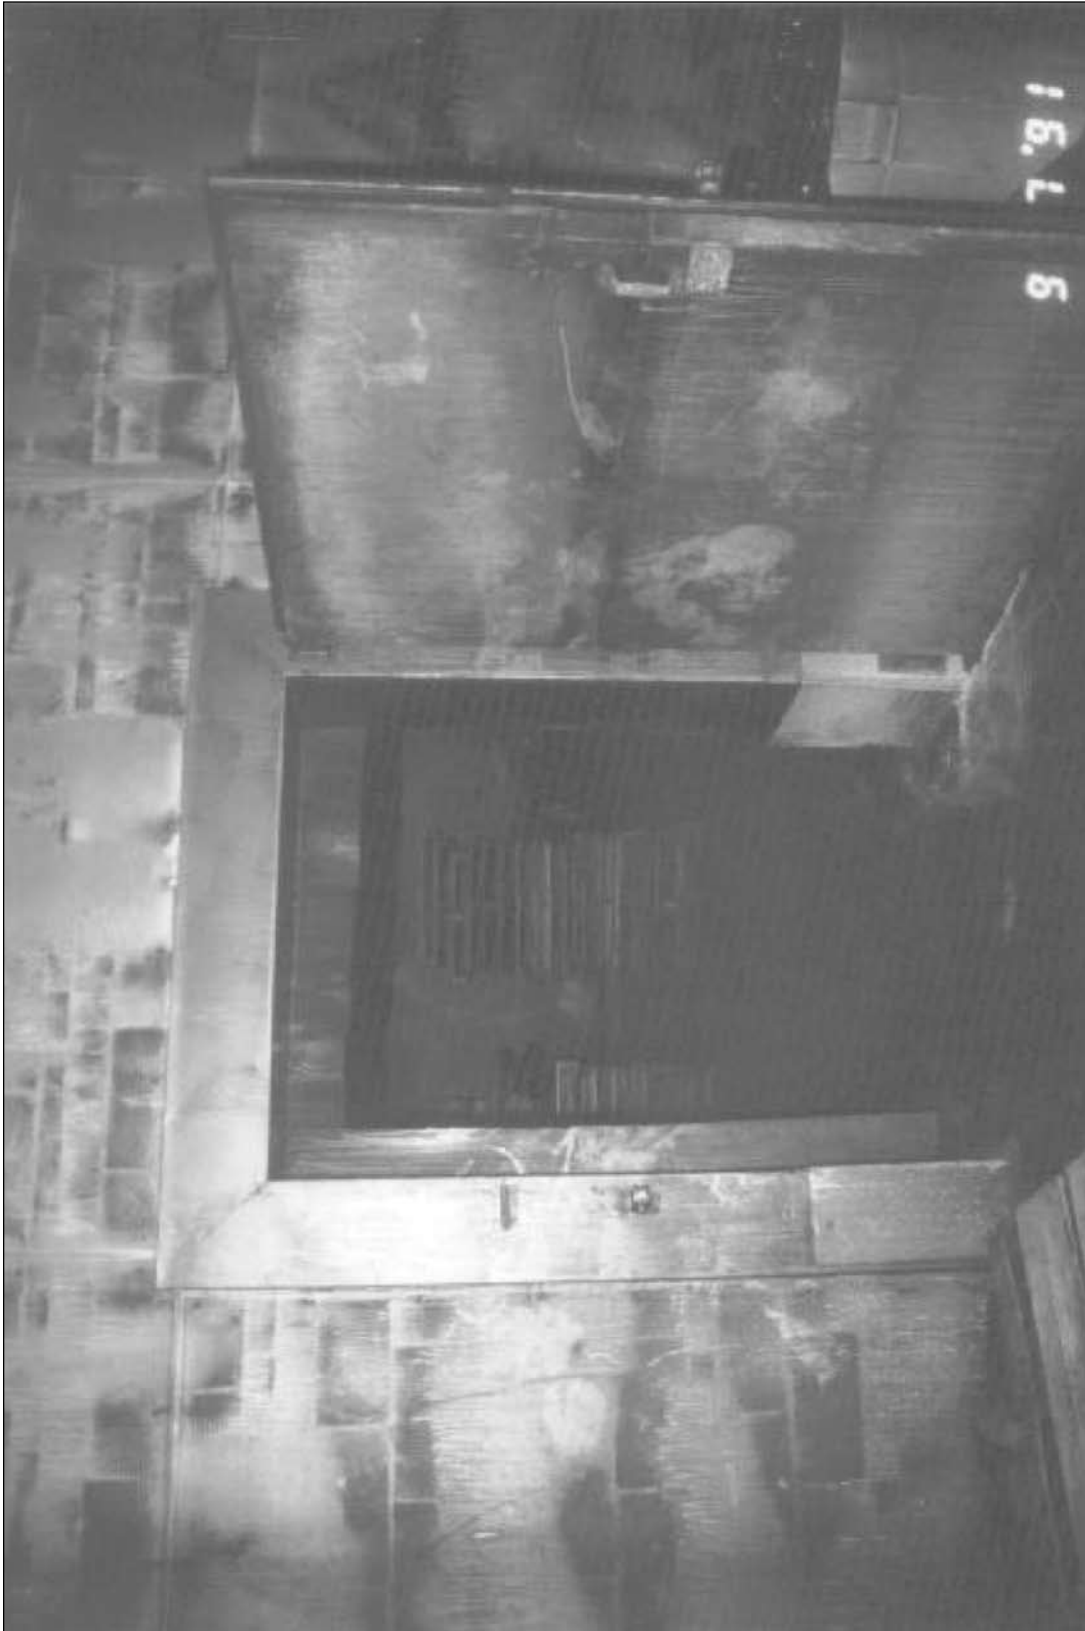
The cooler door, which was at the south end of the building, where the highest fatality count was found.

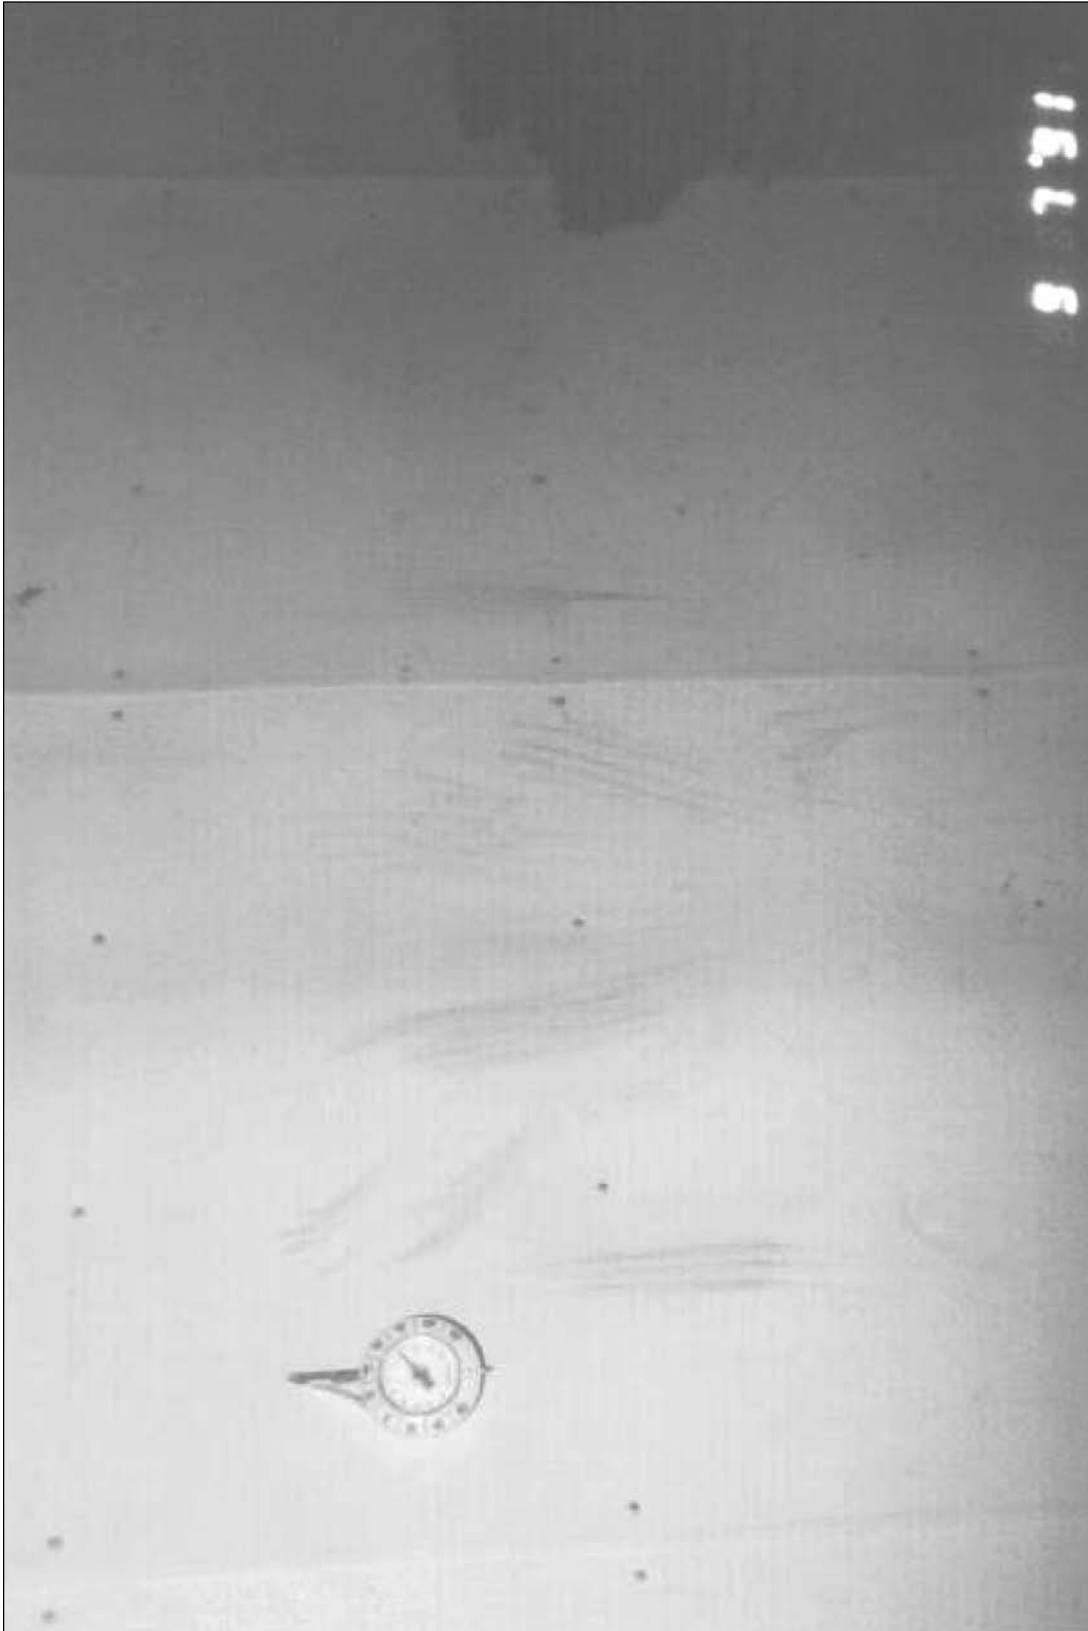
The west wall in the west portion of the cooler. Numerous handprints were found where people were trying to find escape routes.

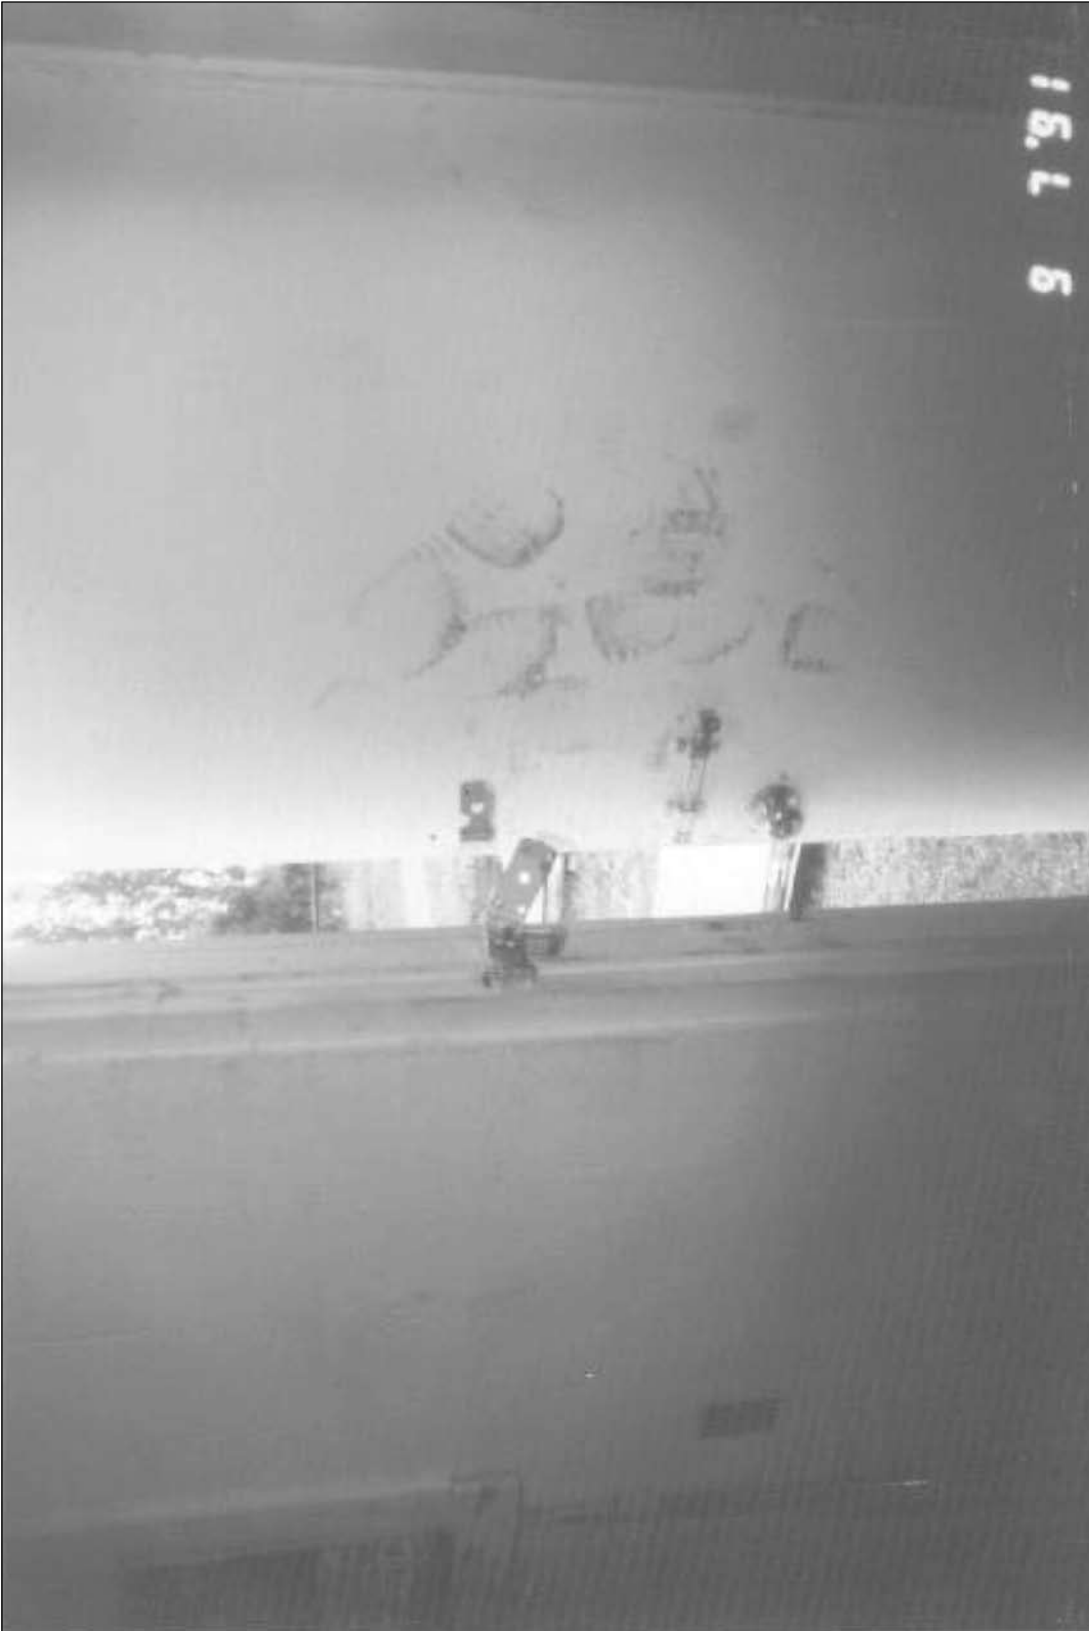
A close-up view of the north door to the break room. Note the footprints and padlock in-place where the door was kicked; it was eventually opened for the escape of some personnel.

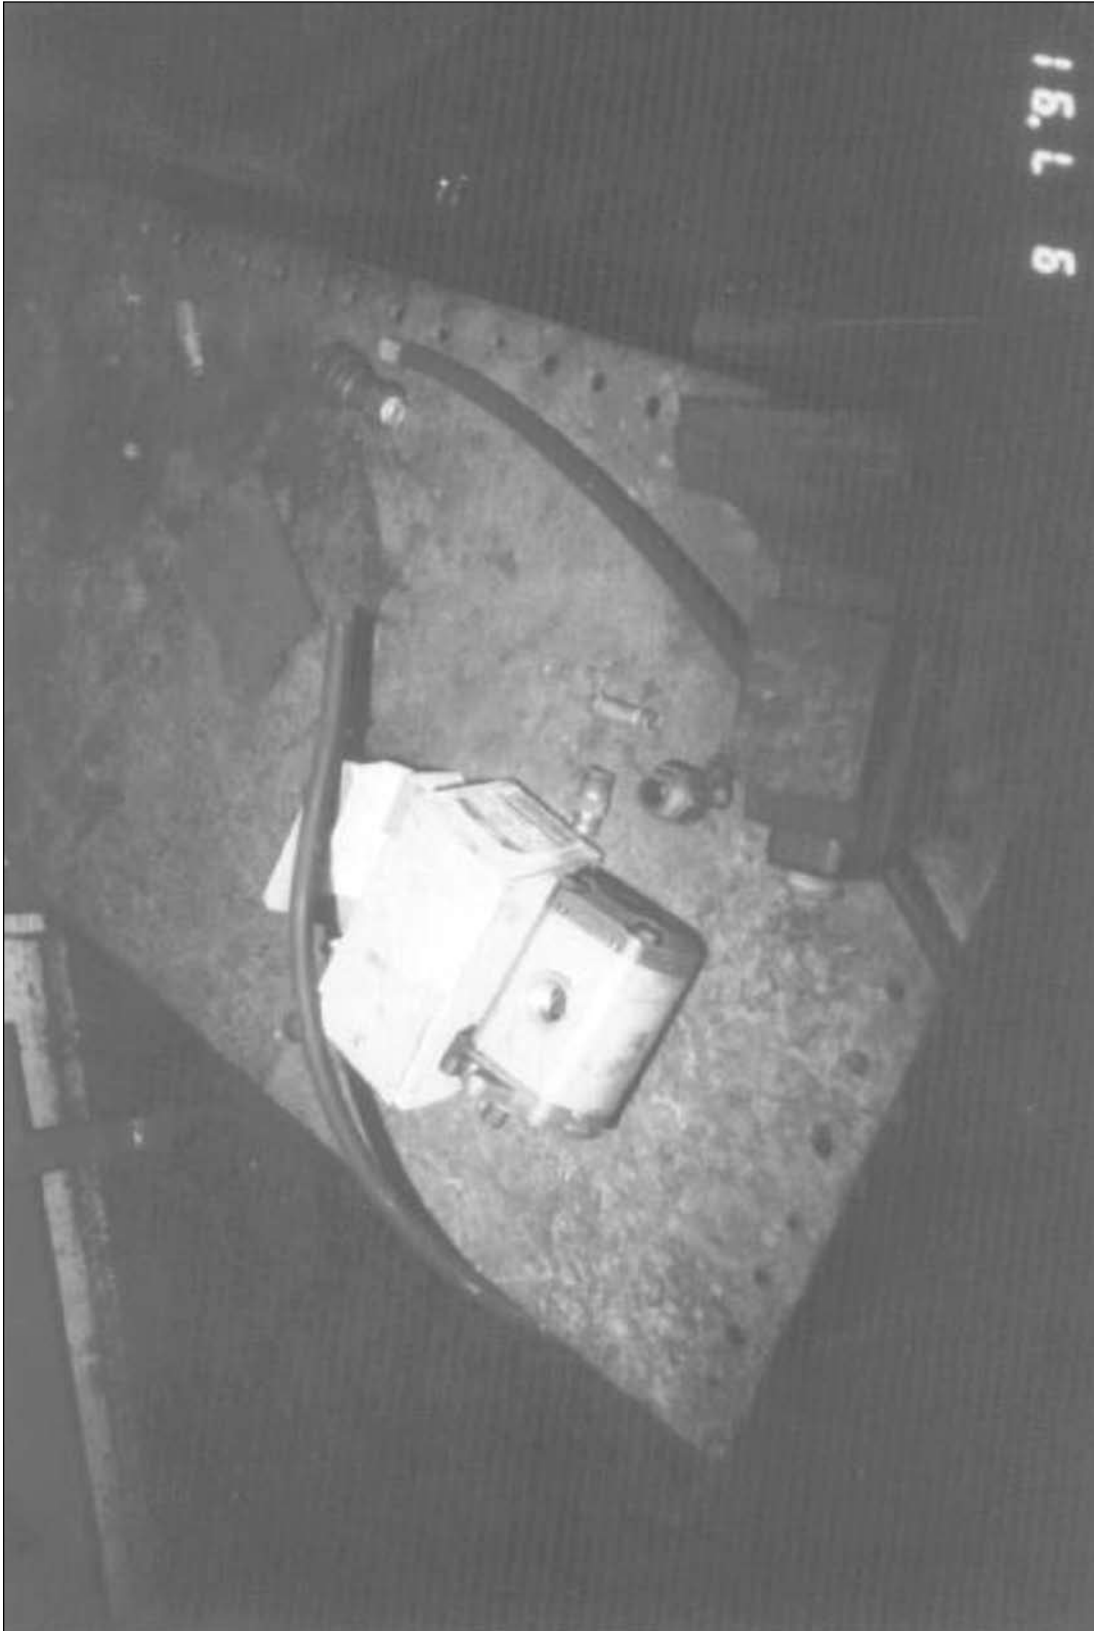
A maintenance worker who survived the fire indicated that the hydraulic line that drove the conveyor had developed a leak. The hydraulic line was turned off and drained of fluid. Then the maintenance worker disconnected the leaking line and replaced it with a factory prepared line.

The factory prepared line, however, was found to be too long and would have dragged on the floor, possibly causing people working in the area to trip. So the maintenance worker reportedly asked for and gained permission to cut the factory prepared hydraulic line to an appropriate length, replaced the end connector with their own connector, and put the line back in-place. This line has been described as a 3/4-inch flex line rated to carry 3,000 psi. Information from plant personnel indicated normal pressure was kept at approximately 800 psi, but it would at times fluctuate as high as 1,200 to 1,500 psi.

The hydraulic line was brought back to operating pressure. Shortly afterward it separated at the repaired connector point. The connector was some four to six feet above floor level with hydraulic fluid being expelled at a pressure of 800 to 1,500 psi. It obviously began to splatter off the concrete floor. Droplets were bouncing back onto the gas heating plumbs for the cooking vat, which turned them into vapor. The vapors then were going directly into the flame. The vapors had a much lower flashpoint than the liquid hydraulic fluid and therefore rapidly ignited.

In sum, the pressurization of the hydraulic fluid combined with the heat was causing an atomizing of the fuel which in all probability caused an immediate fireball in and around the failed hydraulic line and the heating plumbs.

The remains of the hydraulic line that had been cut by the maintenance worker for the repair process that took place just preceding the fire.

4. High pressure equipment maintenance and repairs must be limited to factory trained personnel and specifications.

Operations such as these plants have extensive hydraulic systems. They operate at considerable pressures and, as in these two cases, are integral parts of cooking processes. Moving parts and high pressures will naturally increase the likelihood of failure. Maintenance must be a constant ongoing process. For maximum safety, maintenance personnel must be trained by the factory representatives. If any parts are replaced, they must conform to factory specifications or not be used. If a maintenance division alters any part of the high pressure system, their alterations must meet or exceed factory specifications.
