U.S. Fire Administration/Technical Report Series

Chicken Processing Plant Fires

Hamlet, North Carolina

USFA-TR-057/June/September 1991

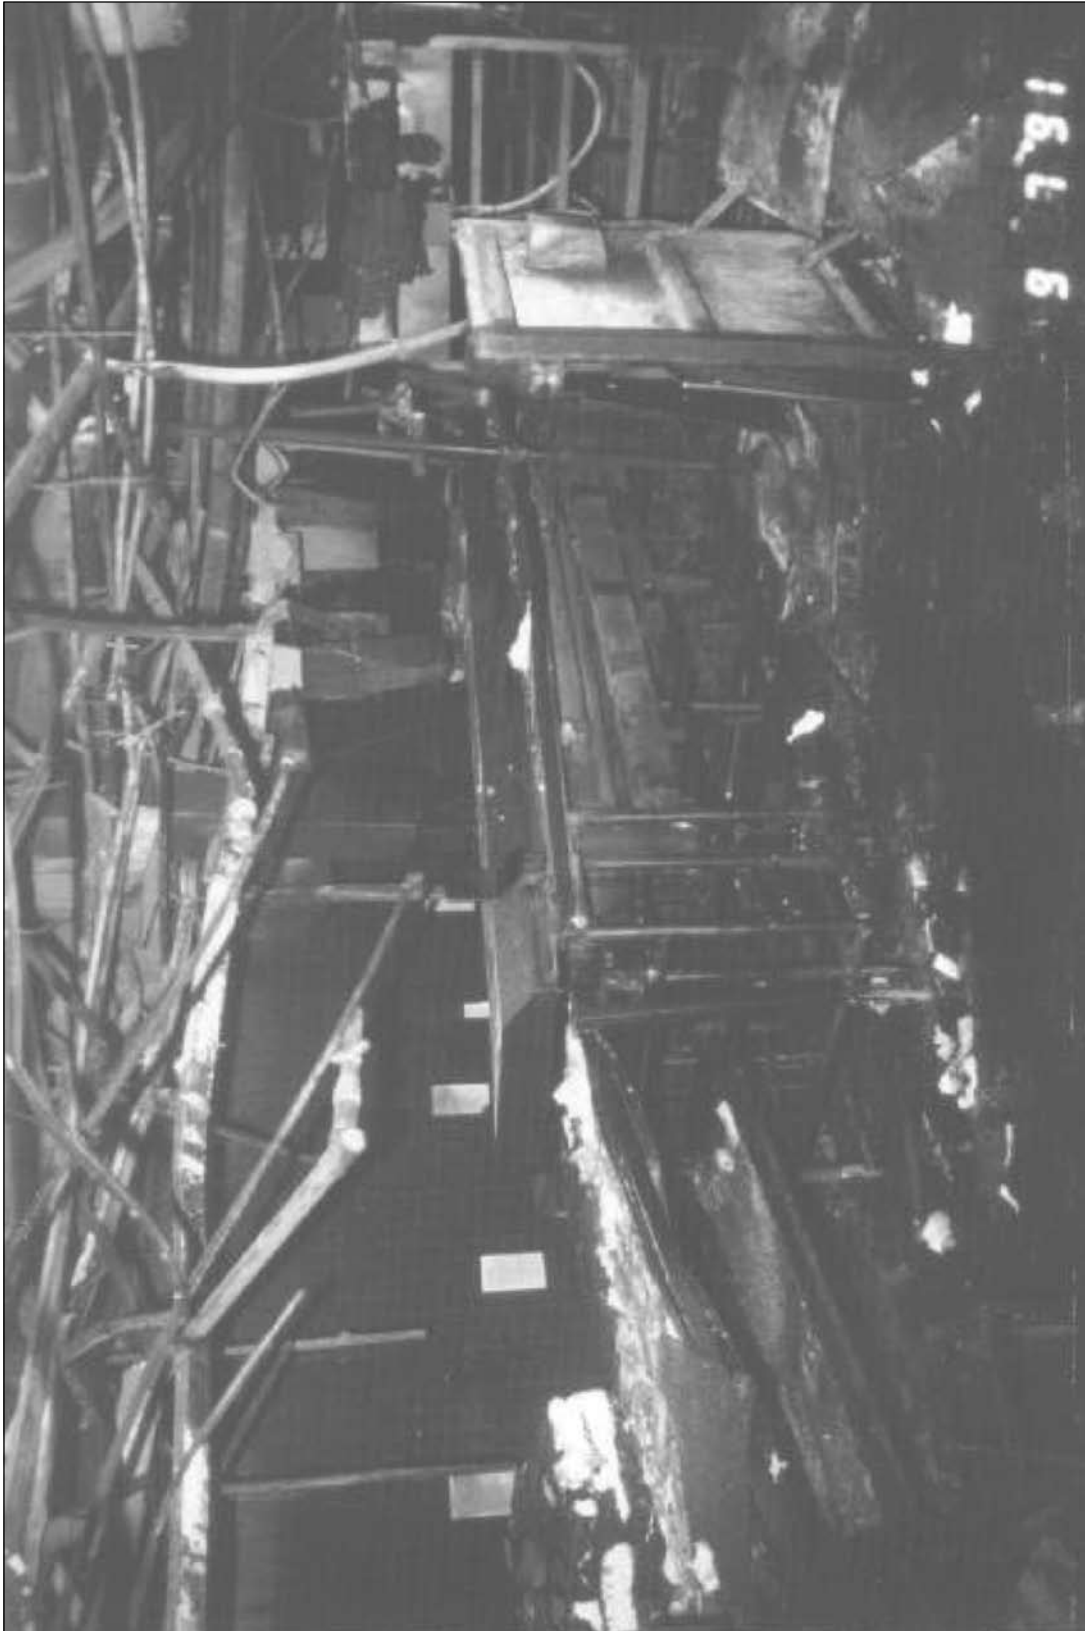
The area of origin viewed from the southeast to the northwest.

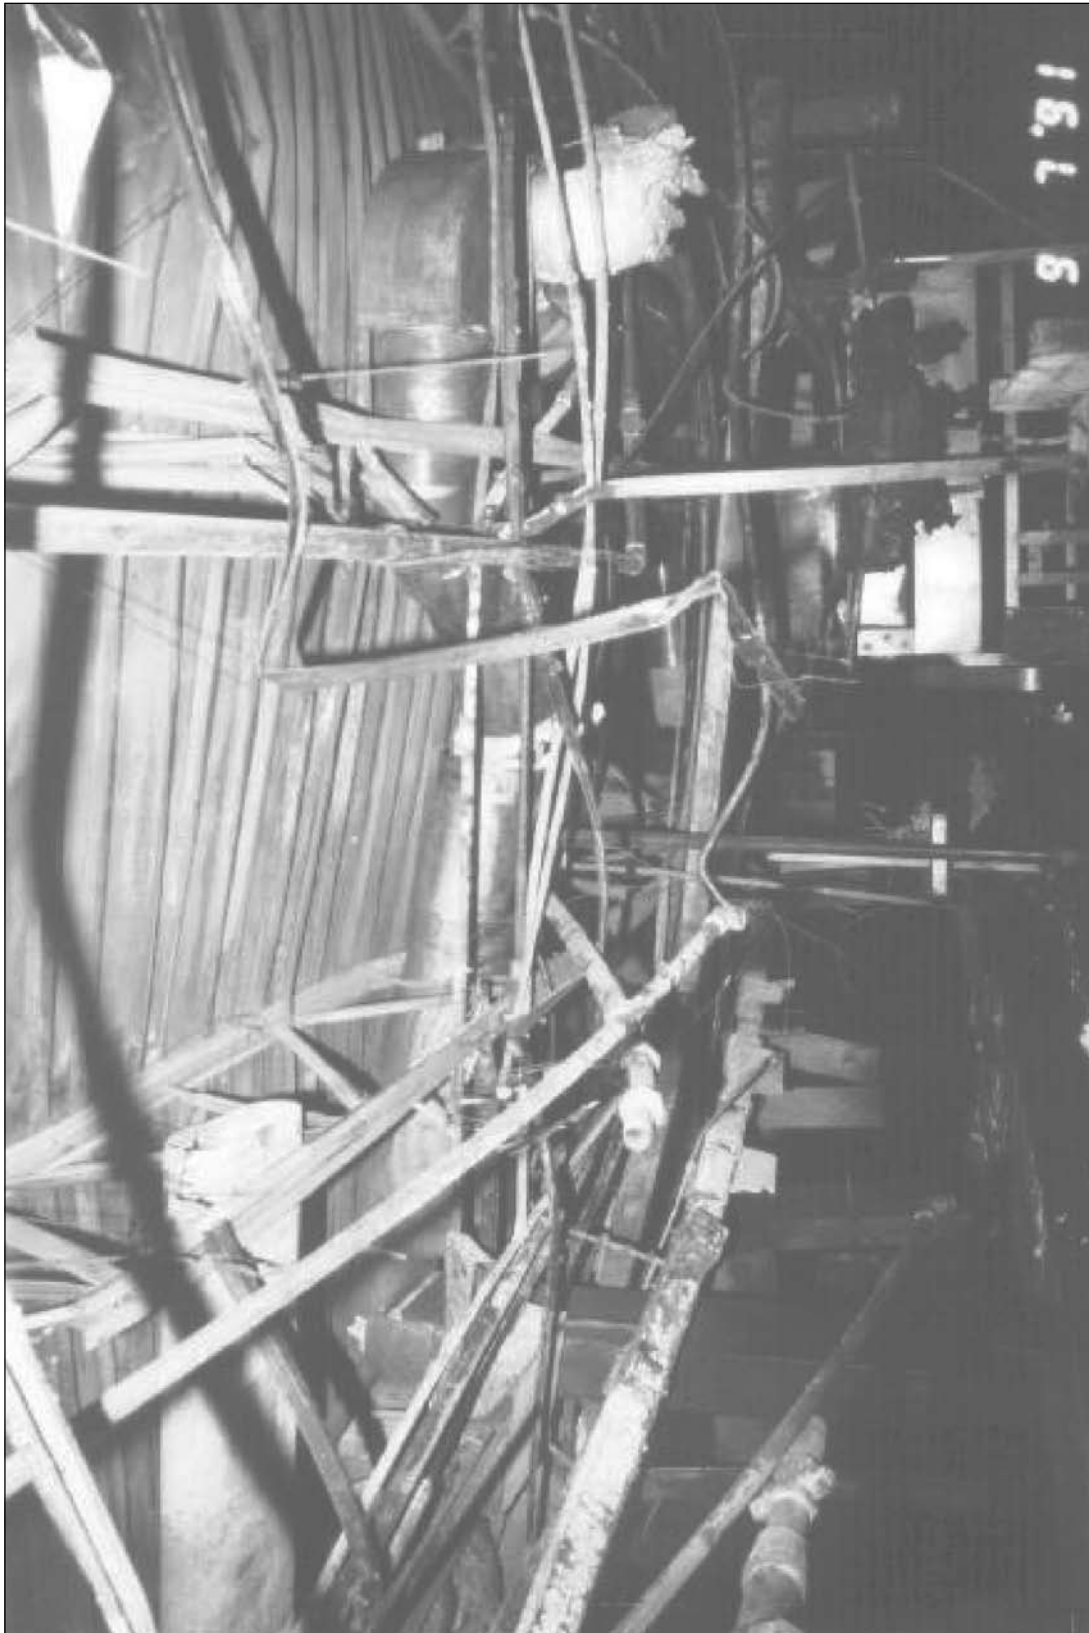
Damage to the steel girders and roof supports over the area of origin.
