U.S. Fire Administration/Technical Report Series

# A Comparison of Two Fires:

The Westview Towers - North Bergen, New Jersey and

The Council Towers Apartments - St. Louis, Missouri

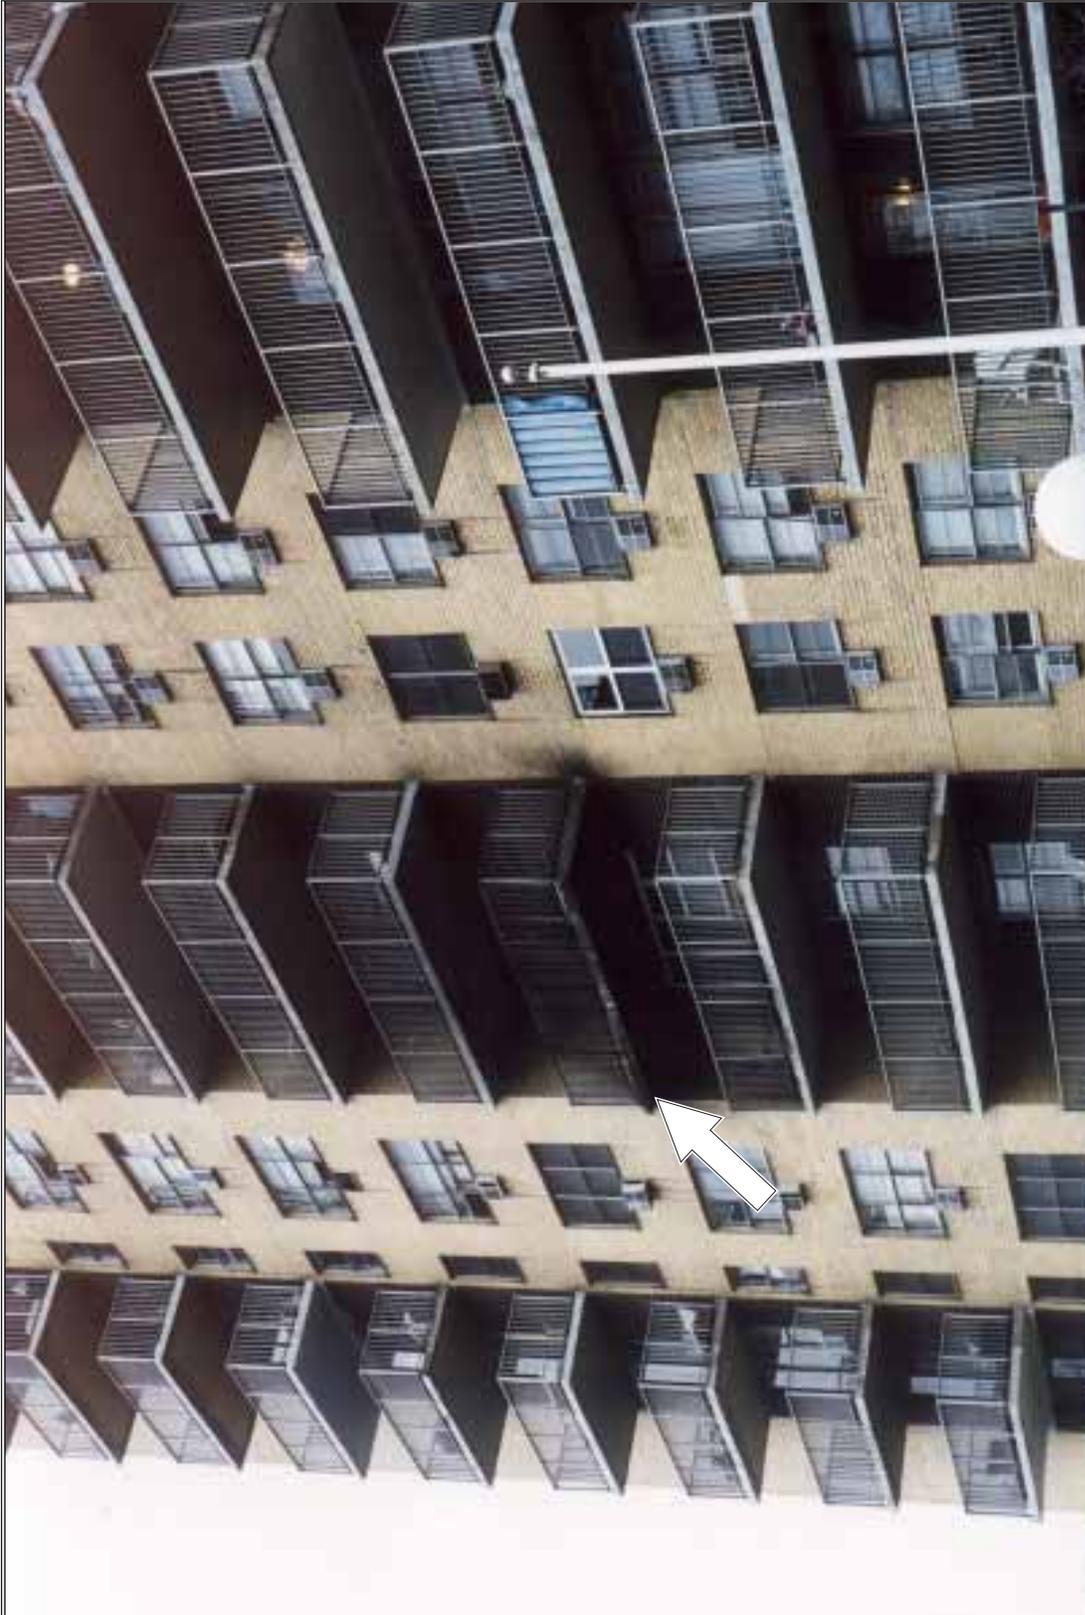
Two of the fatalities occurred in the apartment of origin, #4E, when the victims were trapped by heat and smoke conditions that forced them to retreat to the balcony of their apartment. The balcony was inaccessible by an aerial device and firefighters attempted to reach the trapped victims with ground ladders. One victim fell to her death during this attempt because she lunged at a ladder, which had not been secured to the balcony railing. The other victim succumbed to the intense heat and smoke conditions on the balcony before firefighters could reach her.

Photo 1. Westview Towers – Balcony of Apartment 4E.

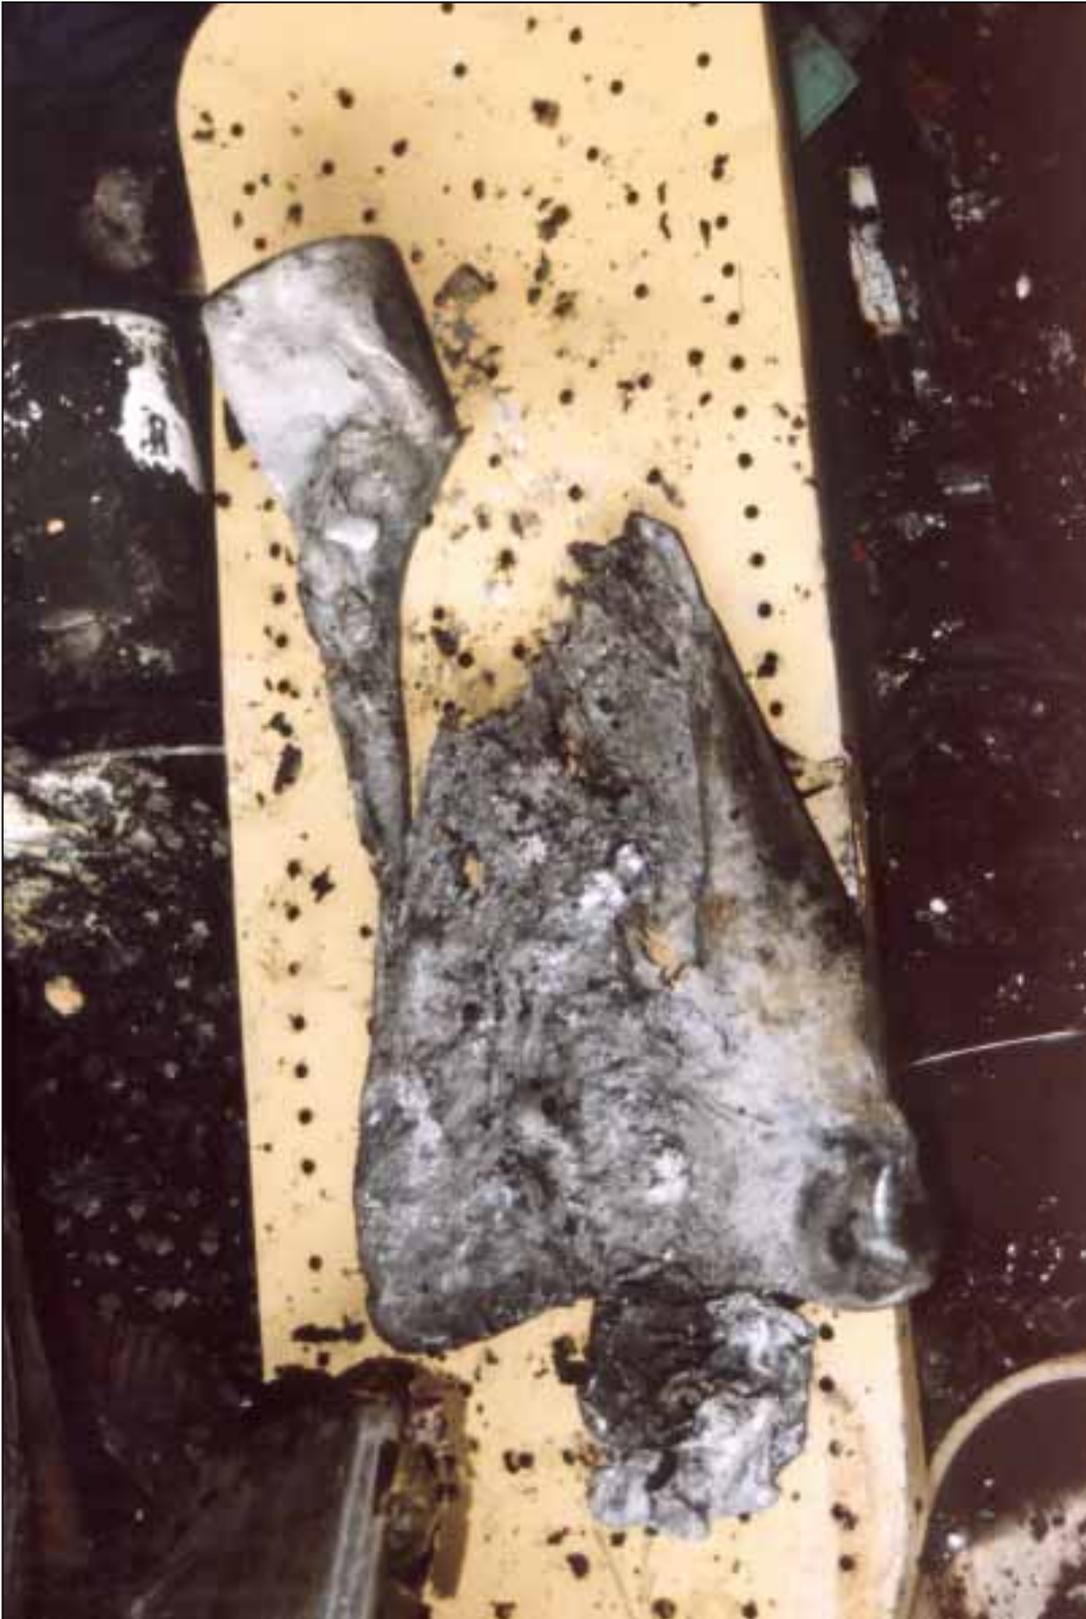
The damage to the partition wall between the two apartments occurred when the aluminum oxygen cylinders in Apartment 2103 ruptured. The remains of three aluminum oxygen cylinders were recovered from the northeast corner of the living room. The release of the oxygen into the burning apartment apparently intensified the rate of combustion and may account for the heavy destruction of the contents and walls. The intensity of the combustion process also contributed to the heat buildup in the hallway and hindered the firefighters in their efforts to extinguish the blaze.

Photo 1. Ruptured aluminum oxygen cylinder

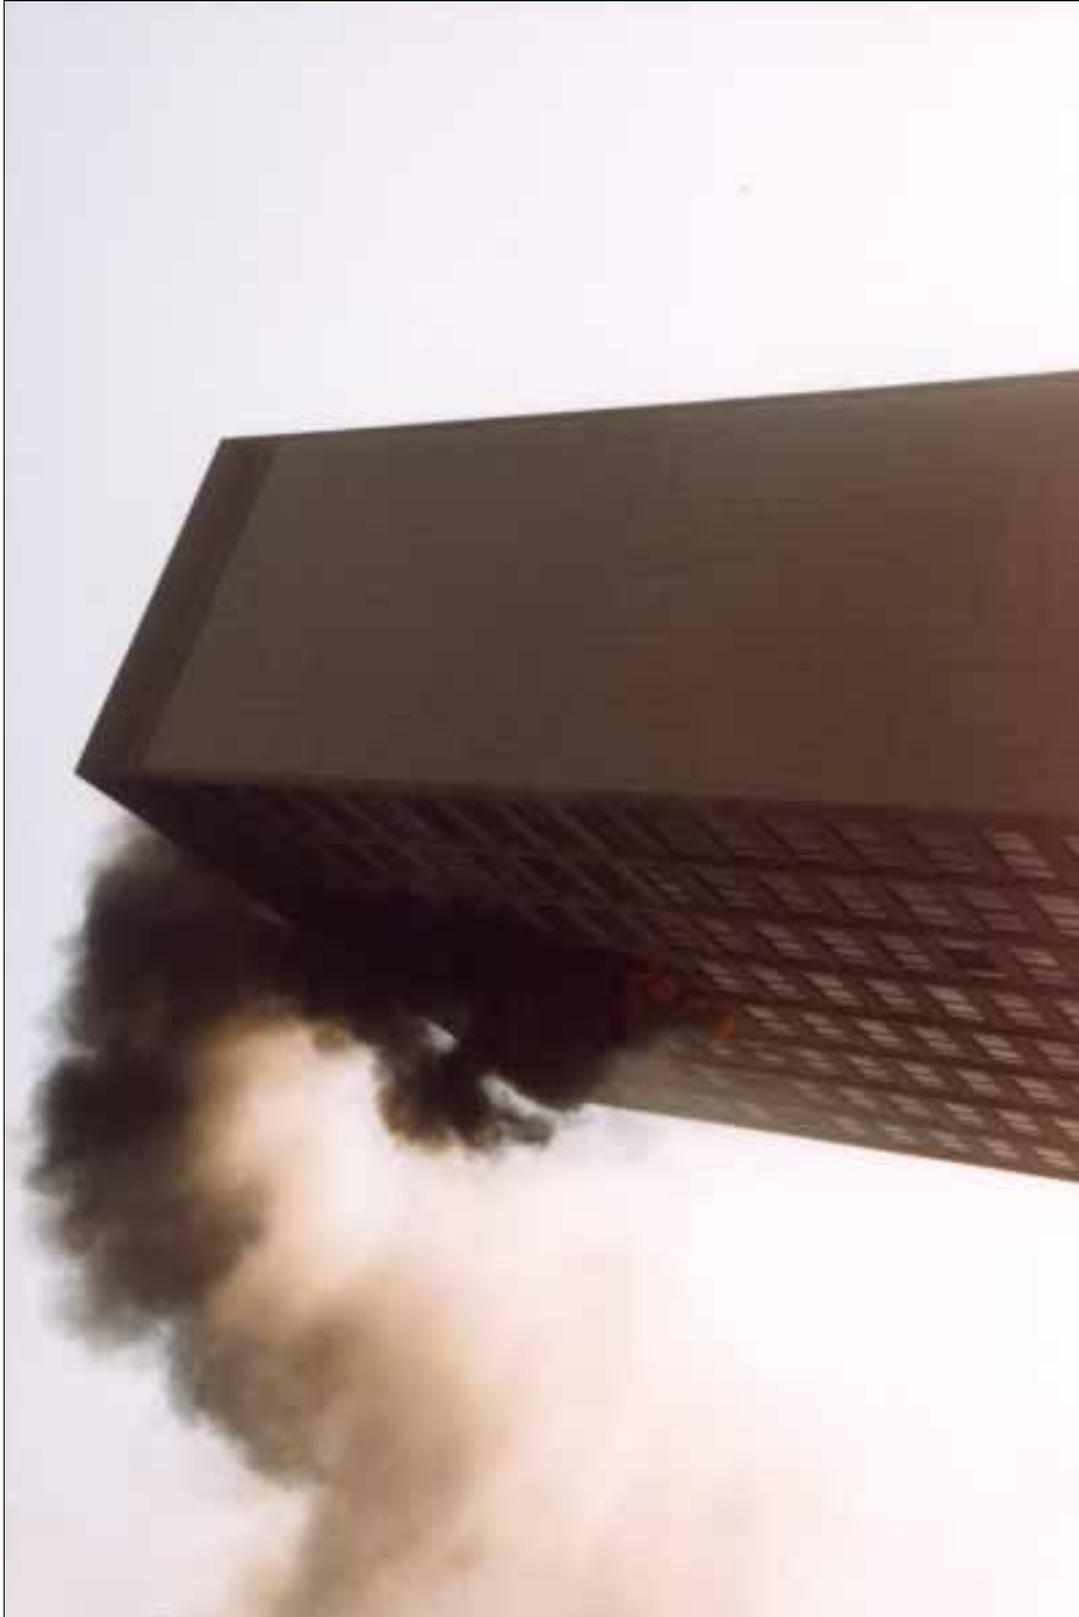
Photo 2. Flames and smoke coming from Apartment 2103

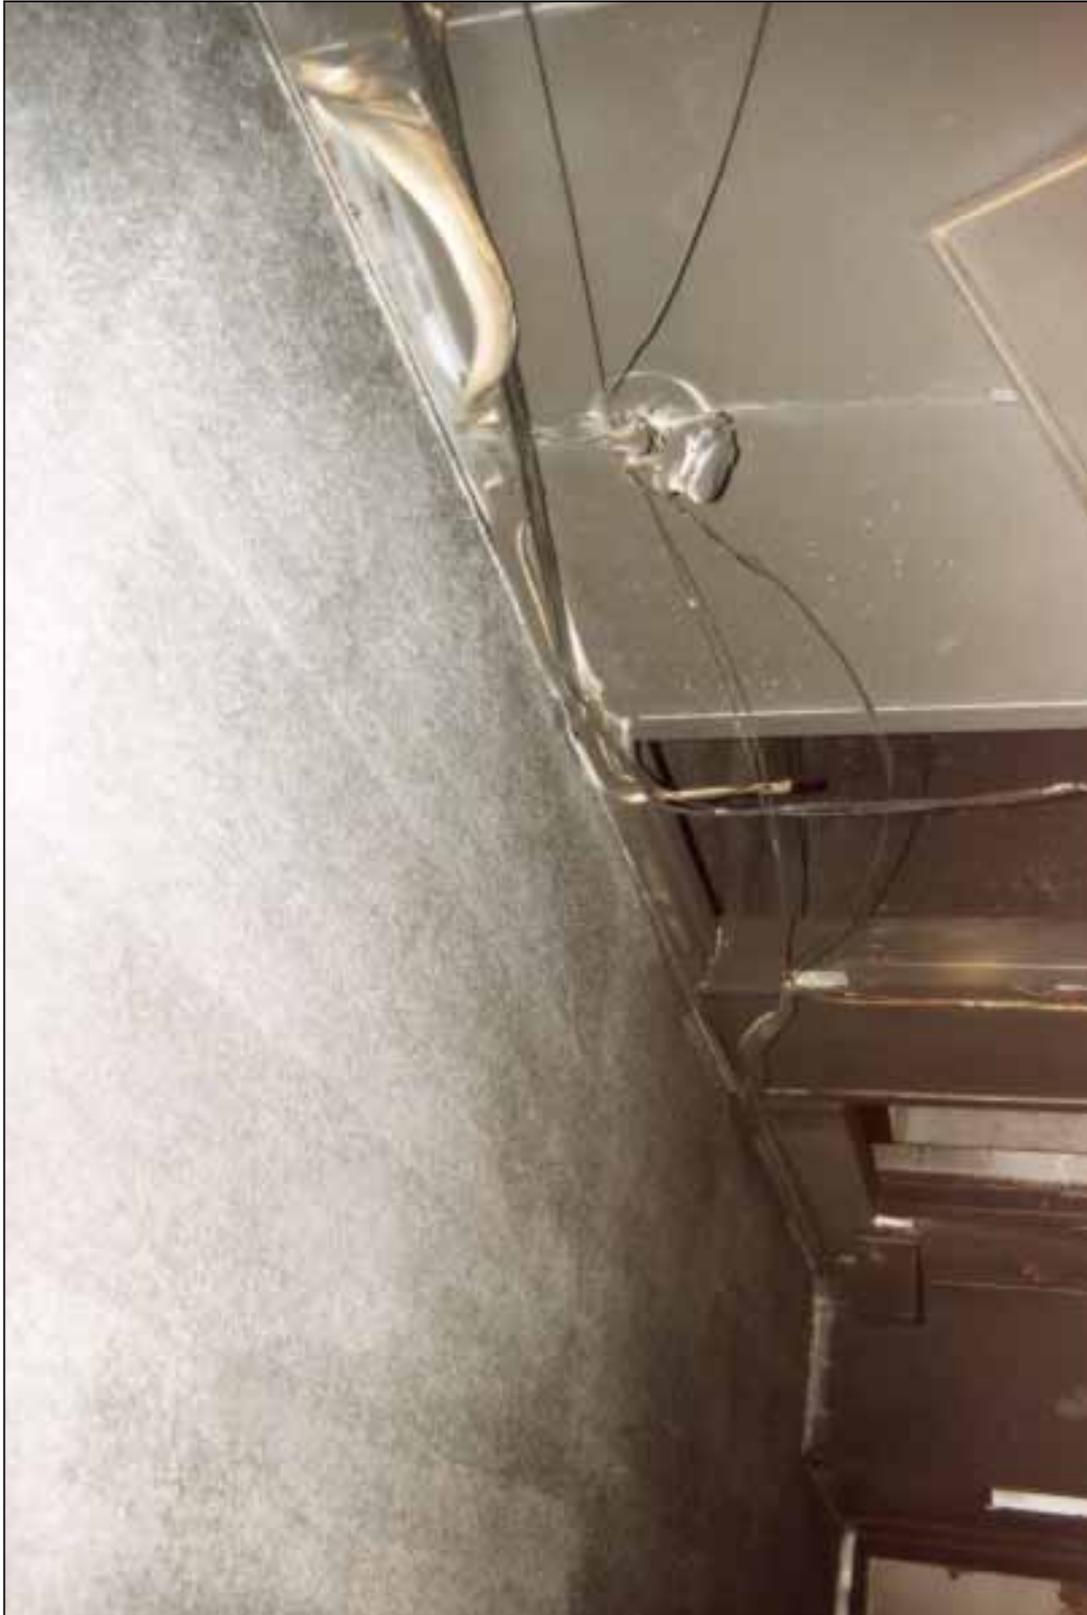
the trash chute. His SCBA cylinder was empty and he had suffered burns to his respiratory tract. He was wearing a PASS device, but due to the confusion during the fire it is unclear if the device was turned on, or if it operated properly. The Captain was unconscious when he was found by his fellow firefighters and his SCBA was entangled in the wiring of the alarm system. The alarm system had been retrofitted and plastic molding located near the ceiling of the hallway concealed the wiring. The molding failed due to the intense heat and the wires sagged down into the hallway. The Captain suffered severe burns to his respiratory system and was permanently disabled.

**Photo 3. Wiring to fire alarm system in the hallway of the 21st floor. (This is the wiring that the Captain became entangled in.)**

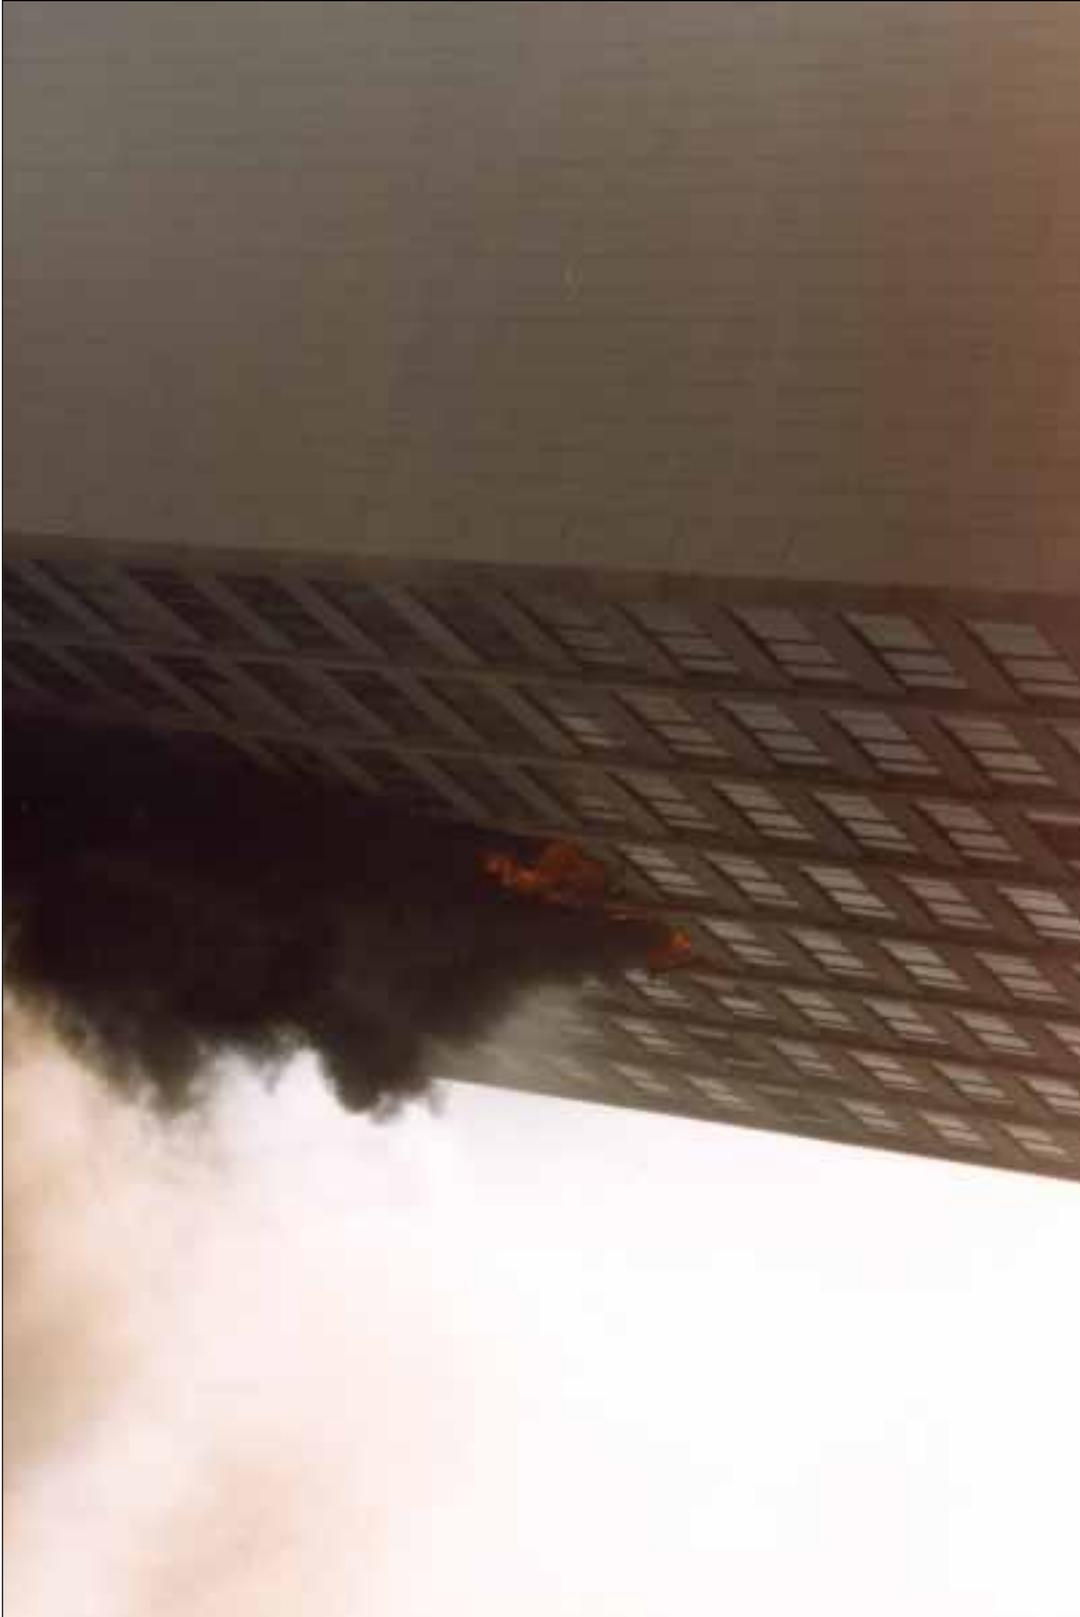
Photo 4. Another shot of the flames on the 21st and 22 floor

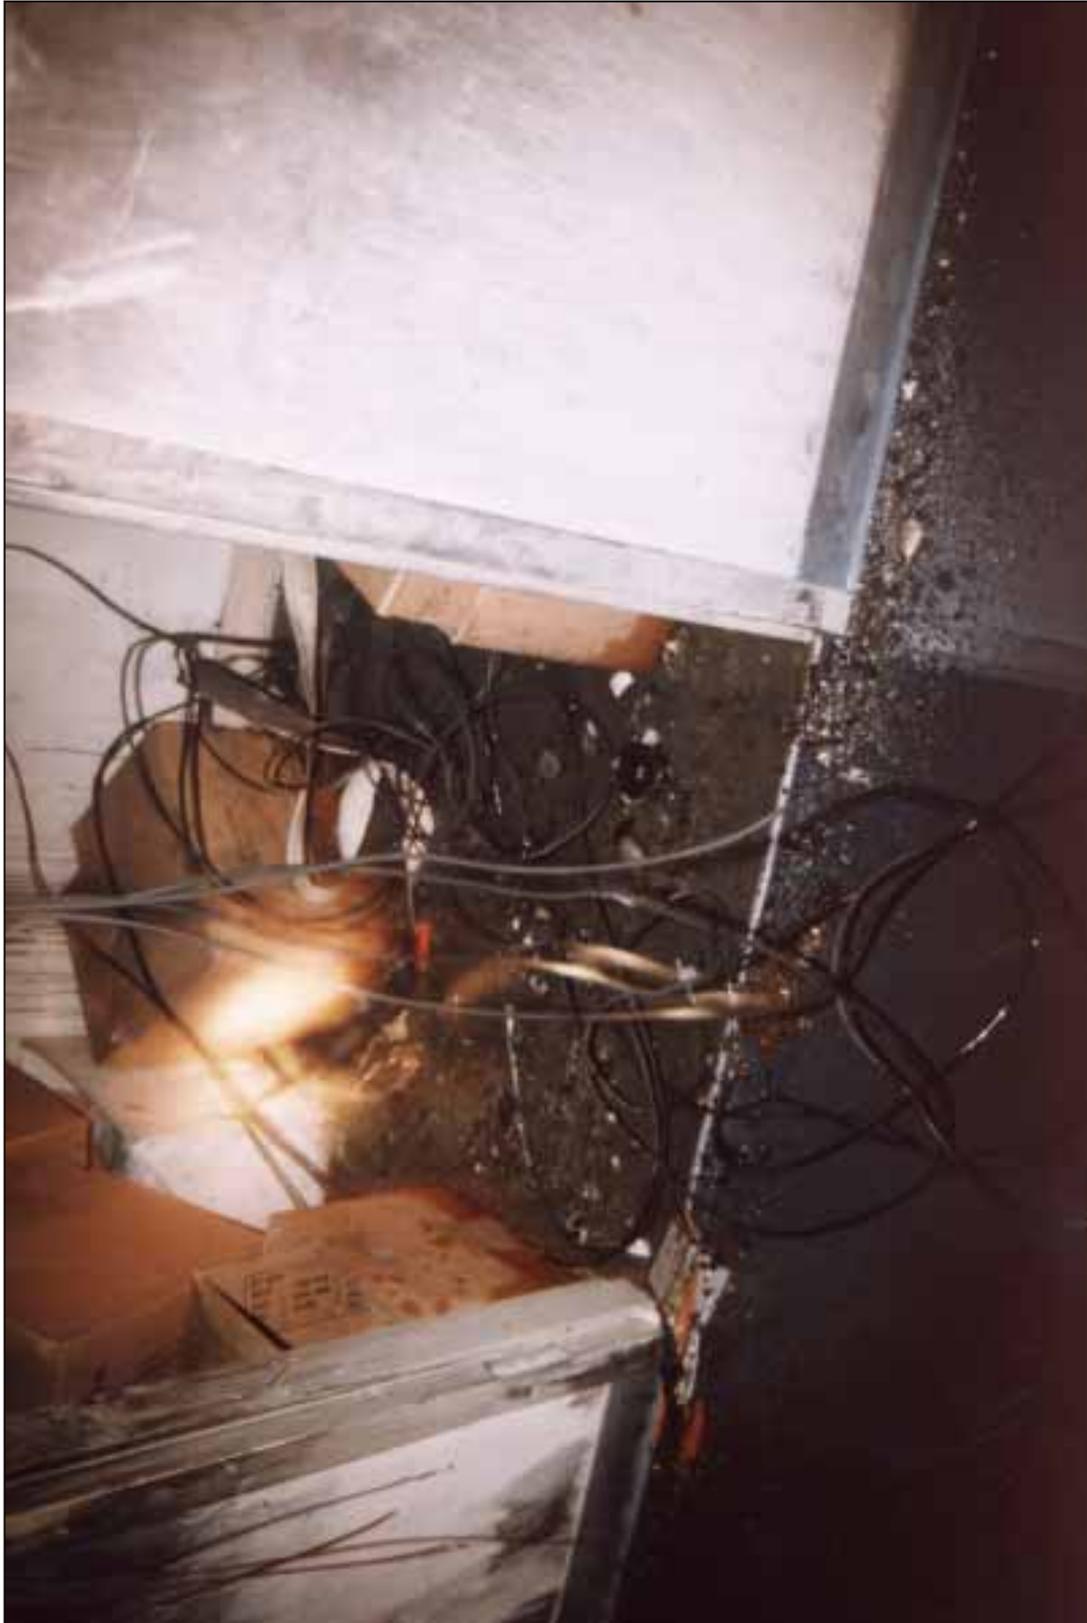
Photo 5. Tangled wiring in trash chute where the Captain was found unconscious

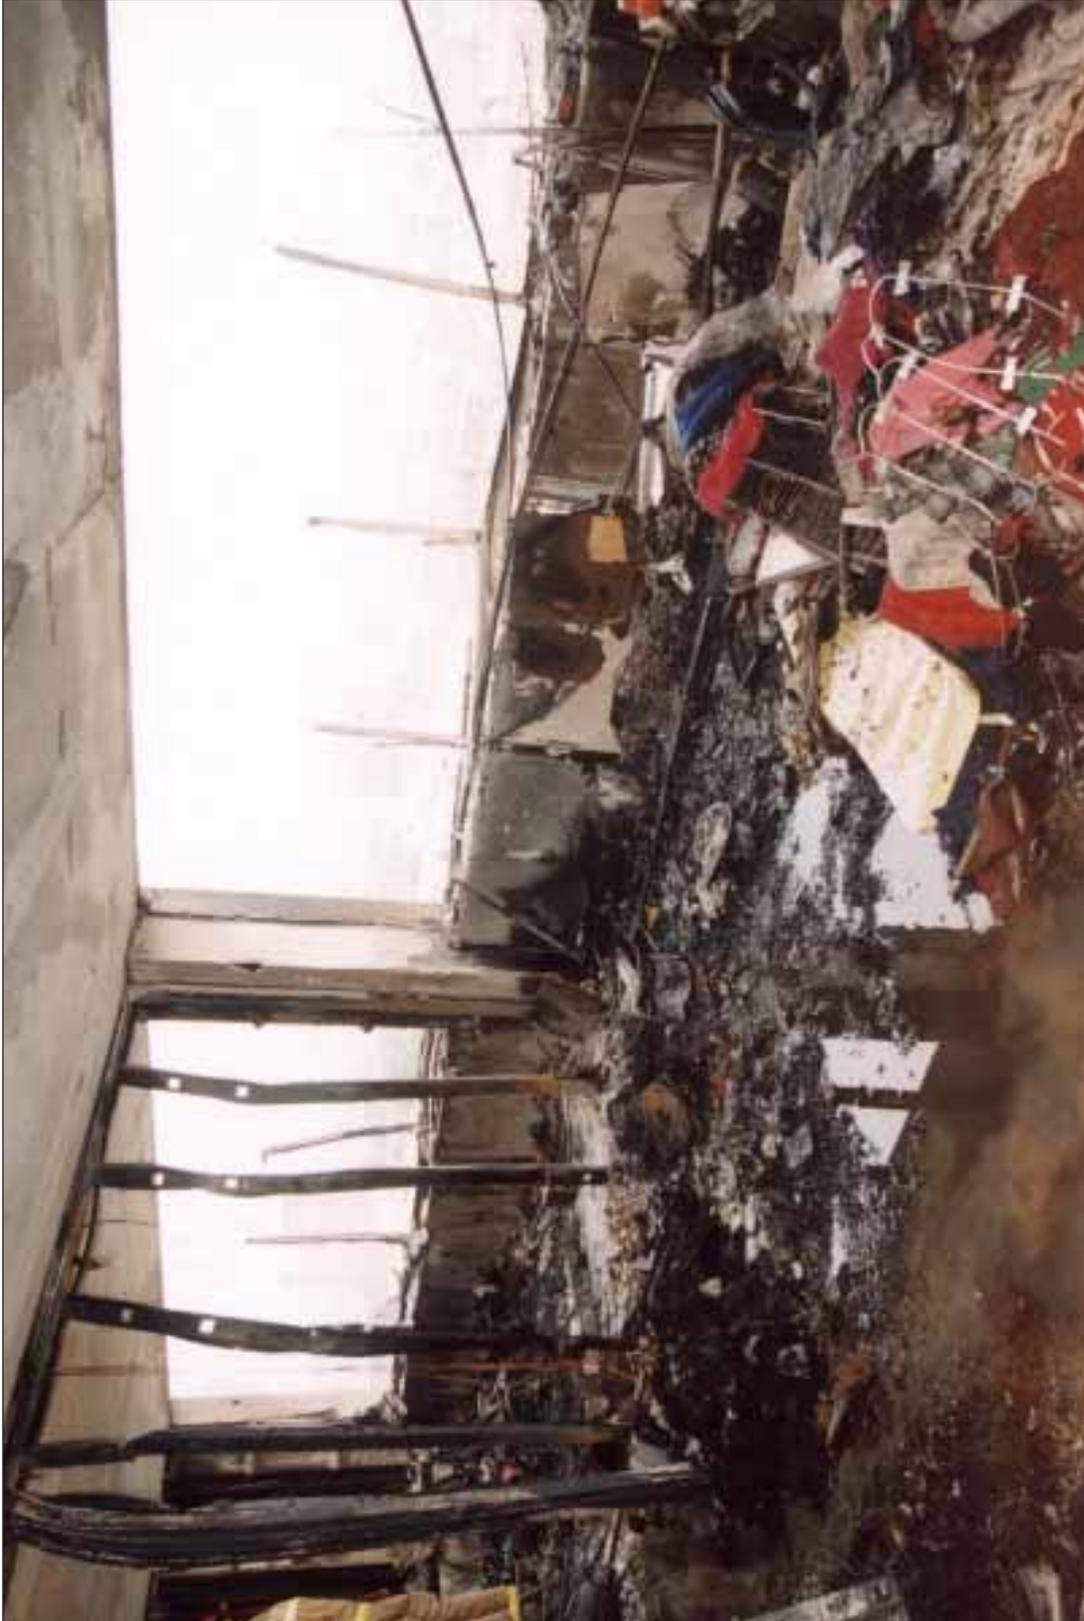
Investigators determined that the area of origin was in the bedroom at the east wall on the north side of the room. Due to the extensive damage the investigators were unable to determine with any degree of certainty the exact cause or ignition source and have classified the fire as “open”. The occupant of Apartment 2103 was known to smoke in spite of suffering from chronic bronchitis and emphysema. Investigators collected an ashtray with a cigarette butt in it along with plastic oxygen tubing and a plastic bag as evidence. The items were found in the kitchen sink.

Photo 6. The interior of Apartment 2103. The area of origin is behind the missing wall in the room where the firefighter is pictured.

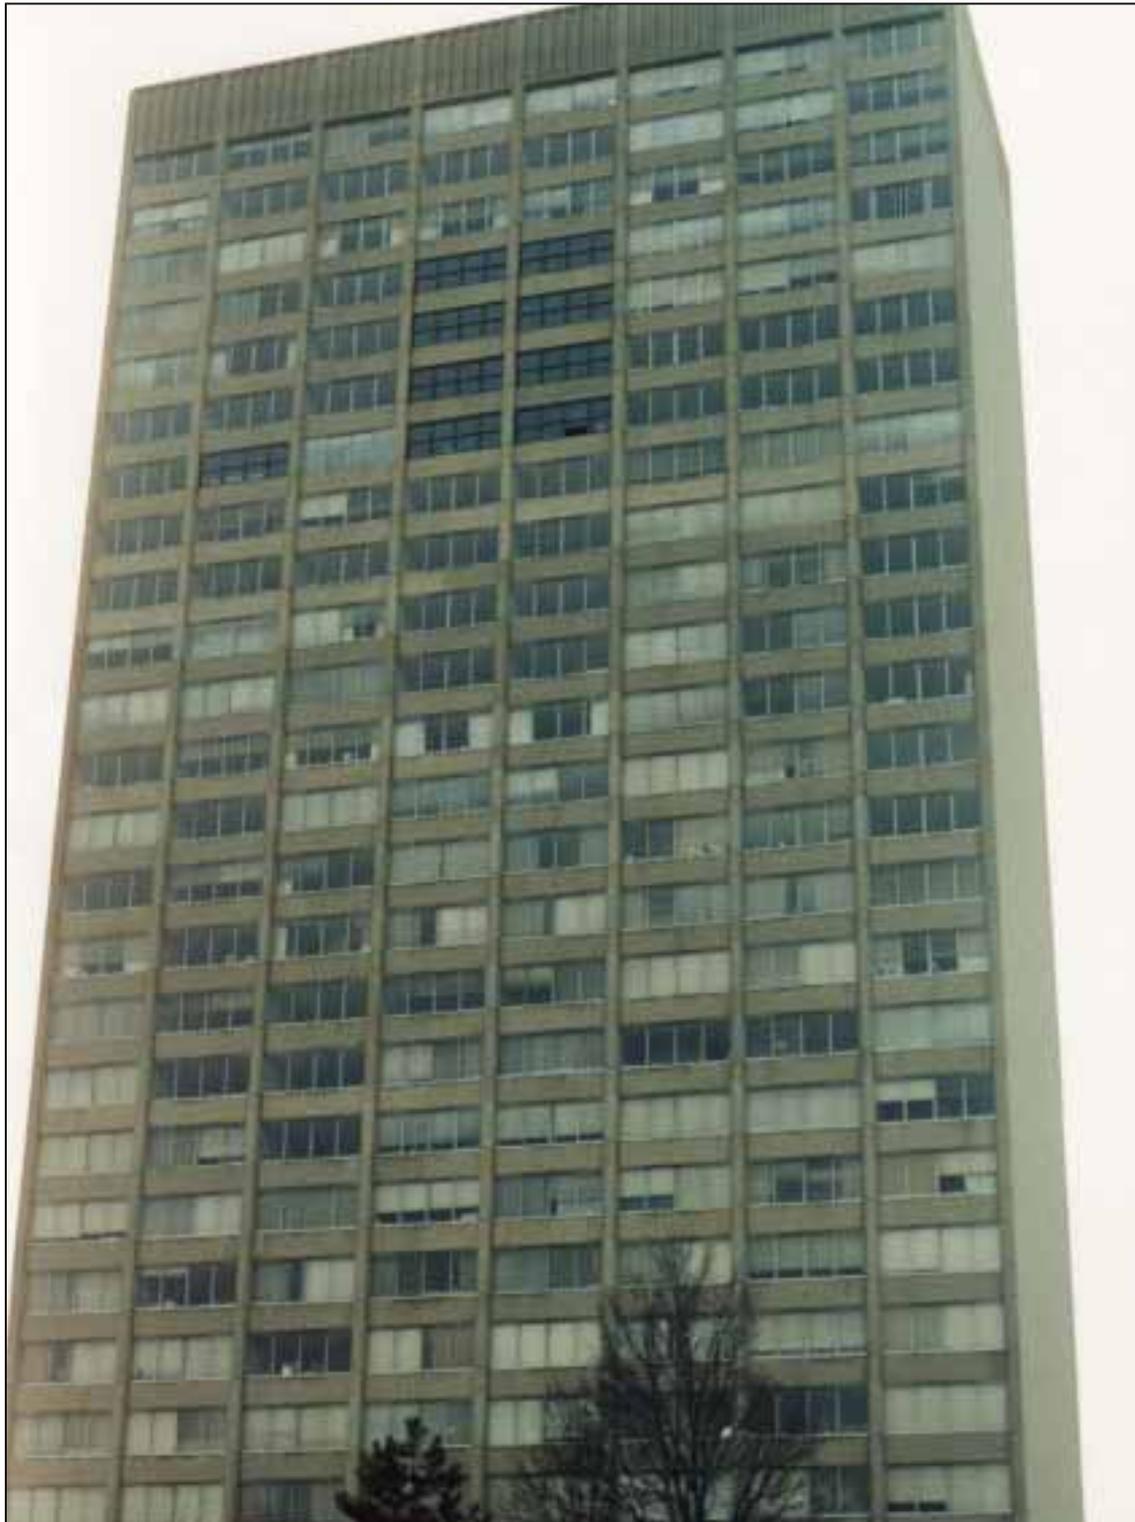
**Photo 7. Council Towers Apartment North Side. Area of fire involvement located seven rows of windows down from the top. Windows have been replaced.**

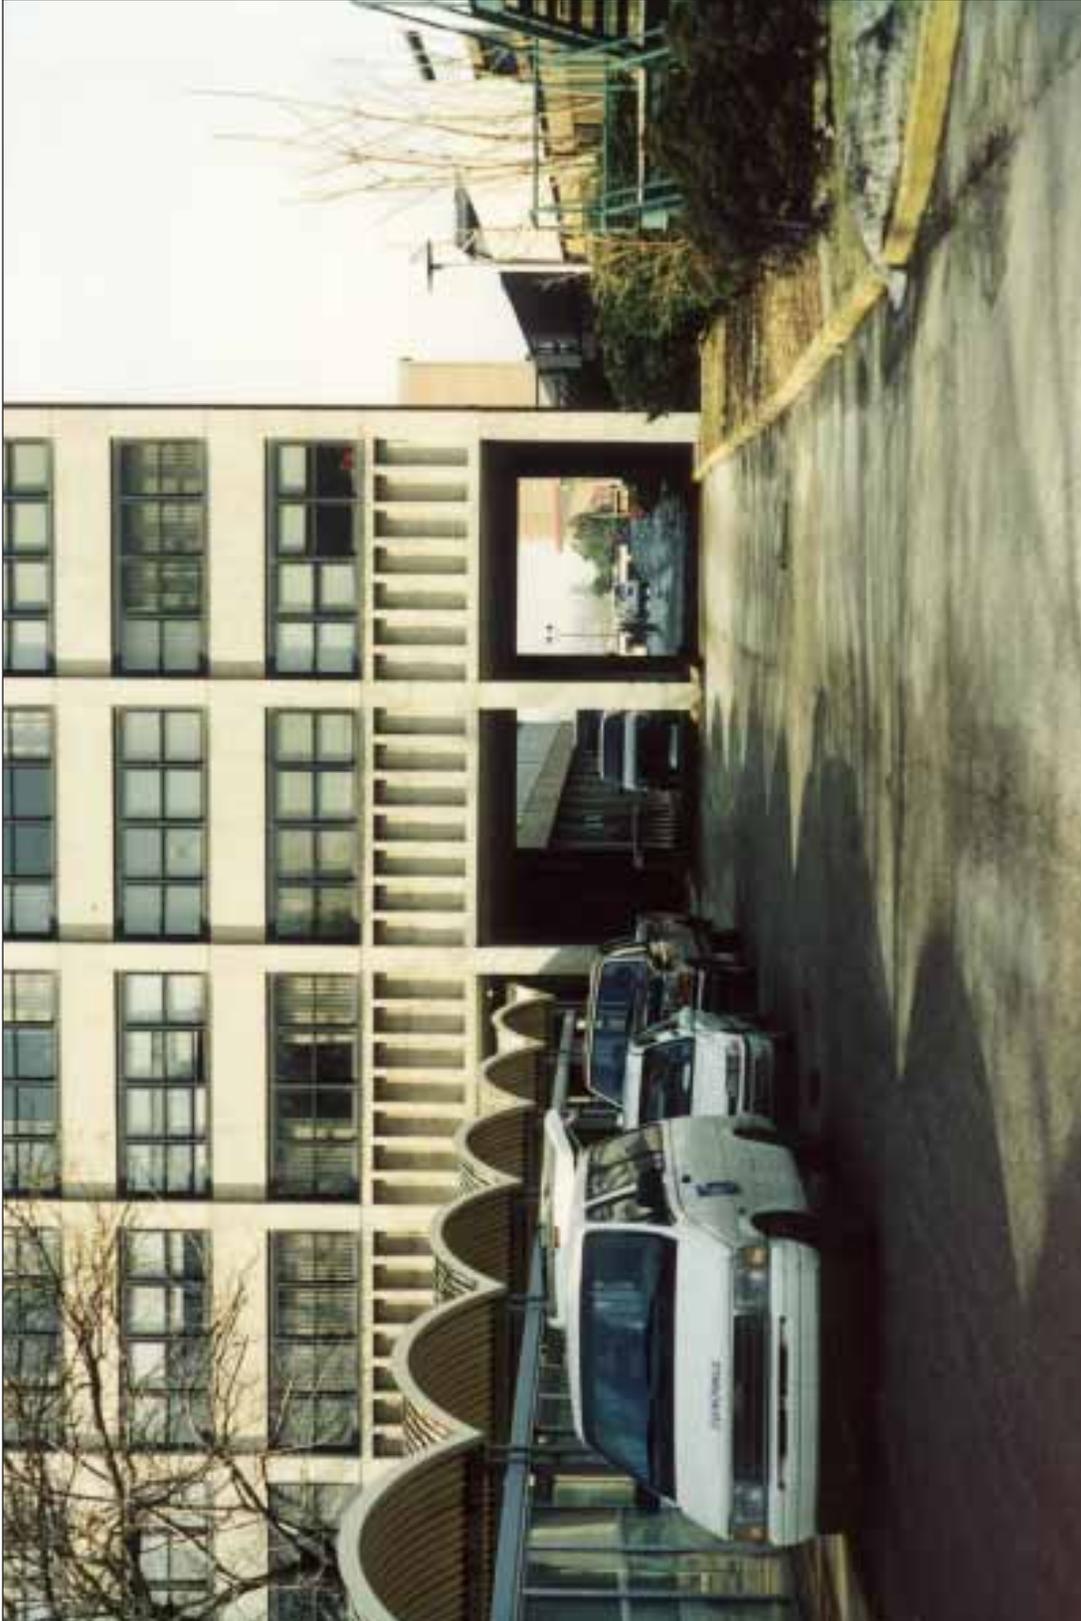
Photo 8. Council Tower Apartment front entrance. (Note access partially obstructed by parked service vehicles.)

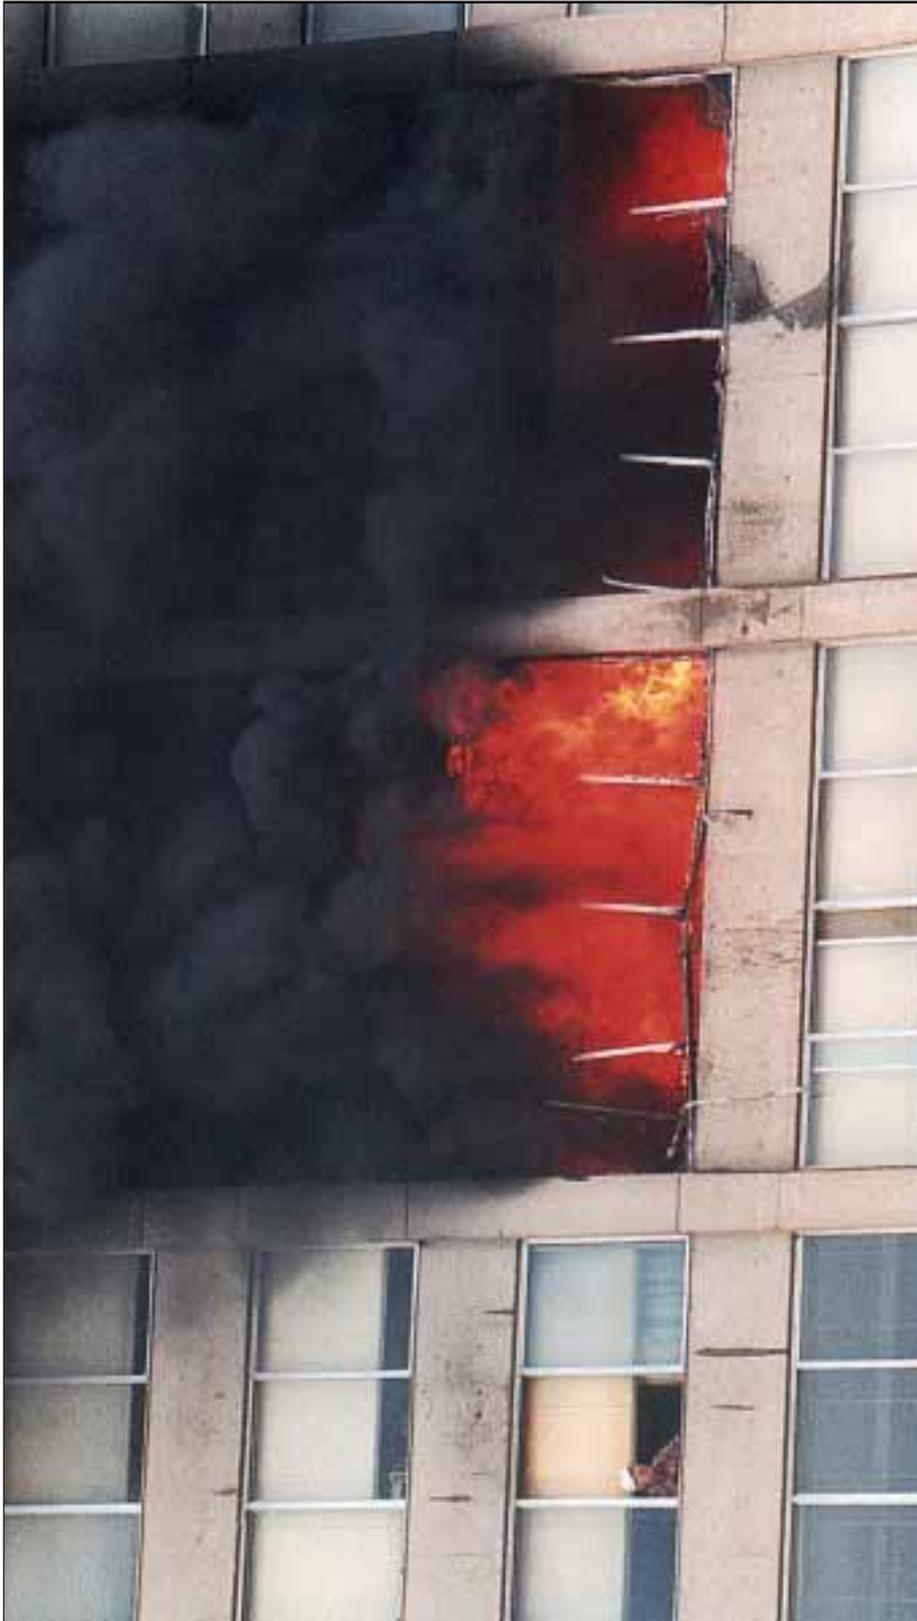
Photo 10. Occupant of Apartment 2104 awaits rescue.
