# Santana Row Development Fire

San Jose, California

USFA-TR-153/August 2002

# **Santana Row Development Fire San Jose, California**

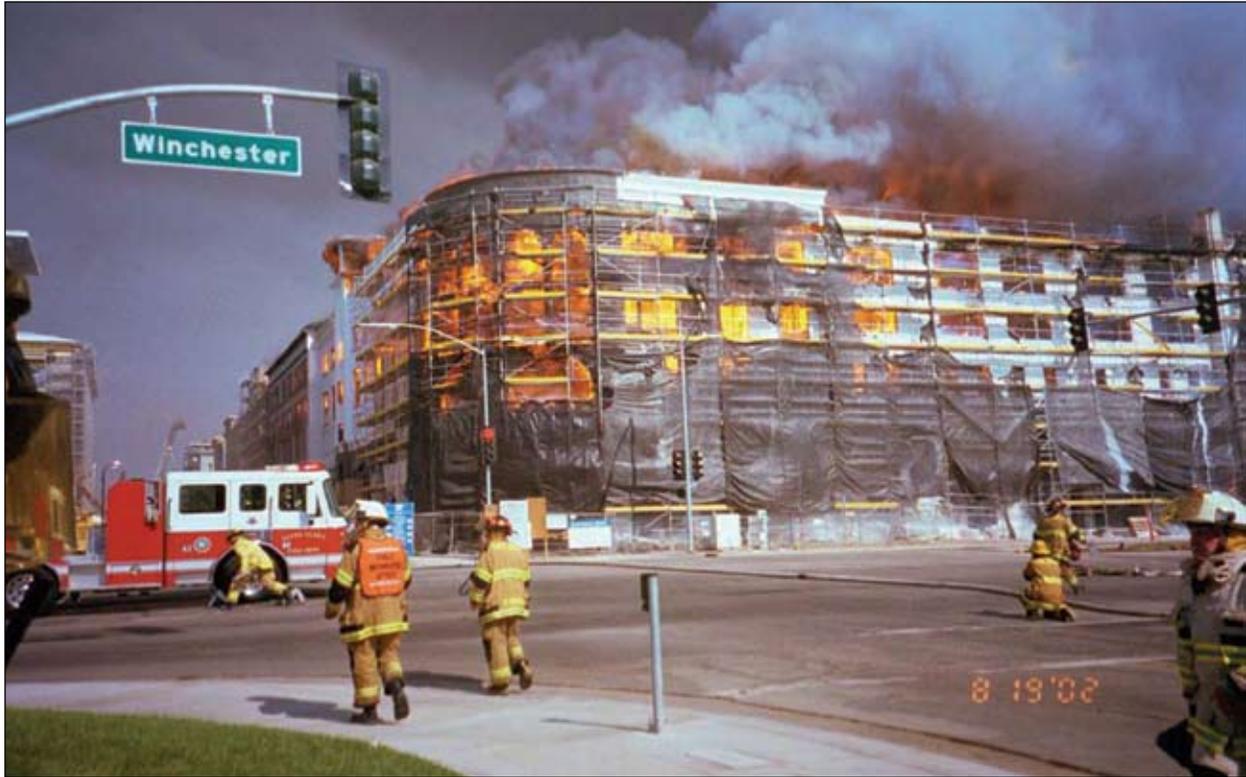
1. Fully involved corner at intersection of Winchester and Olin

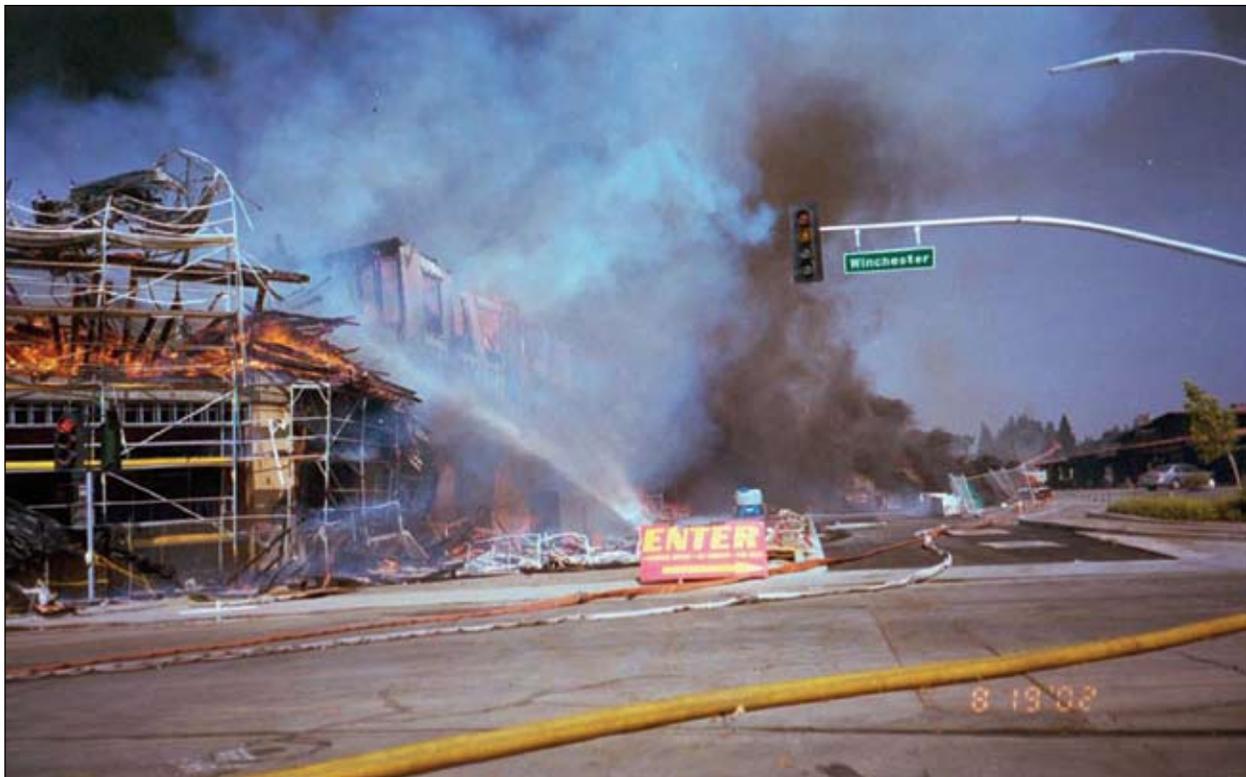
2. Building collapse, burning exposures, master stream, and supply line

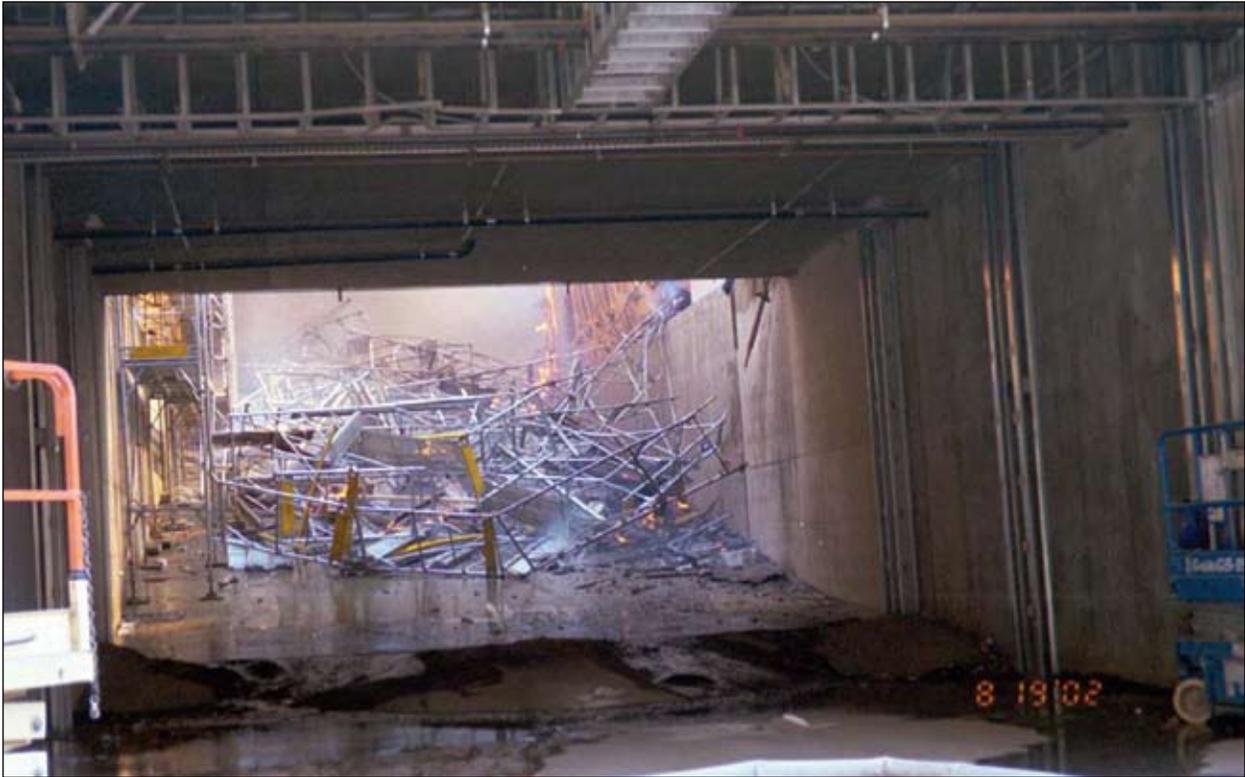
The building was completely surrounded by scaffolding, which was in direct contact with the flames. Fearing a collapse, Command ordered the establishment of collapse zones around the perimeter of the building, which were taped off. Even though ordered to stay out of these zones, some firefighters ignored the dangers and walked into the potential collapse areas. A number of collapses did occur, but no one was injured as a result. Flying embers and radiant heat ignited vehicles, forklifts, portable toilets, and dumpsters. The main office building for the project, located at 400 South Winchester, also sustained fire damage.

3. Collapsed scaffolding in access ramp

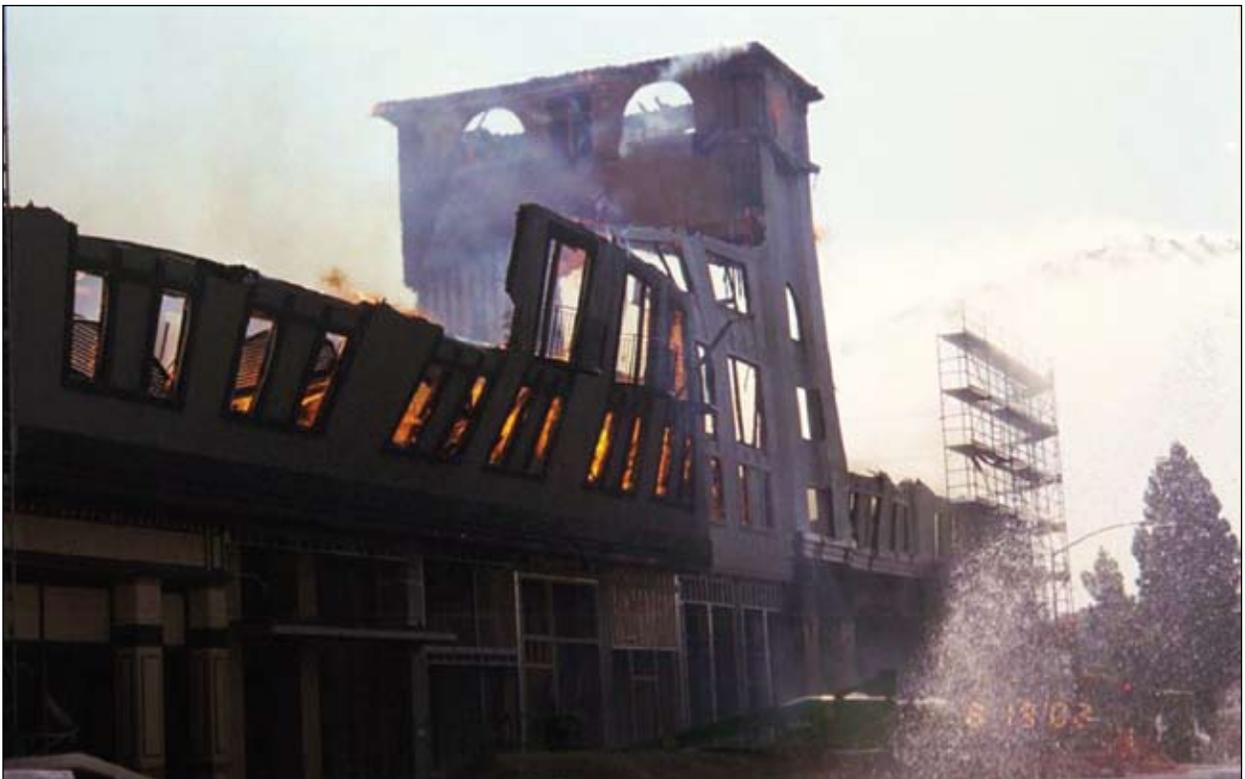
4. Building collapse

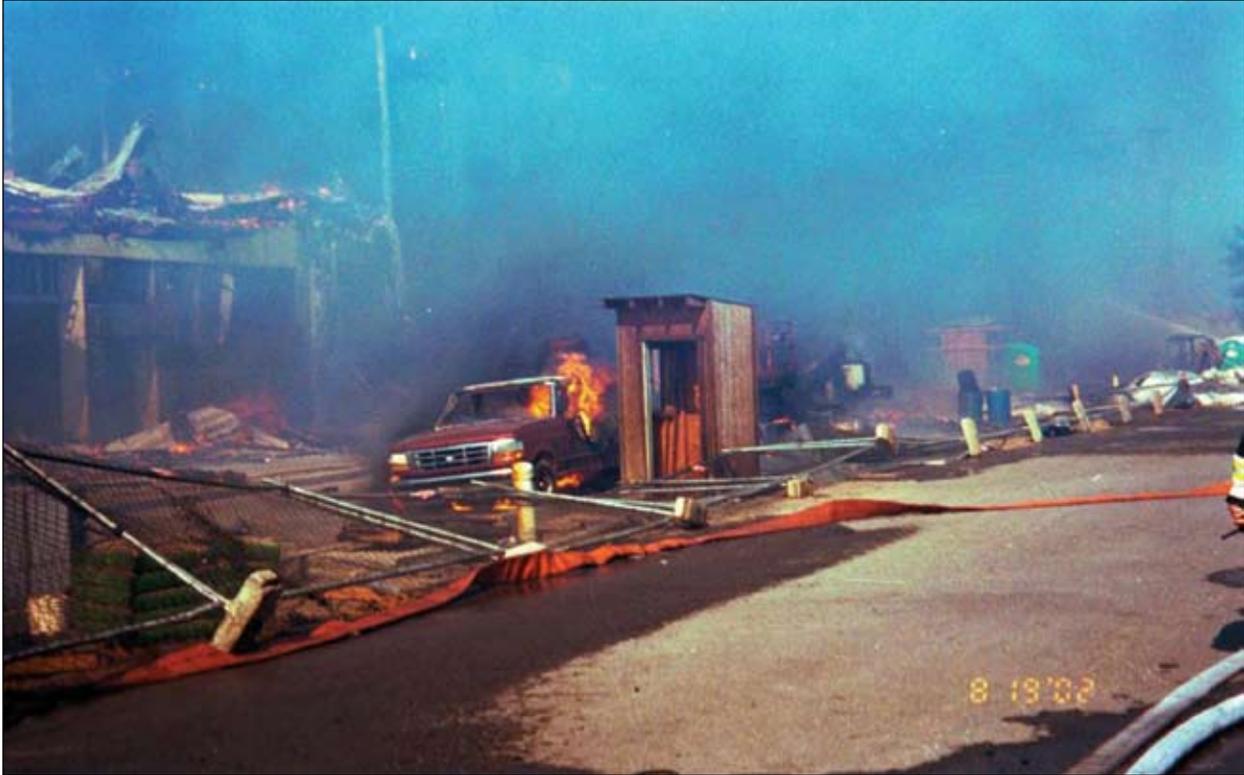
5. Exposure fire—burning vehicle

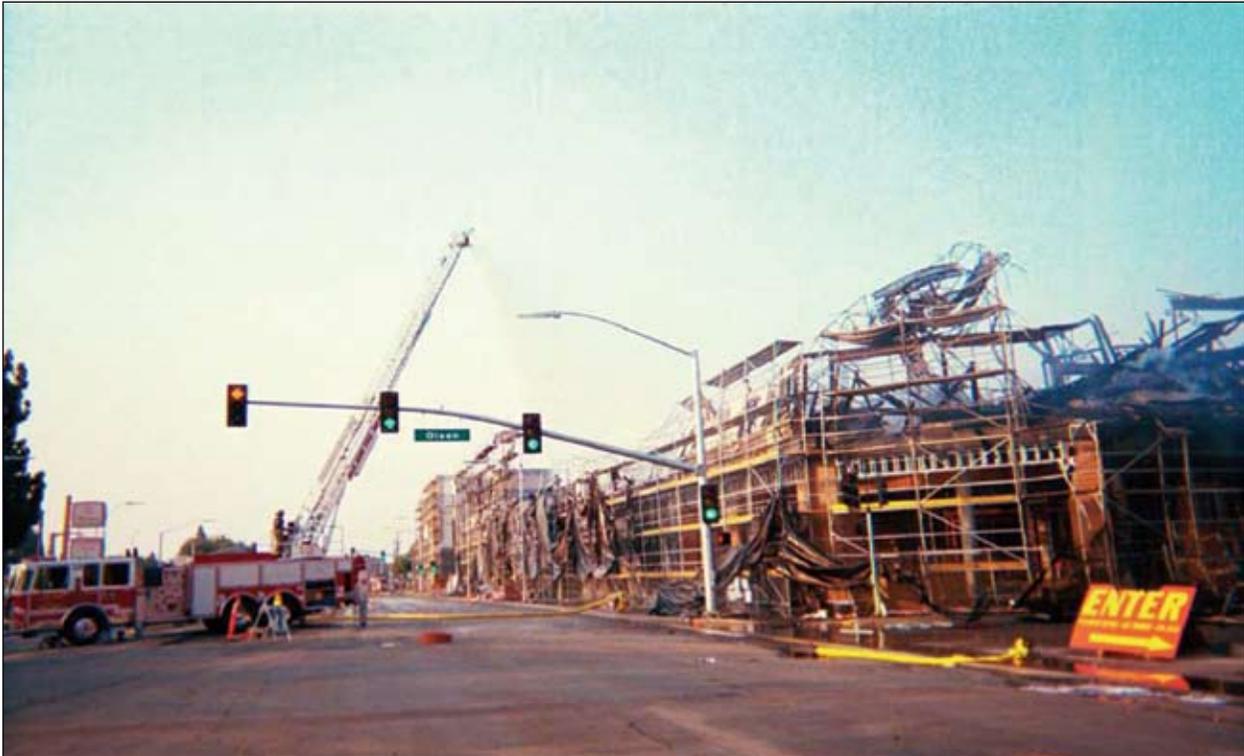
6. Aftermath of complete destruction

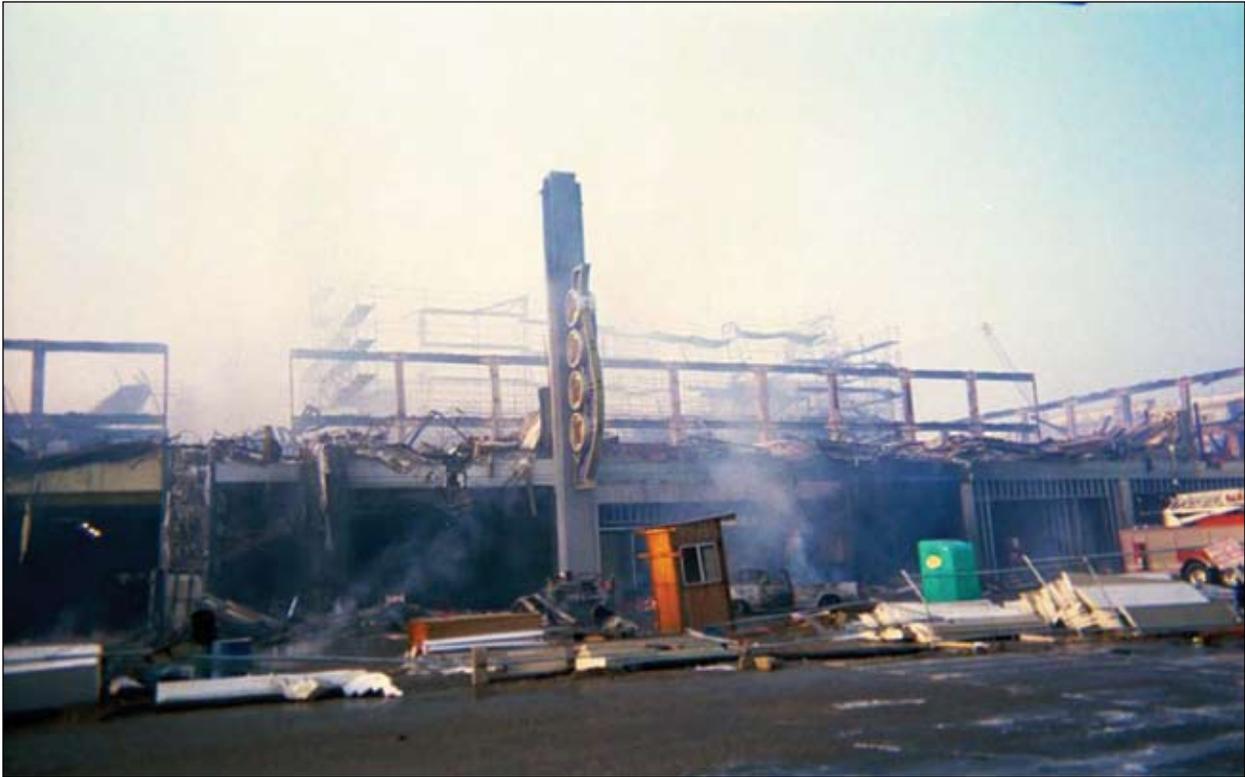
7. Another view of destruction

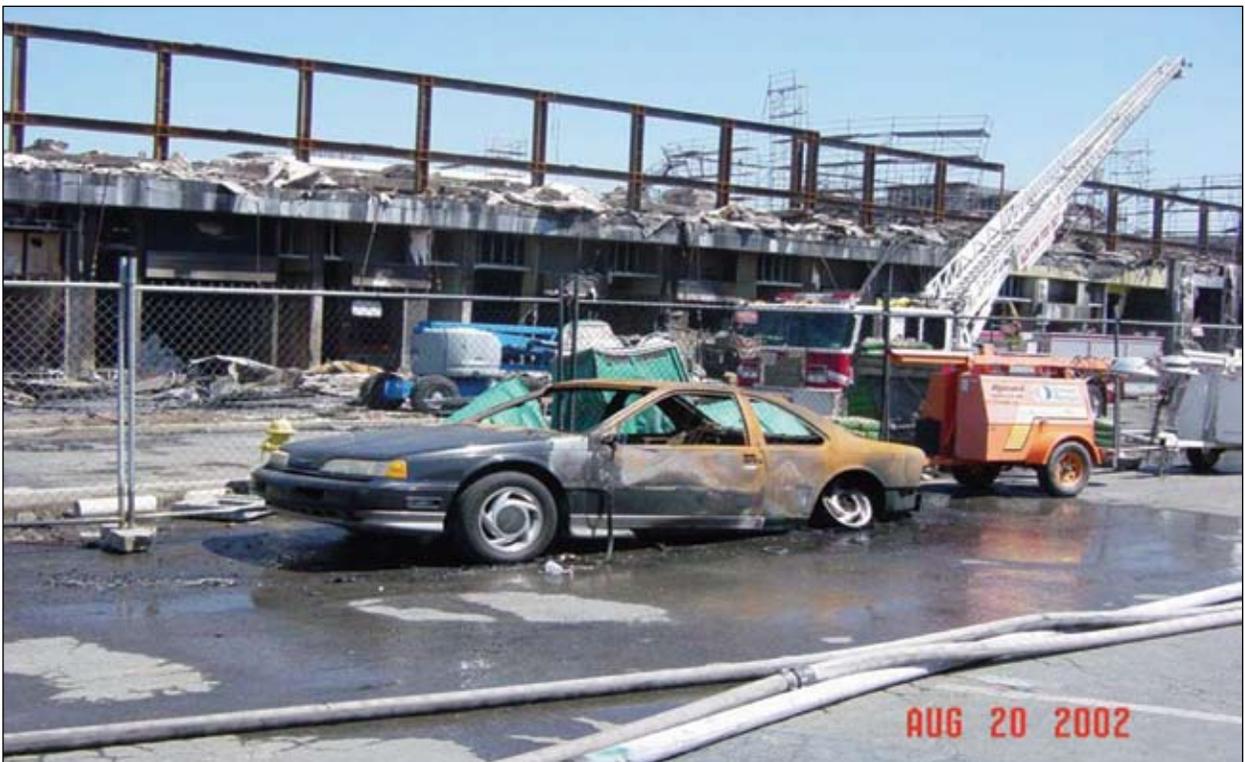
8. Destruction and destroyed automobile

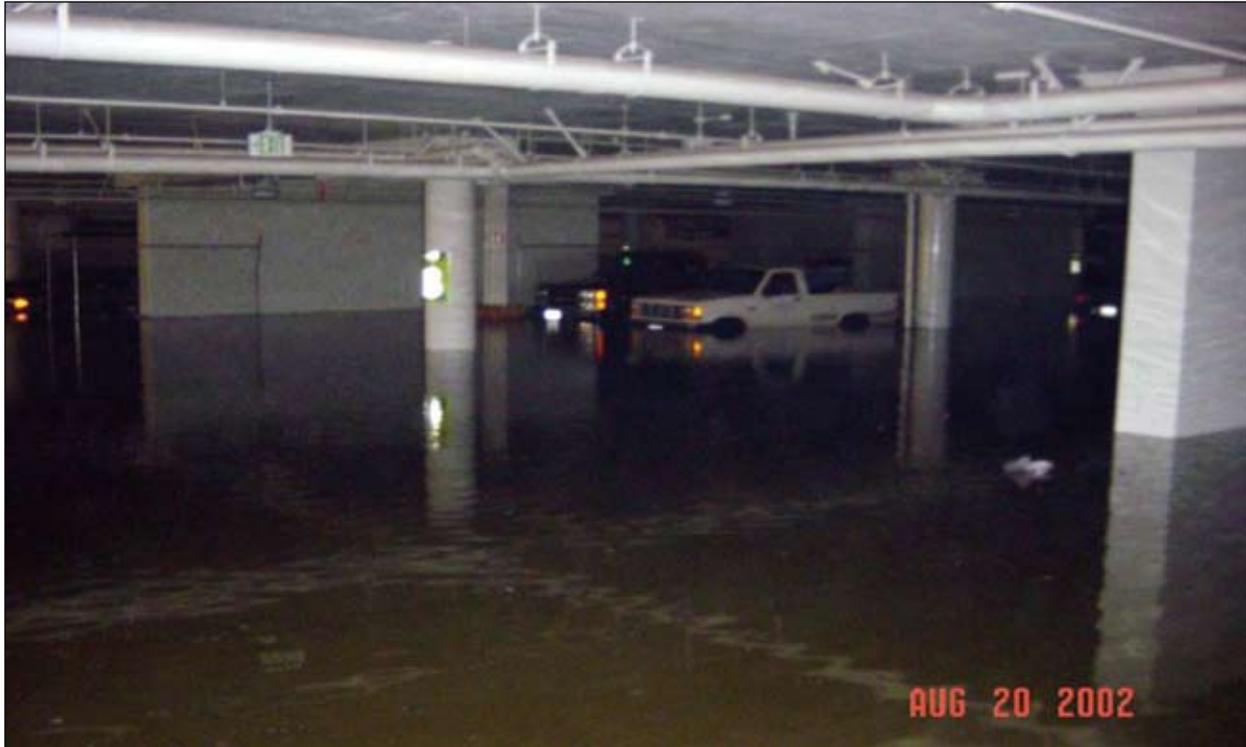
The water utility boosted water pressure to the area to the distribution system's maximum capacity. So much water was pumped onto the fire that the runoff flooded the underground parking garage, damaging approximately 160 vehicles.

9. Flooded parking garage

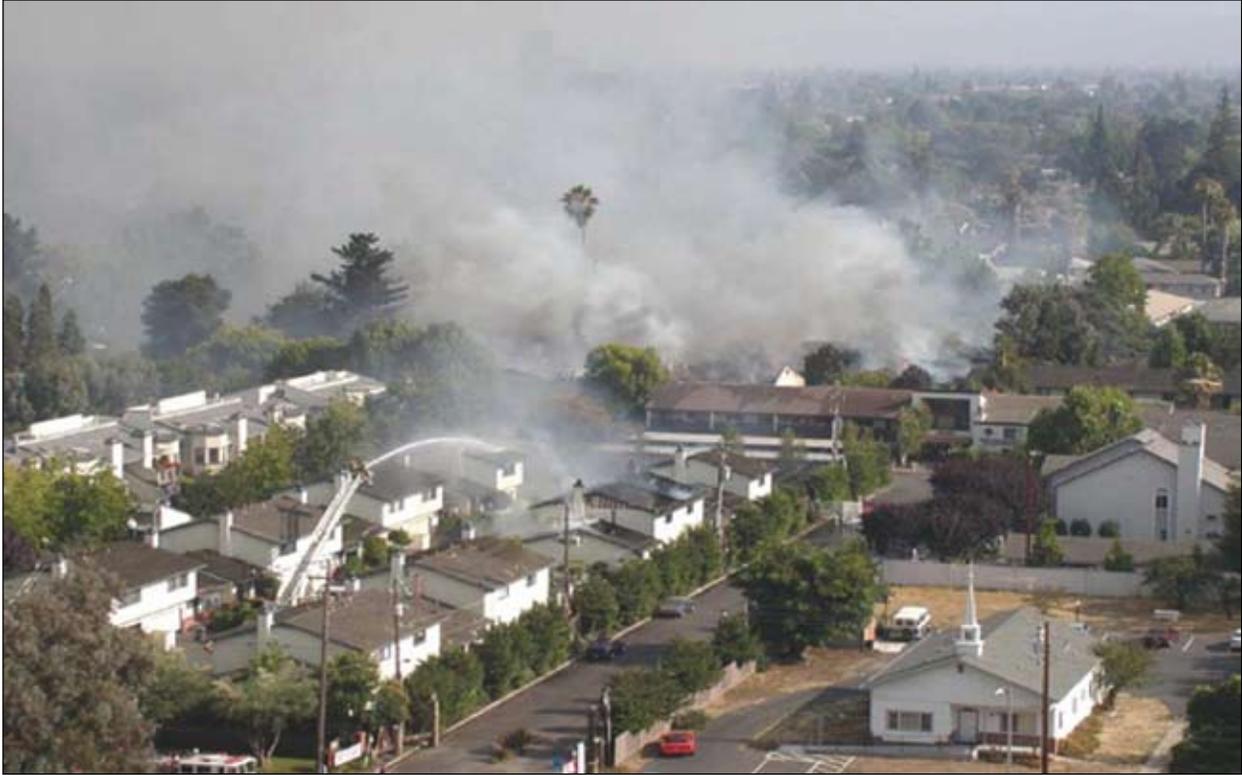
Access to both complexes was limited and none of the buildings were sprinklered. The primary source of ignition was the firebrands from the wood-shake roofs. Buildings with composition roof covering largely escaped the conflagration.

11. Overview of Huff/Moorpark fire
