U.S. Fire Administration/Technical Report Series

Four Firefighters Die in Seattle Warehouse Fire

Seattle, Washington

USFA-TR-077/January 1995

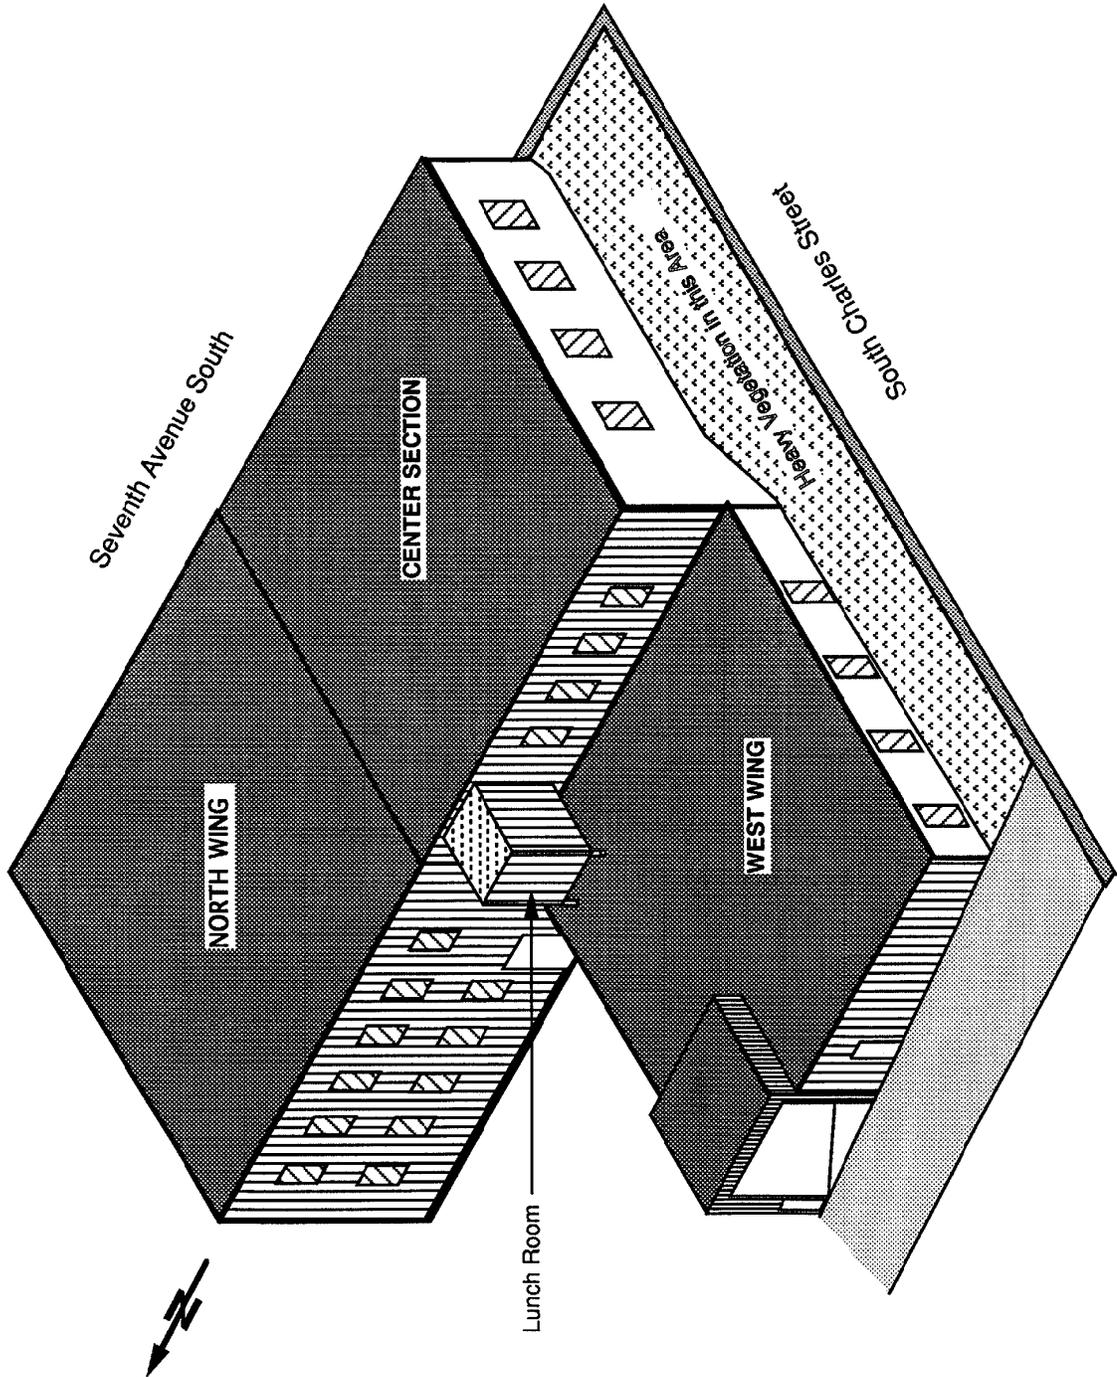
Figure 1A

MARY PANG BUILDING
View from South West

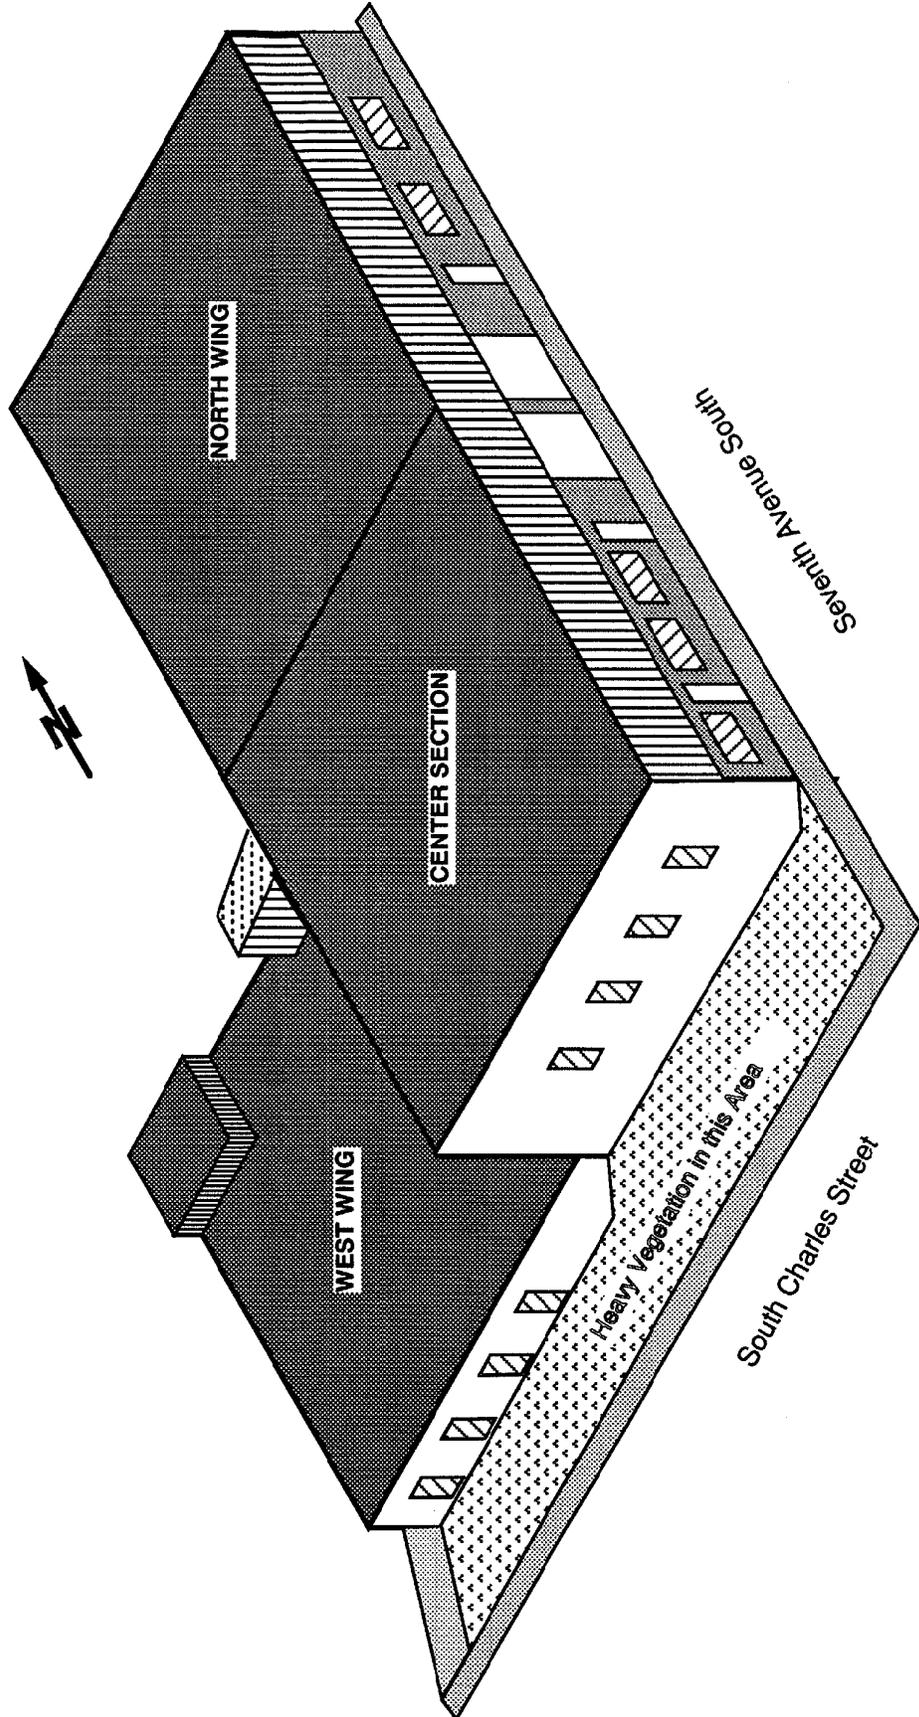
Figure 1 B

MARY PANG BUILDING
View from South East

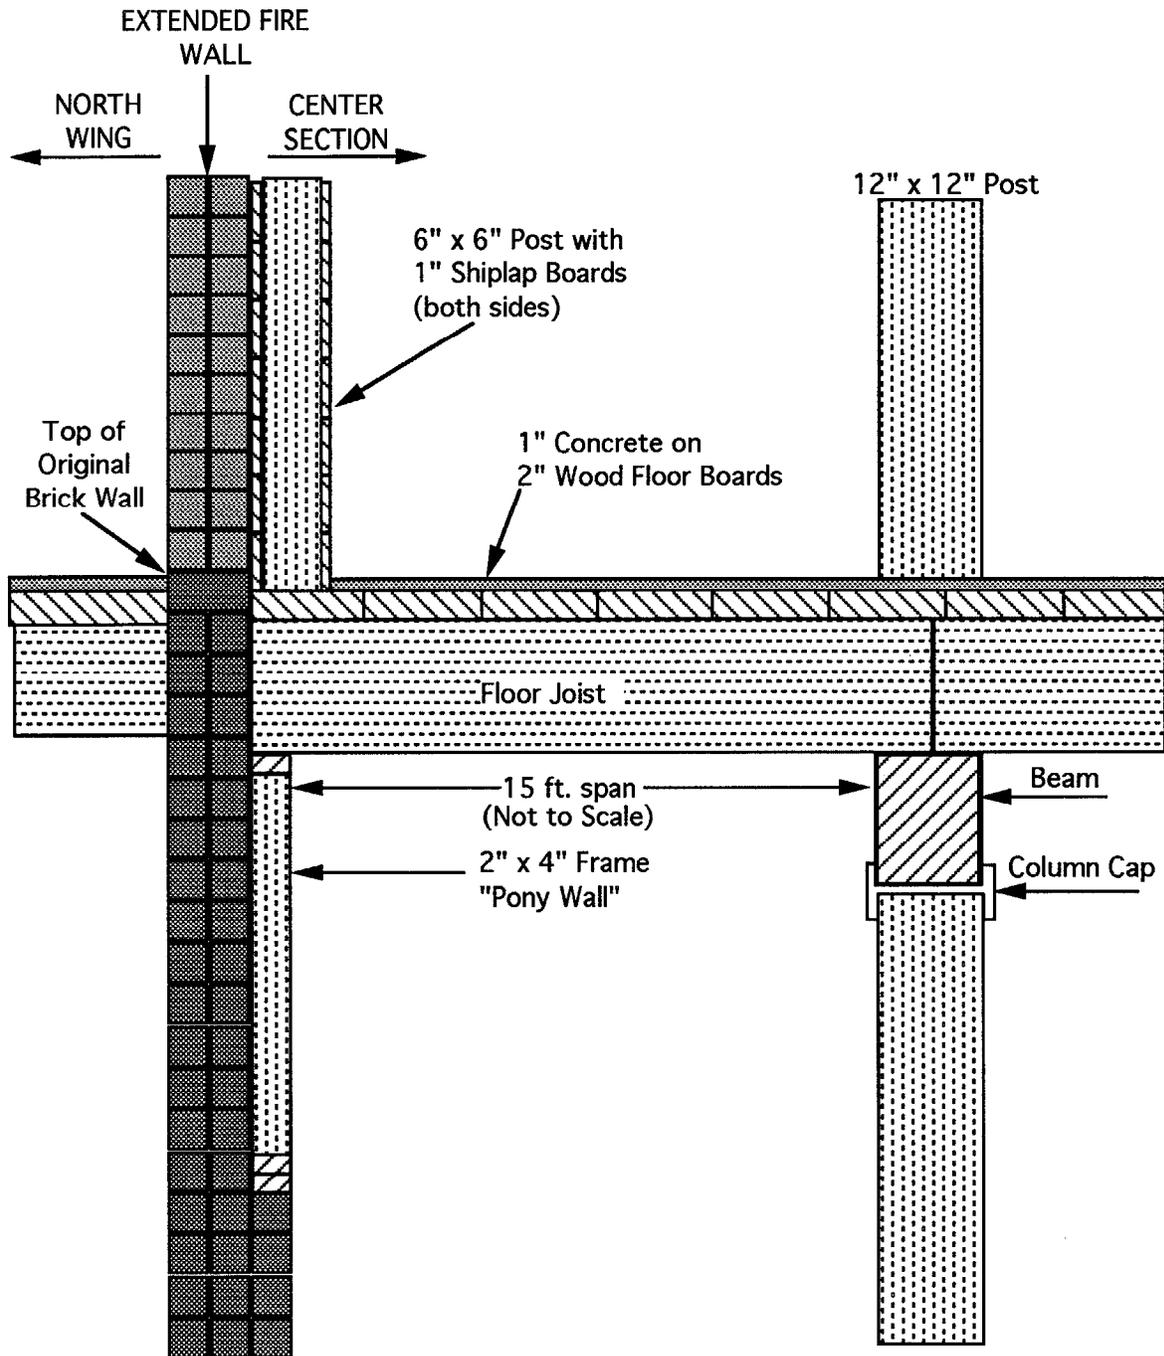
Figure 7

CONSTRUCTION DETAILS AT INTERIOR FIRE WALL (ALL DIMENSIONS ARE ESTIMATES)

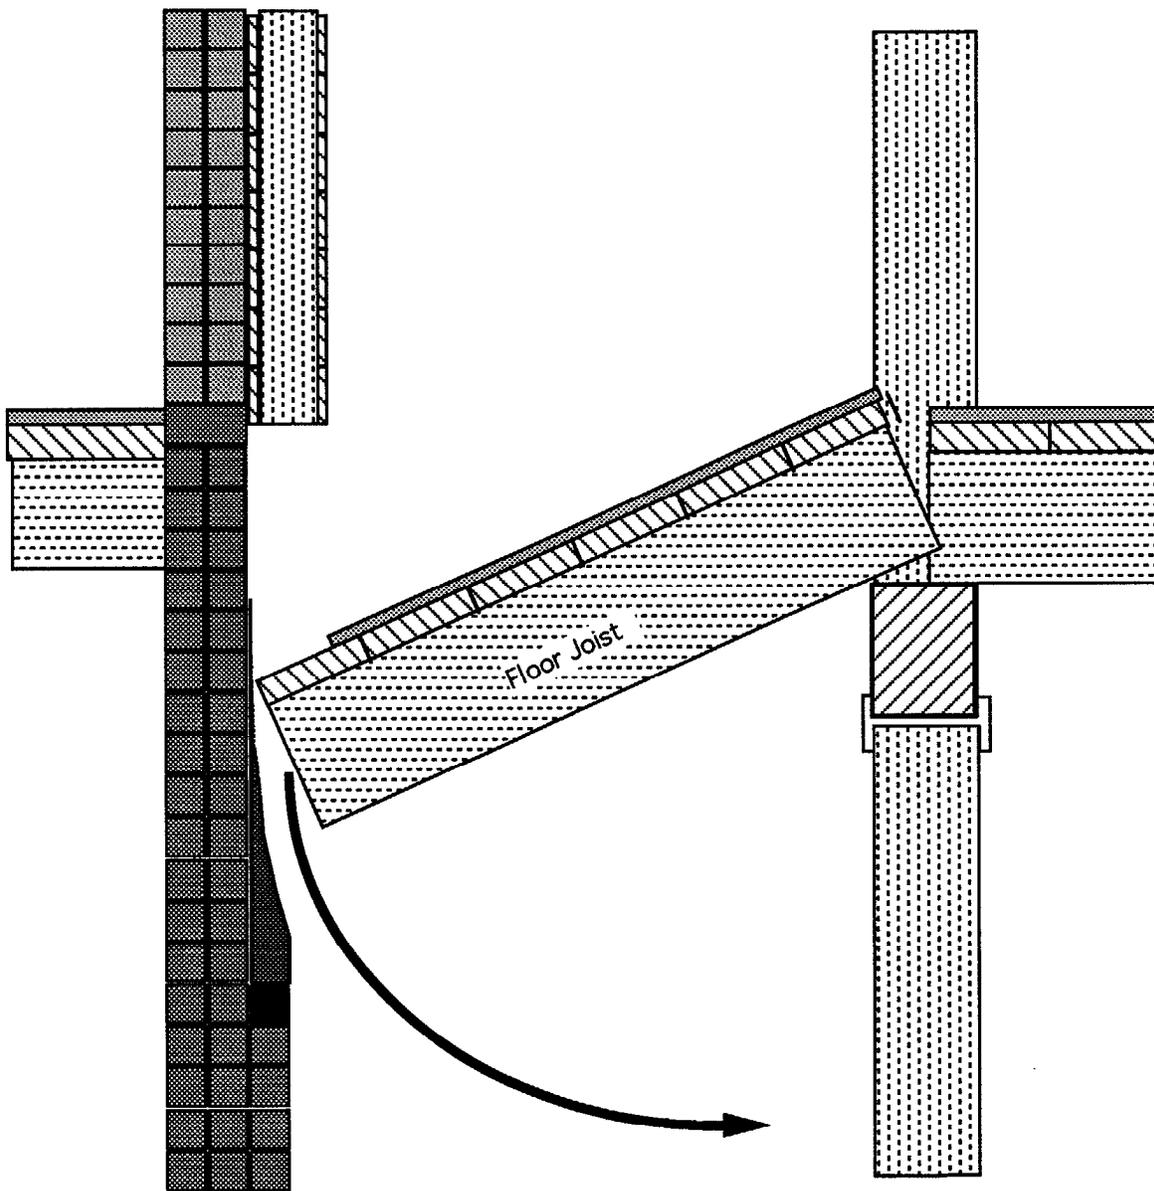
Figure 8

The hidden flaw in the structure was the support for the ends of the new floor joists along the north wall. The original roof was supported by a ledge that was incorporated in the brick wall. Because the new floor was four to five feet higher than the roof, a wood frame “pony wall” was fabricated from 2 by 4 inch wood members and erected on top of the ledge to support the ends of the new floor joists. This assembly did not have the inherent fire resistance of the more massive wood members and could be expected to fail rapidly under fire conditions. The failure of this assembly would release the ends of the floor joists and result in a sudden floor collapse.

Seconds later the building rumbled and flames erupted from the basement as the floor began to collapse. It appears that the “pony wall” failed, dropping the ends of the floor joists. Sections of the wood and concrete floor hinged down into the basement. The flames coming from the basement spread across the underside of the roof and the contents of the ground floor began to ignite in a rapid flashover sequence.

FLOOR COLLAPSE MECHANISM UPON FAILURE OF PONY WALL

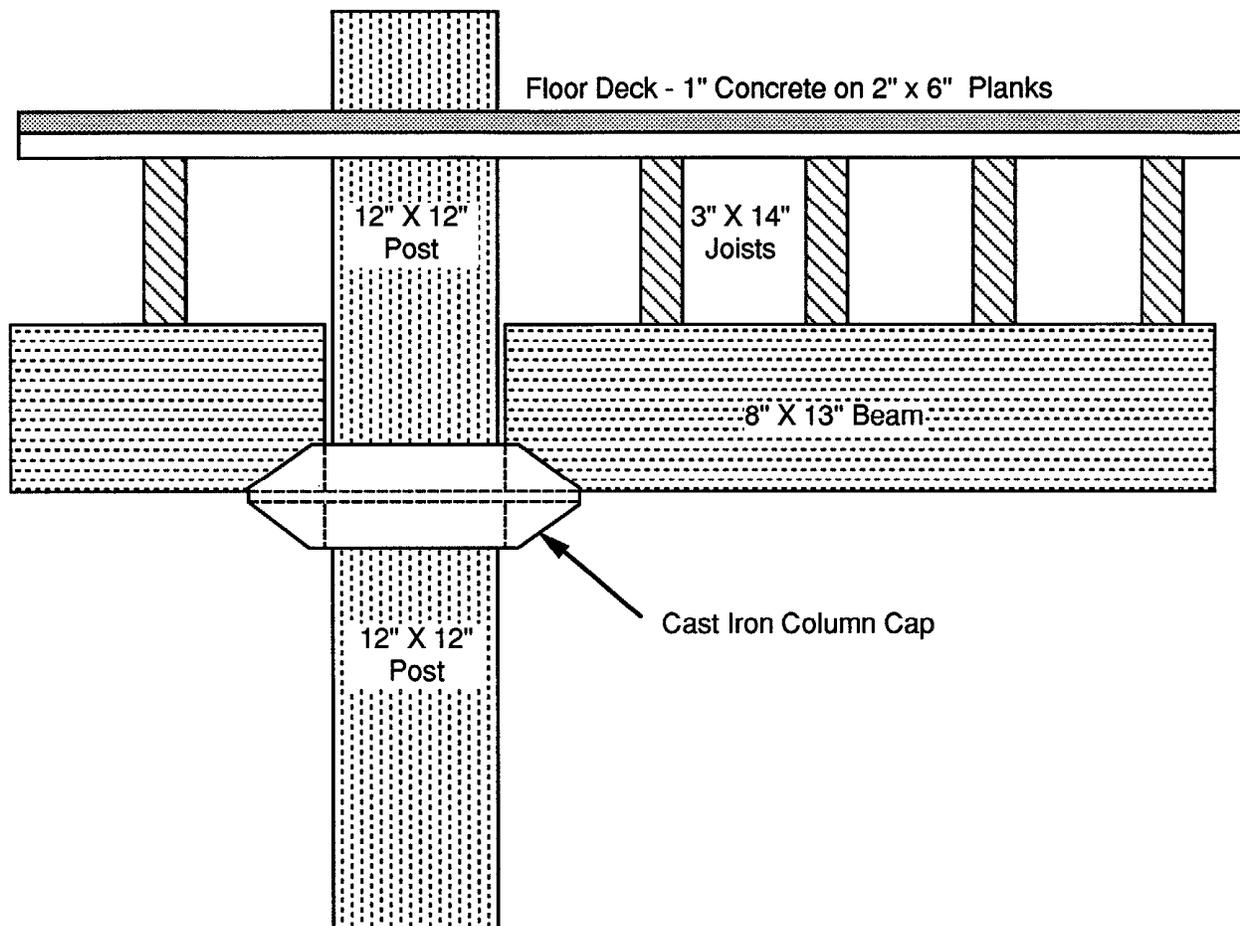
Figure 9

DETAIL OF UPPER FLOOR DECK AND COLUMN CONNECTIONS

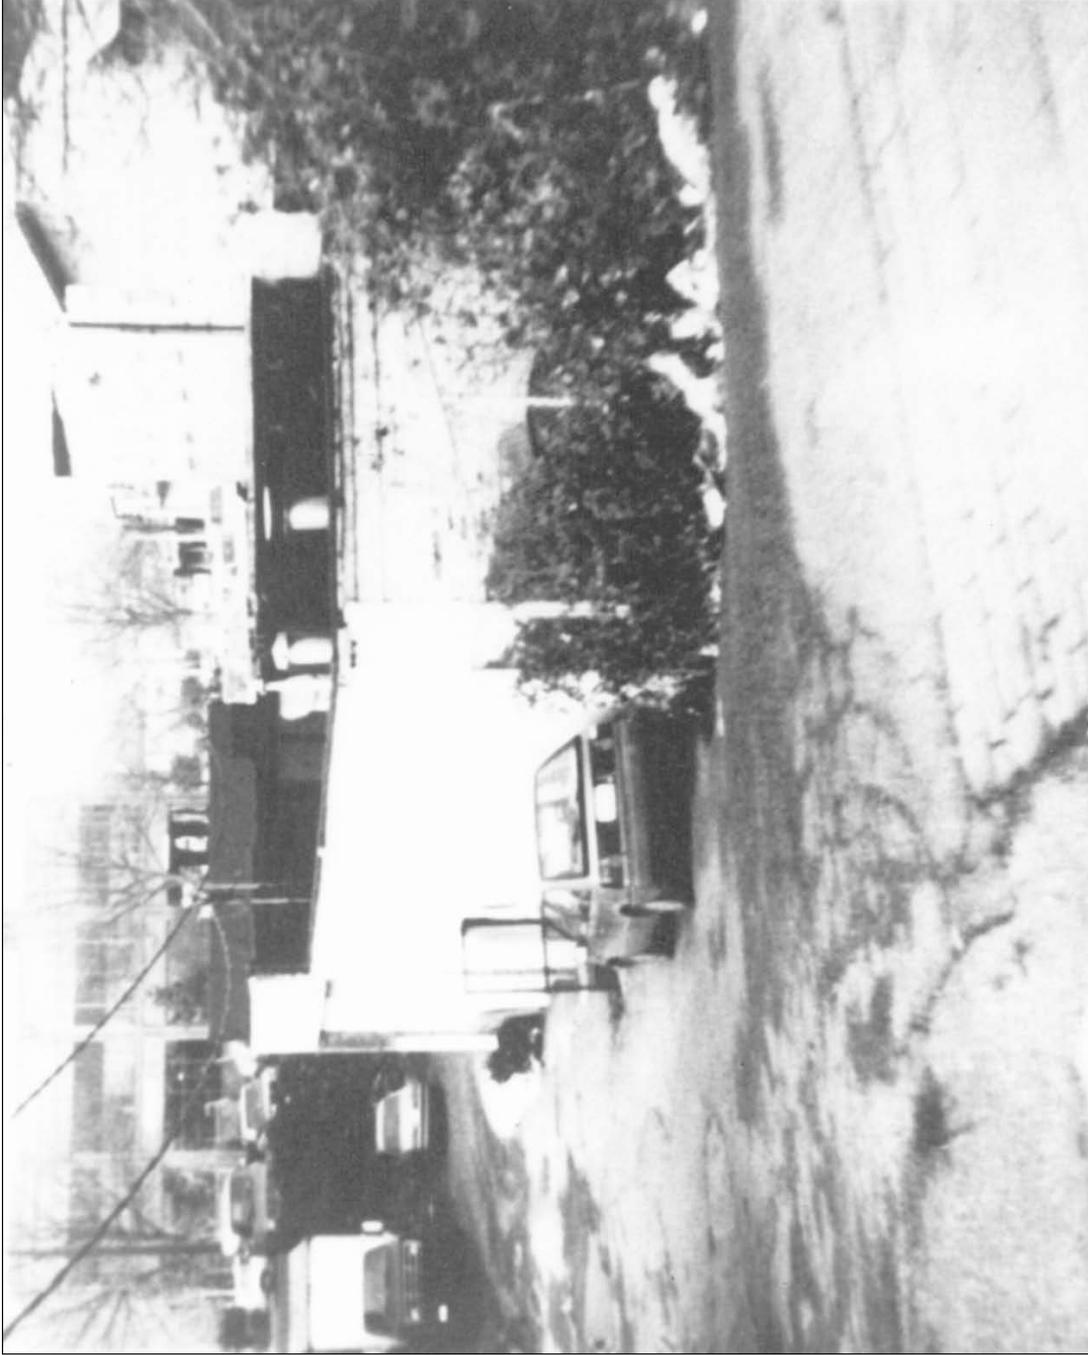
View from the rear (west side) of the Mary Pang building, looking from South Charles Street. The open door is the entrance to the bakery. The heavy vegetation between South Charles Street and the building can be seen on the right side of the picture.

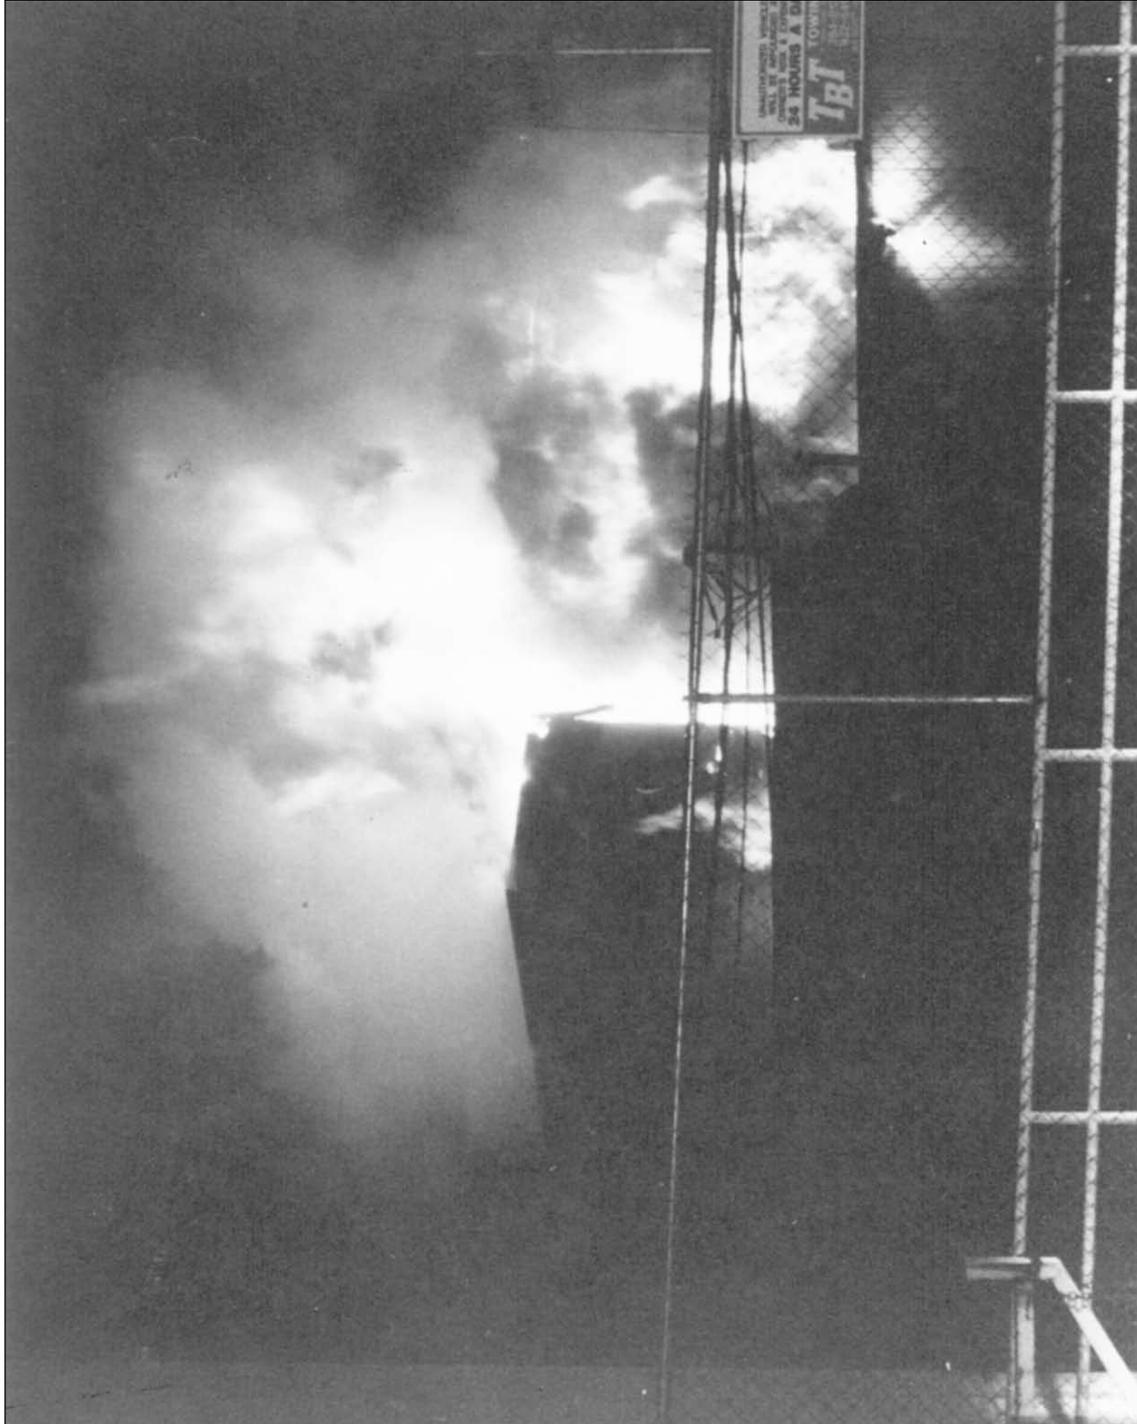
A large volume of fire was visible to units approaching from the west in the early stages of the incident. The outline of the lunchroom is visible next to the tallest flames.

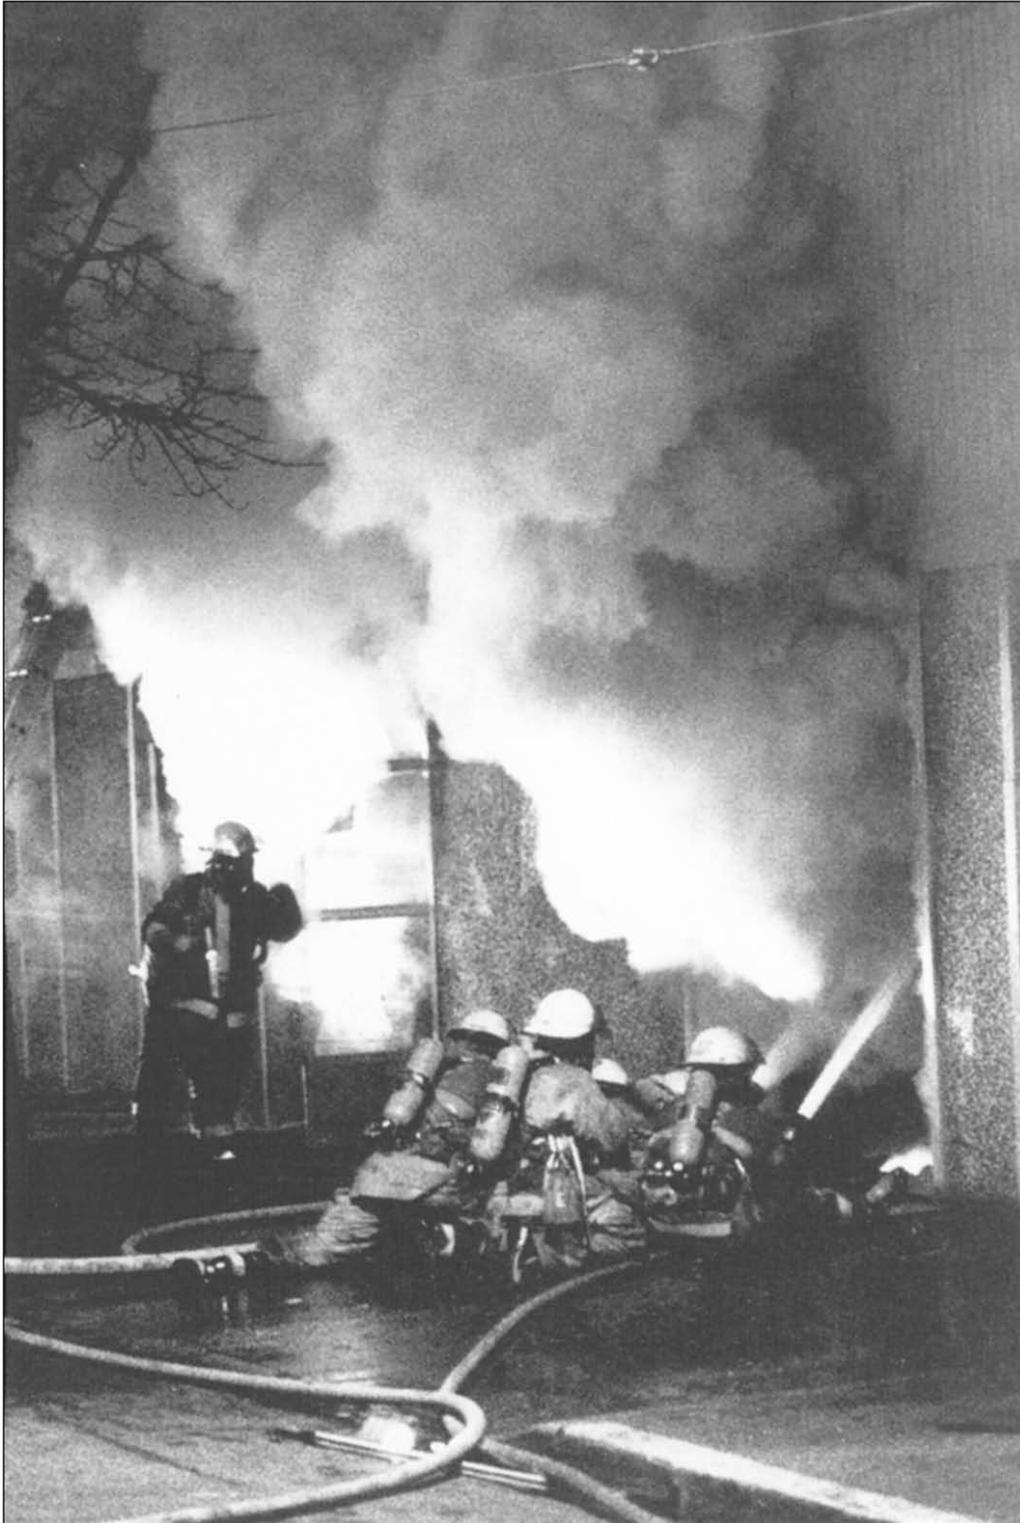
A large volume of fire was visible to units approaching from the west in the early stages of the incident. The outline of the lunchroom is visible next to the tallest flames.
