U.S. Fire Administration/Technical Report Series

Five-Fatality Highrise Office Building Fire

Atlanta, Georgia

USFA-TR-033/June 1989

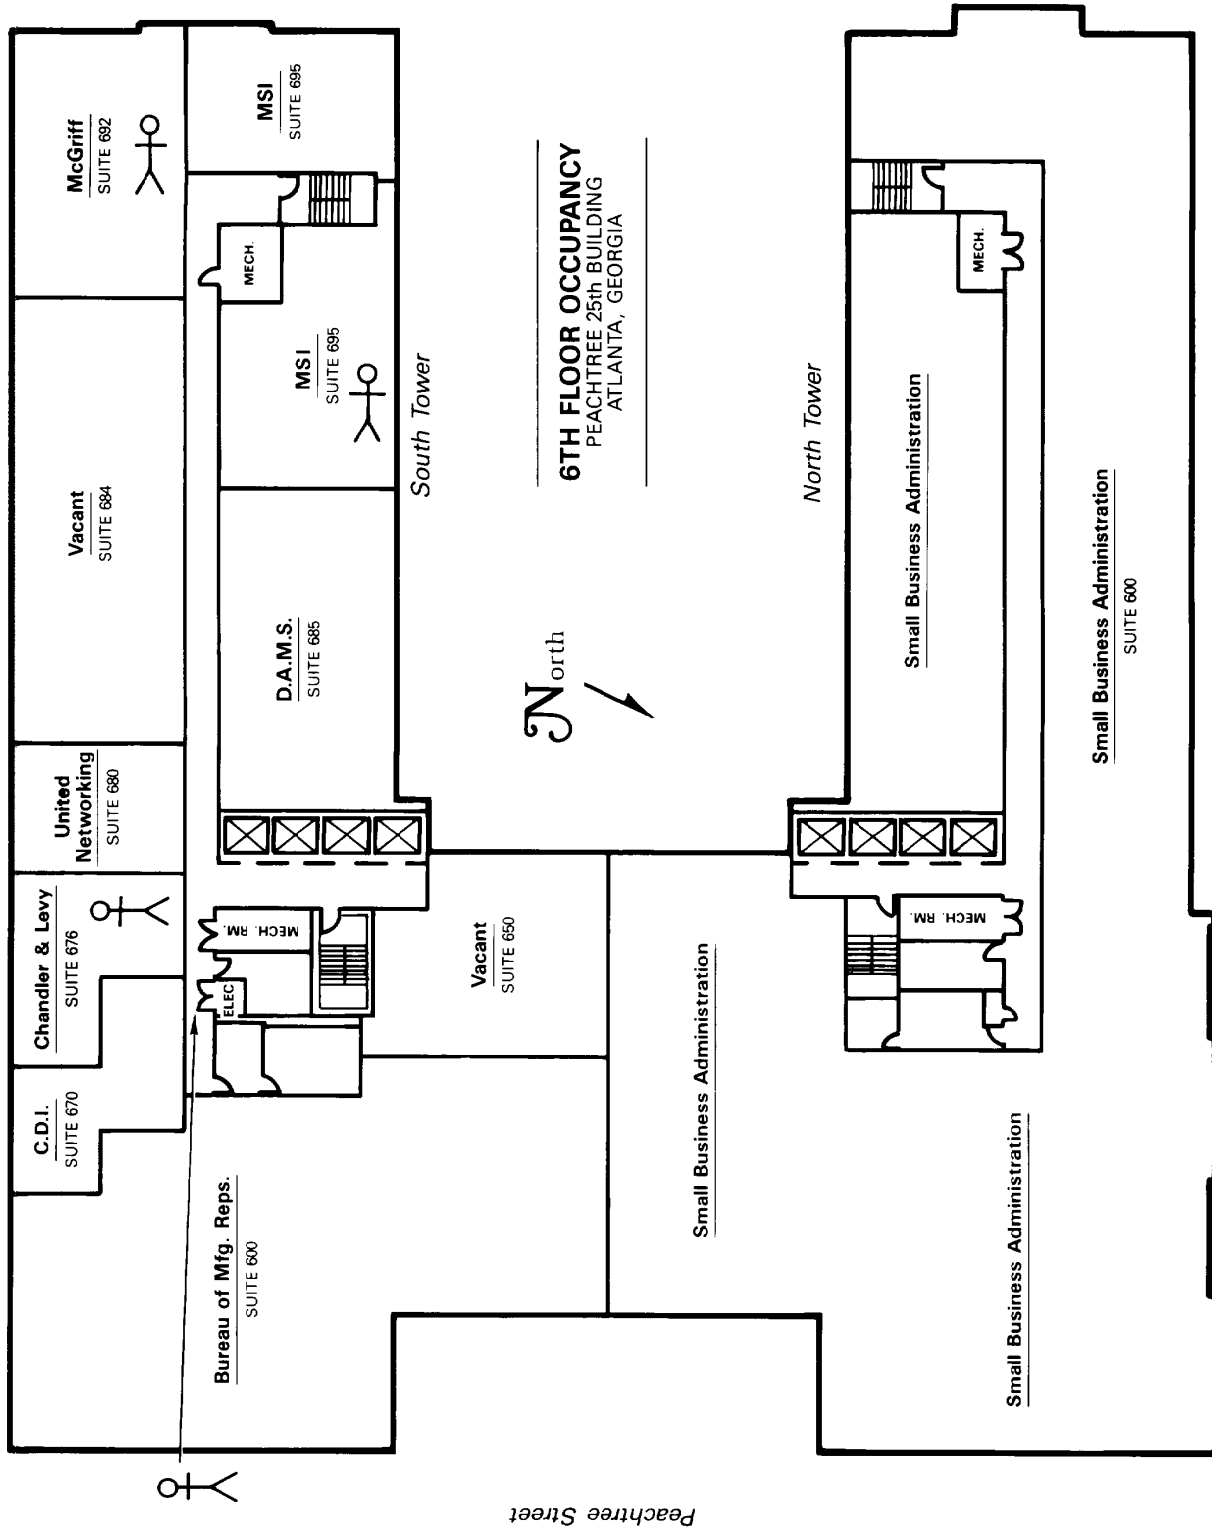
Sixth Floor Plan Showing Location of Victims

A worker who was directly across the hall from the electrical closet (Suite 676) remained in his office and did not break a window. This worker was found dead after the fire.

The one occupant who remained in his office throughout the fire without breaking a window died from smoke inhalation. Heat apparently never reached an excessive level in this office – there was no damage to plastic items stored on bookshelves near the ceiling.

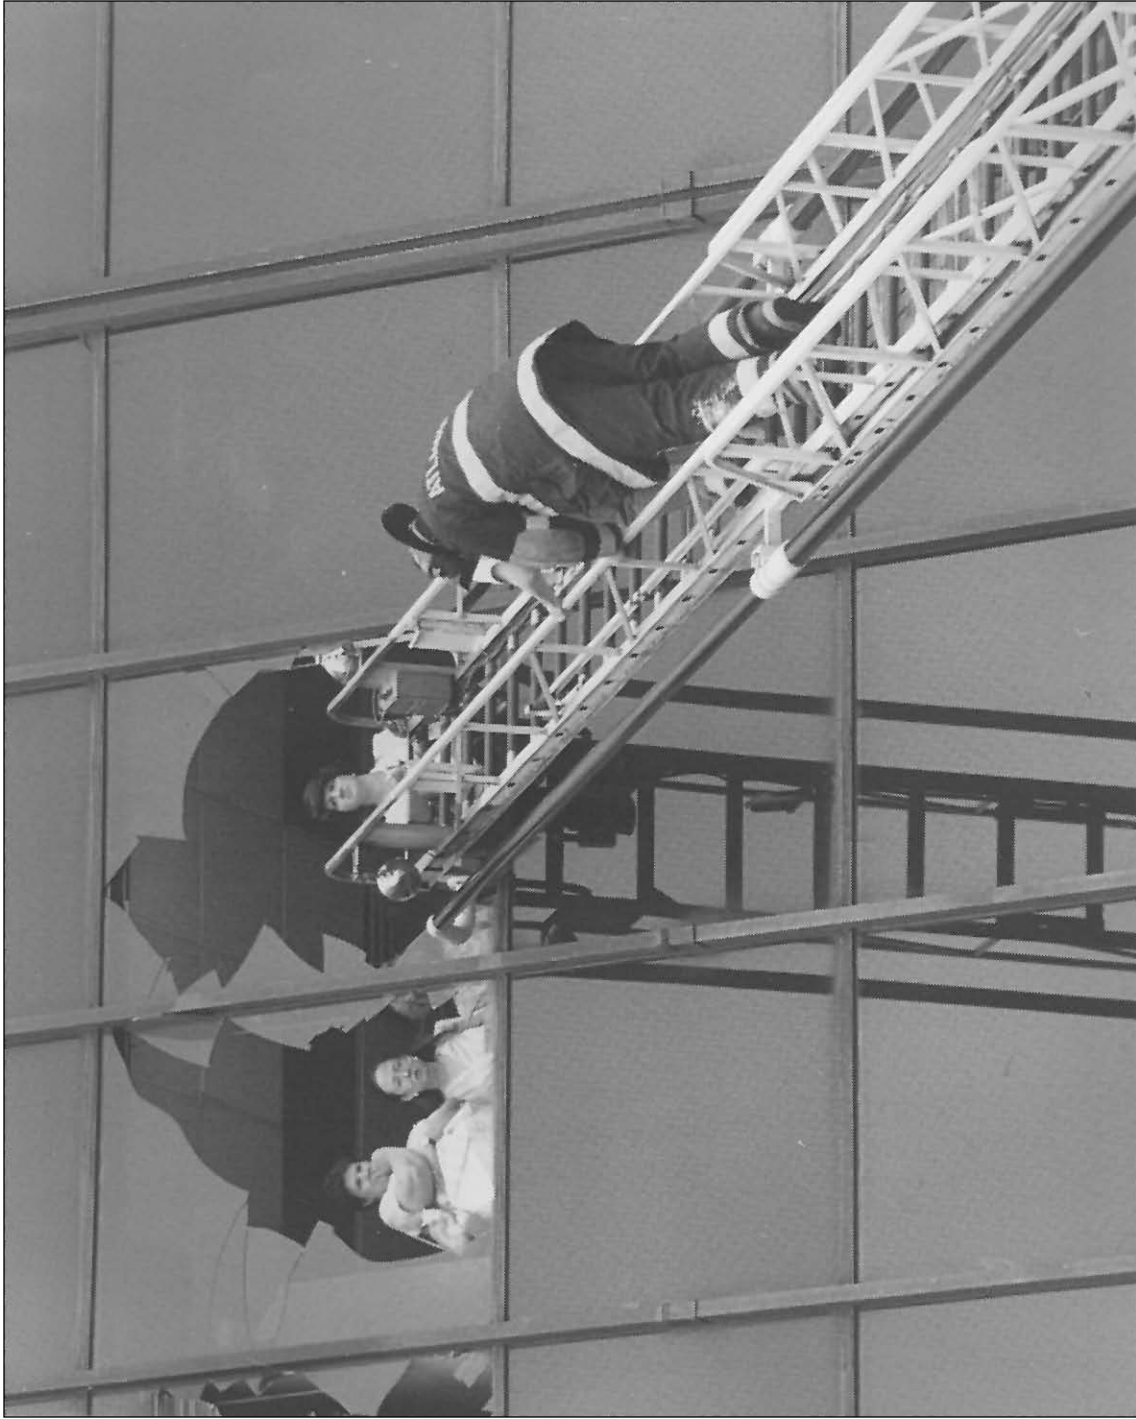
1. Rescue by aerial at front of building.

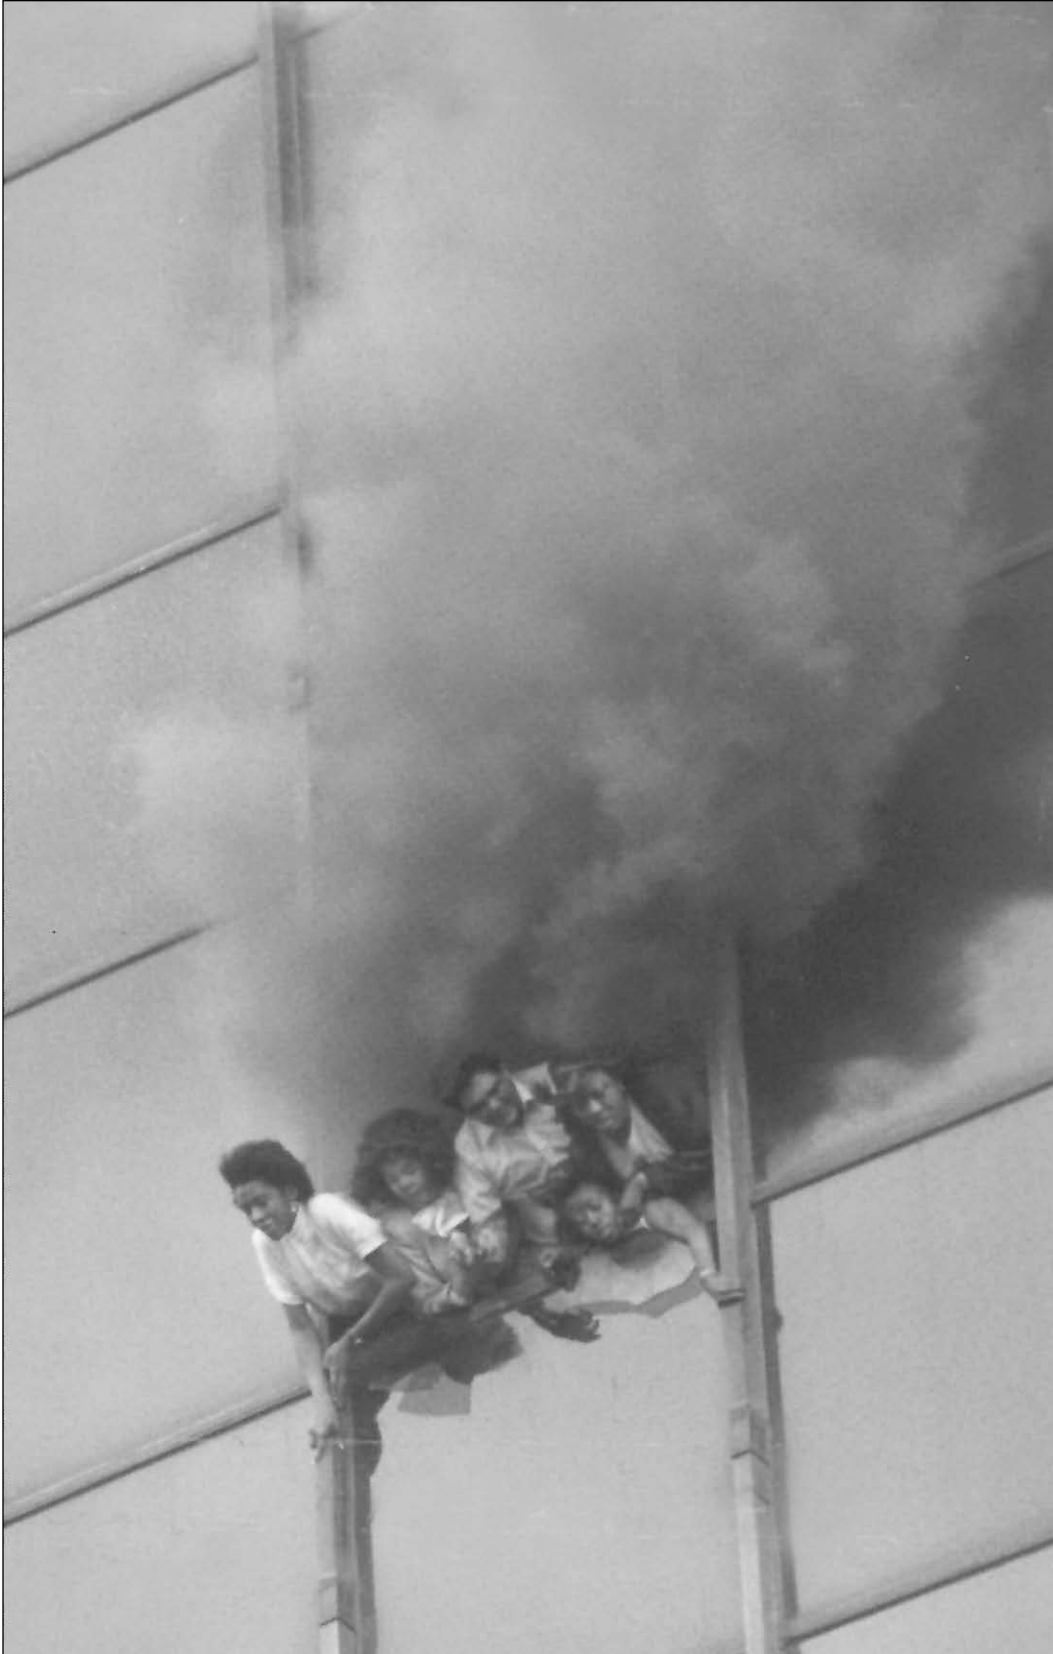
2. Victims awaiting rescue on south side of building, sixth floor.

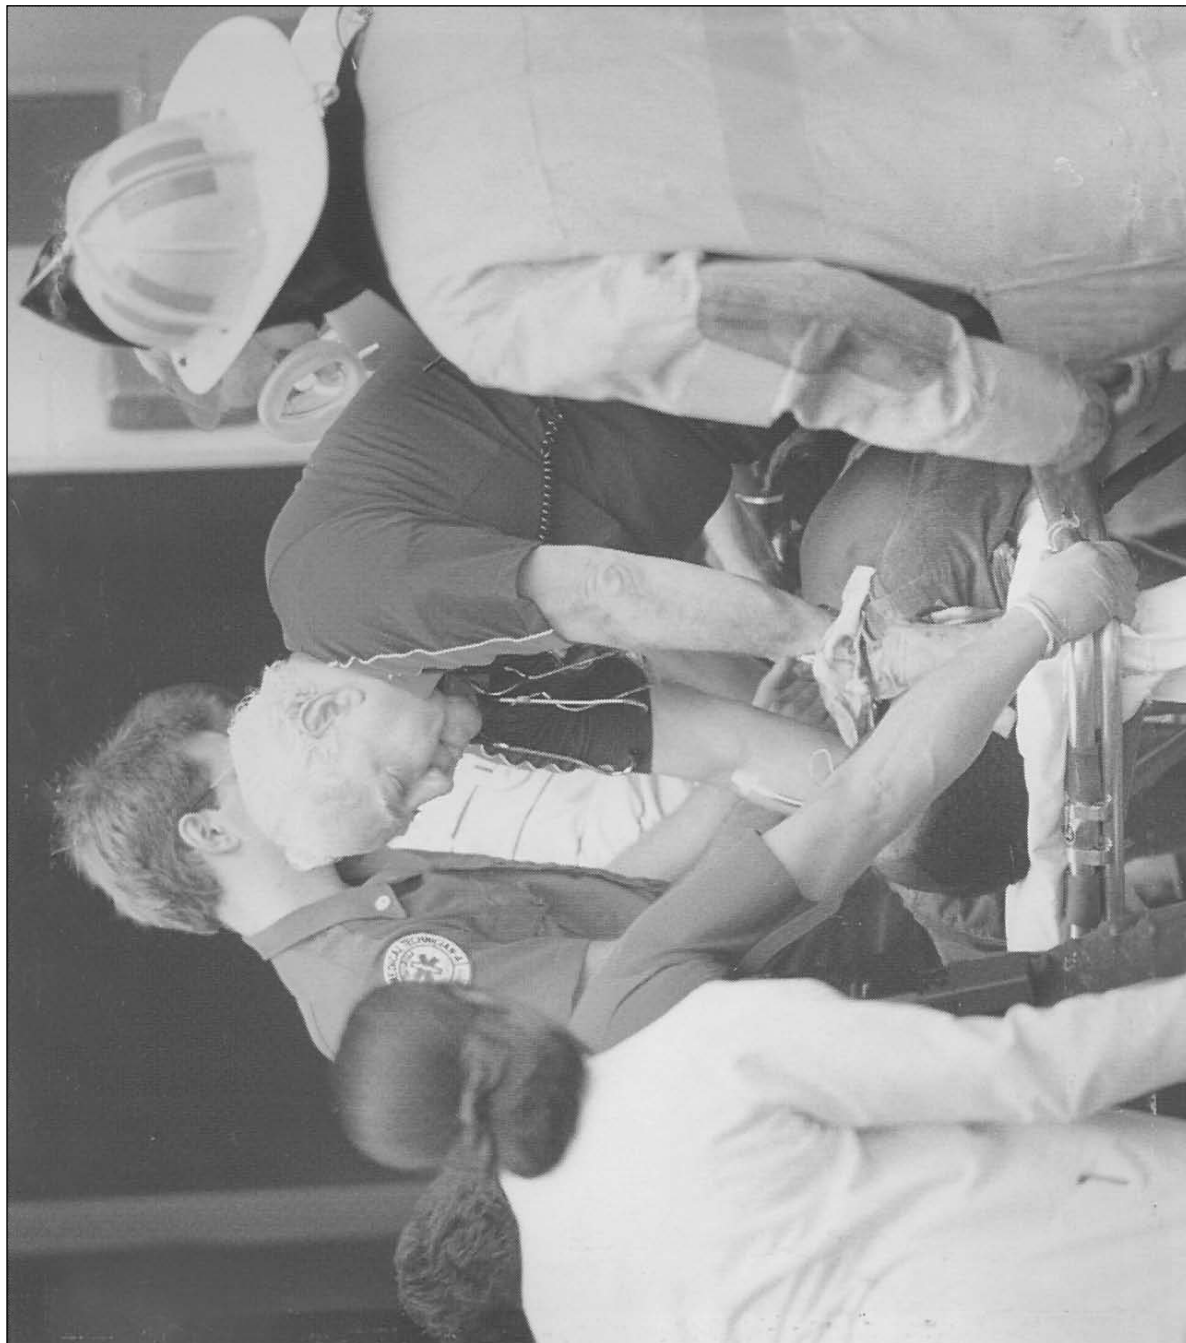
5. Resuscitation attempt on victim removed from rear of sixth floor.

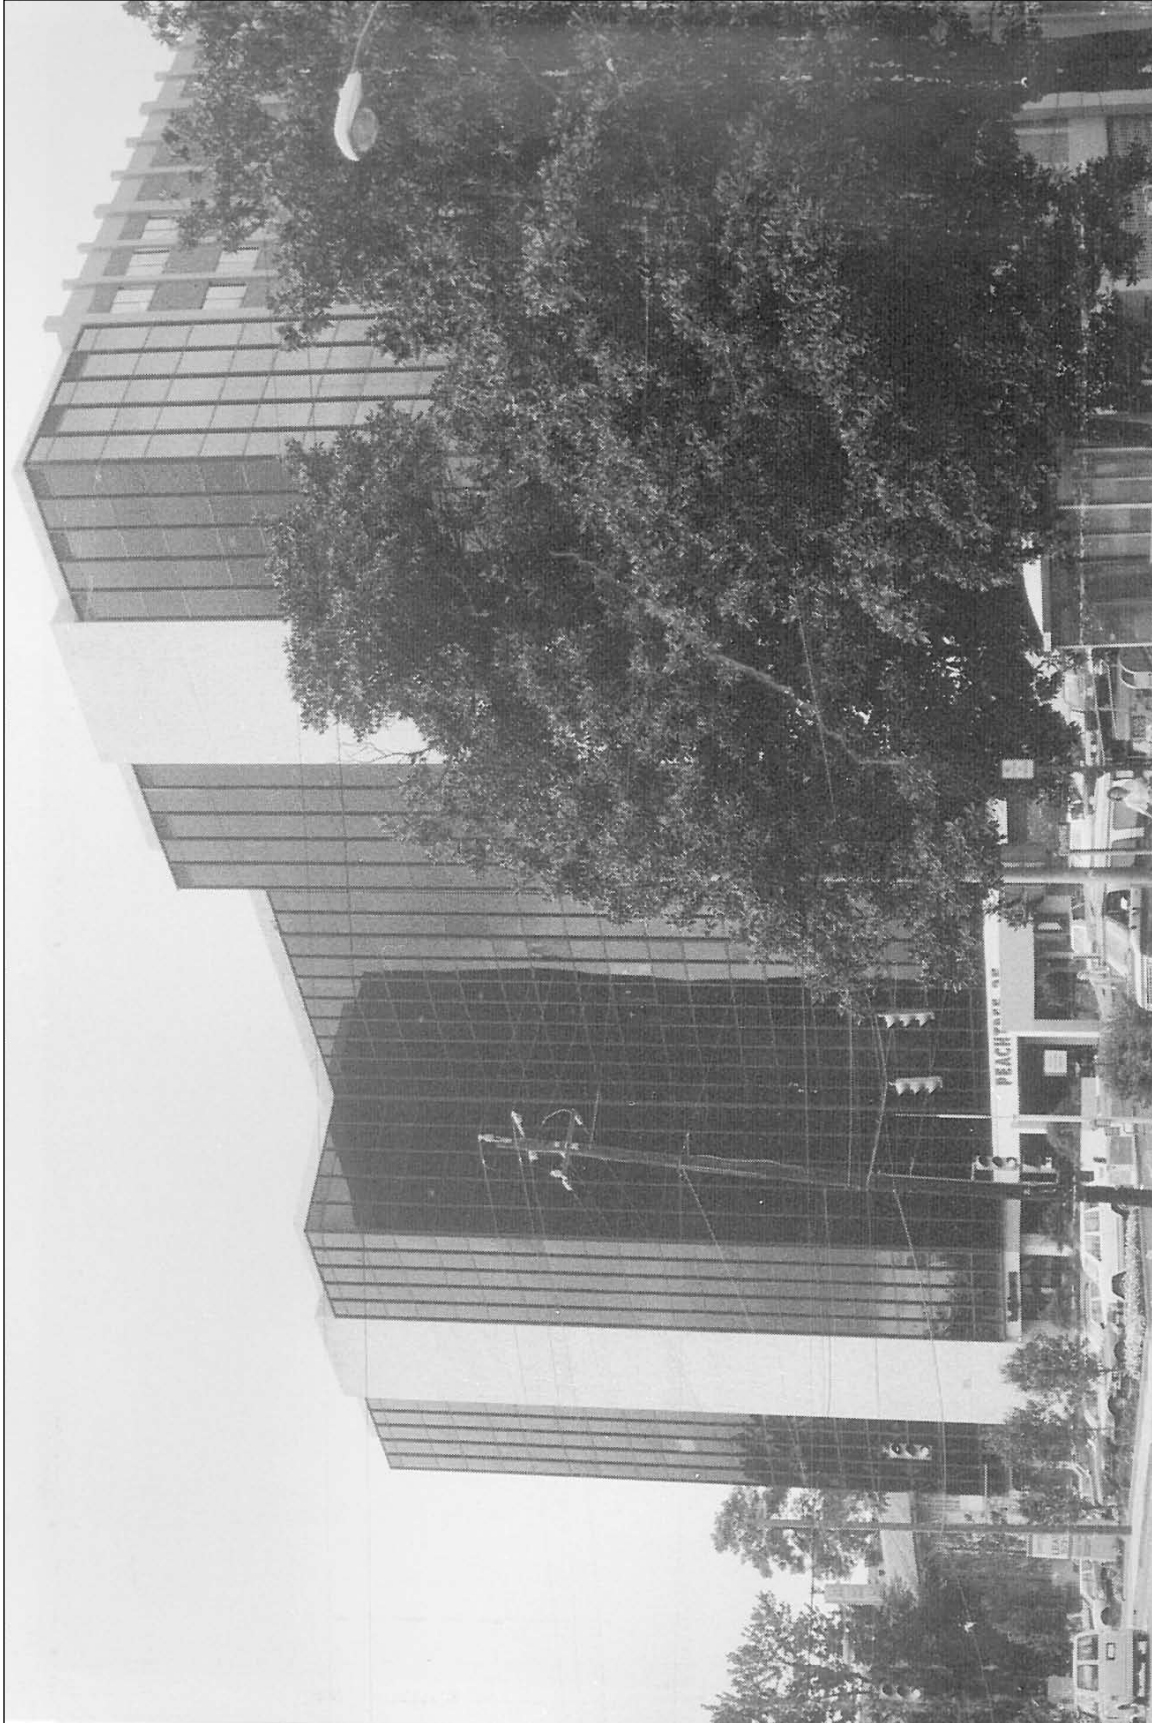
The South Tower, where the fire occurred, was completed in 1969. It was of fire resistive concrete construction and had panel walls of black glass held together with aluminum mullions. Windows ran from approximately two feet above the floor to slightly below the ceiling line. The spaces above the ceiling and below the windows were covered with opaque black glass panels to create a uniform façade. The front of the structure was finished in black glass and gave the appearance of a single building (see photo 7 in Appendix H).

7. Front of building.

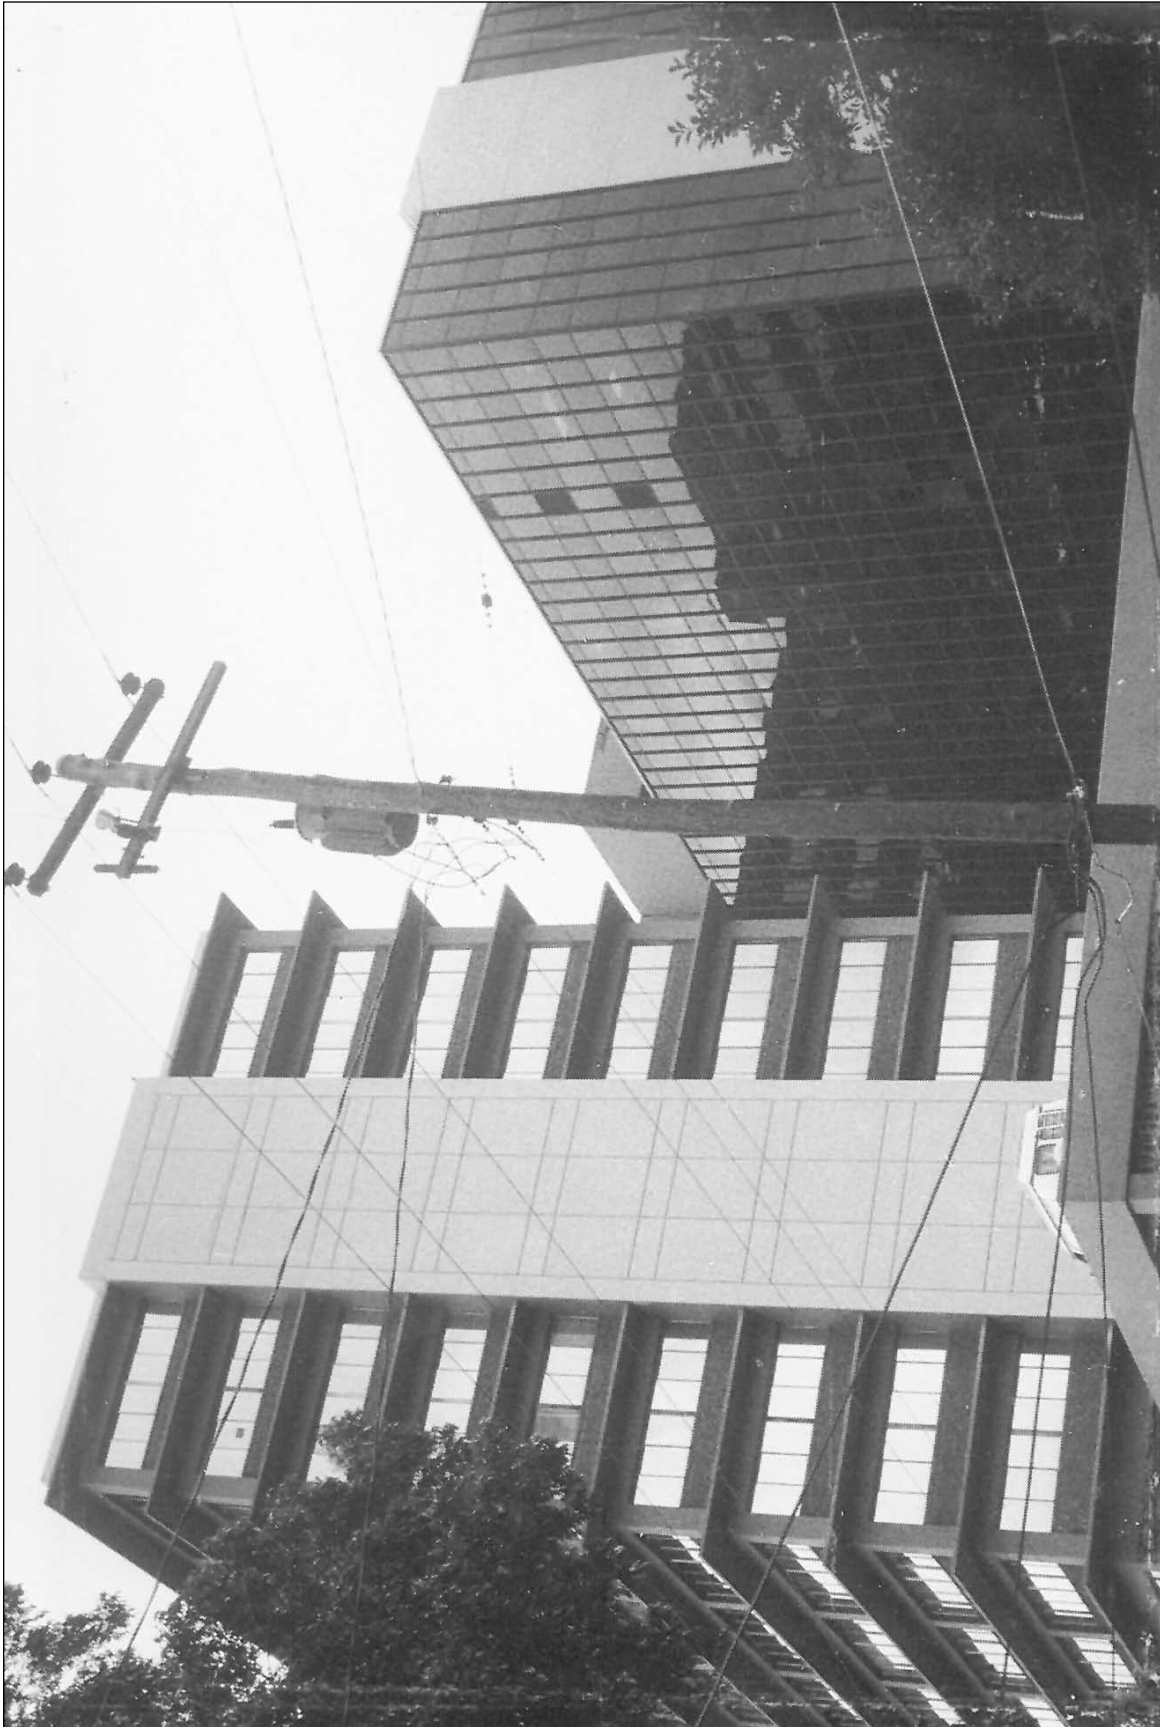
The two towers were arranged in symmetrical fashion. The North Tower, built in 1962, was of fire resistive construction and had an exterior masonry finish with fire canopies (“eyebrows”) running the length of every floor.

8. Rear of building showing differing construction of North and South Towers.

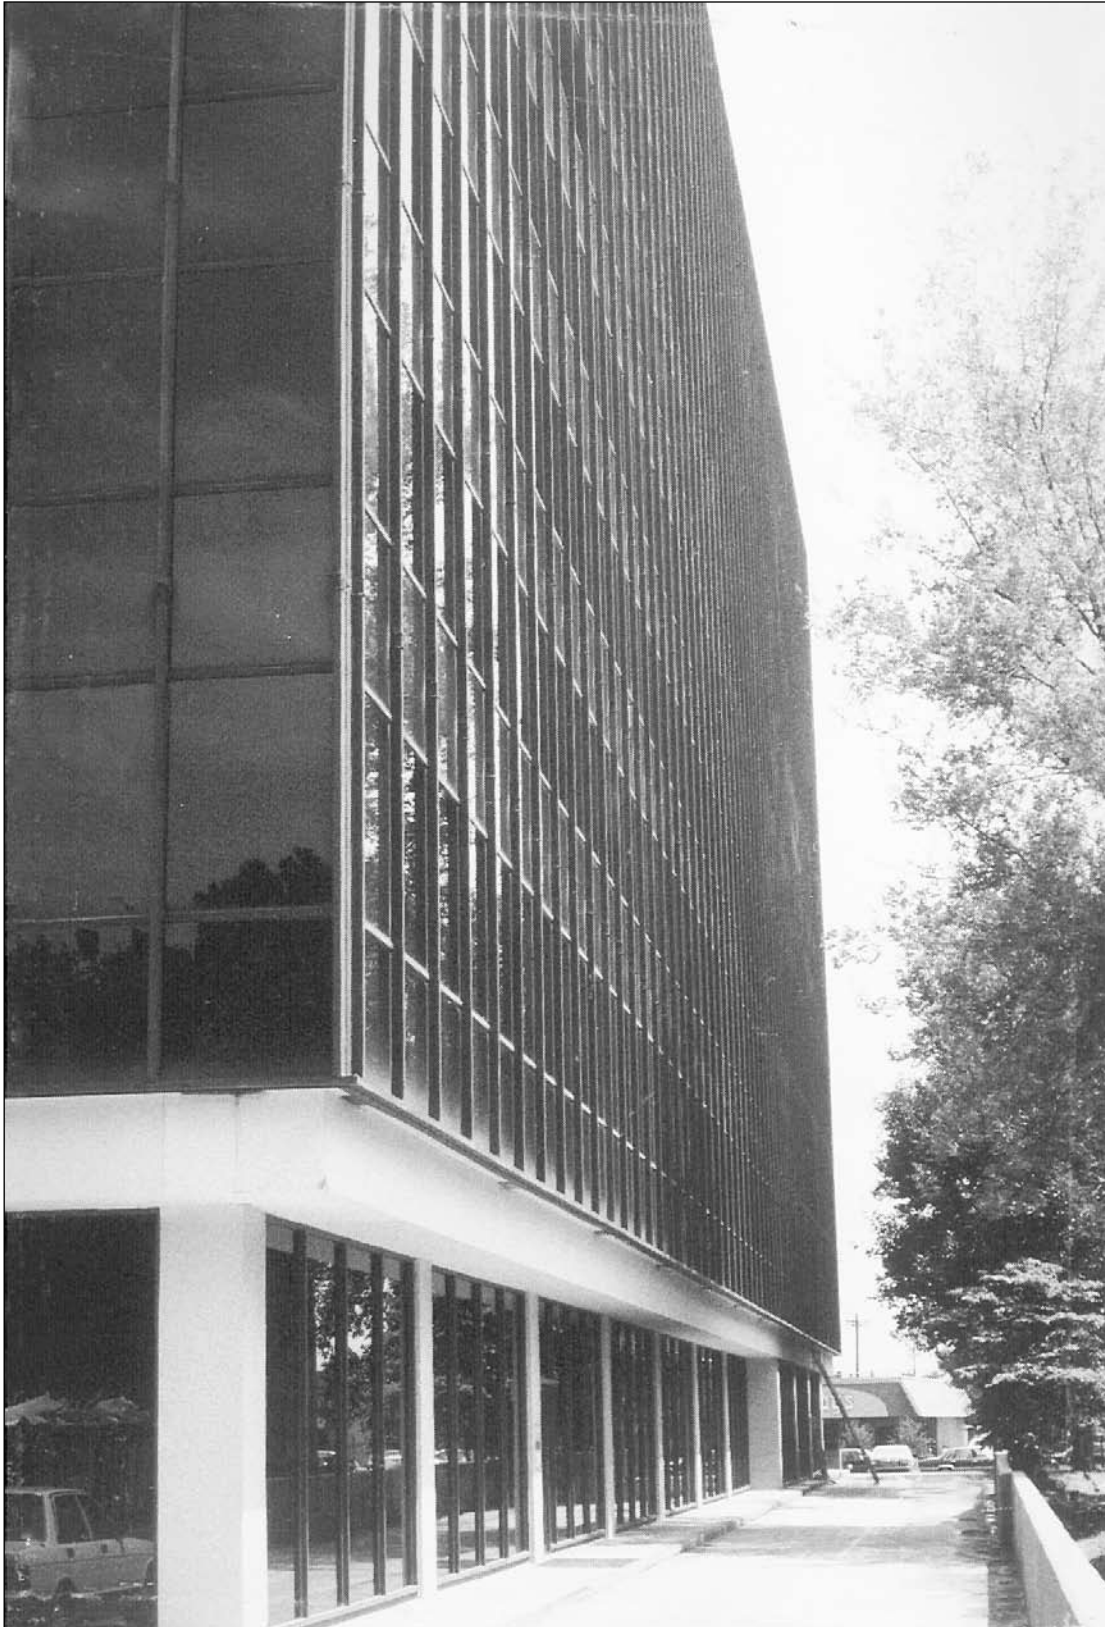
9. South side of building, showing driveway, looking toward front of building (Peachtree Street). Woman who jumped landed on this driveway.

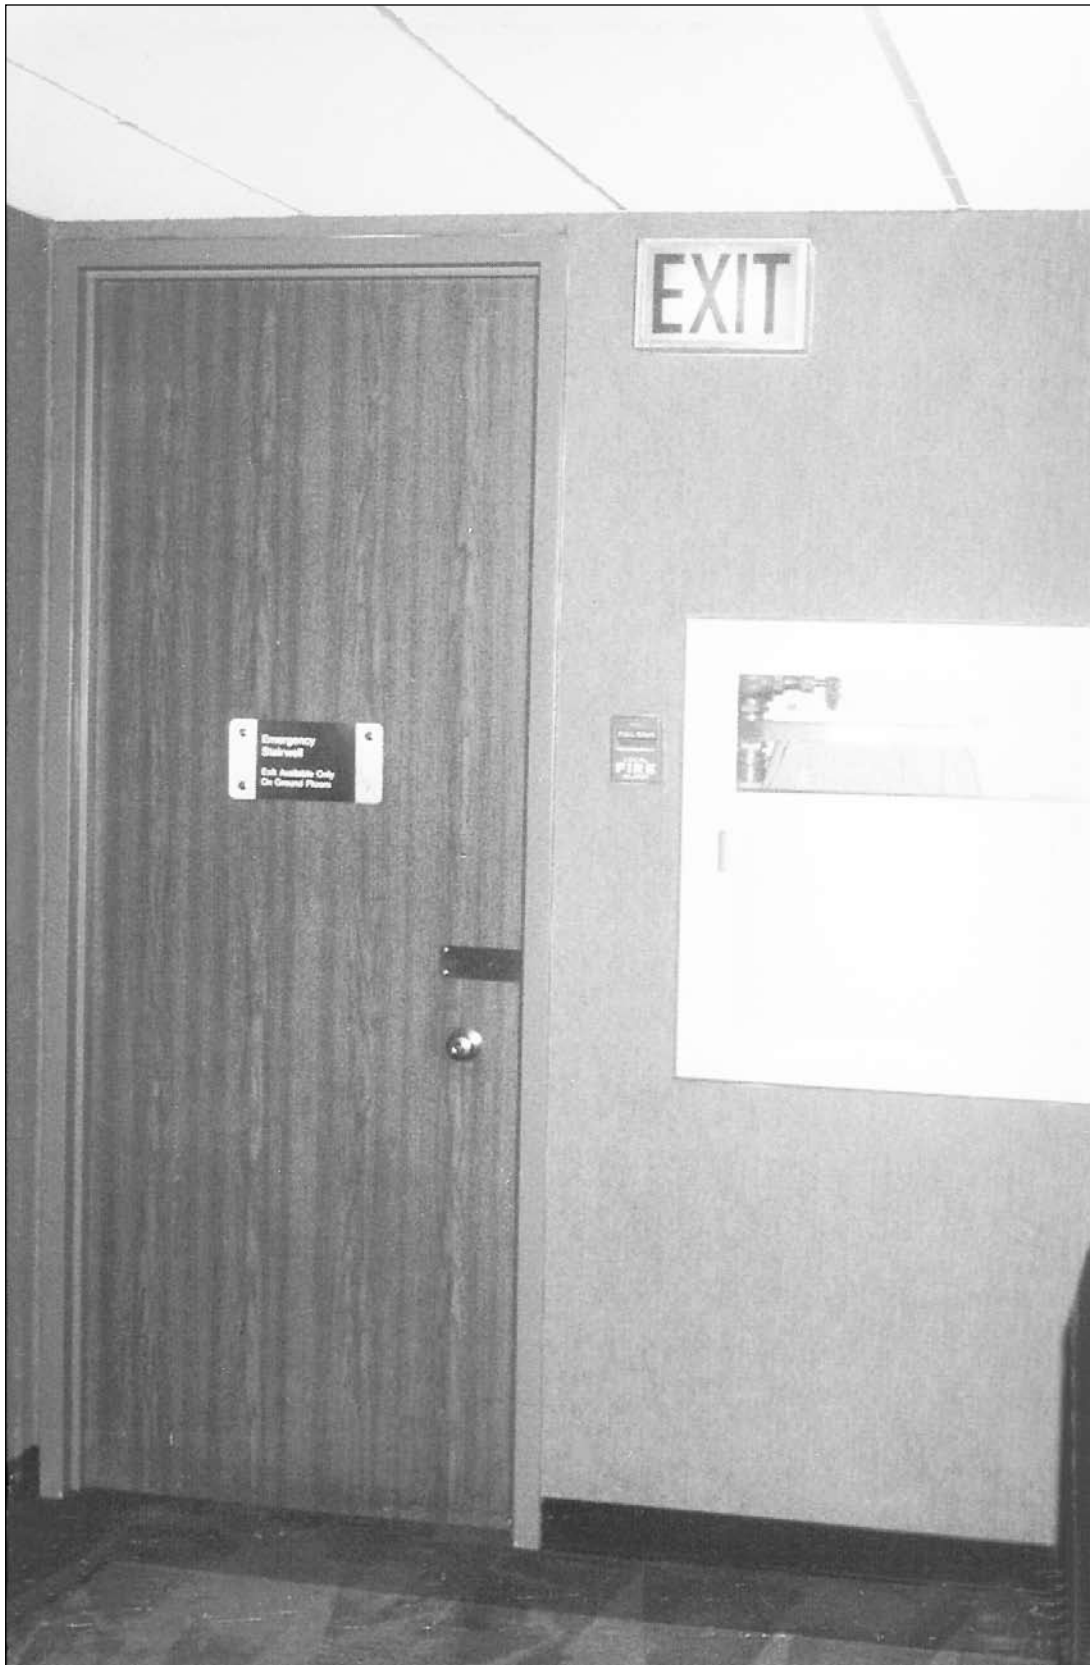
10. Typical exit arrangement at rear of floor, South Tower.

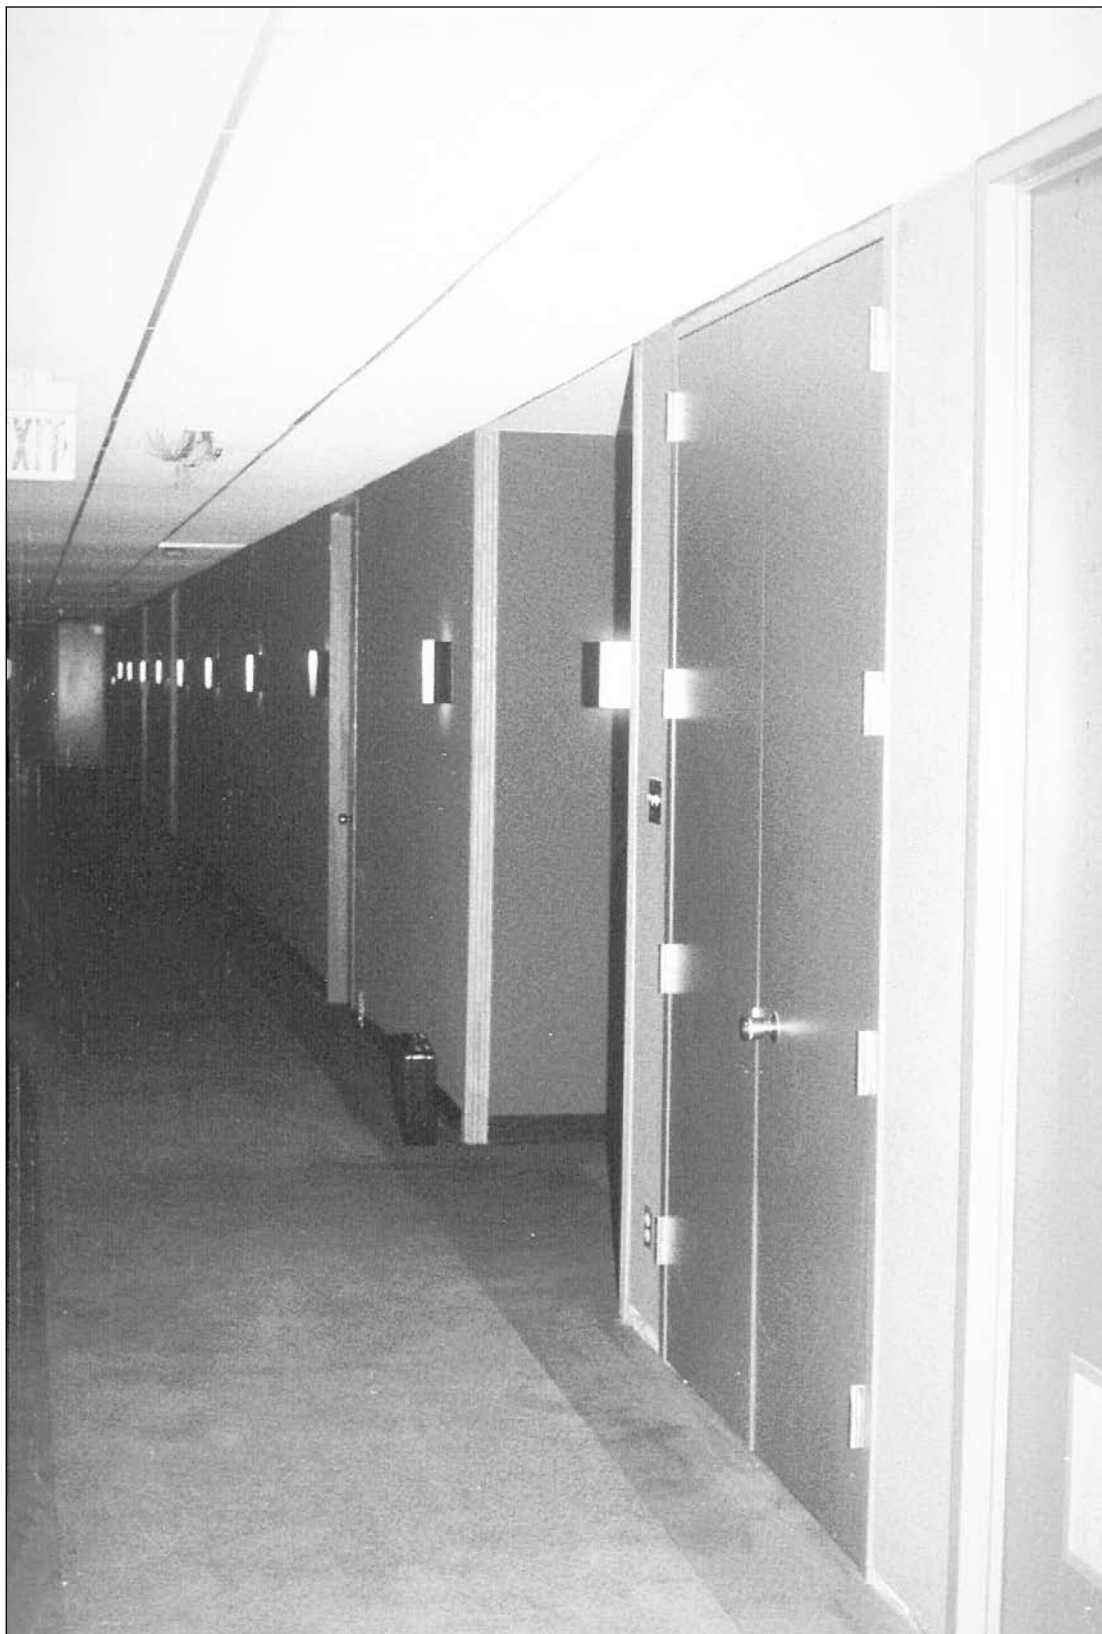
The electric closet where the fire started opened directly onto the exit corridor. When the fire erupted, it immediately blocked the corridor, keeping most victims away from the two exits serving the floor.

The principal vertical penetration floor to floor in the South Tower was an electrical bus duct which ran the height of the building and was inside electrical closets. Each electric closet opened onto the central hallway which served both exits. Other vertical penetrations were incidental.

11. Fifth floor corridor looking toward rear of building. Electrical closet is in foreground. Elevator lobby and front stairway are around the corner to right.

Separation of hazardous areas such as electrical rooms should be considered as a retrofit item in structures where a fire or similar situation could be expected to cause an immediate threat to the ability of occupants to reach exits.

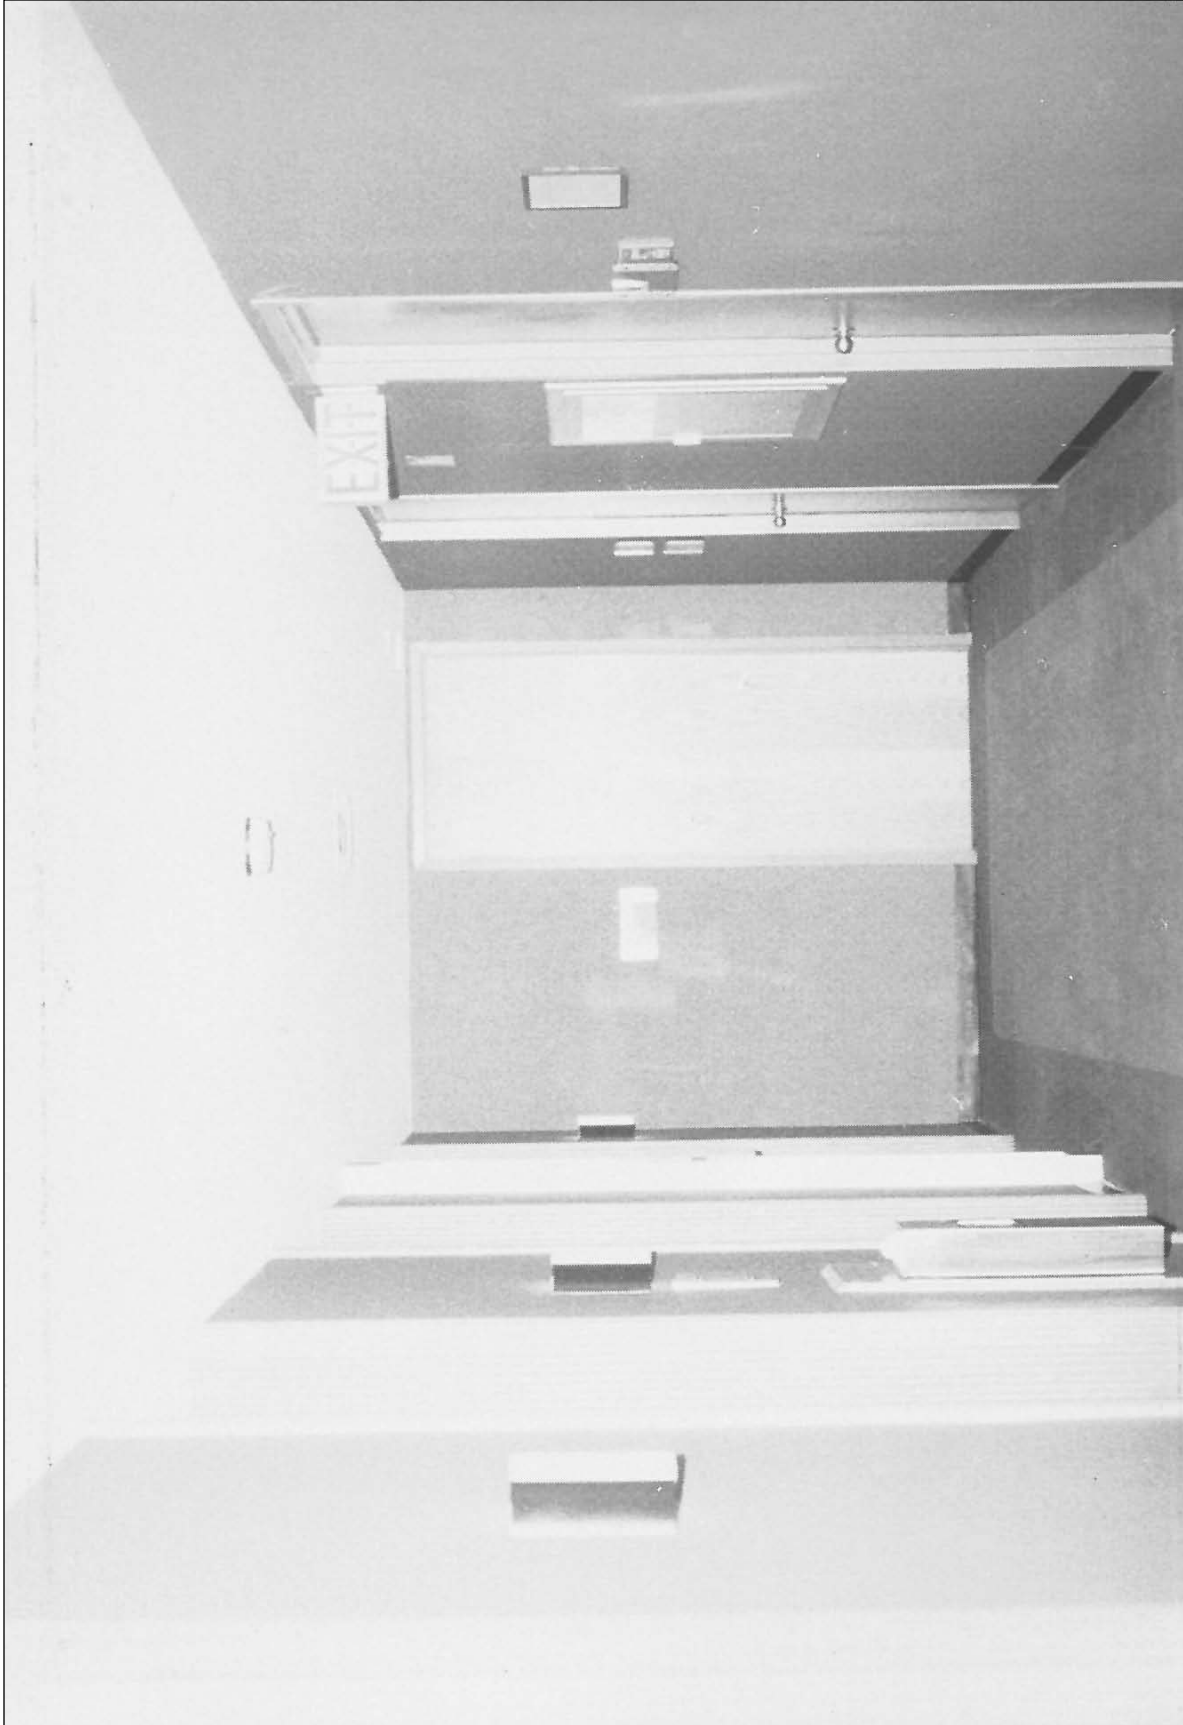
12. Elevator lobby on fifth floor, elevators are to left, exit is to the right. Smoke detectors were not installed on the sixth floor.
