FRACTOGRAPHY OF COMPOSITE DELAMINATION

FINAL REPORT

October 15, 1989

MATERIALS SCIENCE AND ENGINEERING DEPARTMENT
UNIVERSITY OF UTAH

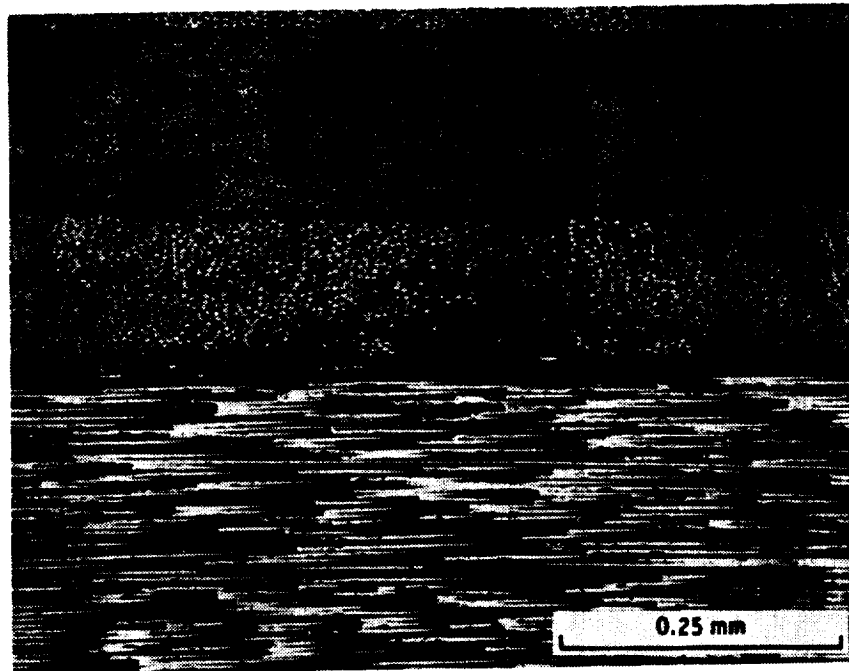
Contrary to expectations, the Mode II crack did not propagate through the resin rich regions between plies in the cross-ply laminates. Instead, propagation was solely within the 0° plies near the boundary with the resin layer. This phenomena was encountered in a study of impact damage (6) as shown in Fig. 14. The explanation offered in reference 6 is that there are residual thermal stresses near the ply-resin boundary that make propagation within this boundary more energetically favorable than propagation in the resin layer.

Figure 14 - Delamination produced by impact showing preferential propagation along the fiber/matrix boundary (reference 6).

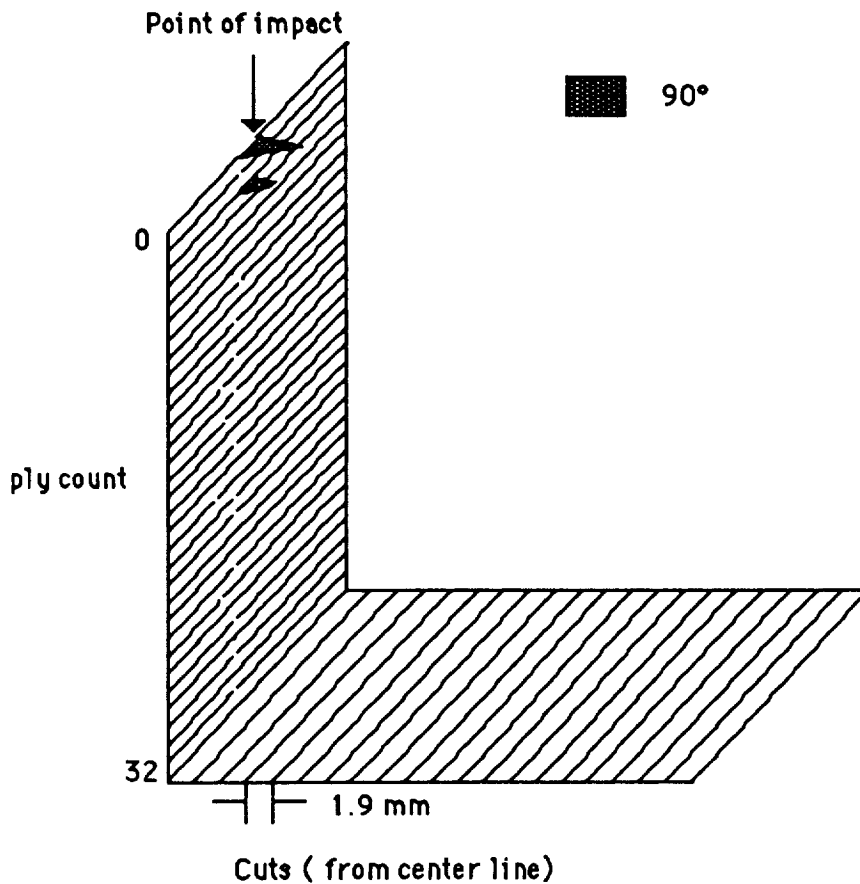
In the first stage obtained after 7 impacts, the damage was concentrated on the front surface (Fig. 22) and the amount of the damage was very small. Only a few transverse cracks were found. The damage at this stage from the C-scan was hardly detectable (Fig. 21a).

Figure 22 - Damage map of AS4/3501-6, (0/90)_{16s} after Σ I.E. = 10J.

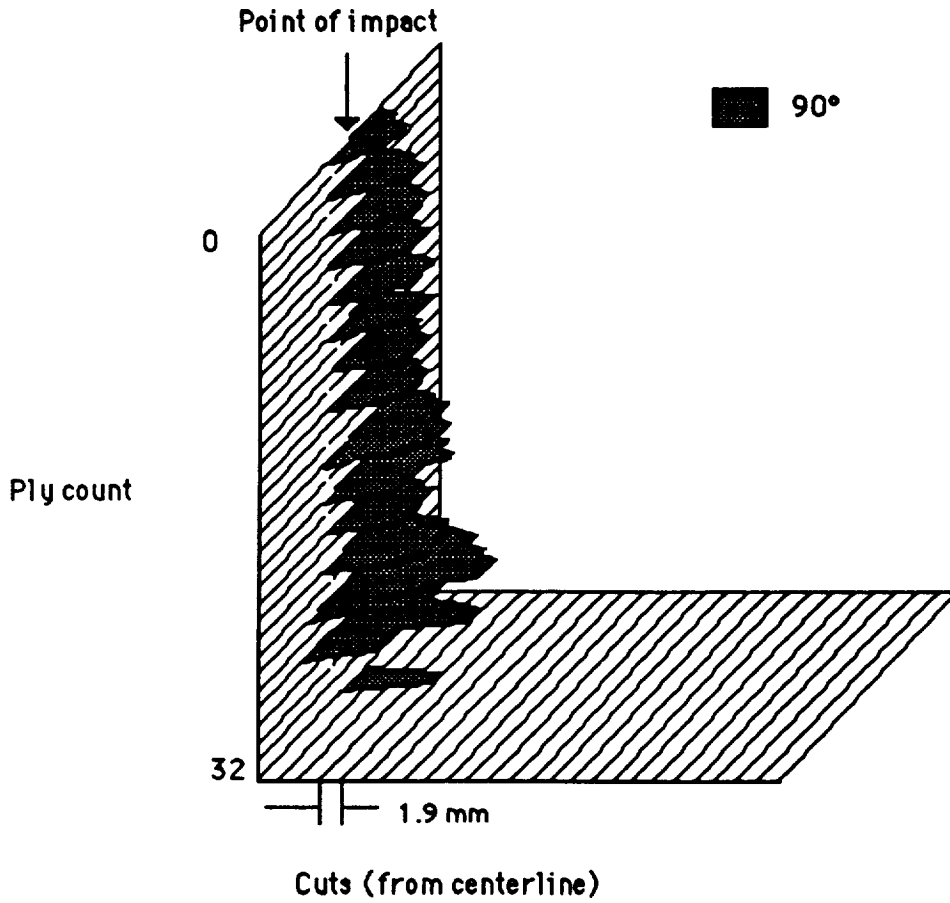
In the second stage, the damage was through the thickness of the sample (Fig.23) and the C-scan clearly showed a damaged area (Fig. 21b). Most damage was transverse cracking and delamination in the 90° plies as shown in Fig. 25a.

Figure 23 - Damage map of AS4/3501-6, (0/90)_{16s} after Σ I.E. = 80J.

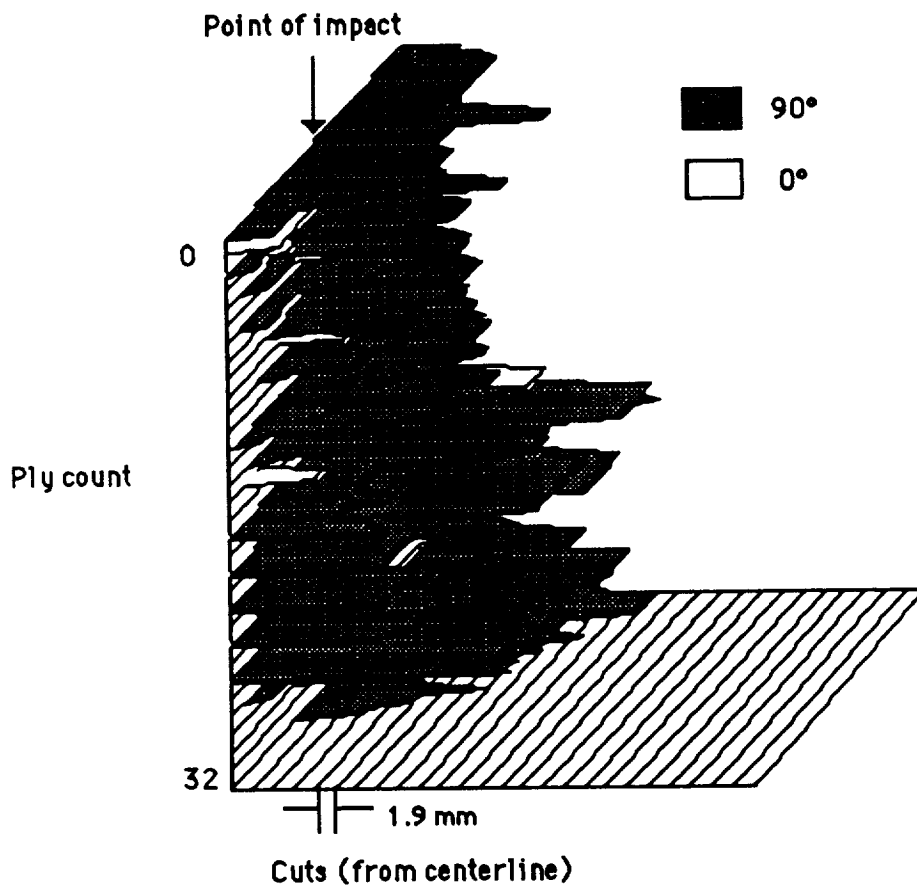
Figure 24 - Damage map of AS4/3501-6, (0/90)_{16s} after Σ I.E. = 170J.

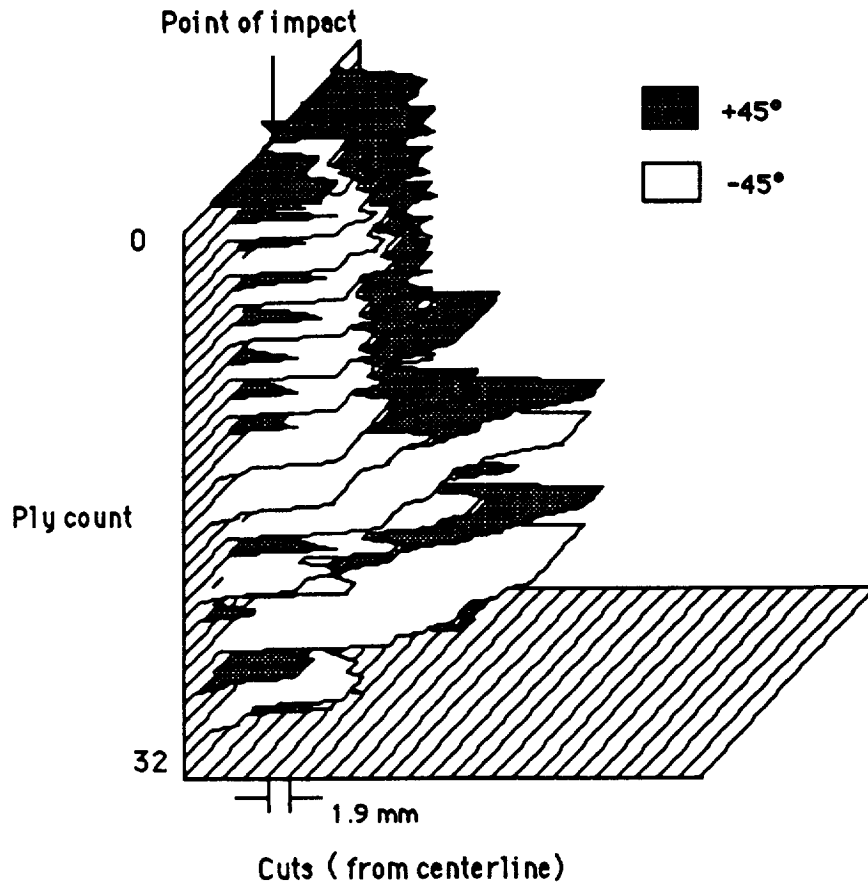
The second stage in the stiffness plot extended to higher cumulative impact energies and the third stage was not as clearly defined compared to the (0/90) laminate. The second stage corresponded to through the thickness damage as shown by the damage map in Fig 28. This damage extended to the edges of the laminate after a Σ I. E. of 300 J (Fig. 29)

Figure 29 - Damage map of AS4/3501-6, $(\pm 45)_{16s}$ after Σ I.E. = 310J.

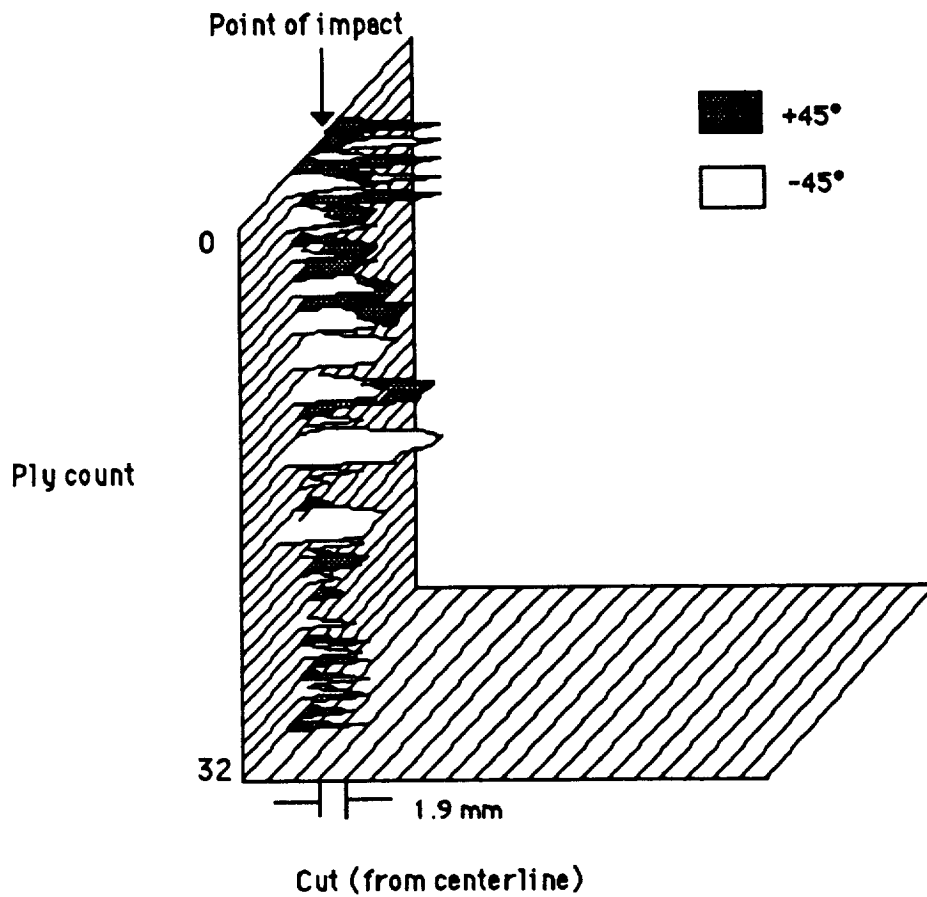
A C-scan at $\Sigma I.E$ of 250 J is shown in Fig. 44 and a corresponding damage map in Fig. 45. The damage was confined to the center of the laminate and through the thickness. The tests were not conducted beyond 250J.

Figure 45 - Damage map of AS4/PEEK, (± 45) at Σ I.E. = 240J
