Systems Tunnel Linear Shaped Charge Lightning Strike Final Test Report

August 1989

***Thiokol* CORPORATION**
SPACE OPERATIONS

Systems Tunnel Linear Shaped Charge Lightning Strike
Final Test Report

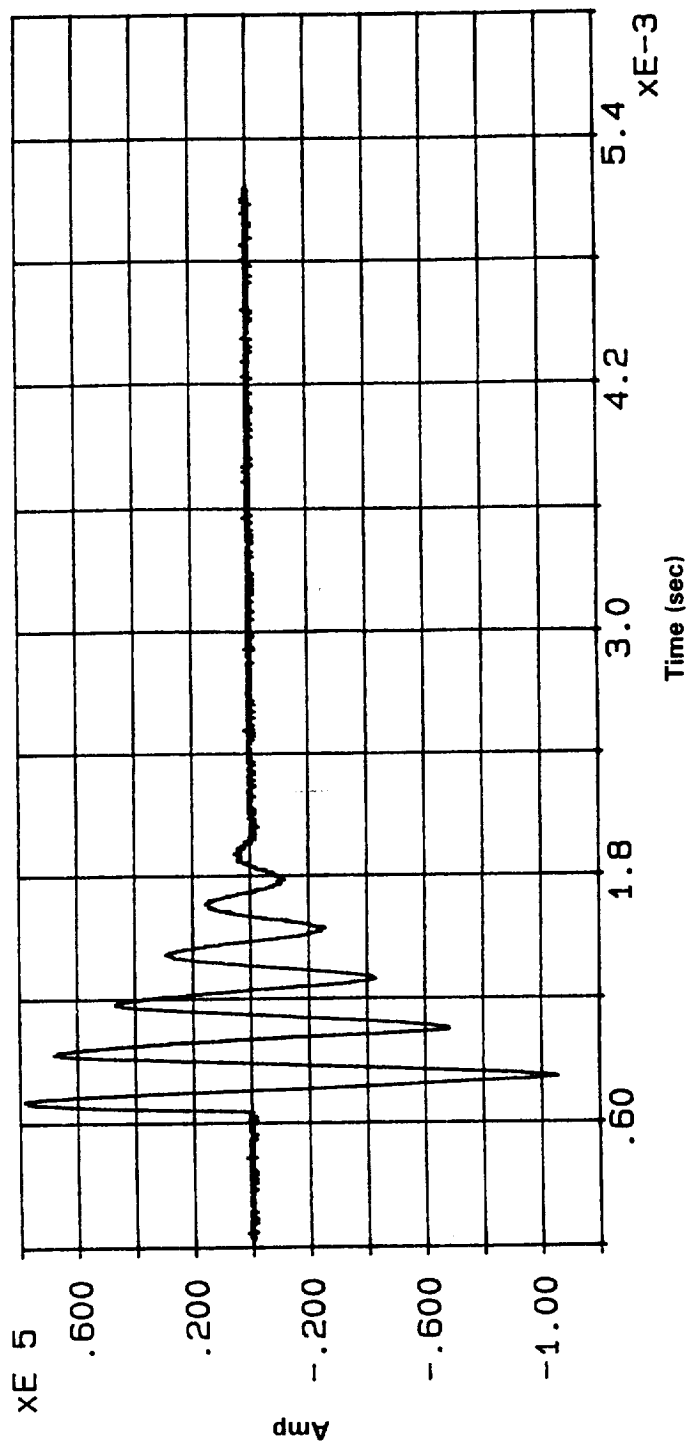
Figure 5. Systems Tunnel LSC Lightning Strike Test—Current-Versus-Time Plot (first lightning discharge)

The minimum current injected (105,000 amp for the first test) was the lowest reliable injected current that could cause an unbond. This level is 52.8 percent of the 200 kA worst-case current called out by NASA's Lightning Protection Criteria Document (NSTS-07636). The action integral of the first test was 88.2 percent of the implied maximum of $2 \times 10^6 \text{ amp}^2 \text{ sec}$ in NSTS 07636.

V_0 : 39 kV
Max Current: -105,600 amp
Action Integral: $1.764 \times 10^6 \text{ amp}^2 \text{ sec}$

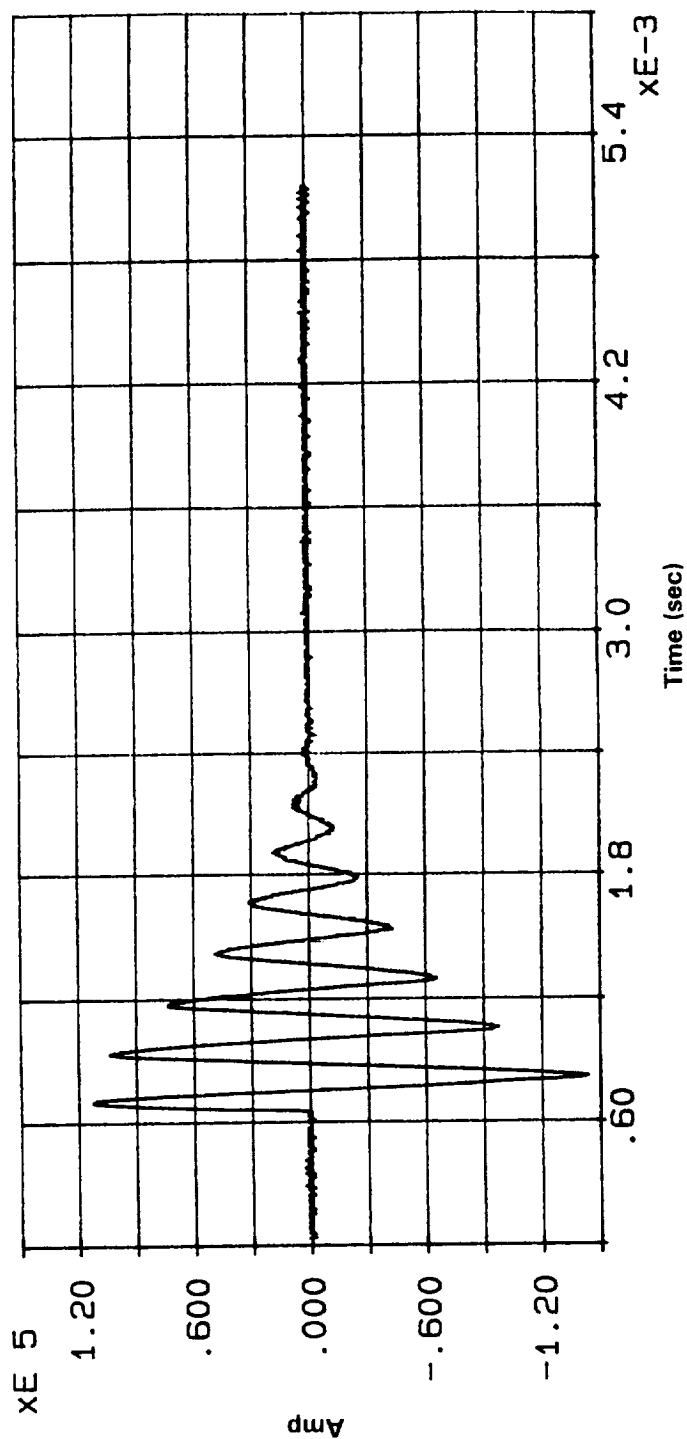
Figure 6. Systems Tunnel LSC Lightning Strike Test — Current-Versus-Time Plot (second lightning discharge)

V_0 : 58 kV
Max Current: -143,600 amp
Action Integral: $3.758 \times 10^6 \text{ amp}^2 \text{ sec}$

Injected currents (143,600 amp) and action integrals ($3.758 \times 10^6 \text{ amp}^2 \text{ sec}$ and $3.685 \times 10^6 \text{ amp}^2 \text{ sec}$) of the second and third tests were very similar. These values were the maximum allowable for the test configuration. The injected currents were 71.8 percent of the NSTS 07636 worst-case condition of 200 kA. The action integrals were approximately 1.85 times greater than the implied maximum of $2 \times 10^6 \text{ amp}^2 \text{ sec}$ in NSTS 07636.

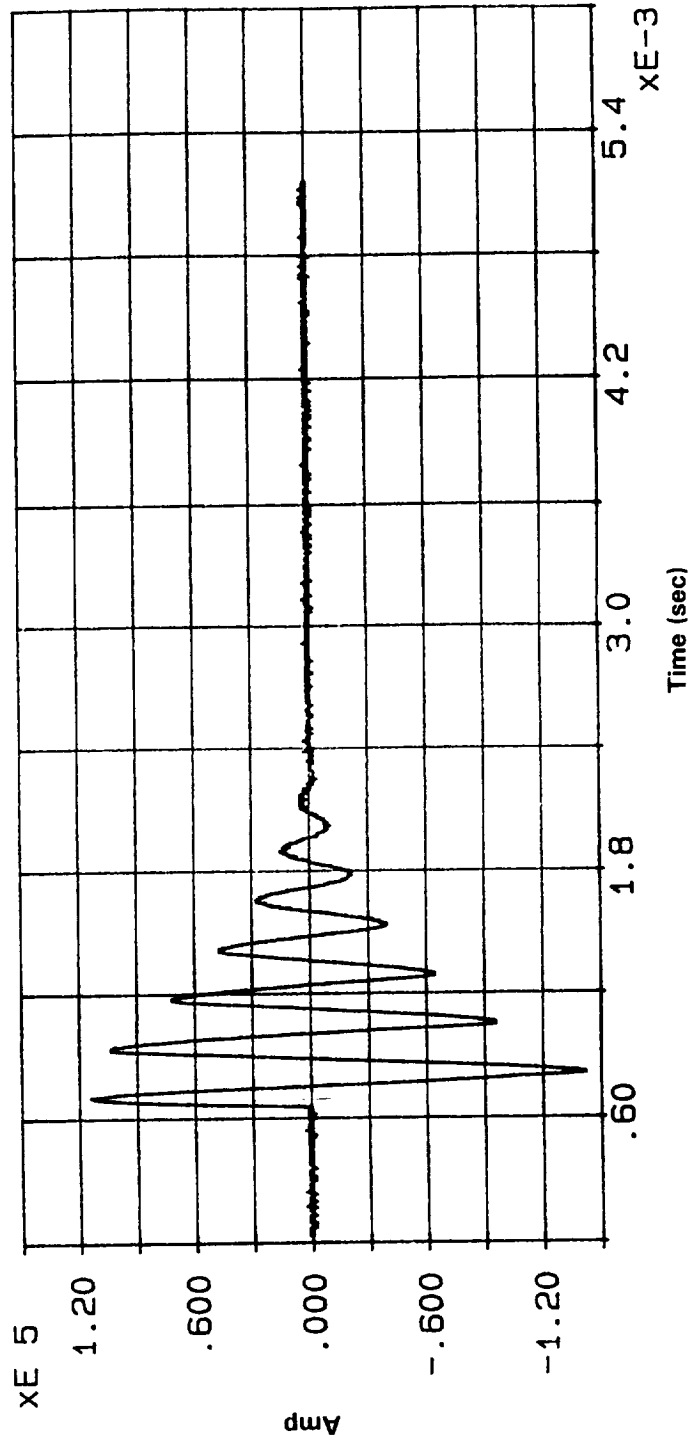
Figure 7. Systems Tunnel LSC Lightning Strike Test—Current-Versus-Time Plot (third lightning discharge)

V_0 : 58 kV
Max Current: -143,600 amp
Action Integral: $3.685 \times 10^6 \text{ amp}^2 \text{ sec}$

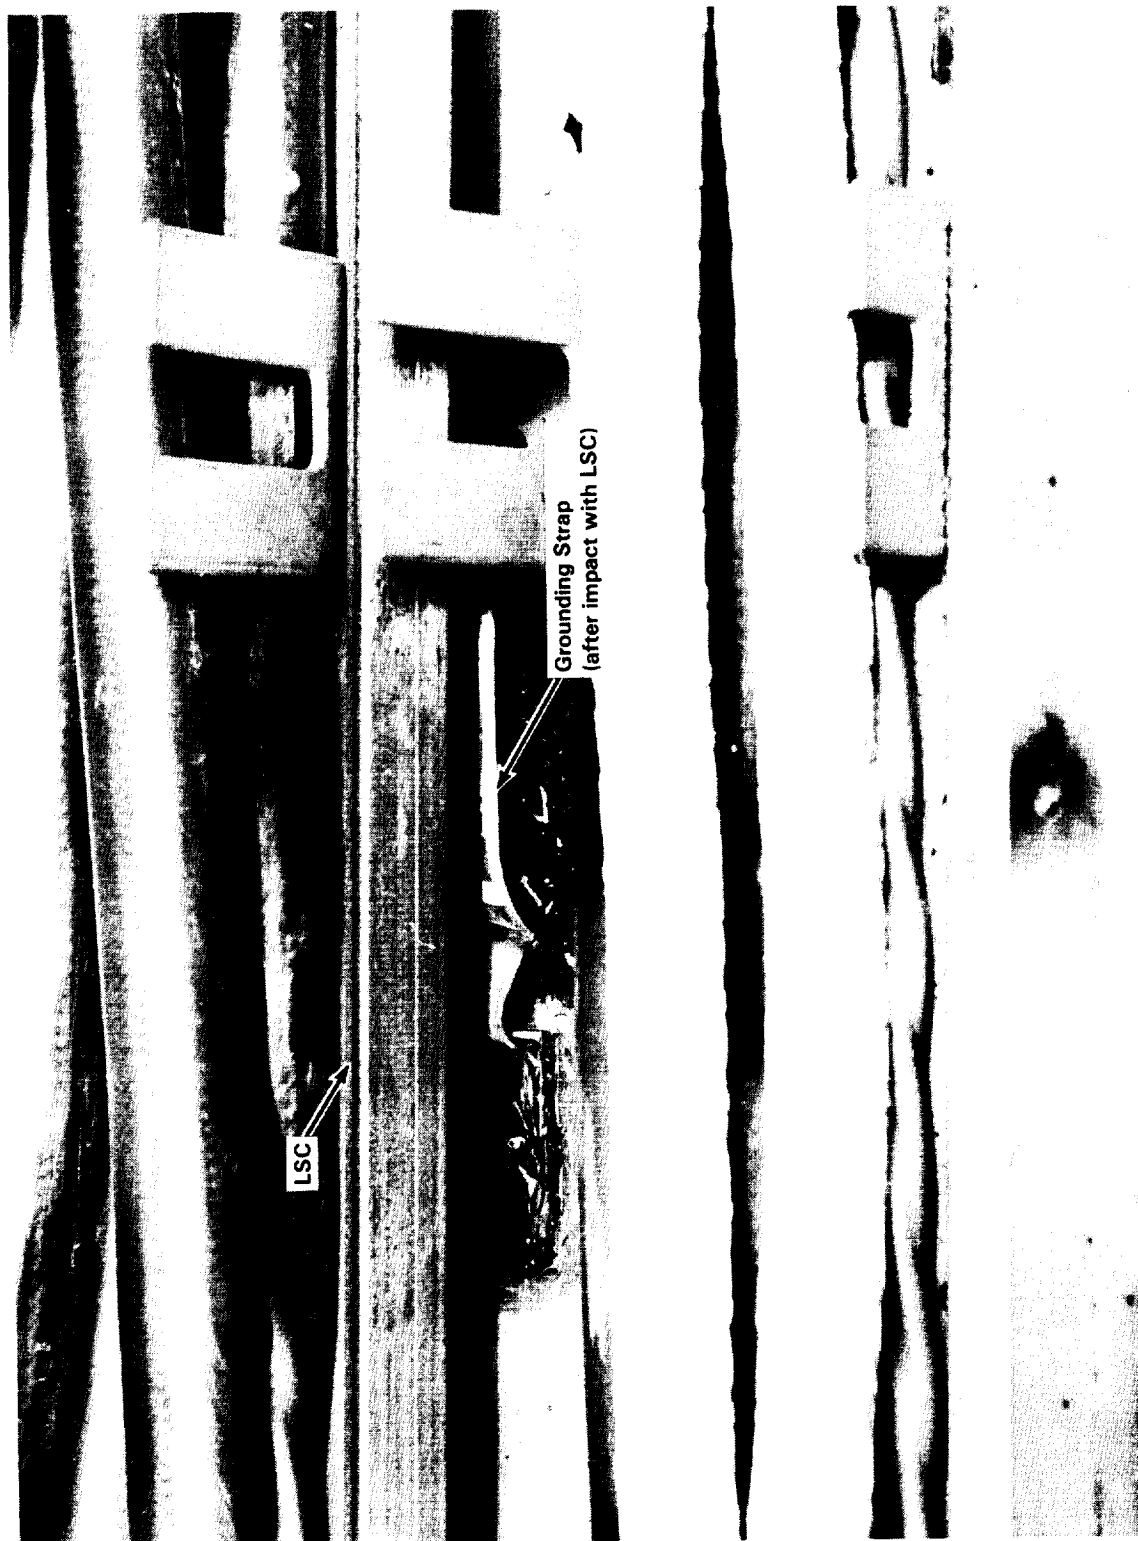
Figure 8. Systems Tunnel LSC Lightning Strike Test — Debonded Grounding Strap

After the completion of lightning strike testing, the systems tunnel cover was removed for LSC visual inspection. All three grounding straps debonded and violently struck the LSC through the openings in the systems tunnel floor plates. Each grounding strap became bent into the same shape as the LSC (Figures 8 and 9). Separation of each grounding strap occurred primarily at the bondline between the strap and the adhesive. Some of the unvaporized adhesive remained on the case.

Slight discolorations of the LSC copper surface were detected around each grounding strap impact location. These discolorations were due to the heat produced during debonding.

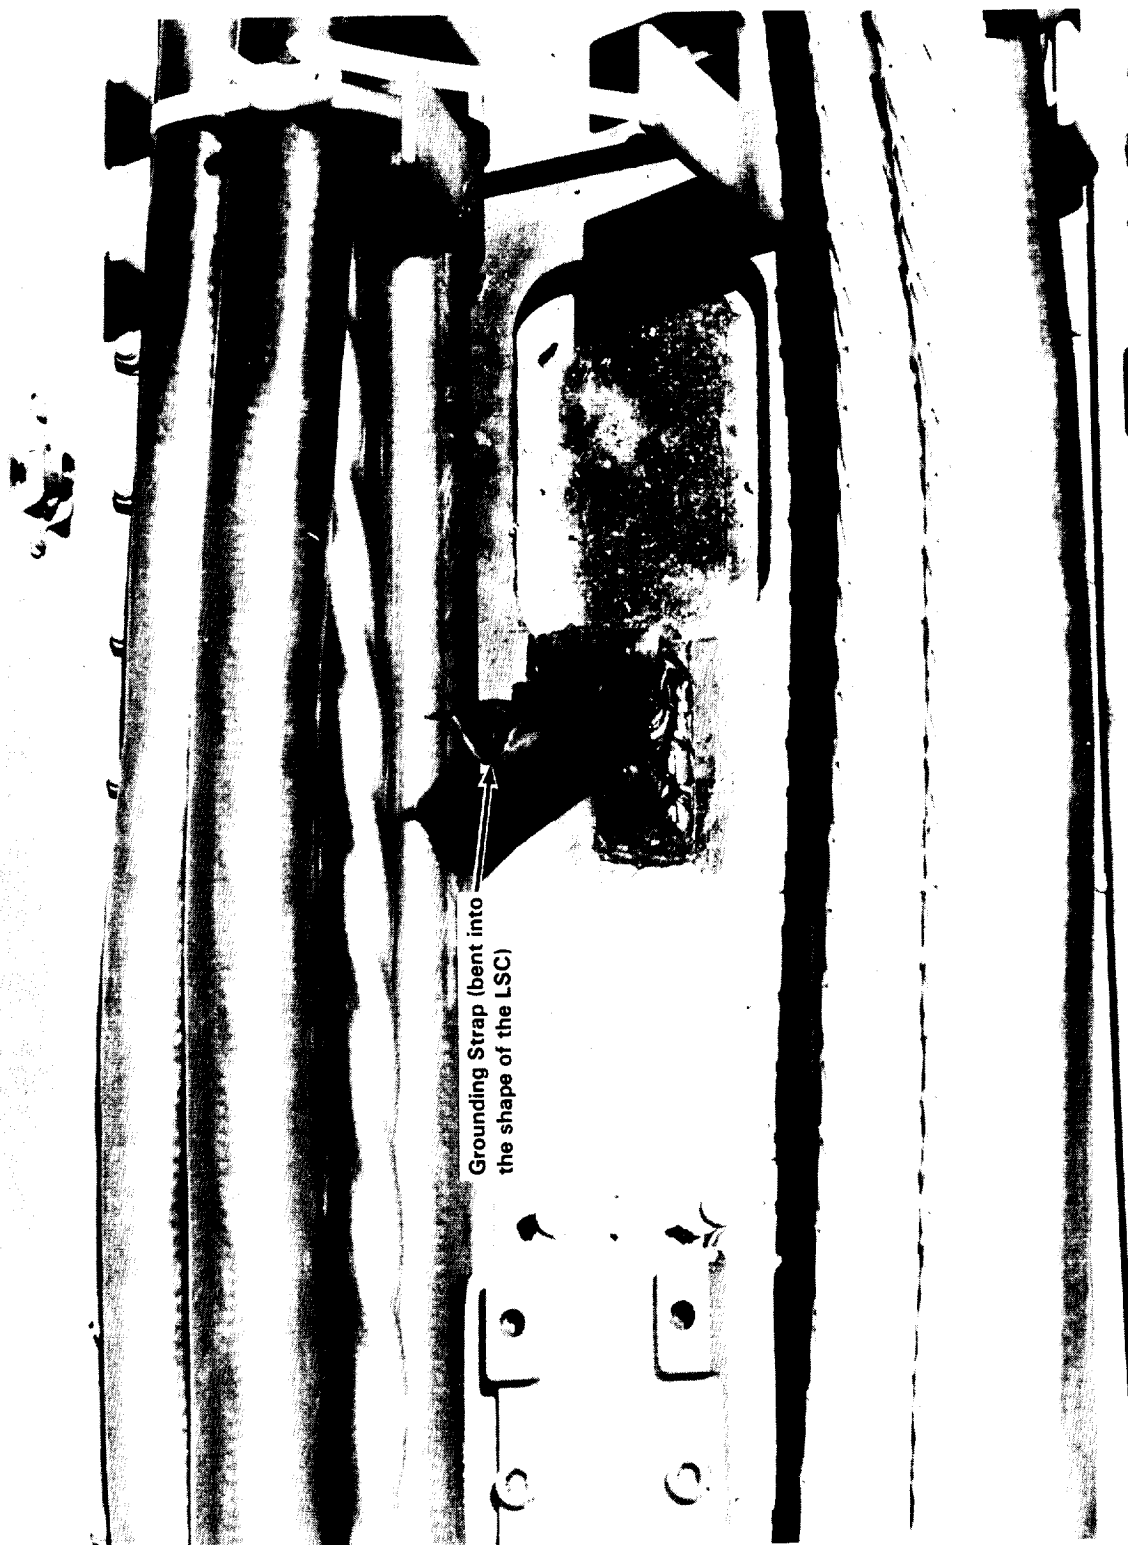
Figure 9. Systems Tunnel LSC Lightning Strike Test — Debonded Grounding Strap (LSC removed)

Final disassembly of the test article consisted of removing the three systems tunnel floor plates from the case section. It became evident that arcing occurred between the case and the systems tunnel floor plate in the vicinity of the grounding strap for the first lightning discharge (105,000 amp). This indicates that the injected current for this strike continued to flow through this area until the end of the pulse. Surfaces where the arc occurred were pitted, and small deposits of aluminum were bonded to the surface of the steel case. An analysis of the arc area was performed by personnel from the Thiokol metallographic laboratory. A Newage Portable Hardness Tester was used to measure the case hardness. Rockwell C hardness at the center of the arc (a 0.75-in.-diameter circle) ranged from 56 to 58 RC (a surface hardness in the membrane

area of the steel case (regardless of depth) of 58 RC is significant enough to damage the structure of the case beyond repair). This hardness was caused by the rapid localized heating due to the arc and then rapid cooling from the rest of the case and the surrounding air. A 0.25-in. area outside of the hardened center was tempered to a hardness from 39 to 43 RC, and the unheated control surface surrounding the arc area was within the normal hardness of 42 to 46 RC. Although the case section used was previously heat damaged during the QM-8 static test fire, the area around the arc was undamaged prior to the lightning test.

Because of the localized hardening of the steel case at the grounding strap area from the first discharge, it is recommended that steel case degradation due to lightning strikes be further investigated. This investigation could determine how different levels of lightning strike discharges cause case damage on preflight and flight RSRMs. Further investigation of the LSC test article to determine the depth of hardening to the steel case and to determine the extent of diffusion of aluminum into the steel matrix is also recommended.
