TWR-17591, Volume IV

## QM-8 FINAL PERFORMANCE EVALUATION REPORT - SEALS

June 1989

**NATIONAL AERONAUTICS AND SPACE ADMINISTRATION  
GEORGE C. MARSHALL SPACE FLIGHT CENTER  
MARSHALL SPACE FLIGHT CENTER, ALABAMA 35812**

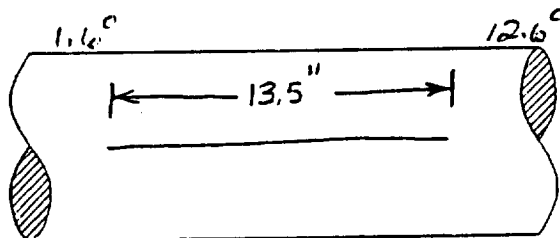
Circumferential  
Scratch

L = 13.5"  
W = .001  
D = indeterminable

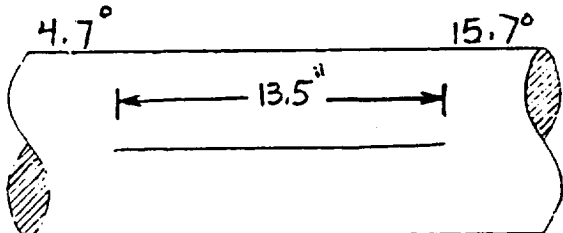
Circumferential Scratch

$L = 13.5''$ $W = .001$ $D = \text{indeterminable}$

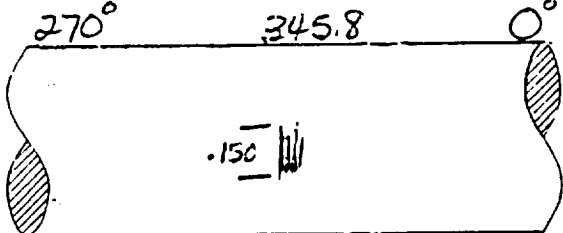
$L = .150$ $W = .001$ $D = .001$

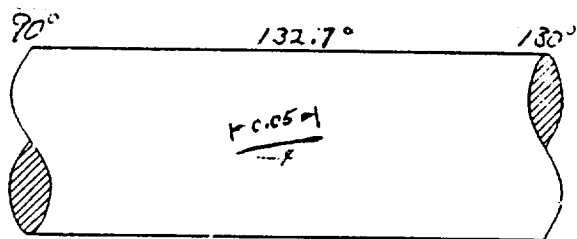
CIRCUMFERENTIAL  
SCRATCH

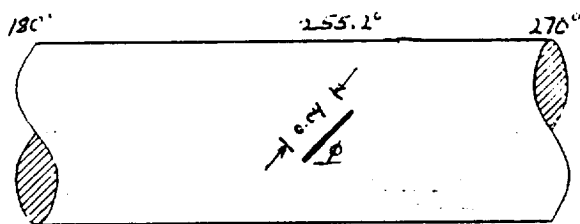
DIAGONAL SCRATCH

$L \approx 0.040$   
 $W \approx 0.003$   
 $D \approx 0.003$   
 $\phi \approx 35^\circ$

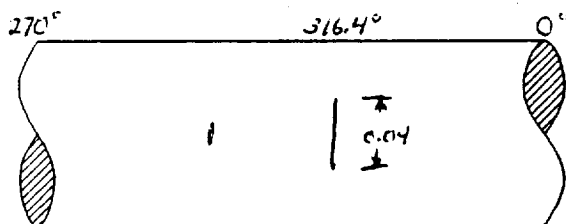
RADIAL CUT

$L \approx 0.040$   
 $W \approx 0.001$   
 $D \approx 0.002$

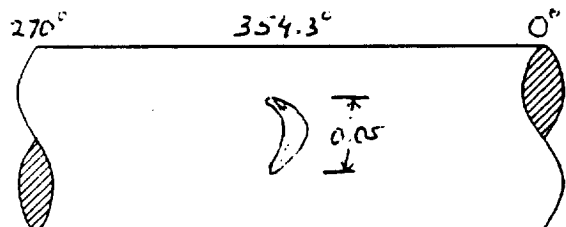
RADIAL NICK

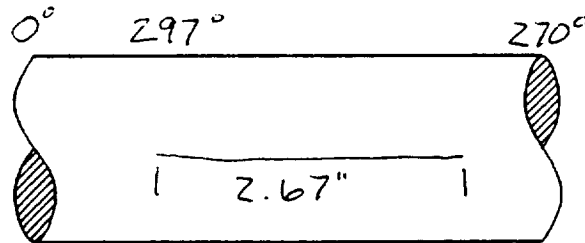
W = .001  
D = indeterminate  
L = 2.67"

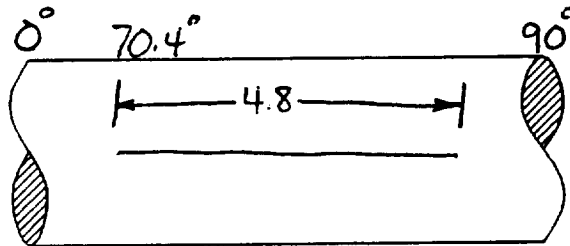
Circumferential  
scratch

$L = 4.8$   
 $W = .001$   
 $D = \text{indeterminable}$

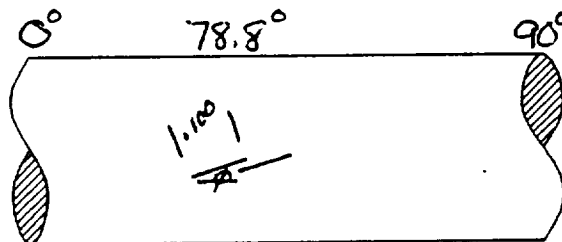
Diagonal  
scratches

$L = .100$   
 $W = .001$   
 $D = .001$   
 $\phi = 10^\circ$

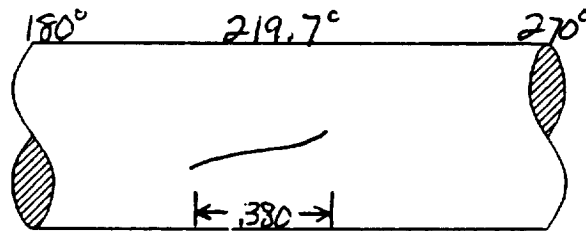
L = .380  
W = .001  
D = .001

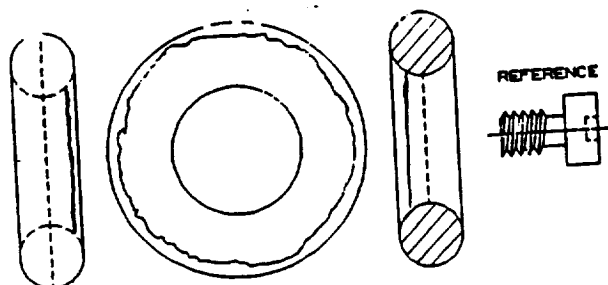
O.O. circumferential  
extrusion

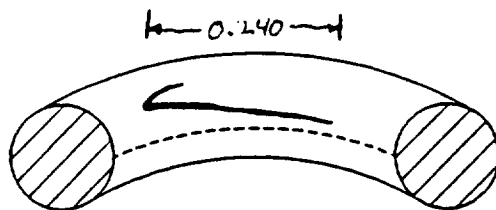
I. O. CUT

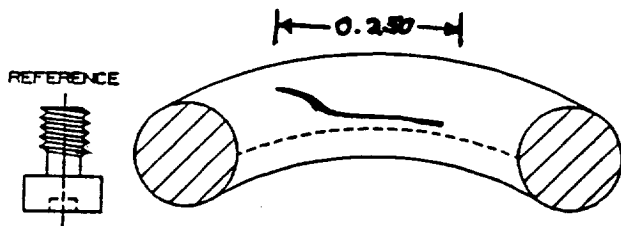
I.D. CIRCUMFERENTIAL  
SCRATCH

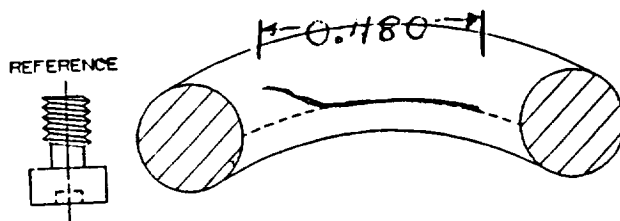
I.A. CIRCUMFERENTIAL  
CUT

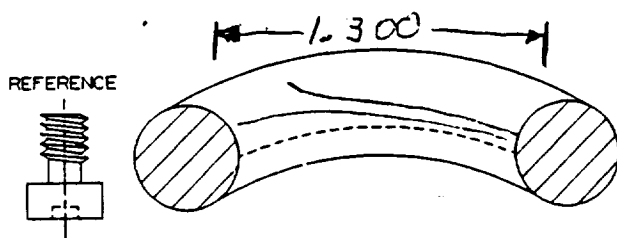
I.D. CIRCUMFERENTIAL  
CUT

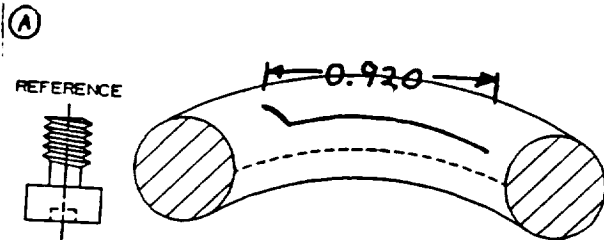
I.O. CIRCUMFERENTIAL CUT  
 $L \approx 0.920$   
 $D \approx 0.040$

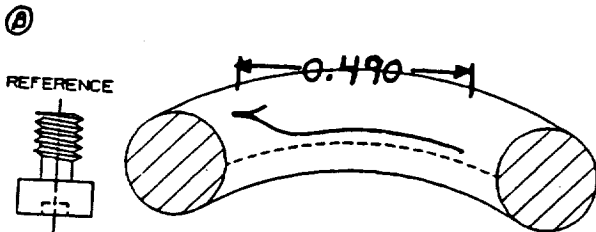
I.O. CIRCUMFERENTIAL CUT  
 $L \approx 0.490$   
 $D \approx 0.020$

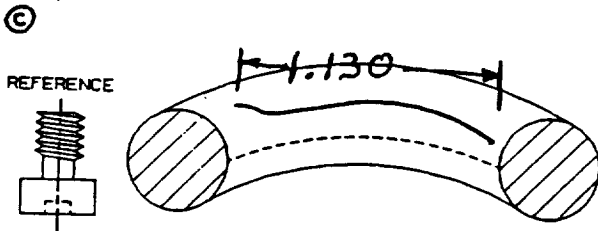
I.O. CIRCUMFERENTIAL CUT  
 $L \approx 1.130$   
 $D \approx 0.020$
