Controls Advanced Research Turbine: Lessons Learned during Advanced Controls Testing

K. Johnson, L.J. Fingersh, and A. Wright

Technical Report
NREL/TP-500-38130
June 2005

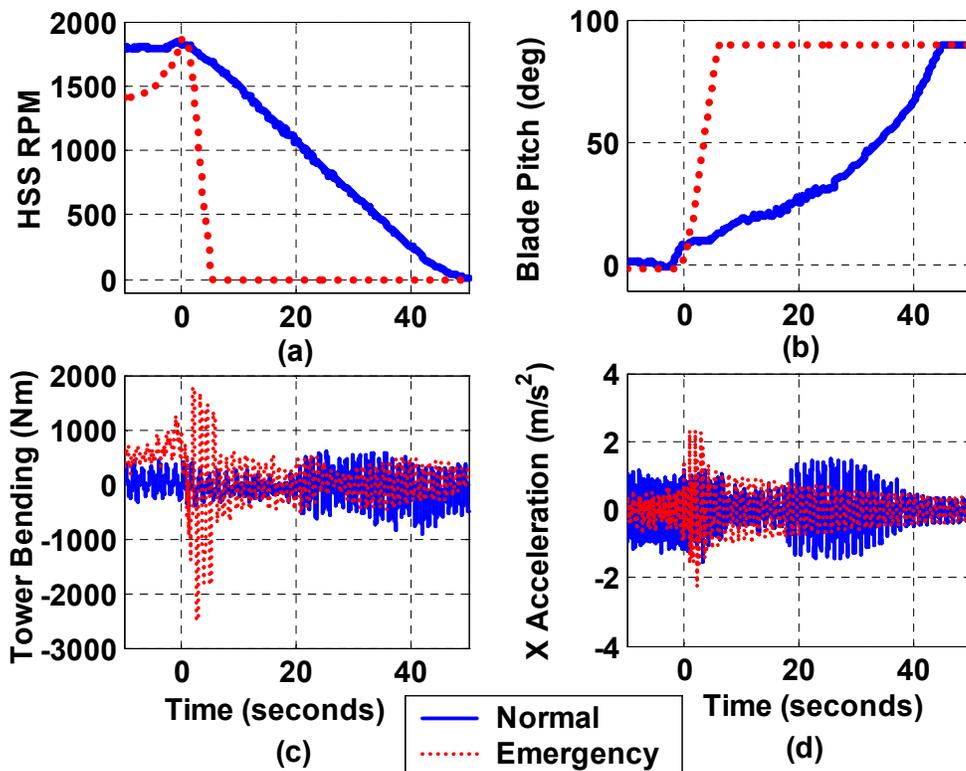
In Figure 4, the normal stop resulted from a teeter brake pressure problem and the emergency stop resulted from a blade pitch following error. In each case, the turbine was operating at just above rated speed (1800 RPM) when the fault occurred, as shown in subplot (a). During the normal stop, the pitch rate stayed low as the blades pitched towards feather in a controlled manner as shown in subplot (b). By contrast, during the emergency stop the blades pitched towards feather at the maximum pitch rate of $18^\circ/s$, reaching a fully feathered position in about 5 seconds. The high-speed shaft RPM decreased correspondingly fast for the emergency stop. In terms of the loads observed by the turbine structure, both the tower bending and x acceleration plots show significant responses to the emergency stop. Neither of these channels showed similar jumps in magnitude at the time of the normal stop. However, it is apparent that the tower bending and x acceleration grew as the pitch reached about 25° in the normal stop,

Figure 4. (a) High Speed Shaft RPM, (b) Blade Pitch Angle, (c) Tower Bending Moment (Nm), and (d) X Accelerometer Output for normal and emergency stops. The emergency stop is harder on the turbine.

though the magnitudes are less than for the emergency stop case. These vibrations are expected for a shutdown in high winds.

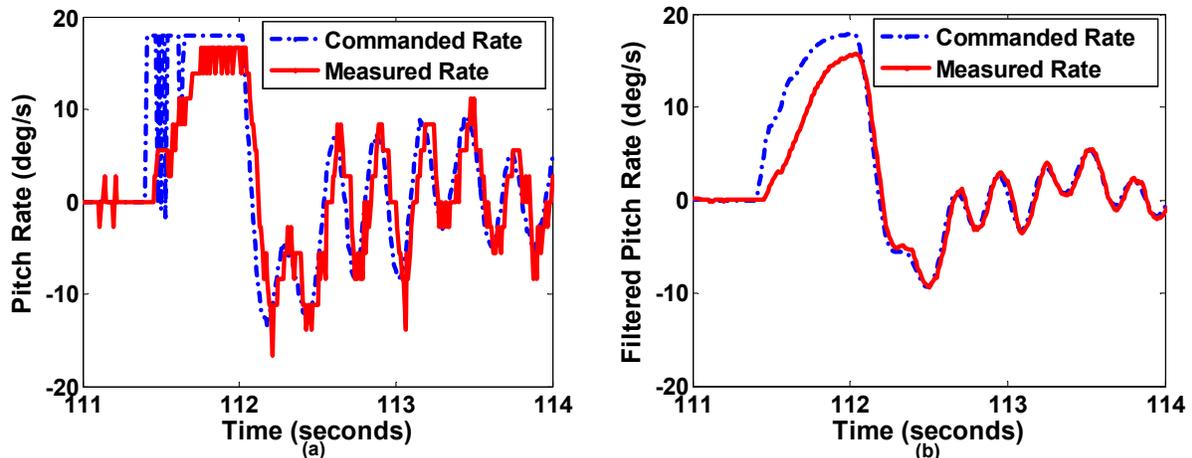
Figure 5 (a) Actual commanded and measured pitch rate, and (b) filtered commanded and measured pitch rate. The maximum pitch rate is $18^\circ/\text{s}$. The measured rate in (a) clearly lags behind the commanded due to actuator lag, even when the rates are low (from 112 – 114 seconds). In (b), the actuator lag is included as a second pole in the filtered commanded rate, causing the two curves to be very close when commanded pitch rates are modest.

Figure 5 contains two plots showing pitch rate and filtered pitch rate for 3 seconds of CART data. In Figure 5(a), the actual commanded pitch rate and measured rate are shown to differ, and the actuator lag is clear. In addition, the quantization error in the position encoder is apparent in the measured rate, which is calculated from this sensor. In Figure 5(b), the pitch rate command has been filtered twice and the measured rate once. In the moderate pitch rate section of the plot, the two curves nearly coincide. When the commanded pitch rate is near its $18^\circ/\text{s}$ limit, however, the actual (measured) rate is unable to keep up.

The two curves in Figure 5(b) are the two primary signals used in our pitch rate following fault. The error tolerance is based on the commanded rate, so that a larger error is allowed when the rate command is higher. In addition, if the pitch drive current is at its limit, the filtered rate error is not required to lie within the error bound as long as the pitch acceleration has the correct sign. Analysis of many hours of operational data have shown that our technique will detect a fault within a couple of seconds, or much faster for most types of faults, but it rarely results in nuisance faults when the pitch system is behaving properly.

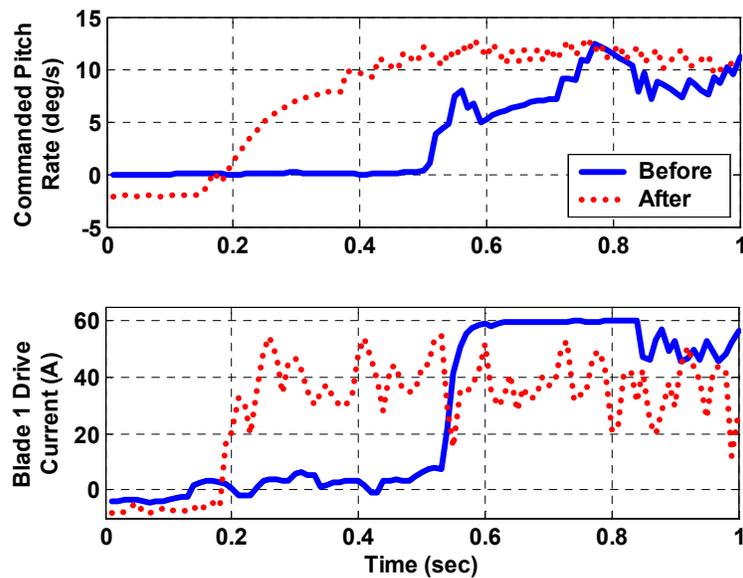
Detection of Actual Pitch Following Fault. Shortly after we implemented the current version of the pitch rate following fault, the fault started to occur regularly on start-up and we immediately assumed that a poorly written fault routine was causing nuisance faults. Further data analysis revealed odd behavior in the pitch system: even when the commanded pitch rate was well within the capability of the CART’s pitch actuators, the actuators would draw the full current allowable, while still not following the commanded rate closely. The amount of current drawn decreased as the pitch system was used for longer time periods, which led us to believe

Figure 6. CART’s commanded pitch rate and blade current before and after changing the pitch gearbox oil. We discovered that the oil we had been using was much too viscous, causing the pitch drive motors to draw high currents until the gearbox warmed up.

that the cause of the high current was temperature-related. After examining the system, we discovered that the oil viscosity in the pitch gearbox was significantly higher than recommended by the gearbox manufacturer (molasses vs. WD-40). In fact, we had been using the wrong oil since the turbine was installed but had never noticed because our fault detection software was not sophisticated enough during the first few years of operation. Figure 6 shows plots of the commanded pitch rate, which has an $18^\circ/\text{s}$ limit on the CART, and pitch drive current before and after changing the gearbox oil. Both cases occurred near turbine start-up when the gearbox oil temperature would have been close to ambient. Clearly, changing the oil allowed for less current to be drawn, even with slightly higher commanded pitch rates.

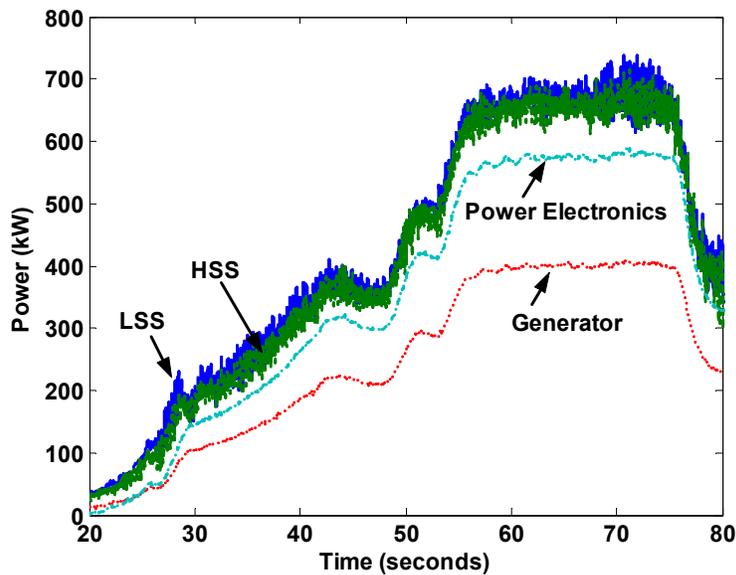
Figure 7. CART power data. The generator power curve is much lower than possible compared to the LSS, HSS, and power electronics power readings.

Generator Power Sensor Failure. The cause of the generator power sensor failure is likely related to the power electronics as well, because the failure corresponded to the transition from constant-speed to variable-speed testing. We know the power sensor measurements are erroneous because they show lower generator power levels than those measured at the power electronics further down the line. The power electronics power measurements are consistent with the high- and low-speed shaft power measurements, given the expected losses. Figure 7 shows the four time-series power plots, with the power electronics power being nearly 50% greater than the generator power. Since it is impossible to create power between the generator and power electronics, the generator power sensor is clearly wrong.

Because both the HSS Prox sensor and Generator Power sensor are redundant, we spent less time trying to fix the problems than we would have if there were no other sensors performing the same or similar measurements. However, we caution that the data from these two sensors should be ignored in those data files in which it is present.

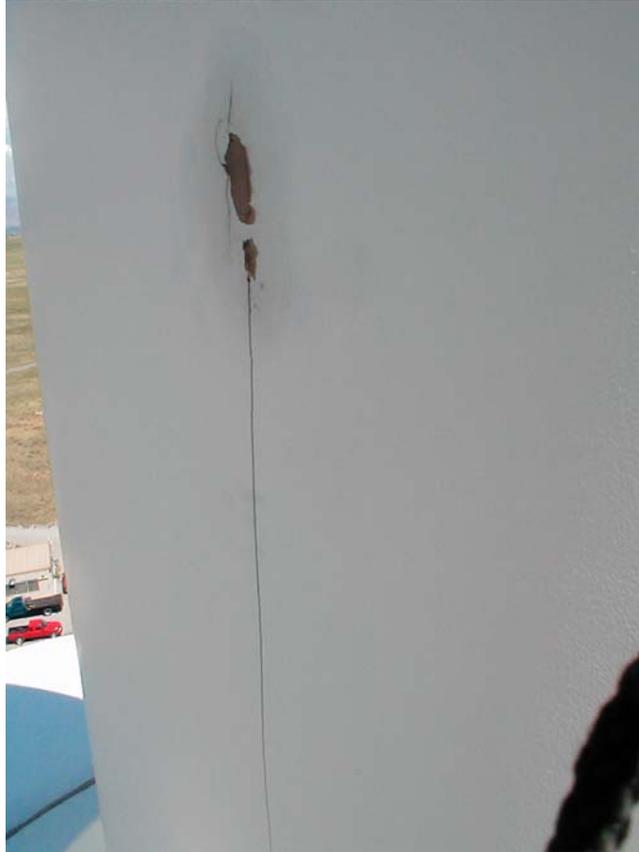
Blade Crack. Another problem we encountered with the CART was a crack in one of the blades near the root. Figure 8 shows the 59 cm crack, which we noticed during a routine inspection. While we do not know what caused the crack (i.e., a sudden event or wear and tear over time), we determined that the crack was only deep enough to damage the blade's external coating. After researching our options for repairing the damage, we decided that, as the crack did not pose a structural risk to the blade, it could be repaired by filling and covering it. We

Figure 8. CART blade crack. The total crack length is approximately 59 cm.

have run the turbine for more than a year since the repairs were completed and have seen no indicators that it has gotten worse.

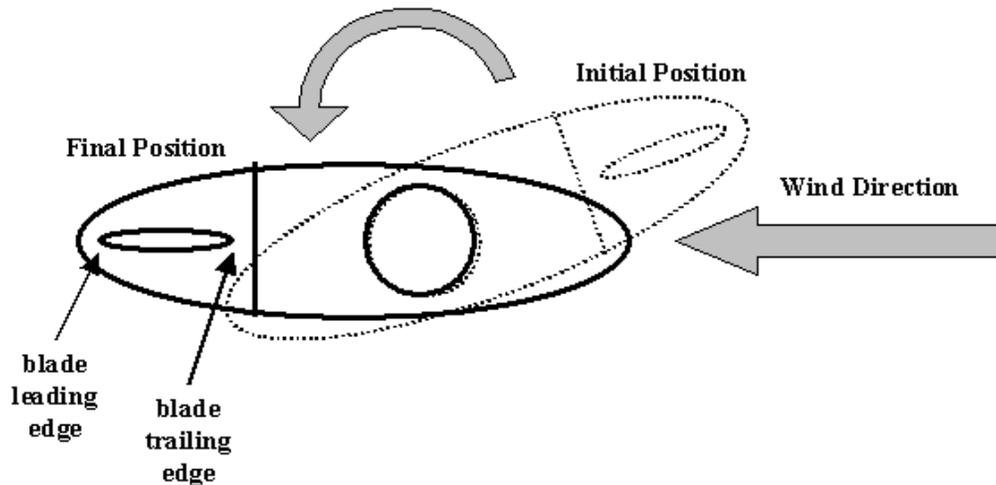
Extreme Wind Event Failure. On December 20, 2004, we observed a high-wind failure event that began when the NWTC lost grid power because of high winds in the early morning before working hours. Although the main NWTC buildings have back-up generators, the turbine grid does not; thus, the CART's Turbinesafety routine performed an emergency stop in response to the power outage. As desired, the blades pitched to feather and the emergency brake set. By chance, the rotor stopped at a near-vertical azimuth position. The mean yaw error was near zero,

Figure 9. CART as a wind vane (top view). A small initial yaw error, locked rotor, near-vertical azimuth position, blades pitched to feather, and yaw brake failure resulted in the nacelle being pushed by strong winds to point downwind.

When the wind calmed down, we found the CART was undamaged, and we discovered two failures in our yaw brake system. The first was our failure to connect the yaw brake to the uninterruptible power supply (UPS) that provides energy to most of the CART's critical components in emergency situations. The second was our failure to understand that the

emergency yaw brake pressure system required manual recharging. We believed it recharged itself automatically, and therefore, the system had not been recharged in years. In the end, we corrected these failures and felt fortunate that these lessons did not come at a much higher cost.
